Early post-restoration re-vegetation performance and critical social and institutional factors in a landowner-involved restoration project on lower Wooden Valley Creek, Napa County, CA

LA227: Restoration of Rivers and Streams, Term Project; Fall, 2010

Morgan Levy and Charles Post

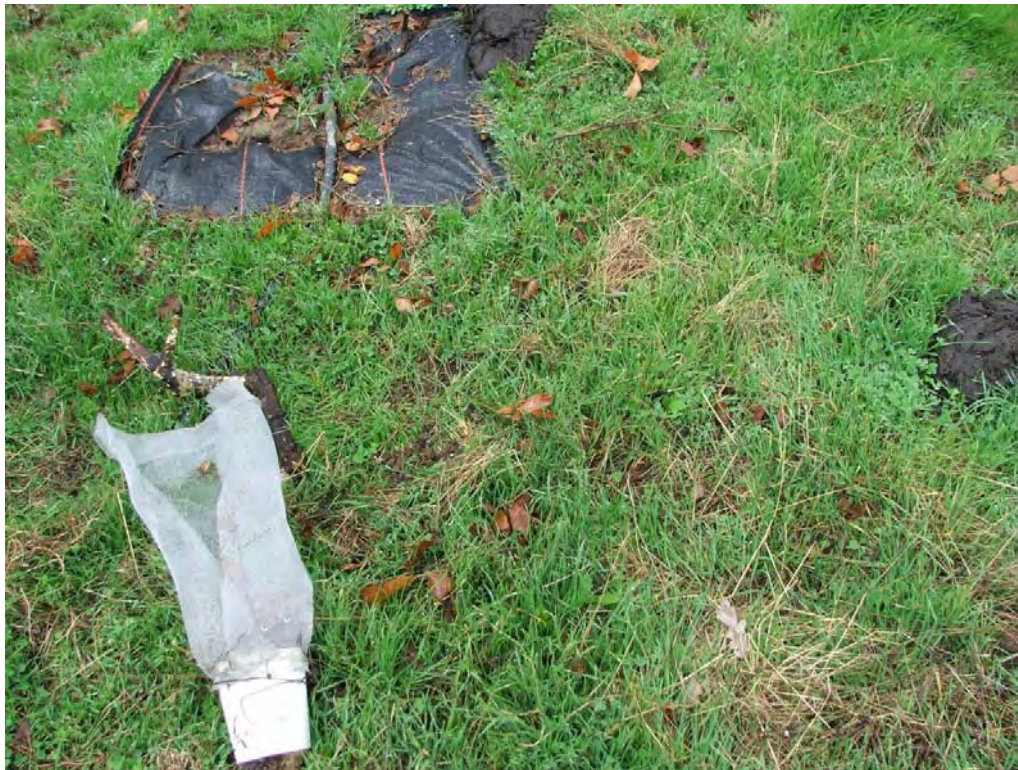
Image 1: planted sapling uprooted by wild pigs.

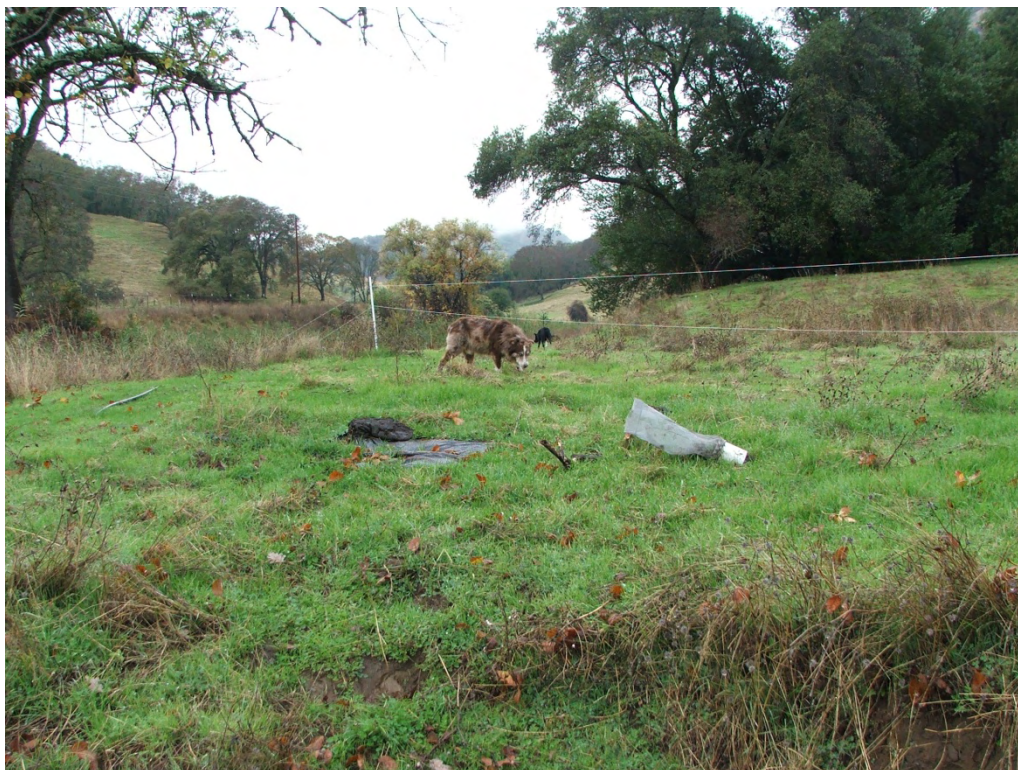
Image 2: same uprooted sapling as in Image 1 above. McQueeney's two dogs, which roam the property freely and herd cattle, and the electric cattle fencing can be seen in the background.

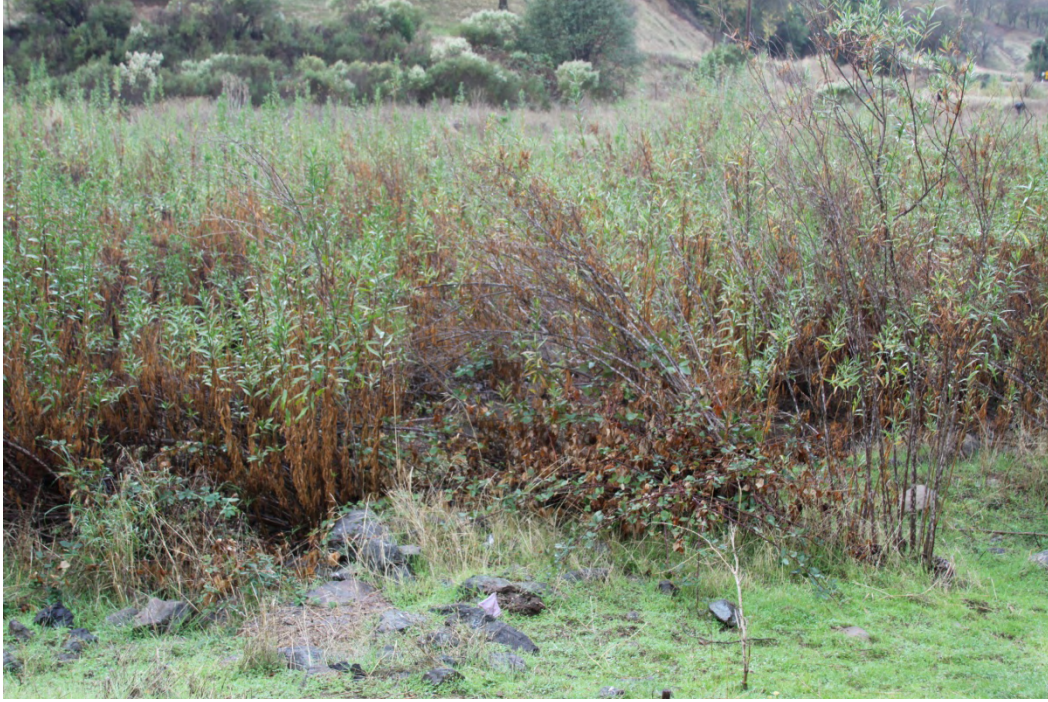
Image 5: Invasive Himalayan Blackberry plants (multiple) in stream bed of lower Wooden Valley Creek along zone 14 of the McQueeney restoration site, approximately 30 feet into stream bed from planting # 15.

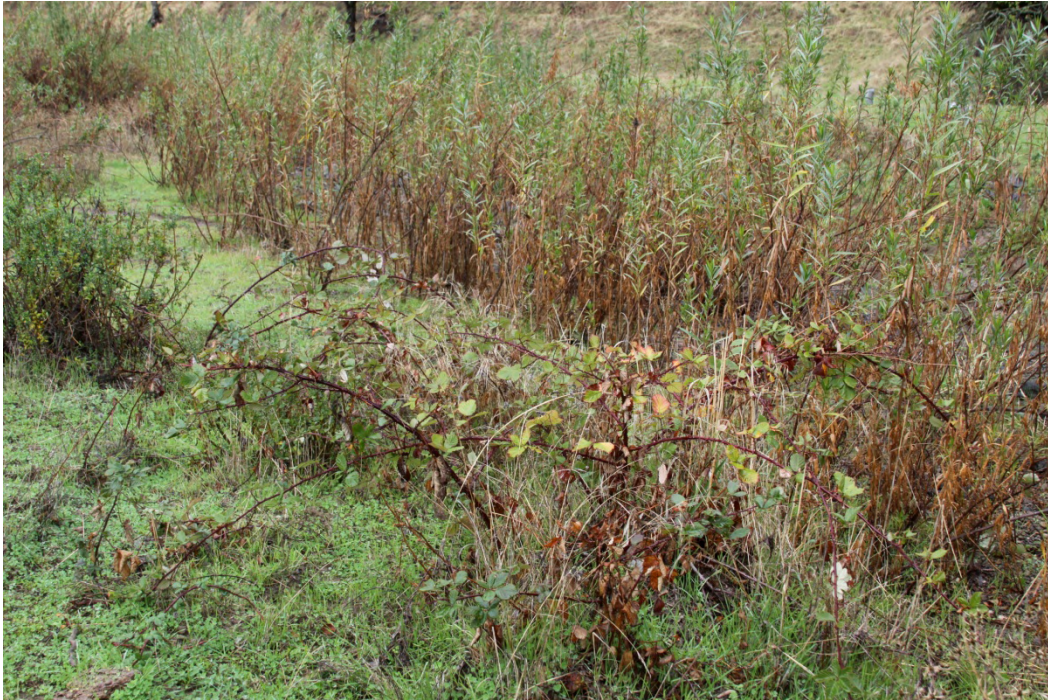
Image 6: Invasive Himalayan blackberry plant in stream bed of lower Wooden Valley Creek along zone 14 of the McQueeney restoration site, adjacent (though further than 20 feet) from native plantings along eastern stream bank.

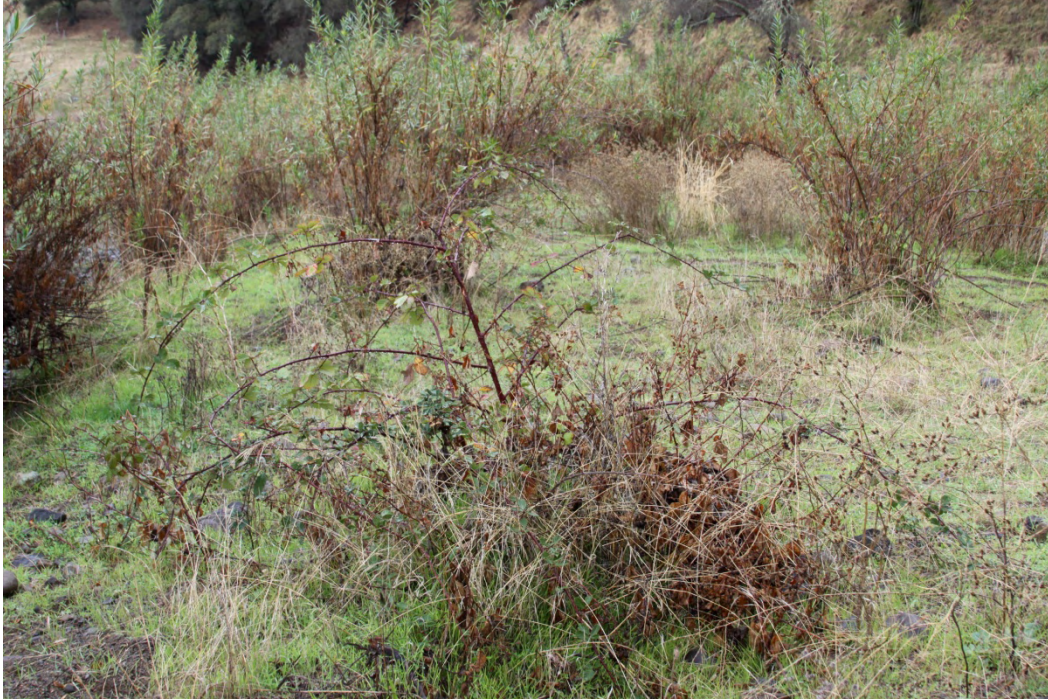
Image 7: Invasive Himalayan blackberry plant in stream bed of lower Wooden Valley Creek along zone 14 of the McQueeney restoration site, adjacent (though further than 20 feet) from native plantings along eastern stream bank.

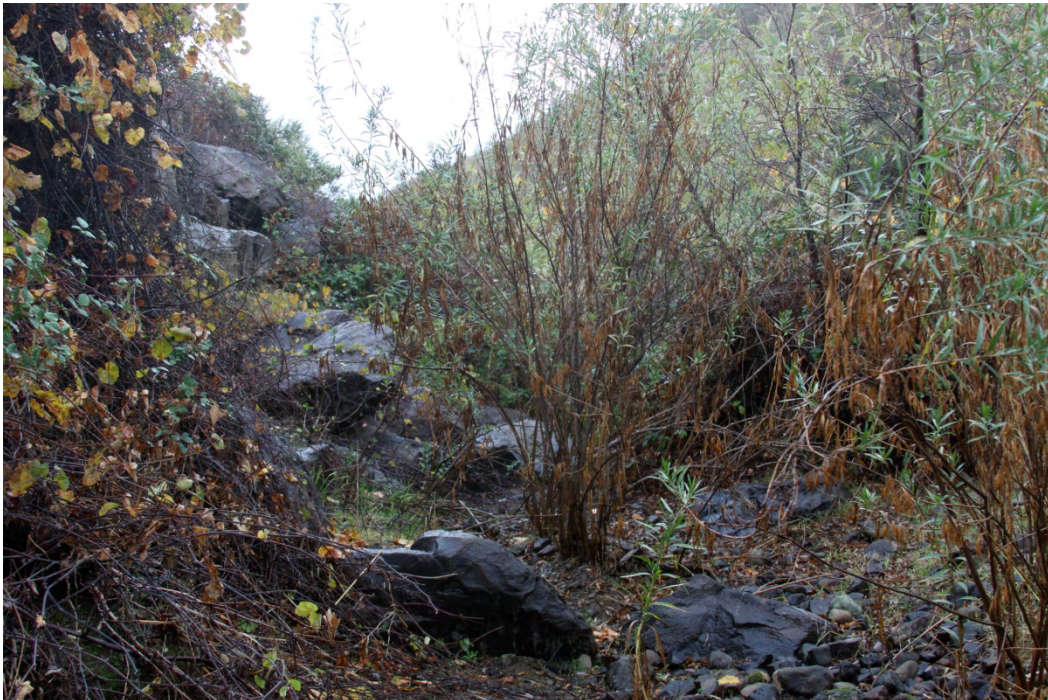
Image 8: Invasive Himalayan blackberry plants along western stream bank of lower Wooden Valley Creek (stream bed is braided towards the northern end of zone 14 and splits into three segments: west, central, and east – zone 14 plantings are on eastern bank). Blackberry is less pervasive along eastern bank, but as shown above, abundant along the steep slope of the western bank where there were no plantings (this year).

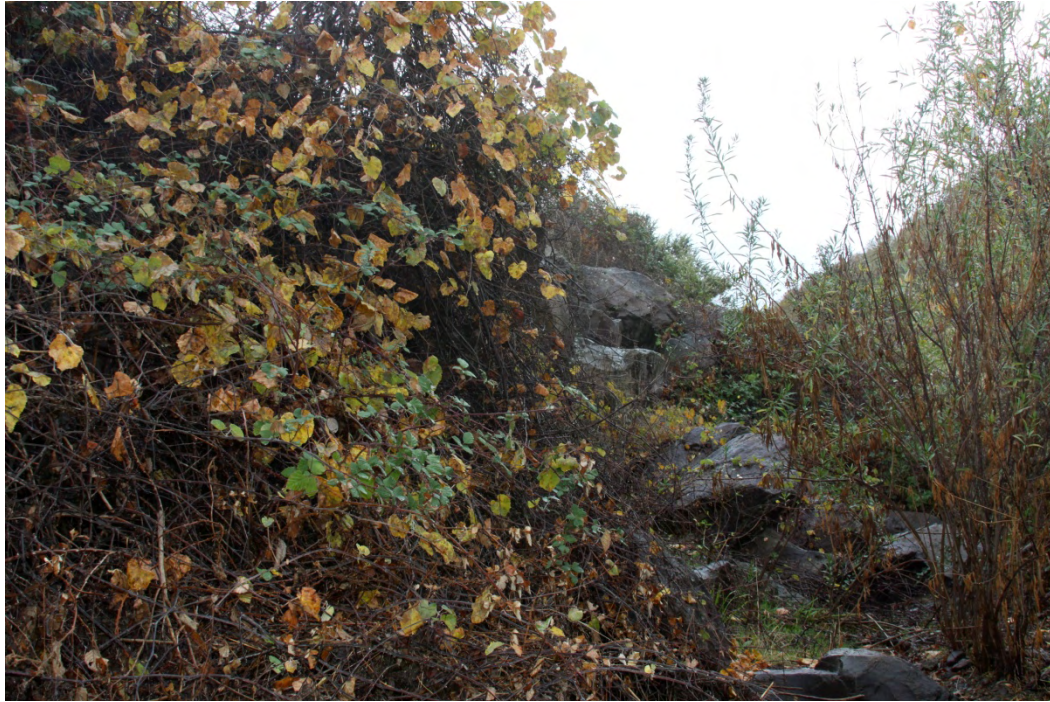
Image 9: See Image 8. Additional invasive Himalayan blackberry along western stream bank in zone 14.

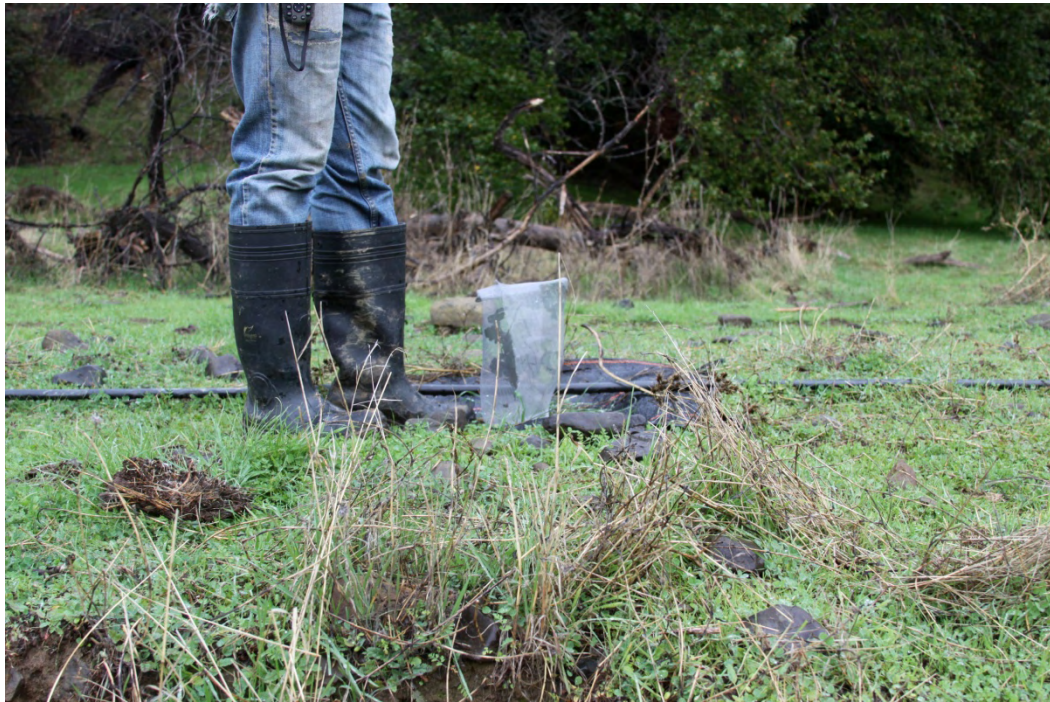
Image 10: Example of height of native planting and protective mesh pocket.

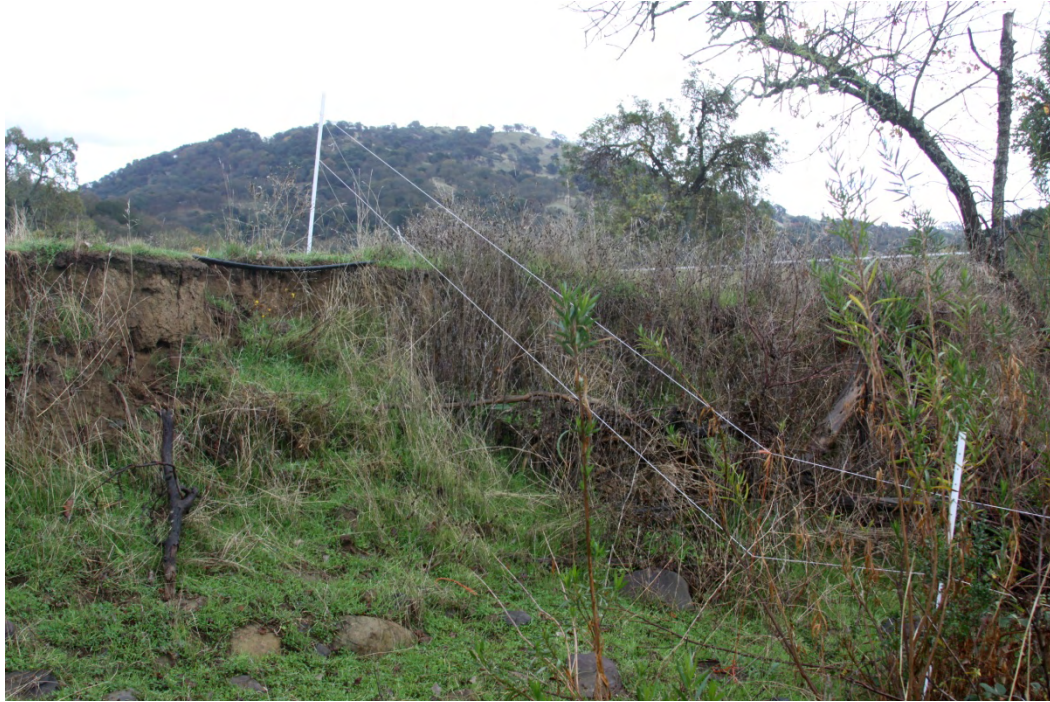
Image 11: Electric cattle fencing on McQueeney property; note that improvisational adjustments are made to the fence in order to accommodate the hilly landscape – in this case, the fencing is tied down by plastic rope and a barbell (orange rope tied to white fence can be seen near the right corner of the photograph). McQueeney must constantly make these types of adjustments to control cattle movement.

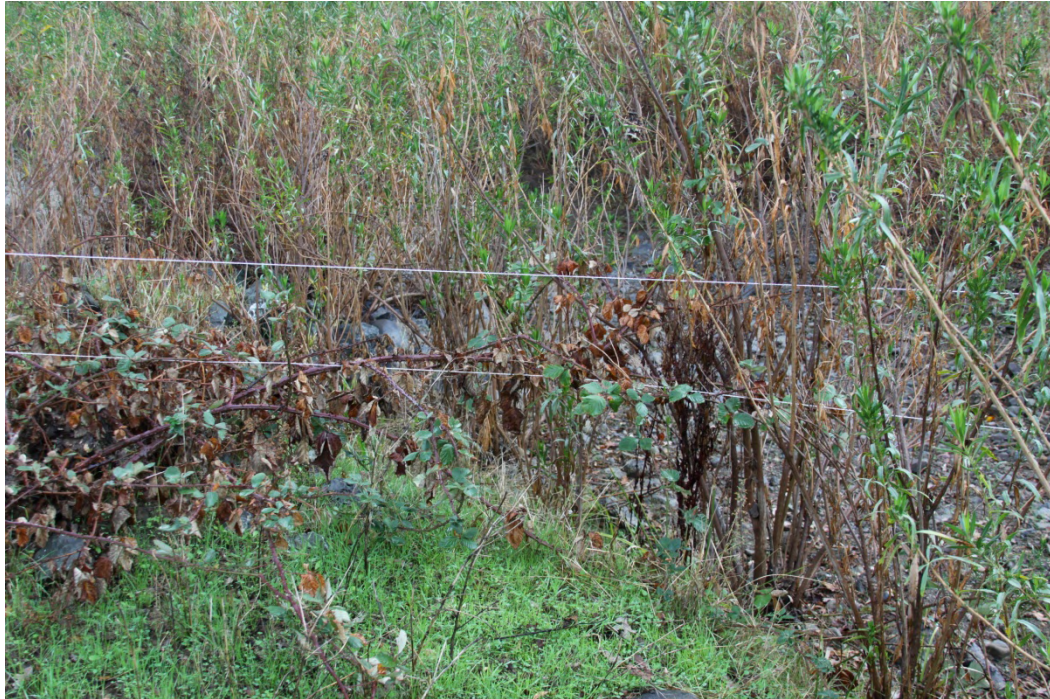
Image 12: Electric cattle fencing running through an outcropping of invasive Himalayan blackberry.

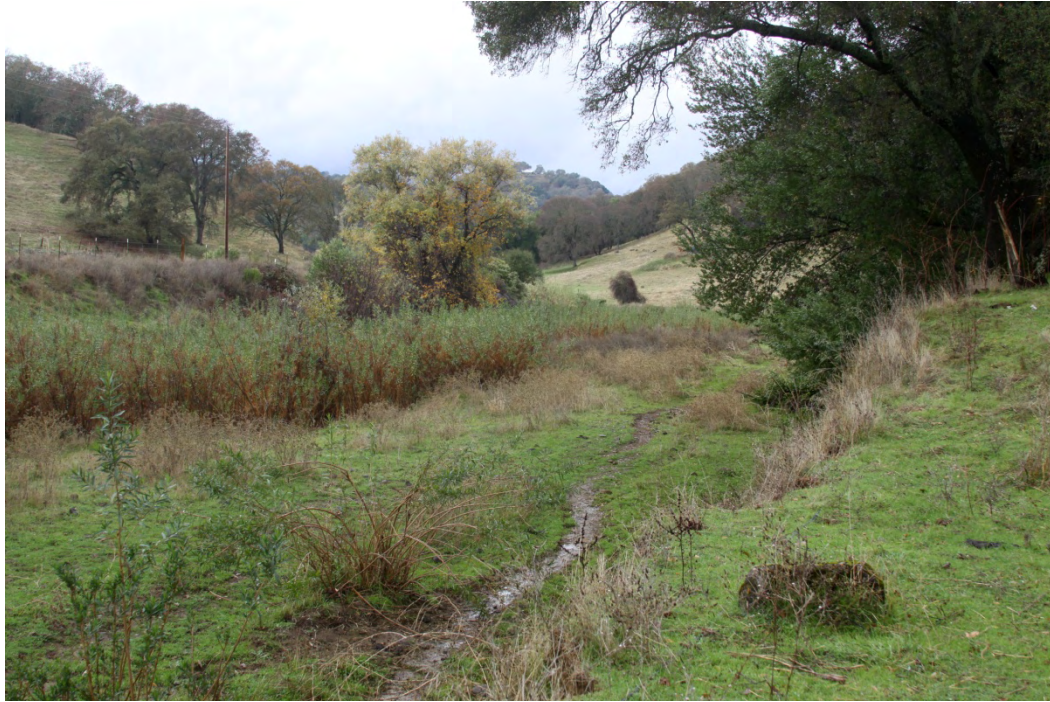
Image 13: Looking north at the beginning of zone 14 along the eastern bank of the lower Wooden Valley Creek. From left to right we see: stream bed with pioneer vegetation, slightly elevated floodplain, and stream bank (along which natives are planted). The elevation from flood plain to stream bank (where saplings are planted) is approximately 3-4 feet in height throughout zone 14.

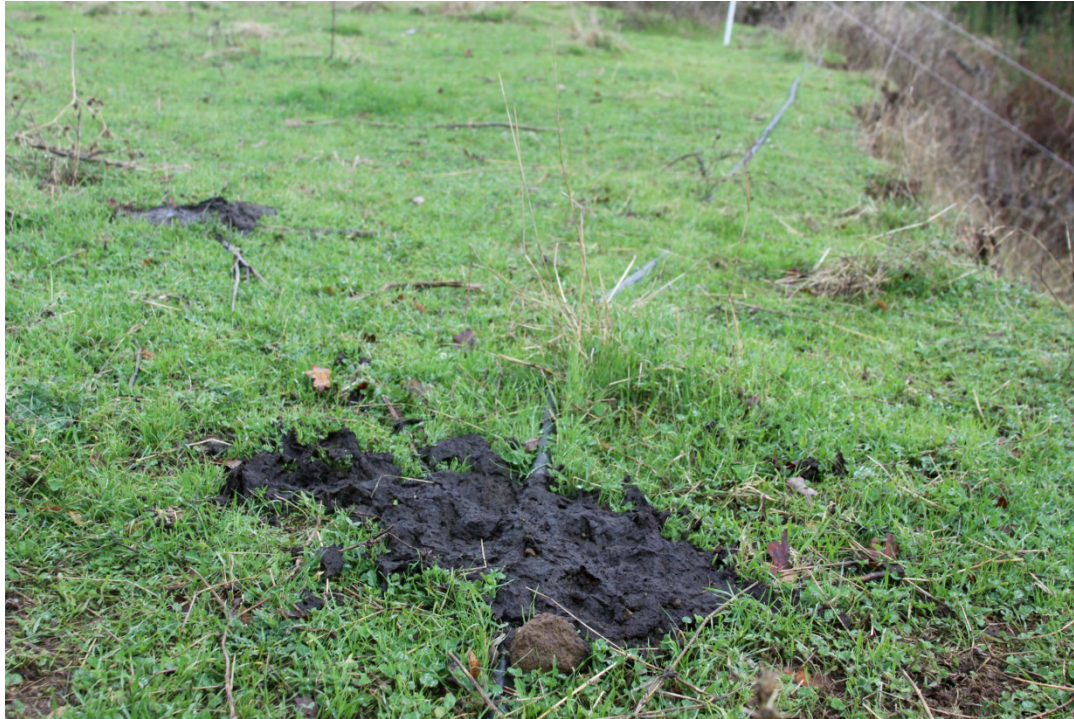
Image 14: Cow manure on irrigation pipe. The cattle have partial access to the stream (electric fence is visible in the background, blocking cattle from a section of the McQueeney property), and because the irrigation runs the entire length of the lower Wooden Valley Creek through McQueeney's property, the irrigation piping runs through actively grazed plots of land.

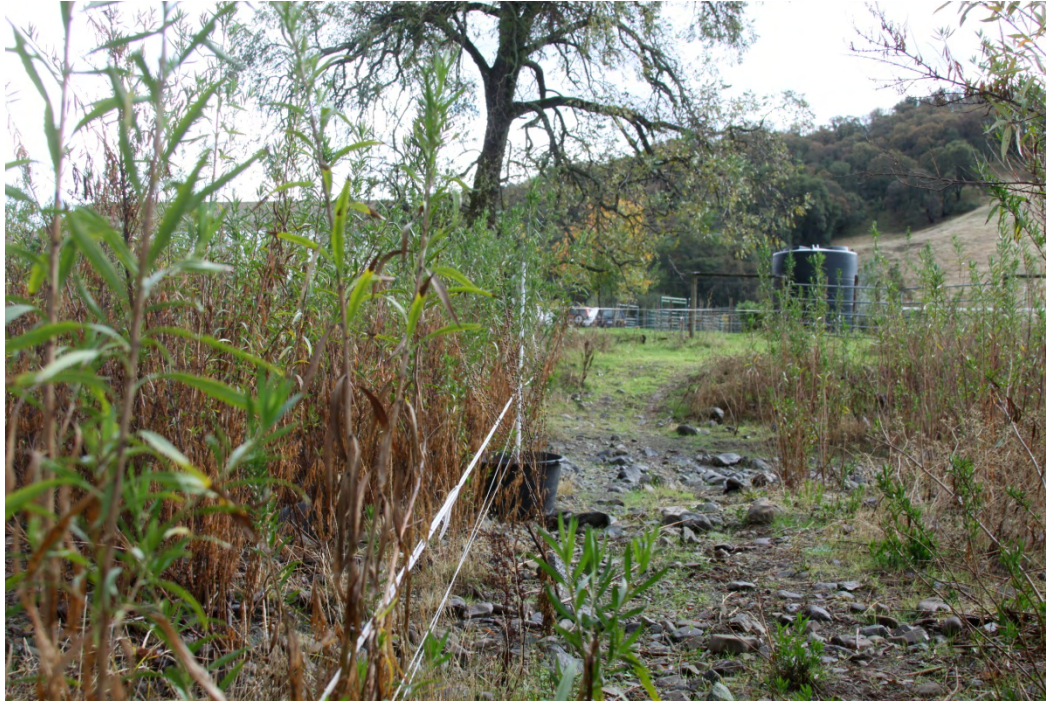
Image 15: Looking west across Lower Wooden Valley Creek; heavily vegetated area on right has been fenced off from cattle grazing for 3 years. This is not restored zone 14, but an adjacent un-planted segment of the lower Wooden Valley Creek directly behind (and north of) McQueeney's home.

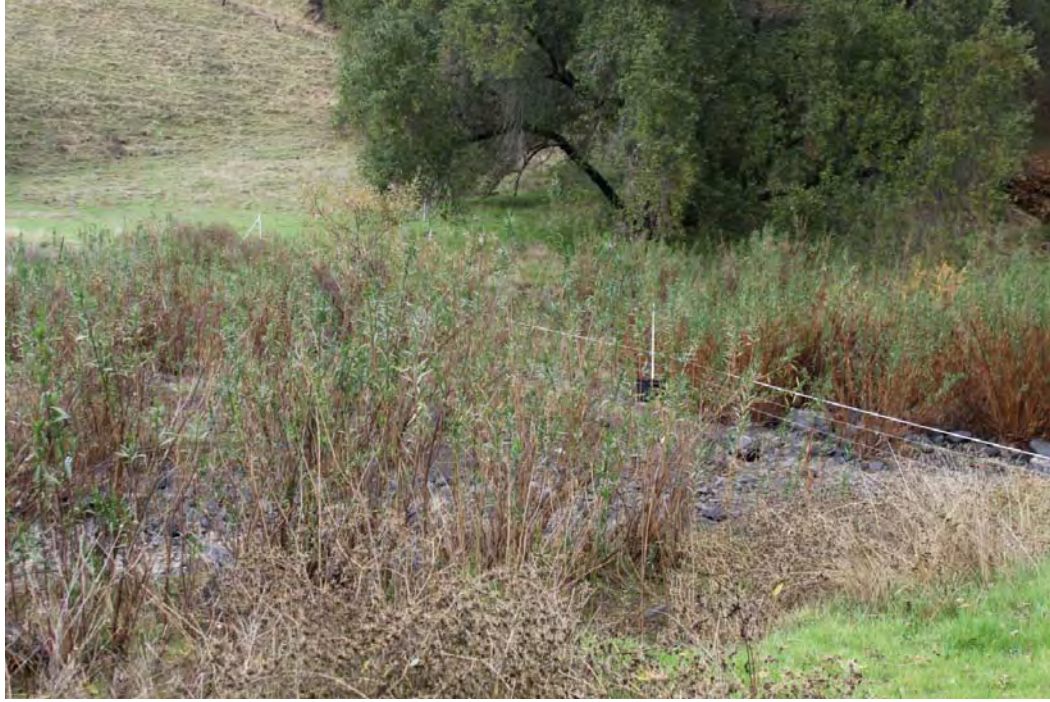
Image 17: View of the entire stream bed (this is same location as in images 14 and 15 above) in the non-restoration segment of the lower Wooden Valley Creek behind McQueeney's house (just south of restored zone 14). Stream bed width is approximately 30 feet at this point (which is narrower than the stream bed north in restored zone 14).
