Evaluation of collapse and non-collapse of parallel bridges affected by liquefaction and lateral spreading.

EVALUATION OF COLLAPSE AND NON-COLLAPSE OF PARALLEL BRIDGES AFFECTED BY LIQUEFACTION AND LATERAL SPREADING

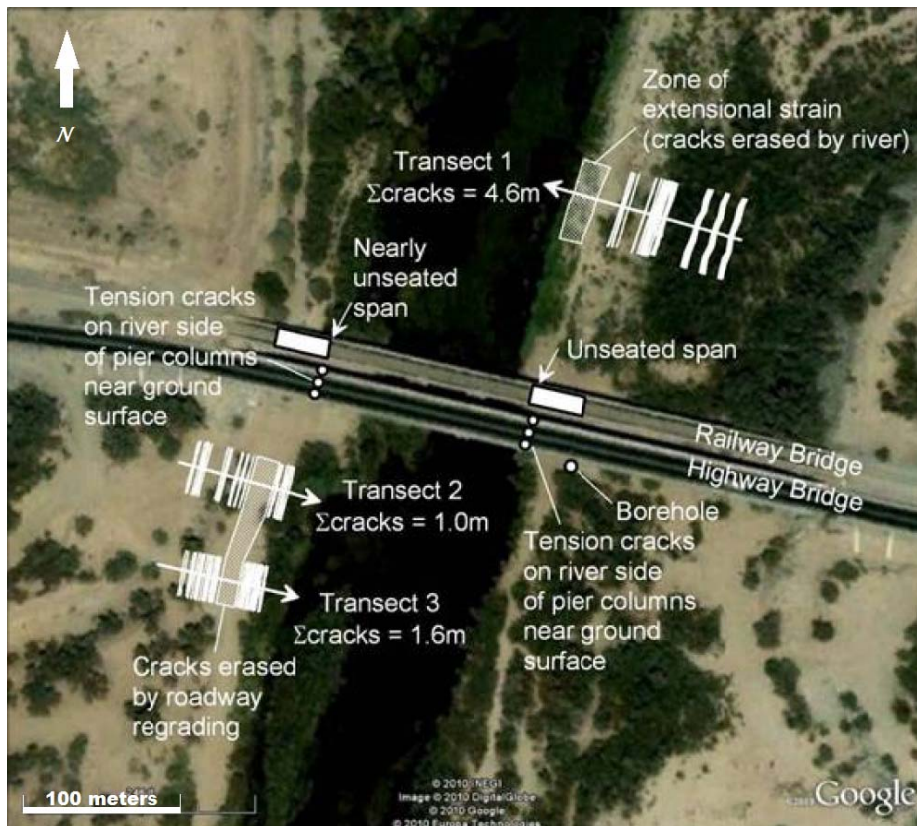
Figure 2: Site map showing lateral spreading and observed structural damage to bridges. After GEER Report (2010).

As shown in Figure 2, lateral spreading cracks were observed on the river banks both north and south of the bridges in the non-liquefied silt crust that overlays the liquefiable sand. It was not evident from the initial reconnaissance whether or not the approximately 4m of silt below the groundwater table liquefied during the earthquake. The sum of the measured lateral spreading cracks was as much as 4.6m along a transect about 60m north of the bridge, although not all the deformation could be directly measured due to heavy vegetation cover and erosion of cracks by the river prior to the arrival of the GEER team.

Measured lateral spreading deformation was greater on the east bank of the river than the west bank, possibly because the river currently flows along the western margin of its floodplain so the alluvial sediments on the east bank are younger and hence looser and more susceptible to liquefaction. This observation could have implications for estimates of potential lateral spreading deformations at similar sites.

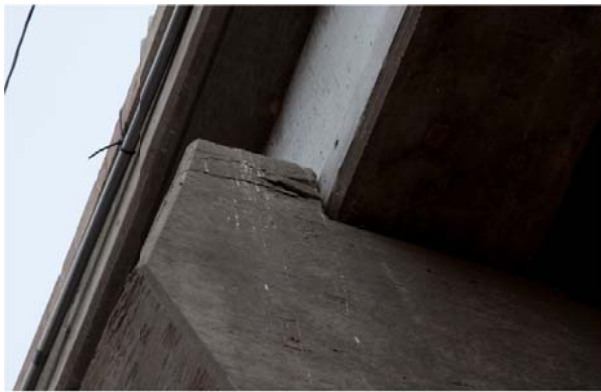
Figure 4: (a) shear key damage at pier cap (photo Richard Woods), (b) vertical ground settlement relative to columns (photo Jim Gingery), and (c) column flexural concrete cracking at base (photo Richard Woods).

1. 30-cm-tall shear key “retainers” extending up from the ends of the pier caps to provide lateral restraint of the edge girders were cracked and spalled, but did not fail, indicating that the bridge was loaded in the transverse direction. The shear keys on the western abutment pier cap were damaged in a similar manner. Transverse offset of the elastomeric bearings was also observed.

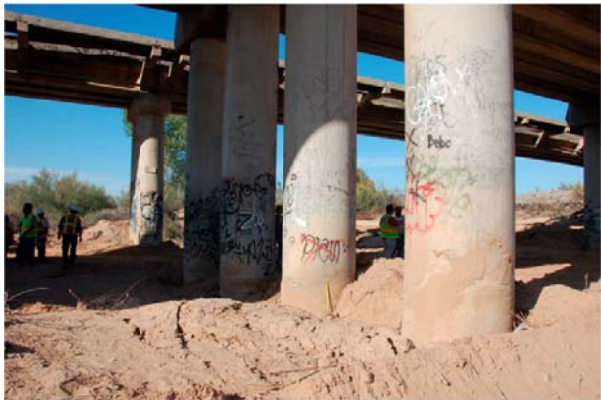
(b)

Vertical settlement of up to 0.5m was observed, likely due to a combination of reconsolidation following liquefaction and deviatoric deformation. At the location of the largest measured vertical ground settlement, the bridge pier settled approximately 0.5m, likely due to static loads, down-drag forces mobilized during liquefaction, and a loss of axial resistance.

3. Vertical settlement of approximately 0.5m of one of the piers resulted in vertical displacement and cracking of the bridge deck immediately above the pier. This pier was adjacent to the span of the railroad bridge that collapsed, on the east river bank.

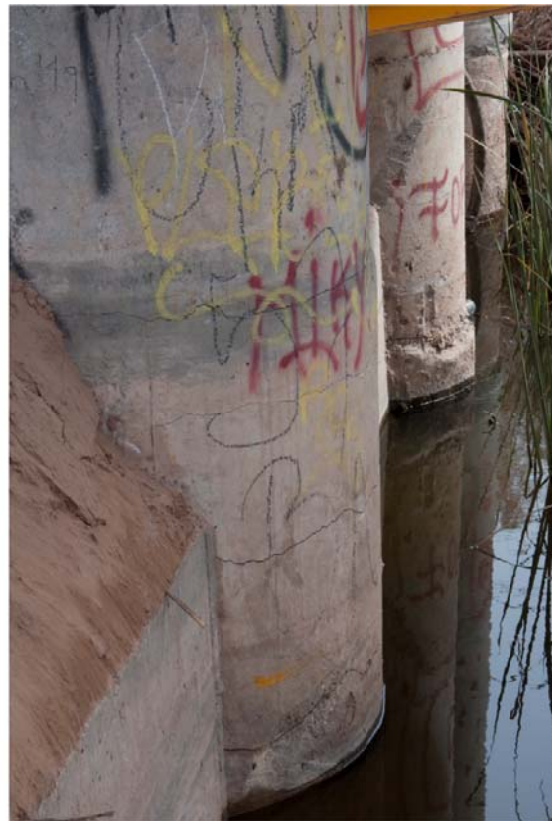
(c)

2. Flexural cracking was observed on the inward (river side) of the columns at the column-to-pile-cap connection of the piers on both sides of the river crossing. The flexural demand indicates horizontal movement of the foundations and pile cap towards the center of the river due to lateral spreading. The bridge deck was cracked above these damaged piers.
