EVALUATION OF COLLAPSE AND NON-COLLAPSE OF PARALLEL BRIDGES AFFECTED BY LIQUEFACTION AND LATERAL SPREADING

Benjamin Turner¹⁾, Scott Brandenburg²⁾, and Jonathan Stewart³⁾

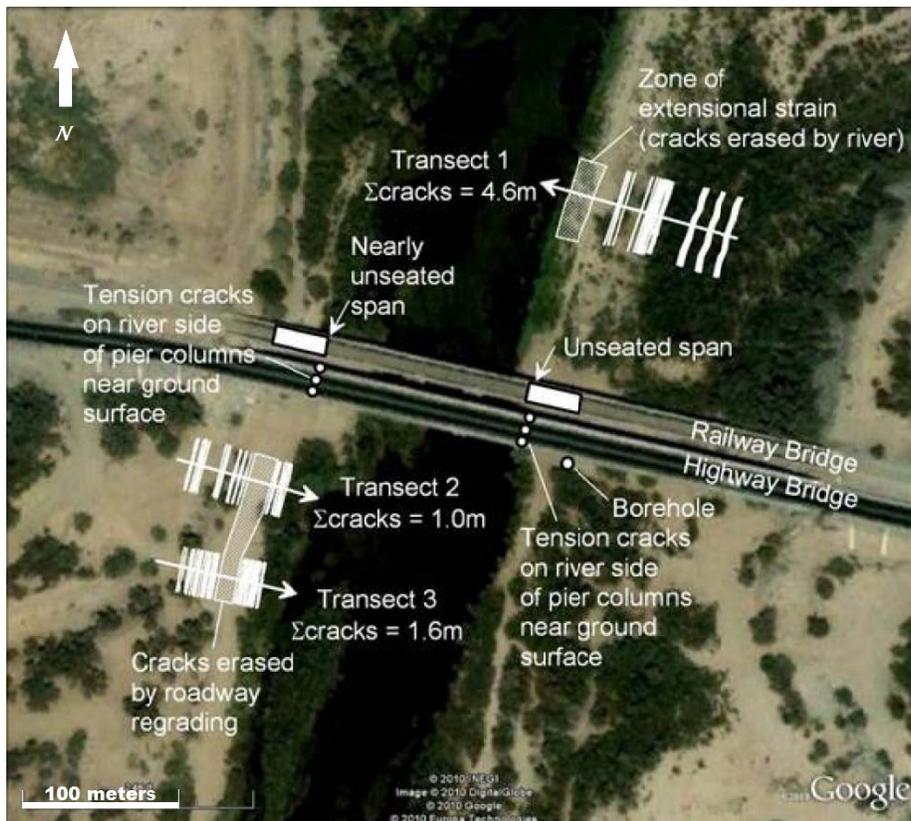
Figure 2: Site map showing lateral spreading and observed structural damage to bridges. After GEER Report (2010).

As shown in Figure 2, lateral spreading cracks were observed on the river banks both north and south of the bridges in the non-liquefied silt crust that overlays the liquefiable sand. It was not evident from the initial reconnaissance whether or not the approximately 4m of silt below the groundwater table liquefied during the earthquake. The sum of the measured lateral spreading cracks was as much as 4.6m along a transect about 60m north of the bridge, although not all the deformation could be directly measured due to heavy vegetation cover and erosion of cracks by the river prior to the arrival of the GEER team.

Measured lateral spreading deformation was greater on the east bank of the river than the west bank, possibly because the river currently flows along the western margin of its floodplain so the alluvial sediments on the east bank are younger and hence looser and more susceptible to liquefaction. This observation could have implications for estimates of potential lateral spreading deformations at similar sites.

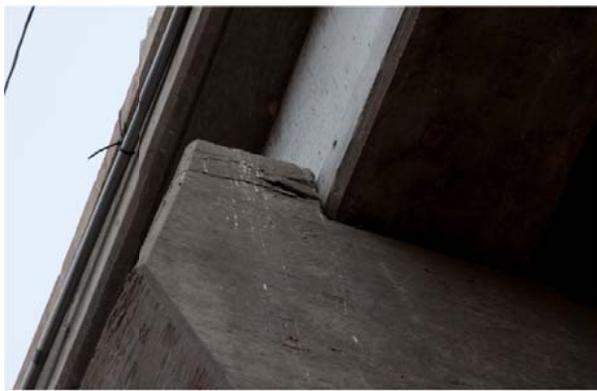
Figure 4: (a) shear key damage at pier cap (photo Richard Woods), (b) vertical ground settlement relative to columns (photo Jim Gingery), and (c) column flexural concrete cracking at base (photo Richard Woods).

1. 30-cm-tall shear key “retainers” extending up from the ends of the pier caps to provide lateral restraint of the edge girders were cracked and spalled, but did not fail, indicating that the bridge was loaded in the transverse direction. The shear keys on the western abutment pier cap were damaged in a similar manner. Transverse offset of the elastomeric bearings was also observed.

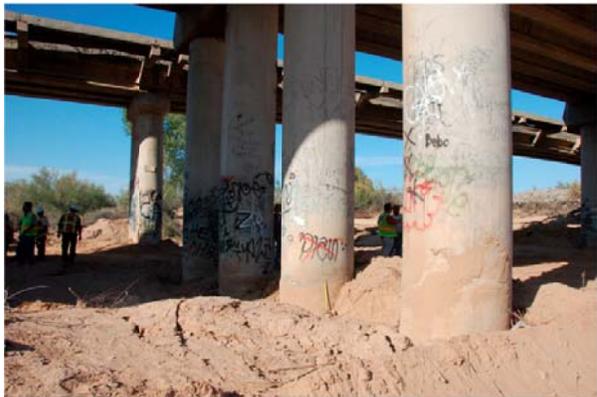
(b)

Vertical settlement of up to 0.5m was observed, likely due to a combination of reconsolidation following liquefaction and deviatoric deformation. At the location of the largest measured vertical ground settlement, the bridge pier settled approximately 0.5m, likely due to static loads, down-drag forces mobilized during liquefaction, and a loss of axial resistance.

3. Vertical settlement of approximately 0.5m of one of the piers resulted in vertical displacement and cracking of the bridge deck immediately above the pier. This pier was adjacent to the span of the railroad bridge that collapsed, on the east river bank.

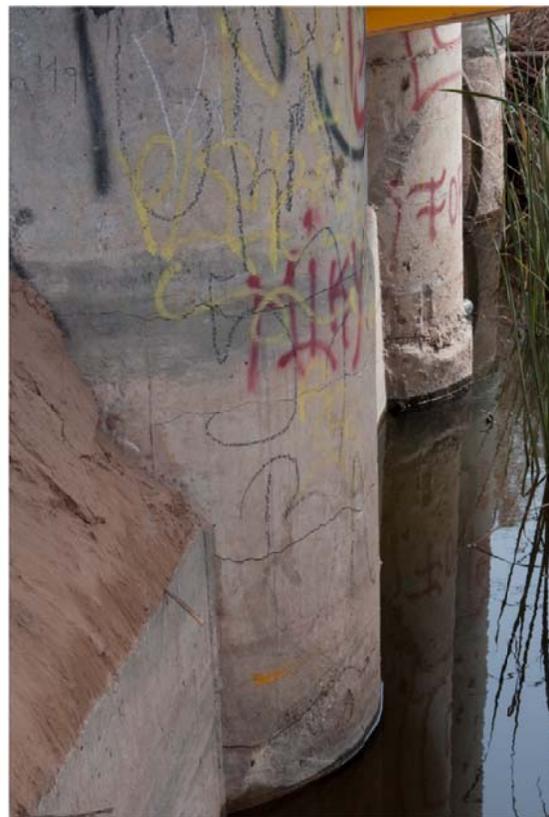
(c)

2. Flexural cracking was observed on the inward (river side) of the columns at the column-to-pile-cap connection of the piers on both sides of the river crossing. The flexural demand indicates horizontal movement of the foundations and pile cap towards the center of the river due to lateral spreading. The bridge deck was cracked above these damaged piers.
