Post-project appraisal of the Sausal Creek restoration project, Oakland, California

POST-PROJECT APPRAISAL OF THE SAUSAL CREEK  
RESTORATION PROJECT, OAKLAND, CALIFORNIA

University of California  
Landscape Architecture 227  
Professor G. Mathias Kondolf  
Fall 2005

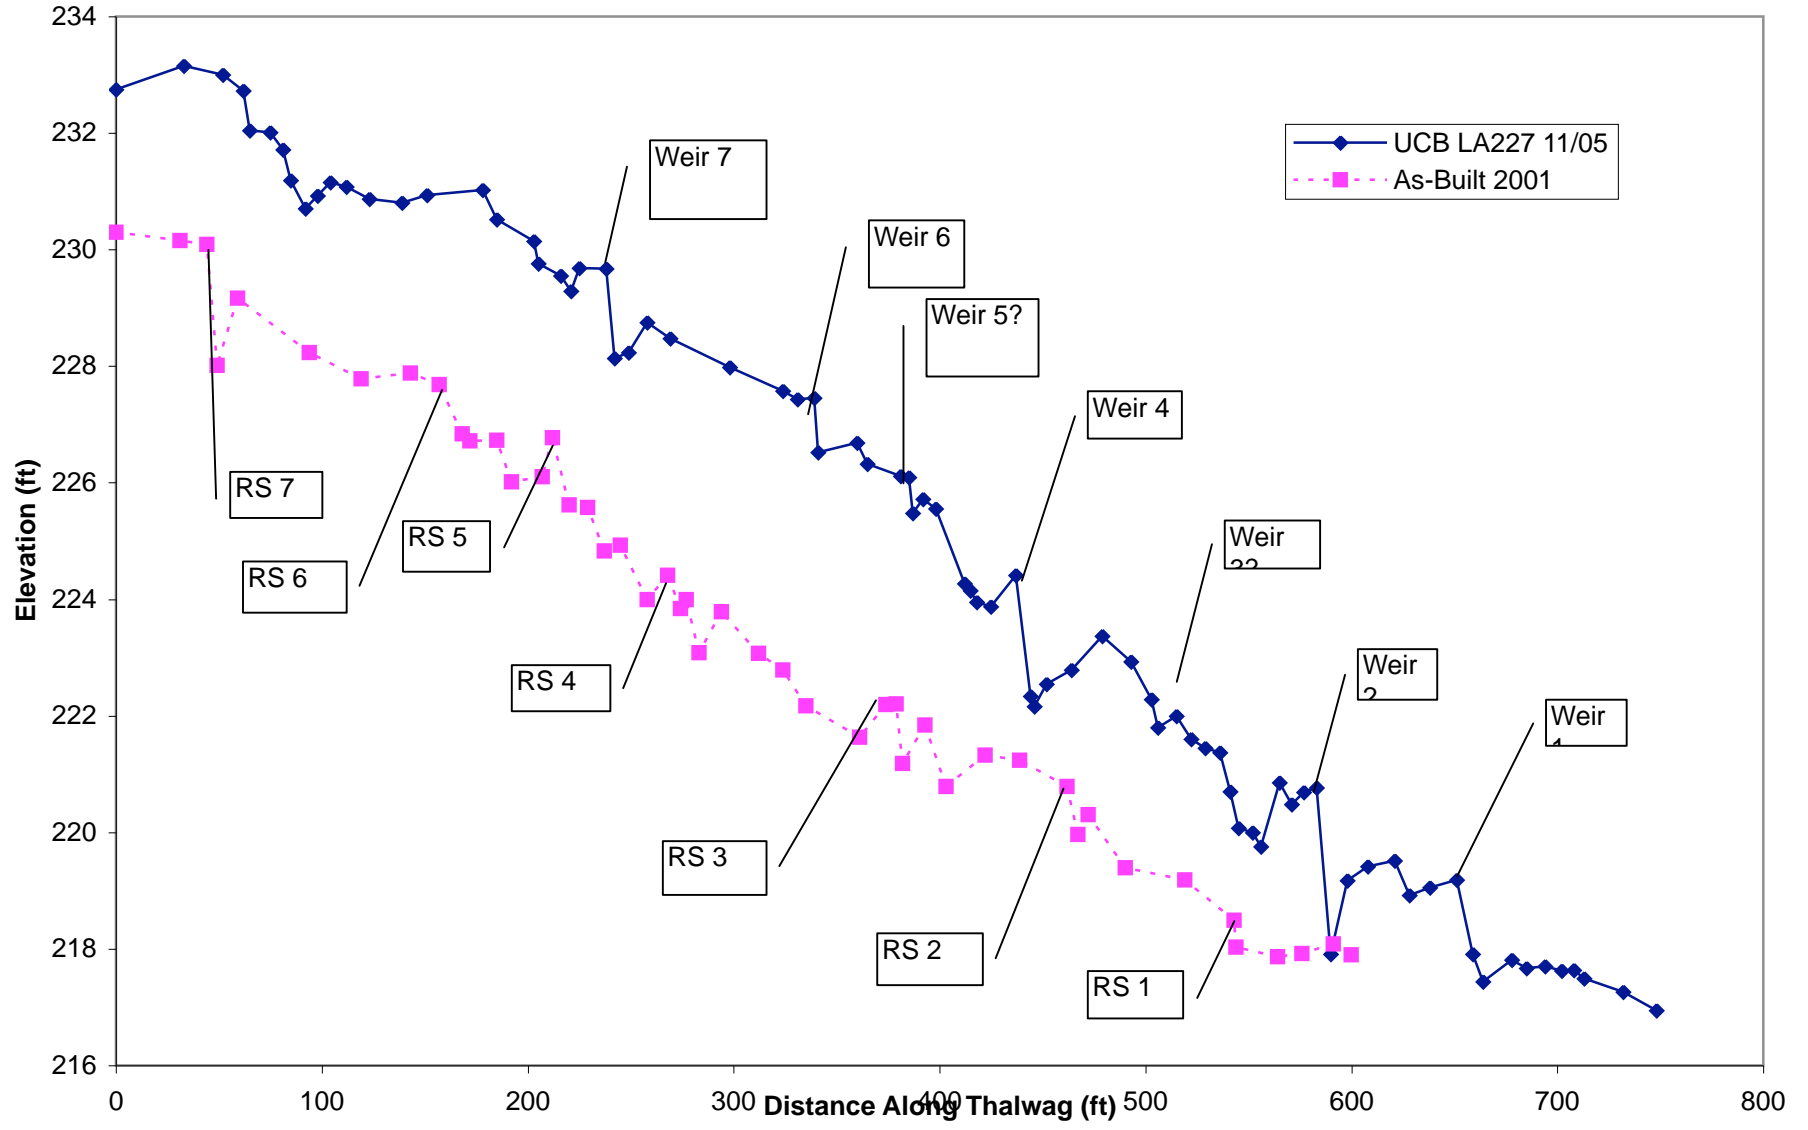
**Figure 9: Longitudinal Profile of Sausal Creek Restoration Site at Dimond Park**

Because the starting point of the as-built longitudinal profile survey was not indicated, it was difficult to compare our data to the as-built data. However, by performing a best-fit line analysis to both sets of data, we found that the slope of the restoration reach has increased by 0.20 percent, which indicates that the channel is stable. The channel slope in the restoration plans was 2.6 percent, but may have been modified during construction. In addition, minor differences in the surveys could be attributed to the number of data collection points or varying horizontal thalweg distances.

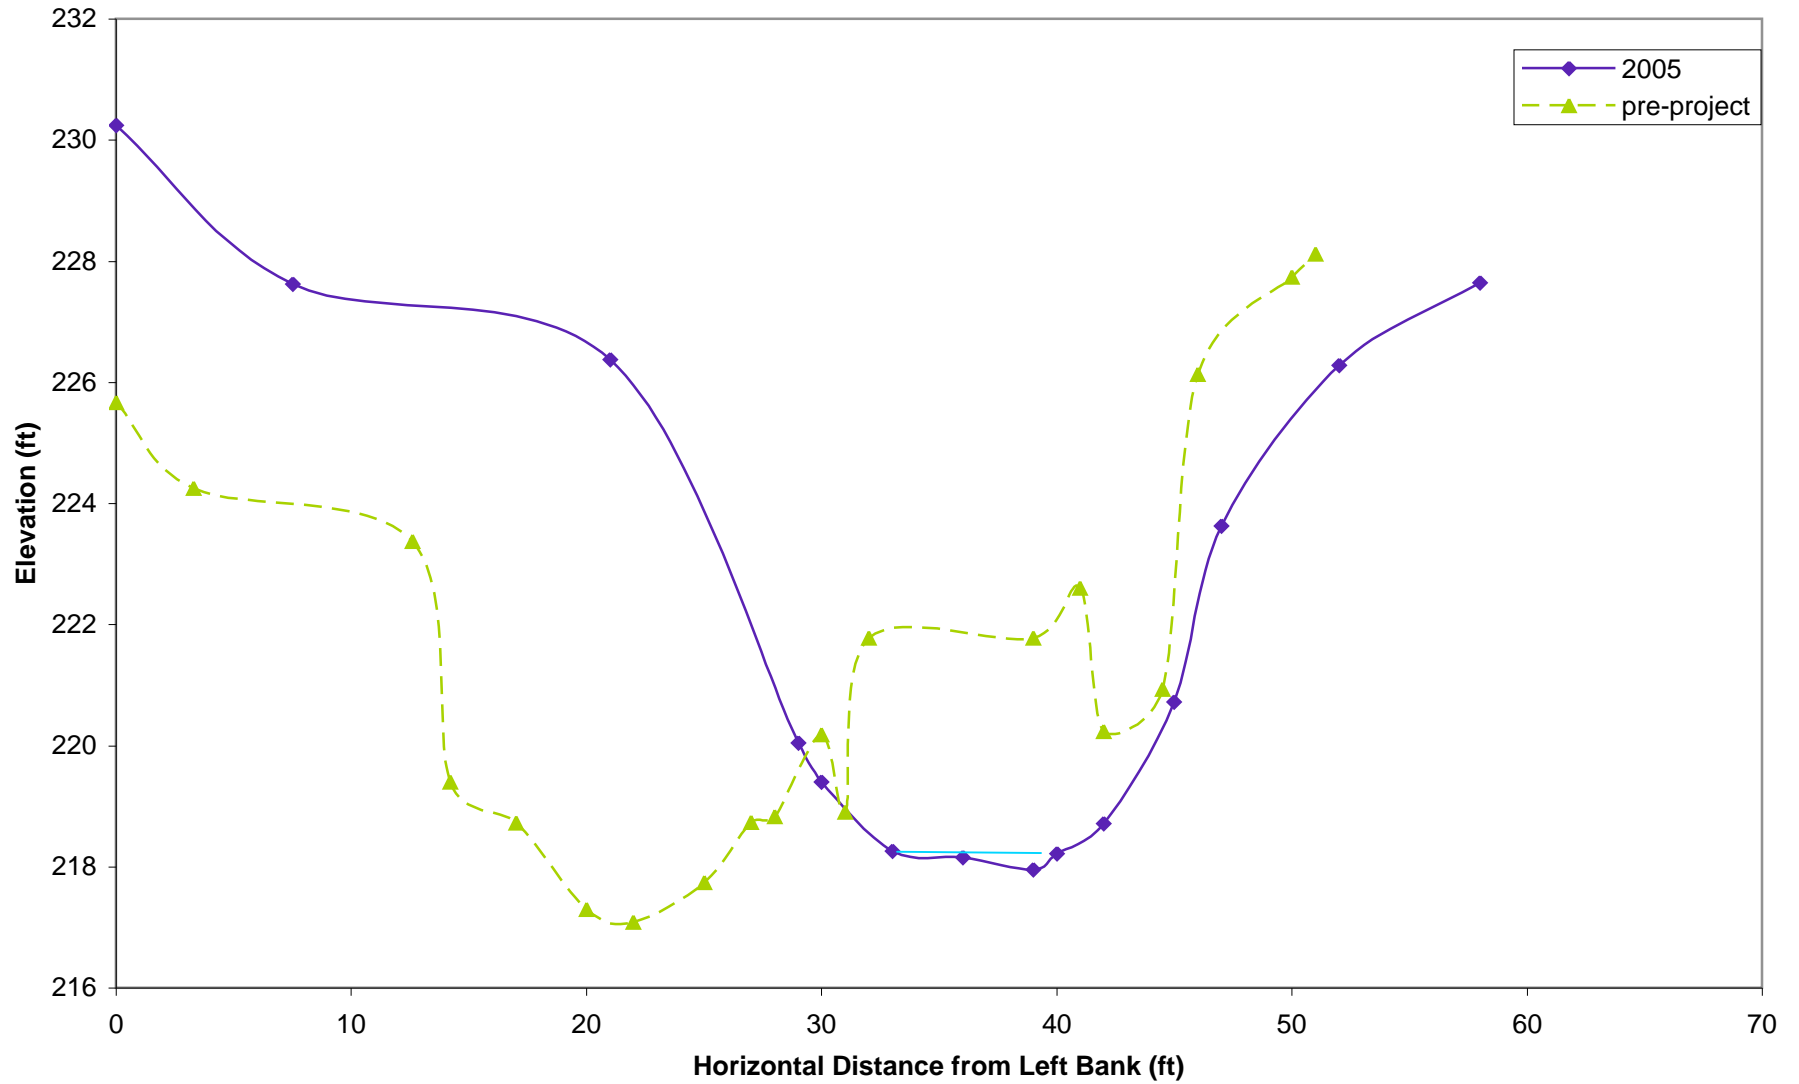
Figure 18: XS "A"

In addition, we were unable to determine the location of the as-built cross sections, which may explain the differences between the as-built and current conditions (Figures 18-27). We did not have as-built data for cross-section A, but we were able to compare current data to the pre-project information (Figure 18). Our survey provides baseline data for future channel assessments.

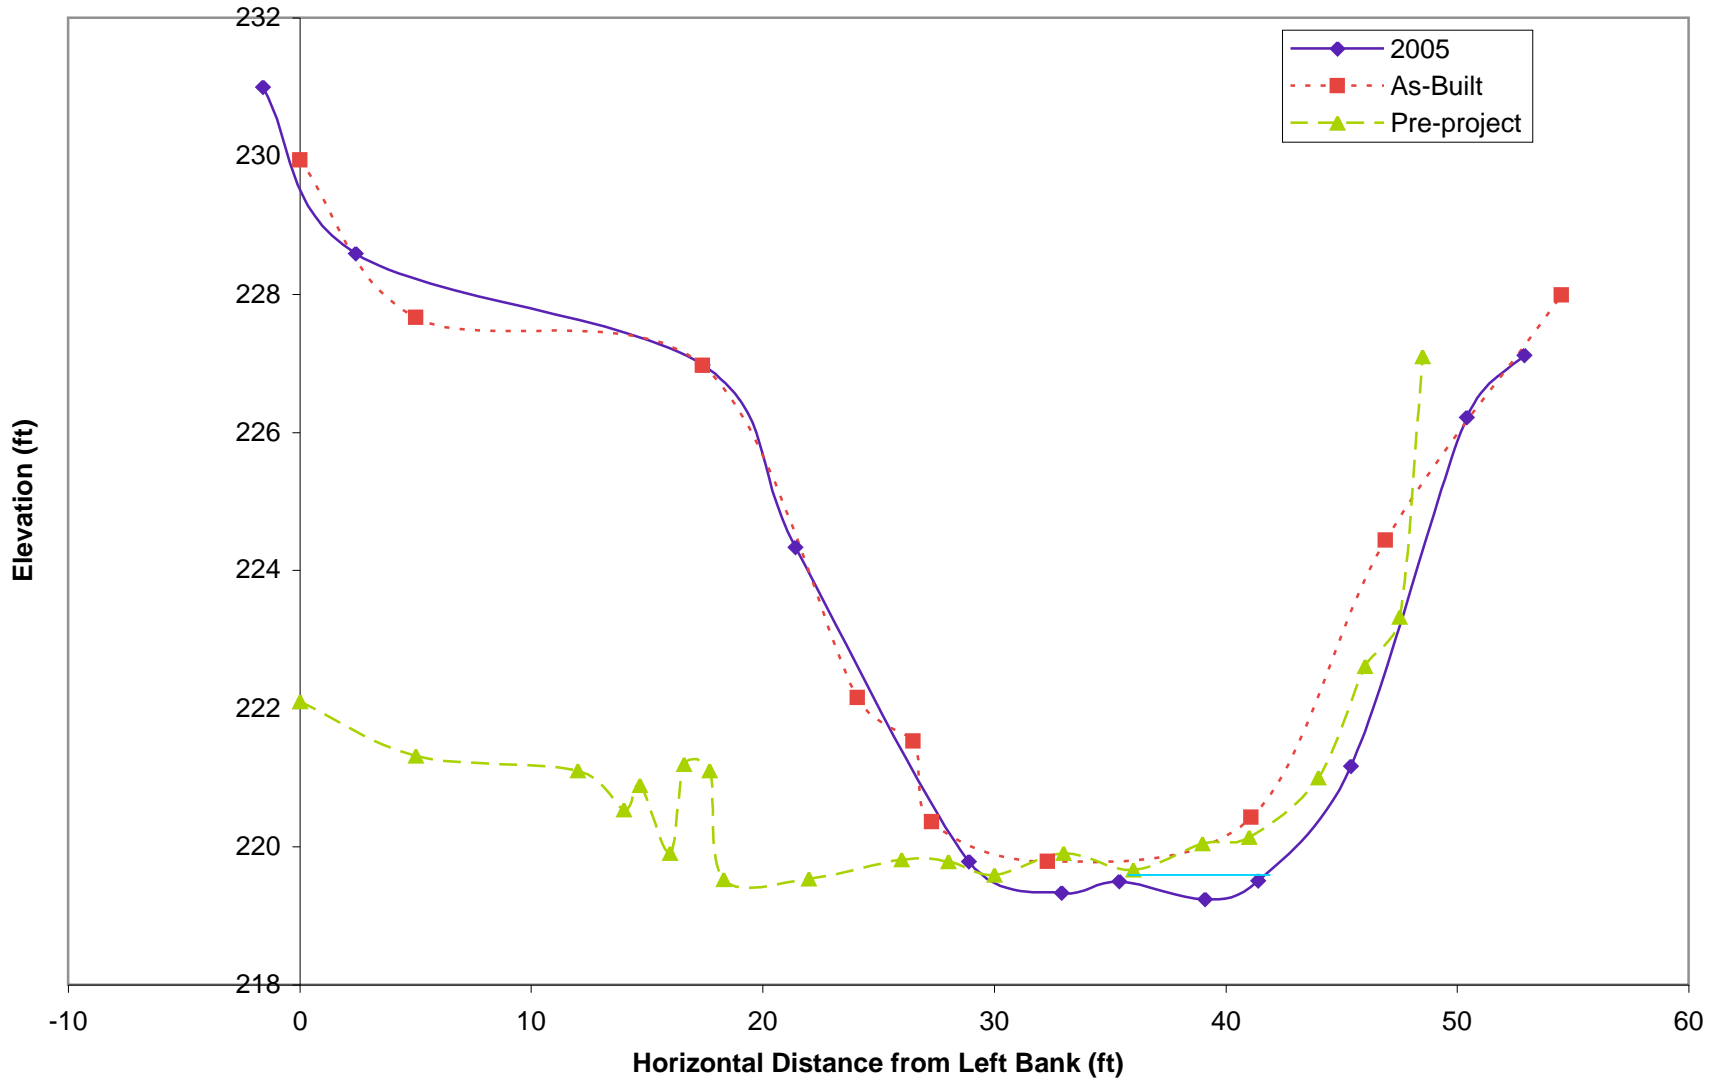
Figure 19: XS "B"

Just upstream of cross-section B, the failing check dam was removed during construction and the channel modification is demonstrated in Figure 19. Since the restoration, the channel has slightly incised and widened. Also, there is deposition along the edge of the trail from erosion possibly caused by dogs.

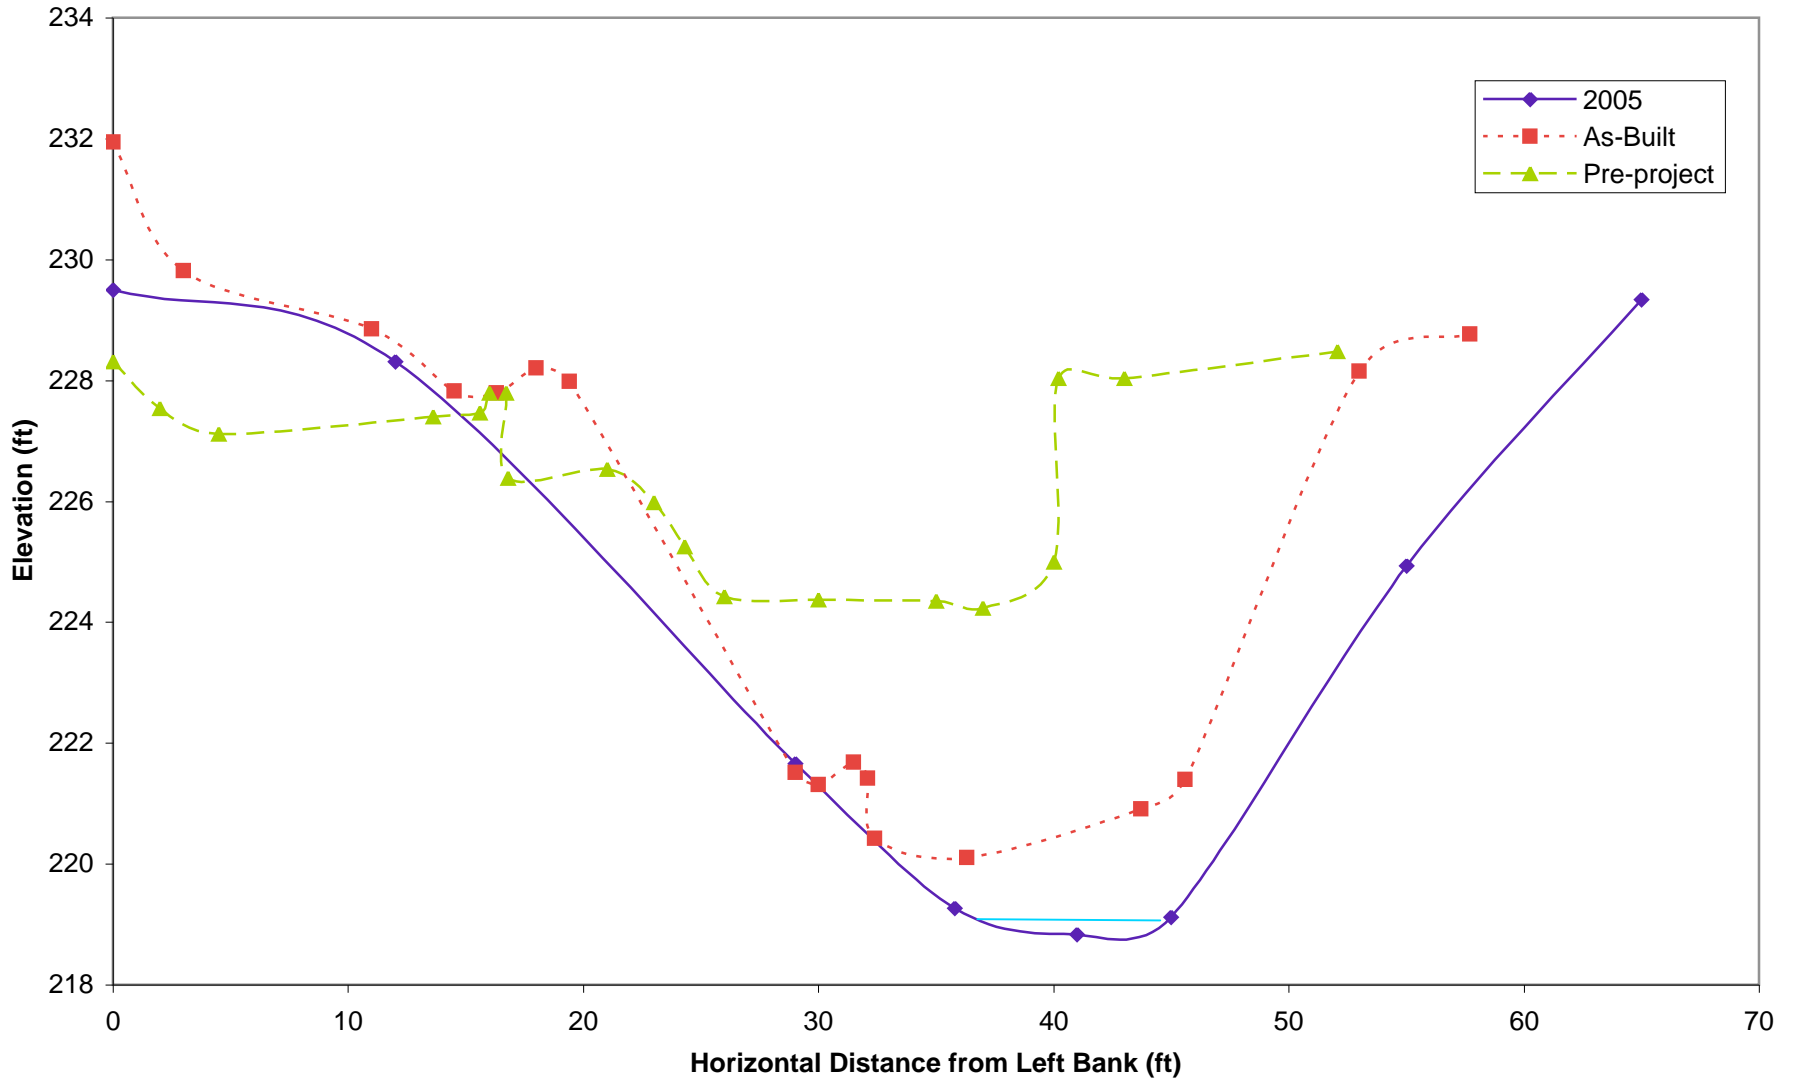
Figure 20: XS "C"

Cross-section C (Figure 20) is located at a rock weir, so we were able to determine its location, but it was difficult to determine where along the rock weir the as-built survey data was collected. Also, the as-built survey includes more survey points. However, it does appear that there is slight channel incision and erosion along the left bank, which could be caused by people and dogs accessing or crossing the creek at the weir.

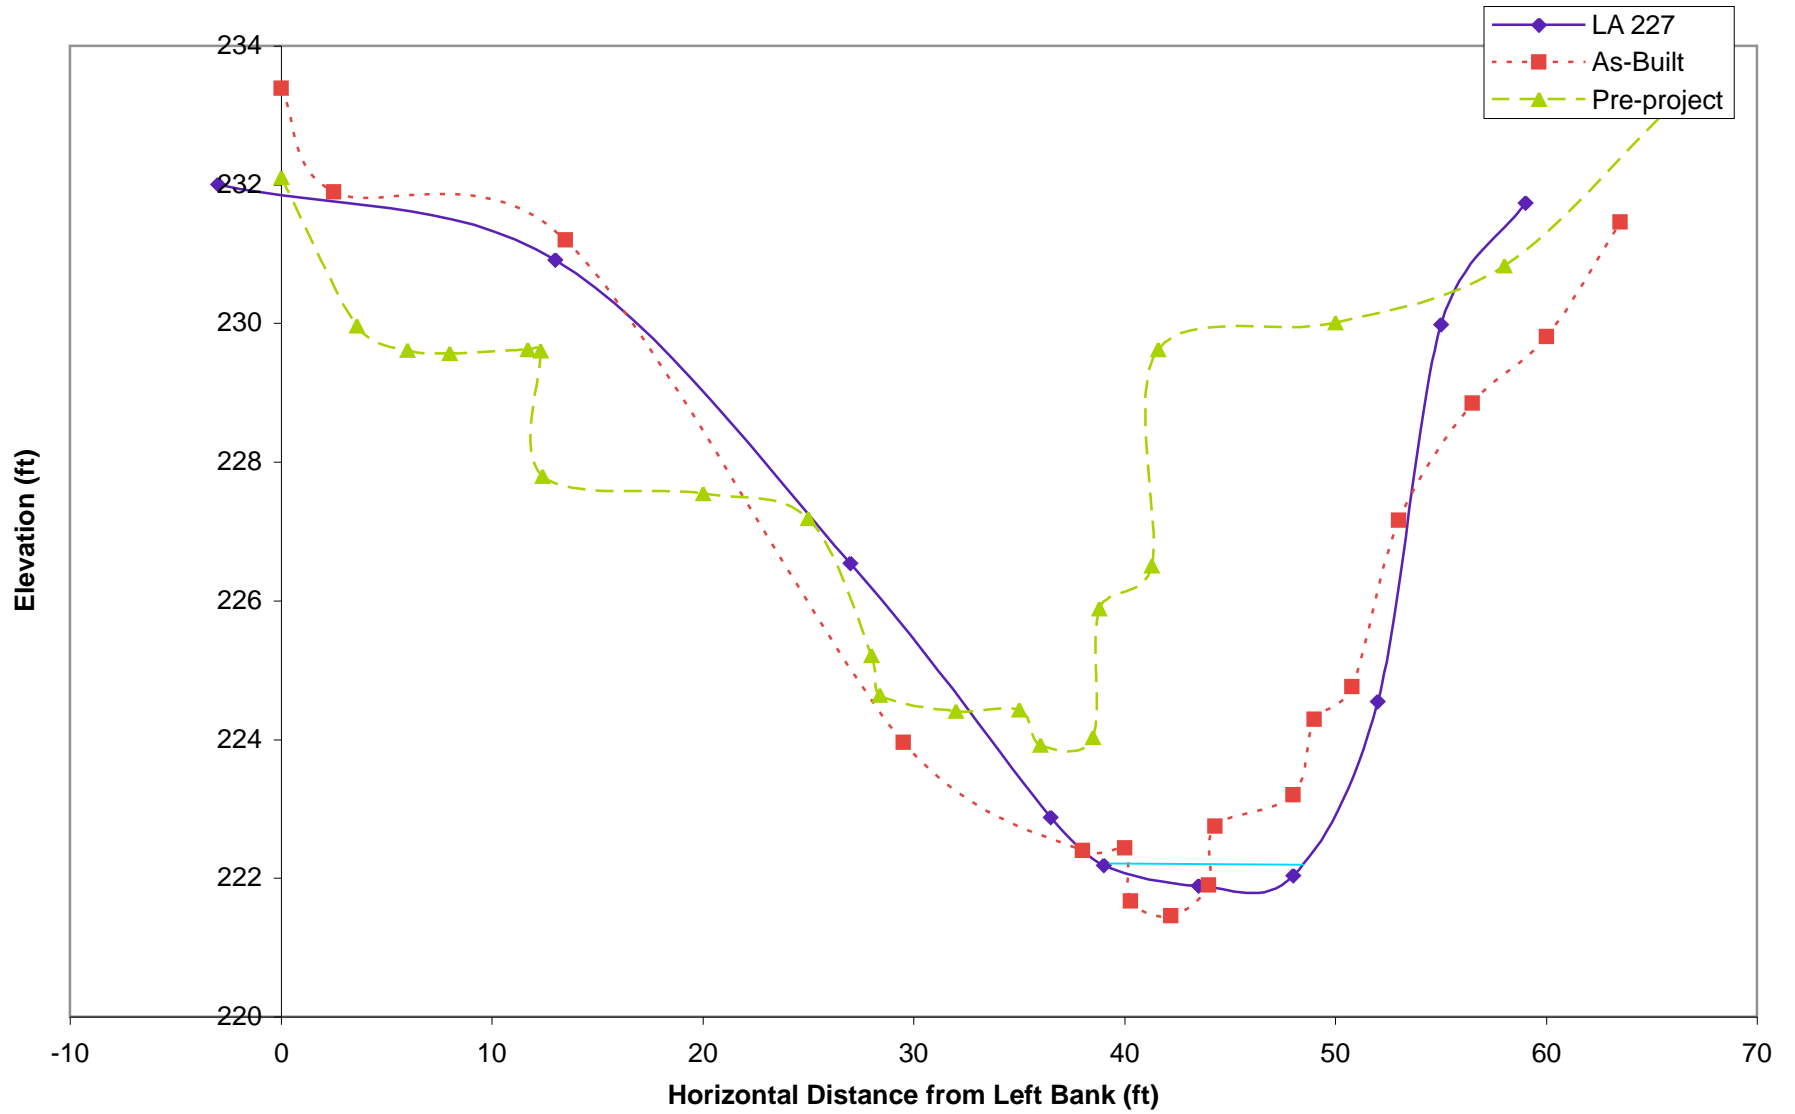
Figure 21: XS "D"

The pre-project channel geometry is evident in cross-section D (Figure 21) where concrete walls were removed to construct the current channel conditions. Again, the as-built survey data includes more data points, and it is difficult to compare the current conditions to the as-built conditions because we are not confident with the location of our survey. It does appear that the channel is stable and the banks may be slightly eroding in some areas and depositing in others.

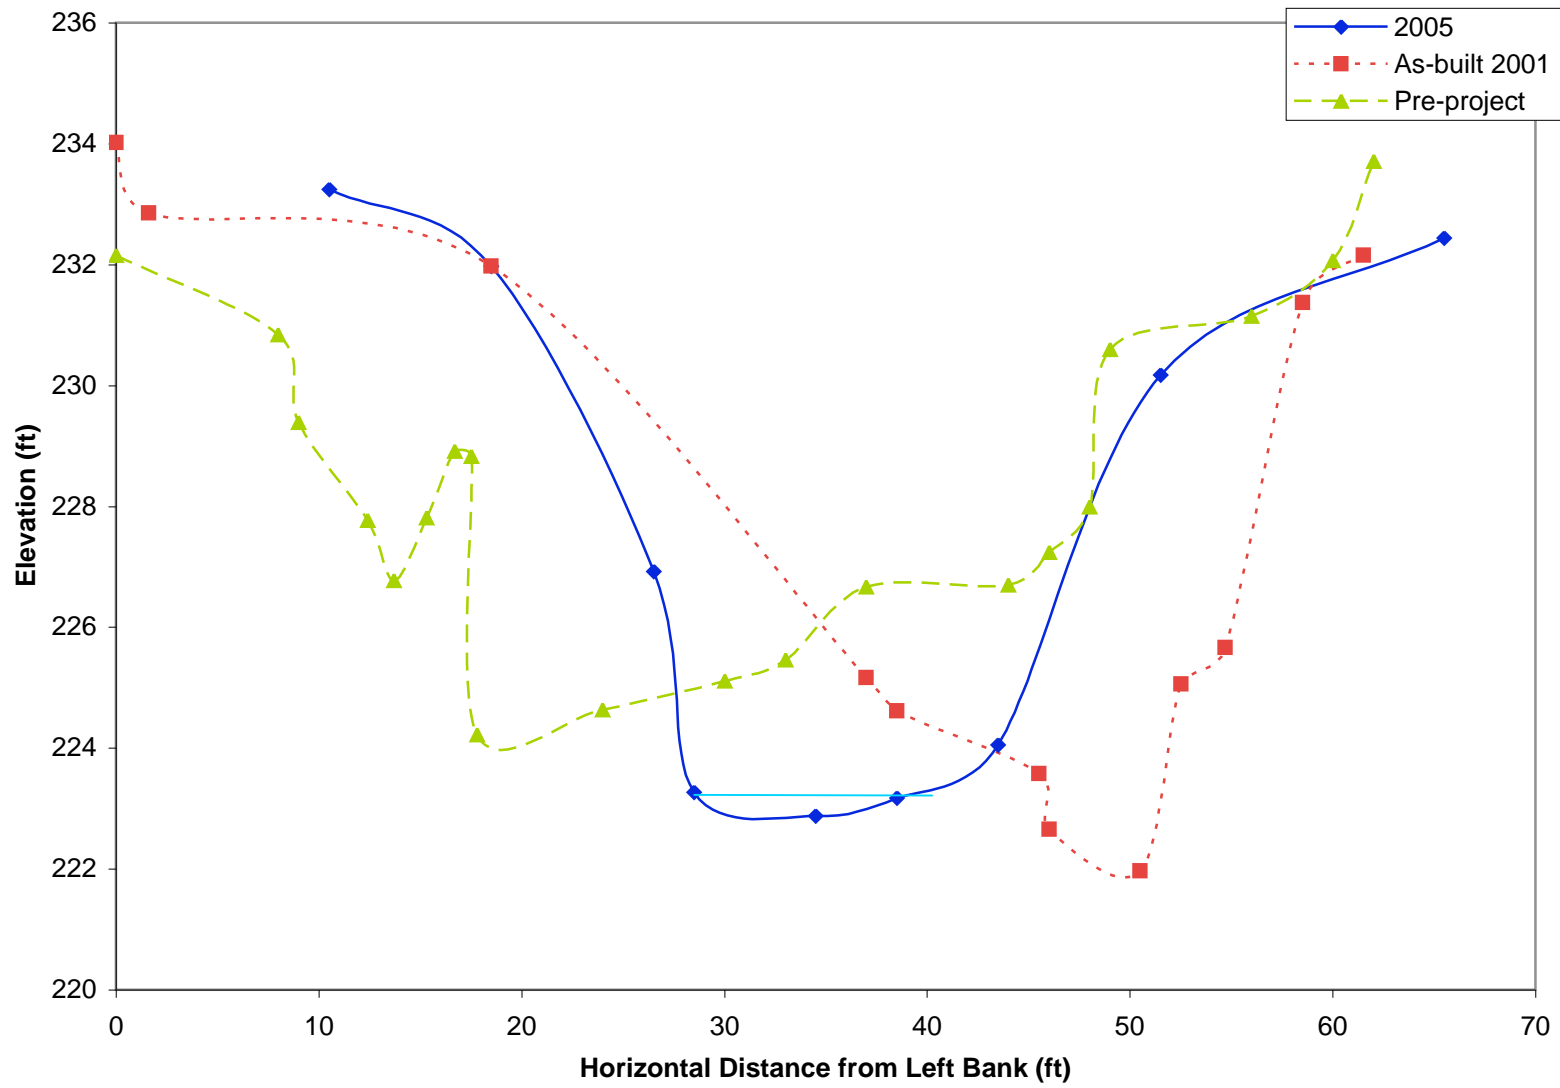
Figure 22: XS "E"

Even though cross-section E (Figure 22) is located at a rock weir, we are not certain the current and as-built surveys were performed in the same location, so this survey provides baseline data for future channel surveys.

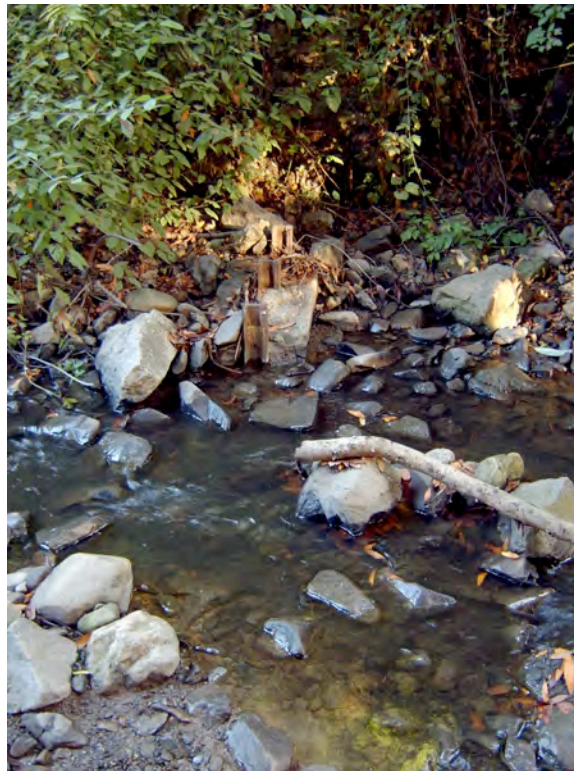
**Remnants of removed debris rack**

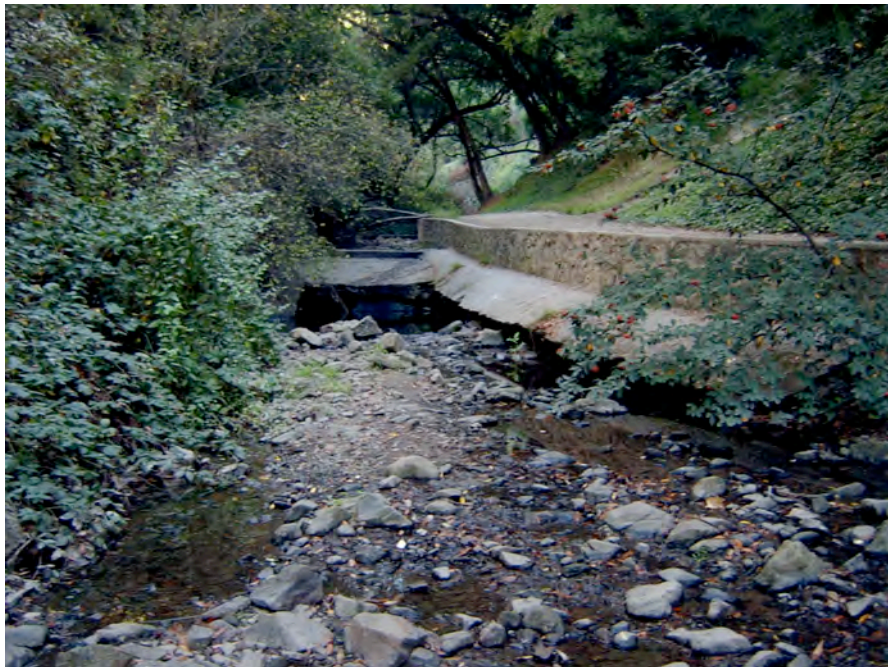
**Channel Incision and Upstream Check Dam**

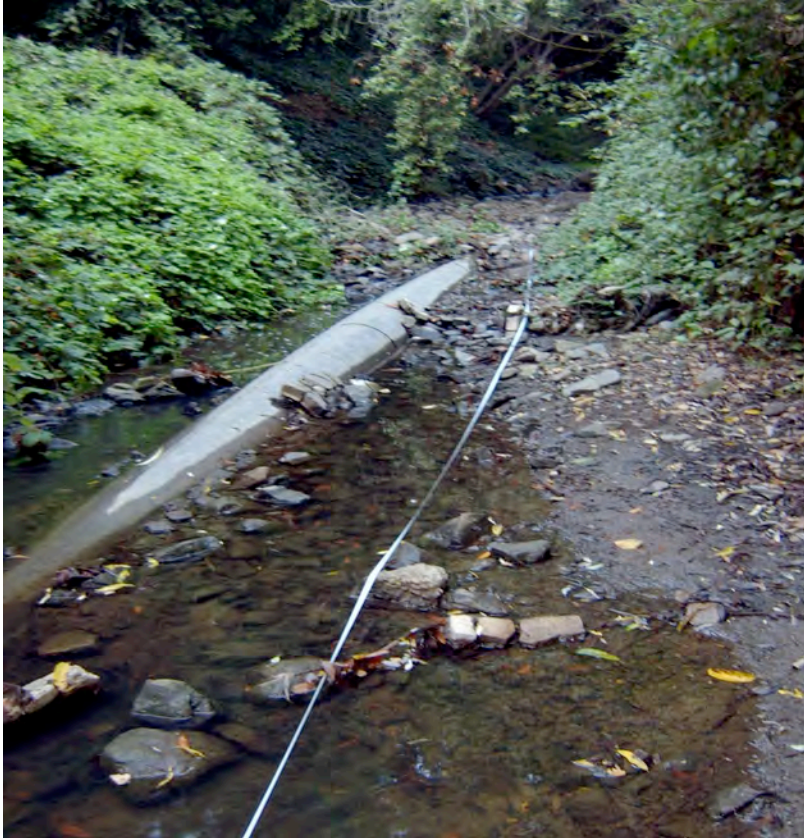
**Sewer Line in Bottom of Channel**

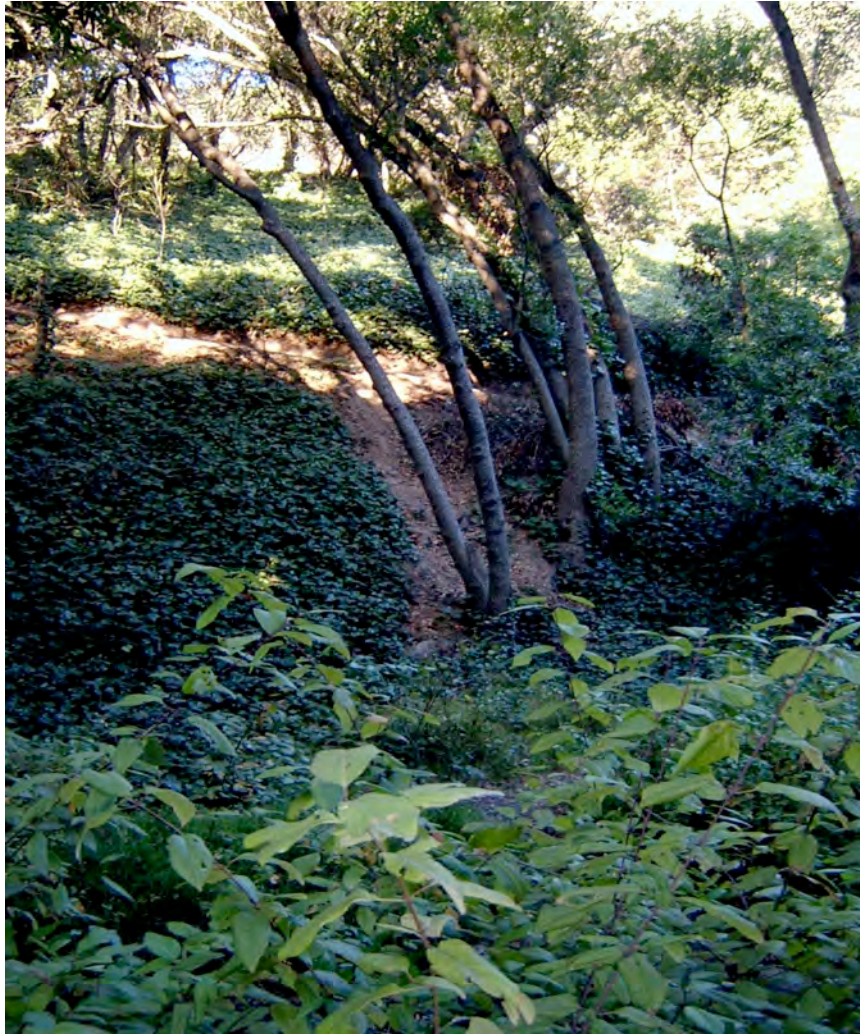
Figure 28: Erosion due to informal creek crossing at rock weir
