State Route 138--Test Site Evaluation

Technical Memorandum

TM-UCB-PRC-2001-2

Re: State Route 138 – Test Site Evaluation

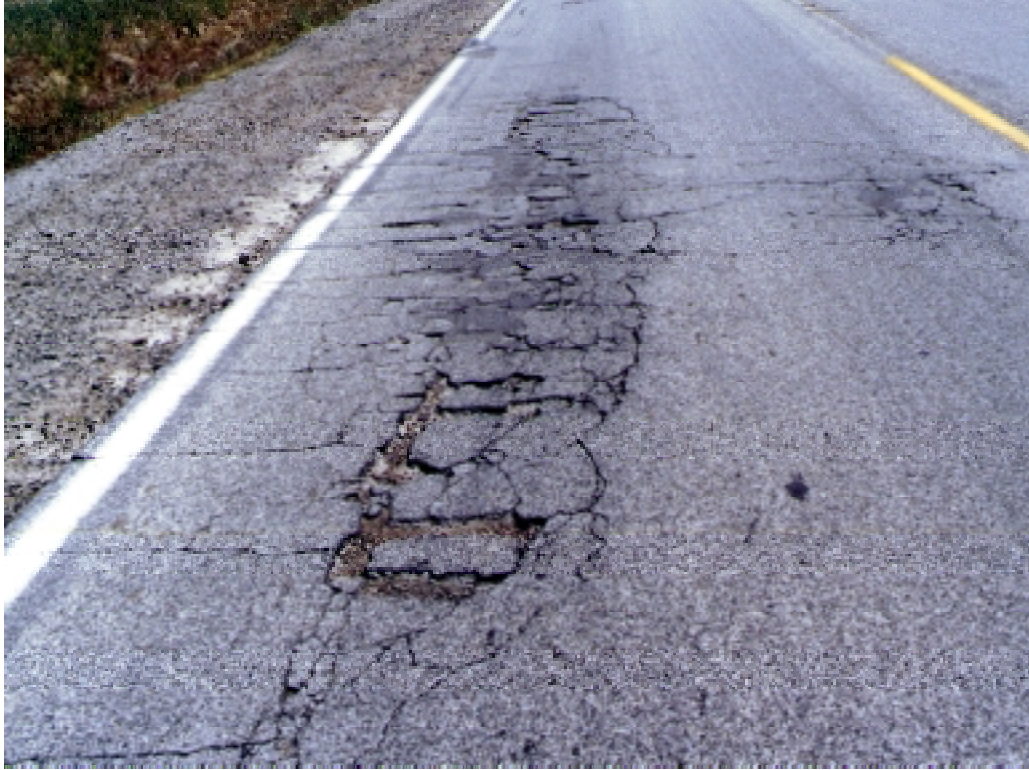
Figure 1. Typical distress visible on State Route 138.

The pavement is generally in poor condition throughout the entire project length. However, in terms of pavement rutting, the eastbound lane is in better condition than the westbound lane.

Longitudinal, transverse and fatigue cracking are visible in both lanes over the entire project length. The transverse cracking occurs at approximately 20-meter intervals. A small amount of raveling is also present. The entire pavement surface has been chip sealed and both Eastbound and Westbound Section 9 and Westbound Sections 12 and 13 have been slurry sealed.

Each 50-meter section had relatively similar distress in both directions. However, severe distress is evident at numerous isolated locations randomly distributed across the westbound lane. This may be due to an increase in the number of trucks, truck weight, or poor construction quality in the westbound lane.

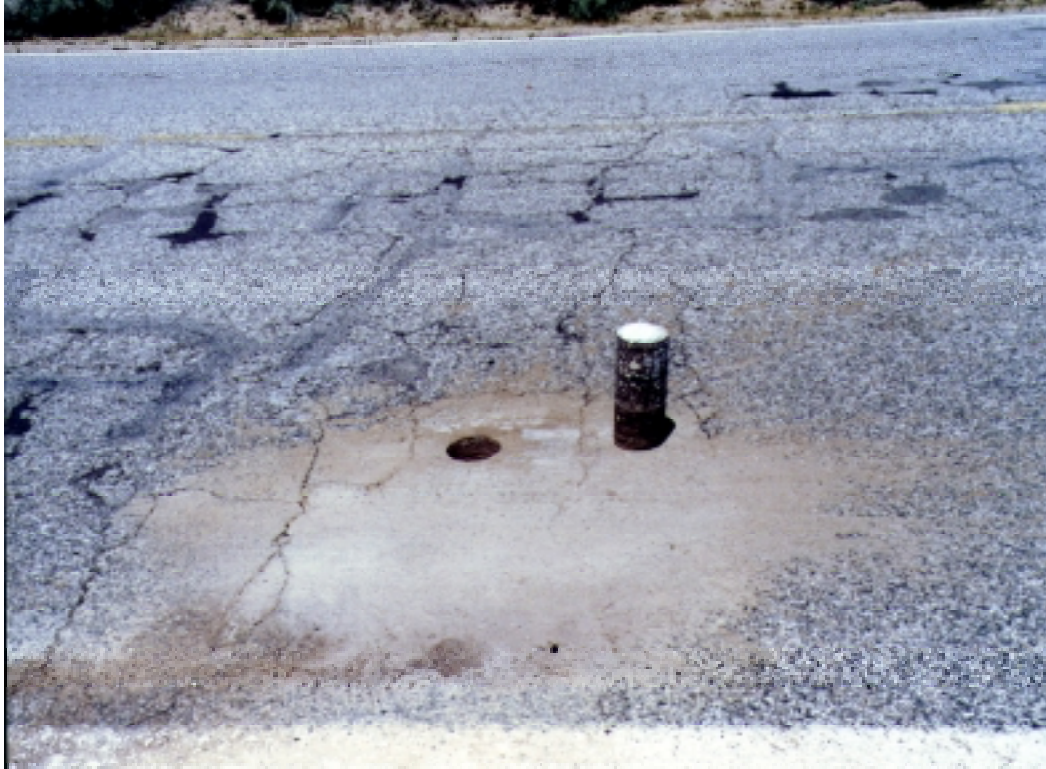
Figure 2. Typical pavement core for State Route 138.

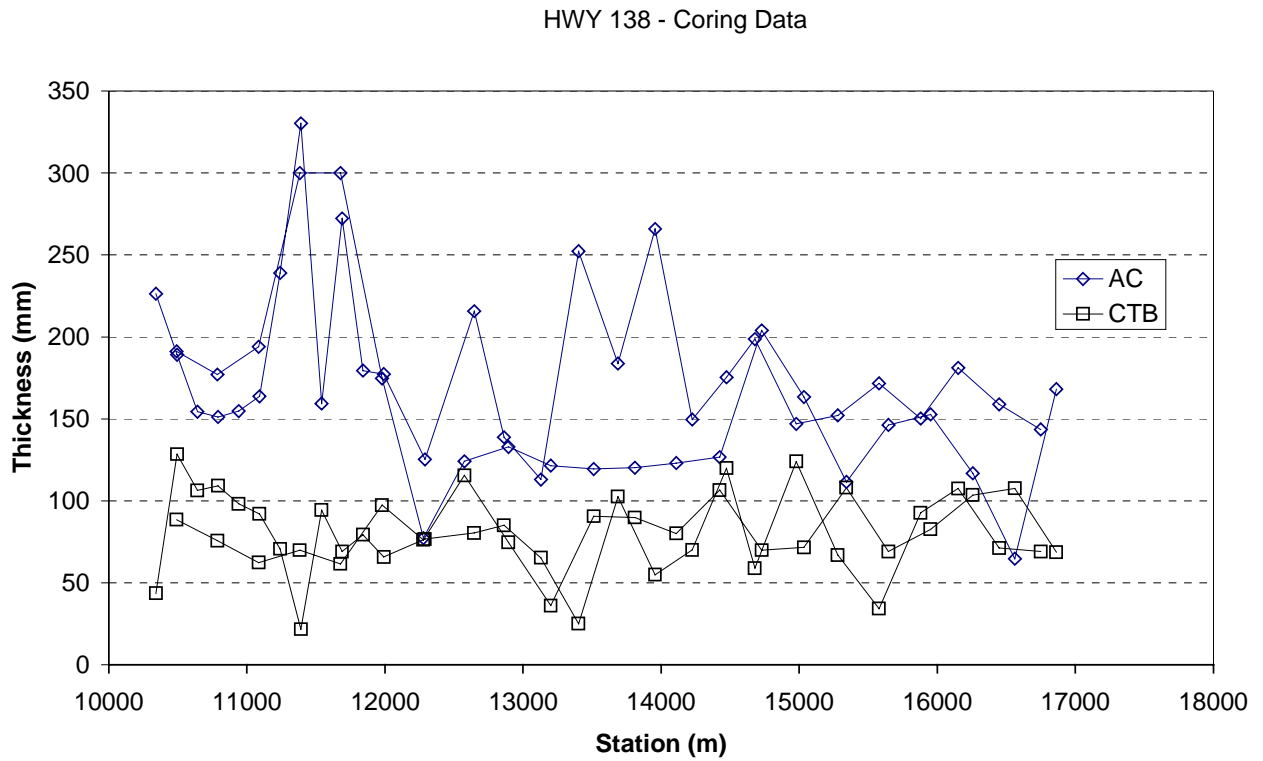
Figure 3. Coring profile for State Route 138.

The coring data was highly variable, as can be seen in Figure 3. The total pavement structural section varies between 150 and 325 mm. Of that total, the AC layer thickness ranges between 115 and 225 mm and the CTB layer thickness ranges between 35 and 125 mm. It is also evident from examination of the cores that there are several AC layers, i.e. “lifts.” During the coring operation, core separation was noted, which indicates a poor bond between the AC layers. However, there was little or no evidence of stripping of the AC. The number of layers varies between 3 and 6 and there is no consistency with regards to the change in thickness of each layer over the length of the project. Also, there is evidence of a fabric interlayer within the pavement. The interlayer exists between 100 to 250 mm above the subgrade. Again, there is no consistency in the AC thickness either above or below the fabric, as shown in Figures 8 and 9.

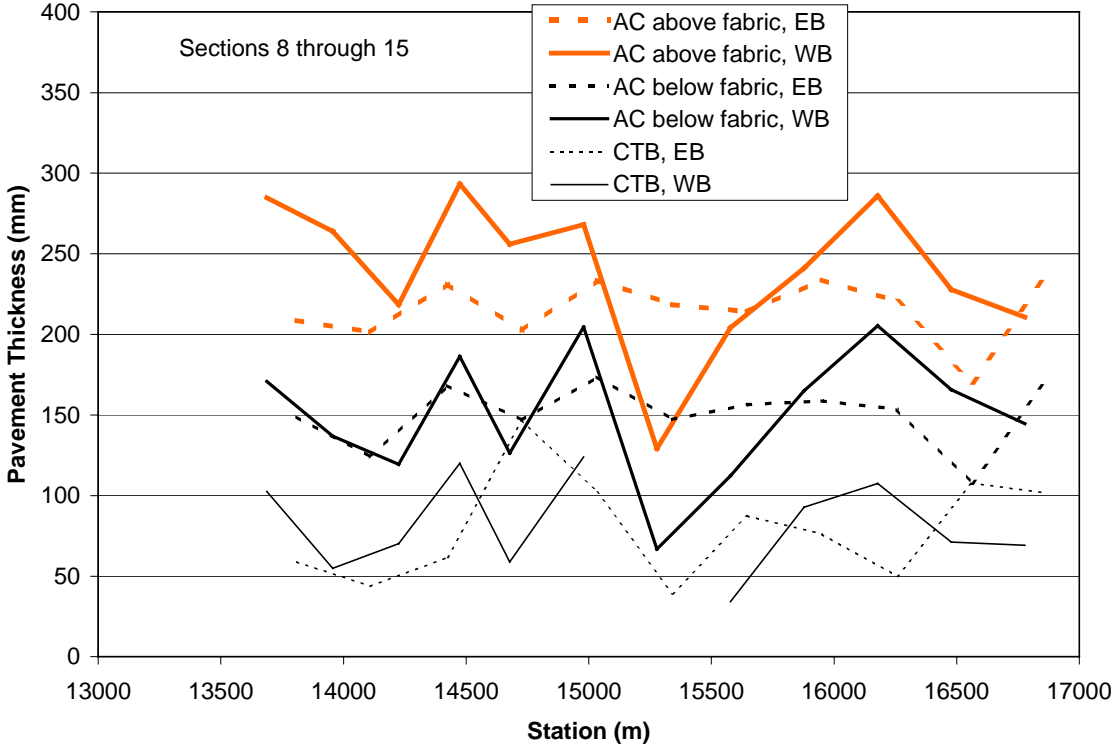
Figure 9. Layer thickness variability, Sections 8–15, State Route 138.

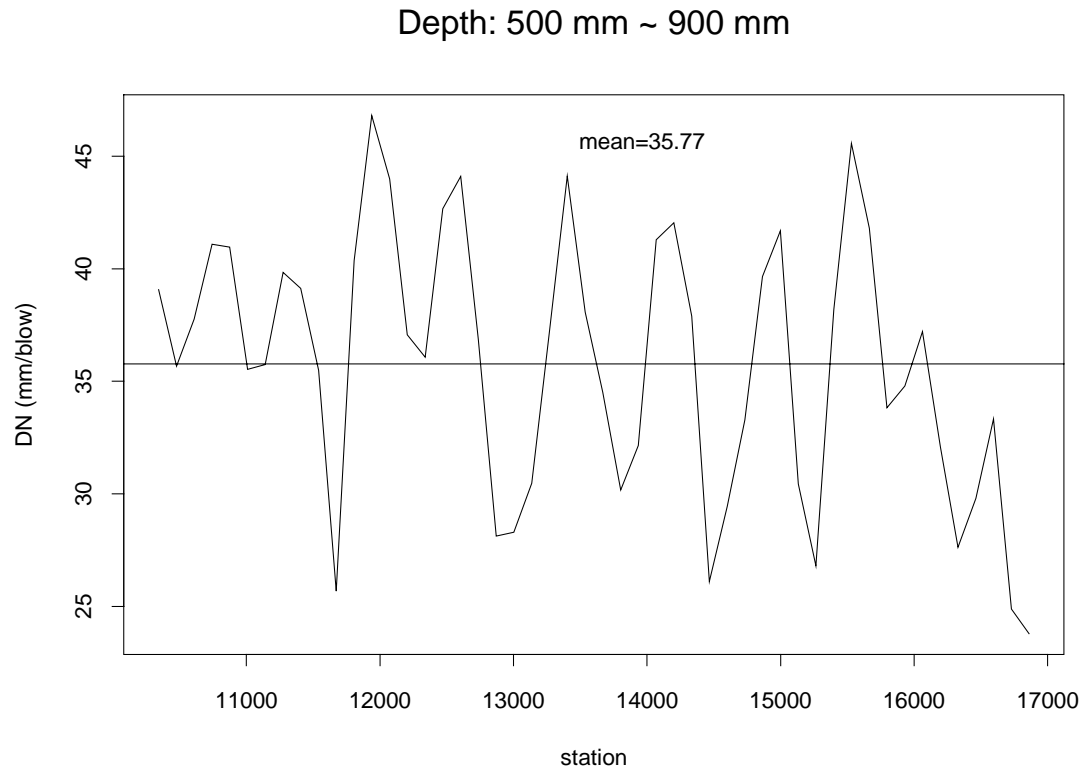
The mean DN for Layer 1 is 9.6 mm/blow and for Layer 2 it is 35.8 mm/blow. This is shown graphically in Figures 11 and 12.

The DCP results are highly variable throughout the entire project. Using the CSIR equation presented in Section 3.3, which correlates DN to effective modulus or stiffness of the material, the estimated stiffness of Layer 1 calculated from the mean DN is 101 MPa (14.6 ksi) and for Layer 2 is 25 MPa (3.6 ksi).

Figure 12. Layer 2 plot of DN versus Station for State Route 138.
