Engineering Reconnaissance following the October 2016 Central Italy Earthquakes - Version 2

Engineering Reconnaissance Following the October 2016 Central Italy Earthquakes *Version 2*

Geotechnical Extreme Events Reconnaissance Association
Report No. GEER-050D
8 May 2017

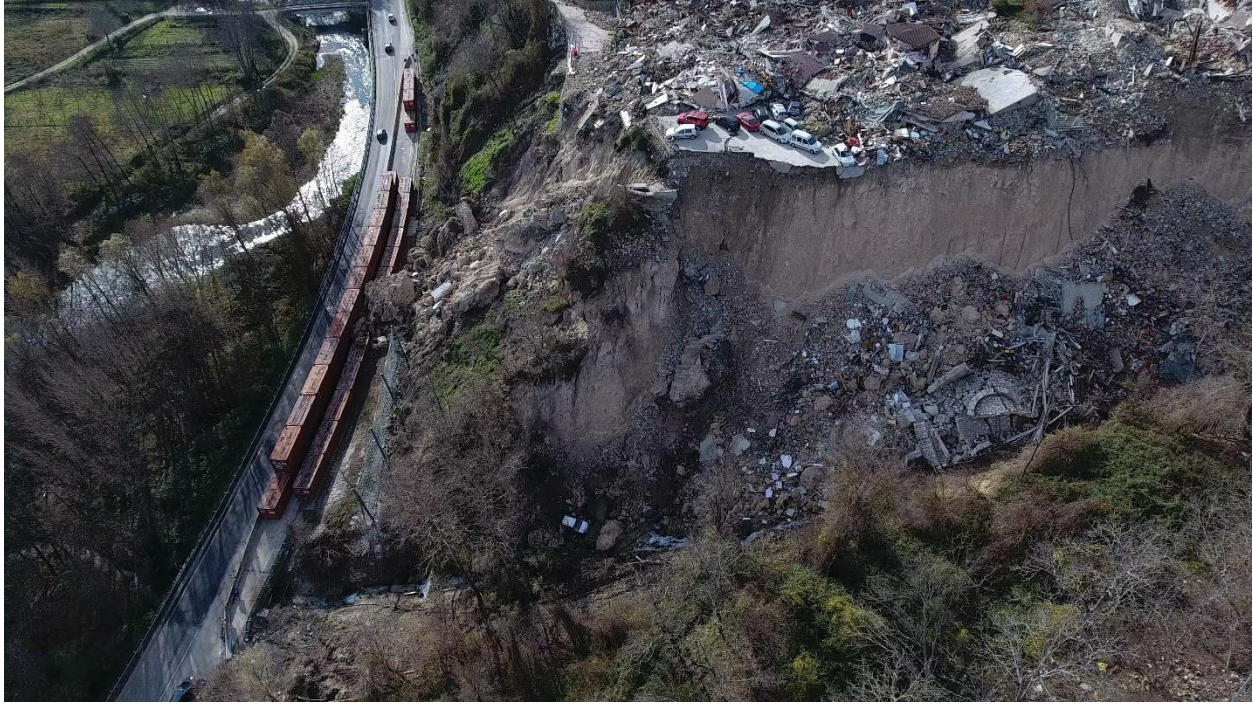
Figure 4.15. View of talus behind failed retaining wall by Strada Statale No. 4 (Location 3b).

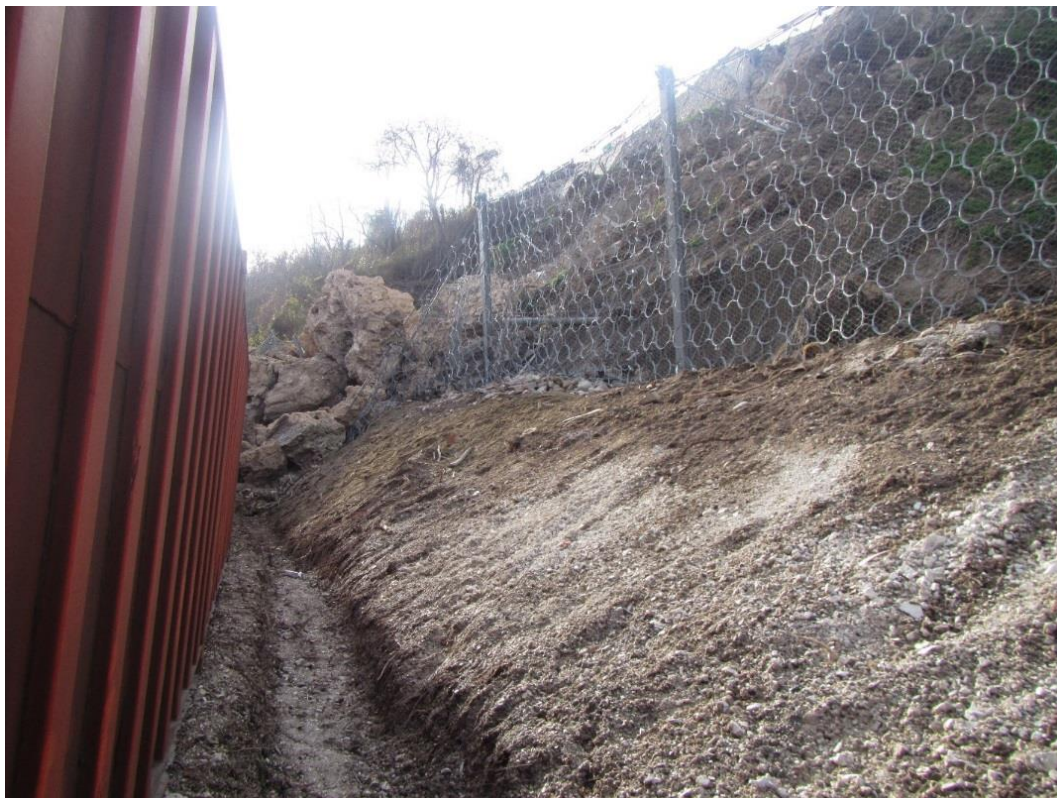
Figure 4.19. View of damaged rockfall netting caused by loose debris material from the landslide above Strada Statale No. 4 (Location 3d).

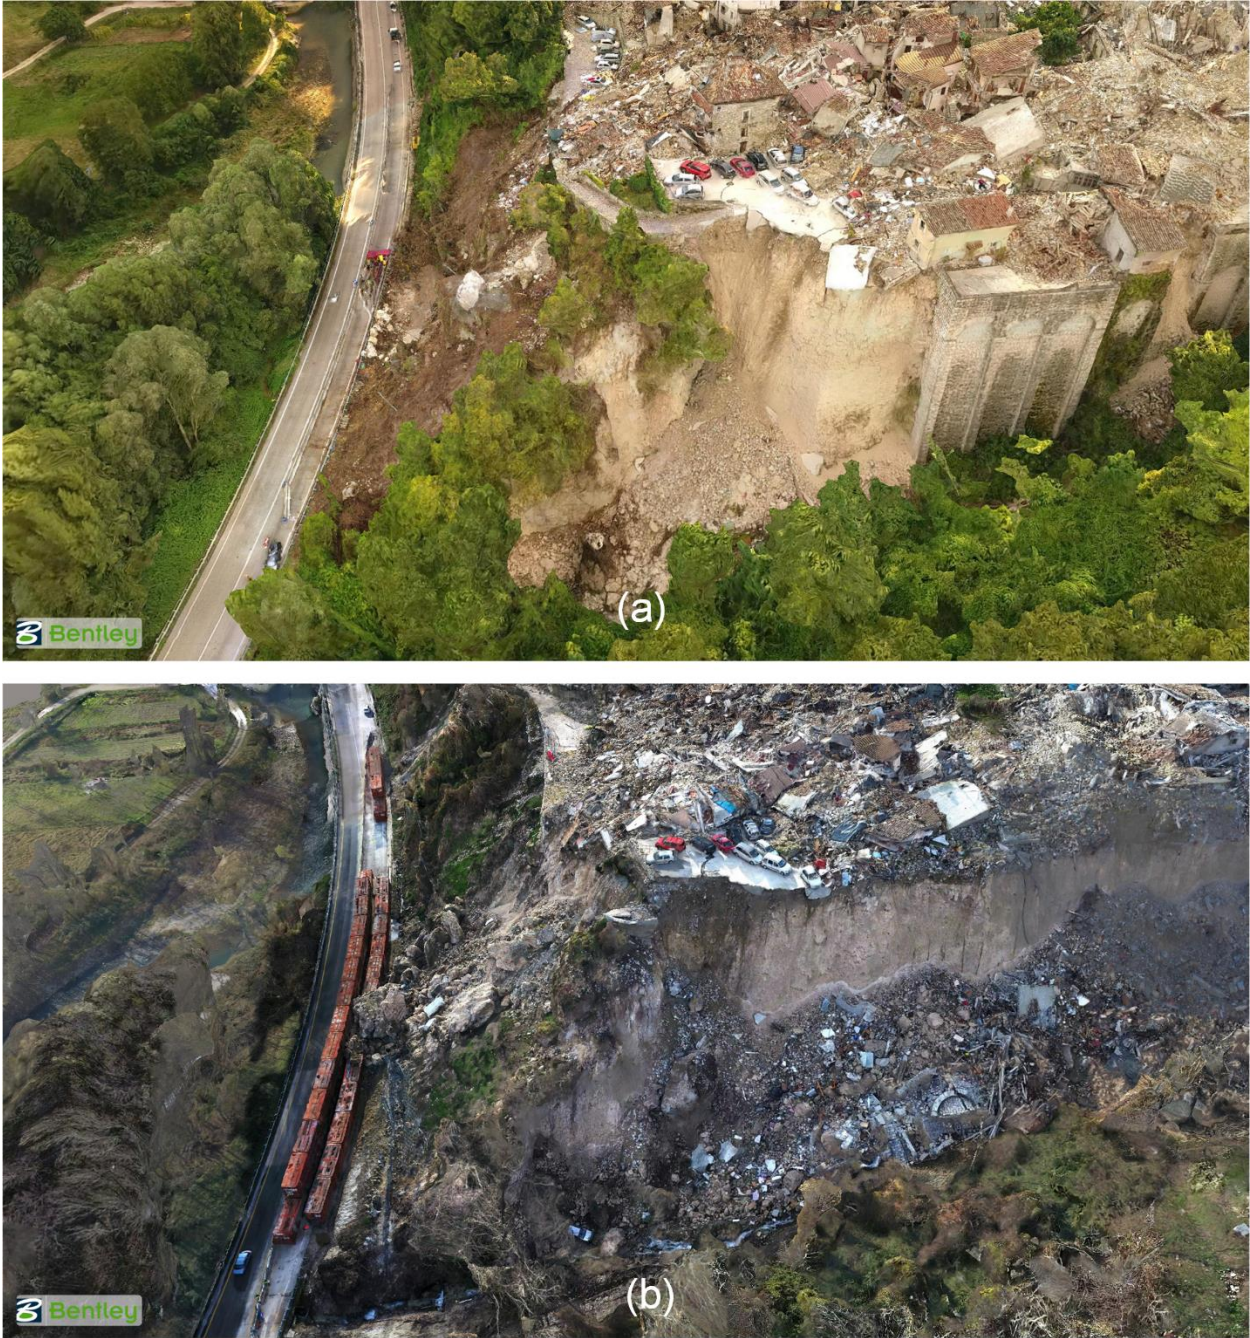
Figure 4.24. 3D model comparison of the failed retaining wall below Pescara del Tronto between September 2016 (a) and December 2016 (b).

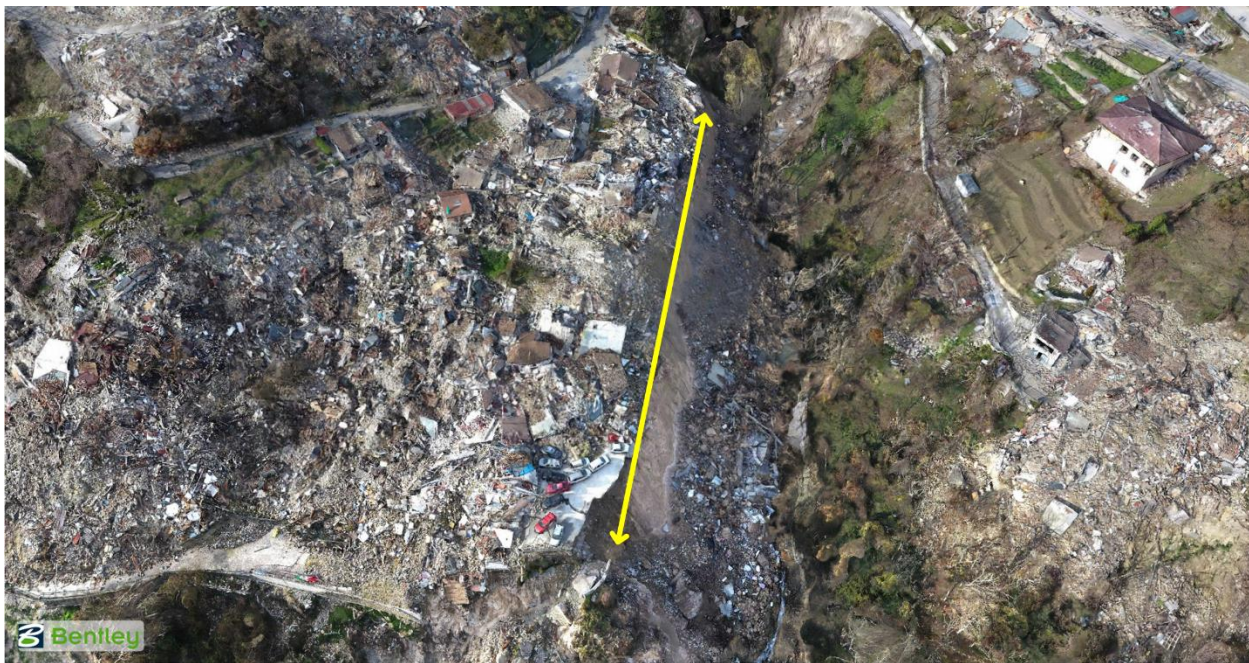
Figure 4.25. 3D SfM model view of scarp linearity behind failed lower retaining wall in Pescara del Tronto.

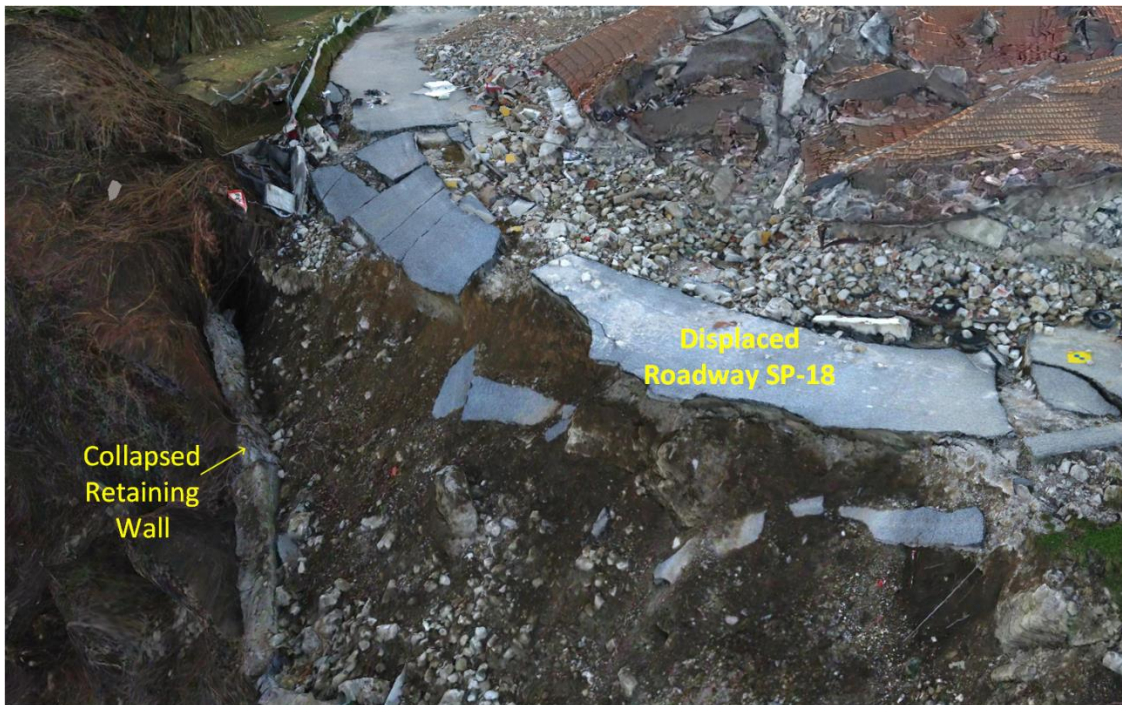
Figure 4.33. 3D model screenshot of the destroyed roadway Frazione Fonte del Campo (i.e., SP-18).

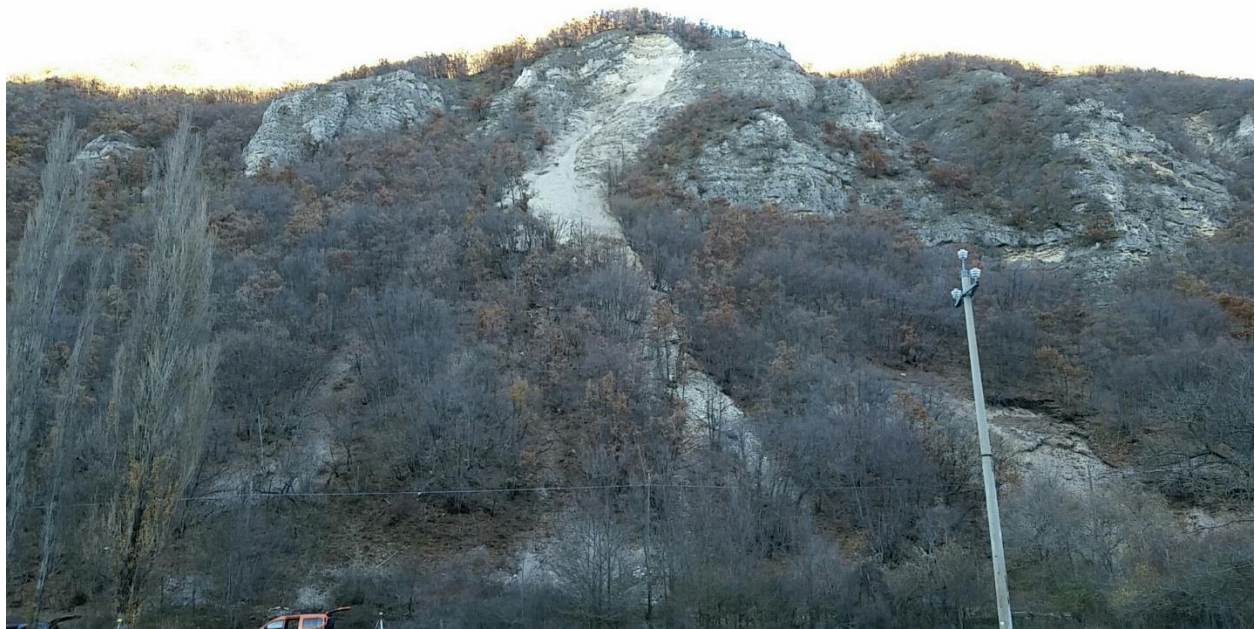
Figure 4.60. Pescia rockfall site 9b. Source area at top with runout damage. Not pictured: runout boulders across road and into field, corresponding to approximate 30 degree Fahrboeschung angles.

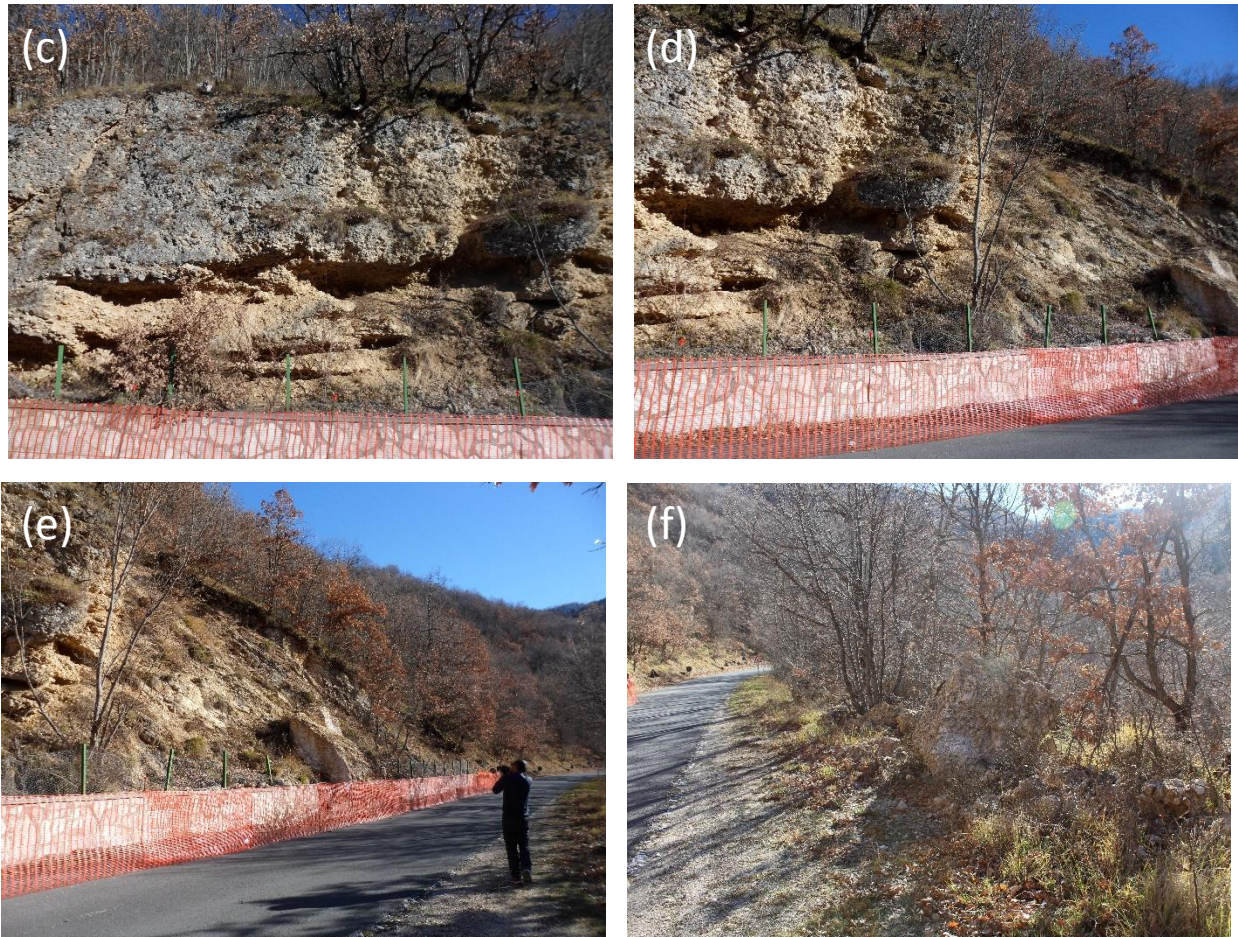
Figure 4.89. Failure in calcareous breccia between Cittareale and Norcia along the SP746: from (a) to (e) view of the all facade; (f) rockfall on the road.

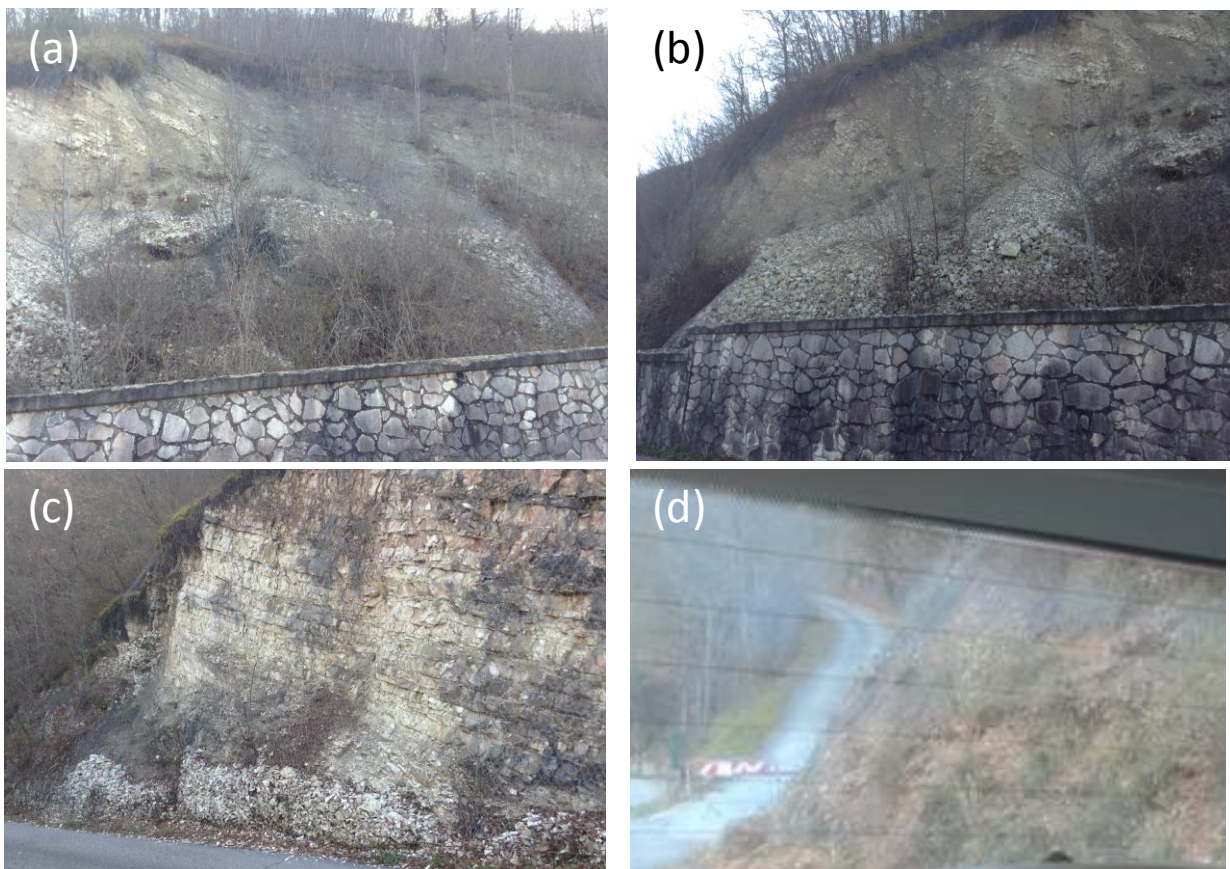
Figure 4.99. Observed rockfalls along SP476 (between Piedivalle and Preci).
