The Present Status of the Bevatron Power Supply

THE PRESENT STATUS OF THE BEVATRON
POWER SUPPLY

UCRL-8345 Rev.
Particle Accelerators
and High-Voltage Machines

November 1, 1958

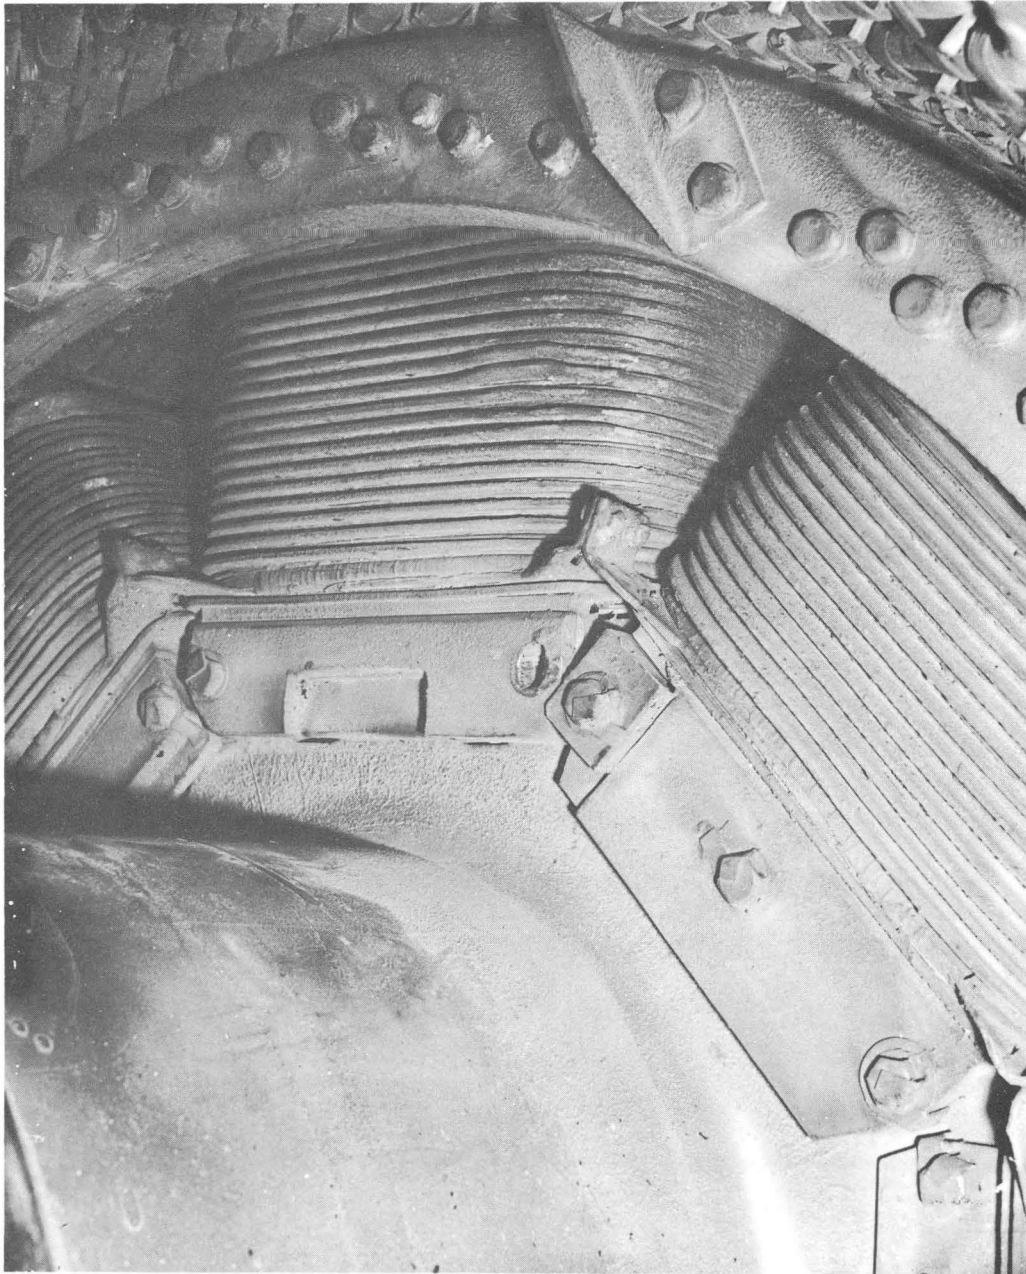
ZN-1992

Fig. 3a. Power-supply damage: broken bolt on generator rotor.

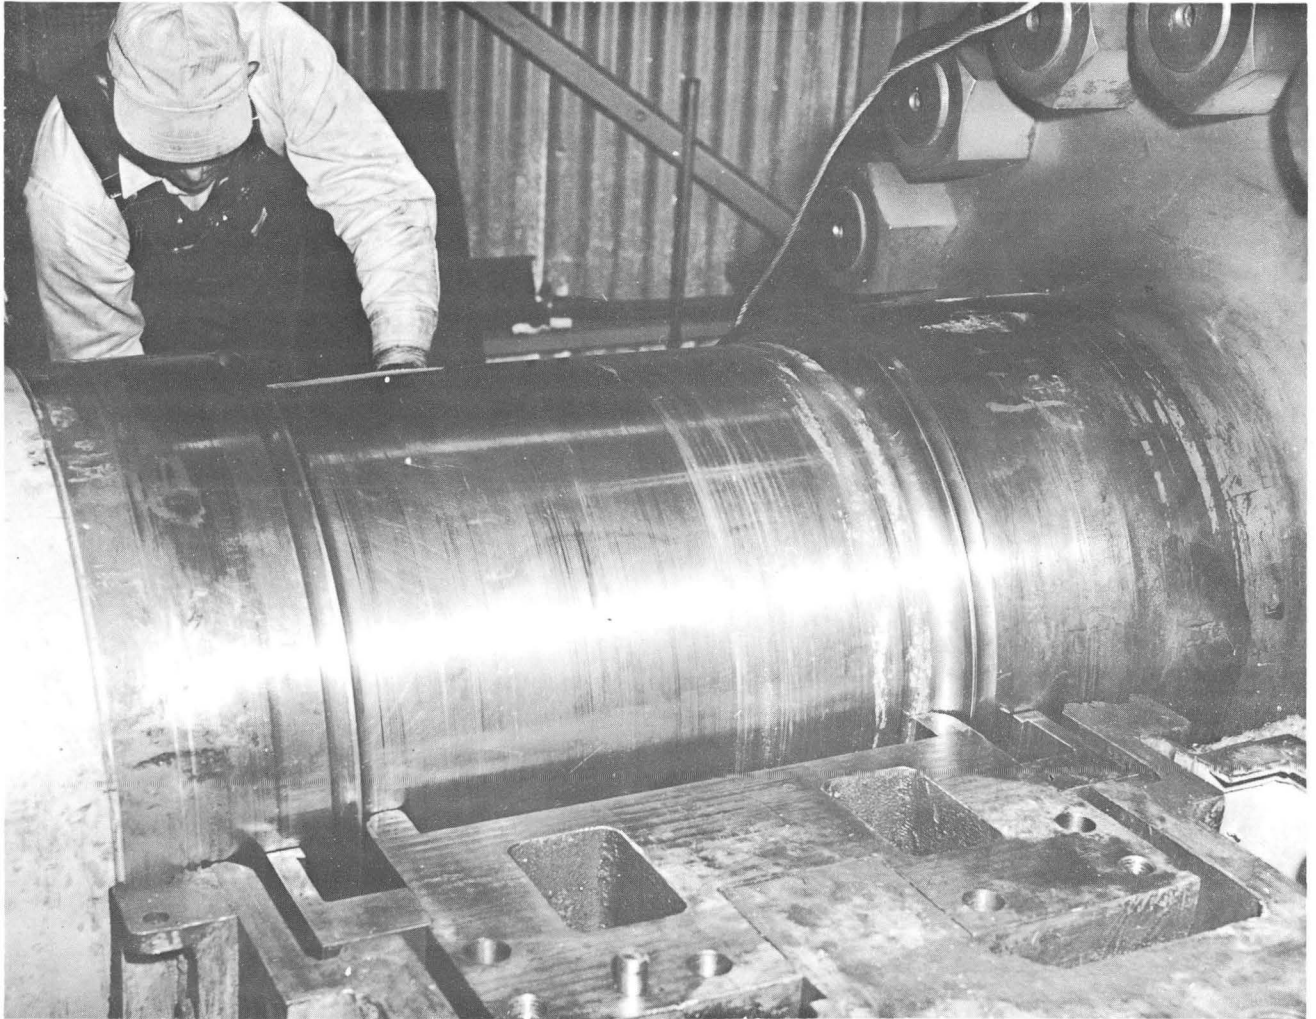
ZN-1993

Fig. 3b. Power-supply damage: damage to generator journal from short-circuit currents caused by broken bolt.

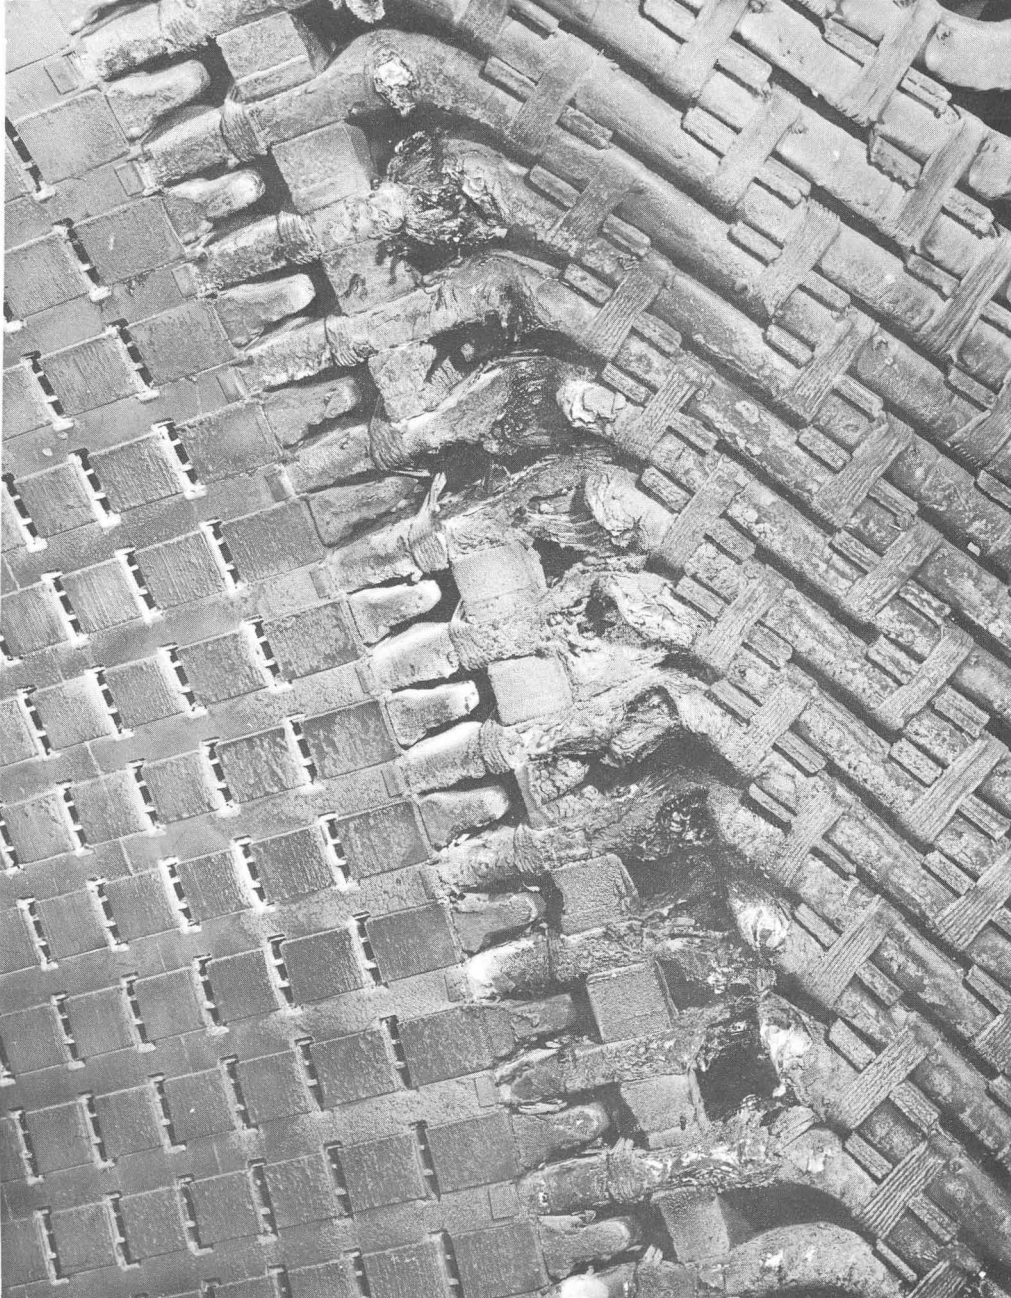
ZN-1994

Fig. 4. Generator stator damage.

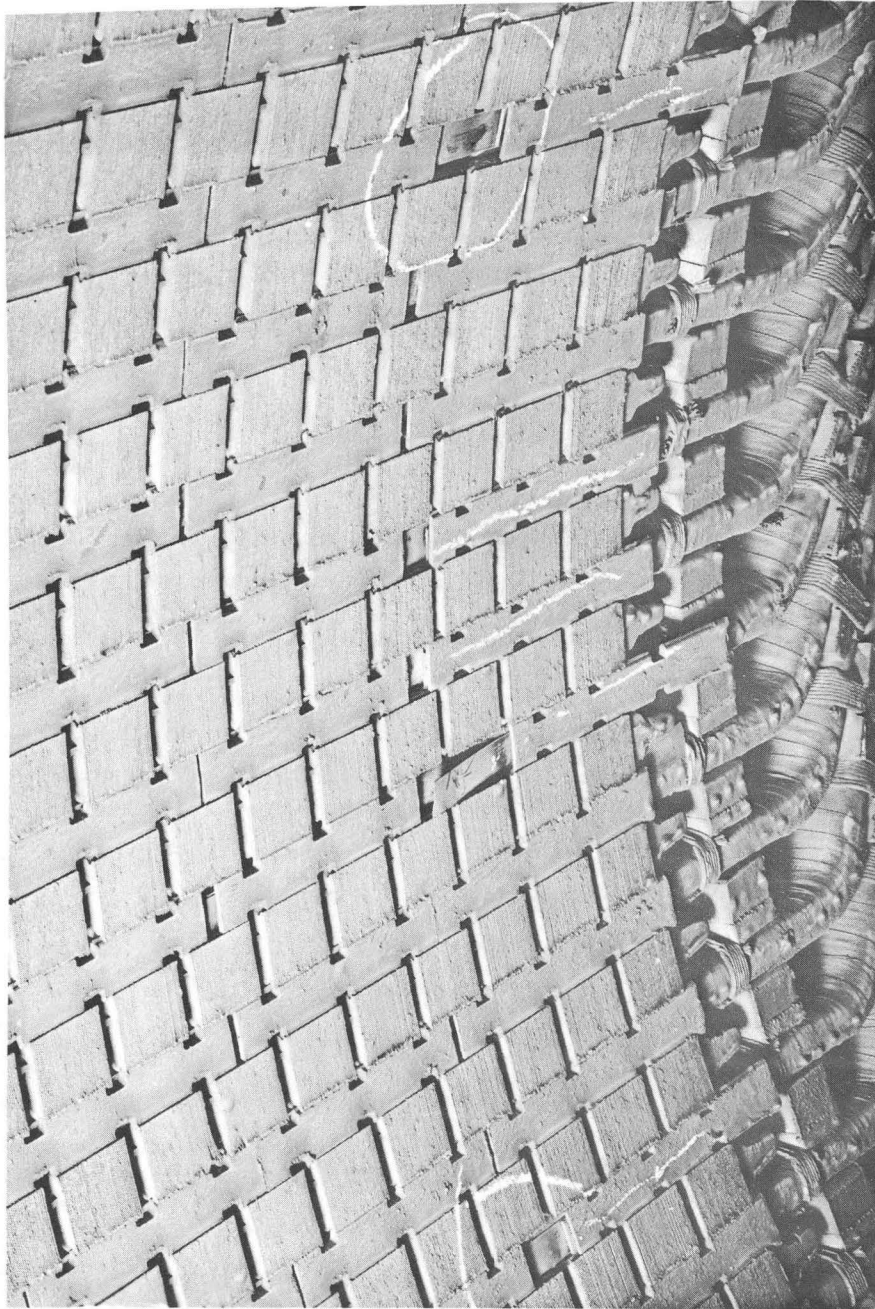
ZN-1995

inadequate. Some wedges moved axially (Fig. 5), and in one case released a stator coil which fell into the air gap and struck the rotor (Fig. 6). This failure occurred during start-up and was detected before the field current was built up. Only minor iron damage resulted although the coil was destroyed.

Fig. 5a. Generator stator: wedge movement.

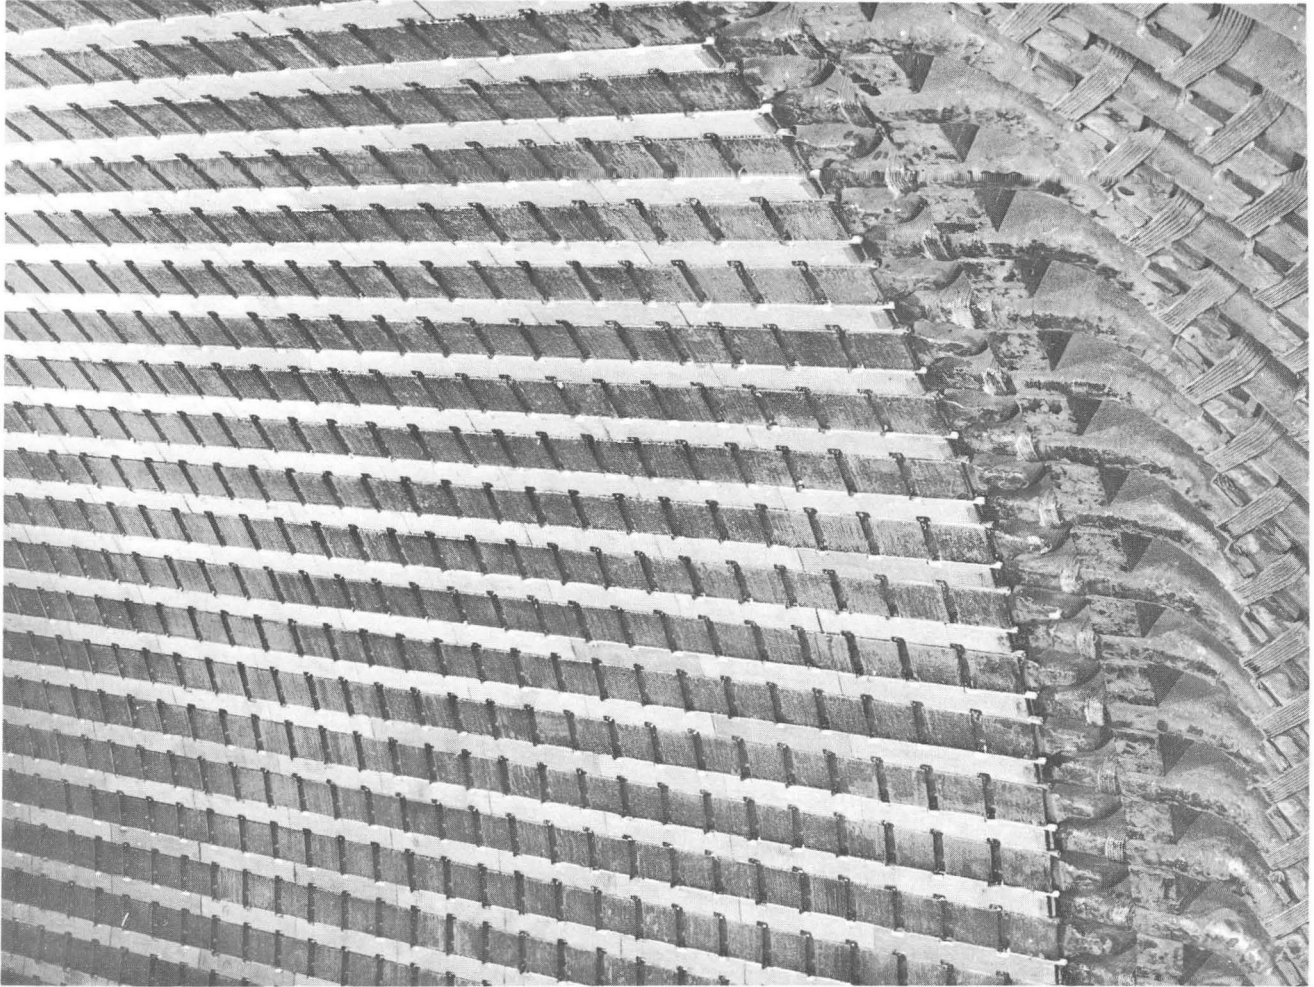
ZN-1996

Fig. 5b. Generator stator: new stator wedge locks.

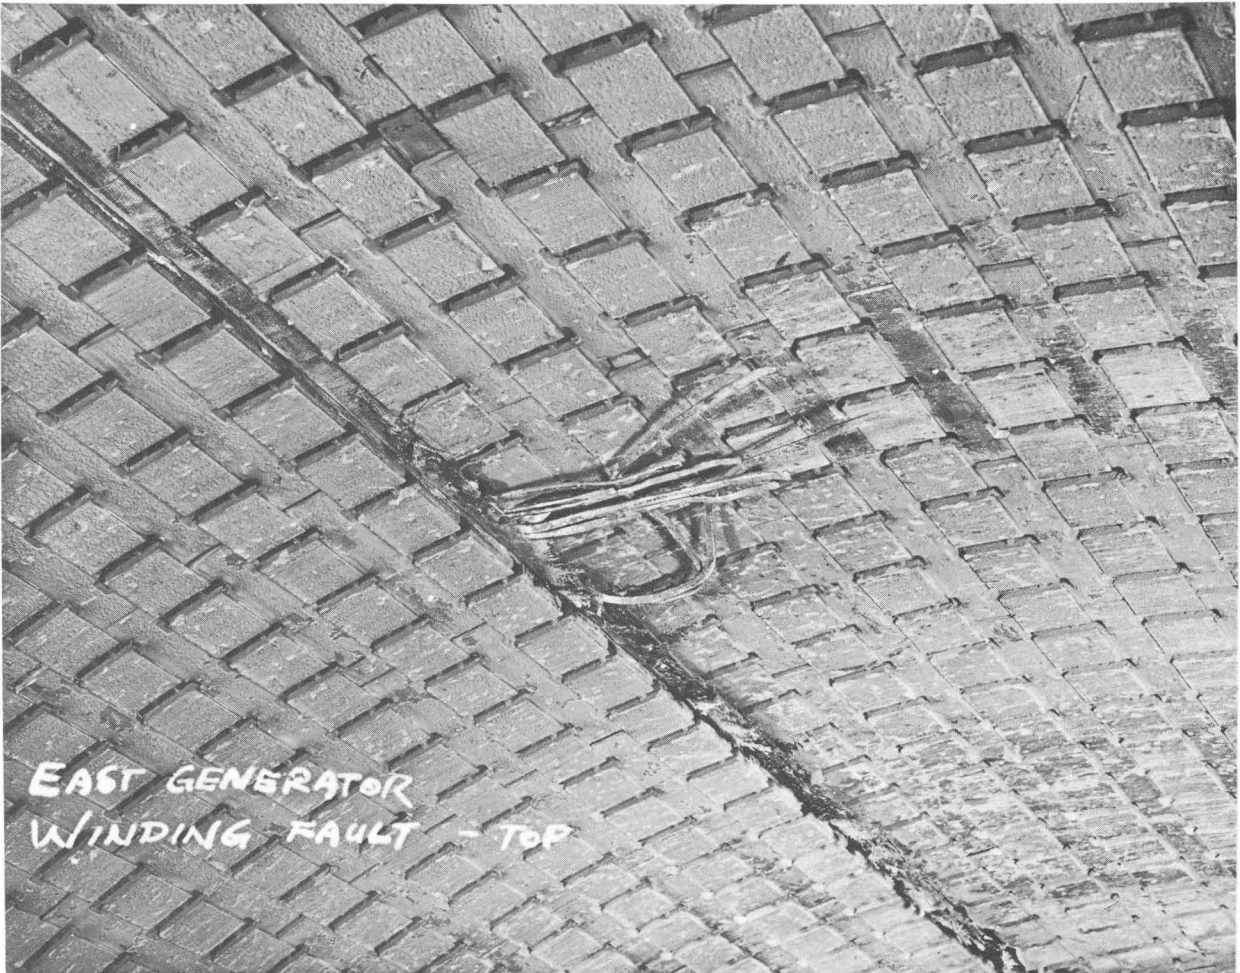
ZN-1997

Fig. 6. Coil turns protruding from generator stator.

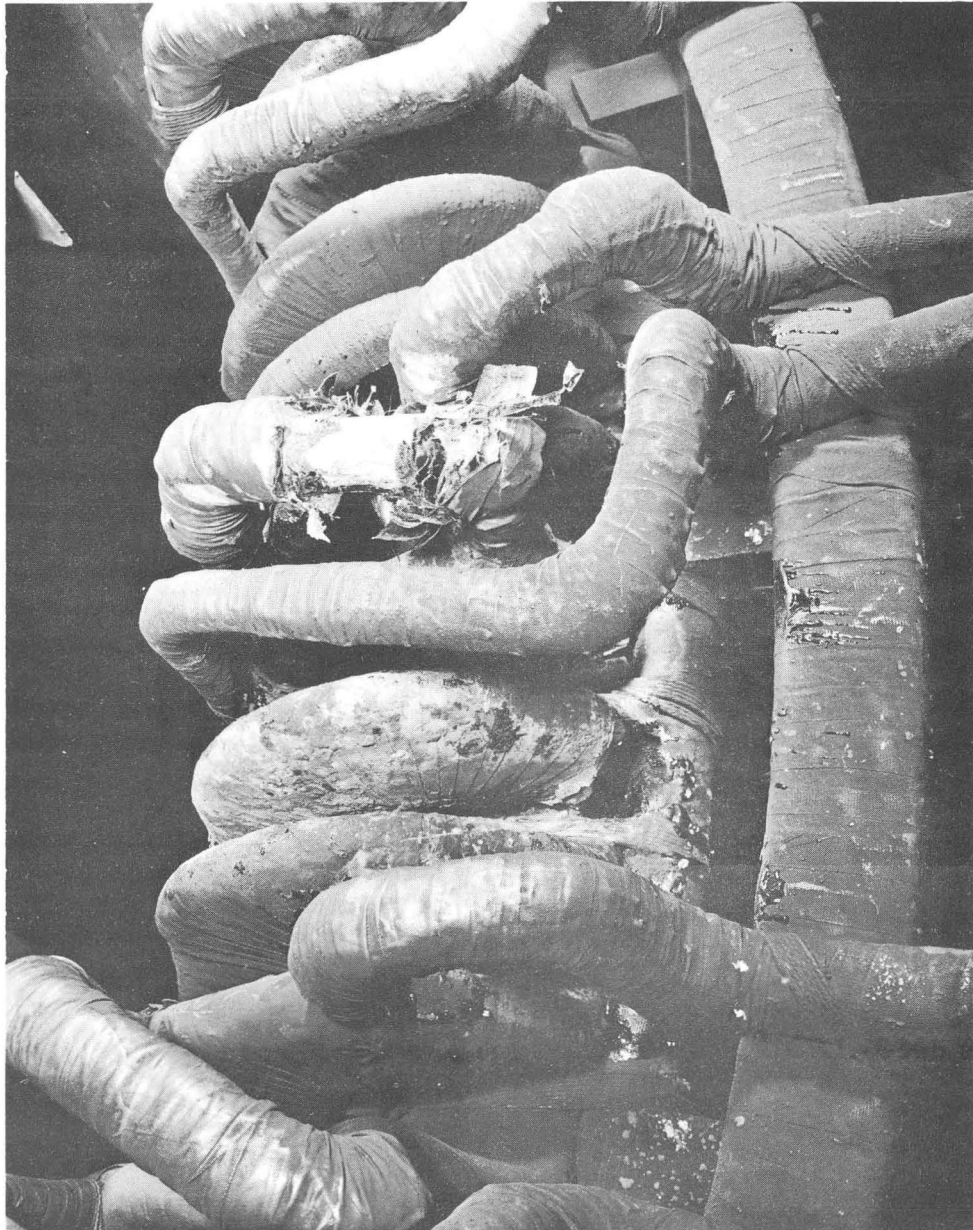
ZN-1998

Owing to commutation transients, abnormally fast voltage spikes of 5 kv per μ sec appear across the generator windings. The end-turn insulation failed in one generator, resulting in a fire and damage to 16 coils. (Fig. 7). (Ten new coils were installed and six damaged coils repaired.) Short-circuit paths for these transients have been provided to prevent future damage. Resistance-capacitance and pure capacitance circuits were tried between phase and neutral, and oscilloscope measurements were made to determine the most effective circuit. The final choice was 0.7 μ f to neutral on each phase, which gave a transient rise time of 1 kv per μ sec.

Fig. 7. Coil knuckle damage in generator stator.

The capacitors were fused at first, but the high harmonic current melted the fuses open, allowing them to explode. The solution to this new trouble required a fuse of sufficient interrupting capacity to clear a phase-to-neutral short in case of a capacitor failure, and sturdy enough to last under the harmonic-current heating. The fuses are available, but no method of monitoring for open fuses has been satisfactory. At present the capacitors are not fused, and to date no capacitors have failed. Periodic high-potential tests guard against faulty capacitors.

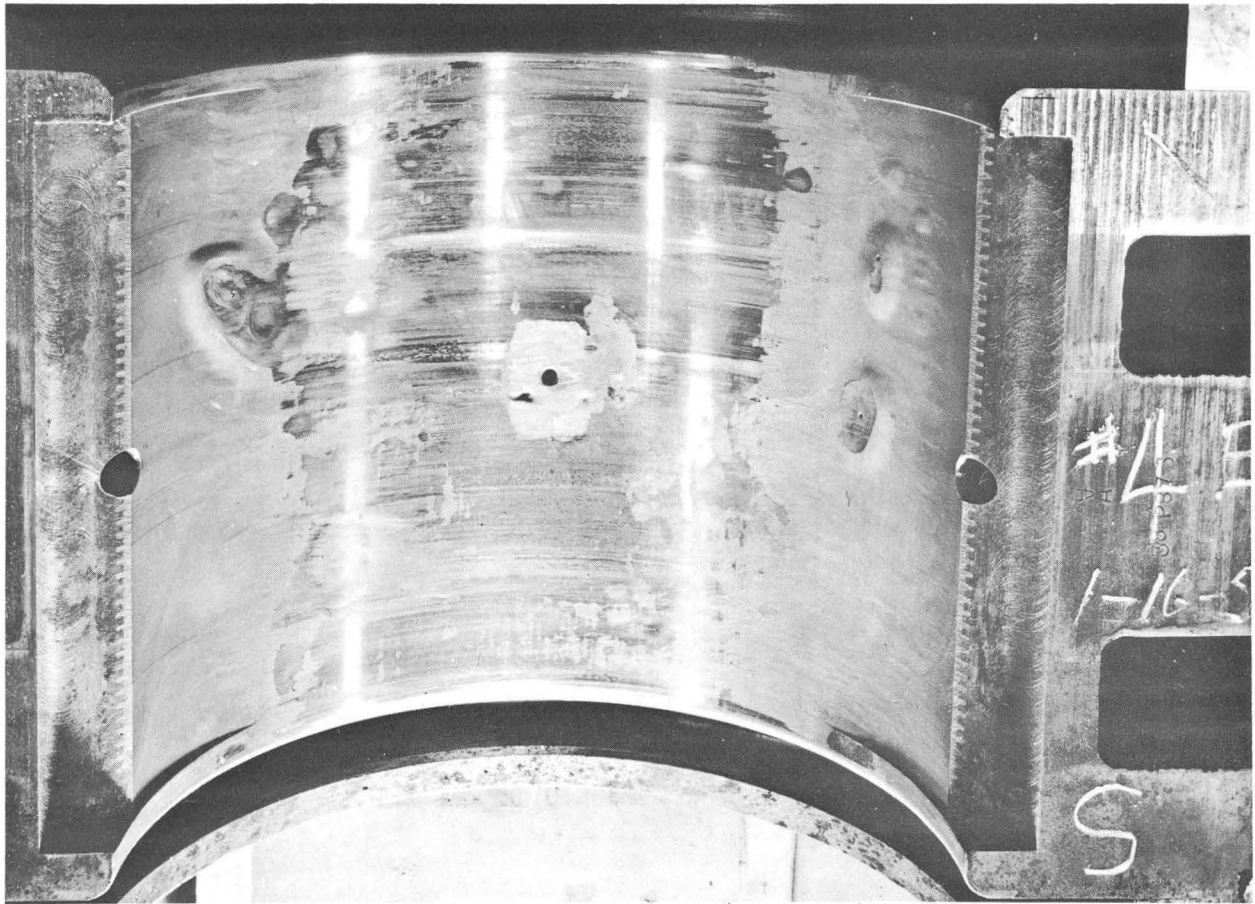
ZN-1999

The bearings are babbitt faces poured on steel shell. After about two years of operation it was found that a bearing would suddenly run hot for a few hours or days and then revert to normal temperature. When these bearings were inspected, it was found that the babbitt had been raised up in blisters and had touched the shaft. The top of the blister had then wiped free of the shaft (Fig. 8). The blisters were drilled and high-pressure hydrogen escaped. The blisters were scraped down, smooth with the original babbitt surface. A pattern of 1/16-in. holes was then drilled through the babbitt to provide a release for future hydrogen accumulation. We conclude that the hydrogen-blister problem is solved.

Fig. 8. Hydrogen blisters on lower half of generator bearing.

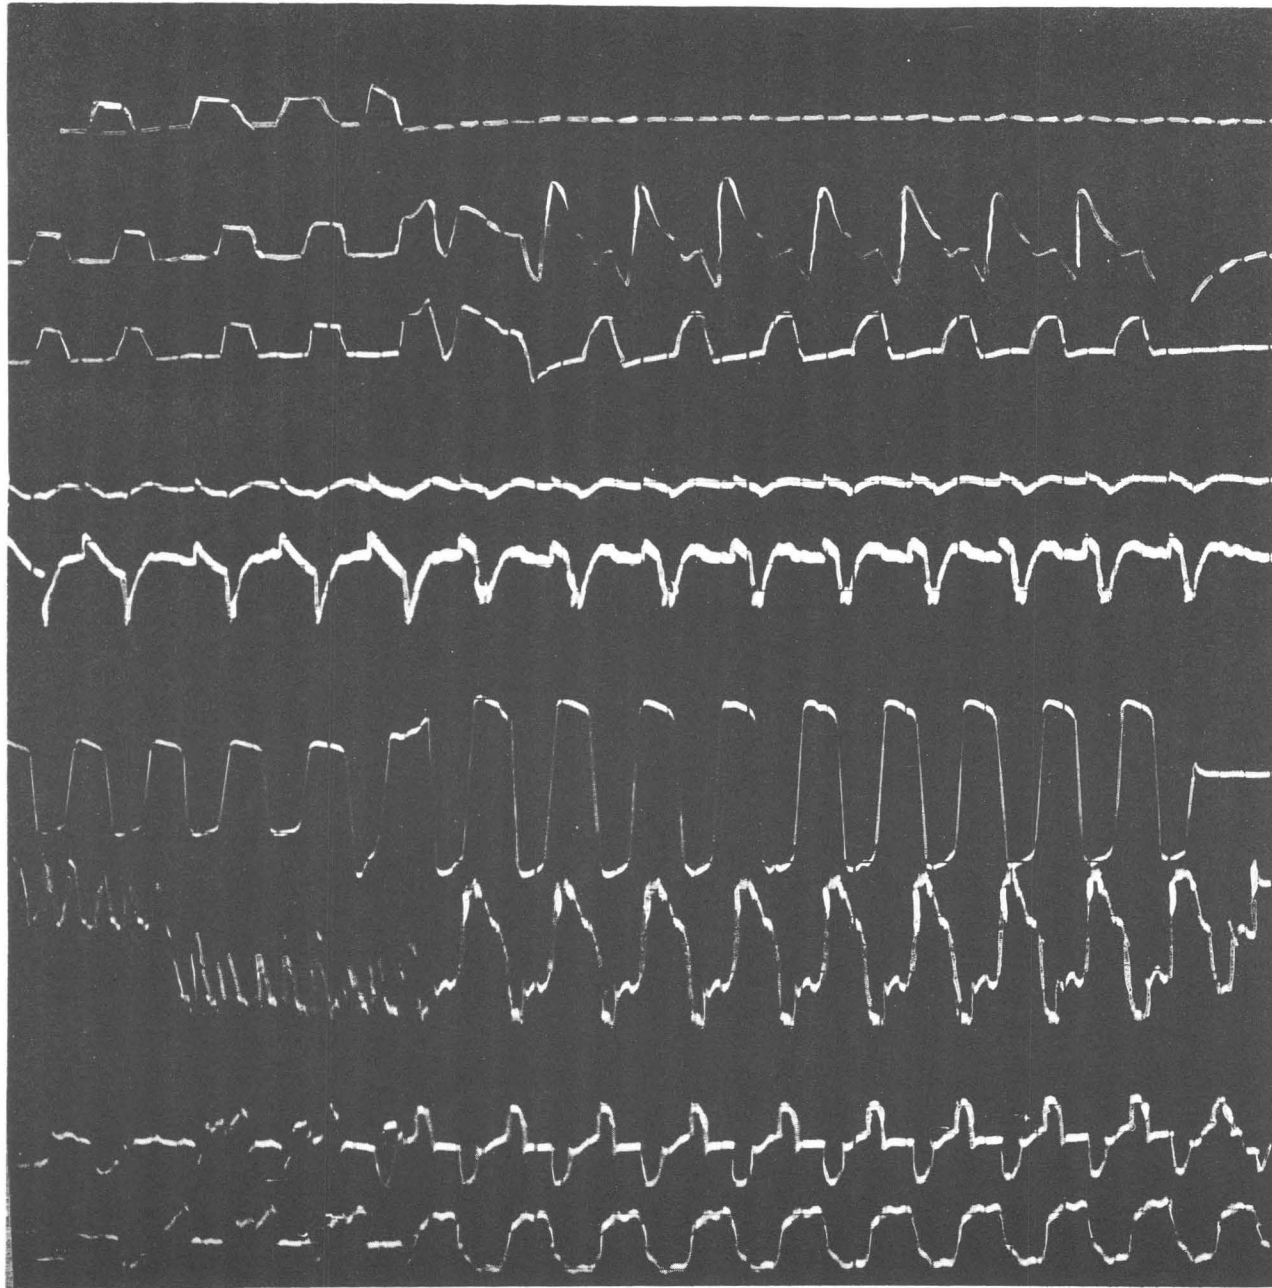
ZN-2088

Fig. 11a. Inversion faults: following current flip.

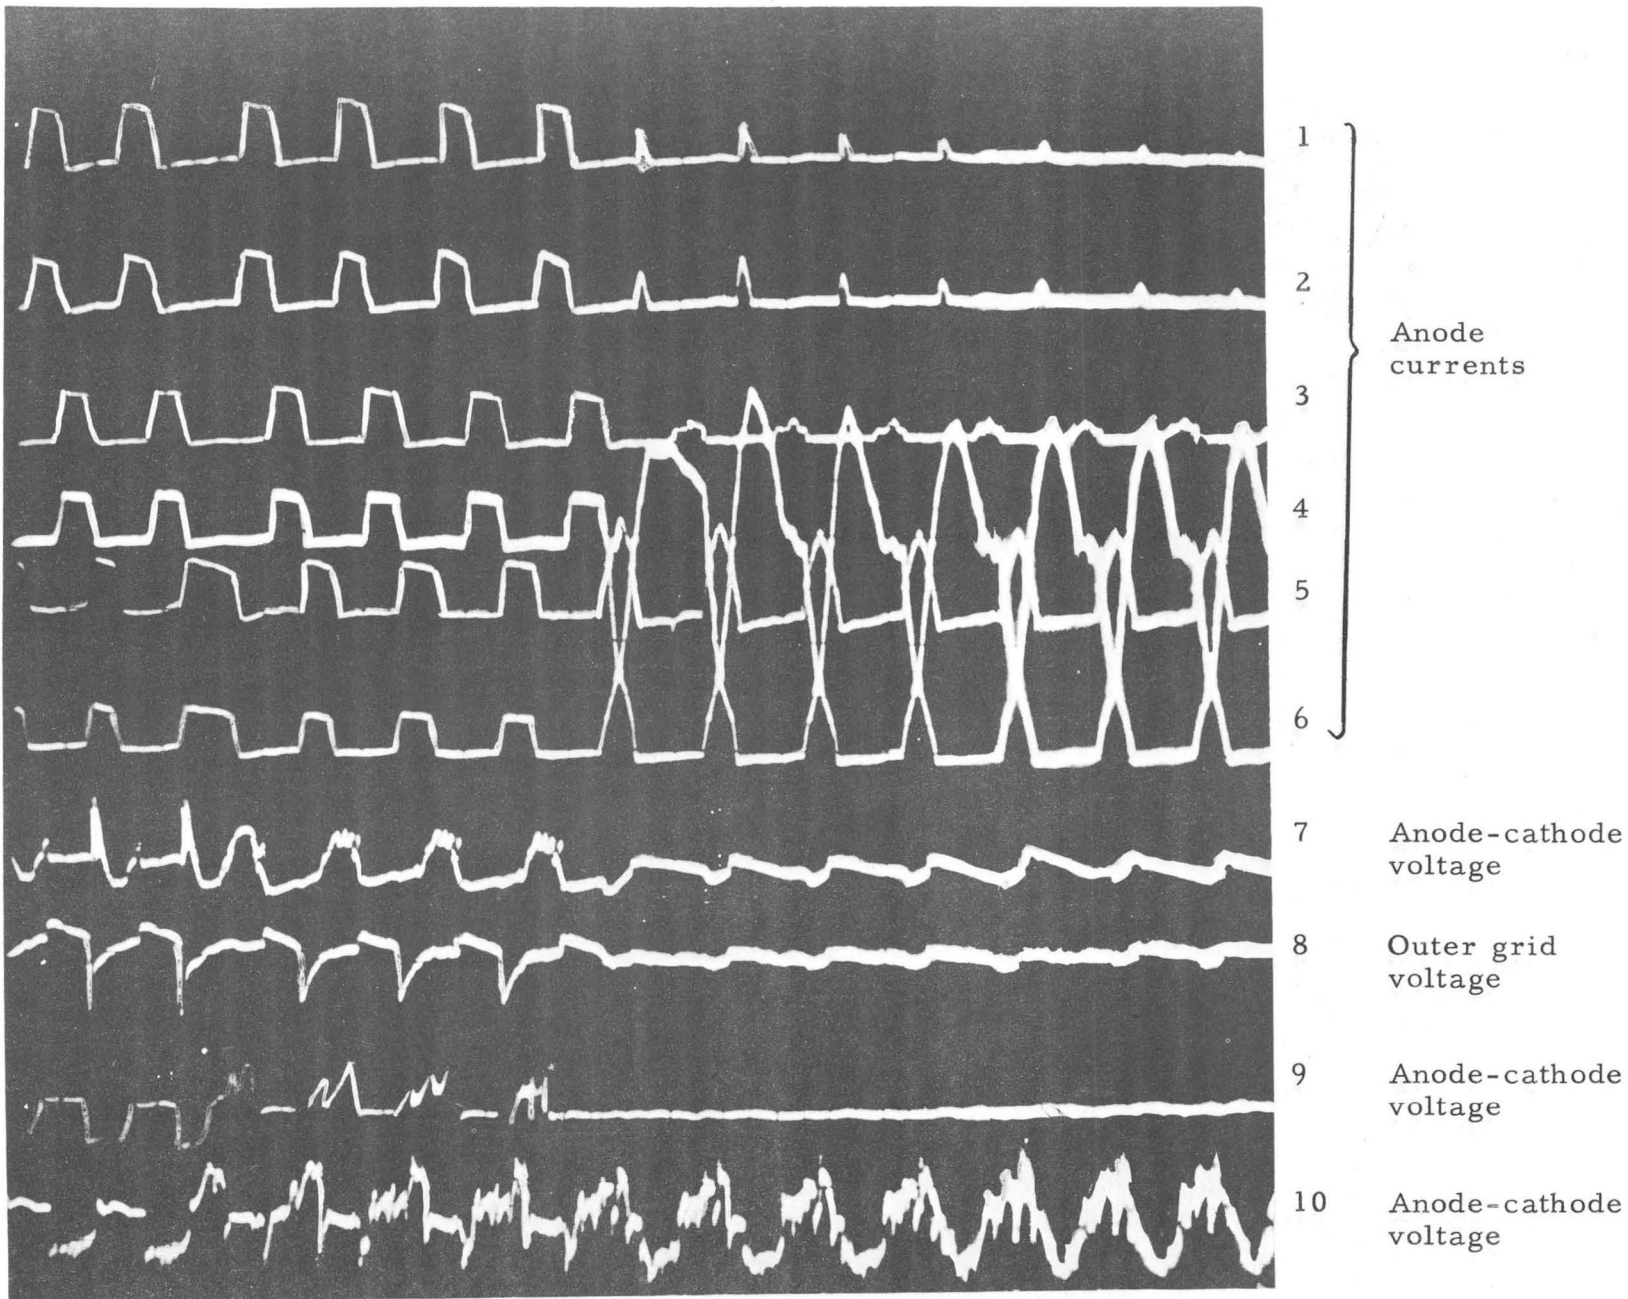
ZN-2089

(a) Arc-throughs following an arc-back. The arc-back occurs after conduction stops and at the instant of initial inverse voltage. Figure 11b shows how an ignitron might "lock-in" to this type of faulting. In examining the current transformer traces, allowance should be made for the poor positive current-pulse traces due to the high dc level through the transformer at peak current. This is the most frequent type of arc-through on the Bevatron power supply. At this time the ignitron is subjected to an inverse voltage of 7500 volts with a rise time of 100 μ sec and a decay of tube current from 2100 amp to zero in 800 μ sec. In the spring of 1958, cushioning circuits consisting of a series capacitor and resistor were connected from anode to cathode of each ignitron. To minimize power loss the values of capacitance and resistance are being optimized. Present units are 3 μ f and 30 ohms per phase.

Fig. 11b. Inversion faults: on anode 4, starting with inversion arc-back.

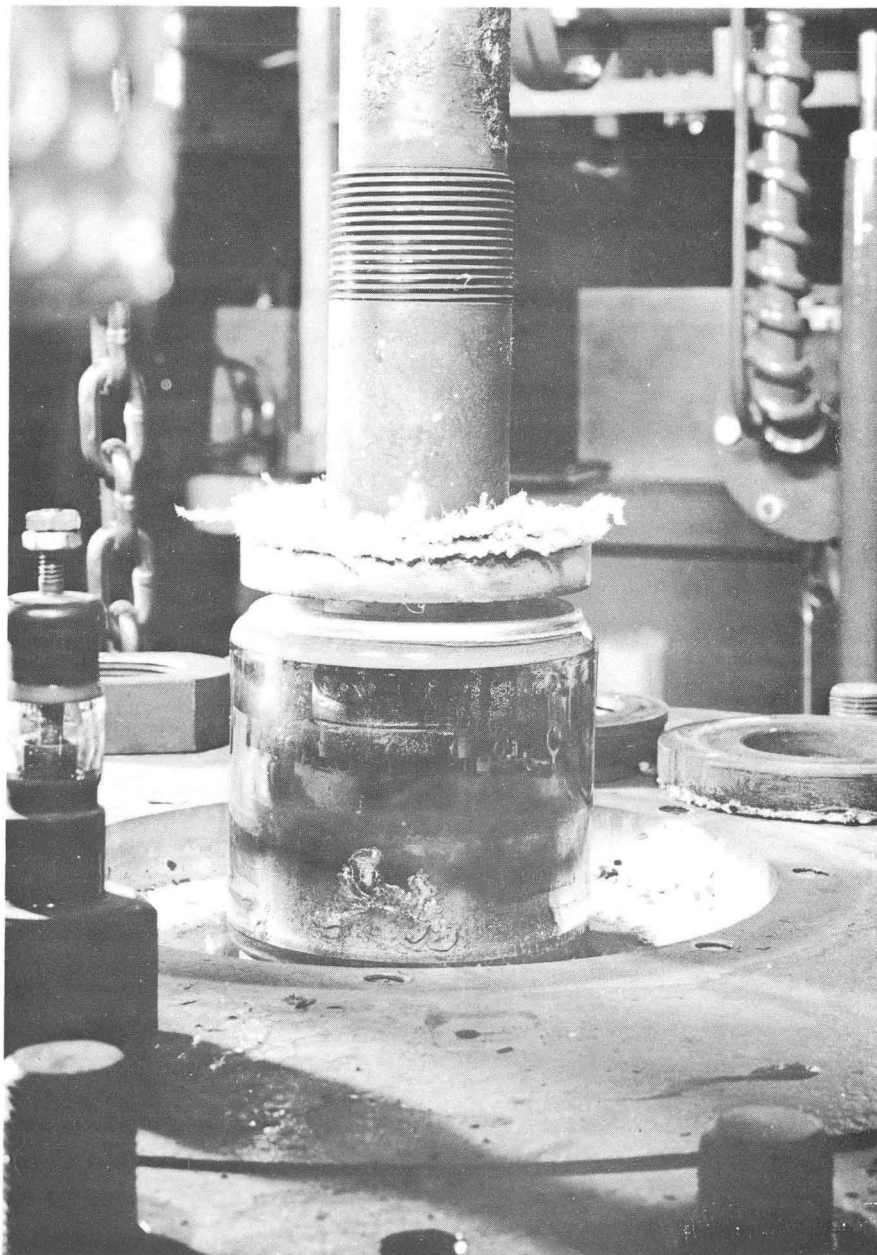
ZN-2000

There are no anode circuit breakers to interrupt this current. During this period the tube carries unidirectional fault current, the arc leaves the mercury pool and travels to the cathode potential parts near the anode. The metal parts are melted from the excessive heat; the glass anode bushing acquires internal surface cracks and, in some cases, the bushing is destroyed.

Fig. 14a. Ignitron anode-stem insulator: spalling and plating of glass anode bushing--grid bushing to left of anode bushing.

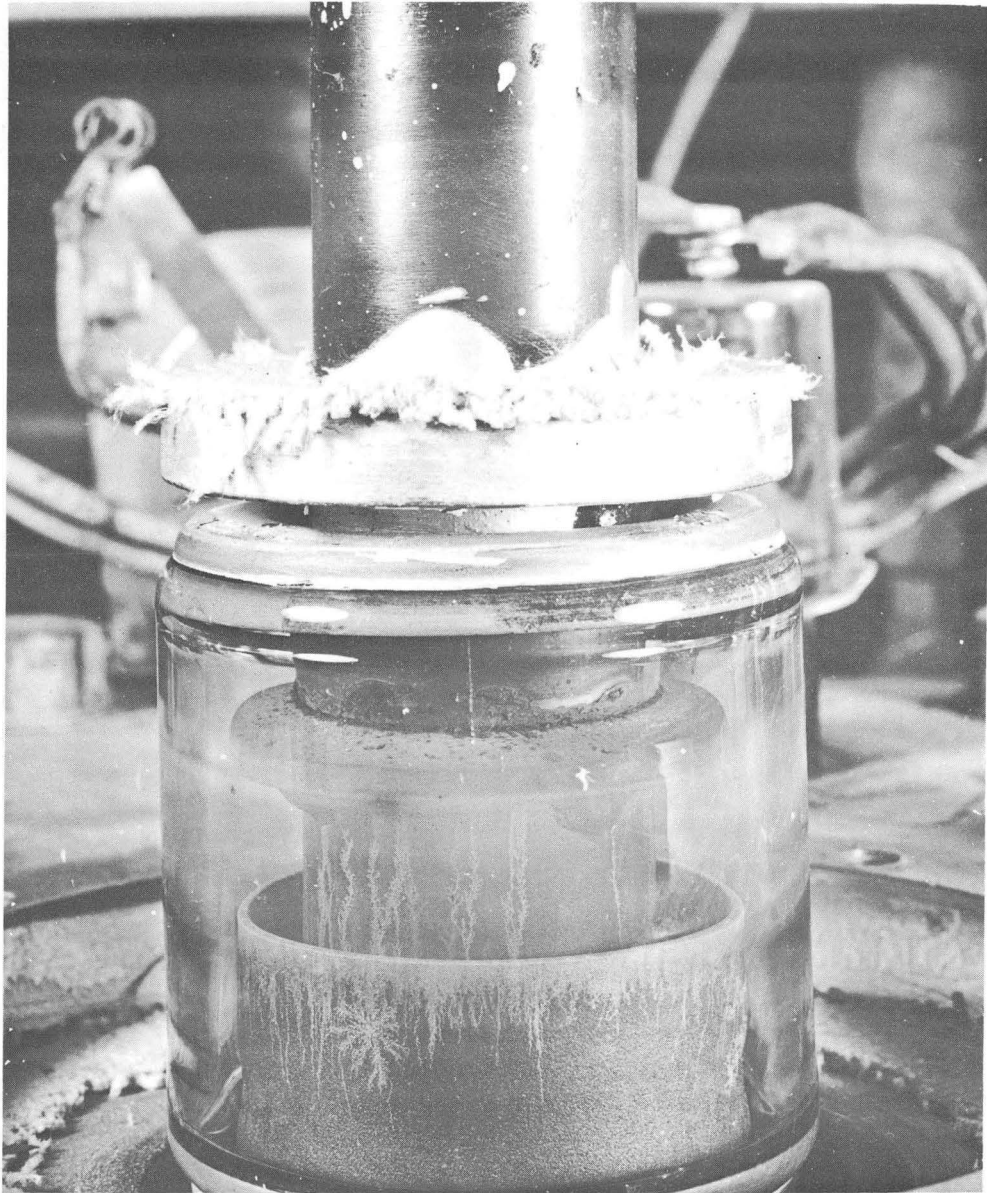
ZN-2001

Fig. 14b. Ignitron anode-stem insulator: arc tracks on anode stem and shield.

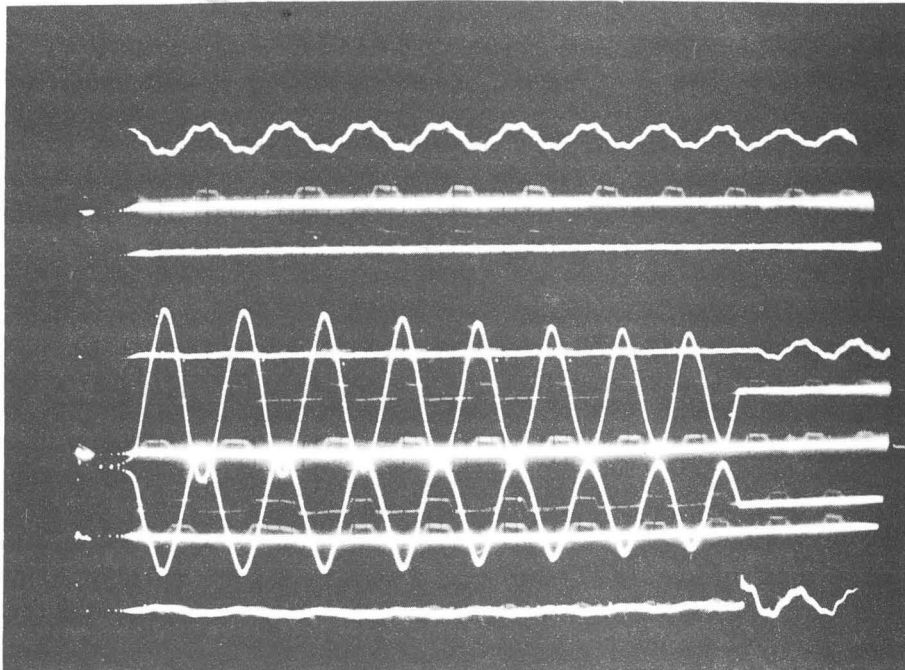
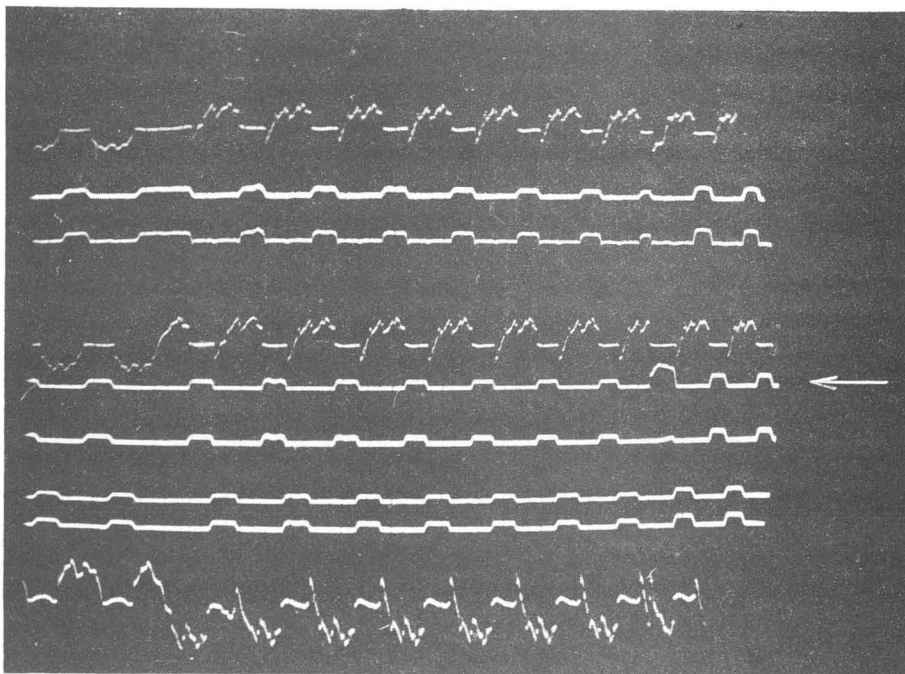
ZN-2092

The most severe fault to both the generator and the ignitrons is an arc-back (Fig. 18). Occasionally arc-back currents reach values of over 30,000 amp for as long as 14 cycles. The fault starts in one tube but may cause a 3-phase arc-back on one ignitron frame. An arc-back occurs on the average of once every four shifts. After an arc-back it is necessary to wait for 15 minutes for the vacuum system to return to normal so as to minimize any sympathetic faults. Arc-backs are detrimental to the generator windings and shaft. (Refer also to the last paragraph under Ignitron Grid Circuits.)

note
one-cycle
arc-through

Fig. 18. Arc-back involving two phases: (a) arc-back pulse; (b) first pulse following arc back.
