Post-breach Monitoring of a Natural Beaver Dam on French Creek

Final Draft: Post-breach Monitoring of a Natural Beaver Dam on French Creek

Kendyl Bree and Eleanor Beshlian

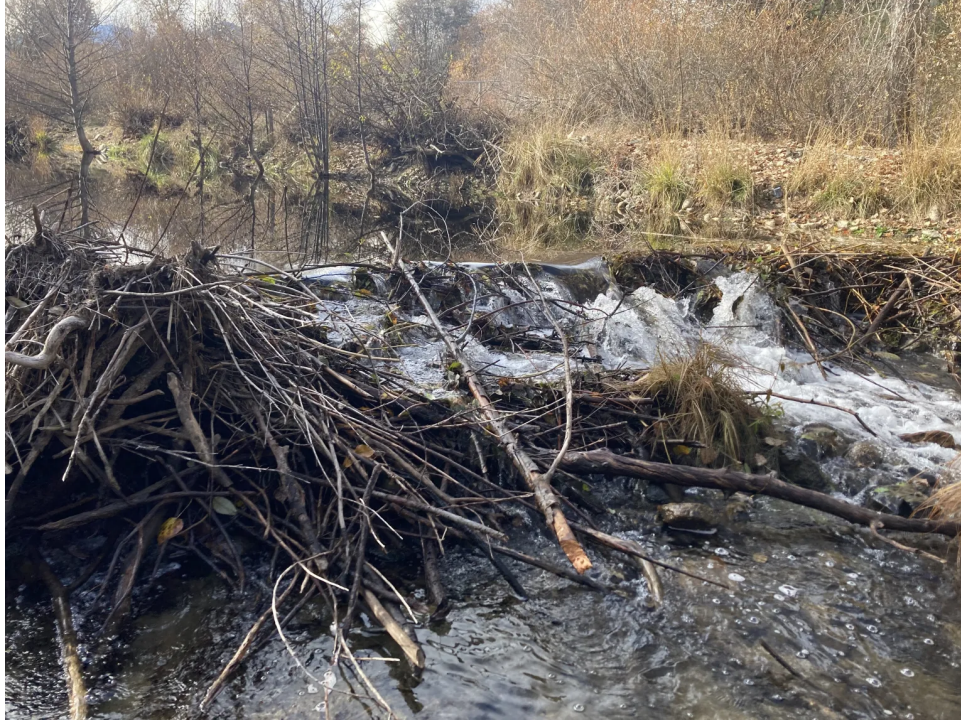
In 2021, high flows led to a breach in the natural beaver dam at the French Creek site (C. Gilmore, Scott River Watershed Council, personal communication, October 2023). The beavers are now rebuilding the damaged dam, though water still flows through the breach (Figure 1). We performed this research the week before the Scott River Watershed Council planned to repair the breach with the installation of vertical posts, which they hope the beavers will build upon and maintain (example pictured in Figure 2). This positions our project to provide unique insights regarding the response of the stream to the breach. Our research addresses how the channel form, groundwater levels, and sediment coarseness were impacted by the 2021 natural beaver dam breach. We hope it may serve as a baseline to inform how the later installment of vertical posts affects the system, to further show the positive impacts of BDAs on French Creek, and the entire watershed.

Figure 1. Looking upstream at the breach in the natural beaver dam on French Creek. 11/5/23, Etna, CA.

In light of the French Creek's role as a spawning ground for coho salmon, particular care should be taken in reinforcing the beaver dam so future fluxes of fine sediment such as the one we observed directly downstream of the breach may be averted.

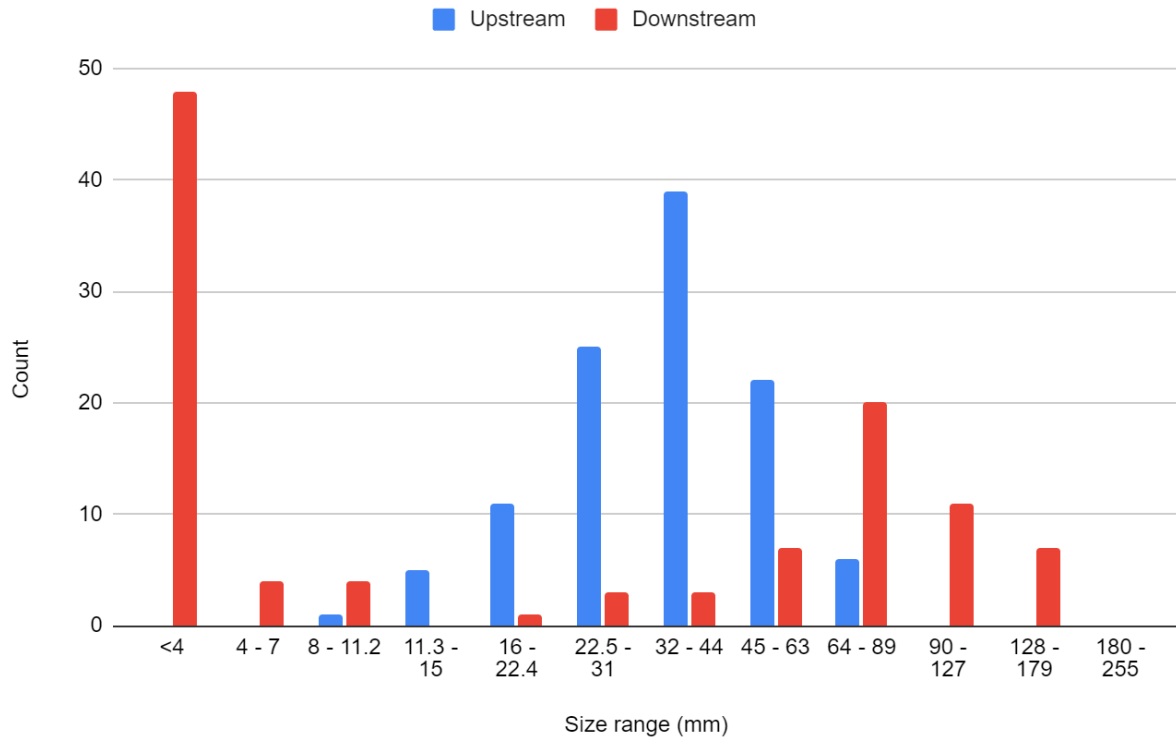
At the upstream site with imported gravel, we observed a roughly normal distribution of grain size centering around the 32-44mm size bracket (Table 1, Figures 4 and 5). The grain size downstream of the dam breach demonstrated a strongly bimodal distribution with peaks in the <4mm and 64-89mm size brackets (Table 2).

Figure 4. Histogram of grain size at upstream and downstream sites.

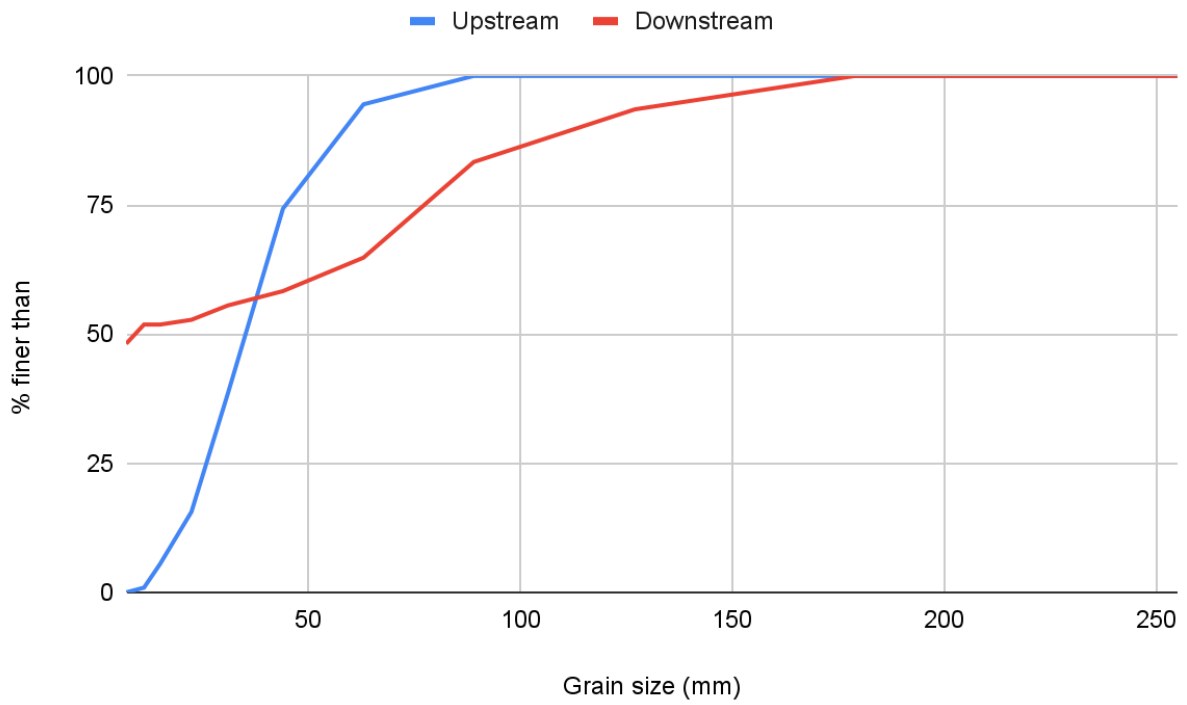
Figure 5. Cumulative grain size distribution at upstream and downstream sites.

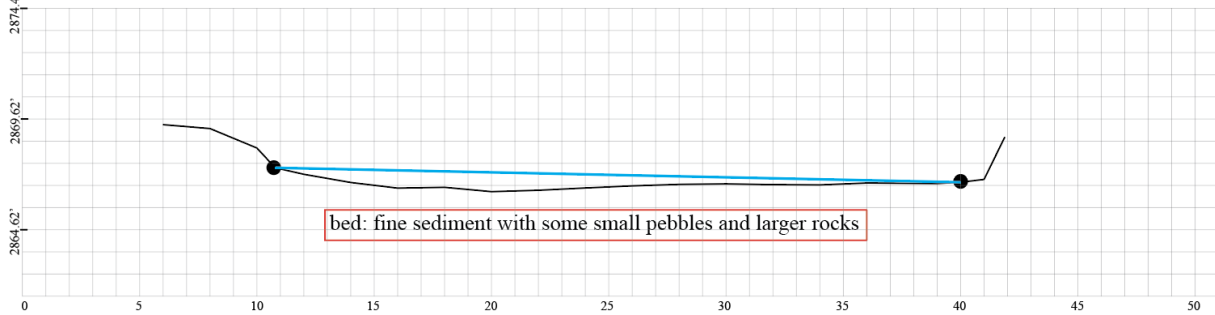
Figure 8. Cross-section 3.

The cross-sections consistently demonstrated a relatively shallow, broad channel (Figures 6, 7, 8, 9). Cross Section 3 (below the breach) featured the smallest below-water area at 19.8 ft². (Figure 8, Table 3). The shallower channel below the dam may be an indication of the impact of the fine sediment released in the breach, and also is in line with our findings on the velocity.

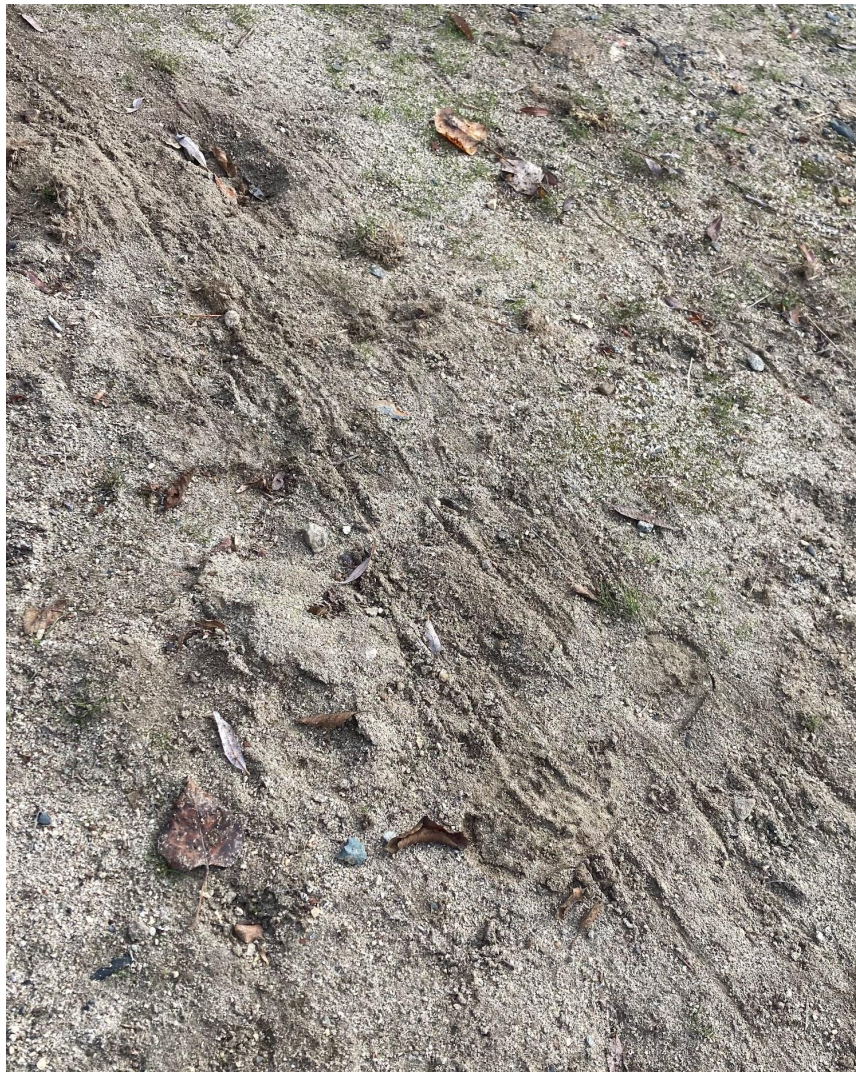
We found a variety of evidence suggesting continued beaver activity at the site, including a drag trail (Figure 12), gnawed vegetation (Figure 13), and chew sticks (Figure 14). These findings correspond with past observations suggesting no cessation in beaver activity since they had established a den at the site (B. Stapleton, landowner, personal communication, November 2023).

Figure 12. Drag trail at French Creek site. 11/4/23. Etna, CA.

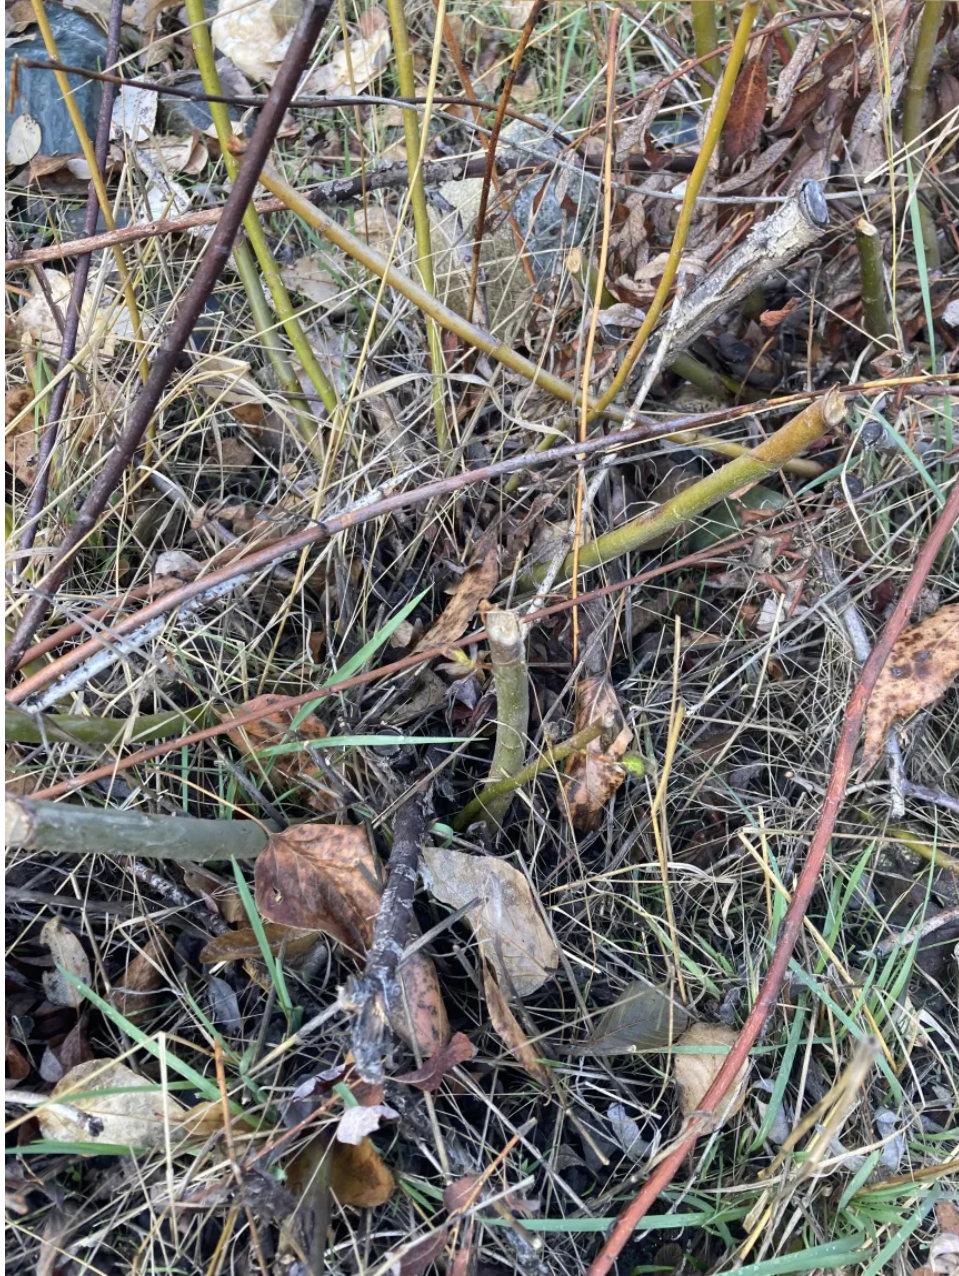
Figure 13. Gnawed vegetation indicating likely beaver presence. 11/4/23. Etna, CA.

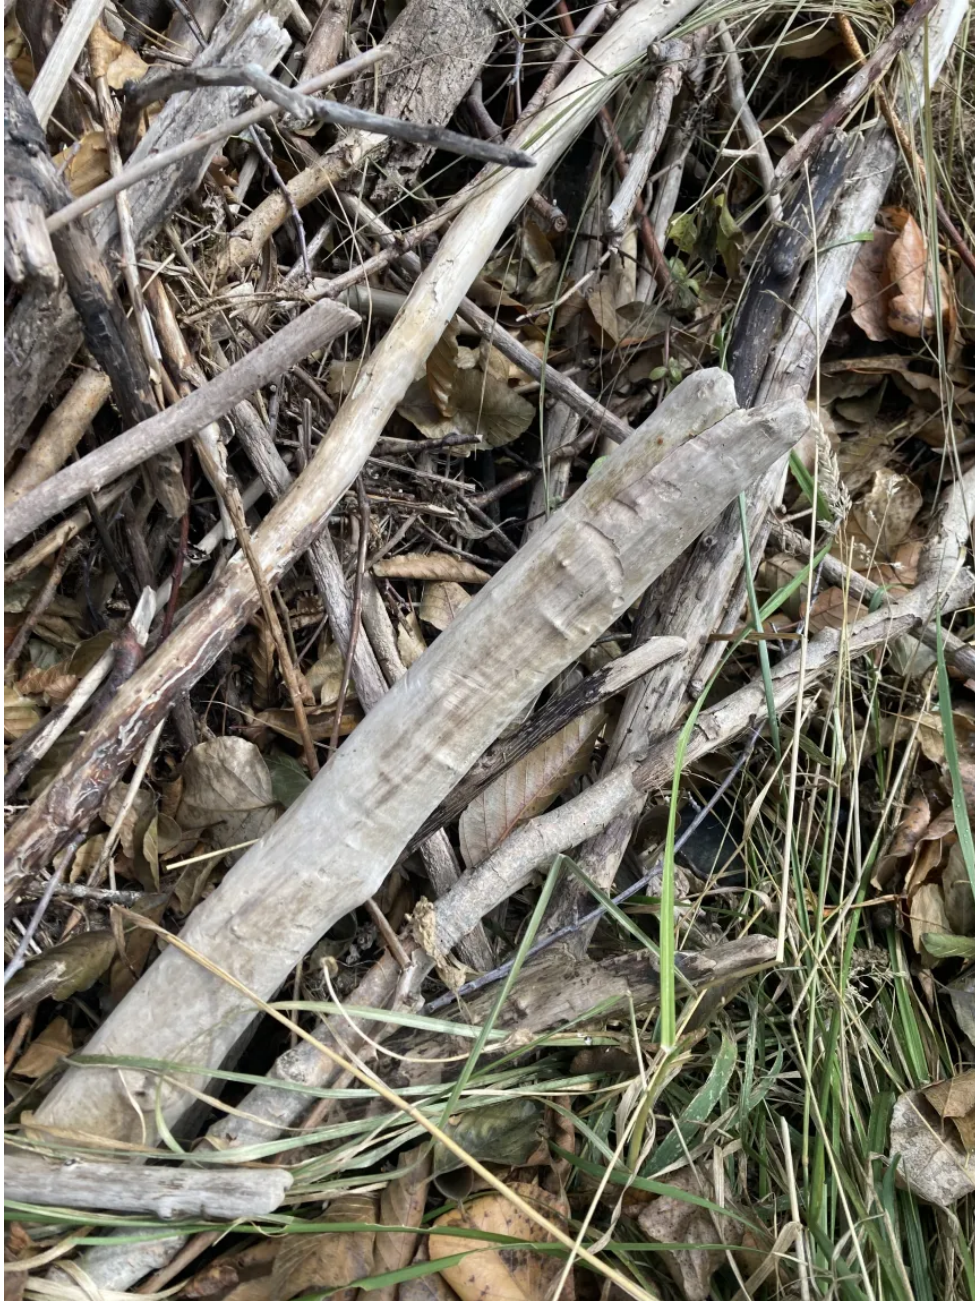
Figure 14. Chew stick found at French Creek site indicating beaver presence. 11/4/23. Etna, CA.
