U.S.—Japan Seminar on Seismic Disaster Mitigation in Urban Area by Geotechnical Engineering June 26-27, 2002 Anchorage, Alaska

#### An Overview of the Great Alaska Earthquake of 1964

by S. J. Brandenberg<sup>1</sup>, & I. M. Idriss<sup>2</sup>

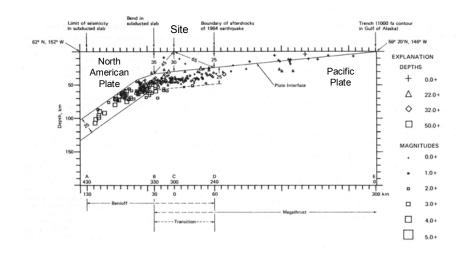
The boundary between the plates where the underthrusting occurs is a northwestward dipping subduction zone. The 1964 Alaska earthquake was a megathrust earthquake, characterized by interplate faulting on the plate interface. The length of the zone that ruptured is about 750 km (Sykes and Quittmeyer, 1981) and the width that ruptured is estimated from 200 km (Sykes and Quittmeyer, 1981) to 360 km (Davies and House, 1979). Slide 4 shows a cross

section of the subduction zone through Anchorage, and the location and magnitude of earthquakes along the plate boundary.

### Cross-Section of Subduction Zone Relative to Anchorage

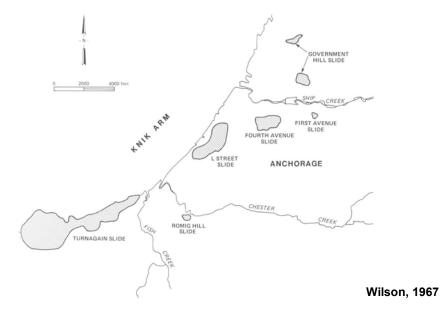
A number of landslides occurred in the Anchorage area. The government hill slide north of ship creek impacted an elementary school. The L Street and the Fourth Avenue Slides occurred in downtown Anchorage. The Turnagain Heights slide, southwest of downtown, involved the largest ground movements of the slides in the Anchorage area. Slide 5 shows the locations and areal extent of the landslides caused by the 1964 earthquake in and around Anchorage. Slide 6 is a photo at the head of the Fourth Avenue Slide.

### Plan View of Landslides in Anchorage Area Caused by 1964 Earthquake

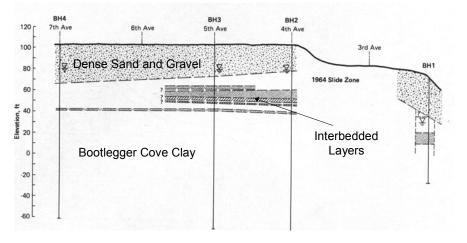
The upper 35 to 40 feet consist of very dense gravels and sands with SPT blow counts that typically exceed 60 bpf. Below the dense sand and gravel lies an interbedded zone consisting of alternating layers of clays, silty sands and sandy silts that extend to a depth of about 65 feet below the surface. The interbedded layers are relatively thin (about  $\pm 1$  to 10 ft) and do not appear to be continuous. The portion of the Bootlegger Cove Clay in the interbedded region is stiff to very stiff and is moderately overconsolidated. A uniform layer of lightly overconsolidated Bootlegger Cove clay underlies the interbedded zone to the maximum depth explored (150 feet below the ground surface). Slide 11 shows the soil conditions observed in the 1982 site investigation. An objective of the 1982 site investigation was to determine whether the Fourth Avenue Slide was caused by liquefaction of silty sand and sandy silt in the interbedded layers, or undrained failure of the Bootlegger Cove Clay.

#### Soil Conditions from 1982 Subsurface Investigation

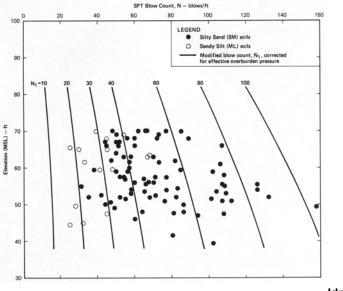
Slide 12 shows the SPT blow counts from the silty sand and sandy silt in the interbedded zone. N1-values in the silty sand layers range from 21 to about 105 bpf, and N1-values in the sandy silts from 16 to 50 bpf. For liquefaction evaluation, the N1-values in the sandy silt layers were increased by 7.5 since the median grain size was less than 0.15 mm. Slide 13 shows the liquefaction potential in the sandy soil in the interbedded zone. The line separating the liquefaction region from the no liquefaction region has been scaled from M=7.5 to M=9.2. The

minimum factor of safety against liquefaction was 1.6, which indicates that liquefaction of these soils was unlikely during the 1964 earthquake (Idriss 1985).

### SPT Blow Counts in Sandy Strata in Interbedded Zone

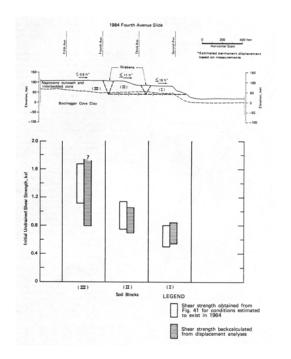
A Newmark sliding block analysis was performed to determine whether the movements measured at the Fourth Avenue slide could be attributed to undrained failure of the Bootlegger Cove clay. Slide 17 shows the undrained shear strength vs. ground displacement that was used in the analysis. For ground displacements less than ½ ft, the peak undrained shear strength was used, and was decreased with each cycle to account for the influence of excess pore pressure. When ground displacements exceeded ½ ft, the residual strength was used. The peak undrained shear strength was varied until displacement from the analysis matched the measured displacement for each soil mass. Slide 18 shows the undrained shear strength from displacement analysis compared with the undrained shear strengths, indicating that the Fourth Avenue slide was caused by undrained failure of the Bootlegger Cove clay (Idriss 1985).

Results of Newmark Sliding Block Analysis

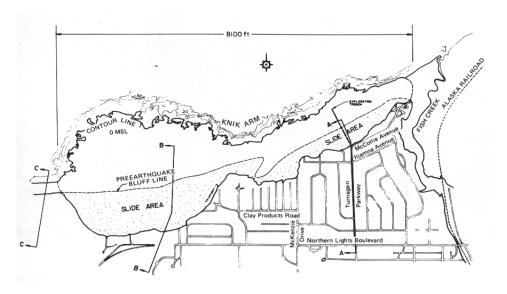
Slide 20 shows a plan view of the Turnagain Heights slide. The slide extended over 8000 feet from west to east along the bluff line, and retrogressed inward up to 1200 feet at the west end and 600 feet at the east end. The area of the slide was about 130 acres. Lateral movement of the slide was as much as 2000 feet. The west end of the slide was undeveloped, and the east end of the slide was a residential area. According to eyewitness accounts, the slide began about 2 minutes after the start of shaking and continued after shaking had ceased. (Seed & Wilson 1967)

Plan of Turnagain Heights Slide Area

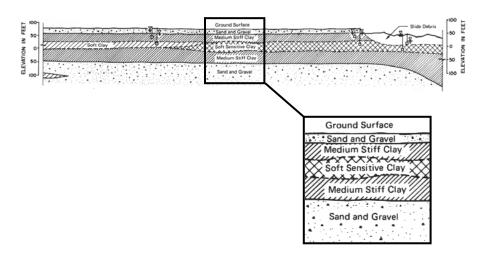
Slide 22 shows the soil conditions at the east end of the slide. The site conditions generally consisted of a surface layer of dense sand & gravel ranging in thickness from 15 to 20 feet at the east end to 5 to 10 feet at the west end. The sand and gravel deposit is underlain by a deep bed of Bootlegger Cove clay about 100-feet to 150-feet thick. The Bootlegger Cove clay is a marine deposit with shear strength decreasing from about 1 tsf at its surface to 0.45 tsf at El. 0, and then increasing again to about 0.6 tsf at El. -30. The clay contains numerous seams of silt and fine sand that are discontinuous ranging in thickness from a fraction of an inch to about 3 feet, but generally not more than several inches. Below El. 10, the sand lenses were less frequent. Seaward of the bluff line the clay was overlain by a layer of estuary silt that sloped gently downward away from the coastline. This material would tend to liquefy during earthquakes and was judged to have played an important role in the development of the slide (Seed & Wilson 1967).

*Turnagain Heights Slide - Soil Profile Through East End of Slide Area*

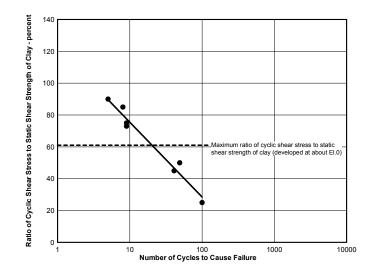
Slide 23 shows results of cyclic direct simple shear tests performed on the Bootlegger Cove clay. For 30 significant cycles, such as might have been developed during the earthquake, failure was induced by a cyclic stress equal to about 55% of the static strength. For the soft sensitive clay with an in-situ static shear strength of about 850 psf, the cyclic shear strength would be about 470 psf (Seed & Wilson 1967).

#### Results of Cyclic Direct Simple Shear Tests of Bootlegger Cove Clay

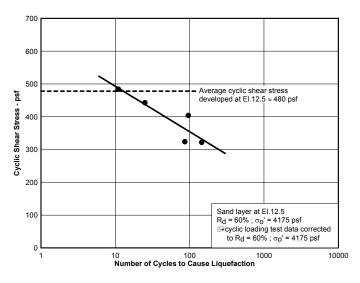
Slide 24 shows results of cyclic triaxial compression tests, corrected for simple shear conditions, performed on sand from the lenses in the clay. A cyclic shear stress of about 420 psf would be required to cause liquefaction in 30 stress cycles. The cyclic shear stress required to cause liquefaction of the sand is less than required to cause failure of the soft clay; hence, it is reasonable to conclude that liquefaction of the sand seams would precede failure of the clay (Seed & Wilson 1967).
