**PROCEEDINGS OF U.S.-JAPAN SEMINAR
ON SEISMIC DISASTER MITIGATION
IN URBAN AREA
BY GEOTECHNICAL ENGINEERING**

**U.S.—Japan Seminar on Seismic Disaster Mitigation
in Urban Area by Geotechnical Engineering**

An Overview of the Great Alaska Earthquake of 1964

by S. J. Brandenberg¹, & I. M. Idriss²

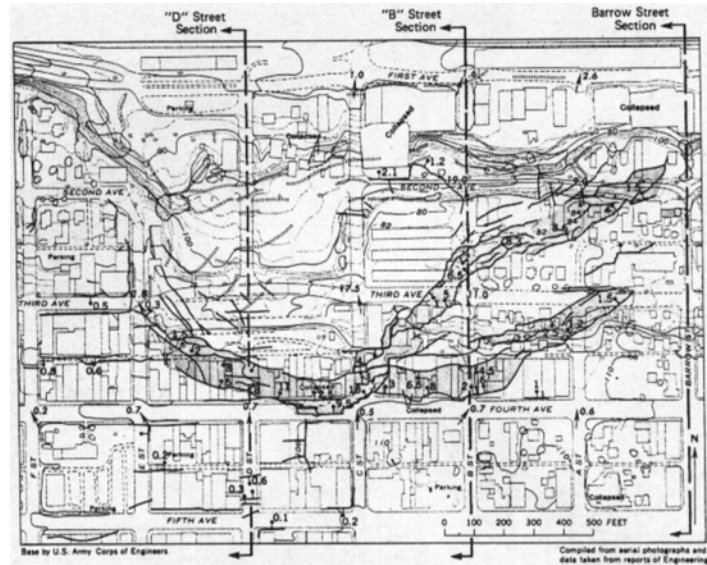
Slide 7 shows a plan view of the Fourth Avenue slide. The grabens and ground cracks are illustrated with dark lines. The slide movement was from south to north (from the bottom of the plan view to the top) toward the bluff along Ship Creek. Slide 8 is a cross-section of the slide mass along D Street. The site consists of a layer of dense sand and gravel about 35 to 40 feet thick overlying a deep layer of bootlegger cove clay. Details of the soil properties are discussed below.

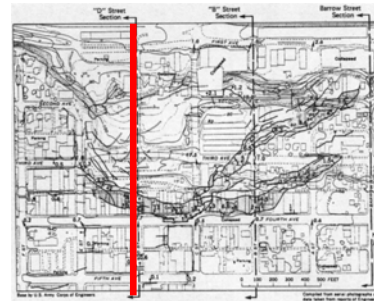
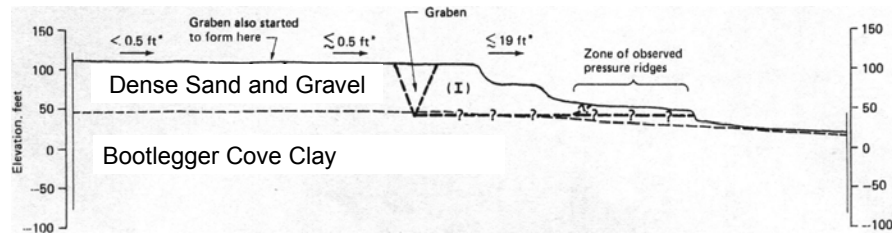
Slide 8

A graben formed along D street, just north of Fourth Avenue. The horizontal movement of the soil mass north of the graben was about 19 feet along a nearly horizontal slip plane. South of the graben, however, the horizontal movement was generally less than ½ foot. Slide 9 shows a cross section of the slide mass along B Street.

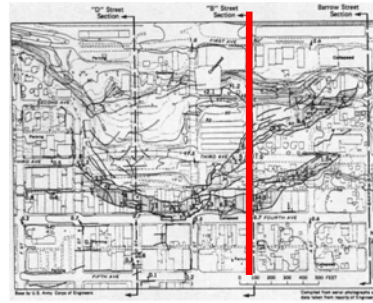
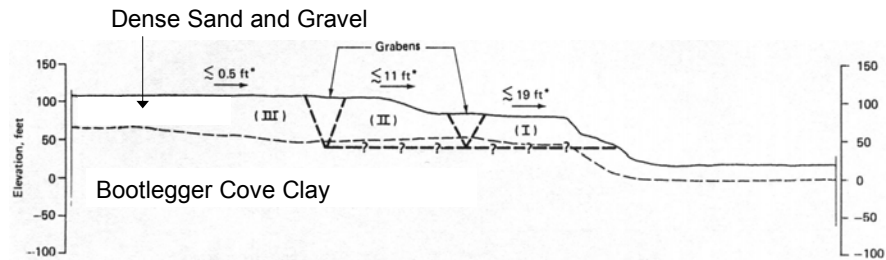
Slide 9

Two grabens developed along B Street, in which vertical movements of up to 10 feet were measured. Horizontal movement of up to 19 feet was observed in the soil mass downslope of the first graben, and up to 11 feet in between the two grabens. Behind the second graben, movement was generally less than ½ of a foot.

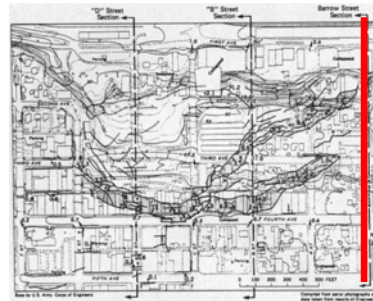
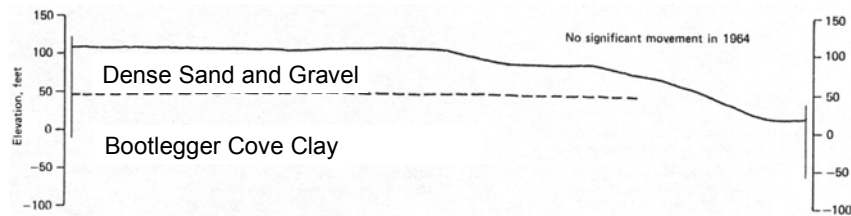
Slide 10 shows a cross section along Barrow Street, east of the slide. There were no appreciable movements along this section in 1964.

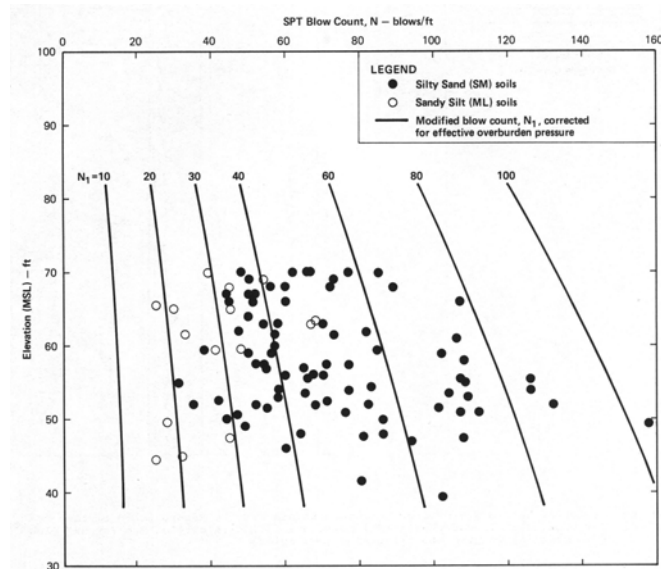
Slide 12 shows the SPT blow counts from the silty sand and sandy silt in the interbedded zone. N1-values in the silty sand layers range from 21 to about 105 bpf, and N1-values in the sandy silts from 16 to 50 bpf. For liquefaction evaluation, the N1-values in the sandy silt layers were increased by 7.5 since the median grain size was less than 0.15 mm. Slide 13 shows the liquefaction potential in the sandy soil in the interbedded zone. The line separating the liquefaction region from the no liquefaction region has been scaled from M=7.5 to M=9.2. The

minimum factor of safety against liquefaction was 1.6, which indicates that liquefaction of these soils was unlikely during the 1964 earthquake (Idriss 1985).

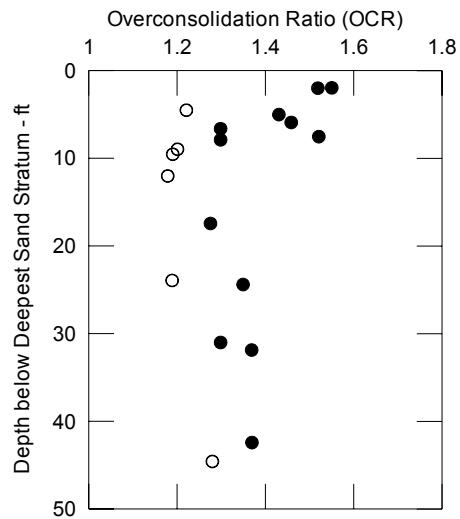
The Bootlegger Cove Clay layers in the interbedded zone are stiff to very stiff with OCR ranging from 3 to 4. Fluctuations of lake level during glaciation and subsequent drainage of the lake probably exposed the sediments to subaerial conditions, resulting in increased strength. Slide 14 shows the OCR of the Bootlegger Cove clay vs. depth below the interbedded layers. The Bootlegger Cove Clay below the interbedded zone is uniform with OCR ranging from 1.2 to 1.5. The SHANSEP (Stress History and Normalized Soil Engineering Properties) was used to evaluate the in-situ undrained shear strength of the clay. Slide 15 shows the peak undrained shear strength from direct simple shear tests performed on samples of the Bootlegger Cove clay. The normalized strength was related to the OCR by $\frac{S_u}{\sigma'_v} = 0.19 \cdot (OCR)^{0.78}$. Slide 16 shows results of cyclic direct simple shear tests. The soil was loaded cyclically until a predetermined excess pore pressure was obtained, then it was monotonically sheared undrained to failure. At $r_u = 0.9$, the strength of the clay was found to be 70% to 75% of the peak undrained shear strength. The residual strength of the clay was estimated to be about 30% of the peak undrained shear strength from results of miniature vane tests, CPT tests and direct shear tests (Idriss 1985).

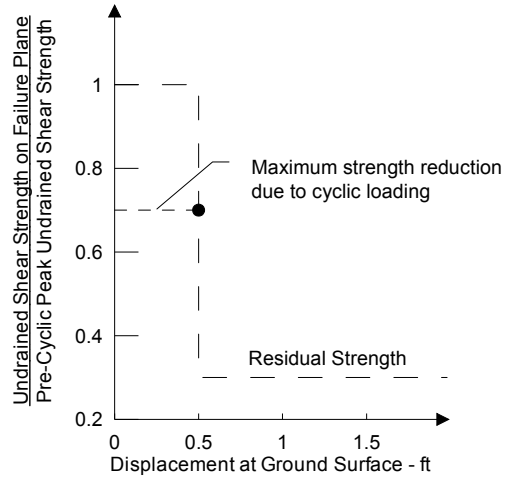
A Newmark sliding block analysis was performed to determine whether the movements measured at the Fourth Avenue slide could be attributed to undrained failure of the Bootlegger Cove clay. Slide 17 shows the undrained shear strength vs. ground displacement that was used in the analysis. For ground displacements less than ½ ft, the peak undrained shear strength was used, and was decreased with each cycle to account for the influence of excess pore pressure. When ground displacements exceeded ½ ft, the residual strength was used. The peak undrained shear strength was varied until displacement from the analysis matched the measured displacement for each soil mass. Slide 18 shows the undrained shear strength from displacement analysis compared with the undrained shear strength estimated to have existed in 1964. There is good agreement between the undrained shear strengths, indicating that the Fourth Avenue slide was caused by undrained failure of the Bootlegger Cove clay (Idriss 1985).

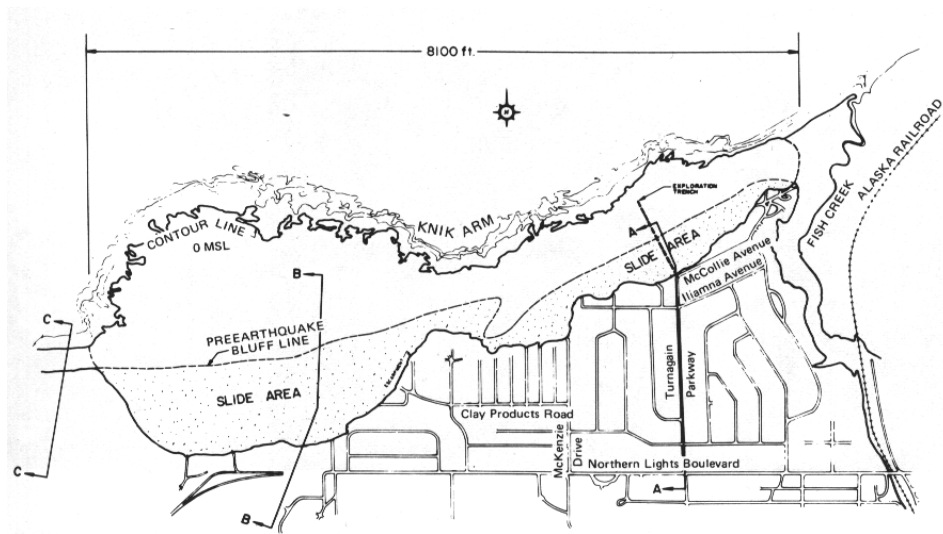
Slide 20 shows a plan view of the Turnagain Heights slide. The slide extended over 8000 feet from west to east along the bluff line, and retrogressed inward up to 1200 feet at the west end and 600 feet at the east end. The area of the slide was about 130 acres. Lateral movement of the slide was as much as 2000 feet. The west end of the slide was undeveloped, and the east end of the slide was a residential area. According to eyewitness accounts, the slide began about 2 minutes after the start of shaking and continued after shaking had ceased. (Seed & Wilson 1967)

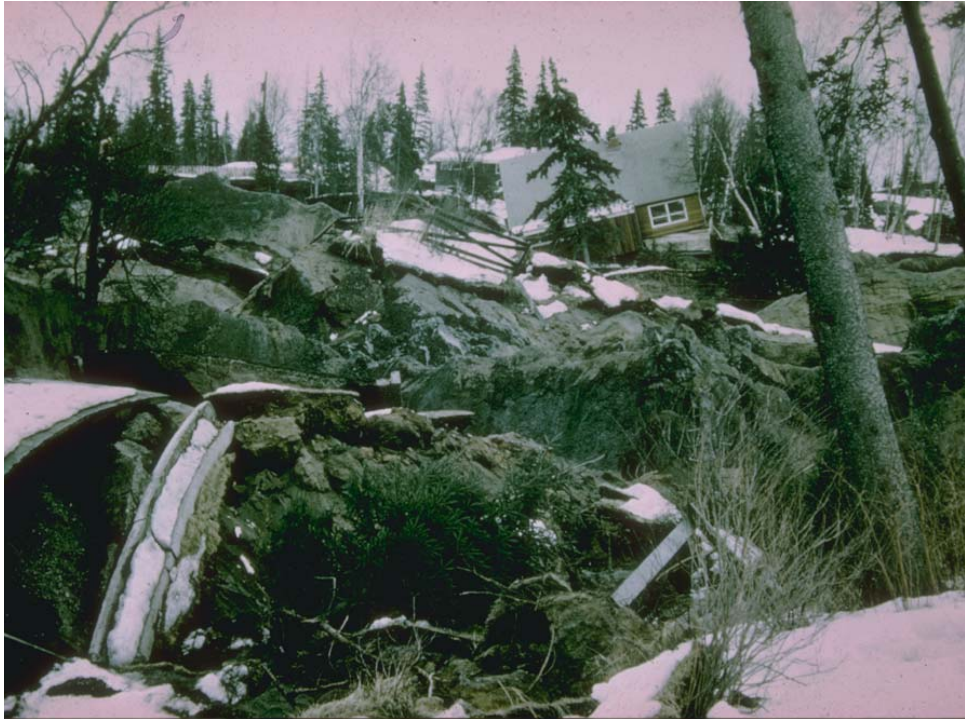
Slide 21 is a photo at the east end of the slide after the earthquake. Within the slide area the ground was broken up into a complex system of ridges and depressions, and average vertical

drop in depressed areas between ridges was 35 feet. 75 homes were destroyed at the east end of the slide. An occupant of one of the houses in the slide area explained “The floor ripped and sand came up from below into the living room,” which indicates that liquefaction occurred during the earthquake (Seed & Wilson 1967).

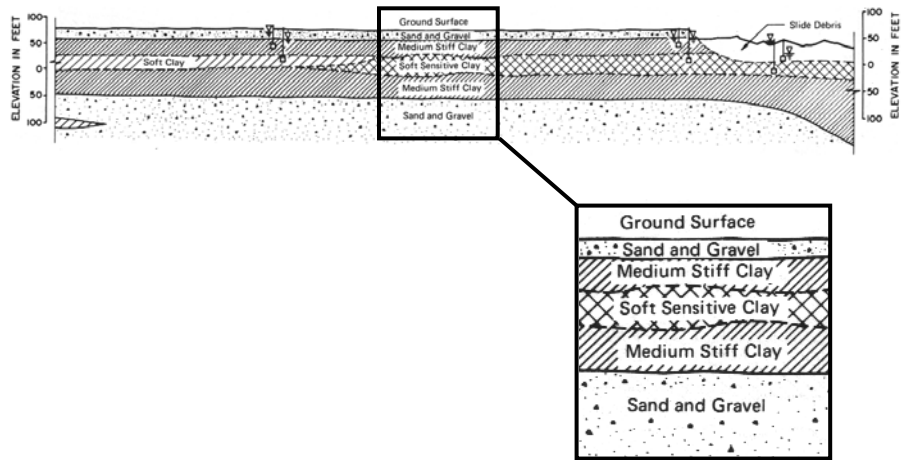
Slide 22 shows the soil conditions at the east end of the slide. The site conditions generally consisted of a surface layer of dense sand & gravel ranging in thickness from 15 to 20 feet at the east end to 5 to 10 feet at the west end. The sand and gravel deposit is underlain by a deep bed of Bootlegger Cove clay about 100-feet to 150-feet thick. The Bootlegger Cove clay is a marine deposit with shear strength decreasing from about 1 tsf at its surface to 0.45 tsf at El. 0, and then increasing again to about 0.6 tsf at El. -30. The clay contains numerous seams of silt and fine sand that are discontinuous ranging in thickness from a fraction of an inch to about 3 feet, but generally not more than several inches. Below El. 10, the sand lenses were less frequent. Seaward of the bluff line the clay was overlain by a layer of estuary silt that sloped gently downward away from the coastline. This material would tend to liquefy during earthquakes and was judged to have played an important role in the development of the slide (Seed & Wilson 1967).

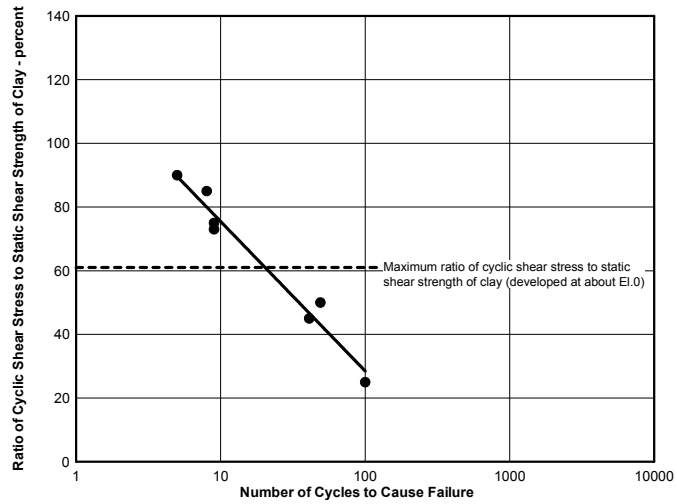
Slide 23 shows results of cyclic direct simple shear tests performed on the Bootlegger Cove clay. For 30 significant cycles, such as might have been developed during the earthquake, failure was induced by a cyclic stress equal to about 55% of the static strength. For the soft sensitive clay with an in-situ static shear strength of about 850 psf, the cyclic shear strength would be about 470 psf (Seed & Wilson 1967).

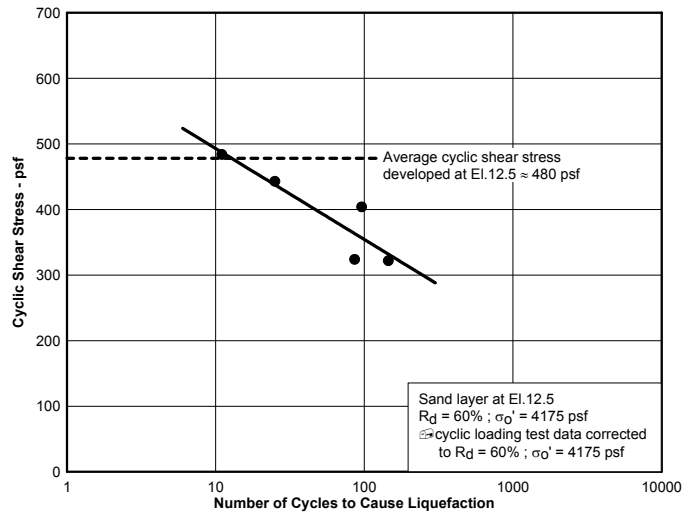
Slide 24 shows results of cyclic triaxial compression tests, corrected for simple shear conditions, performed on sand from the lenses in the clay. A cyclic shear stress of about 420 psf would be required to cause liquefaction in 30 stress cycles. The cyclic shear stress required to cause liquefaction of the sand is less than required to cause failure of the soft clay; hence, it is reasonable to conclude that liquefaction of the sand seams would precede failure of the clay (Seed & Wilson 1967).

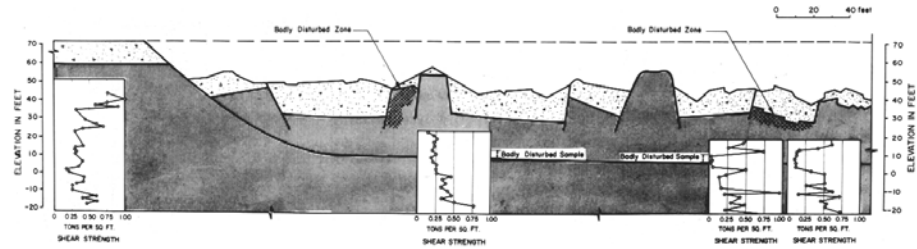
A 1000-ft trench extending from the back of the slide zone to beyond the toe of the original bluff line was excavated on the east side of the slide to observe the distribution of materials in the slide zone. Slide 25 illustrates the findings from the trench excavation. The landslide was primarily translational along a slip surface inclined about 4° downward toward the original toe of the bluff. Clay ridges and depressed grabens were a characteristic feature of the slide area. The ridges underwent large displacements with nearly no change in inclination, and the average vertical displacement of the depressions was 35 feet. The grabens were sometimes inclined downward toward the original bluff line, and sometimes upward toward the head of the slide, indicating a complex slide mechanism.

Seed & Wilson describe the likely slide mechanism, which is paraphrased as follows. Shaking caused liquefaction of the sand lenses at about 5 to 25 feet elevation some distance behind the bluff. The liquefied zone retrogressed backward from the temporarily stable bluffs. As a result of inertial forces and loss of strength of the soil, failure developed at the bluffs as a result of a conventional slide mechanism. The slide material was deposited on the sloping liquefied estuary silt, which carried it downslope, exposing the slide surface and permitting a second slide of the same type. After one or more such slides, the sliding surface merged into the previously weakened zone behind the original bluff line, and the mechanism changed from rotational to translational. The slide then developed quickly, resulting in ridges in the clay and severely depressed grabens. At this time the sliding involved translation on the liquefied sand lenses, but also involved extensive shear zones through the clay as it was remolded. The slide mass moved quickly toward the bay on the liquefied silt. When shaking stopped, the silt and sand

lenses probably stabilized and inertial forces ceased, but sliding continued to progress due to the zones of remolded clay at the shearing surfaces (Seed & Wilson 1967).
