Saeltzer Dam Removal on Clear Creek 11 years later: An assessment of upstream channel changes since the dam's removal

Saeltzer Dam Removal on Clear Creek

11 years later: An assessment of upstream channel changes since the dam's removal

December 14, 2011

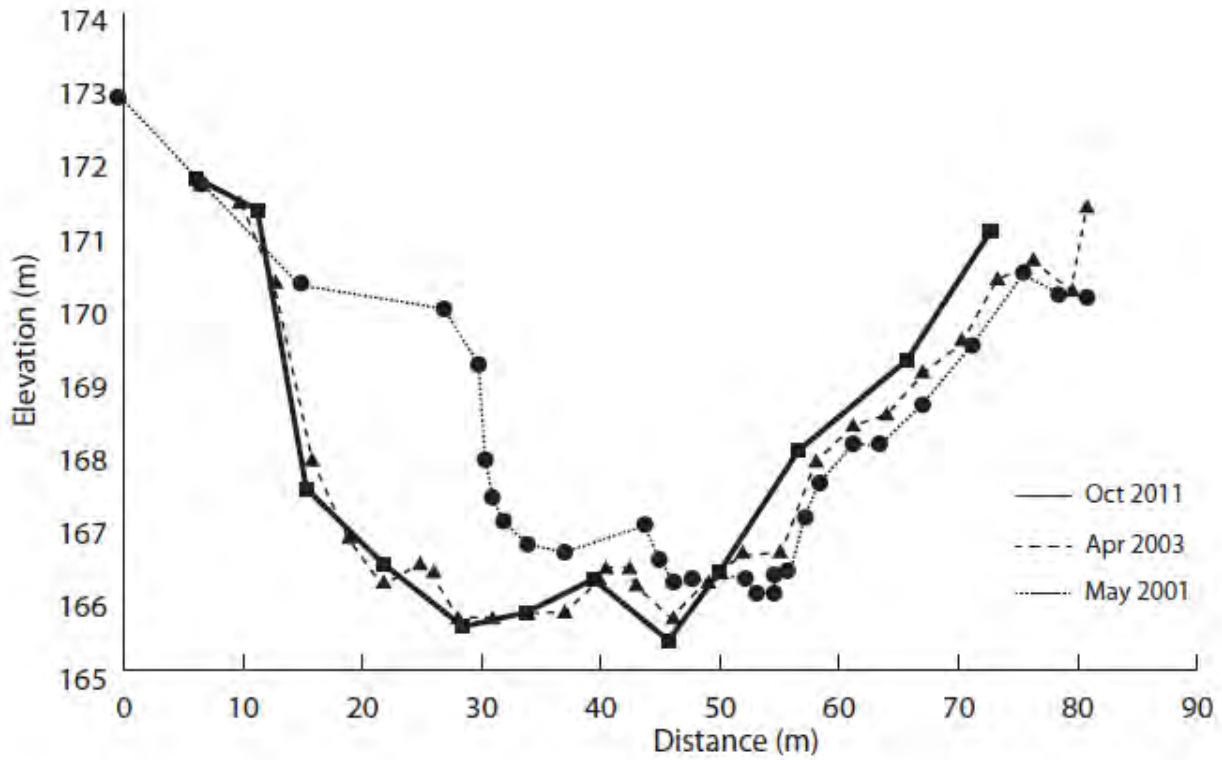
Figure 4.
Cross-section 1.

- We documented little change in cross sections 1 and 2, compared to the rapid change observed in 2003.

2011 results are compared to those from 2001 and 2003. Our 2011 cross section was based on the rebar stake used in Miller and Vizcaino’s 2003 fieldwork. The graph of their cross section 1 is missing from the published report. Based on maps in the 2003 and 2004 reports, we determined that Ferry and Miller’s 2003 cross section 1 is in approximately the same location, so we use it here for comparison. Cross section 1 in 2003 was cut at an angle across the channel, while we surveyed perpendicular to the channel. Thus the 2003 channel appears slightly larger in this graphic, although we have no reason to believe that is actually the case (since aggradation on steep slopes is extremely unlikely).

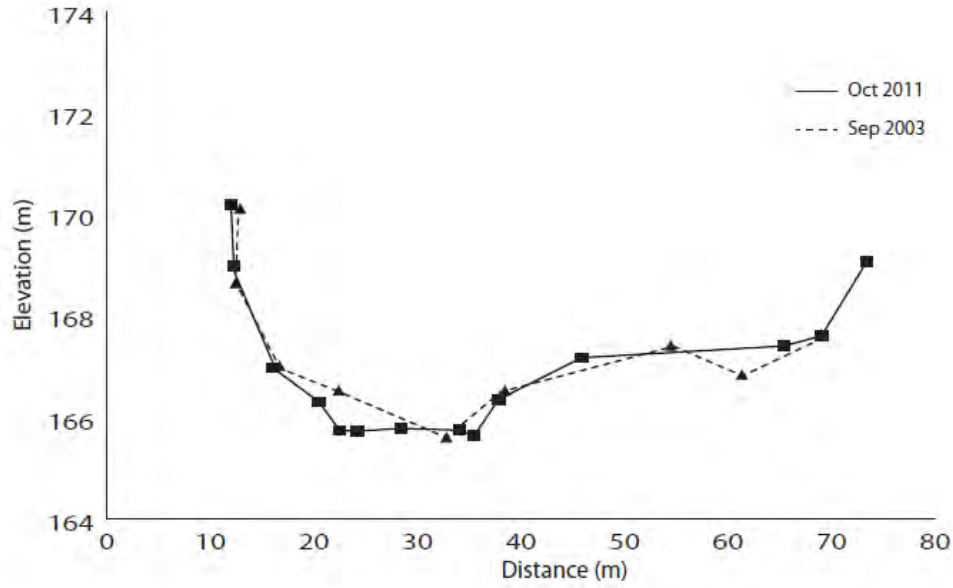
Figure 5.
Cross-section 2.
2011 findings are compared to those from Miller and Vizcaino’s 2003 cross section. (Note: Stillwater’s 2001 study did not survey this cross section).

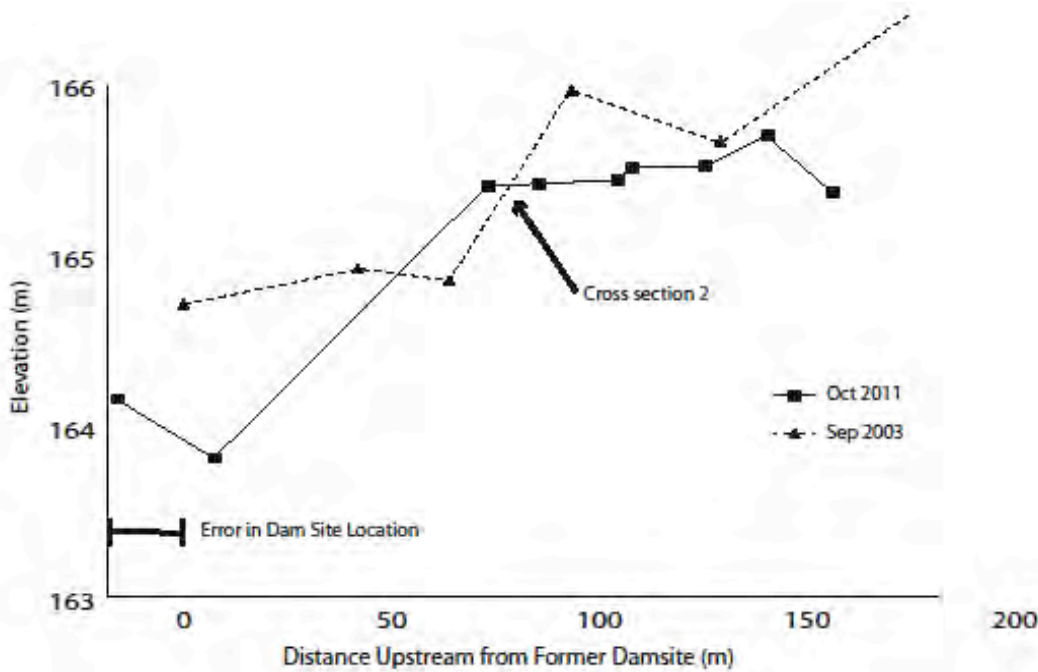
¹⁸ We likely mistook the immediate location of the former dam site (which we used as 0 on the x-axis), and our profile was therefore not properly aligned with long profiles surveyed in previous years. None of the long profiles made indicate a positioning landmark other than the dam site. In making our long profile, we did note the location of cross section 2, and could use this as a stable point to line up our cross section with that from 2003, since we knew from our cross sectional surveys that no incision had occurred in this location. However, it should be noted that the area at the dam site is mostly bedrock, but shows incision of almost 1.6 ft (0.5 m) even after shifting long profile alignment. Given the error inherent in attempting to shift a long profile horizontally without any clear benchmarks, and the low number of data points surveyed in this area in 2003, it is difficult to draw any solid conclusions from the long profiles.

Figure 6.
Long profile of thalweg upstream of the former dam site.
Surveying downstream of the former dam site was impossible due to deep, fast moving water. Long profiles are located based on the former dam site, but there was likely large amount of error in locating the former dam site, resulting in uncertainty in the alignment of the two long profiles.

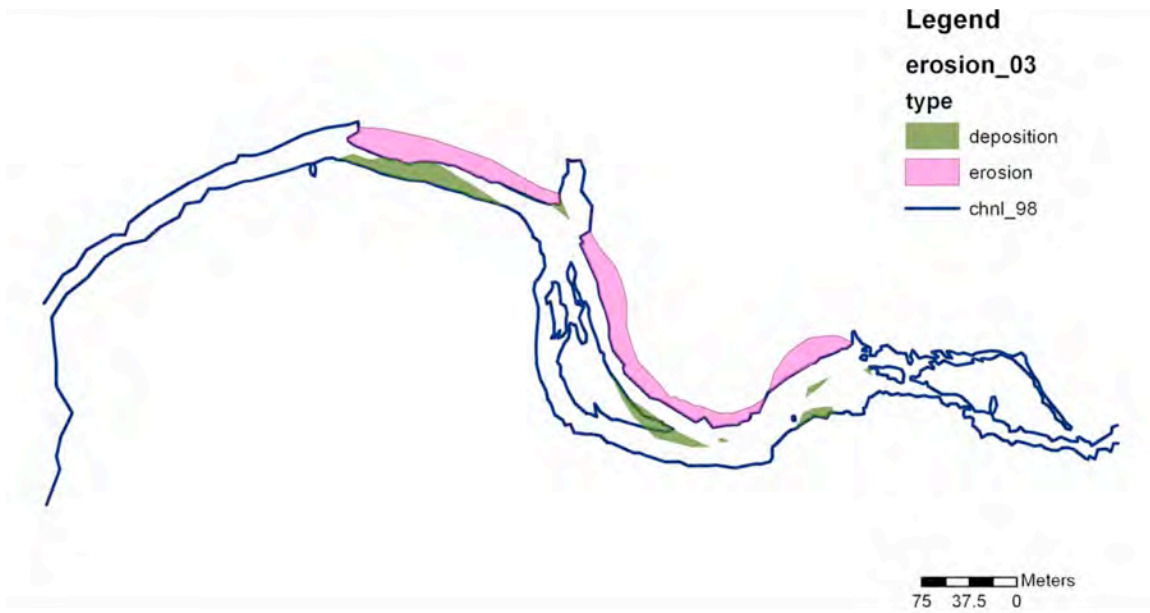
- C. In area C, the channel has continued to move north, toward the outside of the meander bend (Figure 7a). We observed corresponding erosion along the left bank and deposition on the right. The large area of deposition that was evident in 2003 on the south bank in area C eventually stabilized into the large bar present in 2011 (Figures 12a, 7b).

Figure 7a.
Areas of erosion and deposition in 2003/04
(Interpreted from Ferry and Miller 2003). Interpretation methods are described in Appendix A.

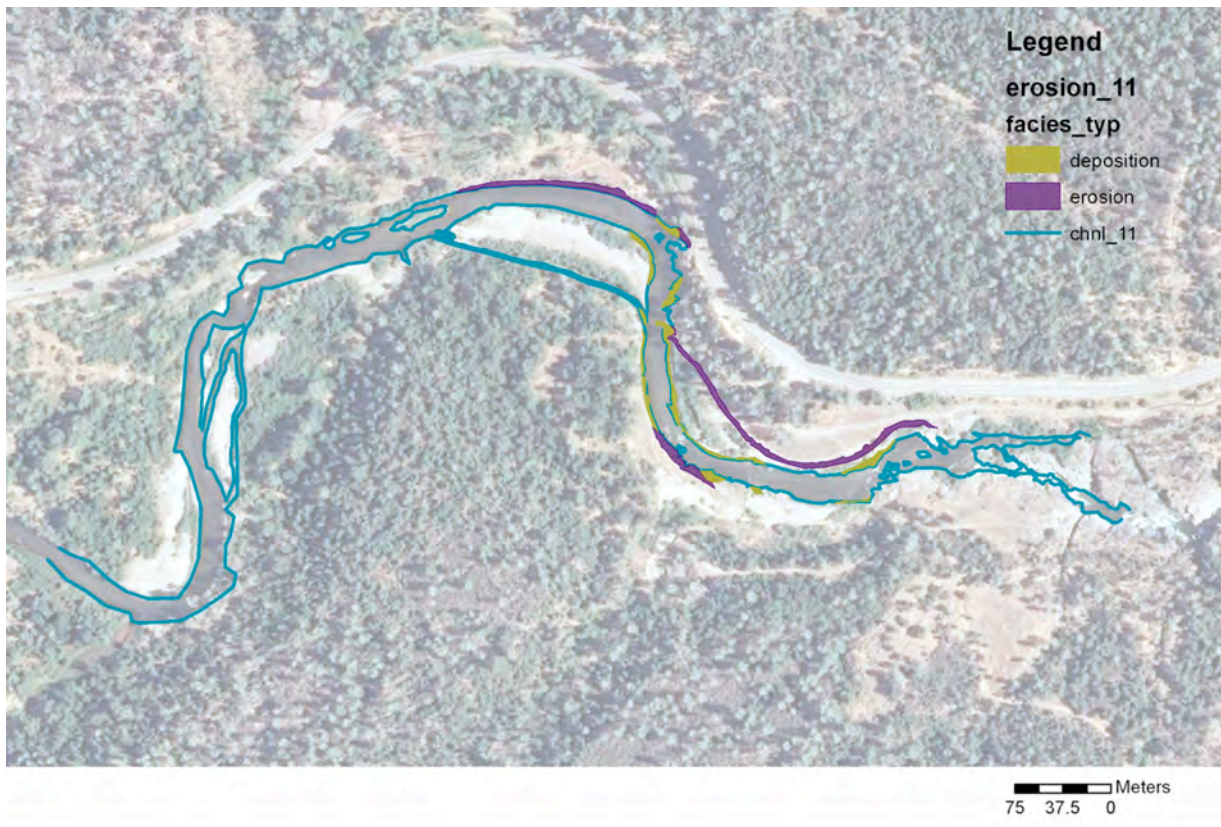
- B. The channel in area B has continued to cut west (Figures 12b, 12c). We noted a small area of active erosion on the right bank in this location, corresponding to a similar area of deposition on the left bank¹⁷ (Figure 7b). The presence of bedrock on the right bank will likely prevent further movement of the channel in this area (Figure A2).

Figure 7b.
Areas of erosion and deposition in 2011.

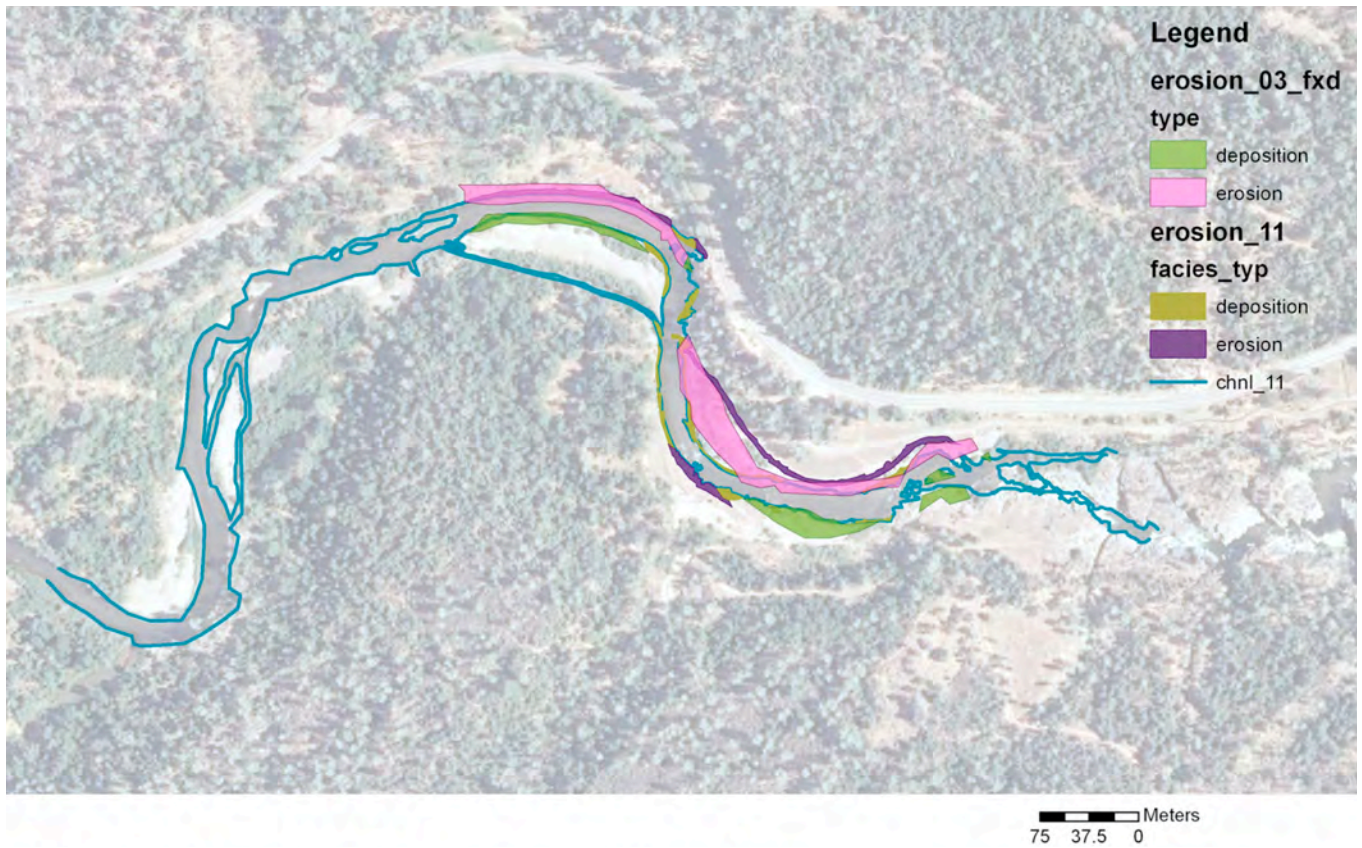
We also observed erosion on the upper left bank in area B. This is in the same location as that observed by Ferry and Miller in 2003 (Figure 7c). Their method for recording erosion and deposition was unclear (Appendix B) and it is difficult to determine whether this bank has eroded since 2003, or if all erosion occurred prior to 2003. However, the presence of large vegetation on the bar between this eroded bank and

Figure 7c.
Compared areas of erosion and deposition, between 2003/04 and 2011, on the 2011 channel.
Note increased erosion in Areas A and C from 2003 to 2011.

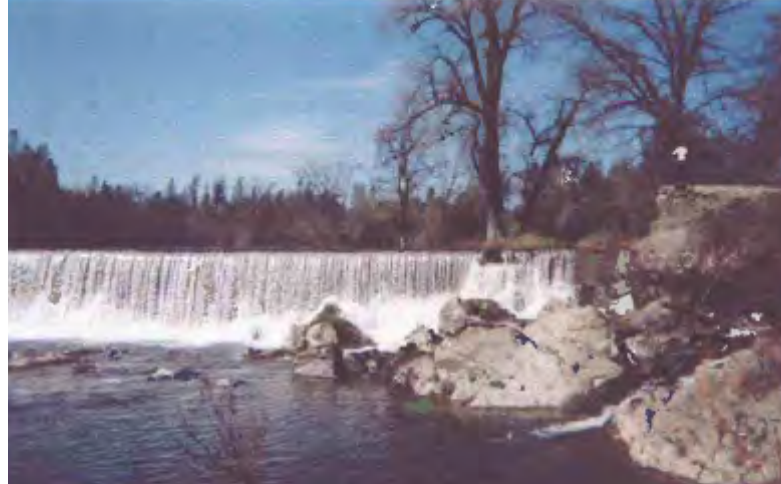
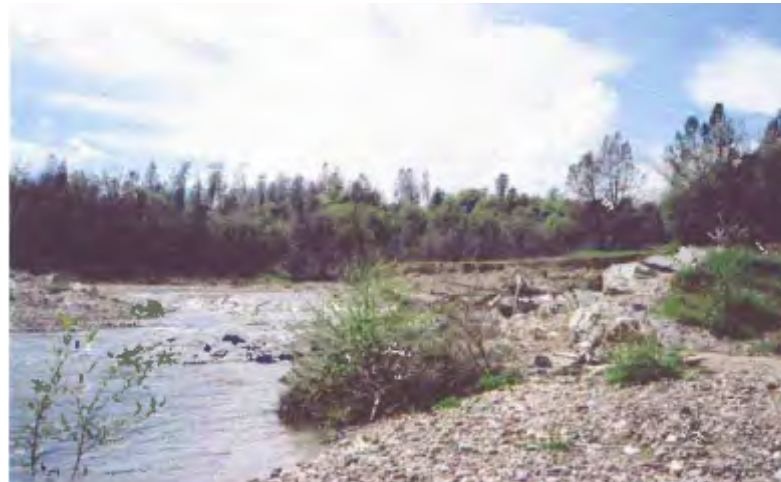
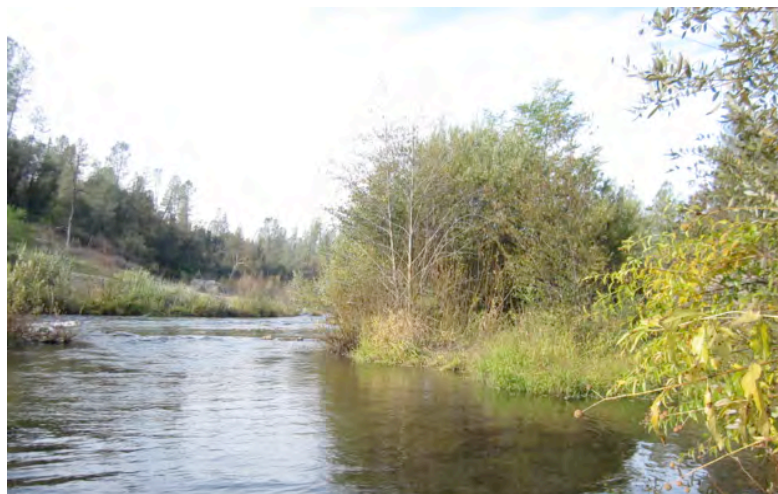
Comparison of imagery (Figures 8, 9, 10) reveals that significant riparian vegetation die-off occurred in the years immediately following dam removal, as noted in previous studies (Ferry and Miller 2003, Miller and Vizcaino 2004). Dams and associated upstream reservoirs lead to a saturation of surrounding sediment down to bedrock and a localized rise in the water table. After dam removal (and reservoir emptying), the water table subsides, potentially stranding and leading to the mortality of riparian vegetation along the margins of the former reservoir (Shafroth et al. 2002). Ferry and Miller (2003) and Miller and Vizcaino (2004) both cite this die-off as a probable and major contributor to the observed erosion in this time period. From 2003 to present day, considerable riparian vegetation had become established, most of which appears to be several years old. The presence of this vegetation confirms that significant erosion has not recently occurred, and suggests a reinforcing pattern of bank stability in which vegetation reduces the availability of bank sediment for mobilization and in turn grows larger each season, leading to even greater bank stability.

Figure 8. Upstream view, Saeltzer Dam. (A) Pre-2000 before removal; (B) April 2003; and (C) October 2011. Pre-dam removal and 2003 photos from Ferry and Miller 2003. Note extensive vegetation growth from 2003 to 2011.

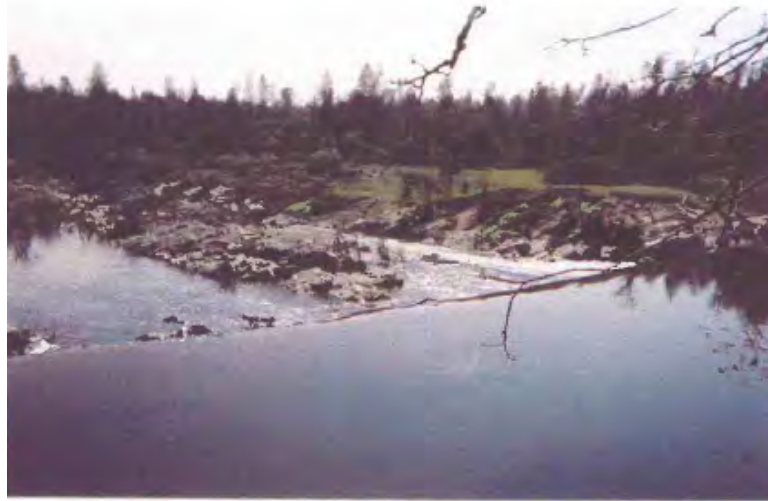
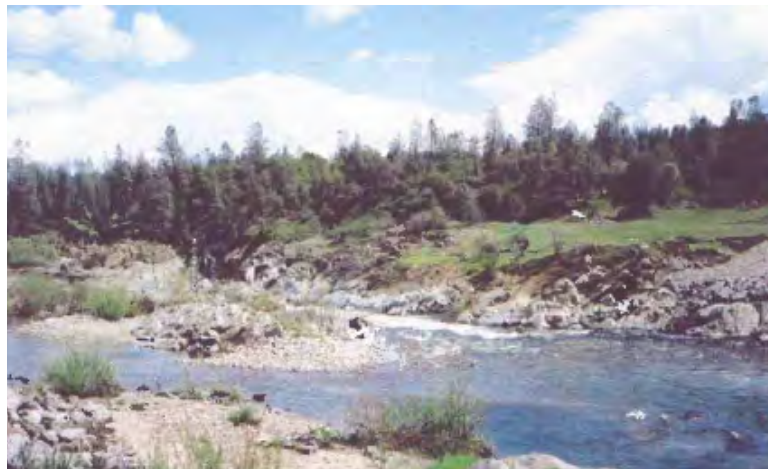
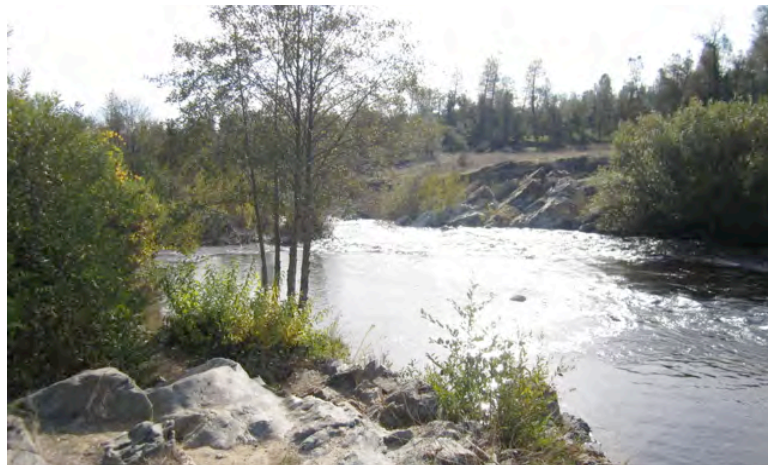
Figure 9.
Downstream view, Saeltzer Dam. (D) Pre-2000, before removal; (E) April 2003; and (F) October 2011.
Pre-dam removal and 2003 photos from Ferry and Miller 200. Note extensive vegetation growth since
2003.

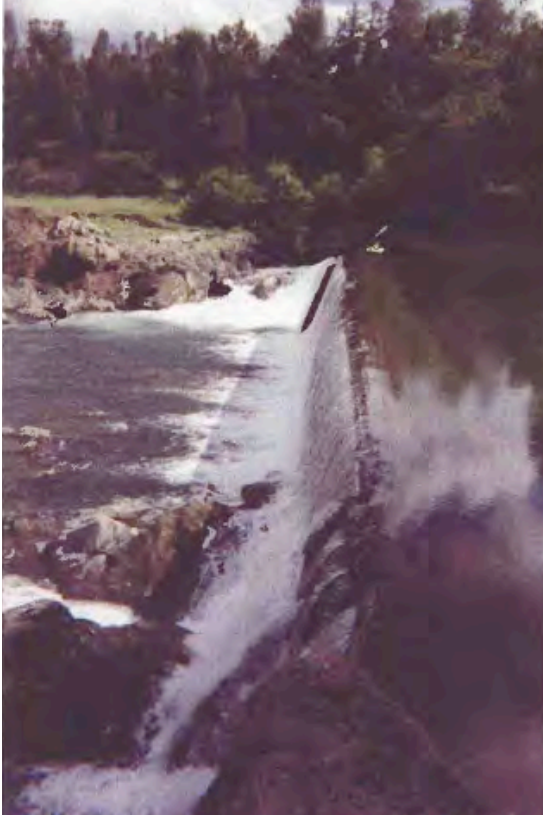
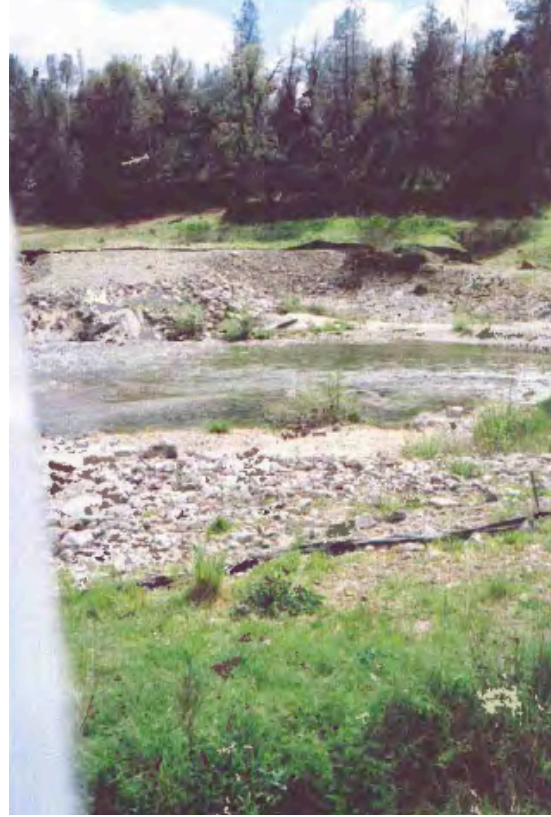
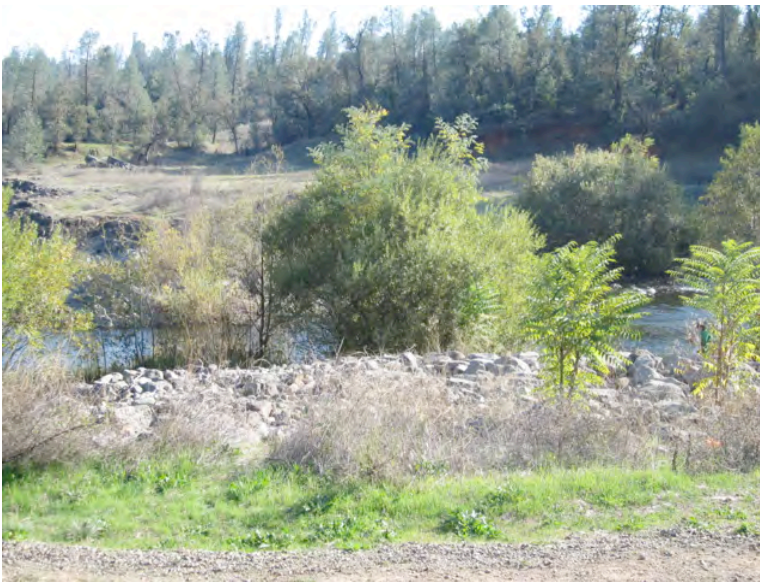
Figure 10. North to south bank view, Saeltzer Dam. (G) Pre-2000, before removal; (H) April 2003; and (I) October 2011. Pre-dam removal and 2003 photos from Ferry and Miller 2003. Note extensive vegetation growth since 2003.

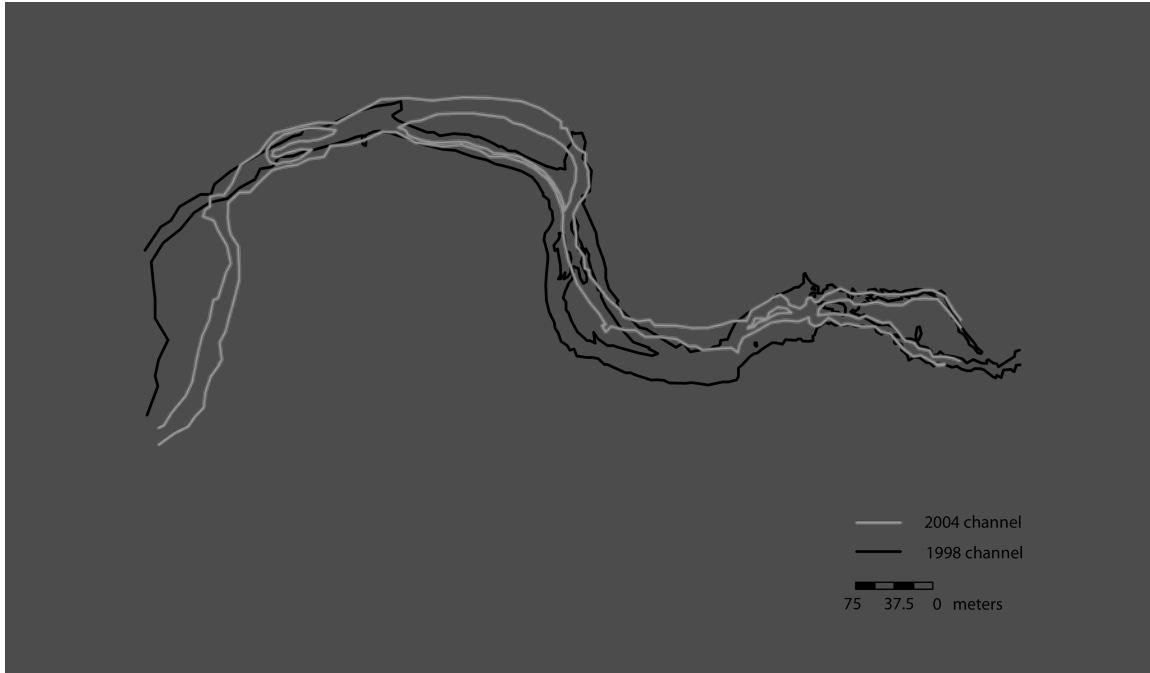
Figure 12a.
Channel change between 1998 and 2004.

- A. In the first 490 feet (150 m) upstream from the former dam site (area A), the channel moved north by approximately 65 to 100 feet (20 to 30 m) as measured from the channel center.
- B. In the next 330 feet (100 m) (area B), the creek has abandoned the southeastern (river left) high flow channel upon draining of the reservoir. (This dry high flow channel was noted during the Ferry and Miller (2003) study.) The deeper northwestern channel previously cut southeast through a former bar island. In the field, Ferry and Miller

- (2003) observed substantial erosion on the left (northwest) bank in this area.¹⁵ They proposed that erosion in this area was due to death of riparian vegetation upon lowering of the reservoir water level. The banks in this area are comprised of unconsolidated fine sediment and cobbles, which would be easily eroded during periods of high flows without stabilization provided by vegetation (Ferry and Miller 2003).

- D. In the third bend, approximately 2300 feet (700 m) upstream of the dam site in area D, the channel moved approximately 160 feet (50 m) east. This may be related to a meander cutoff that occurred just upstream during this time period (Figures 13a, 13b, 13c).¹⁶ Meander cutoffs result in a steeper channel grade, and an associated increase in water velocity and sediment transport (Knighton 1998). This increase in velocity likely caused the major eastward shift of area D between 1998 and 2004.

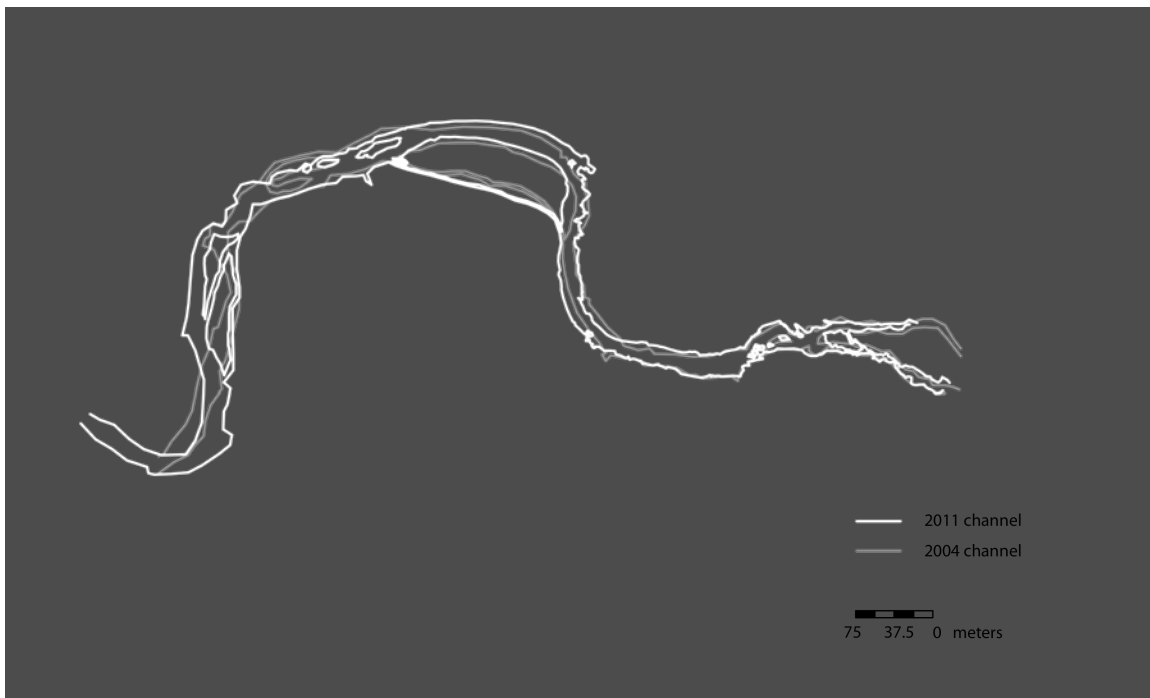
Figure 12b.
Channel change between 2004 and 2011.

Conversely, channel change from 2004 to 2010 (Figure 12b) was relatively minor compared to that observed from 1998 to 2004 (Figure 12a); except in area D, where significant braiding has occurred since 2004.

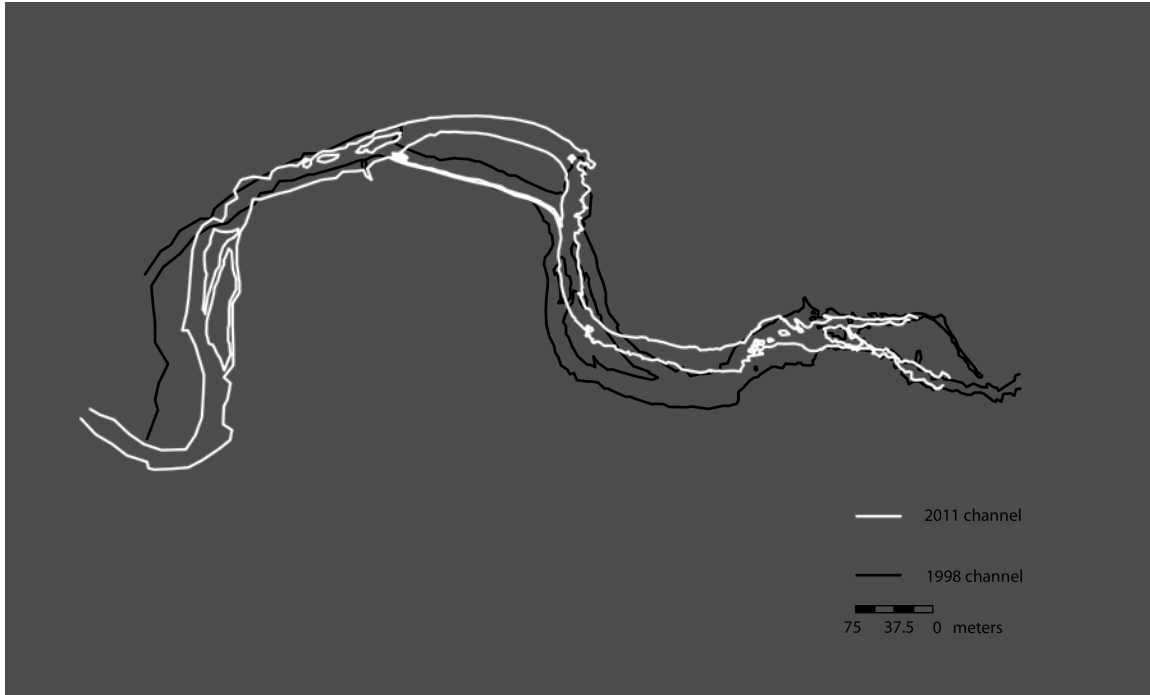
Figure 12c.
Channel change between 1997 and 2011.

- D. Substantial braiding was observed in area D (Figure 12c). We suspect that this may be deposition of sediment transported due to the meander cutoff just upstream. The channel steepening associated with meander cutoffs results in increased water velocity and sediment transport (Knighton 1998). The increased velocity continued to push the channel in area D eastward, while the increased sediment transport likely resulted in increased sediment deposition, creating the braided channel observed in 2011.

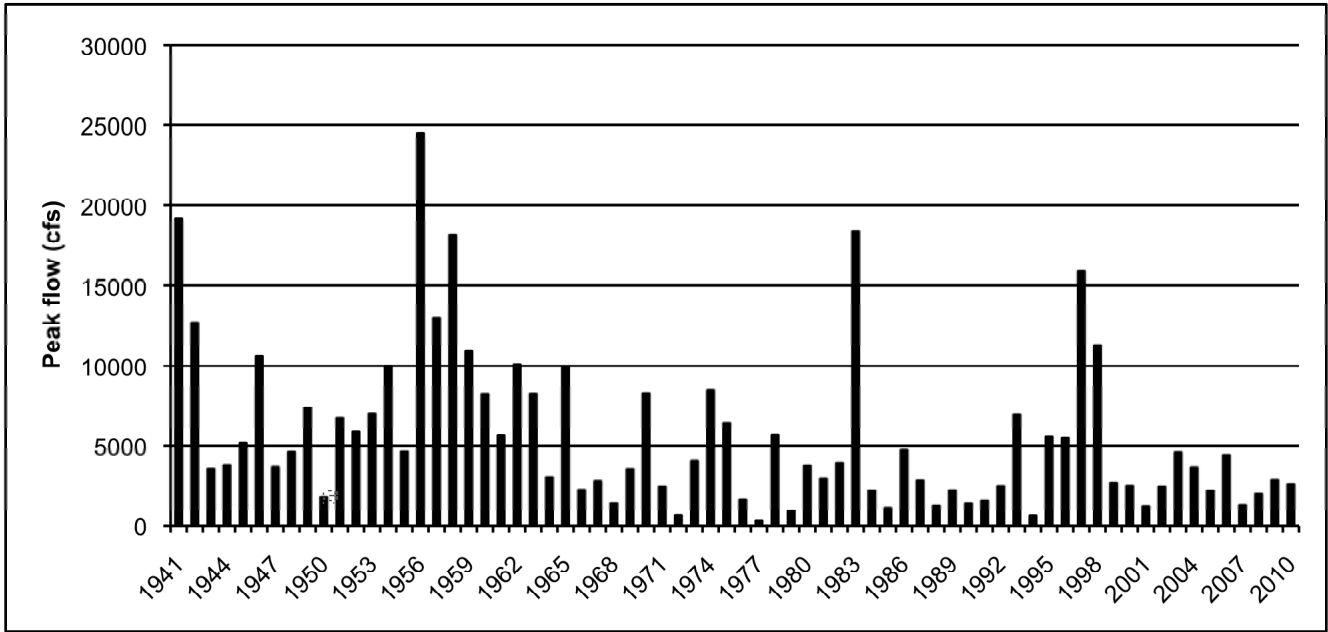
Figure 14.
Peak Annual Flow (cfs) 1941-2010.

- Creek high flows between 2003 and 2011 occurred at levels that were, from 2001 to 2003, sufficient to mobilize sediment. On December 30, 2005, for example, there was a significant flow event (4,400 cfs) that approached the high flow volumes seen in the winter and spring of 2003—flow volumes that had caused substantial geomorphic change in the creek (Figure 14). The highest flows recorded from 2000 to 2001 were likely too low to trigger substantial post-dam sediment movement and geomorphic adjustment.

From USGS gauge 11372000 on Clear Creek near Igo, CA. Note the 4,500 cfs flow recorded on December 31, 2005. In 2011, we found minimal incremental erosion from 2003 despite this substantial flow event.

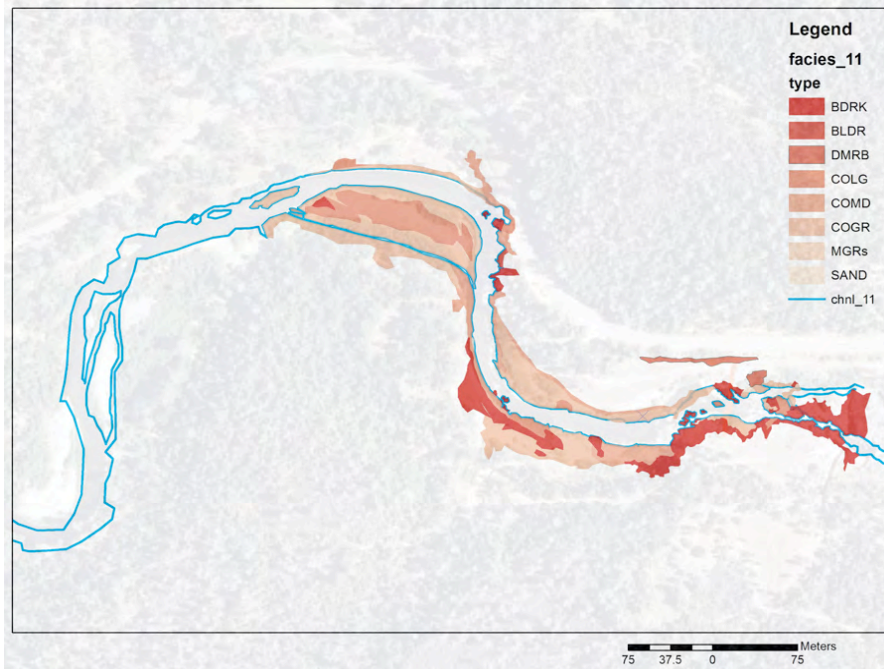
Figure B1.
2011 Substrate facies map.

Eight substrate types were observed: sand, mixed gravel embedded in sand, small cobble and mixed gravel, medium cobble, large cobble, boulder, bedrock, and dam rubble. Total observed area for each substrate type was calculated in square meters (Table B1).

Small cobble with mixed gravel was the dominant type, primarily observed in those areas where channel change occurred between 1998 and 2011 (Figure 12c). Exposed bedrock was also significant (Figure B2), as we believe its presence aids in stabilization since 2004. Our 2011 observations of areas of erosion and deposition further support this conclusion (Figure 7b).
