Post Project Appraisal of Village Creek Restoration, Albany, CA

LA 227 Restoration of Rivers and Streams

December 12, 2005

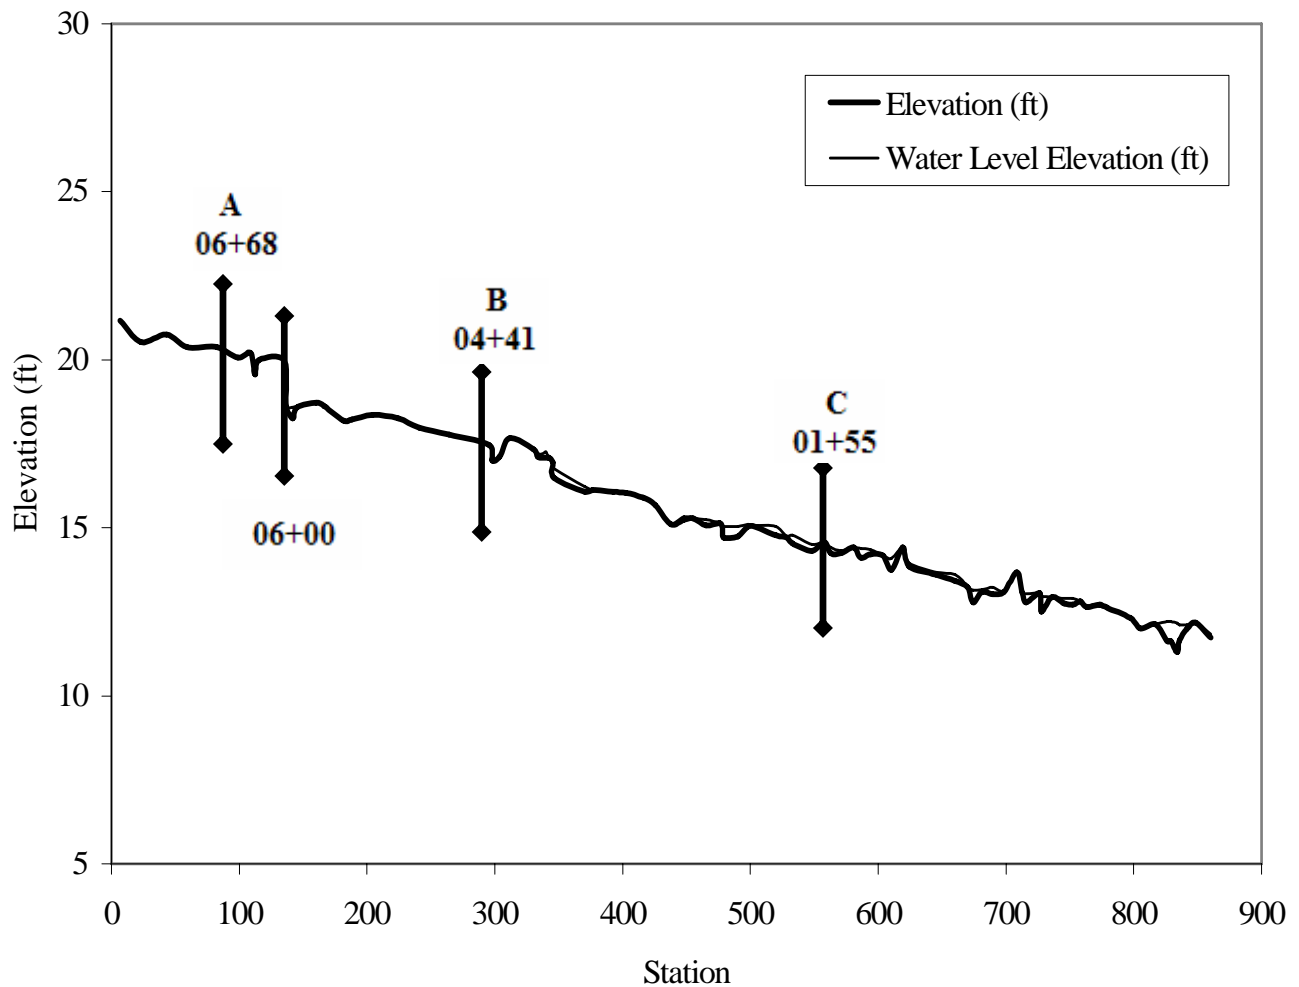
Figure 5: Longitudinal Profile with Water Depth (November 2005)

A graph of the longitudinal profile reveals that the channel ranges from an elevation of 21.16 at the upstream culvert to an elevation of 11.74 at the downstream culvert. The pool and riffle structure of the channel currently consists of a mostly dry bed with several small pools of standing water with the largest pool at around 830 feet from the upstream culvert and a large,

scour pool around at Station 06+00 (Figure 5). The thalweg of the channel is approximately 860 feet long, thus the average channel slope is 0.011 feet/feet, same as that of the as-built slope (Table A.2). It is evident therefore that even though the average channel slope is the same as the as-built slope, the complexity of the channel's thalweg has changed.

portion of the creek can lead to flooding near the upstream culvert. In the future, sediment augmentation may become necessary to replenish the lost sediment in the middle reach. We recommend installation of rock or log weirs to minimize channel erosion as well as close monitoring of the headcut.

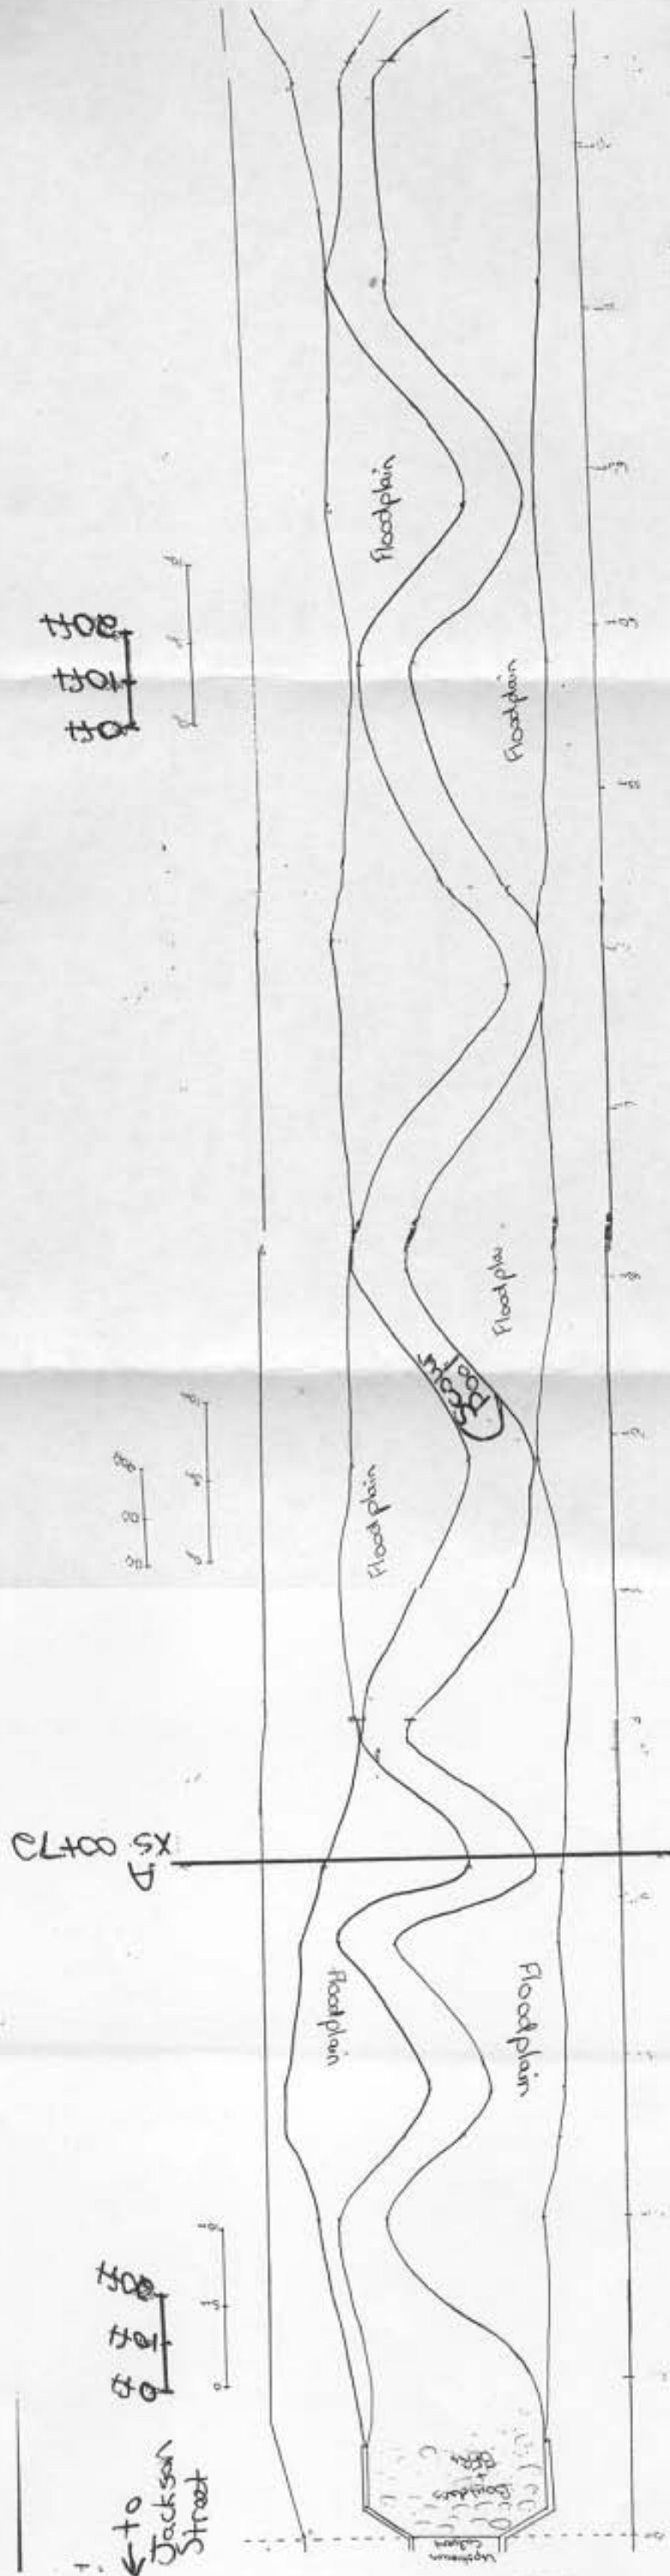
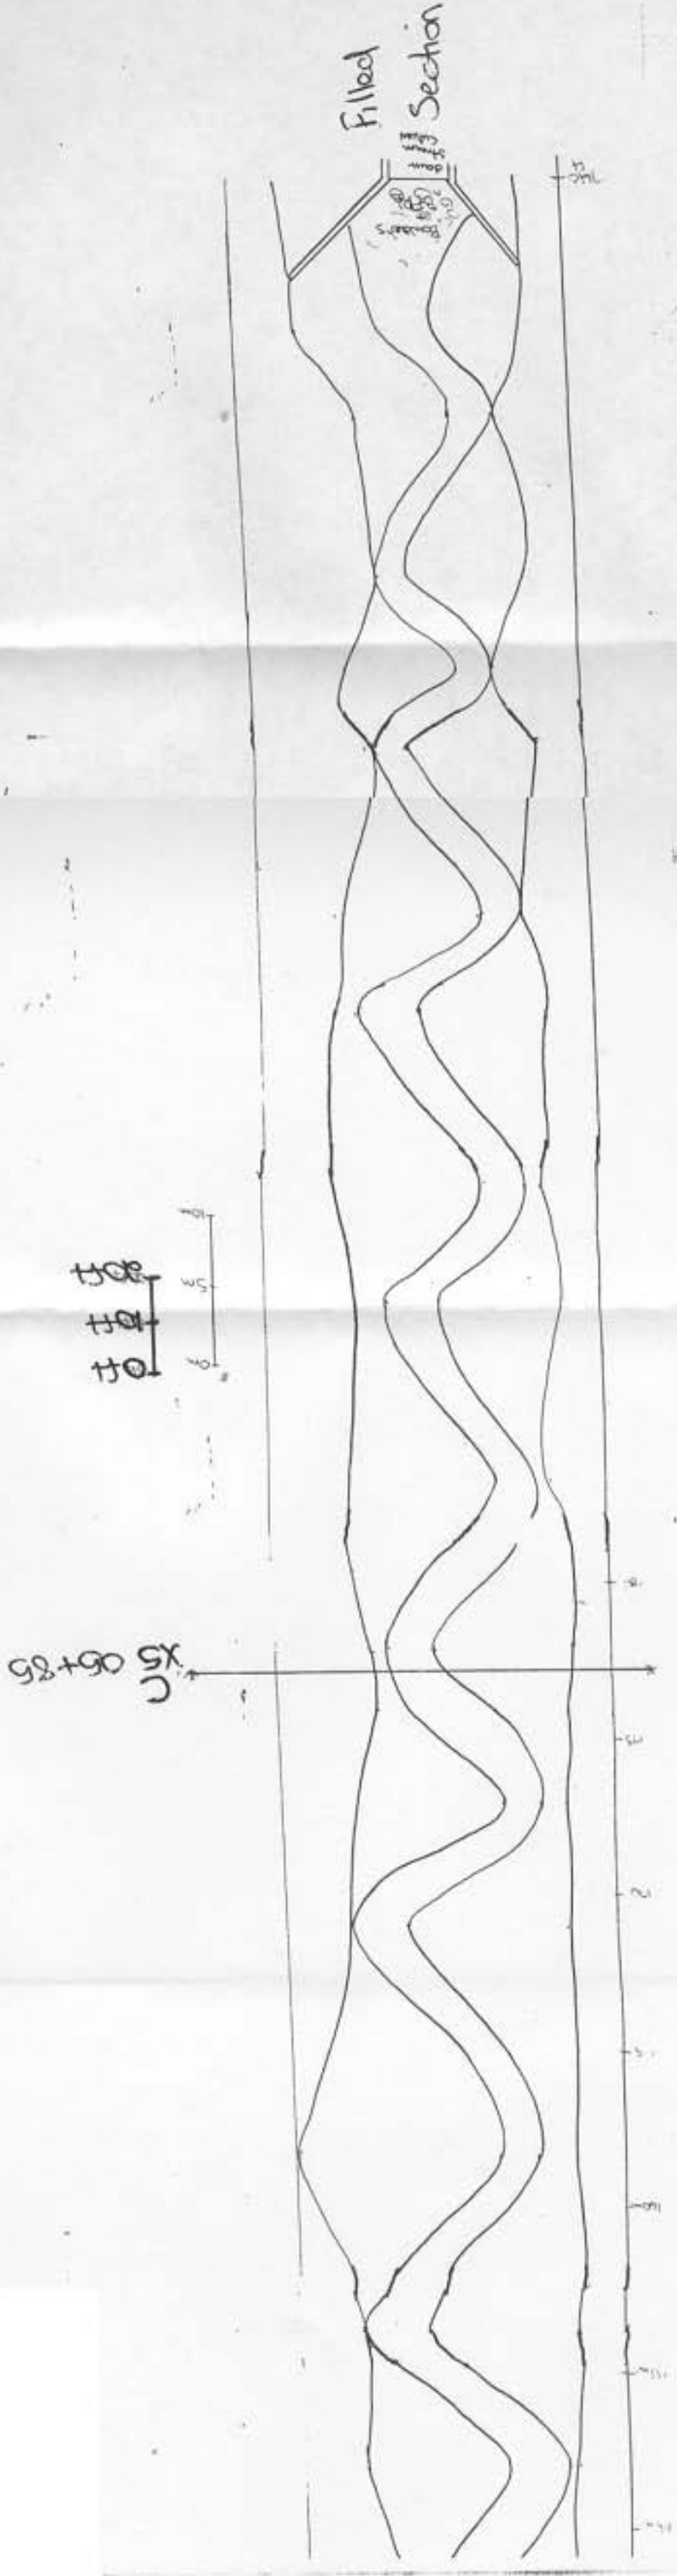
The channel map shows the evolution of the channel bed since 1998. The general shape of the channel has not significantly changed except for slight movement in some meanders (Figures A.1-3 and B.1-3). One significant difference is that the current channel bed changes directions 41 times during the 740 feet between the two culverts, while the as-built channel shape included 42 changes. The bend located at approximately 250 feet from the upstream culvert (04+90) has straightened since the restoration. We found that there is 860 feet of meander for the 740 linear foot reach. This results in approximately 116 feet of meander per 100 linear feet. Although we do not know the as-built meander length, the design called for 160 feet of meander per 100 linear feet. Therefore, the current channel contains about 324 feet less meander than the original design. Considering the channel shape has not changed significantly, except for the loss of one meander bend, the as-built meander length could not have been the design length of 160 feet per 100 linear feet. It would have been slightly larger than the current ratio of 116 feet of meander to 100 linear feet.
