Warm-Mix Asphalt Study: Field Test Performance Evaluation

Partnered Pavement Research Center (PPRC) Contract Strategic Plan Element 4.18:
Warm Mix Asphalt

DOCUMENT RETRIEVAL PAGE		Technical Memorandum: UCPRC-TM-2013-08			
Title: Warm-Mix Asphalt Study: Field Test Performance Evaluation					
Authors: D. Jones					
Technical Leads: T. Joe Holland (Caltrans) and Nathan Gauff (CalRecycle)					
Prepared for: Caltrans and CalRecycle		FHWA No.: CA142385D	Work submitted: 04/05/2014		Date December 2013
Strategic Plan Element No.: 4.18		Status: Final		Version No.: 1	
Abstract:					
<p>A number of warm-mix asphalt test sections were constructed in California between 2007 and 2010 to assess long-term performance under selected traffic and climate conditions. A range of pavement designs were assessed, but the six projects evaluated in this report focused on open-graded friction courses with polymer-modified (PG 58-34) and rubber-modified (PG 64-16) binders (three projects each). The main purpose of these experiments was to monitor performance under actual conditions and to quantify any benefits associated with using warm-mix asphalt under specific situations, such as with long hauls, in cool

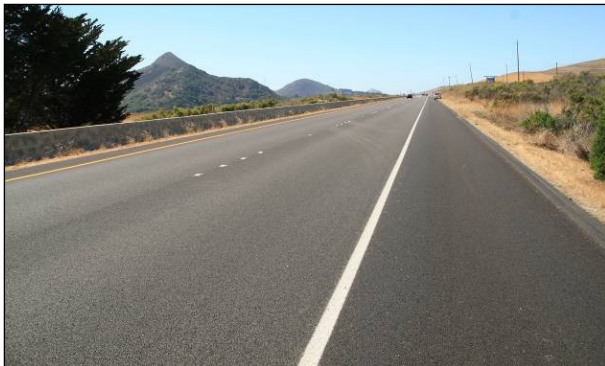
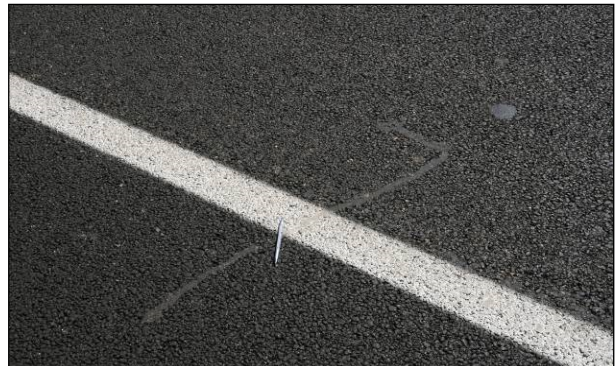
Figure 3.1: Morro Bay Control, May 2007 (0 months).

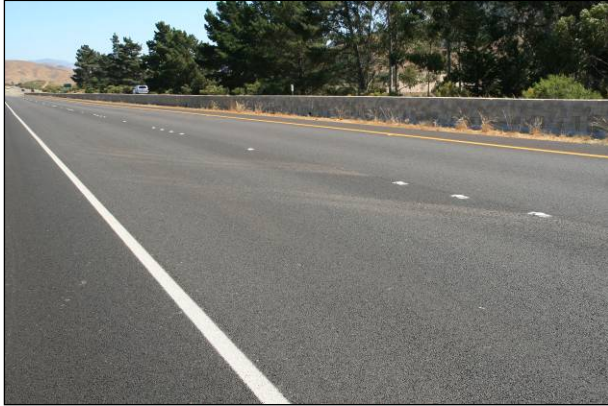
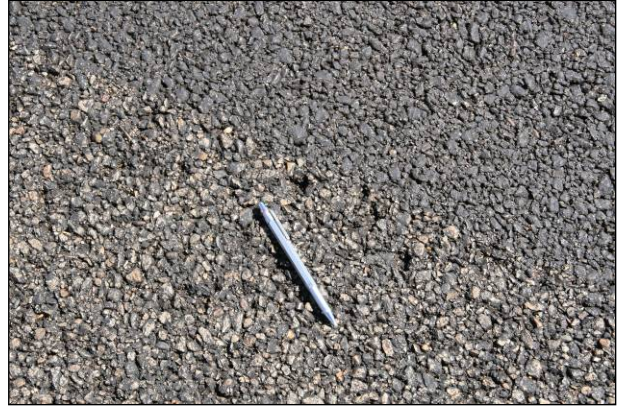
Figure 3.2: Morro Bay Control, May 2007 (0 months), track marks.

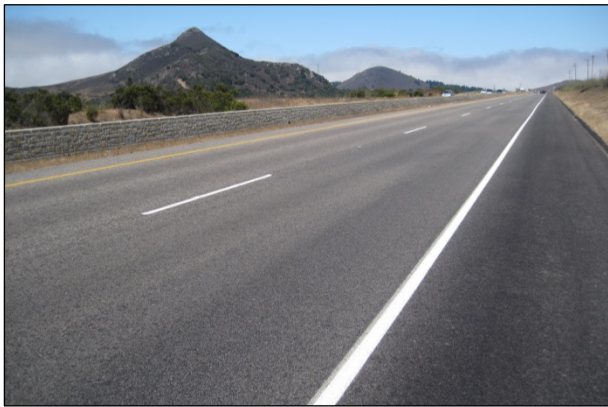
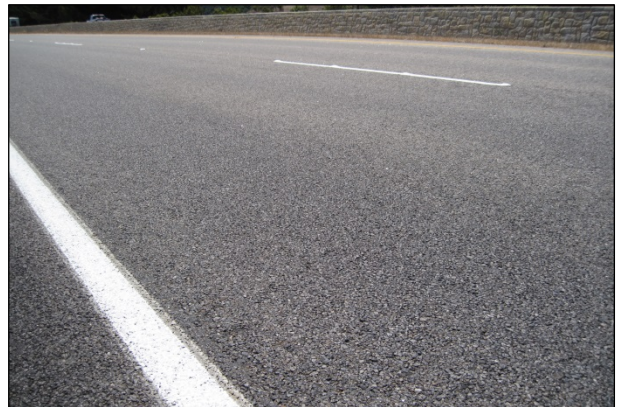
Figure 3.4: Morro Bay Control, June 2013 (73 months).

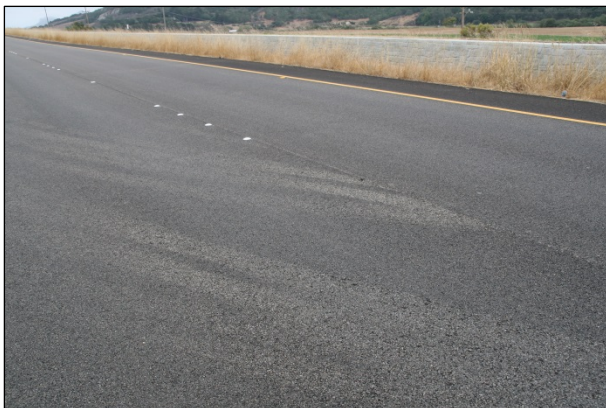
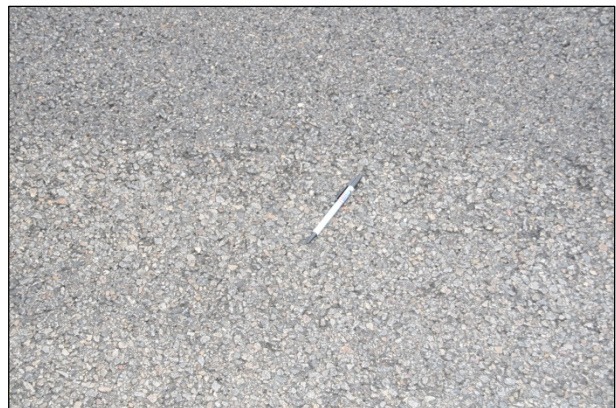
Figure 3.13: Morro Bay Sasobit, May 2007 (0 months), track marks.

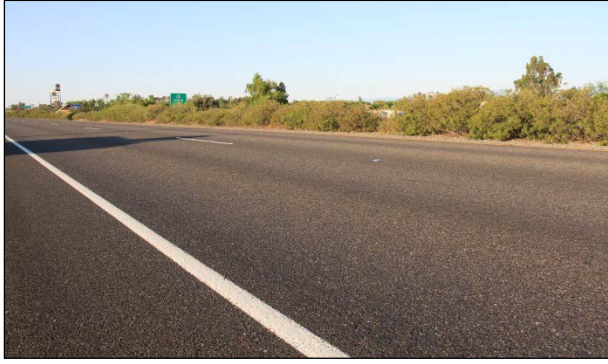
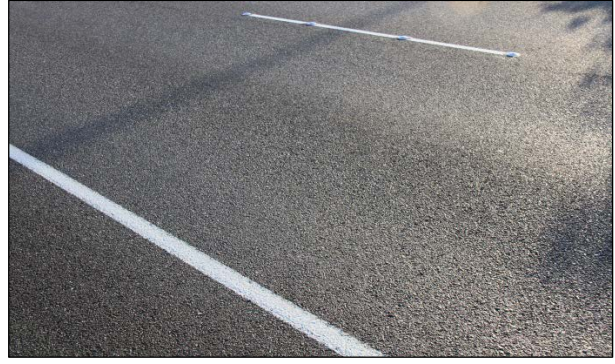
Rut depths of approximately 0.16 in. (4.0 mm) were measured on both the control and Evotherm sections. This indicated that rut performance on the hot- and warm-mix sections was similar after 12 months of trafficking and that binder oxidation rates had probably stabilized. No other deterioration compared to the June 2009 baseline measurements was noted on the sections after 12 months of traffic.

Figure 5.2: Orland Control, June 2011 (24 months). Note ruts in wheelpath.

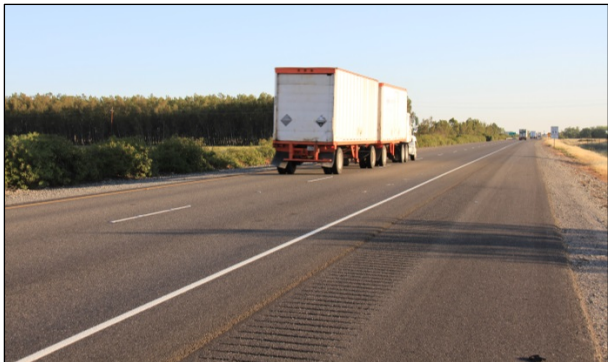
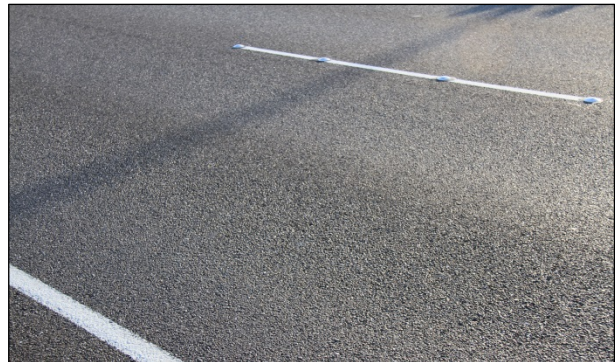
Minor rutting (average between 0.08 in. and 0.1 in. [2.0 mm and 3.0 mm]) was measured in the wheelpaths of the truck lane on the warm-mix section. No rutting was measured on the control section. The difference in rutting performance was attributed to lower oxidation of the binder in the warm-mix and consequent lower stiffness. Similar early rutting on warm-mix test sections was observed during accelerated loading tests conducted earlier in the warm-mix asphalt study (1). No other deterioration compared to the June 2009 baseline measurements was noted.

Figure 5.4: Orland Evotherm, June 2011 (24 months). Note ruts in wheelpath.

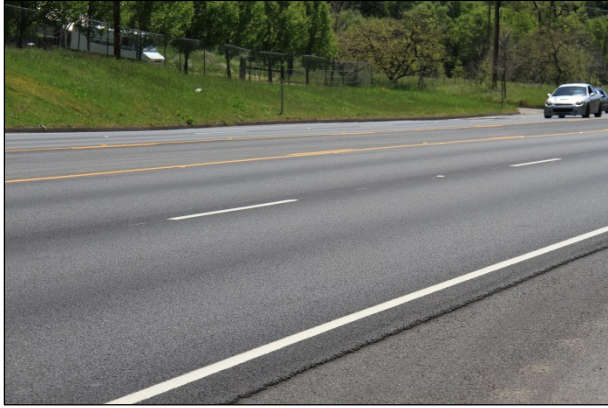
The road surface resembled a typical open-graded friction course and was given an overall rating of “good.” Some localized areas of what appeared to be segregation in the mix were noted. Some open longitudinal joints were also noted. No early stone loss was noted, and no other problems were observed. Water was effectively draining through the friction course and out through the sides of the road.

Figure 8.2: Auburn Evotherm, August 2010 (0 months). Note segregation and open joint.

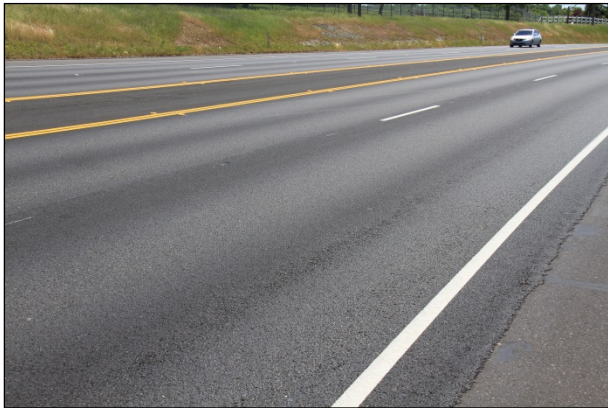
Reflected transverse cracking and some minor raveling in the outside wheelpath of the outside lanes was noted in some areas of the project. Given that no hot-mix control was available for comparison purposes, it was not clear whether these distresses were related to the warm-mix technology, to construction issues, or to other factors. No further deterioration compared to the August 2010 baseline measurements was noted.

Figure 8.3: Auburn Evotherm, July 2012 (24 months). Note deterioration and reflected crack.
