BEVATRON OPERATION AND DEVELOPMENT. XIII

February, March, April 1957

Walter Hartsough and William Salsig

MAGNET-COIL SHROUD: FAILURE AND REPAIR

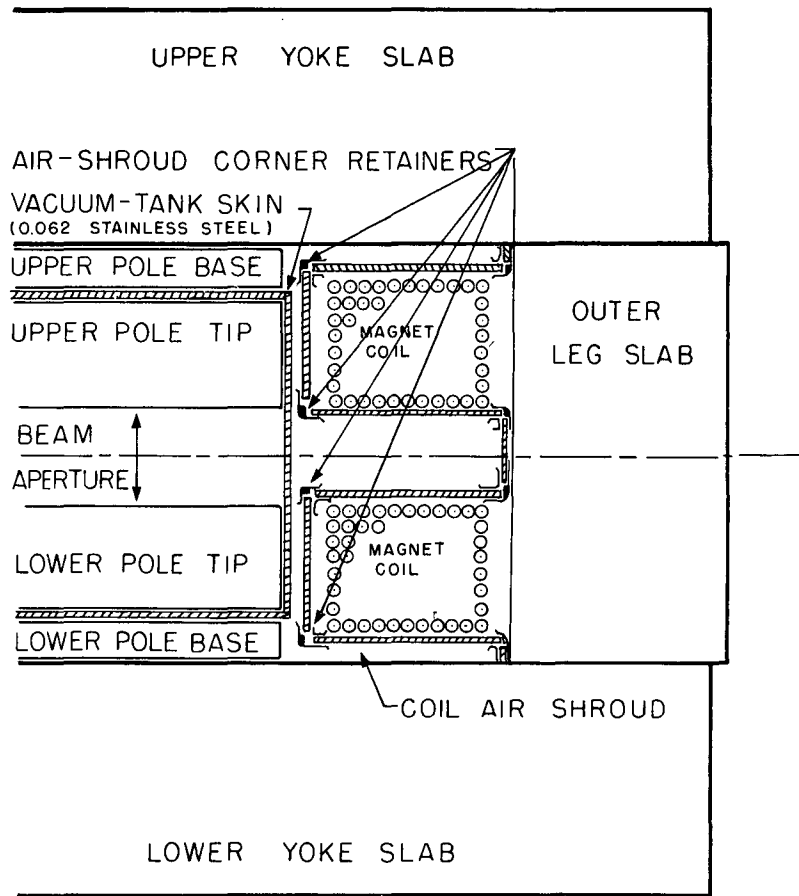
MU-14209

Fig. 1. Simplified cross-section view of the Bevatron in the region of the outer-radius coil.

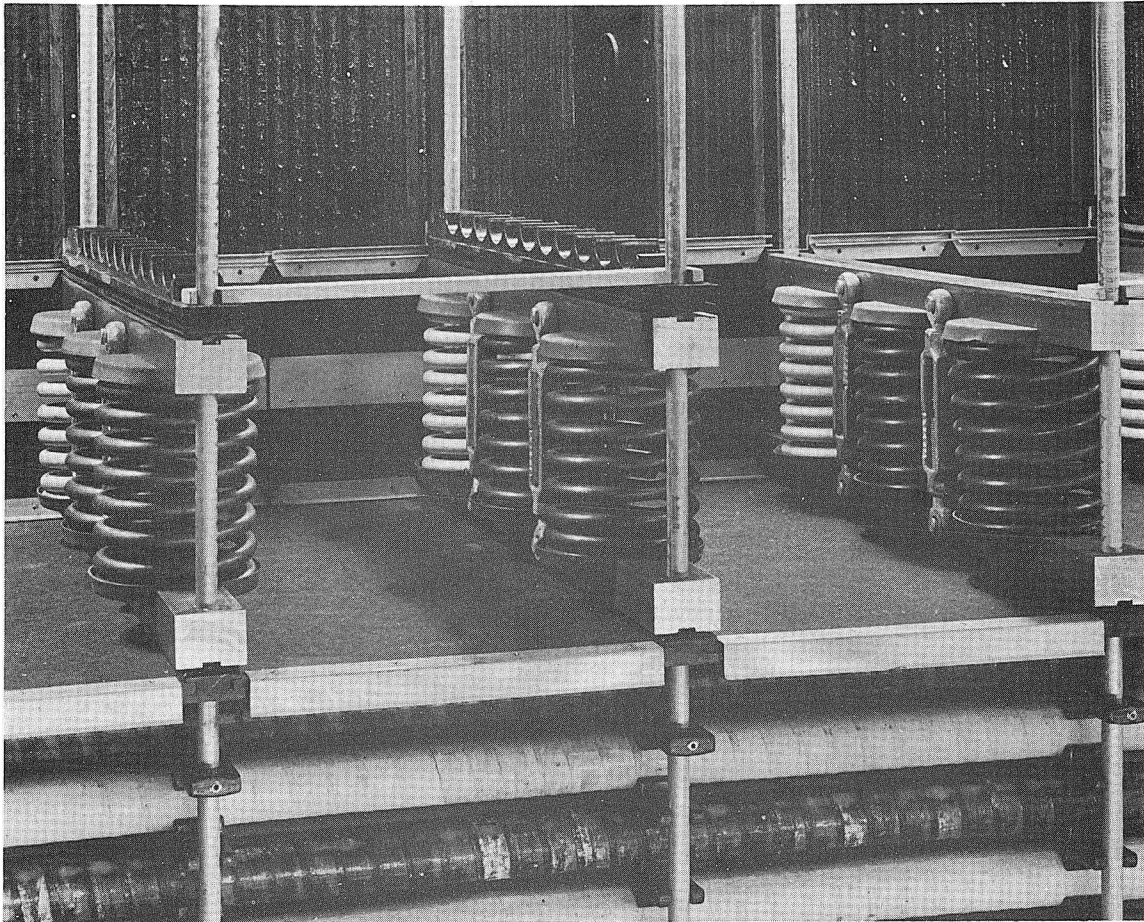
ZN-1900

Figure 2 shows the coil boxes during the original construction period before the vacuum tank was installed.

Fig. 2. Lower magnet coil, upper-coil spring supports, and upper-coil form during construction of the Bevatron. This picture was taken before the vacuum tank was installed and clearly shows the relationship of the coils, coil forms, coil boxes, and the coil-box corner retainers.

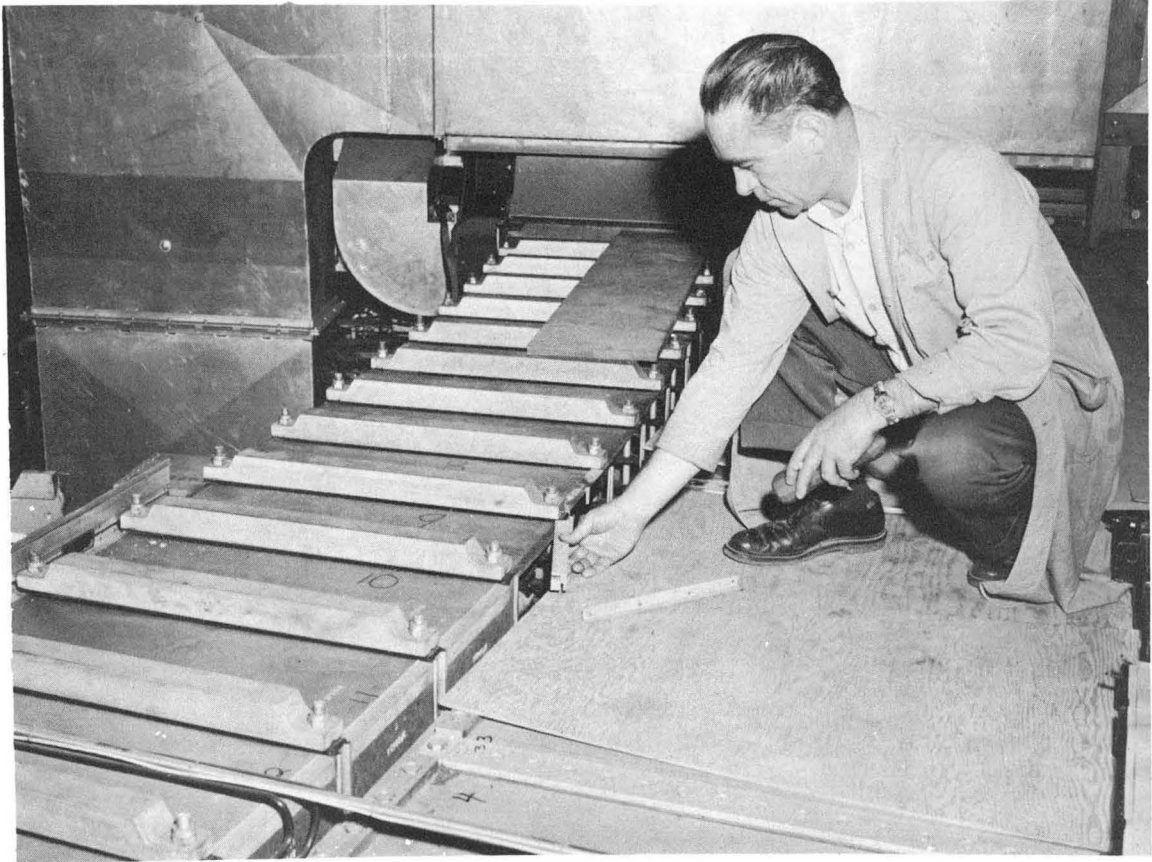
ZN-1901

Fig. 3. Replacement of the coil-box mild steel retainers with bakelite retainers.

Remotely operated tools were therefore built which allowed deriveting in place, and retrieving of the corner retainers. New bakelite retainers (Fig. 3) were made which could be installed without disassembly of the shroud and could be remotely handled during installation. Additional inspection and cleaning tools were designed and built.

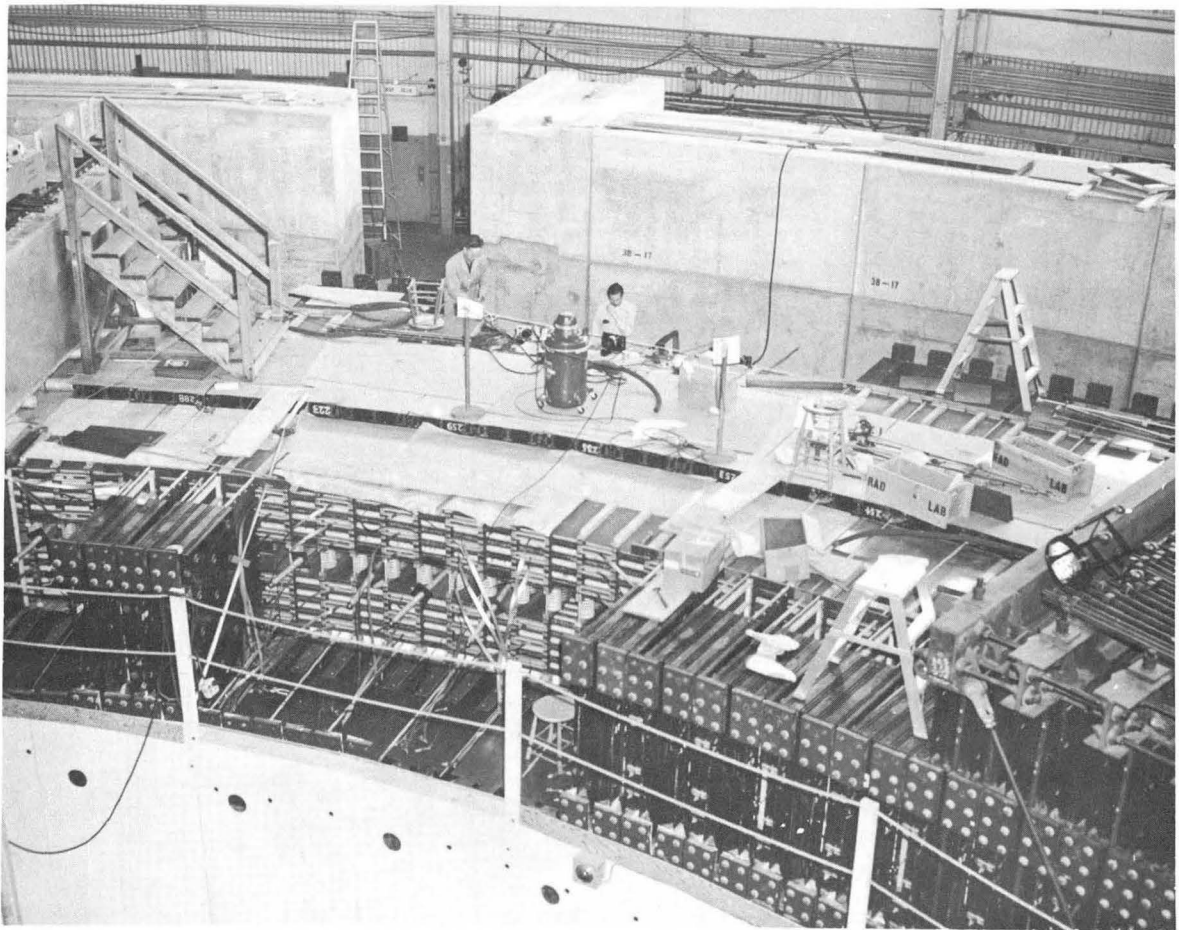
ZN-1902

Fig. 4. Rework of magnet-coil boxes.

The actual corrective rework began on February 7. Because the coil forms are radially constrained by the inner and outer leg slabs, the danger of the coils' deforming existed if the magnet were disassembled in large sections. The corrective work was therefore carried on in regions of not more than seven magnet sectors in azimuth (Figs. 4 and 5). Generally speaking, work was done in two quadrants simultaneously.

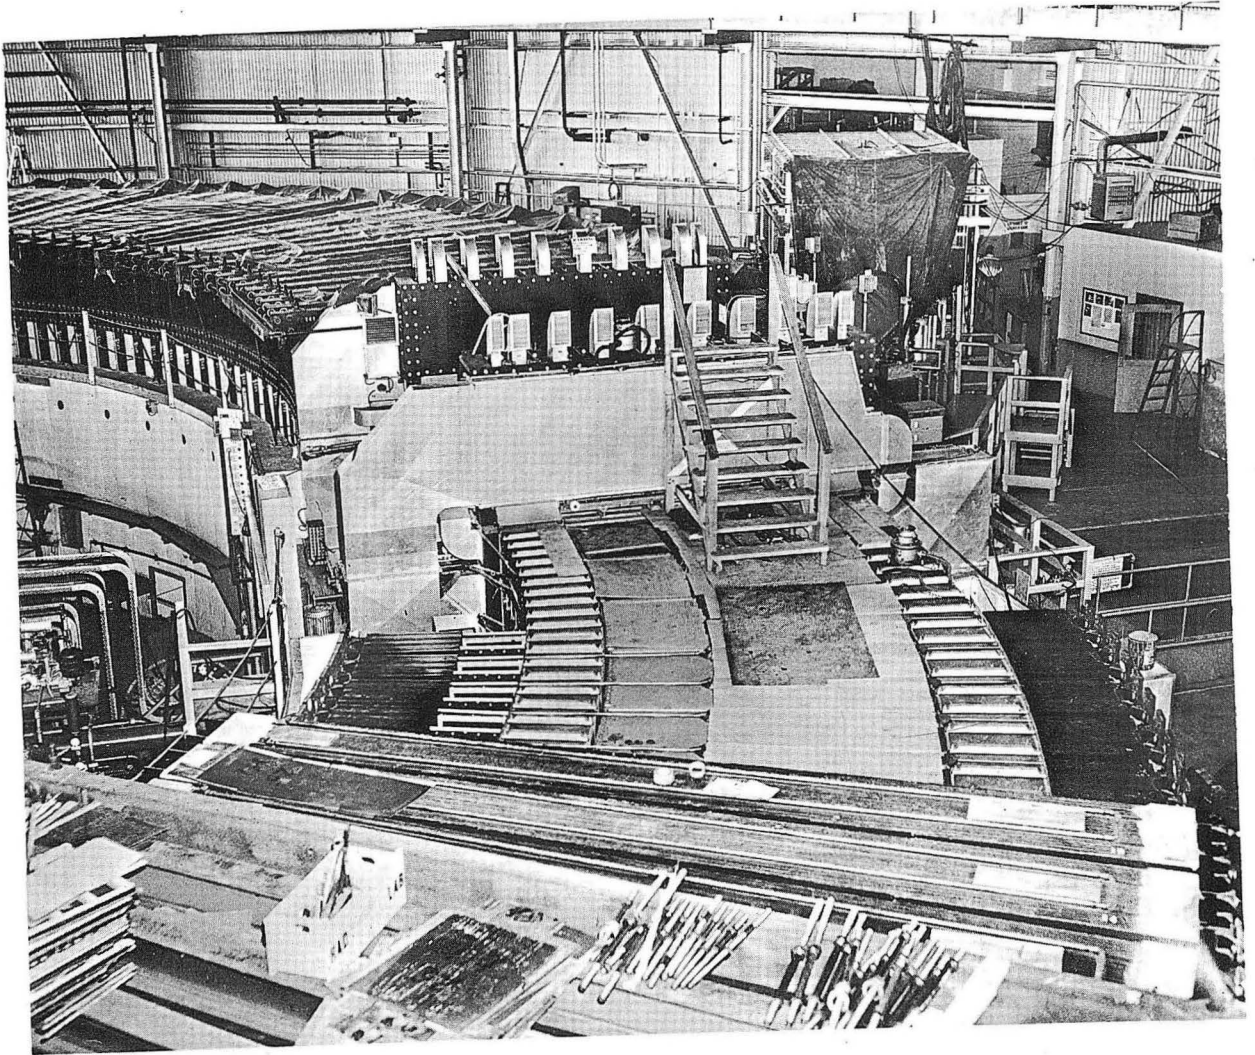
ZN-1903

Fig. 5. Rework of magnet-coil boxes.

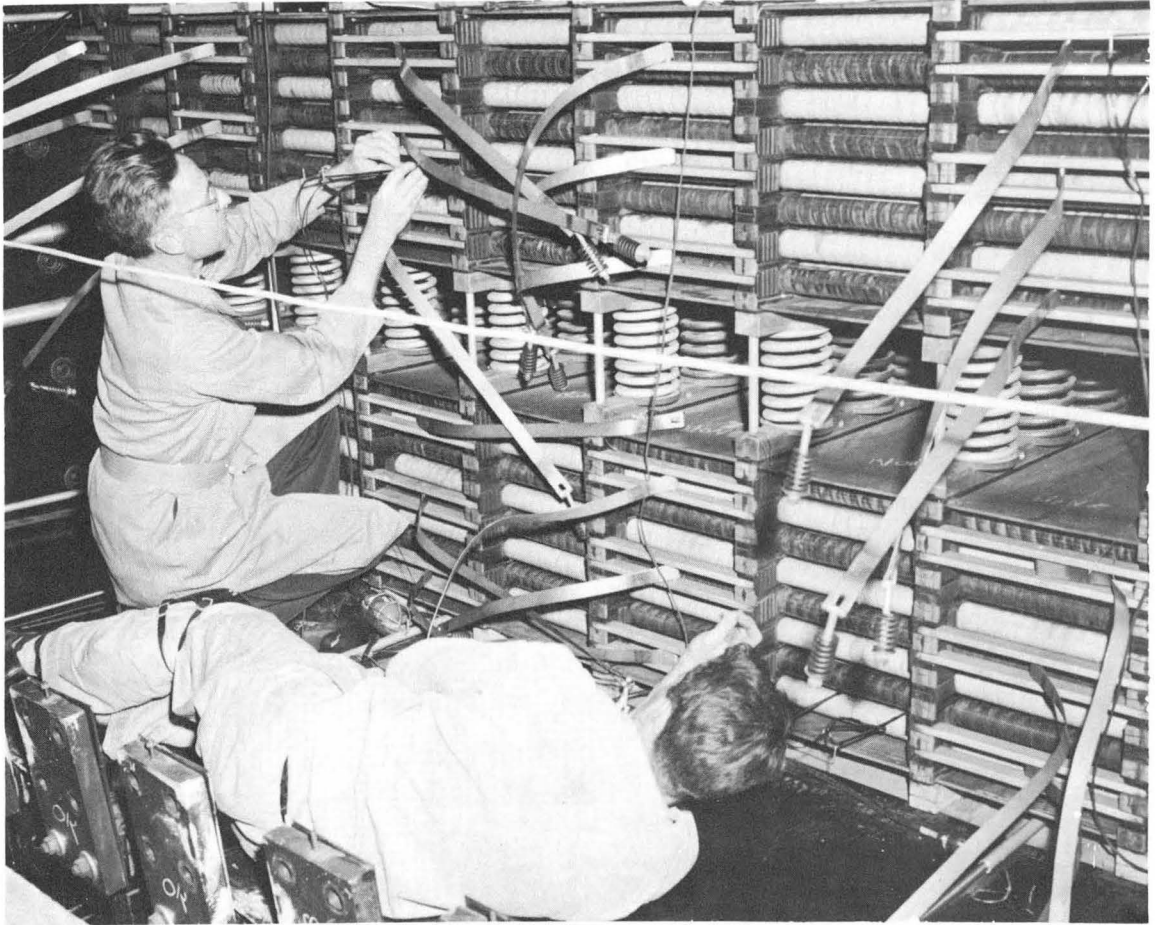
ZN-1904

1. A thorough inspection was made of the coil spaces and of the magnet-winding insulation by means of specially designed illuminated viewing prisms (Fig. 6).

Fig. 6. Visual inspection of the magnet windings, using illuminated prisms.

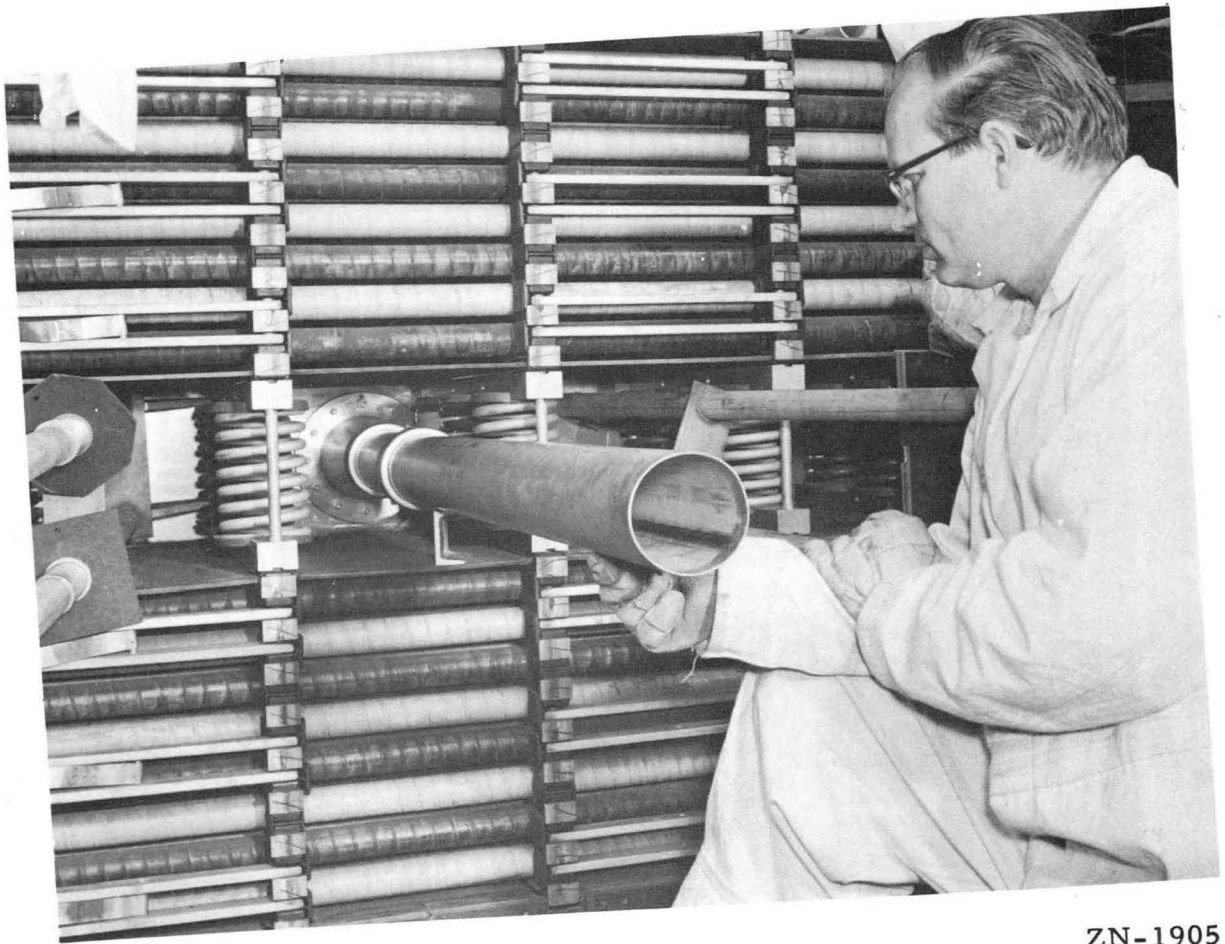
ZN-1905

Fig. 8. Vacuum tube at the northwest beam-exit location during installation.

2. Install a bellows-articulated vacuum tube from the vacuum-tank wall, terminating in a 0.010-inch-thick aluminum window just outside the magnet leg slab (Fig. 8). Particles are thus retained in vacuum 5 feet further than before, and the 0.062-inch stainless vacuum-tank wall beam obstruction was replaced with 0.010 inch of aluminum.

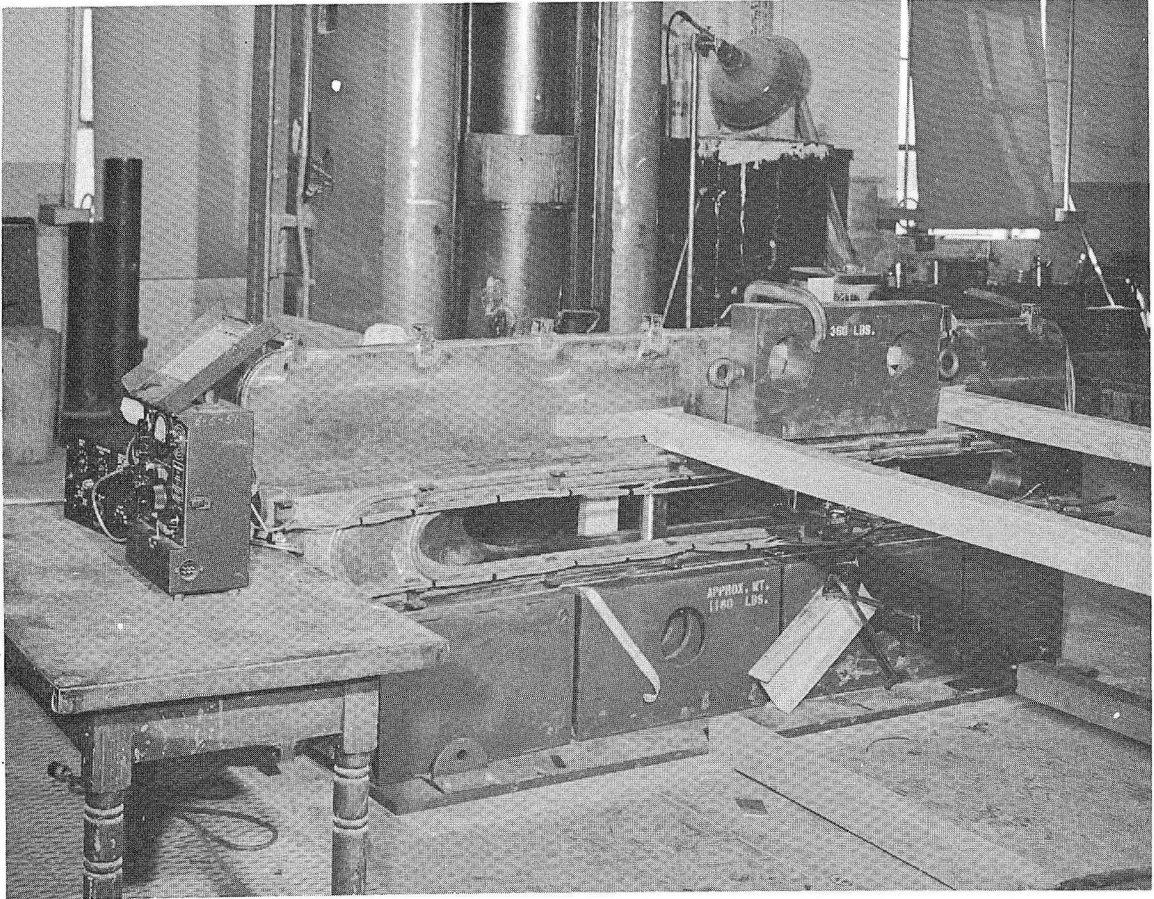
ZN-1906

Fig. 9. Four-sector stanchion during proof-test in the U. C. Structural Engineering Lab. materials testing machine.

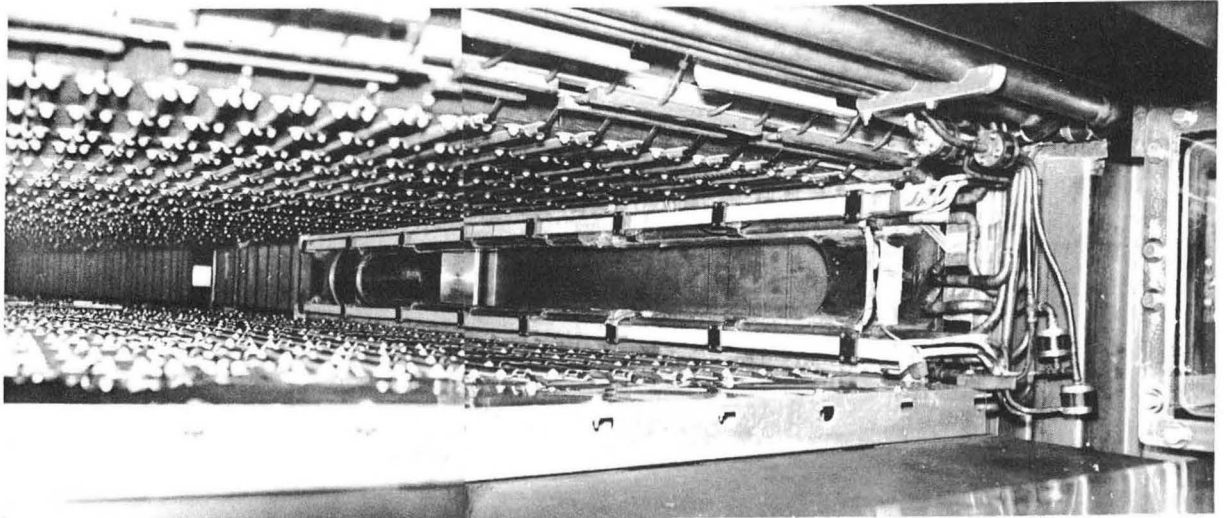
ZN-1909

Fig. 12. Four-sector stanchion installed at the exit end of quadrant III. The one-sector stanchion for the northwest experimental area (K-meson beams) can be seen toward the left side of the photograph.

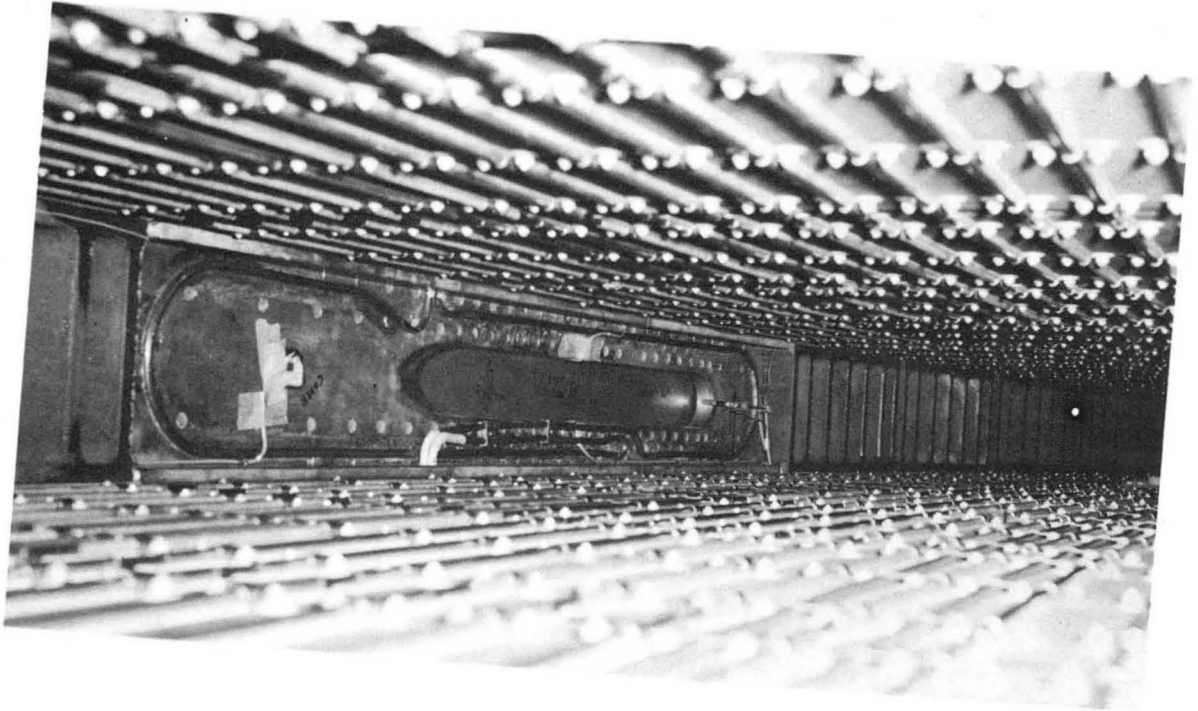
ZN-1914

Fig. 17. Three-sector stanchion installed in the Bevatron.

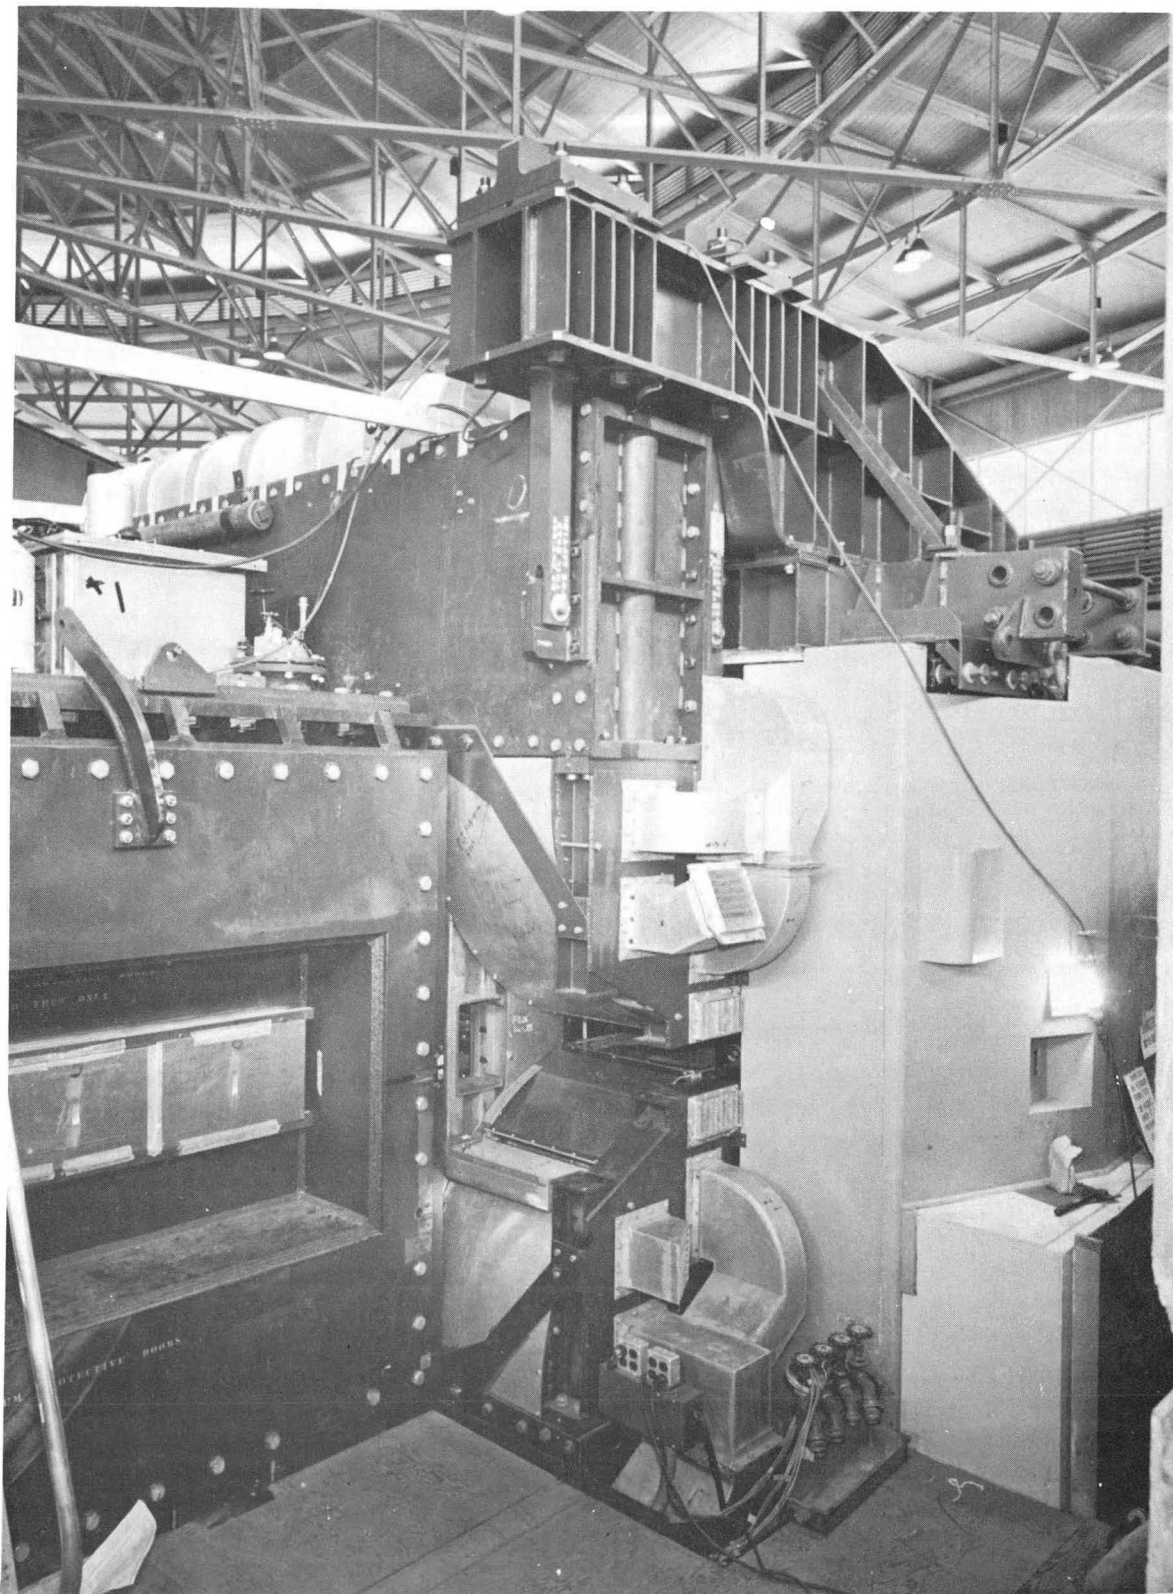
ZN-1915

Fig. 18. Upper coil-box support beam in place at the west experimental area.

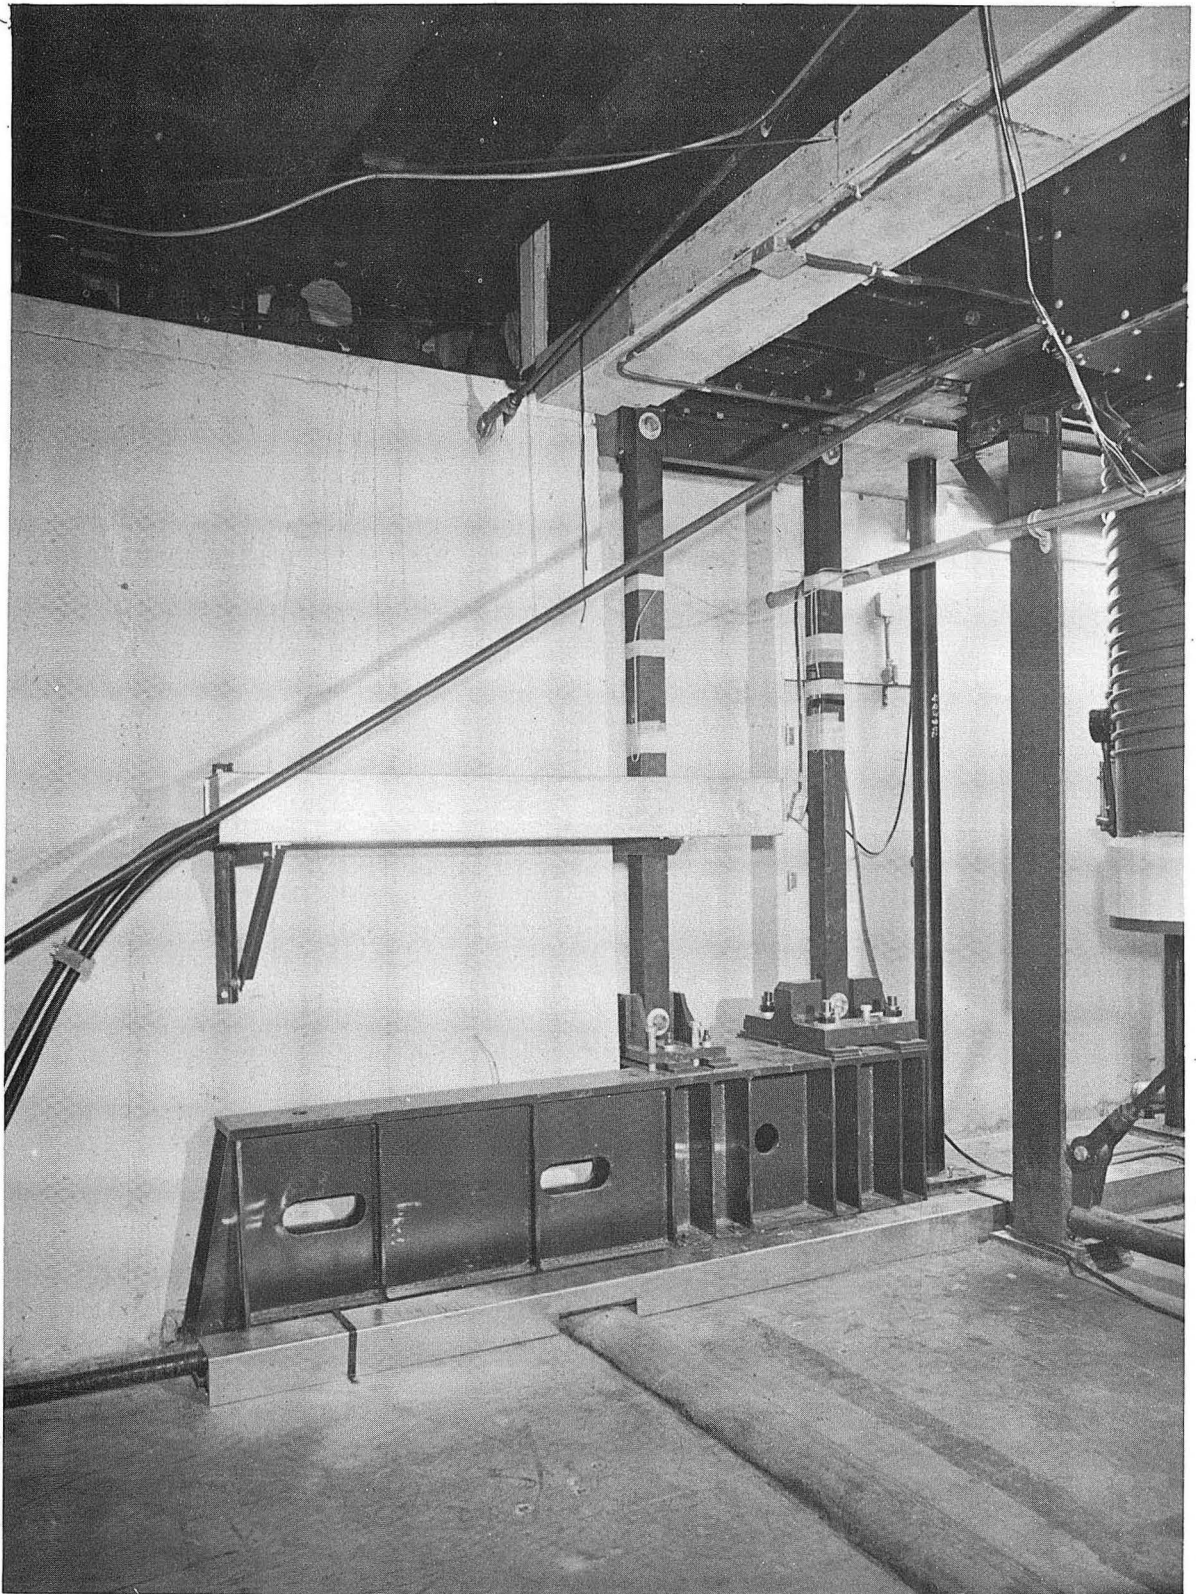
ZN-1916

Fig. 19. Lower coil-box support beam and links in place at the north experimental area.

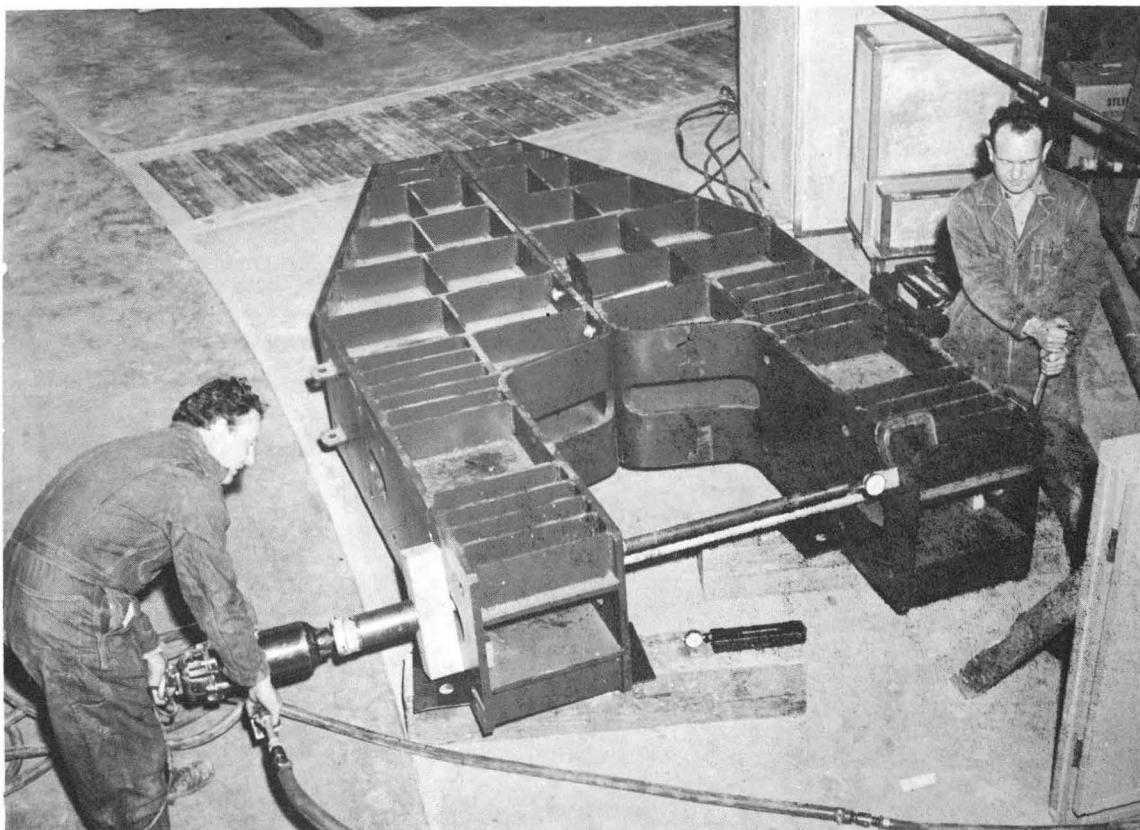
ZN-1917

Fig. 20. Upper coil-box support beams during proof stressing and load test.

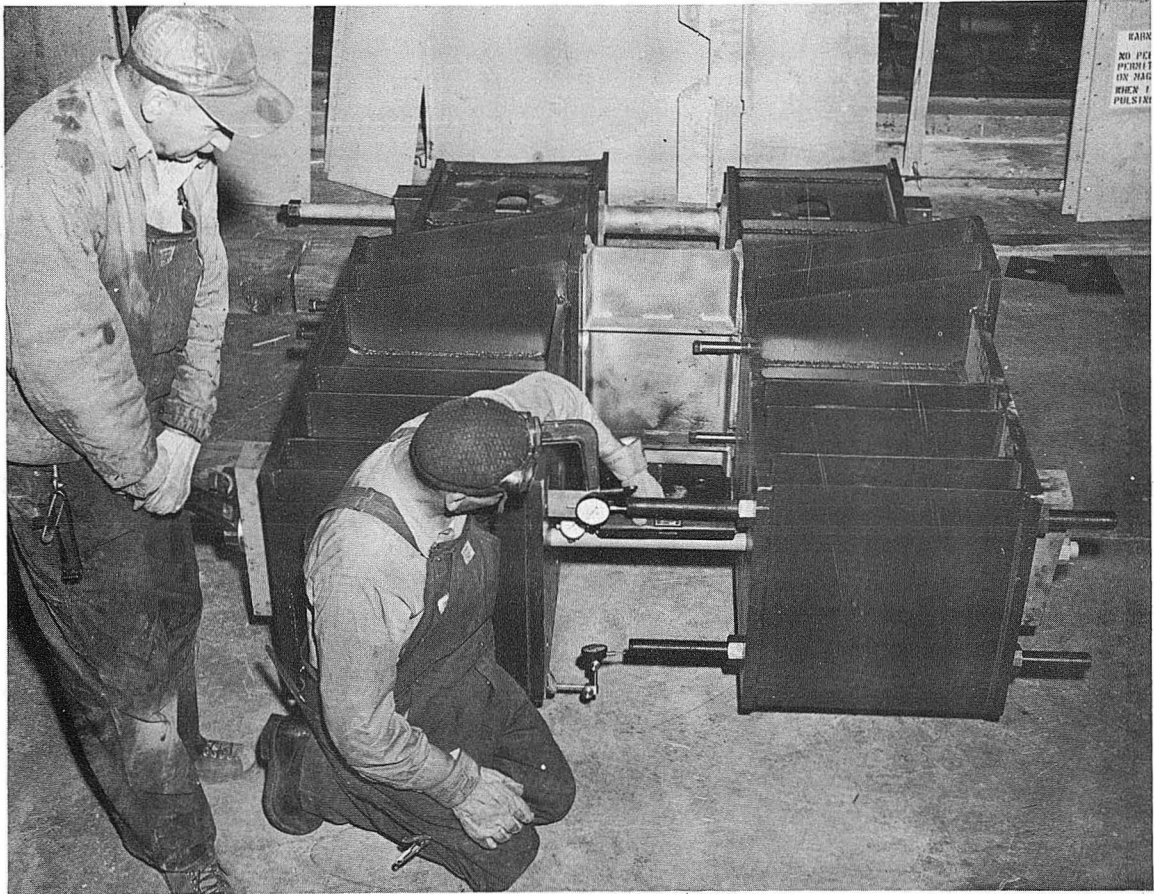
ZN-1918

Fig. 21. Lower coil-box support beams during proof stressing and load test.

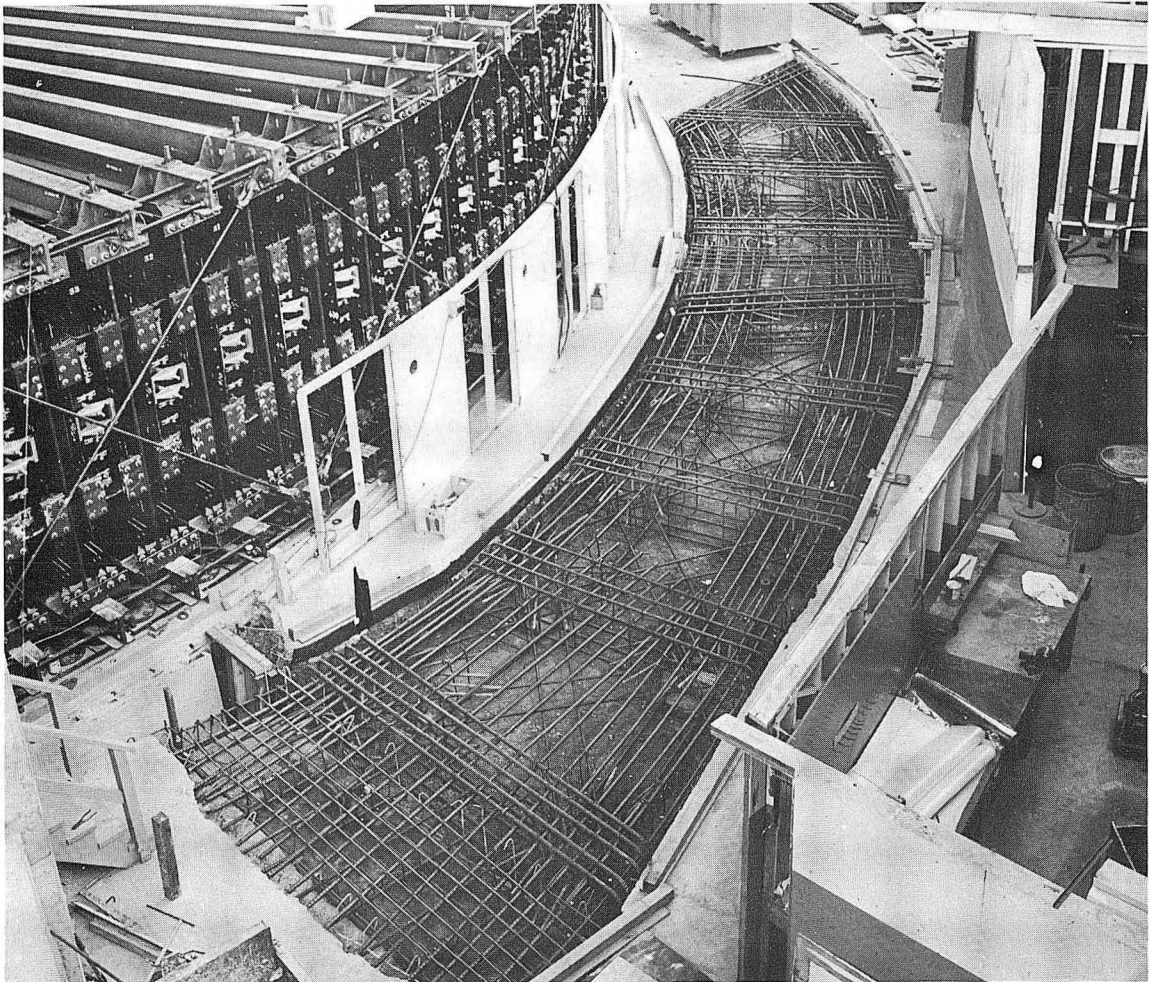
ZN-1919

The foundation of the radiation-shielding wall, prior to this shutdown, extended from the north straight section past the west experimental area to the south straight section. The shielding that continued toward the east from both the north and the south straight sections was supported on the original floor slab by placing the wall well away from the magnet foundation, by using timbers to distribute the load, and by limiting the height and thickness of the wall. In the near future, these two extensions will be improved and will be continued east to the linear accelerator from the north, and to the east straight section from the south, and along the linear accelerator to the ion gun (Fig. 23). At the new north experimental area the shielding wall will be made similar to the wall that exists at the west experimental area. To permit these improvements and to allow placing the wall close to the magnet foundation (better shielding and more economical use of the limited building space), suitable footings had to be installed. Figure 24 pictures a section of this recent shielding-wall foundation work during the construction period. The shielding-wall load will be distributed via the reinforced concrete slab to concrete piers, which will carry the load to earth below the foundation level of the Bevatron magnet.

Fig. 24. Extension of the foundation for the concrete radiation-shielding wall, Quadrants I and IV.
