Addressing channel incision through floodplain reconnection: Revisiting the Lower Tassajara Creek project

PRELIMINARY REPORT

LA227 Restoration of Rivers and Streams

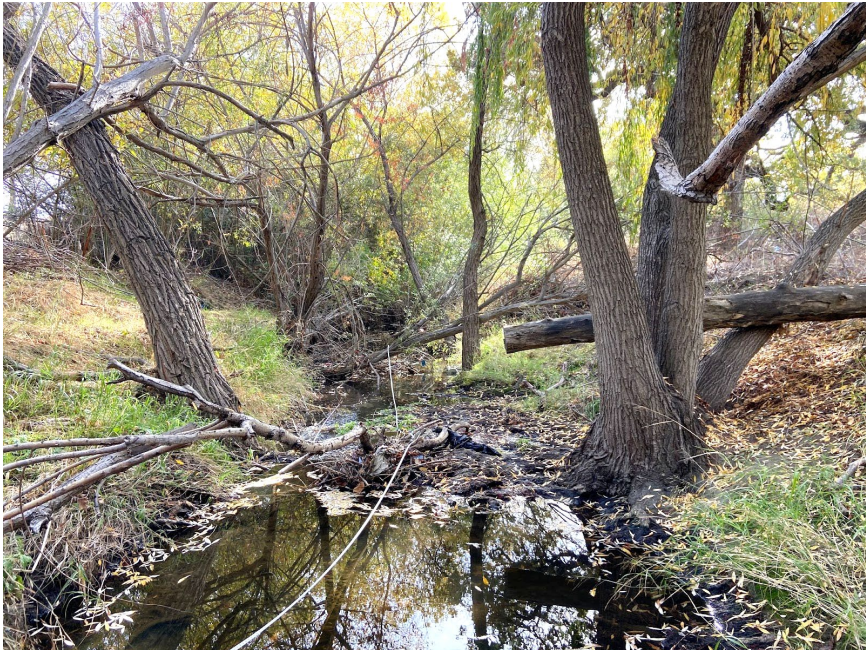
Figure 18. Photograph of low flow channel conditions at Cross Section B

looking downstream toward XS B from the channel thalweg

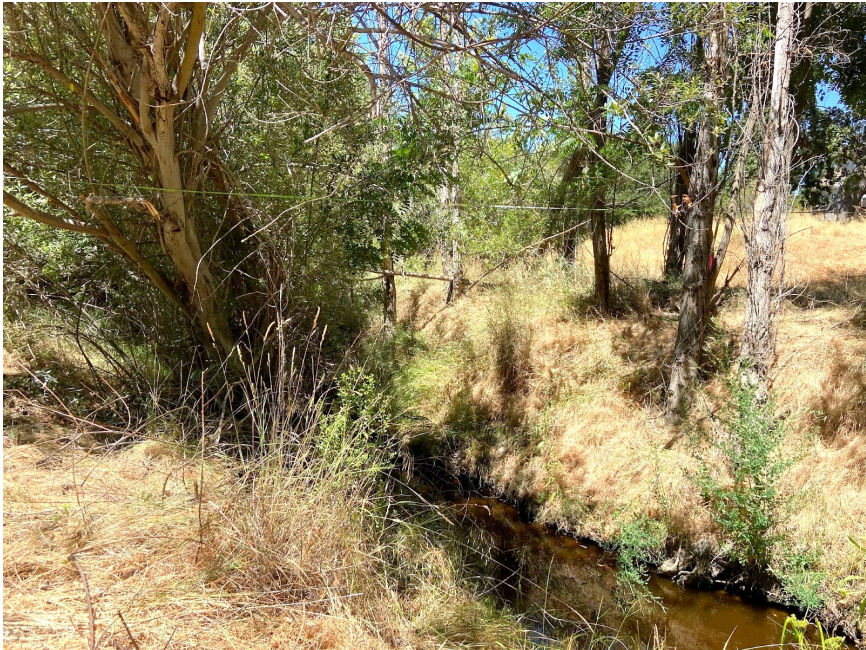
Figure 19. Photograph of low flow channel conditions at Cross Section E

looking upstream toward XS E from the right bank

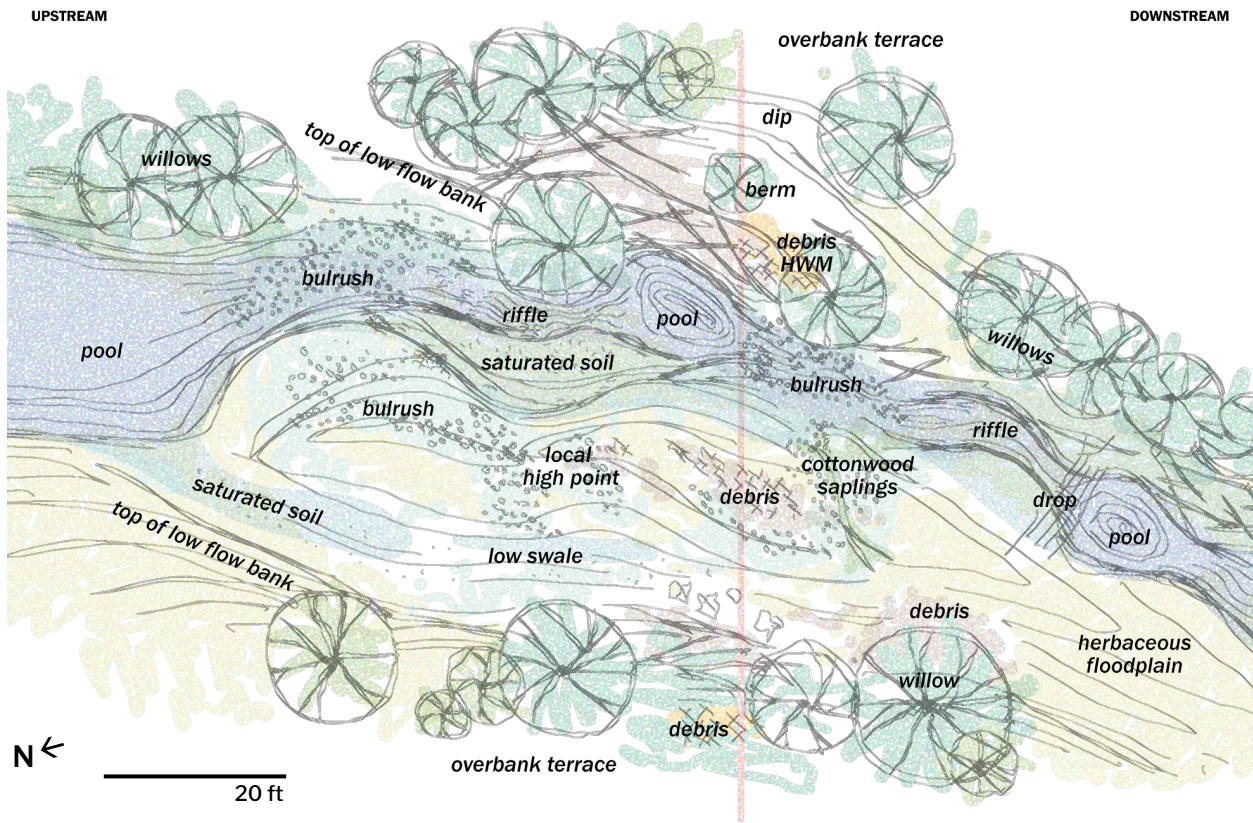
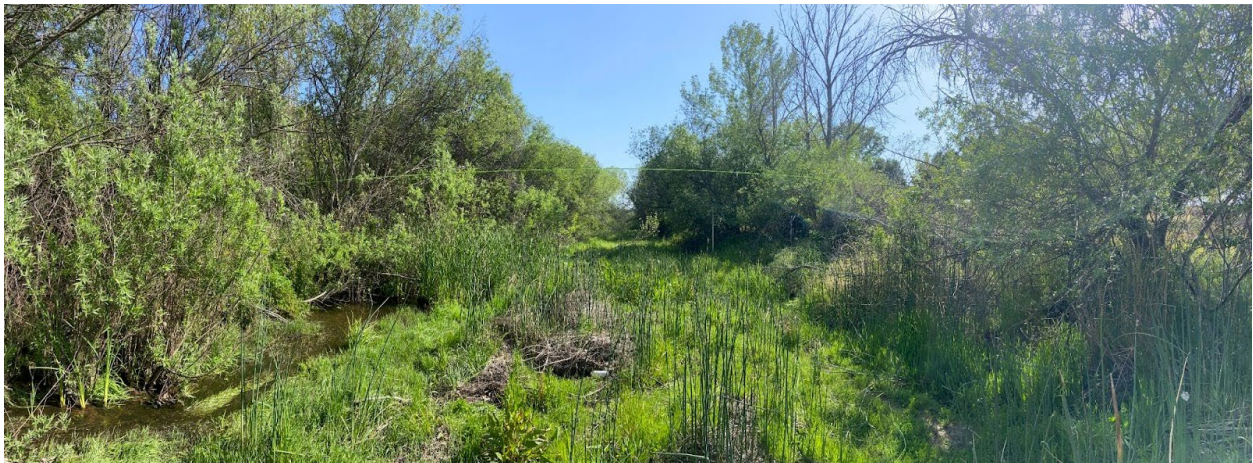
Figure 20. Field sketch and photograph of low flow channel conditions at Cross Section H

In the lower reach with the lower-capacity 2-year flow channel, the 2022 survey of cross section G suggests overbank deposition and the formation of a natural levee on the left bank. At the farthest downstream cross section H, apparent deposition within the low flow channel has led to the formation of complex microtopography (Figure 20). Cottonwood seedling recruitment, debris deposition among wetlands plants, step-pool topography, and secondary cutoff channel development were all observed at this location.

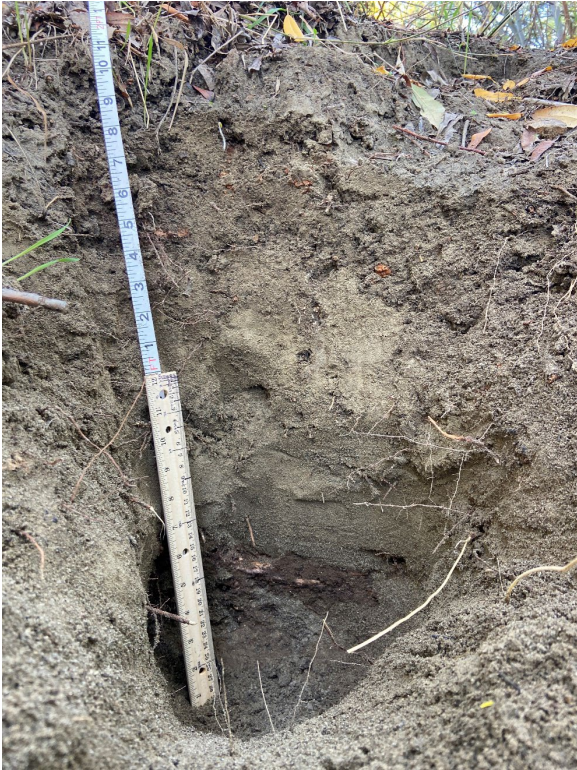
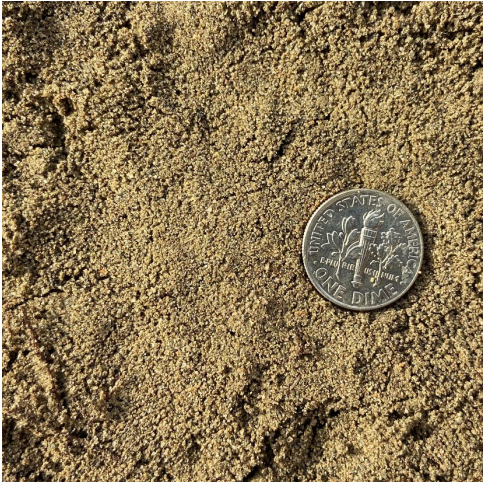
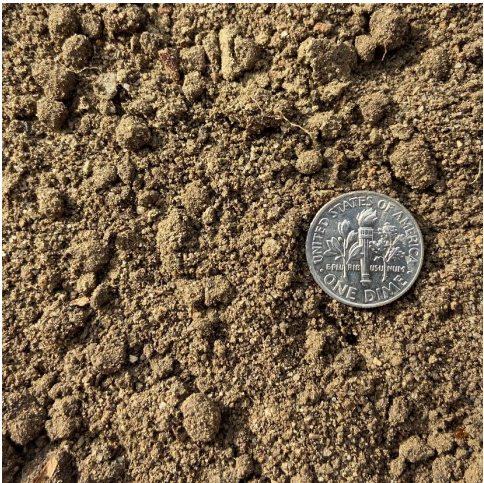
Figure 27. Potential depositional landform at XS B left bank

Both the LiDAR comparison and the cross-section overlays revealed apparent depositional landforms that appeared between 2006 and 2021. These areas are concentrated in the upper reach from Gleason Dr to Central Pkwy, including at cross sections B and D, and are consistent between the two analyses. Zones of increased elevation tend to extend in the longitudinal direction, including downstream of existing landforms (e.g., the depositions below the promontory) and vegetation (e.g., at the coyote brush on the floodplain near cross section D) or among dense willows (as observed on the right bank at cross section B). The longitudinal forms on the floodplain near cross section D are among the most visually striking; they are made up largely of sand with a consistently fine texture (Figure 28). I excavated a hole at cross section B and observed coarser sand at depths of 2 feet below the surface, with finer sand at the surface (Figure 27).
