Local site effects and incremental damage of buildings during the 2016 Central Italy earthquake sequence

ABSTRACT

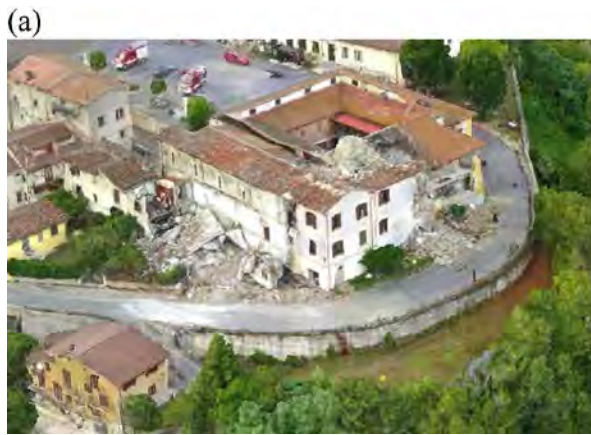
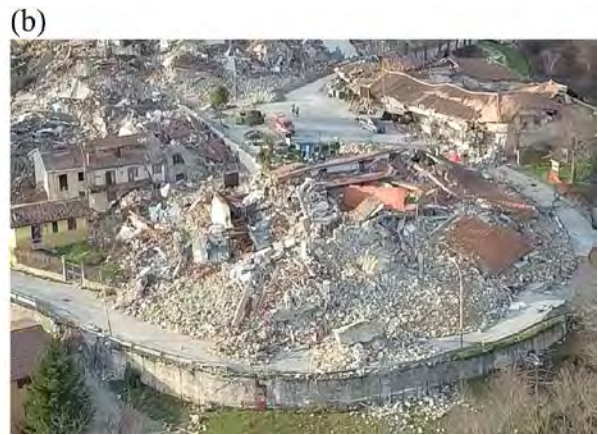
372 Figures 8a and 8b show an aerial view of the east part of the village during the first and
 373 the second surveys, respectively, including the local church and the police station, which
 374 eventually collapsed because of multiple earthquake excitations. Figures 9, 10 and 11
 375 illustrate characteristic cases of minor-to-moderate shear and out-of-plane damage after the
 376 August event that led to abrupt collapse because of the earthquake sequence. Age of
 377 construction, high spectral accelerations for periods lower than 0.3s (which match the natural
 378 periods of low-rise buildings) and the variation of spectral polarization across several events
 379 were likely the main contributors to the observed catastrophic damage patterns. Given the
 380 location of Accumoli, topographic effects may also have contributed to the observed damage.

382 **Figure 8.** Aerial photos of the east side of Accumoli after (a) the first earthquake and (b) the entire
383 earthquake sequence.

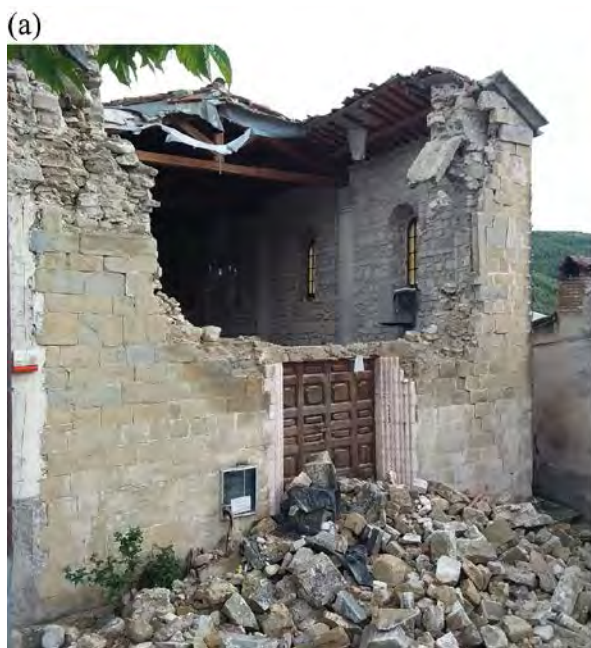
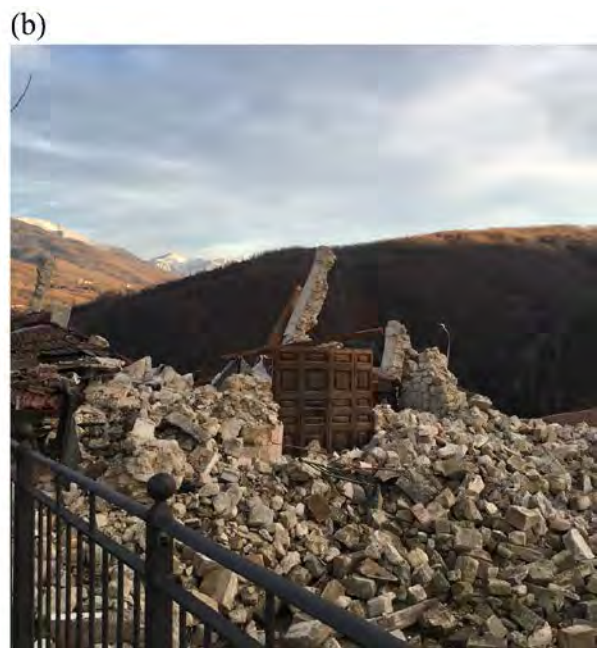
Figure 9. The local church: (a) after the first earthquake; and (b) after the entire sequence.

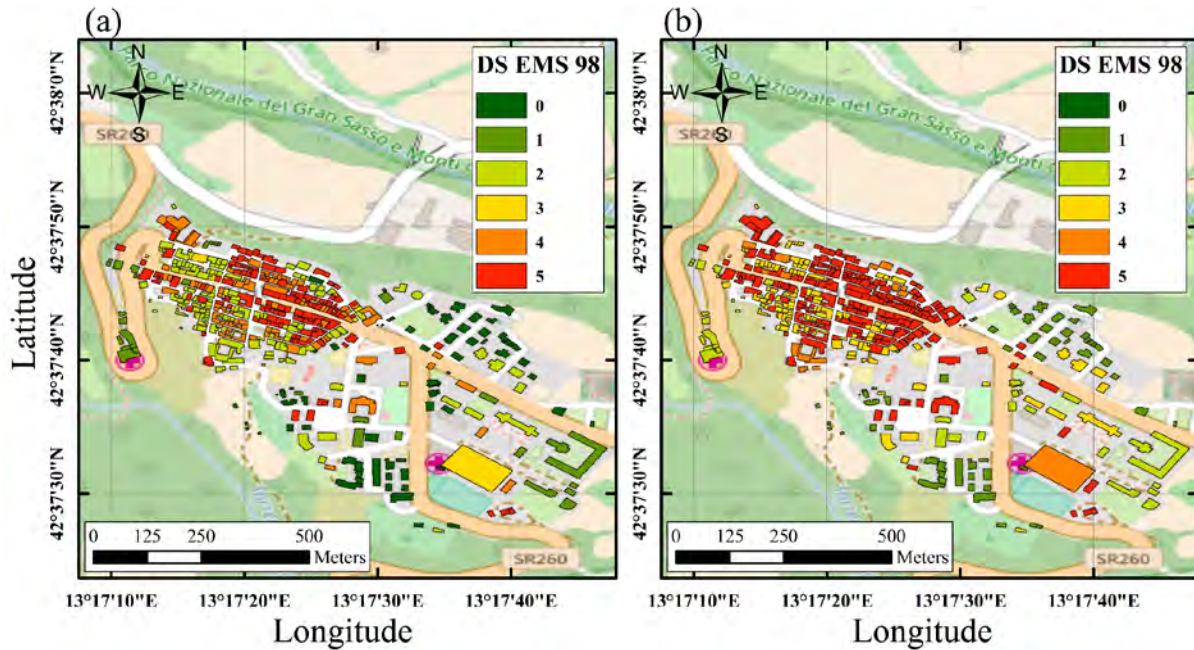
408 Figure 12 shows the structural damage levels observed during the two surveys. The 24
409 August event caused severe damage to the south-east part of the historical city center along
410 the main avenue (Corso Umberto I). As observed in the case of Accumoli, many buildings
411 that were still standing after the first event with only a small residual capacity to additional
412 horizontal actions, fully collapsed because of the subsequent September and October events.
413 The shifting of damage states between the aftermath of the first event and the end of the

414 entire sequence is reflected in the following inspection results clearly indicating a major shift
 415 to most critical damage states: intact buildings (D0) were reduced from 30% to 18%,
 416 buildings with minor damage (D1) were increased from 5% to 10%, moderate damage (D2)
 417 was reduced from 24% to 6%, D3 increased from 1% to 21%, D4 decreased from 17% to 3%,
 418 and collapsed buildings (D5) had a significant increase from 23% to 42%.

419
 420 **Figure 12.** Damage levels observed in the center of Amatrice (a) after the 24 August earthquake
 421 (during the first survey), and (b) after the entire sequence (during the second survey).

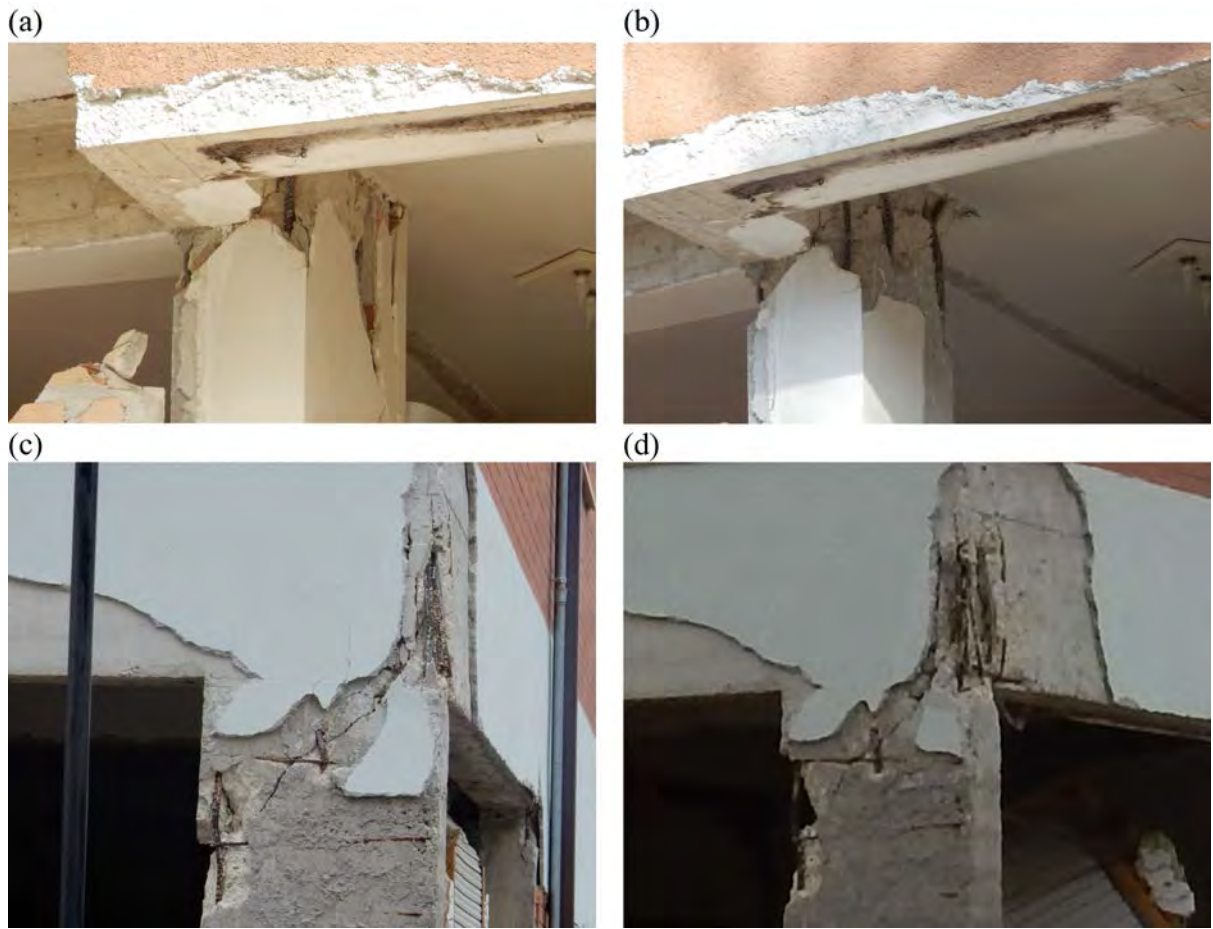
449 **Figure 14.** Beam-column joints. Concrete spalling and local bar buckling due to lack of transversal
 450 reinforcement after the 24 August event (a,c) and after the earthquake sequence (b,d).

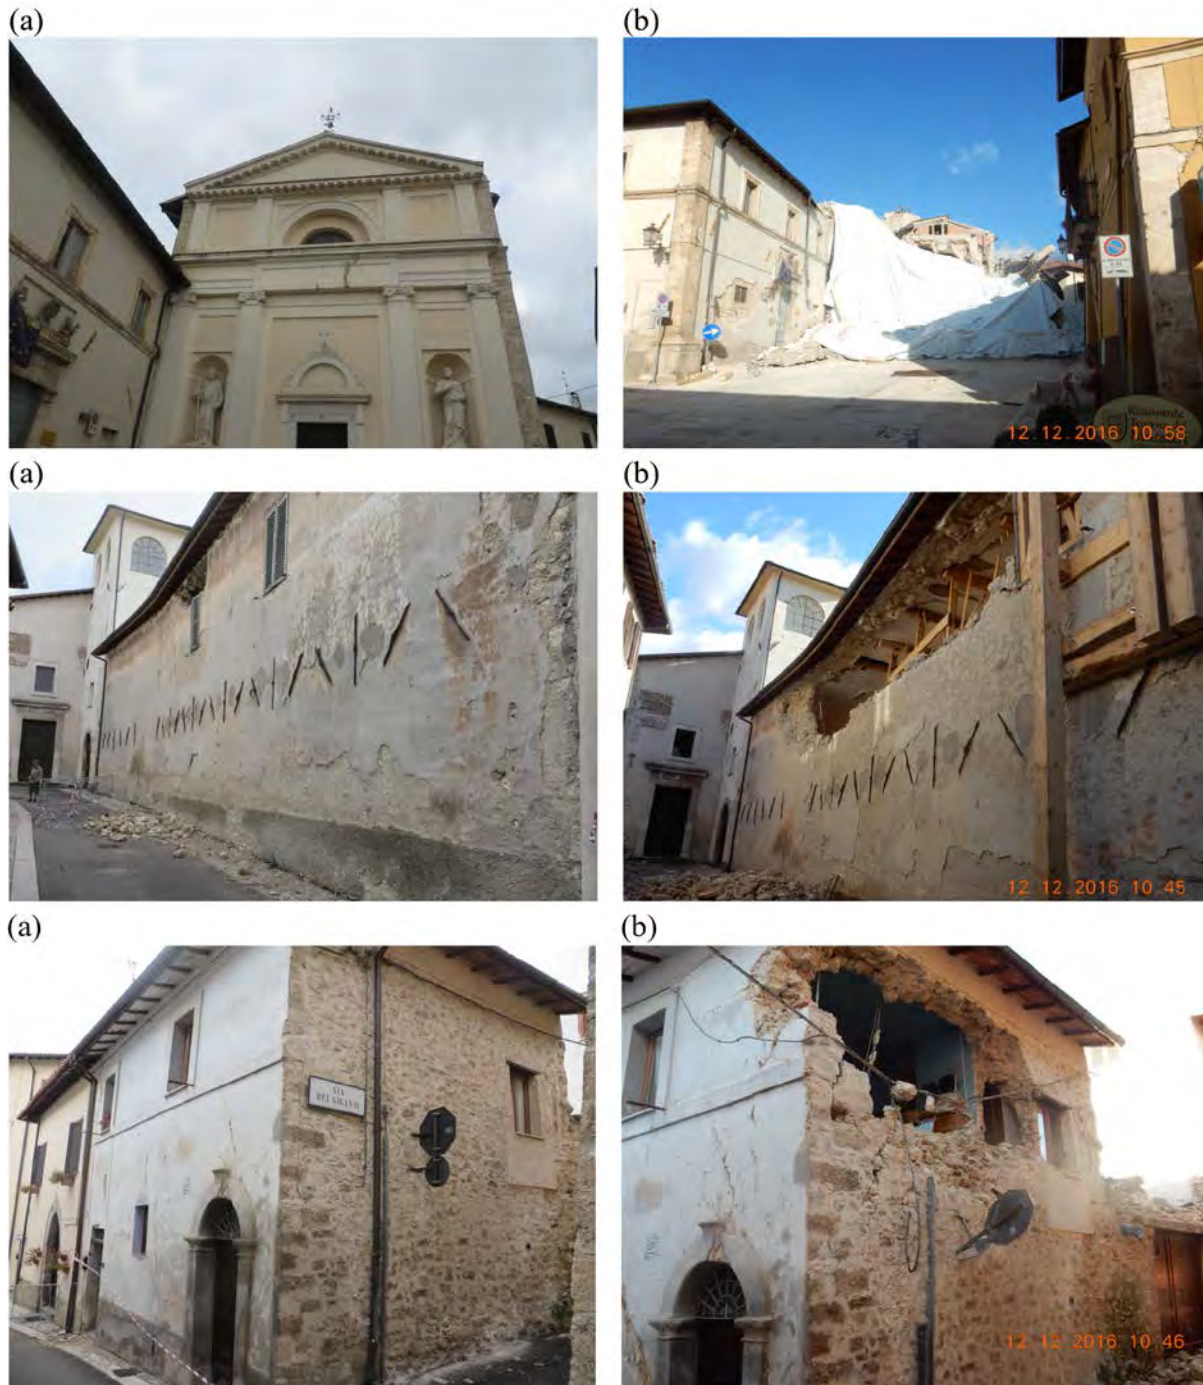
539 Figure 20 (top) shows one of the churches that was slightly damaged by the **M6.1** 24
 540 August seismic event but collapsed following the **M6.5** 30 October event. Many historical
 541 churches in Norcia experienced similar damage evolution, as shown for instance in Figure 20
 542 (middle), where the out-of-plane failure of a historic monastery and the partial loss of support
 543 of the roof is depicted. Notably, the wall failure was concentrated at a level higher to that of
 544 the seismic retrofit, thus highlighting that the retrofit shall not be only localized on the
 545 ground level but also take into consideration the reduced axial load and weak diaphragm
 546 action of the masonry walls at the higher level. Figure 20 (bottom) shows two masonry
 547 residential buildings with irregular masonry construction that experienced only minor
 548 cracking during the first earthquake, but significant out-of-plane and in-plane wall failure

549 under subsequent events.

551 **Figure 20.** Seismic damage observed in characteristic masonry buildings (a) after the 24 August
 552 earthquake and (b) at the end of the entire seismic sequence.
