Geotechnical reconnaissance findings of the October 30 2020, Mw7.0 Samos Island (Aegean Sea) earthquake

Bulletin of Earthquake Engineering, 20(14)

Abstract

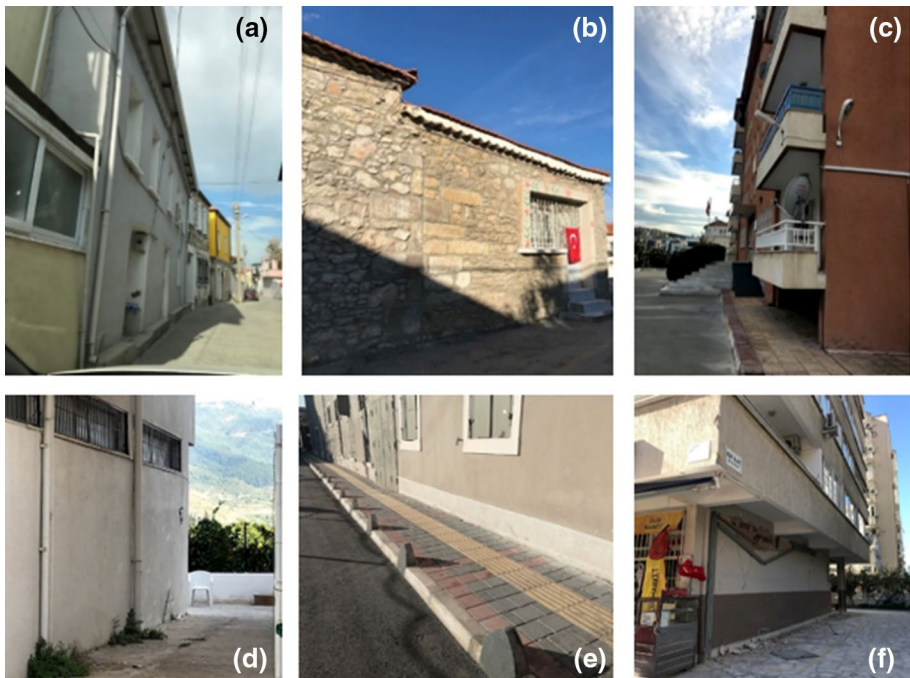
Fig. 1 Indicative cases of satisfactory foundation performance on the Anatolian side: **a** Urla, **b** Cesme, **c** Kusadasi, **d** Gumuldu, **e** Izmir Konak, and **f** Izmir Bayrakli

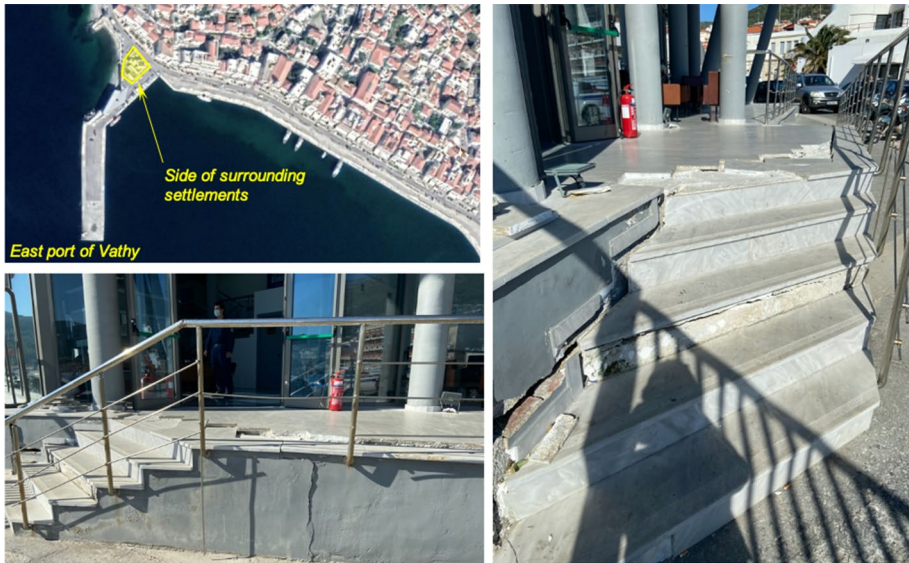
Fig. 4 Damage observed around the Port authority building in Vathy, Samos (location: $37^{\circ}45'27.0''$ N $26^{\circ}58'15.4''$ E). The cracks indicate soil settlement/distortion around the building which remained intact and functioning 8 days after the earthquake

On the island of Samos, no foundation failures were observed in the visited areas, with the possible exception of structural damage due to lateral spreading (see later Sect. 3). Figure 4 illustrates the Port authority building at the Eastern port of Vathy, where the observed damage patterns indicate a satisfactory piled foundation performance. Indeed, despite cracks and settlements around the building, the structure per se remained intact and was operating normally eight days after the earthquake when the HAEE/ETAM team inspected the site. At this point, it remains unclear whether these settlements are related to liquefaction, dynamic compaction, or failure of the retaining wall and an associated overall displacement of the backfilled soil (see Sect. 5 on the performance of the quay wall at the same site.)

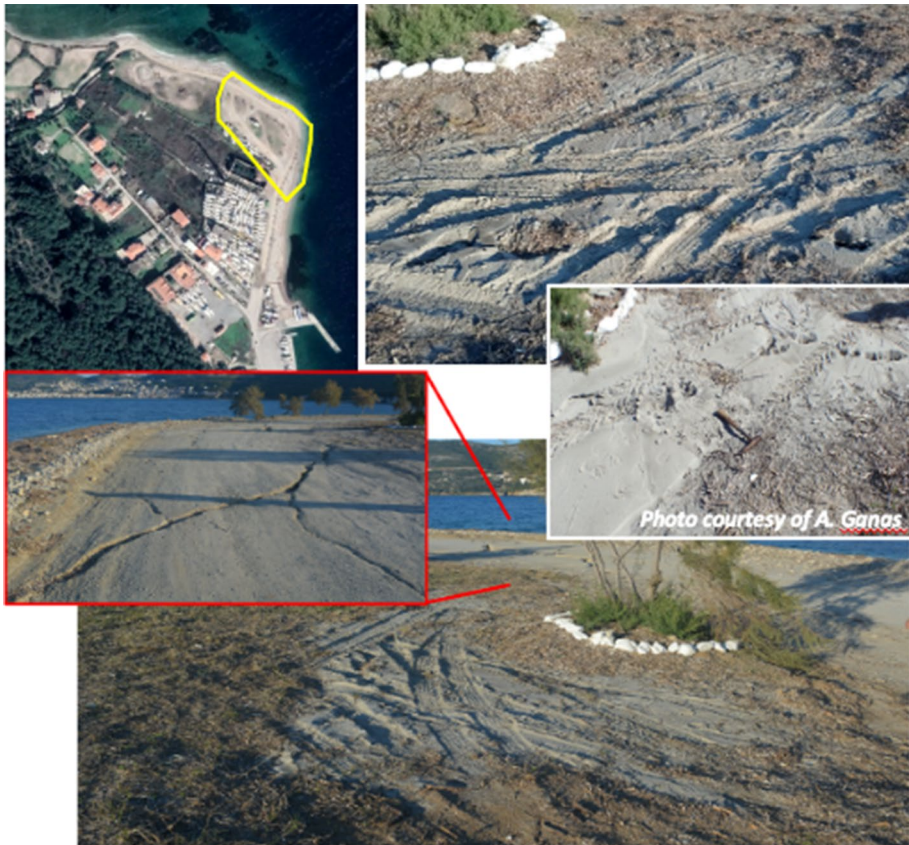
Manifestation of earthquake-induced liquefaction in the free field was observed in the area of Malagari, north-west from the town of Vathy, capital of the island of Samos. Specifically, the reconnaissance team located nearshore surface manifestations of liquefaction in the form of sand ejecta of grey color. As can be seen in Fig. 10, by the time the HAEE/ETAM team visited the site of interest (8 days after the earthquake), the ejecta had been slightly distorted due to the passage of vehicles. Nevertheless, the sand boils and their ejecta alongside with

Fig. 10 Surface manifestations of earthquake-induced soil liquefaction in the form of sand boils in Malagari (location: $37^{\circ}45'24.6''$ N $26^{\circ}57'28.8''$ E—aerial imagery from 3001 ft) [photos taken by the HAEE/ETAM reconnaissance team and Dr. A. Ganas from NOA]

their broader extent were still easily visible and distinguishable. In the same area, ground cracks compatible with a lateral spreading mode of failure were observed and are emphasized in the inset of Fig. 10. The combination of the aforementioned with a free face to water, like in Malagari, eases the process, but lateral spreading has been manifested also in case histories with no free face (e.g. Balboa Boulevard failure during the 1994 Northridge earthquake—e.g. Stewart et al. 1996, Pretell et al. 2020). Trenching and soil sampling at two locations at the Malagari site were performed, which yielded two rough cross-sections and three grain size distributions for samples at three distinct depth intervals at the site illustrated in Figs. 11 and 12 respectively. The fines portion in all three samples was found to be non-plastic.

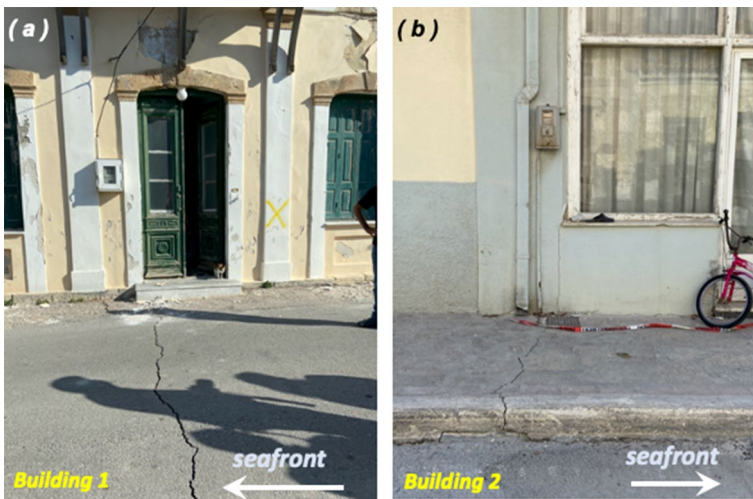
Lateral spreading effects were also evident through structural damage at other nearshore locations in the northern part of the island. Specifically, Figs. 14 and 15 illustrate three buildings and their location close to the north shore of the island, in the neighborhood Vyrsodepsia in Karlovasi. No surface manifestation of liquefaction was identified nearby, but the ground cracking crossing the street pavement and running through the buildings (the two in Fig. 16 are about 70 m inland and the one in Fig. 17 is about 20 m inland), in combination with the level/mildly sloping ground, the shallow water table, and the free face to the sea are all compatible with the hypothesis of lateral spreading.

Fig. 16 Buildings likely affected by lateral spreading towards the seafront in the neighborhood of Vyrsopepsia in Karlovasi **a** 37°47'57.6" N 26°42'12.5" E and **b** 37°47'59.3" N 26°42'20.0" E [photos taken by the HAEE/ETAM reconnaissance team]

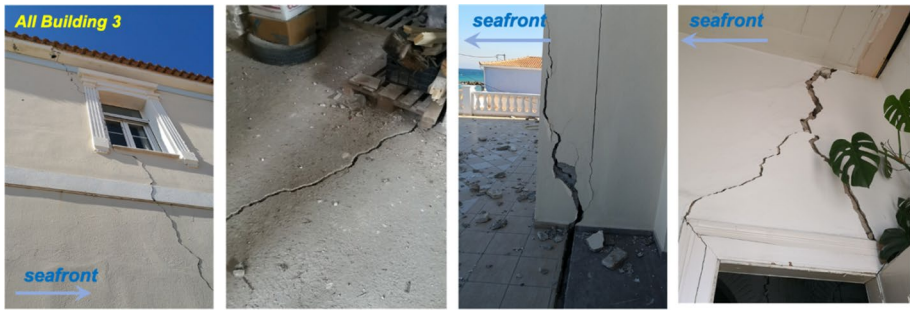
Fig. 17 Building affected by lateral spreading towards the seafront in the neighborhood of Vyrsopepsia in Karlovasi ($37^{\circ}48'01.1''$ N $26^{\circ}42'20.6''$ E). The cracks observed running across the building indicate 3-5 cm of movement [photos courtesy of Prof. K. Antonopoulos]

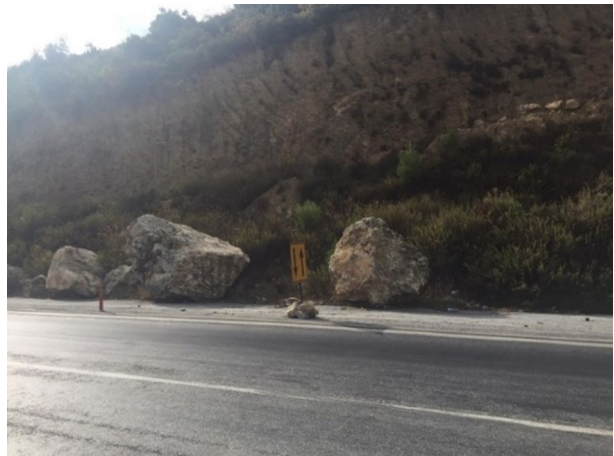
In Anatolia, a limited number of rockfalls were observed by the benches of highways, one of which is illustrated in Fig. 18. Some potential and existing landslide sites were also inspected, but no signs of seismically induced movements were documented and are thus

Fig. 18 Fallen rock blocks in the Anatolian side ($37^{\circ}53'50.4''$ N $27^{\circ}22'06.2''$ E)

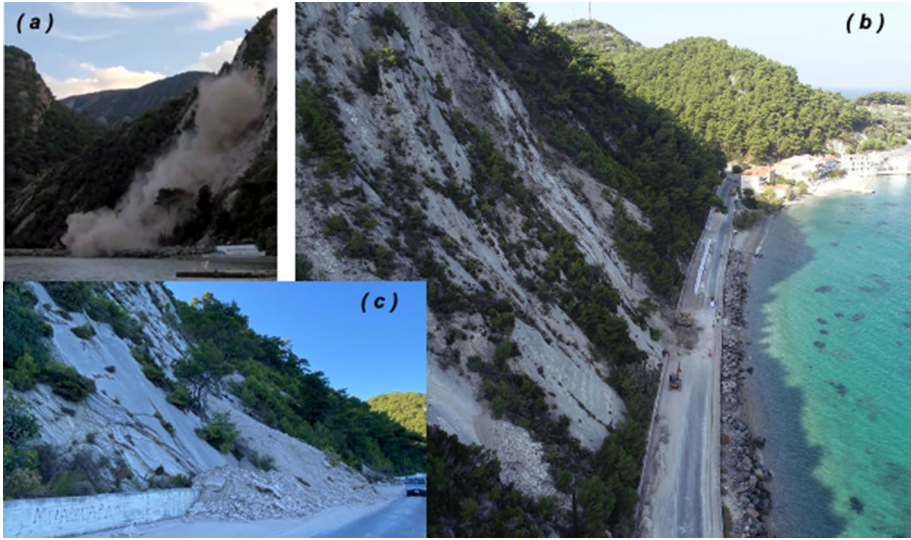
A weathered rock slide was recorded at a steep slope close to Avlakia region (Fig. 21), which caused a temporary closure of the road. The main geological formations in the above area are marbles with intercalations of schist (Cetin et al. 2021). However, the road access

Fig. 21 **a** Snapshot of Avlakia rockslide from a video recorded during the failure (source: <https://www.cnn.gr/ellada/story/240726/seimos-samos-vinteo-apo-katolisthisi-sta-aylakia>) **b** aerial photograph of the slide 2 weeks after the earthquake (courtesy of I.N. Spyrou and Prof. K. Ziopoulou 37°47'48.0" N, 26°51'27.7" E), and **c** a closer view of the rockslide illustrating the rock formation more clearly (picture by HAEE/ETAM reconnaissance team)

was quickly recovered after a few days by temporary restraining measures with large concrete blocks placed at the slope toe (Lekkas et al. 2020). Detachments of sandy marls and marly limestones were recorded very close to a residential building in Kokkari region (Fig. 22), while lighter failures referring to rockfalls and detachments of limestones, were observed close to the villages of Potami and Koumeika (Fig. 23a and b respectively). Slope

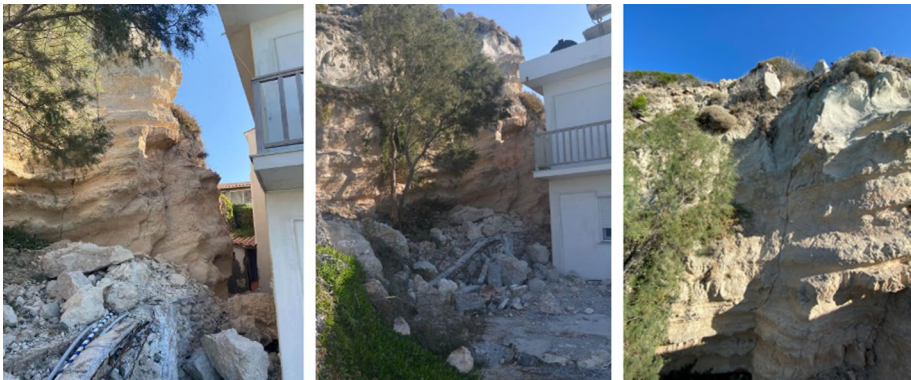
Fig. 22 Detachment of sandy marls and marly limestones recorded very close to a residential building in the Kokkari region (photos taken by the HAEE/ETAM reconnaissance team, 37°46'49.9" N, 26°53'35.0" E). Vertical open cracks are visible, clearly susceptible to detachment and toppling

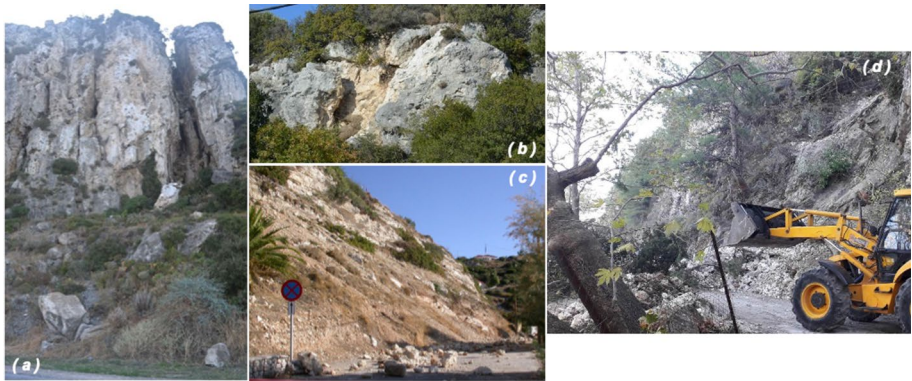
failures of similarly low intensity were also recorded by other reconnaissance teams. These include limestone segments falls in the area of Remataki (next to Pythagorio—Fig. 23c) or rockfalls close to the village Stavrinides (Fig. 23d).

Fig. 23 **a** Rockfalls observed at the road network close to the village of Potami (photo taken by the HAEE/ETAM reconnaissance team, $37^{\circ}47'17.6''$ N, $26^{\circ}40'00.5''$ E), **b** Detachment of limestone segments close to the village of Koumeika (photo taken by the HAEE/ETAM reconnaissance team, $37^{\circ}42'33.7''$ N, $26^{\circ}44'52.9''$ E), **c** Falls of limestone segments on a provincial road in the Remataki region (photo reported by Lekkas et al. 2020), and **d** Slope failure close to the village of Stavrinides (photo reported by HSGME 2020)

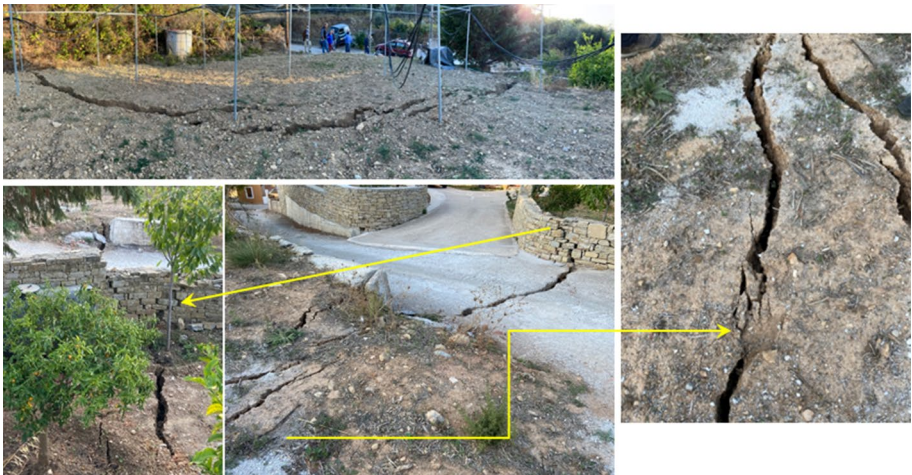
In the village of Kontakeika, extended ground cracks (openings of about 10–20 cm) were observed that were compatible with the mobilization of a larger, albeit very mild, slope or could be more broadly characterized as seismically-induced secondary ground failures (Fig. 24). The HAEE/ETAM team did not locate other similar indications of ground cracking in the near or extended vicinity of Kontakeika so, at this point in time, it is challenging to draw conclusions regarding the nature of this observation. According to local engineers, the Municipality of Samos had repaired the pavement in that particular location several times in the past, which suggests a pre-existing creeping landslide that could have been reactivated by the earthquake. The cracks extended on both sides of the street through soft soil formations (Fig. 24).

Fig. 24 Ground and pavement cracks in the village of Kontakeika (Samos), indicative of the mobilization of an extended but mild slope or more broadly characterized as seismically-induced secondary ground failures. The cracks extended on both sides of the street through soft soil formations. Arrows in the figure explain the relative location of the cracks

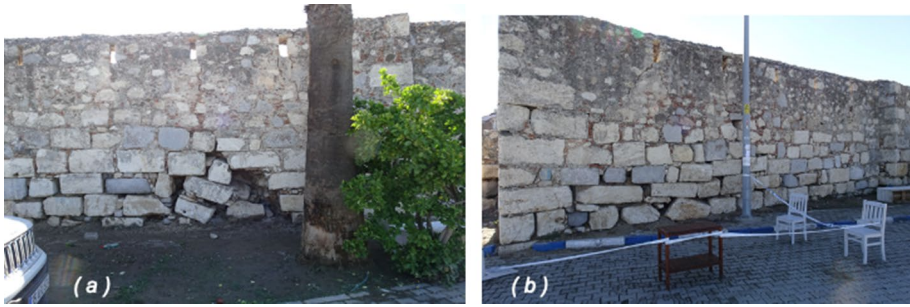
There are no reported failures of engineered retaining structures in Turkey. During the reconnaissance studies, a limited number of tilted and/or partially collapsed safety walls were observed, as documented in Fig. 27. Additionally, no damage on retaining walls due to seismic shaking was encountered during the reconnaissance inspections of the sites in the south of İzmir province, as shown in Fig. 28. These stone walls are generally used to provide a buffer area between the cut slopes and highway to obstruct or retard the shallow failures to reach the highway. Regardless of the height of these stone walls, no seismically-induced deformations or failure was observed on the highway connecting Menderes to Gumuldur. No damage was found on the sides of spillway channels of the dams in the region. No sign of any structural damage was likewise observed on these walls (Fig. 29). Figure 30 shows the sidewalls of the river canal in Sığacık Marina, hit by the tsunami after the earthquake. No structural distress can be observed on these walls, which suggests that the severity of shaking was modest despite its proximity to the rupture. Additionally, no signs of liquefaction or permanent deformations were reported.

Fig. 27 Deformed and cracked safety wall at **a** $38^{\circ}11'40.93''$ N $26^{\circ}47'3.47''$ E/14:16/October 31, 2020, and **b** $38^{\circ}11'40.34''$ N $26^{\circ}47'3.22''$ E /14:22/October 31, 2020

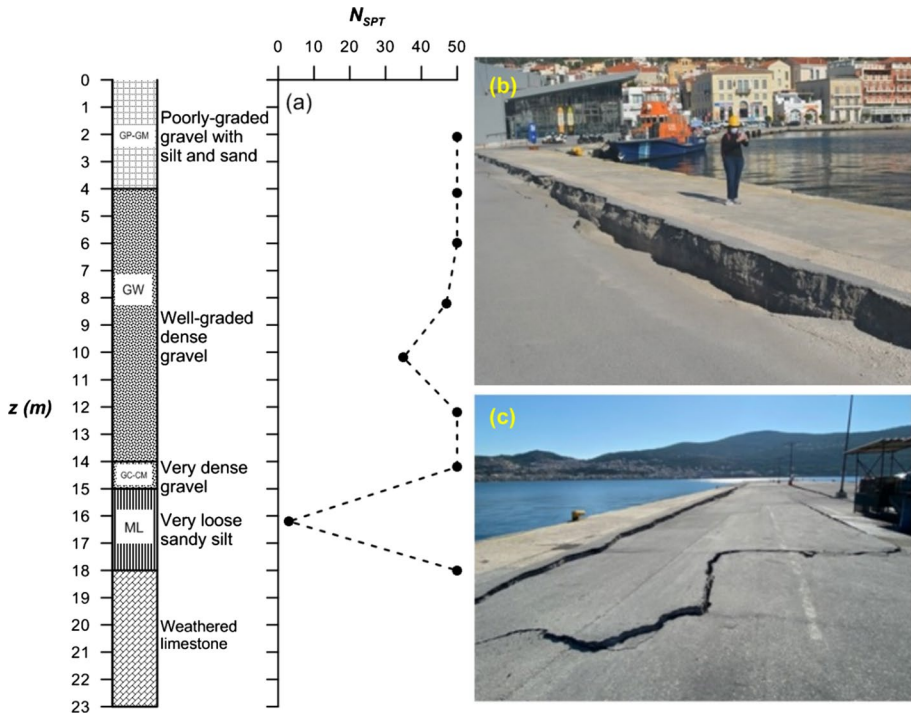
The jetty of the eastern (old) port experienced extensive longitudinal and transverse open cracks—several centimeters wide—whilst the backfill behind the quay wall experienced a subsidence that locally exceeded 50 to 60 cm (Fig. 34). In Fig. 34b, traces of gravels and sand are visible behind the quay wall. These might be remnants of ejecta partially washed out by the tsunami. The presence of ejecta could be the result of liquefaction of a very loose sandy silt layer located 15 to 18 m deep, right beneath the backfill material (Fig. 34a). Similar observations of ejecta behind quay walls have been made in many previous earthquakes (Professor G. Bouckovalas—*personal communication*), even in the absence of any native liquefiable soil layer. As such, any observed ejecta may be due to liquefaction and wash out of a loosely deposited fine silty-sand phase which fills the voids of a typically much coarser backfill gravel skeleton that does not participate in the load-carrying capacity of the wall (Professor G. Bouckovalas—*personal communication*). This could explain the lack of excessive displacements and rotations of the wall towards the sea. Construction records from the said ports and further investigations can elucidate this further.

Fig. 34 a Crude log of borehole BH1 located at the jetty of the old port of Vathy, where the liquefiable layer of the very loose sandy silt layer is located at a depth of 15 m (data provided by G. Milionis—elaboration by Em. Rovithis) and SPT blow count with depth. b Subsidence of backfill material behind the quay wall at the eastern (old) port, measuring up to 60 cm. c 10–15 cm wide longitudinal and transversal open cracks, located on the pavement over the backfill material, in contact with the quay wall

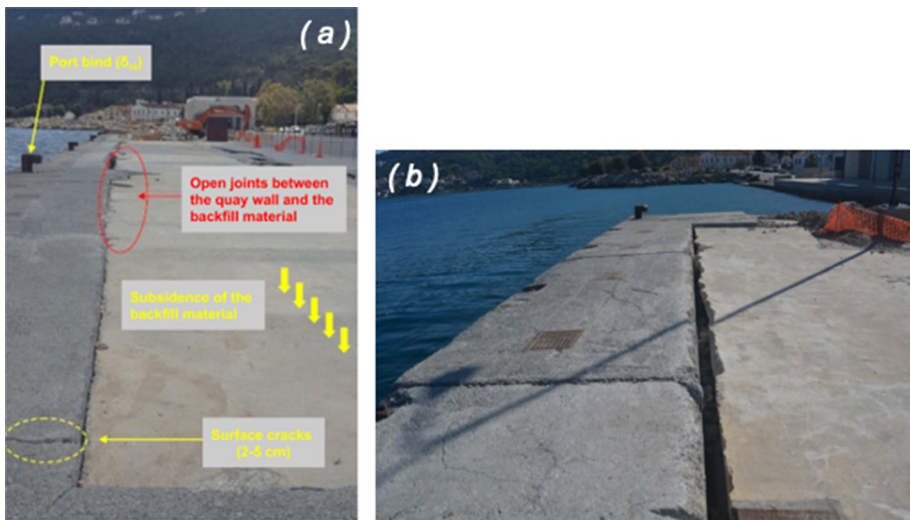
Figure 36a illustrates a view of the pre-existing open joints between the quay wall and the backfill material and the subsidence of the backfill material behind the quay wall about 3 years ago (Triton 2017), and its comparison to Fig. 36b which illustrates its condition immediately after the earthquake (HAEE/ETAM reconnaissance report 2020).

Interestingly, the earthquake damage observed is quite similar, but most probably intensified by the earthquake. At the time the site was visited by the HAEE/ETAM team, the construction operations in response to the Triton (2017) study were ongoing. Hauled construction materials did allow the team to delineate between those and any potential liquefaction-induced ejecta at the site. Nevertheless, given the geotechnical data liquefaction might have taken place on a rather limited scale and probably worsened the existing damage. In addition, the quay walls at this particular site are massive and consequently subject to large inertia forces mostly due to their own mass and not due to seismic earth pressures from the backfill. Consequently, it is likely that the quay walls at the Malagari port rotated somewhat outwards during the earthquake, thus widening any pre-existing gaps (Triton 2017) and also leading to some settlement of the backfill next to the wall. As such, it is rather unlikely that the present picture of the quay wall damage can be attributed entirely to liquefaction and dynamic settlement.

Fig. 36 View of the quay wall at new (Malagari) port, Vathy, from NW to SE direction: **a** photo taken 3 years before the earthquake (Triton 2017); **b** photo taken a few days after the earthquake (HAEE/ETAM reconnaissance report 2020)

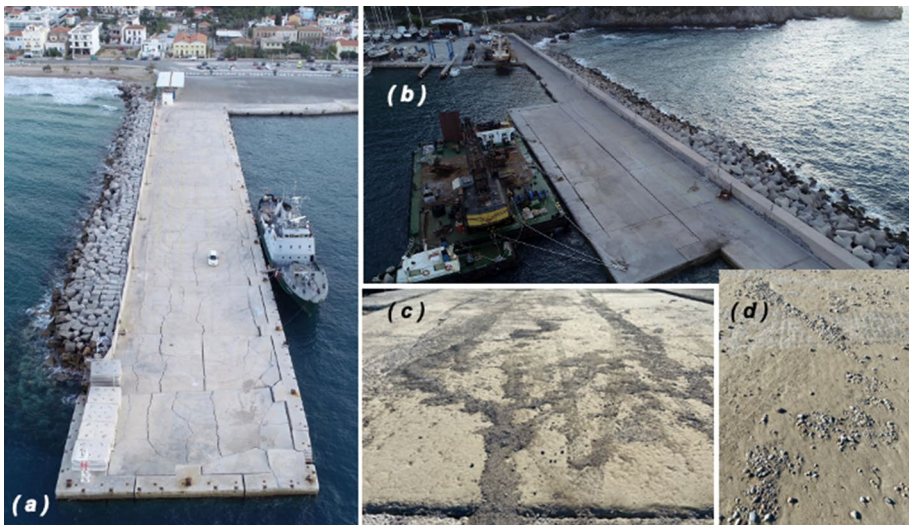
The port of Karlovasi suffered damage to both jetties, namely: subsidence of the backfill material (or the subsoil), mild tilting and displacement of the quay walls towards the sea, cracks (both transversely and parallel) to the quay walls. Also, grey-brown ejecta of sand-gravel mixture was found on the west quay wall, which possibly emerged through the cracks. Even in the absence of sufficient data to substantiate the occurrence of liquefaction, it appears that liquefaction is a reasonable scenario. This possibility is reinforced considering that the surface layer of grey-brownish silty sand identified at the high school area, seems to be continuing and getting thicker close to the sea shore. However, without additional geotechnical data, it is impossible to draw conclusions and this is only a hypothesis in accordance to the subsurface structure at Vathy. Last but not least, the construction details of each port need to be accounted for, since the placement of a backfill under “wet” or “dry” conditions can severely affect its dynamic response in seismic events. Figure 38

illustrates both jetties (east and west), as well as ejecta observed on the western quay wall. Nevertheless, it is hard to tell whether the cracks and subsidence/tilting patterns are earthquake induced, or merely pre-existing gravity-induced effects.

Fig. 38 **a** East quay wall of Karlovasi port, **b** west quay wall of Karlovasi port, **c** ejecta on the west quay wall, presumably the product of liquefaction occurrence, and **d** a detailed view of the ejecta, brownish to grey color, mostly sandy and silty with some gravels (aerial photographs courtesy of I.N. Spyrou and Prof. K. Ziotopoulou)

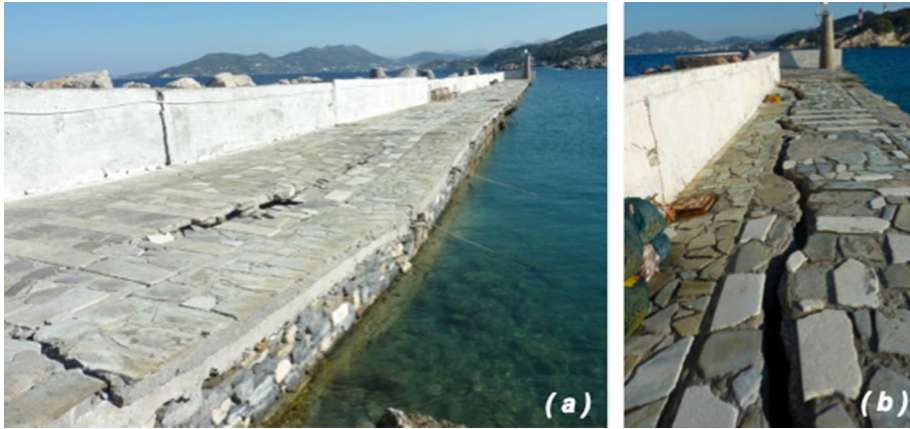
Kokkari is a small village in the northern part of Samos, situated about 10 km NW from Vathy. It has a small port mainly serving fishing boats and small yachts. The reconnaissance team of HEAA visited Kokkari and observed that the quay wall had suffered severe subsidence, 10 to 20 cm wide open cracks alongside the sea front, and mild tilting towards the sea, as shown in Fig. 39. It is unclear whether the deformations were pre-existing i.e.

due to the low quality of the quay wall construction and the lack of protection of its underwater part from scour. Problems related to low bearing capacity and differential settlements due to a soft and compressible surface soil layer at the foundation of the jetty cannot be excluded. However, no clear traces of liquefaction were detected following the earthquake.

Fig. 39 **a** Differential subsidence of the quay wall of Kokkari port with wide open cracks alongside and transversely, **b** close view of an open crack of 10 to 15 cm alongside the sea front (HAEE/ETAM 2020)

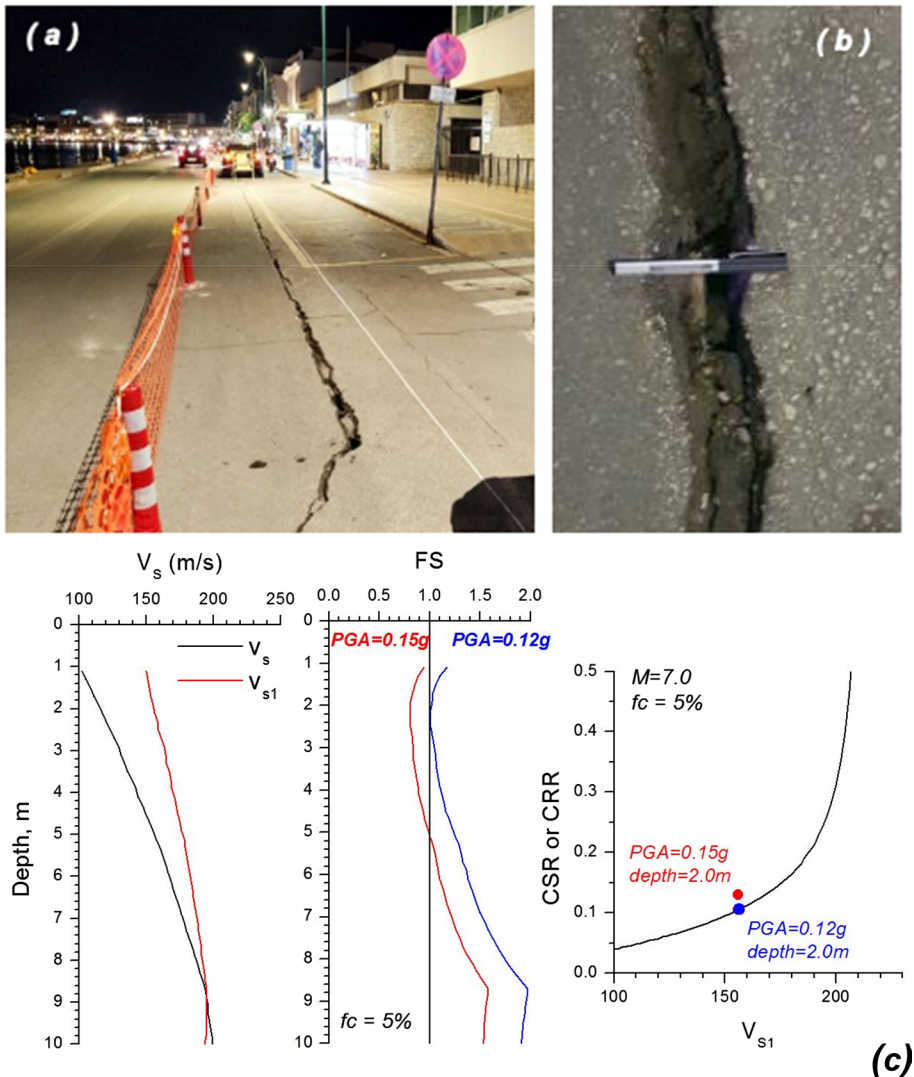
Earthquake-induced failures were also observed in the port of Chios island, situated approximately 80 km north of the fault, referring mainly to surface cracks of considerable width and depth (Fig. 40a), as reported in the post-earthquake preliminary report by Pelekis and Roumelioti (2020). At specific locations these cracks were about 10–15 cm wide and about 40 cm deep (Fig. 40b). Such type of failures in the port of Chios may indicate soil liquefaction that was marginally triggered during the earthquake, and ensuing lateral spreading effects towards the shoreline, as suggested by Pelekis and Roumelioti (2020). The existence of inclined strata below the filling material of the quay walls and pre-earthquake damage due to gravity loads (e.g. scour of its foundation) should be considered when interpreting the observed seismic behavior. The possibility of marginal triggering of soil liquefaction was reinforced following a series of MASW field tests, which revealed the existence of soft/low-strength surficial soil layers with shear wave propagation velocity of about 100 m/s. A preliminary V_s -based assessment of the safety factor against soil liquefaction (Andrus and Stokoe, 2000) revealed a potential triggering of the phenomenon during the $M_w=7.0$ event for PGAs above approximately 0.12 g (Fig. 40c).

Fig. 40 **a** Earthquake-induced surface cracks parallel to the quay wall front in the port of Chios, **b** close-up view of 10–15 cm wide and 40 cm deep surface cracks, and **c** preliminary Vs-based assessment of the safety factor against soil liquefaction at the depth of 2 m for PGA equal to (i) 0.15 g and (ii) 0.12 g (Pelekis and Roumelioti, 2020)
