Preliminary Environmental Investigations at the Lawrence Berkeley Laboratory

I. Javandel

November 1990

LBL-29898

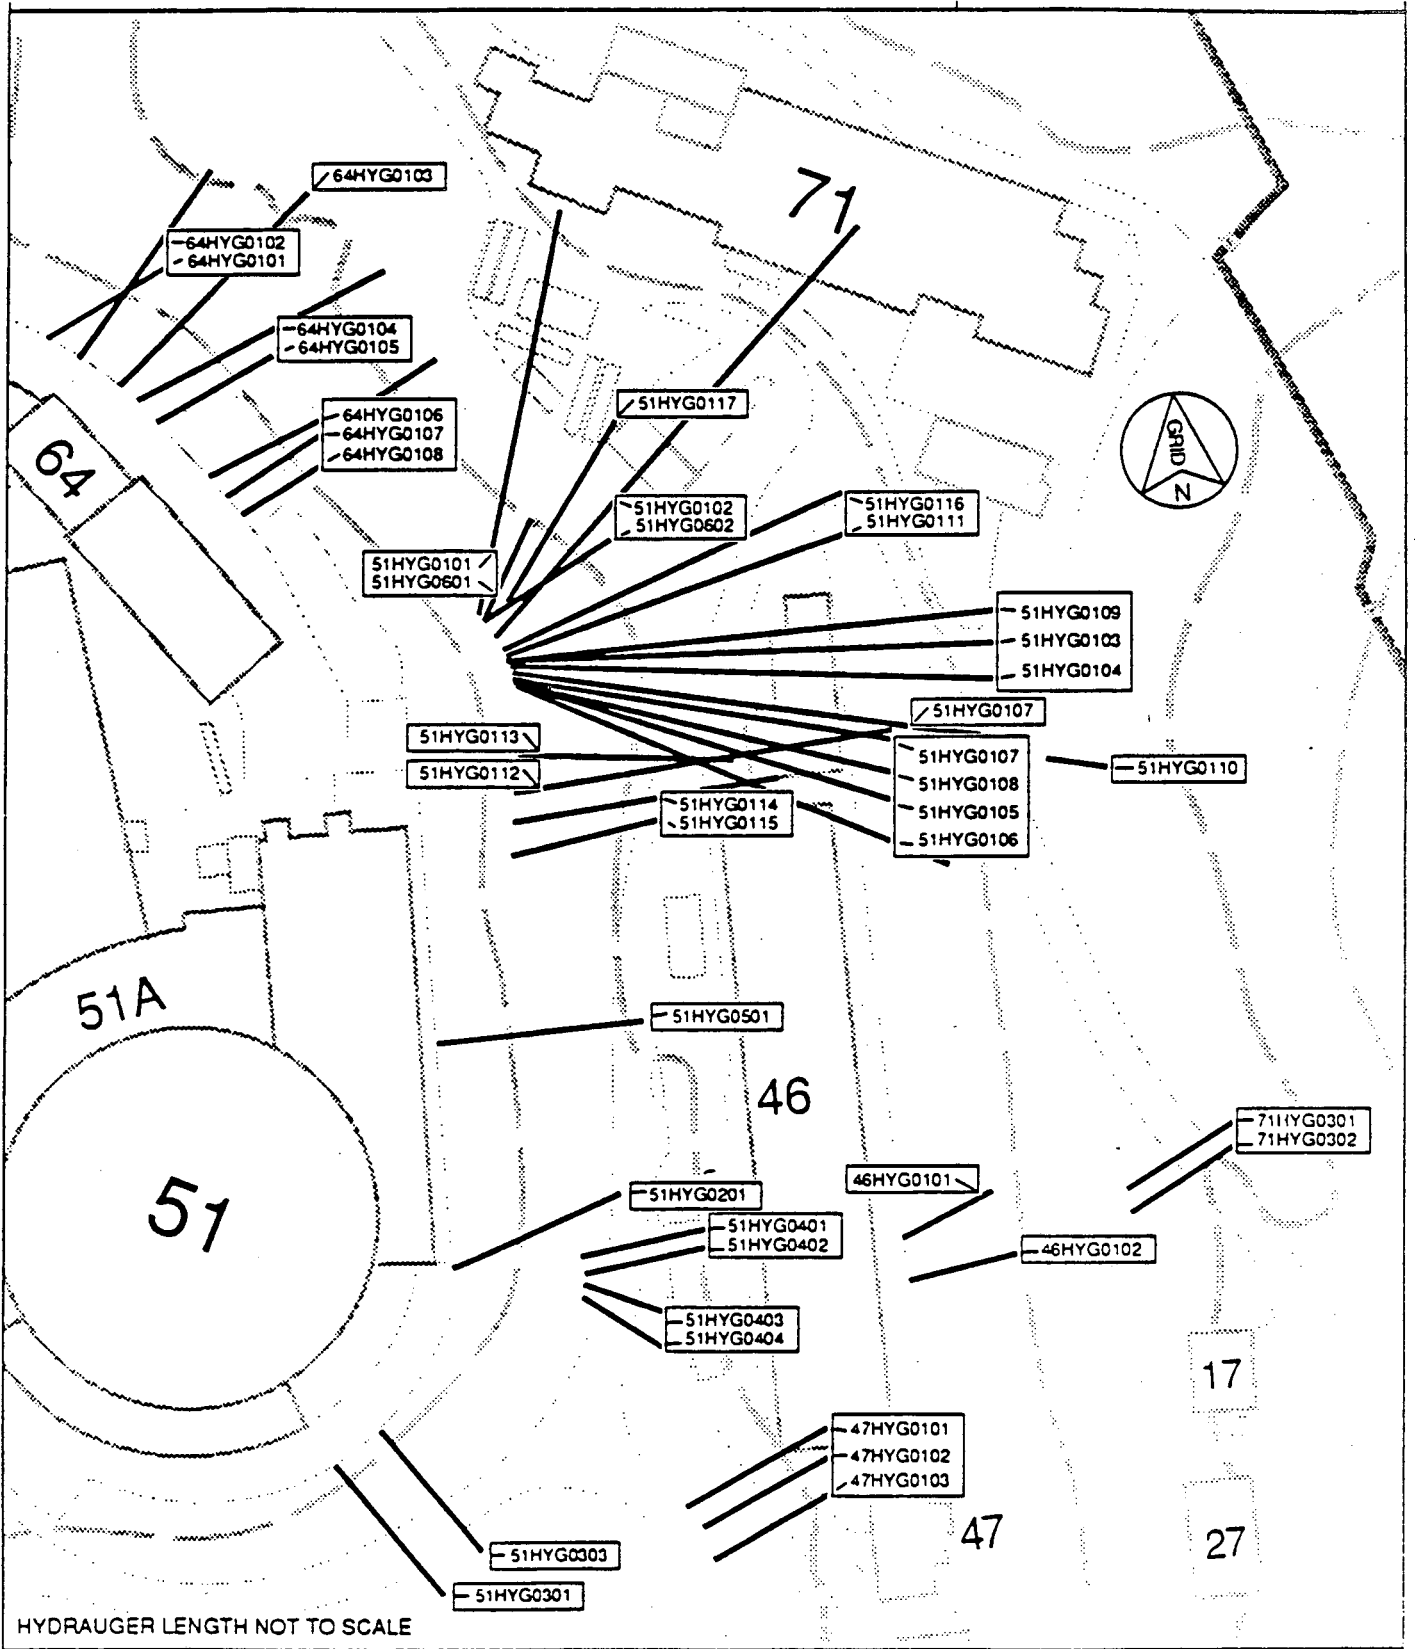
Figure 7 shows approximate positions of hydraugers in the vicinity of Buildings 46, 51 and 71. Although design information for the hydraugers are available, their exact trend and dip are not known. LBL conducted an inventory of all hydraugers at the site in February 1990. APPENDIX A presents the approximate trend, dip, diameter and length of all the hydraugers at LBL, as well as their present condition.

Figure 7. Approximate positions of hydraugers in the vicinity of Buildings 46, 51 and 71.

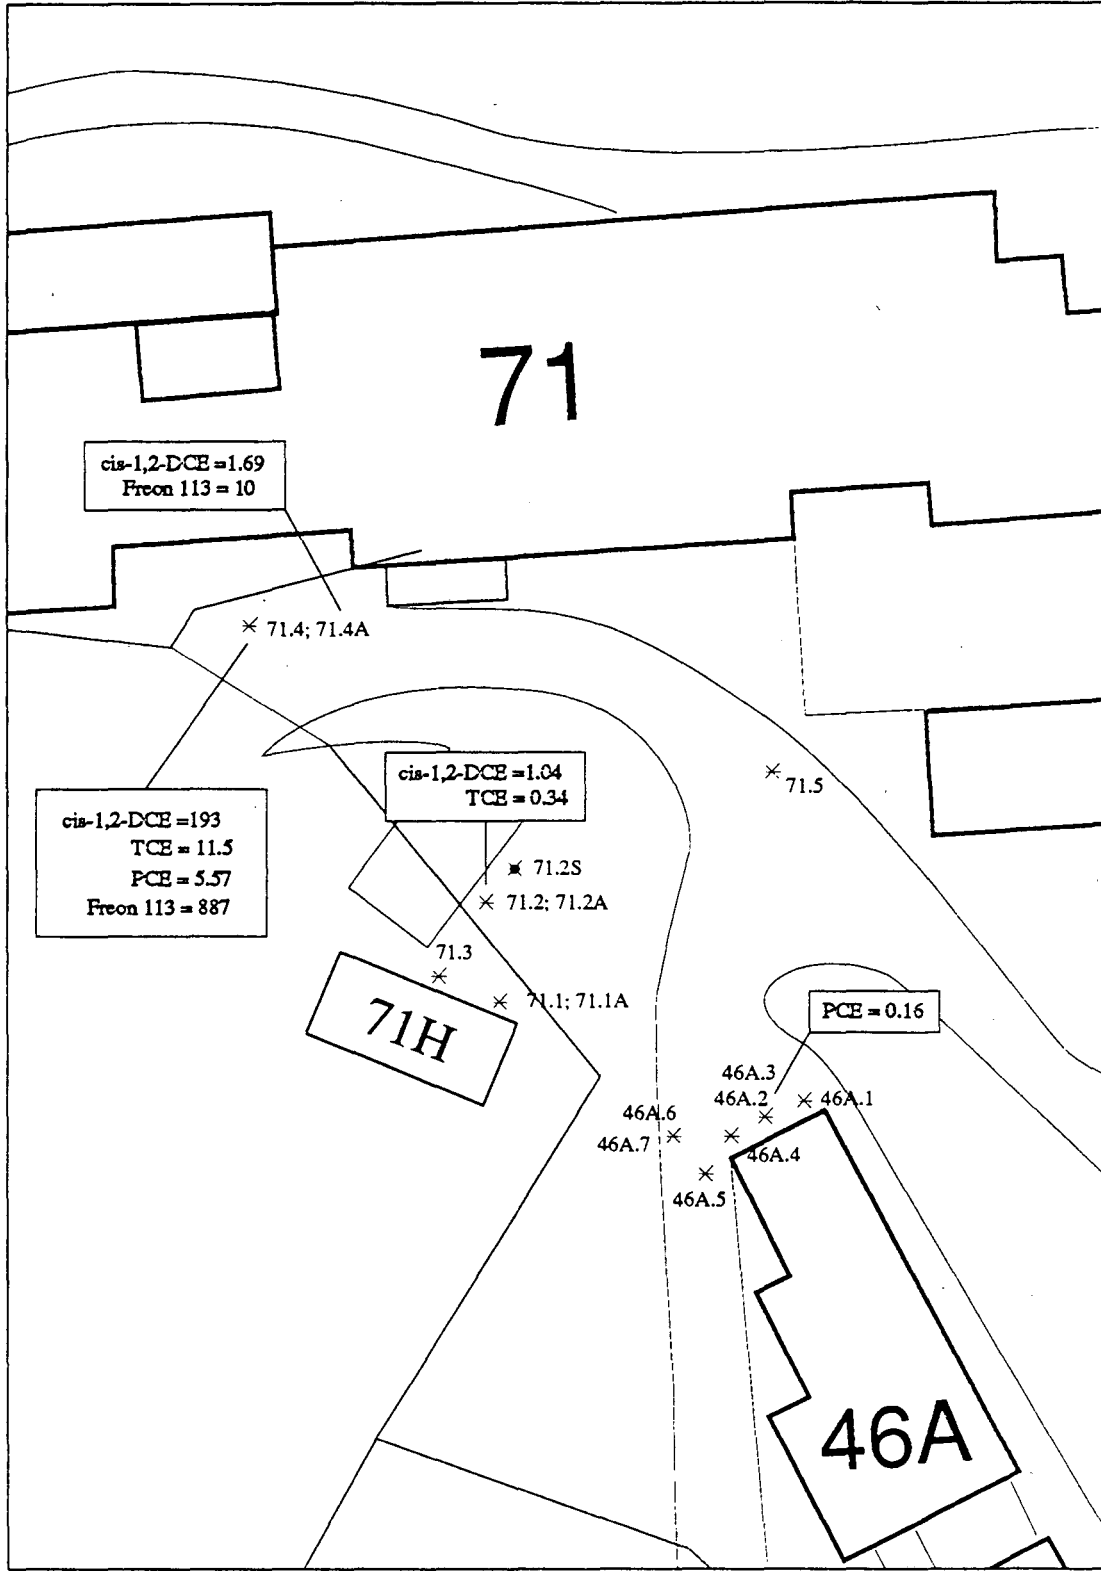
ESD-9010-0040

Figure 11. Soil gas survey results in the area of Bldgs. 46A -71.

2. The same three chemicals that have been consistently observed in water samples taken from Hydrauger No. 51.01.03 were detected in the soil gas collected from point 71.4. Meaning that some sort of pathway should bring these chemicals from that area near point 71.4 to that part of the groundwater that enters the hydrauger.
3. The fact that Well 31-63 adjacent to Building 46A does not show PCE, TCE and DCE suggests that the source of these chemicals could not be from the Building 46A area.
4. The fact that none of the wells and slope indicator located at the northwest corner of Building 46 show any contaminant eliminates the possibility of the northern part of that building to be a source of these three chemicals.

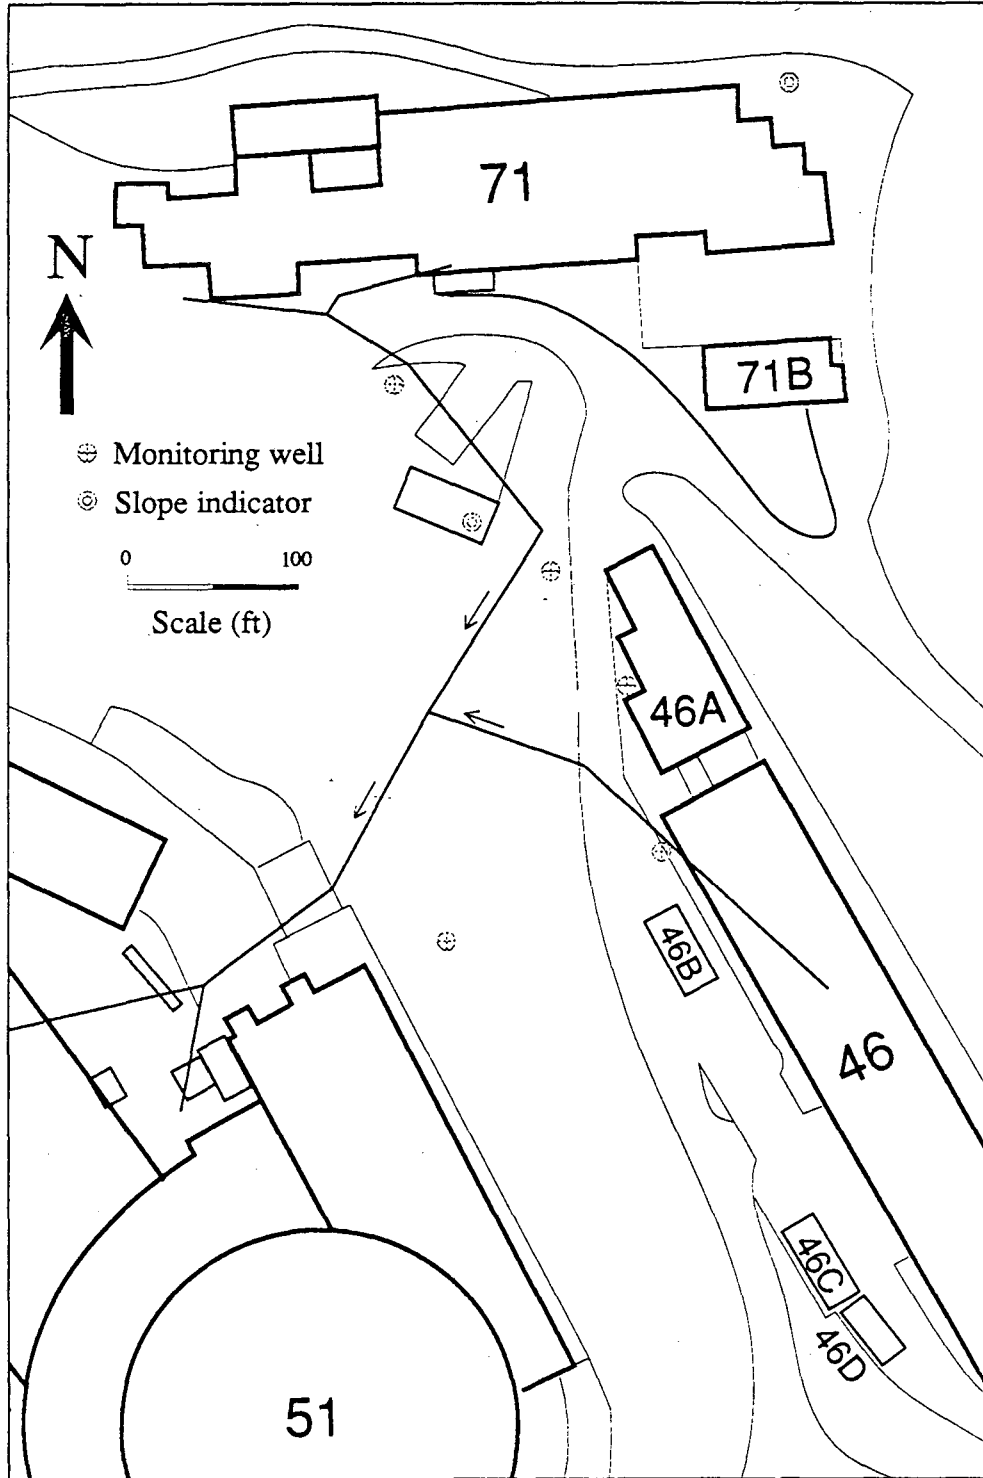
ESD-9010-0030

At this stage of study, before deciding on further drilling, we had to come up with some sort of scenario for contaminant releases. On one hand, we could not confirm any major spills on the Building 71H Parking Lot. On the other hand, we were positive that all of the contaminants detected in groundwater in this area were used in the past in both Buildings 71 and 46. Talking with the staff, nobody remembered any significant spills outside these buildings. In a visit to Building 71 we observed some floor drains in the area where solvents have been used. No underground tanks for either product or waste of chlorinated hydrocarbon were used in this area. Therefore, a possible source for the release of contaminants to the environment was sanitary sewers. Figure 12 shows the sanitary sewer system in between Buildings 46, 51 and 71.

Figure 12. Sanitary sewer lines in the vicinity of Bldgs. 46, 51 and 71.

The above explanation is another indication that the sanitary sewer from Building 71 could be a pathway for delivery of PCE, TCE and DCE to the groundwater west of the road passing beside Building 46.

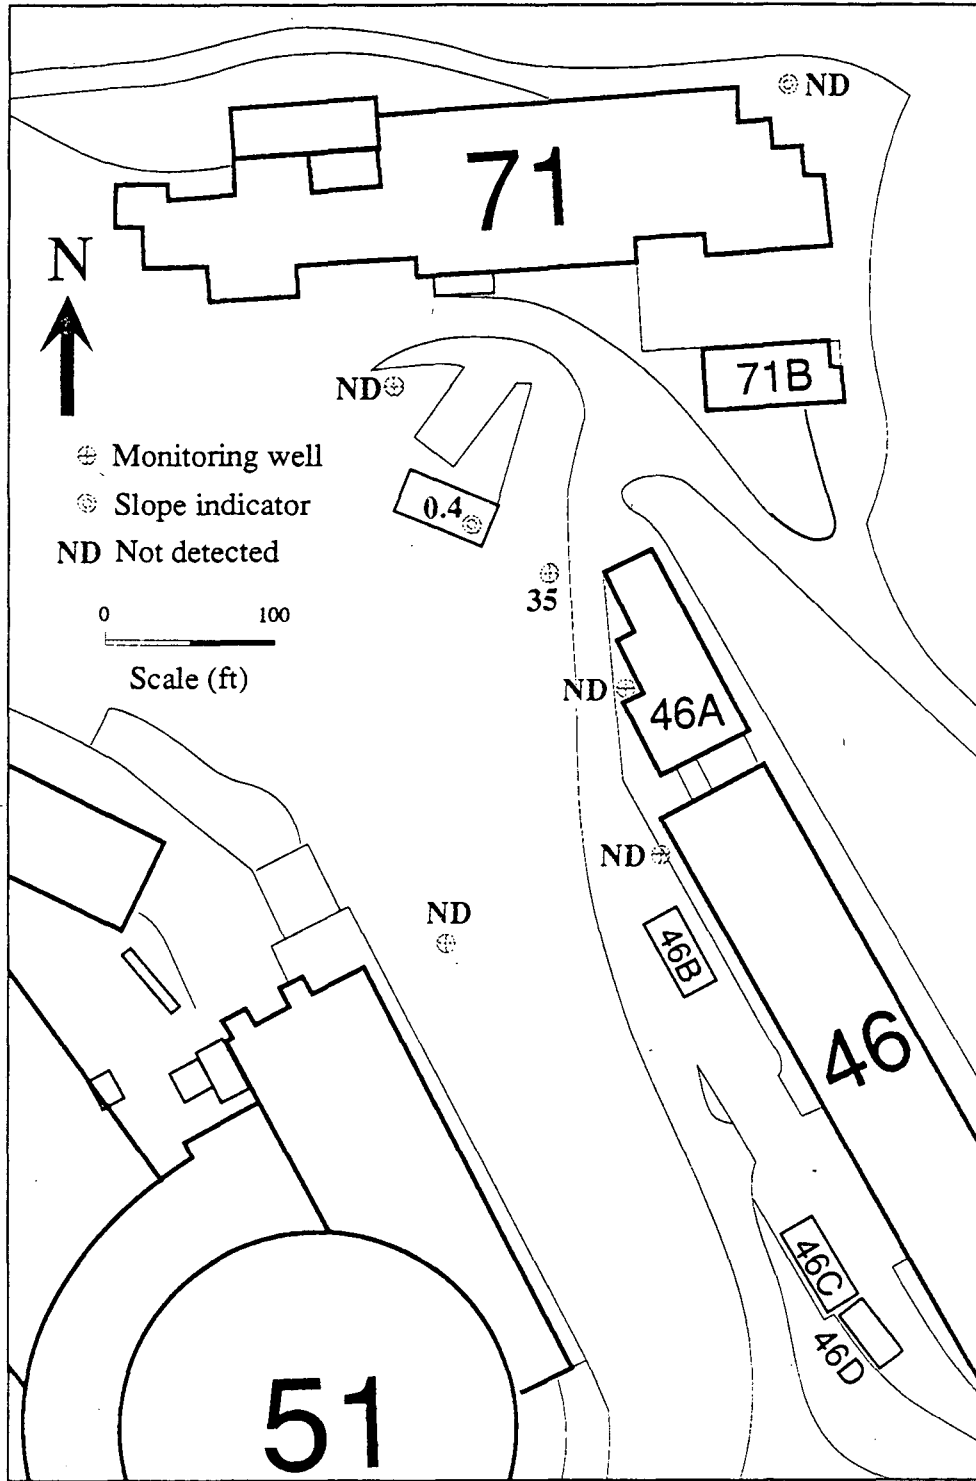
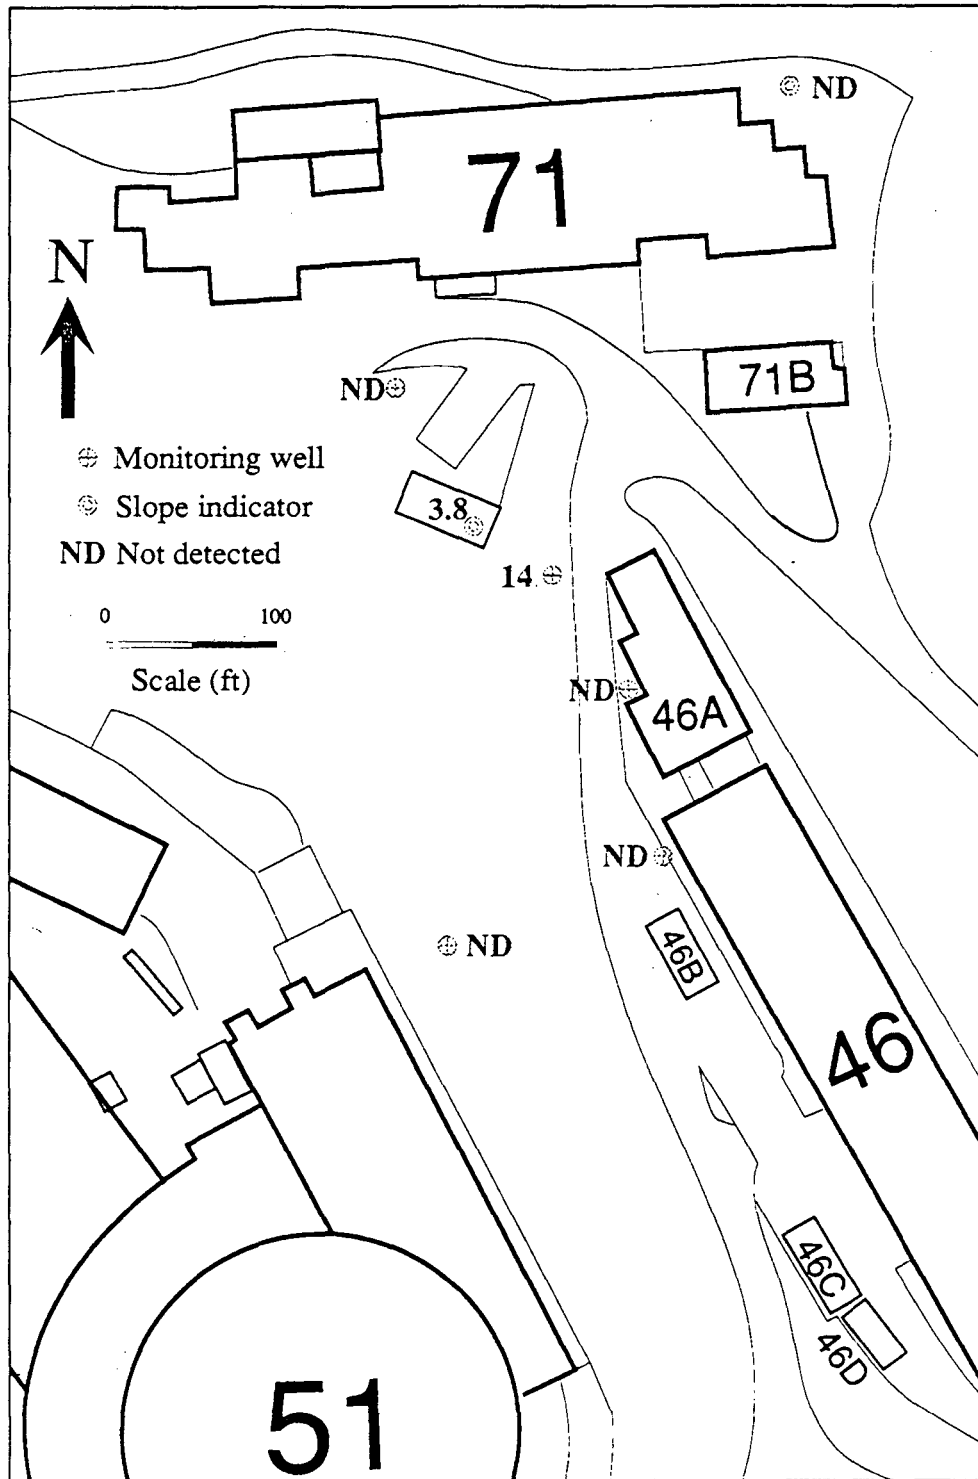
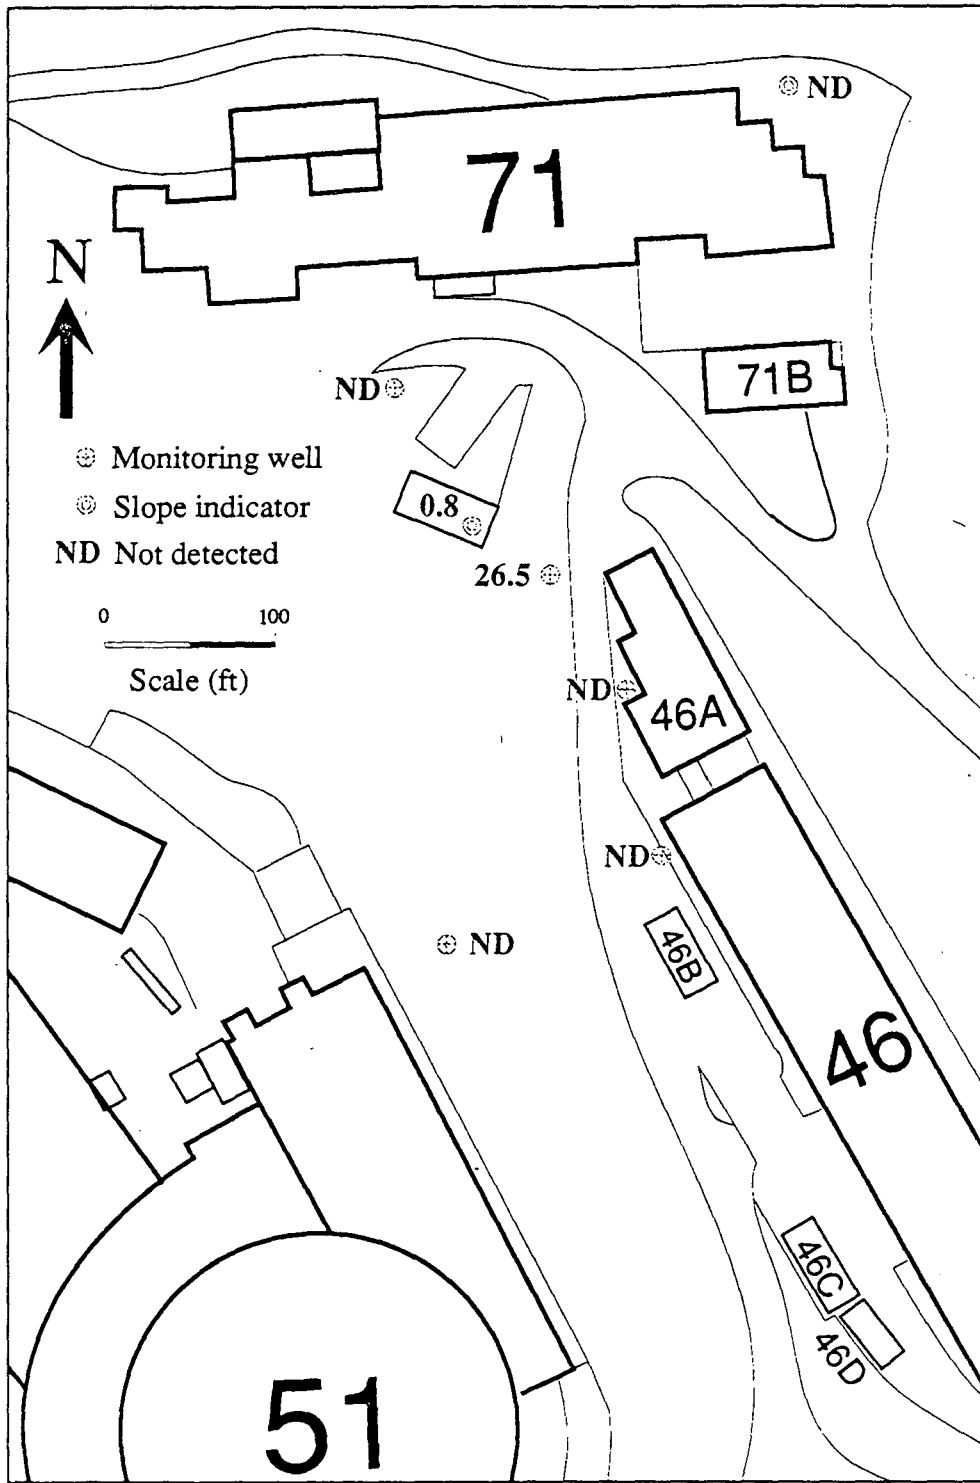
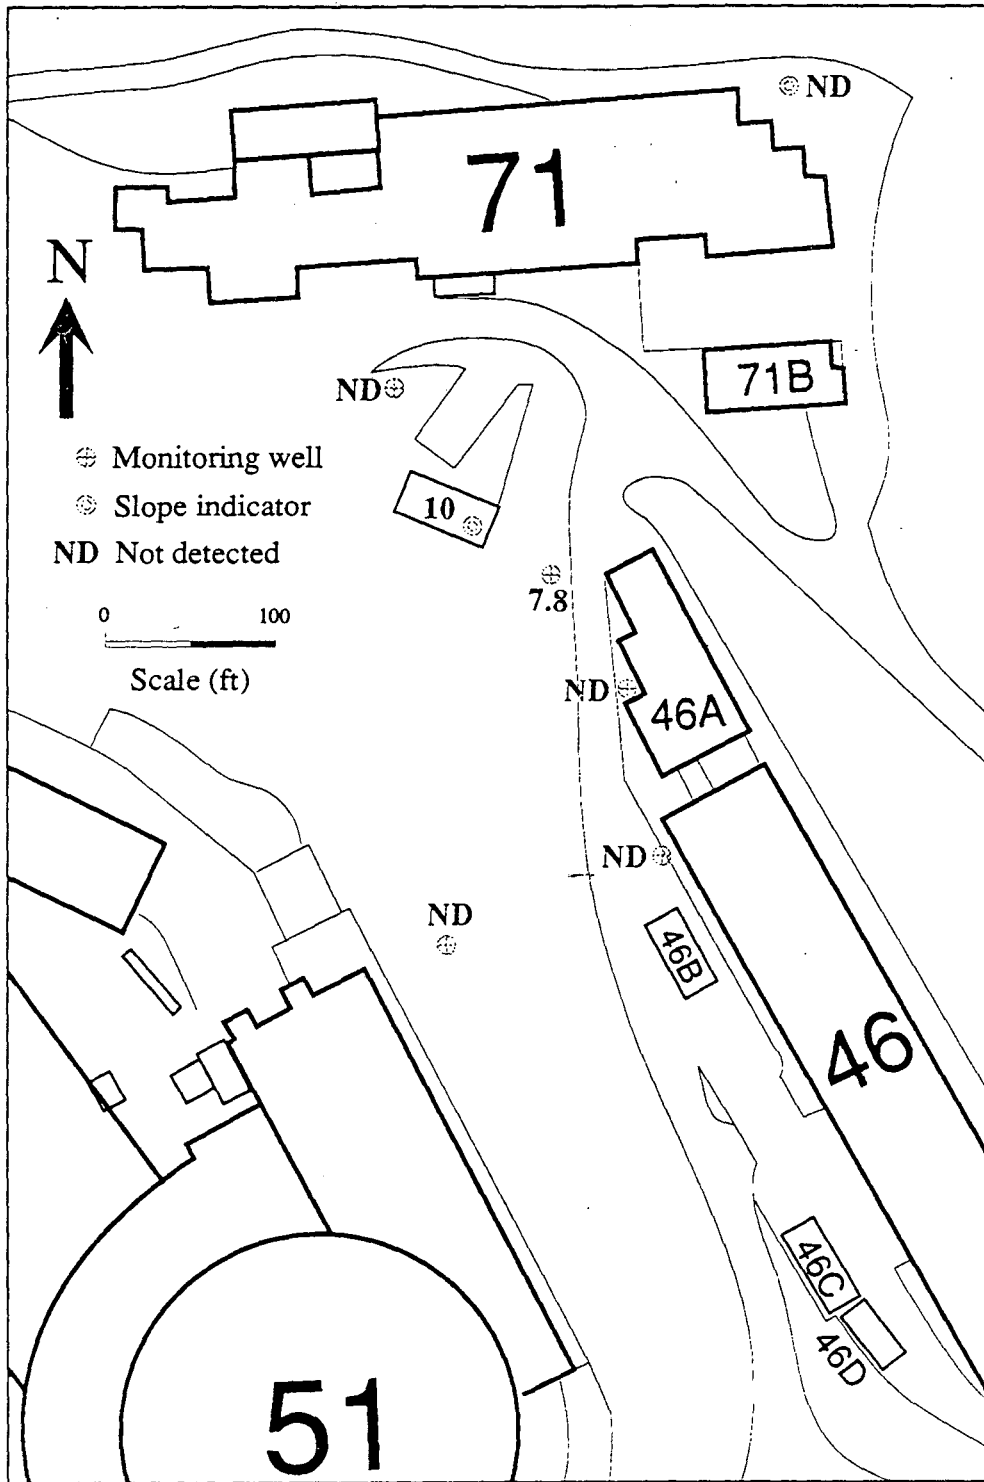
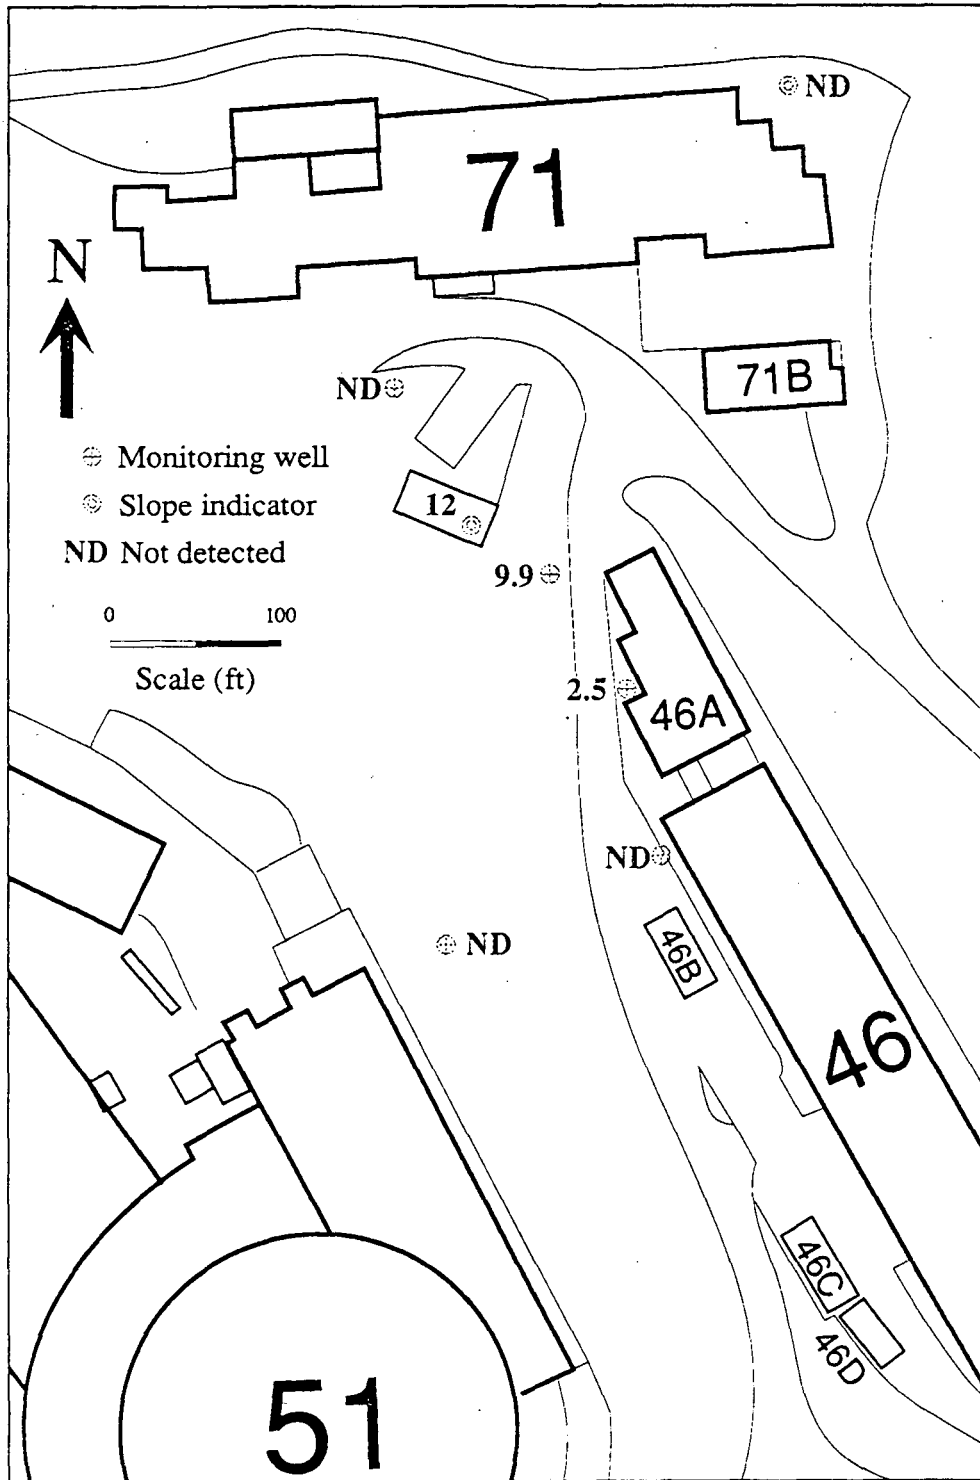
Figures 15 through 19 present the distribution of PCE, TCE, cis-1,2-DCE, 1,1-DCE and 1,1-DCA, respectively, in this area. A careful examination of these figures suggests that the plume of contamination in the groundwater is limited to a narrow area along the old bed of Blackberry Creek.

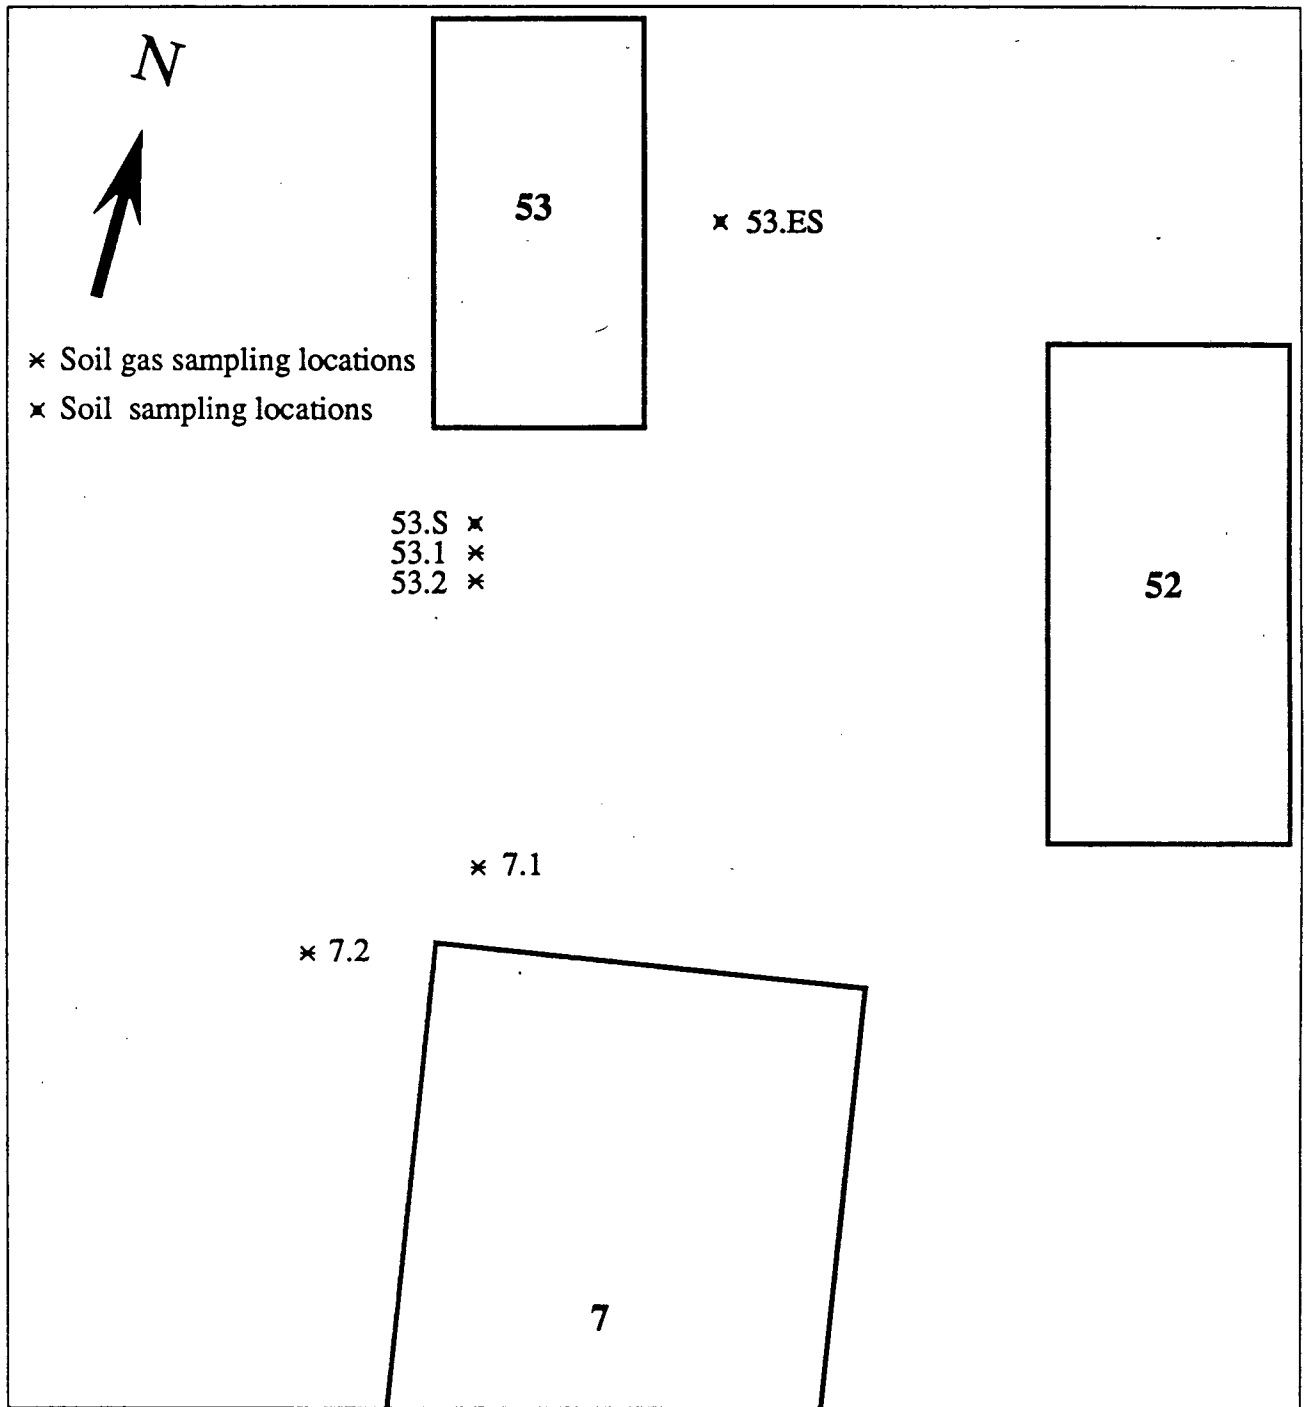
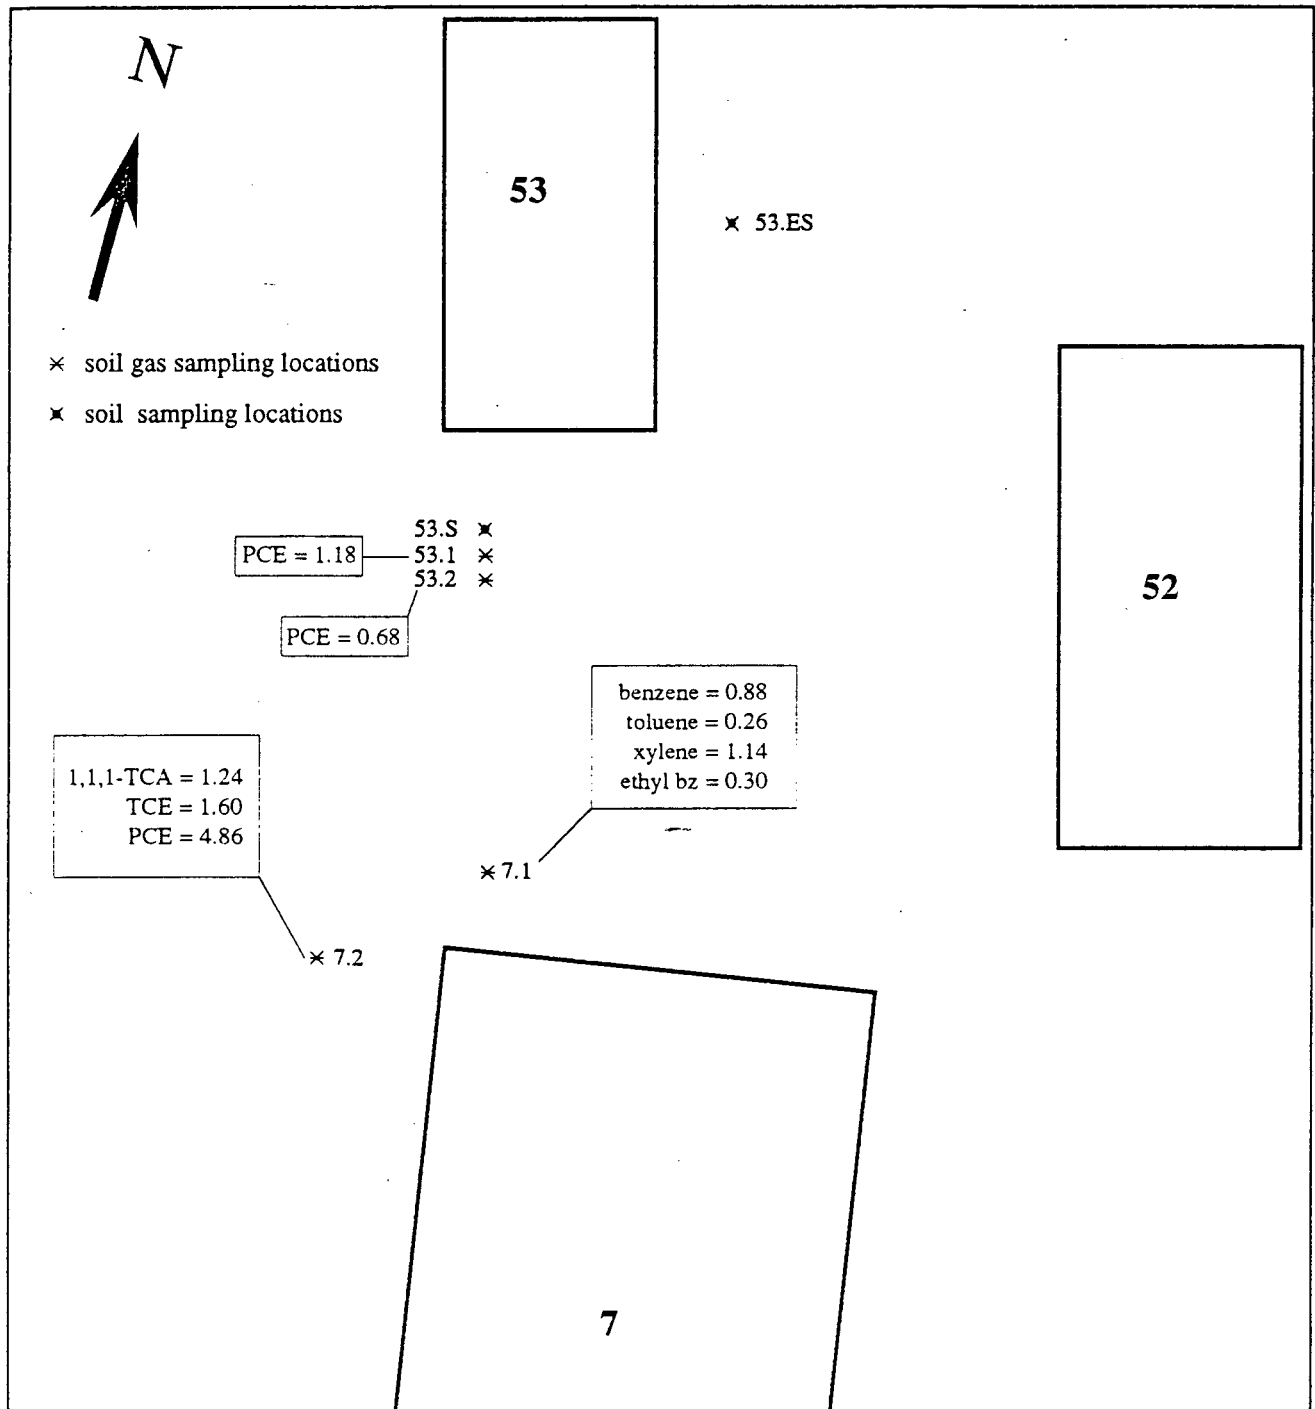
Two rounds of soil gas surveys were carried out at this area. Figure 21 shows the location of round one soil and soil gas sampling and Figure 22 presents the results of these activities. At that time we had not yet developed the scenario of the sanitary sewer system as a source of contamination. Therefore, we concentrated close to the area where groundwater contamination had been observed during the 1988 study. Since Building 53 has been a shop in which solvents were used, we started at the front of this building. Two soil gas samples were collected at 5 and 18 ft depths. The shallow sample showed a small concentration of PCE (1.18 $\mu\text{g/L}$) and the deeper one about half as much. A soil sample (53.S) was then collected from 4 ft depth. It showed very small amounts (less than 1 $\mu\text{g/kg}$) of gasoline compounds such as toluene, and xylene. But no trace of other organic solvents was detected.

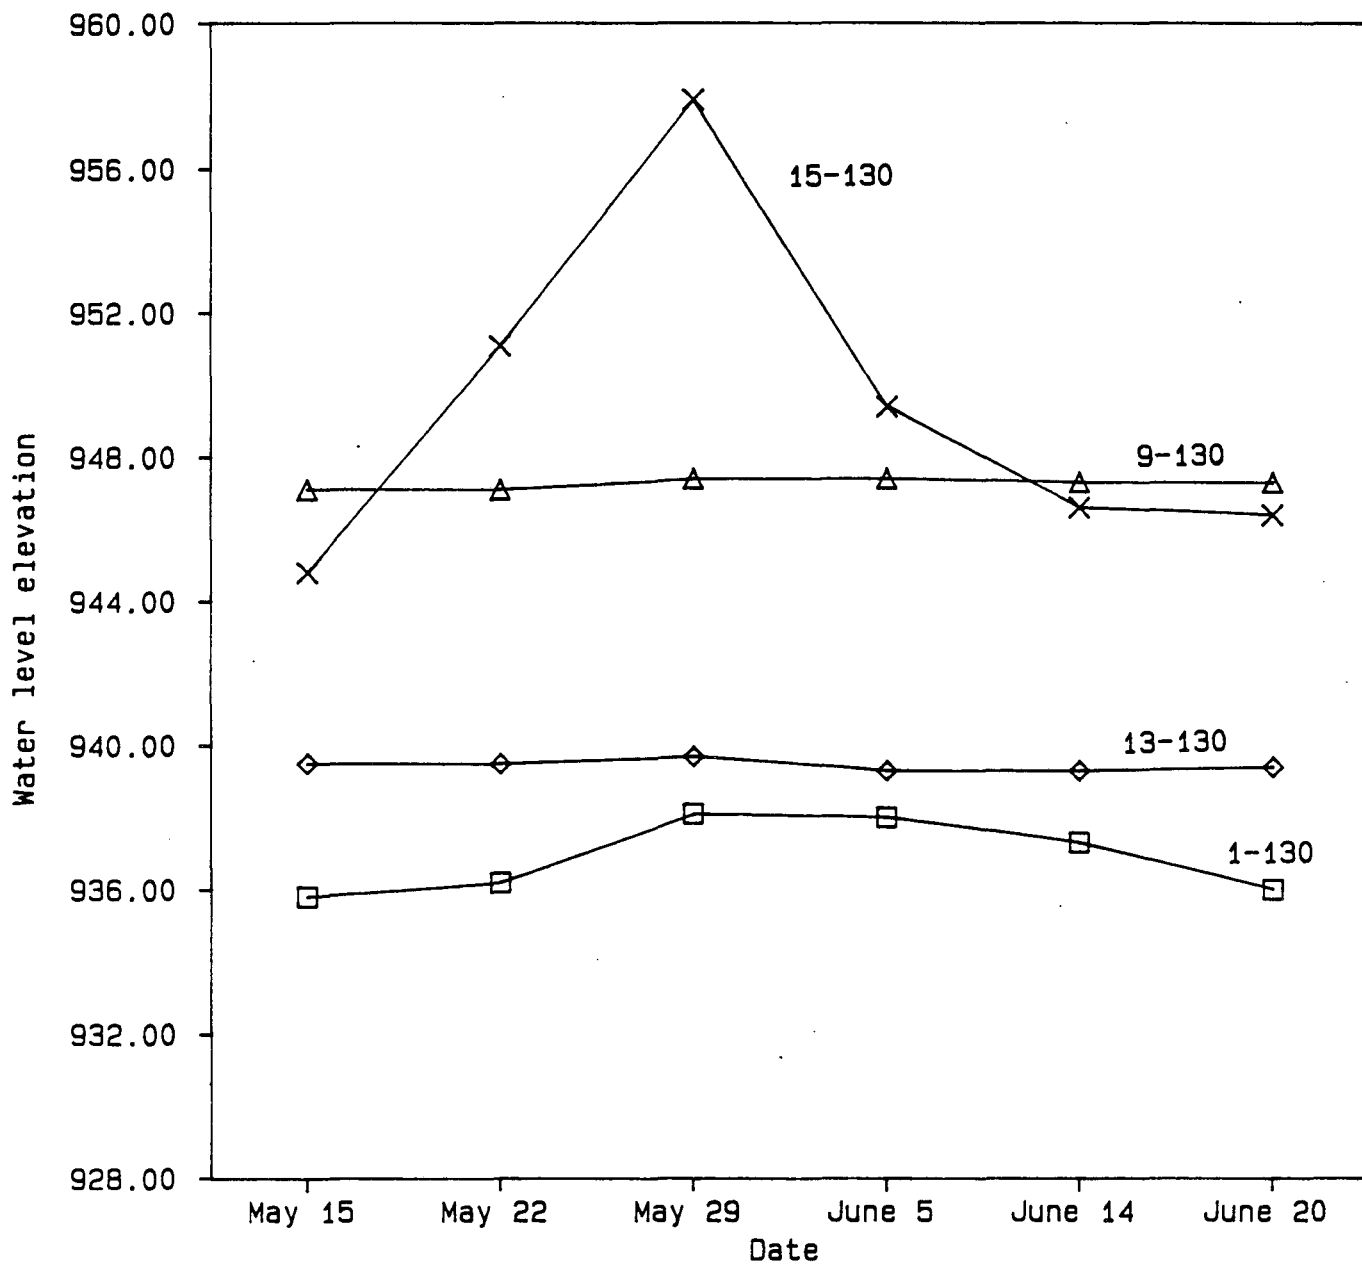
Water levels were routinely measured in these wells and slope indicators. Well 15-130 showed a sharp rise and fall of water level, about 15 feet, during the late May 1990 rainfalls (see Figure 33). Other three wells in this area did not show any significant or fast response to that rainfall. This observation may be an indication that Well 15-130 is connected to a major fracture system or other high permeability channel. If this is true, any contaminant that could have entered into this well could be easily washed away in a short period of time.

Figure 33. Time variation of water levels in four wells in Buildings 69 and 75 area.
