Preliminary Environmental Investigations at the Lawrence Berkeley Laboratory

I. Javandel

November 1990

LBL-29898

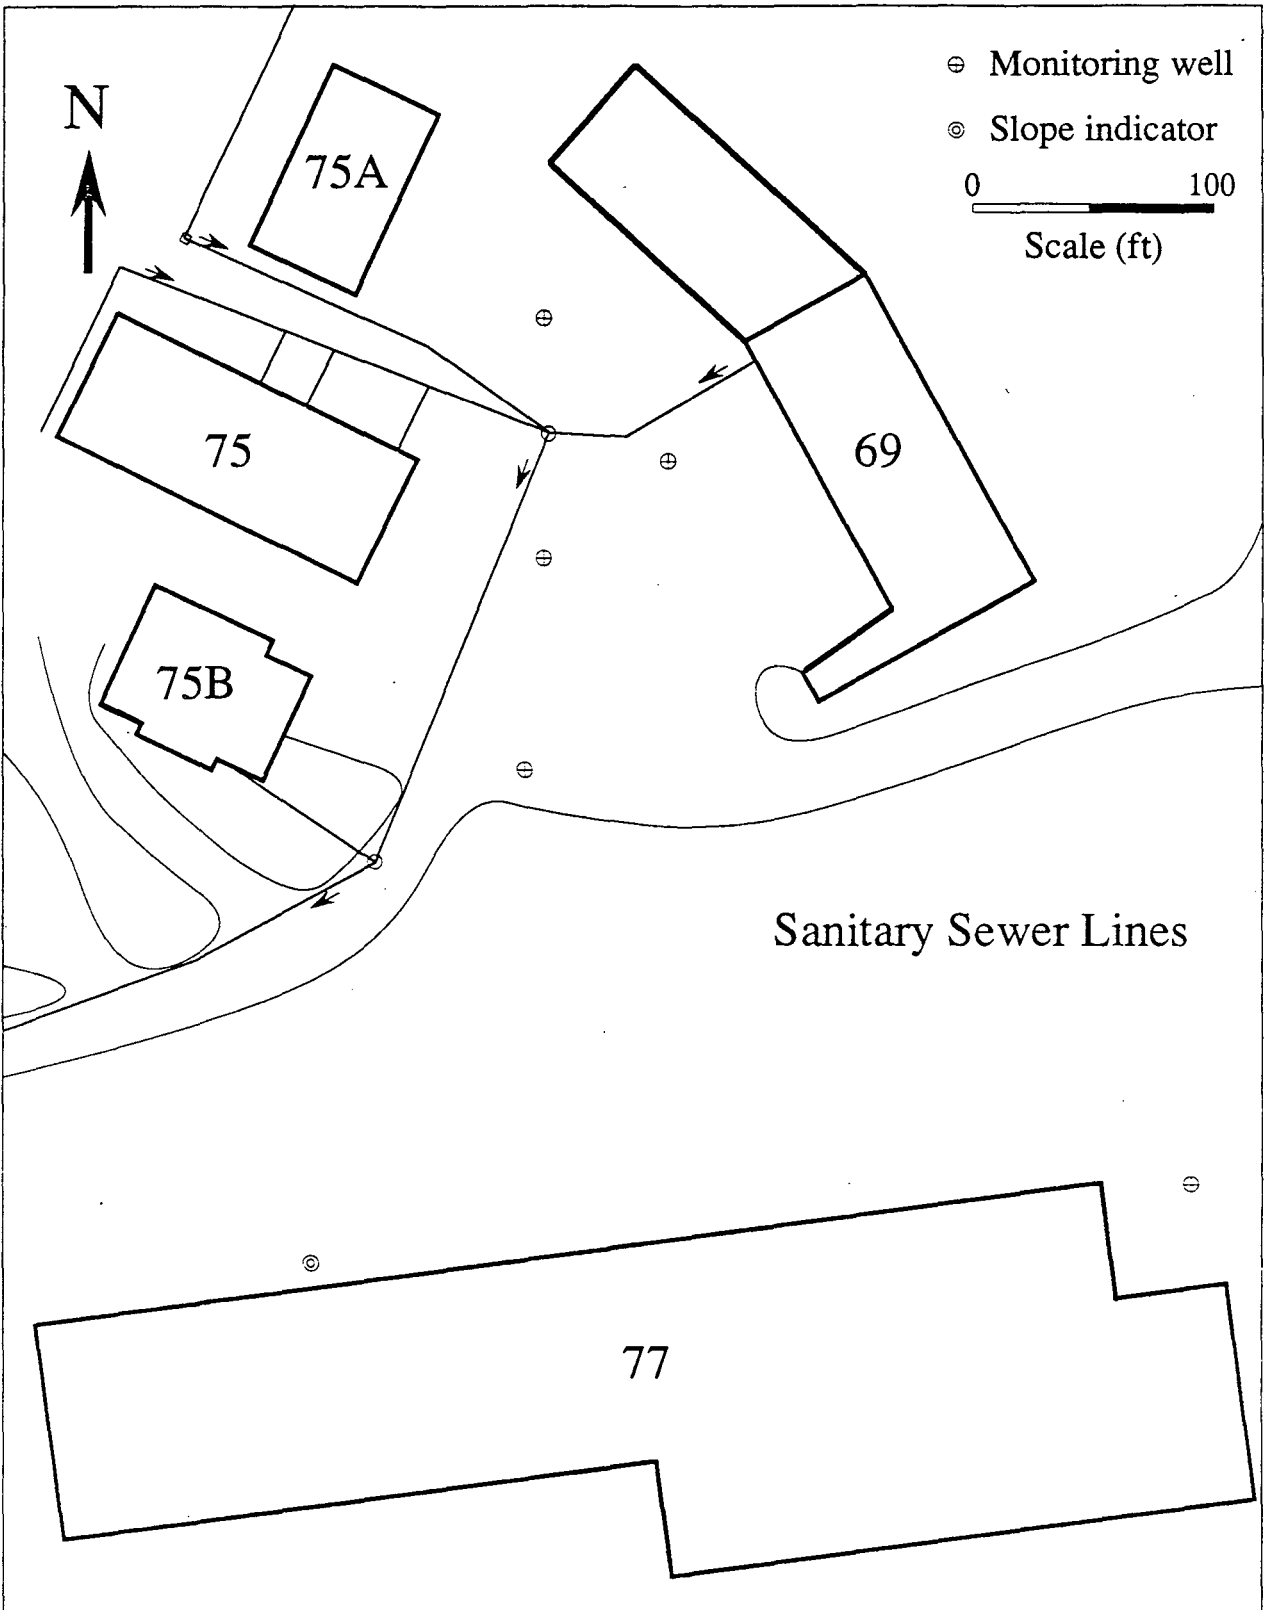
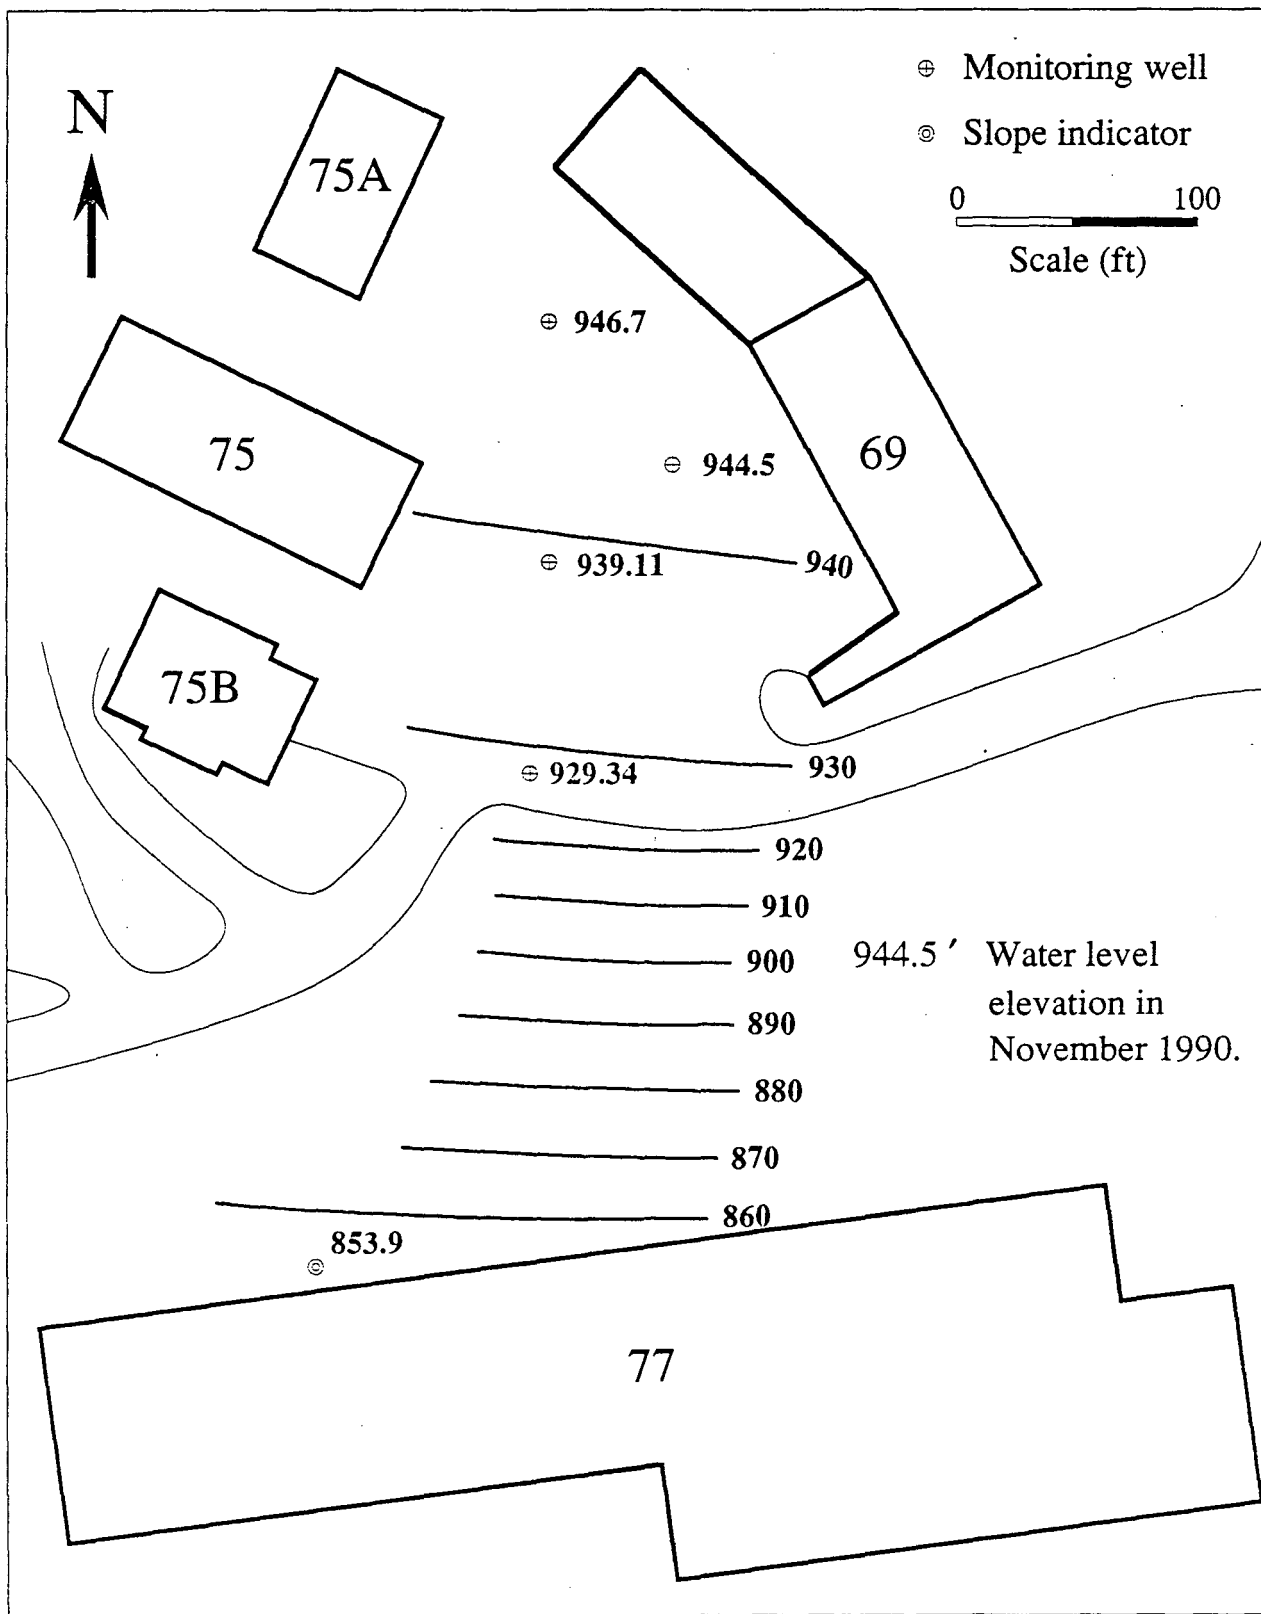
Figure 35 shows the sanitary sewer lines in this area. Since the general direction of groundwater in this area is from north to south (see Figure 36), contamination observed in Well 9.130 can not be explained by leakage from these lines. During September 1990 we conducted the first round of soil gas surveys in this area. Figure 37 shows the locations where soil gas samples were collected and tested. Points 69.1 and 69.3 were chosen at two sides of the contaminated Well 9.130. Points 69.2, 69.4 and 69.5 were randomly selected because this area was used as a salvage yard in the past and some spills could have occurred. Two other points, namely 75.1 and 75.2 were selected to be very close to the sanitary line out of Building 75. All of the above soil samples were collected from a depth of 5 ft.

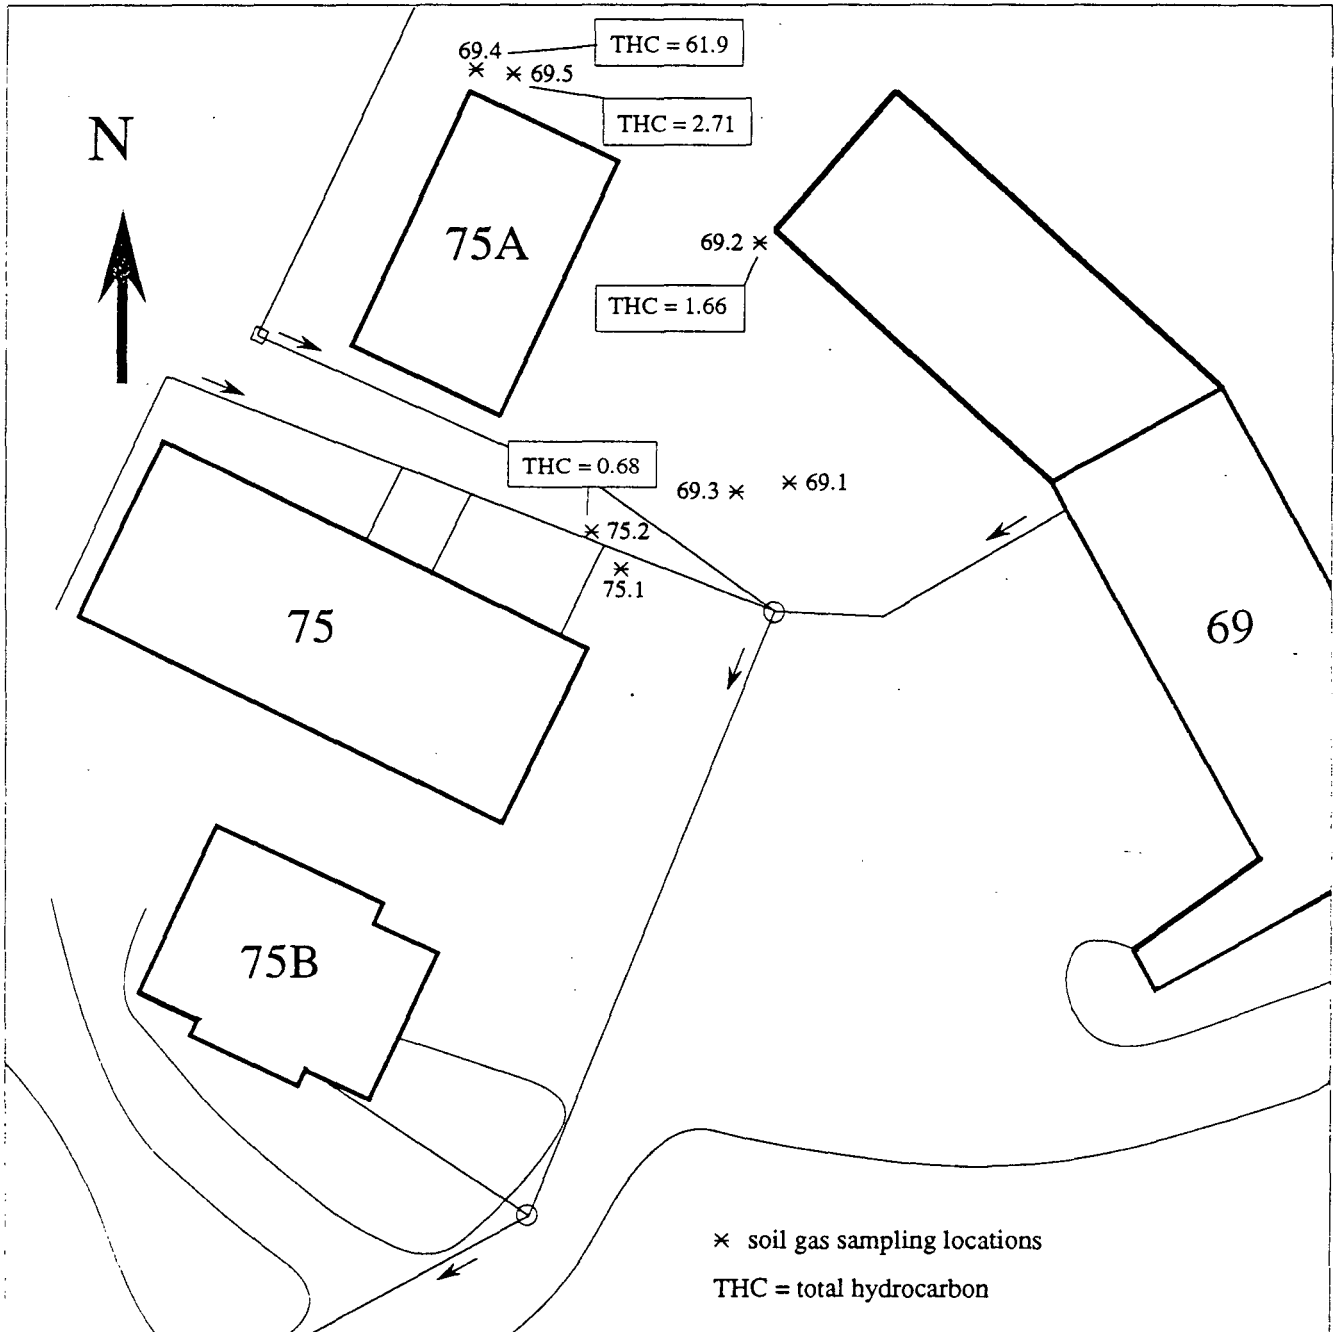
ESD-9010-0036

Results of this soil gas survey are also shown in Table 5. No significant amount of TCE or PCE were detected in these soil gas samples. Figure 38 shows total hydrocarbons detected in these samples.

Figure 38. Results of soil gas analysis in the vicinity of Bldgs. 69, 75 and 75A.
