Stability investigation and stabilization of a heavily fractured and loosened rock slope during construction of a strategic hydropower station in China

This paper presents a case history of the 205 m high intake slope at the Huangjinping (HJP) hydropower station on the Dadu River. Deformation and cracks developed on the cut slope during excavation, and the deformation extended onto the natural slope above the cut, giving rise to serious safety concerns. Research was conducted to study the engineering geological conditions and the deformation characteristics of the slope during excavation. In situ monitoring data and possible causes of cracking were analyzed. The results show that the zone of loosened rock mass extended much deeper into the rock mass than it did at other sites in the region because of the tectonic history of the site and cutting. The empirically designed cable anchors with lengths of 40 m or 45 m were insufficient to stabilize the slope, while the remedial cable anchors as long as 100 m successfully stabilized the slope. The analytic method and procedure used in this paper could be useful to similar projects.

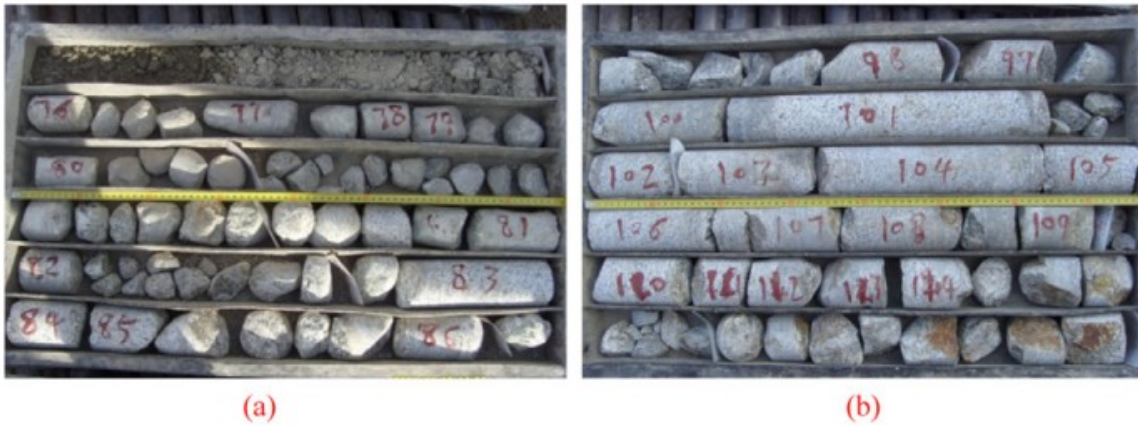
Fig. 5. The drill core of: (a) loosened fractured zone (b) heavily loosened zone.

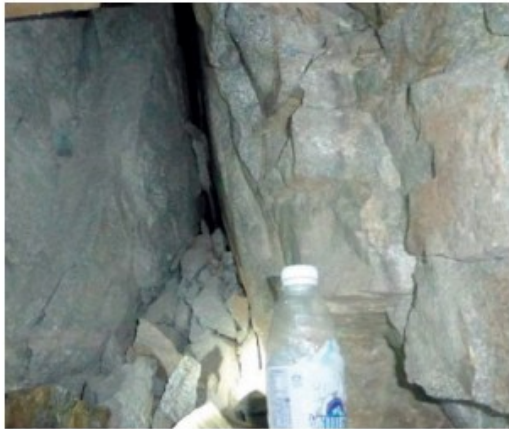
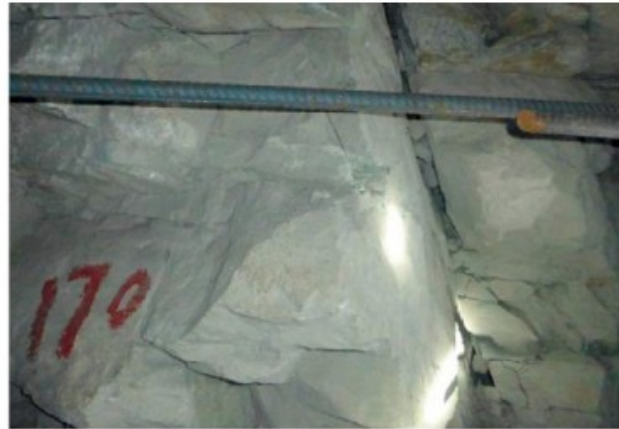
(b) The horizontal depth is 130m

(c) The horizontal depth is 170m.

Fig. 16. Typical open joints in the loosened rock mass on the HJP intake slope.

In Table 3, the authors has summarized the maximum in-situ stress at the underground powerhouse, and the horizontal loosened depth of the bank slopes of four hydropower projects on the Dadu River. Then, the relationship between the above results and the distance from the Gongga Mountains (GGM) are drawn in Fig. 14. These comparisons indicate that the closer the site to the Gongga Mountains (GGM), the lower the in-situ stress magnitude and the larger the horizontal loosened depth. Among the four projects, the horizontal depth of the loosened zone is the greatest at the HJP project site, while the measured maximum in-situ stress is the lowest. Second, in order to study the influence on the rock mass structure, the authors compared the distribution of discontinuities between the left abutment intake slope of the HJP and the right abutment slope of CHB, which is somewhat far from the Gongga Mountains. For the HJP intake slope, 733 discontinuities divided into 21 sets were mapped, as shown in Fig. 15(a). For the right abutment slope of CHP, only 341 discontinuities divided into 9 sets were mapped, as shown in Fig. 15(b). These results indicate that the discontinuities on the HJP intake slope are abundant and essential; no persistent and dominating discontinuity trends were identified. In addition, the joints and fractures remained open, and did not progressively close with depth, as would be expected with increasing overburden stress (in Fig. 16).
