The Present Status of the Bevatron Power Supply

UCRL 8345 REV.

THE PRESENT STATUS OF THE BEVATRON POWER SUPPLY J. Gordon Harding, Harold W. Vogel, and Thomas W. Sibary

This report brings up to date the description of the Bevatron power supply. Changes made since the original installation are described, and problems still encountered are treated.

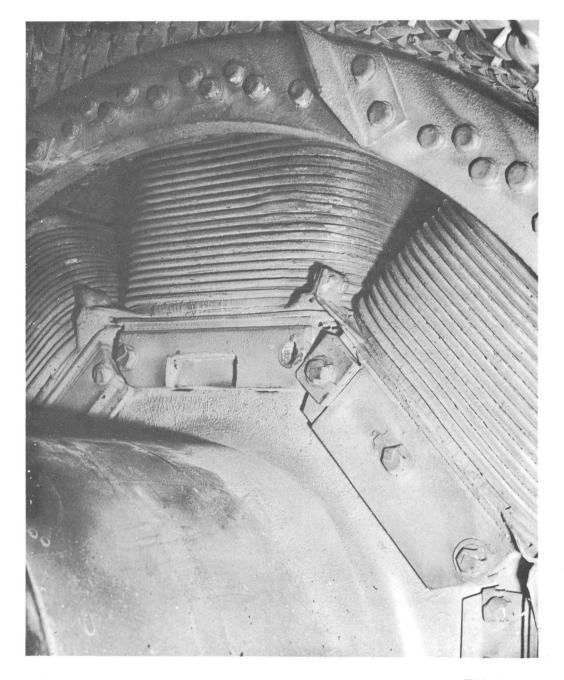
Generator troubles have been many and varied. Electrical troubles have arisen from: moving slot wedges, end-turn insulation failure, rotor coil connection failure, stator coils falling into the air gaps, stator burnout caused by a broken bolt from the rotor (Figs. 3 and 4), and journal etching as a result of bearing-insulation shorts. Mechanical problems have been primarily due to shaft misalignment and to lubricating-oil system and bearing troubles.

Fig. 3a. Power-supply damage: broken bolt on generator rotor.

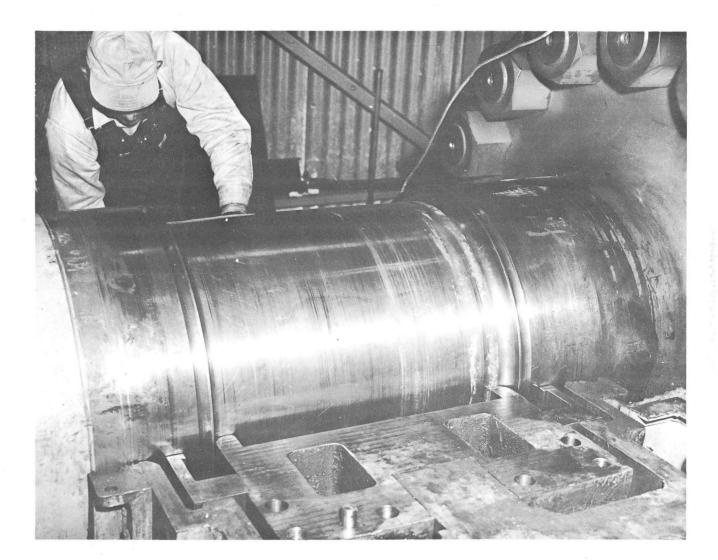
Fig. 3b. Power-supply damage: damage to generator journal from short-circuit currents caused by broken bolt.

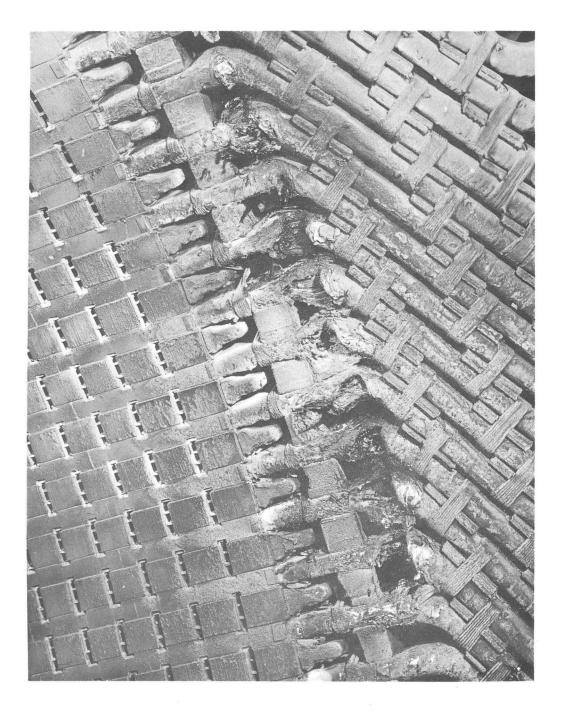
Fig. 4. Generator stator damage.

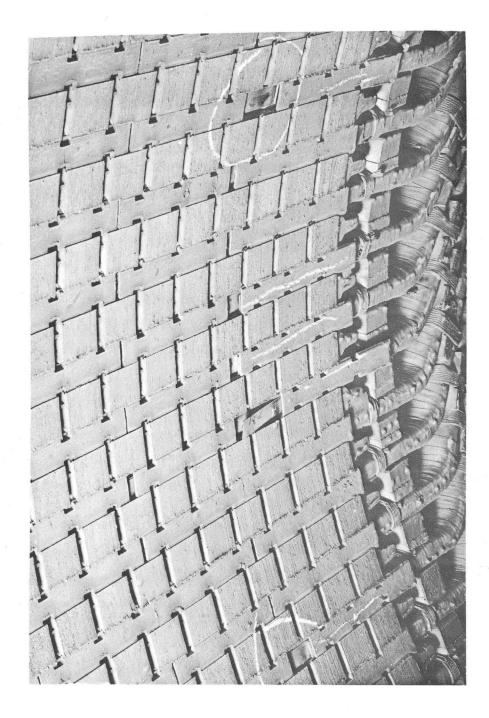
Because the generators deliver pulsed loads, the windings are subjected to violent mechanical shocks. The original design provided adequate extra bracing for the end turns and paralleling rings. The slot-wedge construction, however, was of the type used in standard machines, and proved inadequate. Some wedges moved axially (Fig. 5), and in one case released a stator coil which fell into the air gap and struck the rotor (Fig. 6). This failure occurred during start-up and was detected before the field current was built up. Only minor iron damage resulted although the coil was destroyed.

Fig. 5a. Generator stator: wedge movement.

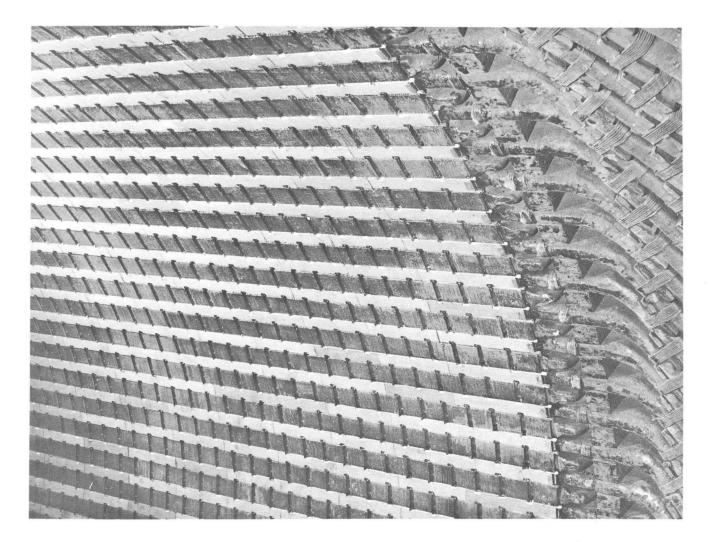
Fig. 5b. Generator stator: new stator wedge locks.

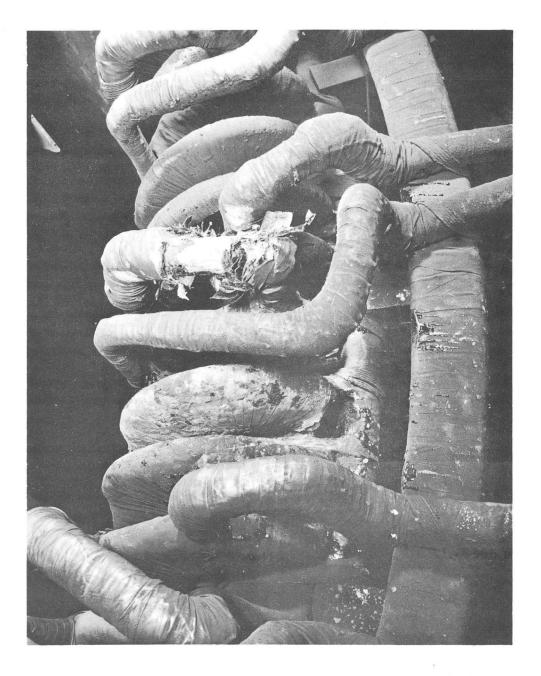
Fig. 7. Coil knuckle damage in generator stator.

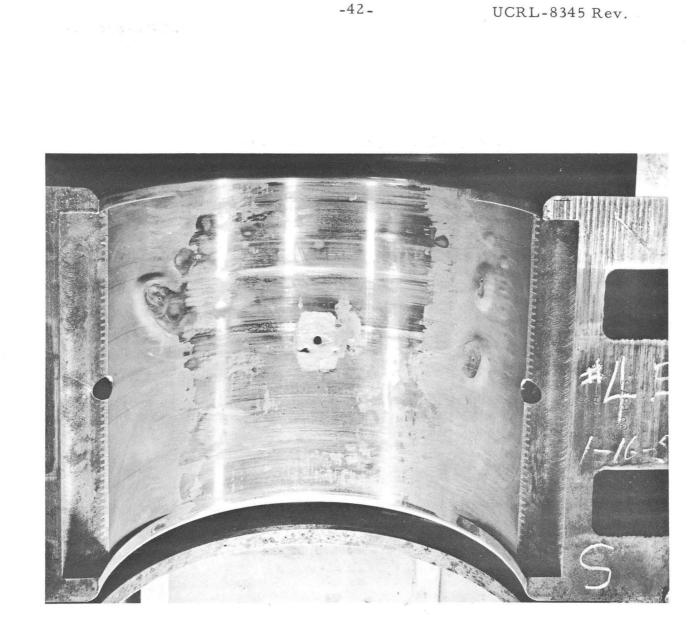
The bearings are babbitt faces poured on steel shell. After about two years of operation it was found that a bearing would suddenly run hot for a few hours or days and then revert to normal temperature. When these bearings were inspected, it was found that the babbitt had been raised up in blisters and had touched the shaft. The top of the blister had then wiped free of the shaft (Fig. 8). The blisters were drilled and high-pressure hydrogen escaped. The blisters were scraped down, smooth with the original babbitt surface. A pattern of 1/16-in. holes was then drilled through the babbitt to provide a release for future hydrogen accumulation. We conclude that the hydrogen-blister problem is solved.

Fig. 8. Hydrogen blisters on lower half of generator bearing.

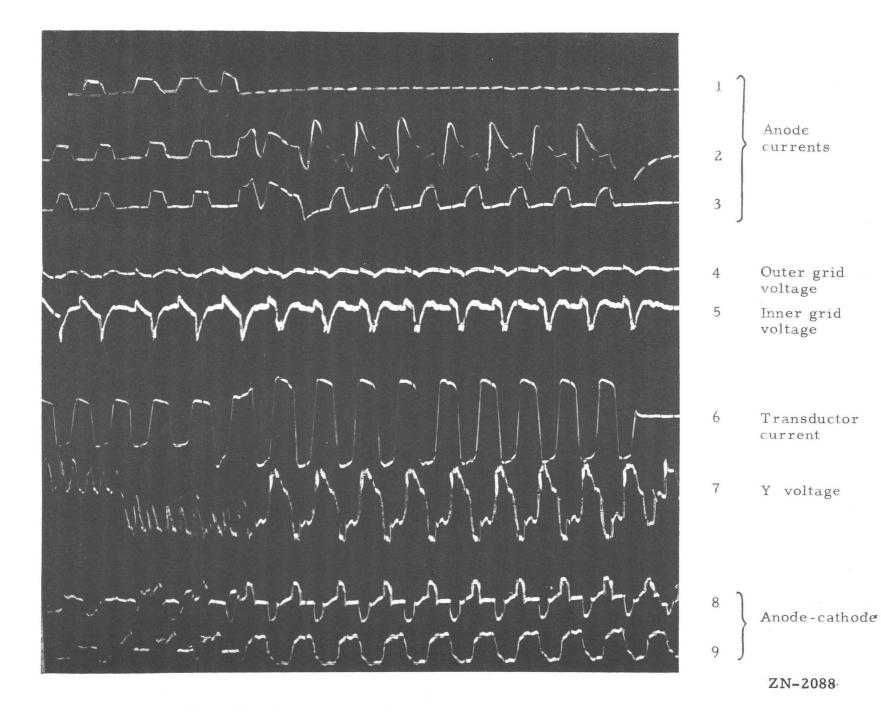
Fig. 11a. Inversion faults: following current flip.

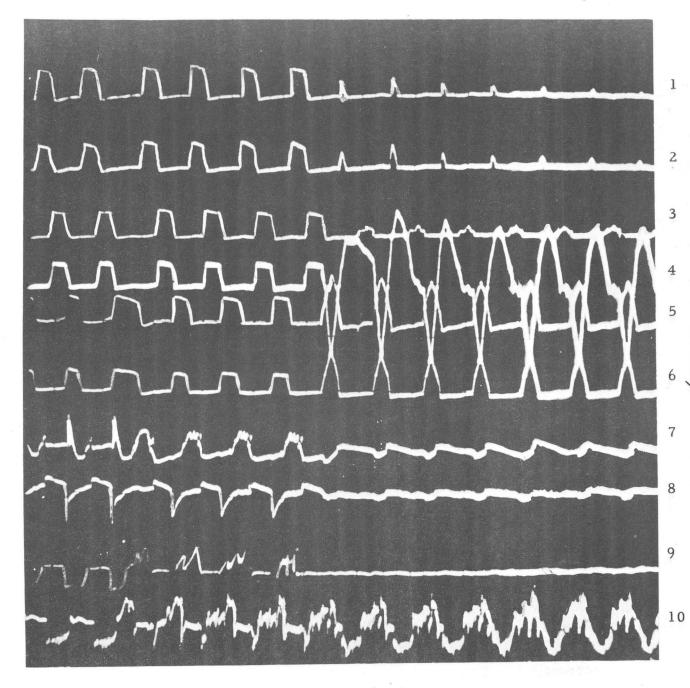
(a) Arc-throughs following an arc-back. The arc-back occurs after conduction stops and at the instant of initial inverse voltage. Figure 11b shows how an ignitron might "lock-in" to this type of faulting. In examining the current transformer traces, allowance should be made for the poor positive current-pulse traces due to the high dc level through the transformer at peak current. This is the most frequent type of arc-through on the Bevatron power supply. At this time the ignitron is subjected to an inverse voltage of 7500 volts with a rise time of 100μ sec and a decay of tube current from 2100 amp to zero in 800 μ sec. In the spring of 1958, cushioning circuits consisting of a series capacitor and resistor were connected from anode to cathode of each ignitron. To minimize power loss the values of capacitance and resistance are being optimized. Present units are 3 μ f and 30 ohms per phase.

Fig. 11b. Inversion faults: on anode 4, starting with inversion arc-back.

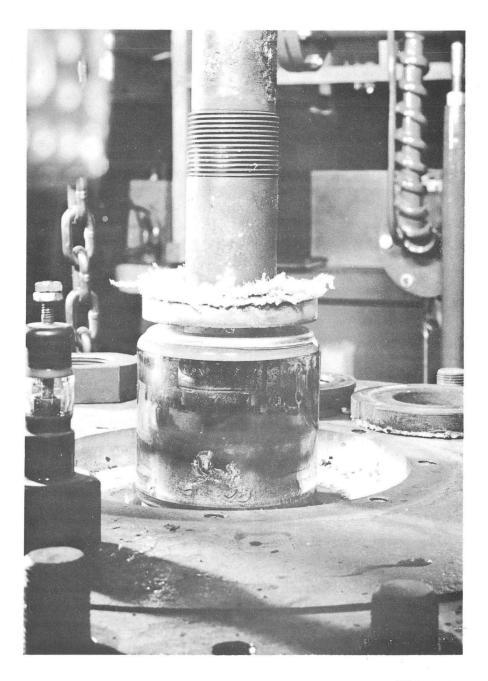
There are no anode circuit breakers to interrupt this current. During this period the tube carries unidirectional fault current, the arc leaves the mercury pool and travels to the cathode potential parts near the anode. The metal parts are melted from the excessive heat; the glass anode bushing acquires internal surface cracks and, in some cases, the bushing is destroyed.

Inversion arc-backs reach approximately 8,000 amperes peak, but the current periodically goes through zero and thus the arc may not necessarily cause the damage of a normal arc back. The common appearance of an ignitron anode stem assembly after several months operation is shown in Fig. 14. Internal parts of an ignitron also showing signs of arc tracks are pictured in Fig. 15.

Fig. 14a. Ignitron anode-stem insulator: spalling and plating of glass anode bushing--grid bushing to left of anode bushing.

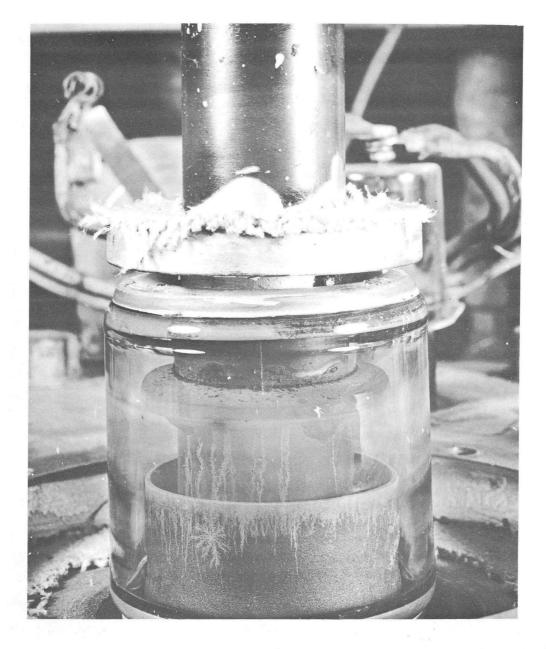
Fig. 14b. Ignitron anode-stem insulator: arc tracks on anode stem and shield.

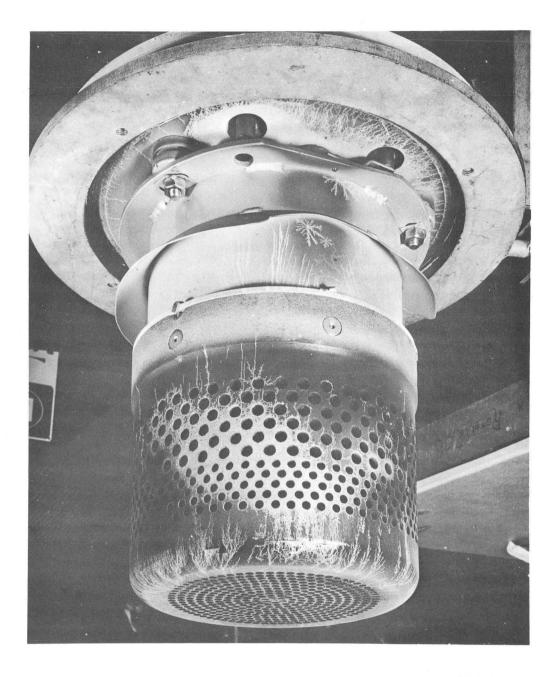
Fig. 15a. Interior parts of ignitron: outer graphite grid.

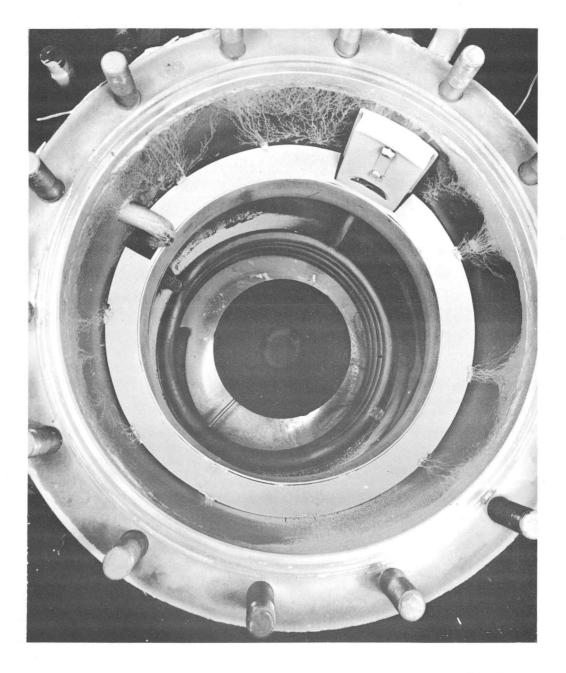
The iron rust settles out on cooling coils producing a thermal insulating layer which affects the cooling efficiency. Therefore, it is necessary to provide periodic flushing of the ignitrons to avoid hot spots on the tank walls. The iron rust also settles out in low spots and must be flushed out to prevent restriction of the water flow. It has been necessary at times to stop the Bevatron operation to correct ignitron overtemperatures.

Fig. 15b. Interior parts of ignitron: ignitron tank, showing cooling coils and blast bubble at center and vacuum connection at upper right.

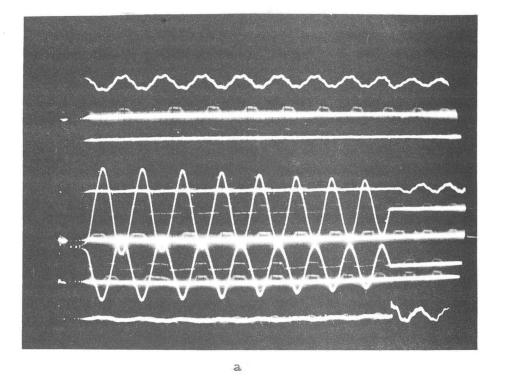
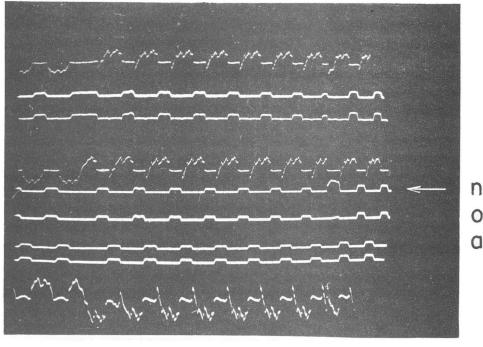
The most severe fault to both the generator and the ignitrons is an arc-back (Fig. 18). Occasionally arc-back currents reach values of over 30,000 amp for as long as 14 cycles. The fault starts in one tube but may cause a 3-phase arc-back one one ignitron frame. An arc-back occurs on the average of once every four shifts. After an arc-back it is necessary to wait for 15 minutes for the vacuum system to return to normal so as to minimize any sympathetic faults. Arc-backs are detrimental to the generator windings and shaft. (Refer also to the last paragraph under Ignitron Grid Circuits.)

note one-cycle arc-through
