High Energy Wide Area Blunt Impact Damage to Internal Structural Components of Composite Aircraft Fuselage Structures

A dissertation submitted in partial satisfaction of the  
requirements for the degree Doctor of Philosophy

Structural Engineering

Moonhee Nam

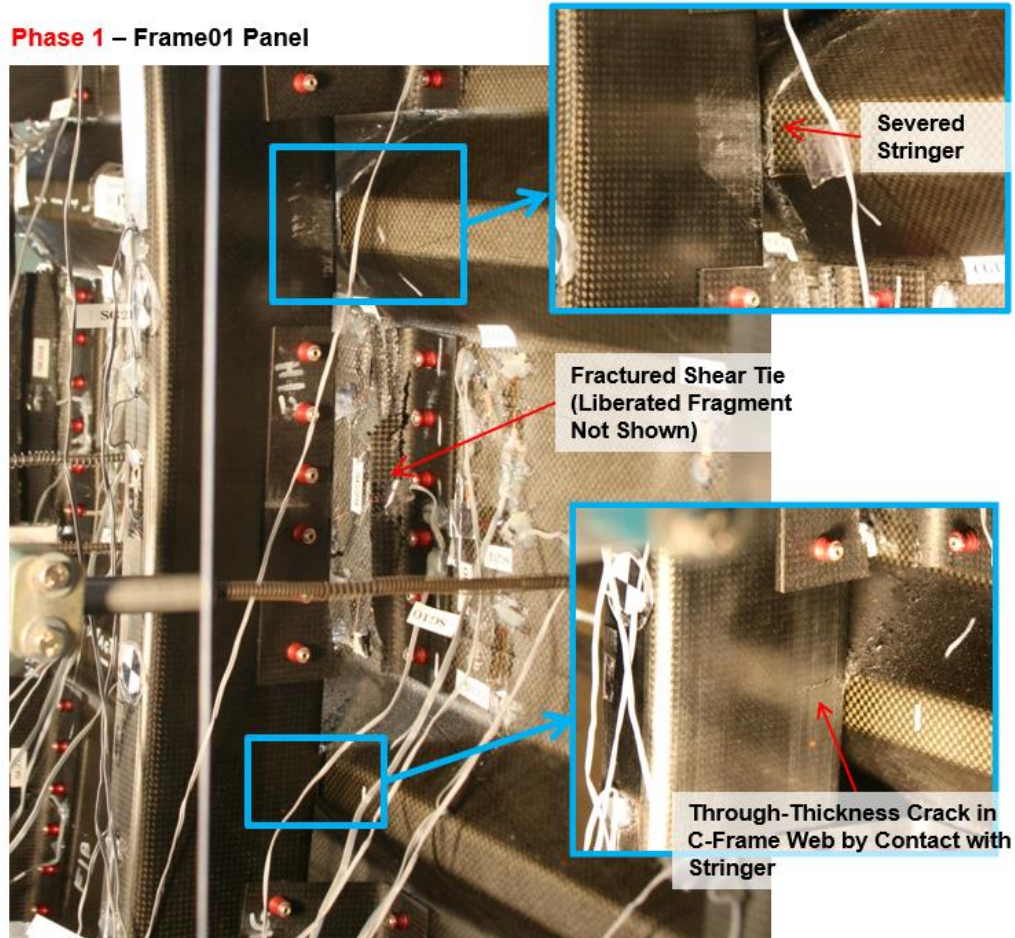
Figure 2.4 shows internal damage after the Frame01 test which quasi-statically applied load directly onto two shear ties. The damage initiated at the shear tie curved corner, more specifically, shear tie corner delamination due to the composite material's low interlaminar tension strength (opening moment loading in curves sections induces radial tension stress). With more loading, the shear tie was fractured as shown in Figure 2.4 by the direct compressive load from the bumper. The following failure events were contact between the C-frame and the stringers, and local twisting of the C-frame due to absence of the stabilizing component (the fractured shear tie). The key failure last event was contact induced failures between C-frames and the stringers in the impact zone. As shown in Figure 2.4, the stringer was severed as the frame impinged into it. Through thickness frame cracks occurred. Delamination between the stringer flanges and the skin was also found due to the severed stringer crack reaching the stringer-to-skin interface.

**Figure 2.4: Internal damages of Frame01 panel loaded onto shear ties [8, 11].**

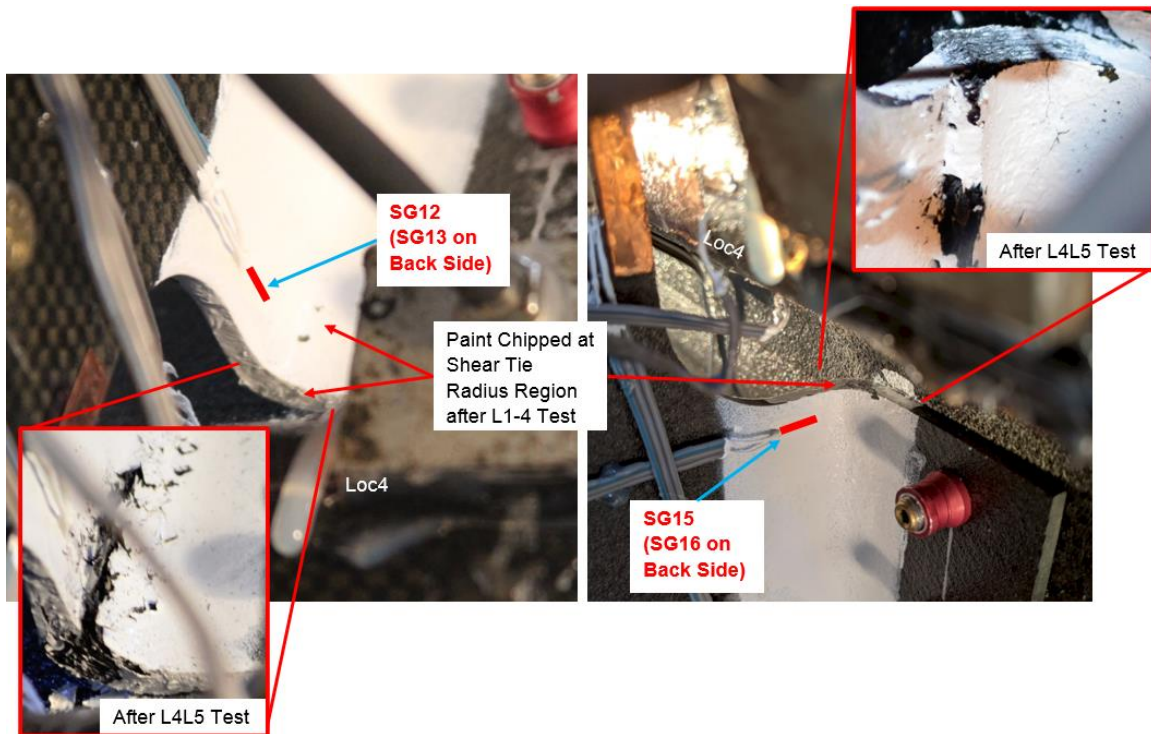
For Loc4-1 tests, the paint chipping point from the radius region was not clearly captured by the video record, but after Loc4-1\_L1-4 test, through the visual inspection, the paint chipping was observed at the radius region of the lower and upper side of Loc4 mouse hole as shown in Figure 3.45. For the Loc4-2\_L6 test, this initial damage mode was assessed with the video record, capturing the paint chipping at Loc4 upper mouse hole section. Figure 3.45 shows additional close-up view after Loc4-1\_L4L5 test capturing shear tie radius delamination and fiber crushing damage by the direct compressive load from the bumper.

**Figure 3.45: Paint chipping and delamination at shear tie radius region at upper (Left) and lower (Right) side of Loc4 mouse hole after Loc4-1\_L1-4 with close-up view after Loc4-1\_L4L5.**

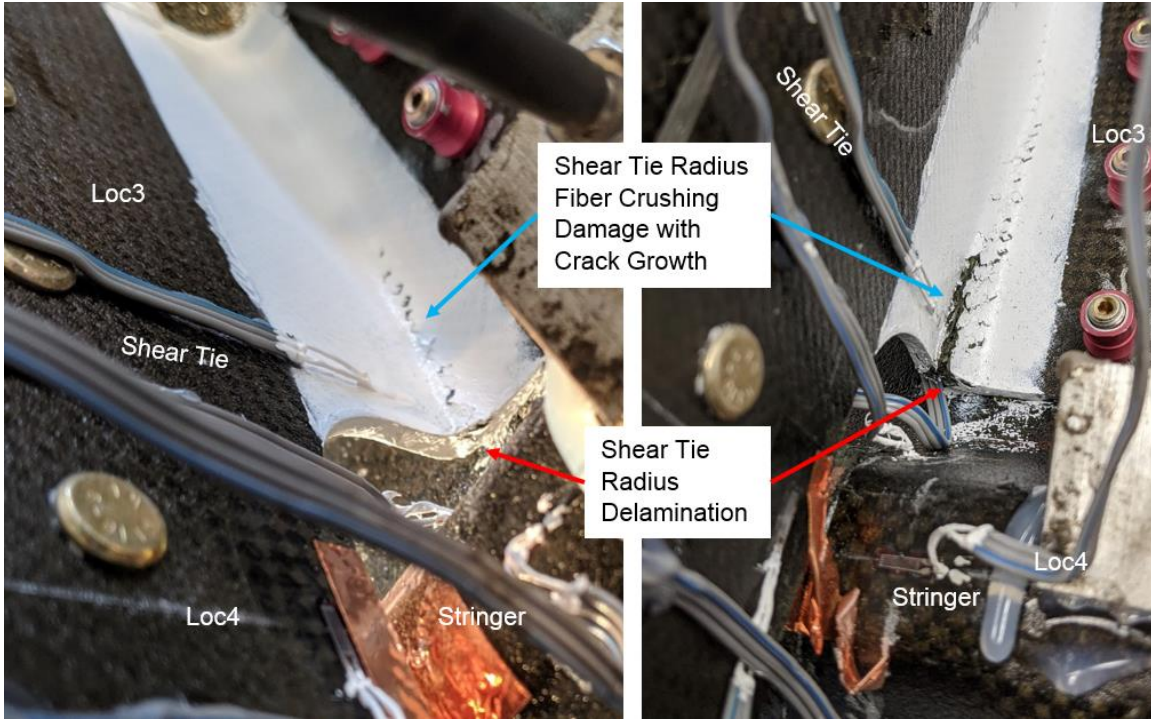
In Figure 3.48, after Loc4-1\_L2L3 and L4L5 tests, based on visual inspection, the shear tie radius delamination and fiber crushing damage are captured along the shear tie radius region showing crack growth due to the increasing direct compressive load from the bumper at Loc4.

**Figure 3.48: Shear tie radius delamination and fiber crushing damage with crack growth after Loc4-1\_L2L3 (Left) and L4L5 (Right) test.**

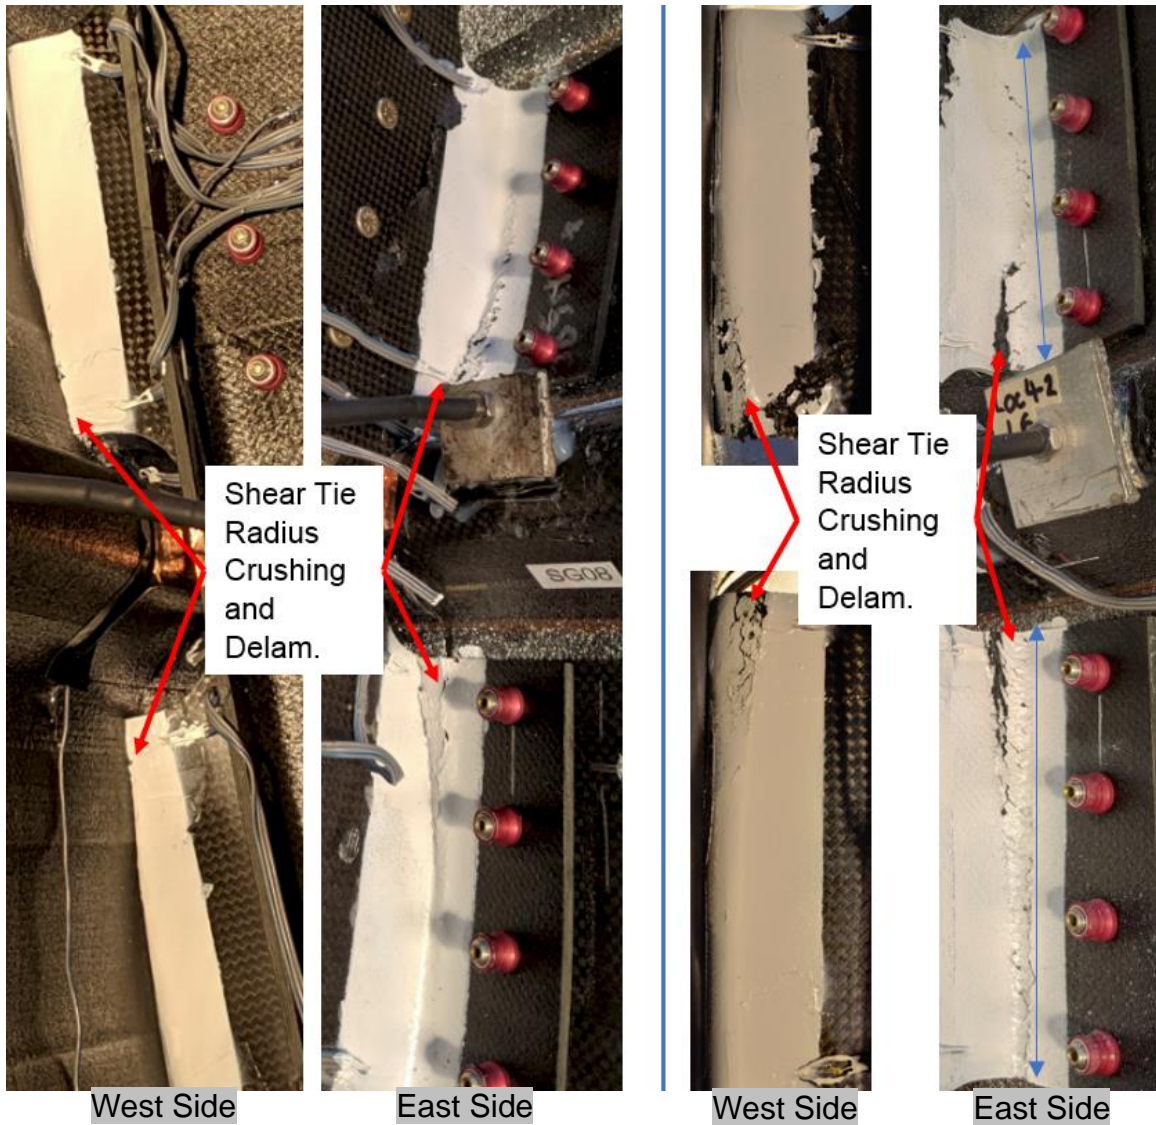
In Figure 3.49, the shear tie radius crushing was captured at the maximum load in Loc4-1\_L4L5, and after Loc4-2\_L6 test as well. During Loc4-1\_L2L3 and Loc4-2\_L6 loading, the crack growth initiated from Loc4 shear tie radius section and grew upward and downward along the shear tie radius region, as observed by the video examination.

**Figure 3.49: Shear tie radius delamination and fiber crushing damage with crack growth at maximum load of Loc4-1\_L4L5 (Left) and after Loc4-2\_L6 (Right) test.**

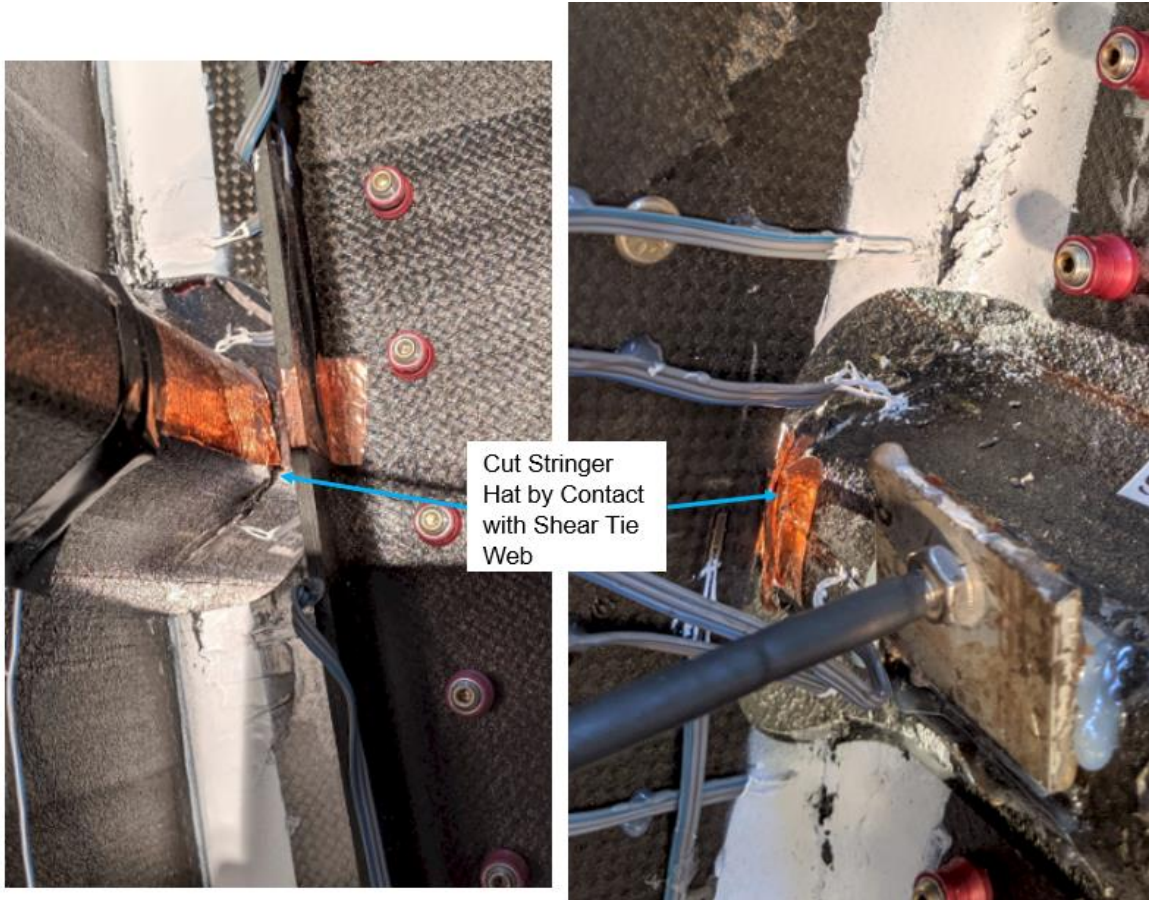
**Figure 3.56: Stringer cut by the shear tie web contact after Loc4-1\_L4L5.**

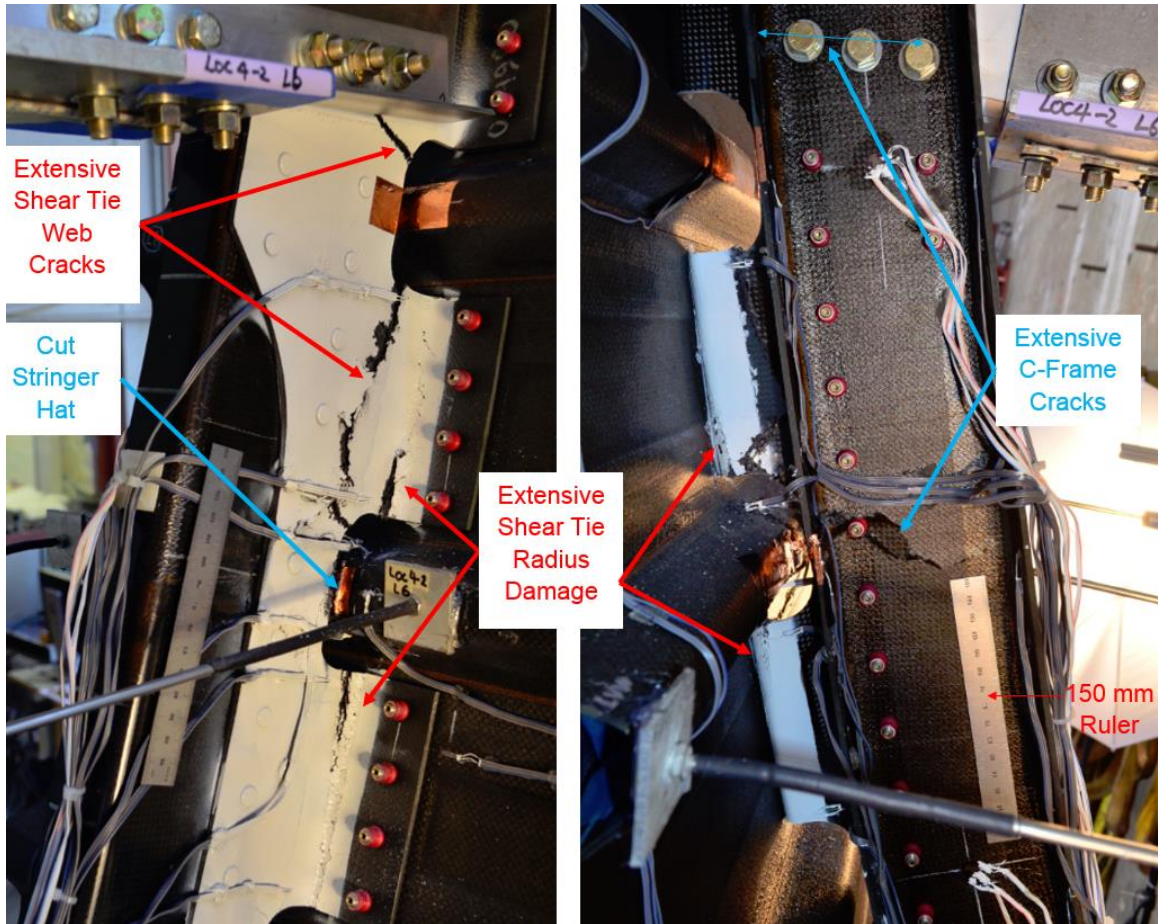
**Figure 3.59: Extensive shear tie, stringer, and C-frame damage after Loc4-2\_L6 test.**

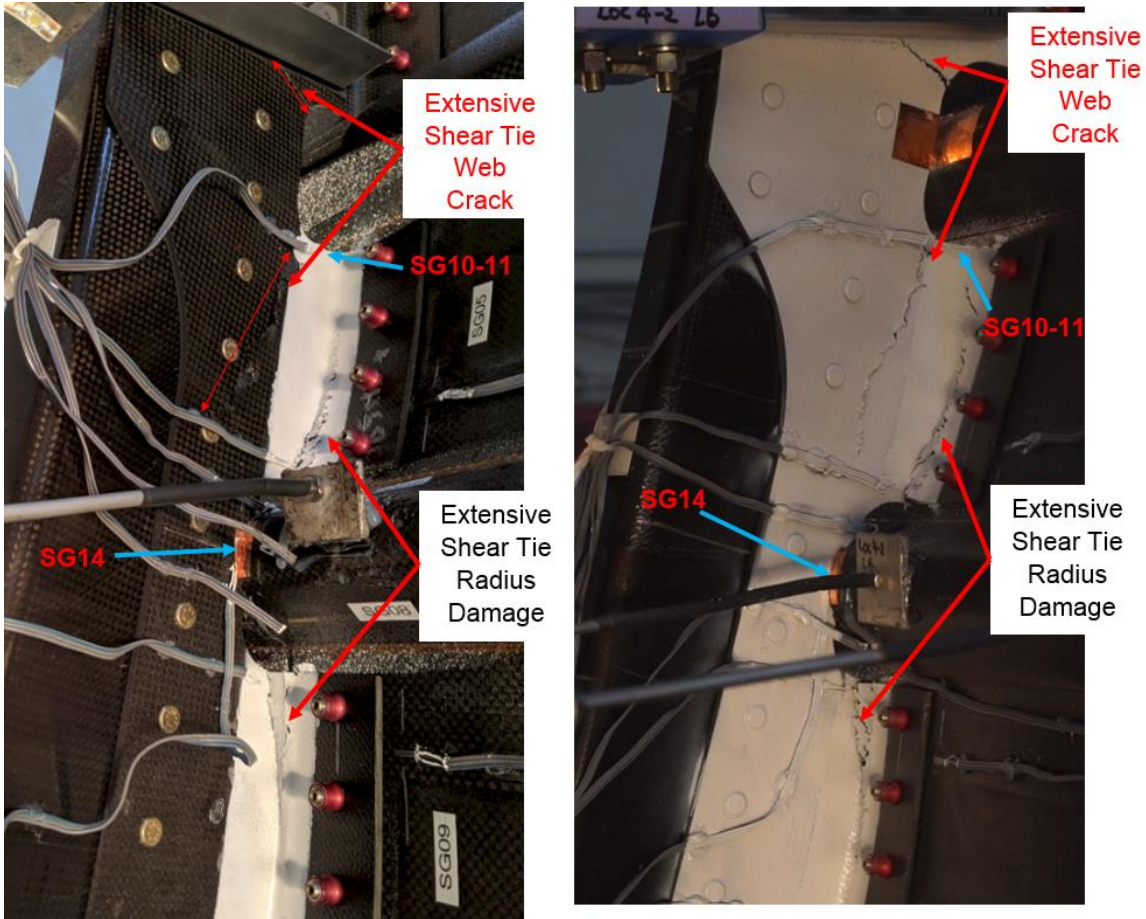
**Figure 3.60: Extensive shear tie damage at maximum load in Loc4-1\_L4L5 test (Left) and in Loc4-2L6 test (Right).**

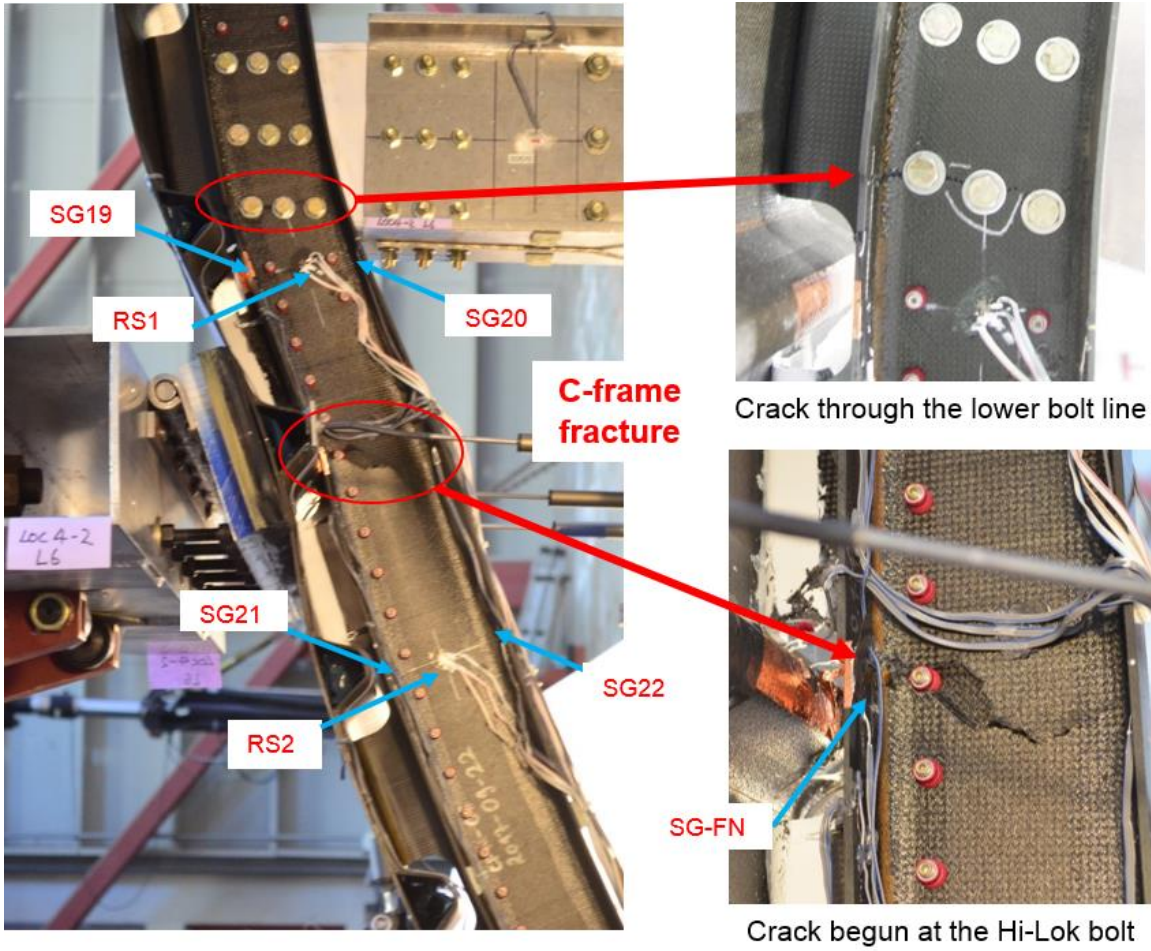
Figure 3.64: C-frame fracture at Loc4 and floor joint at maximum stroke in Loc4-2\_L6.

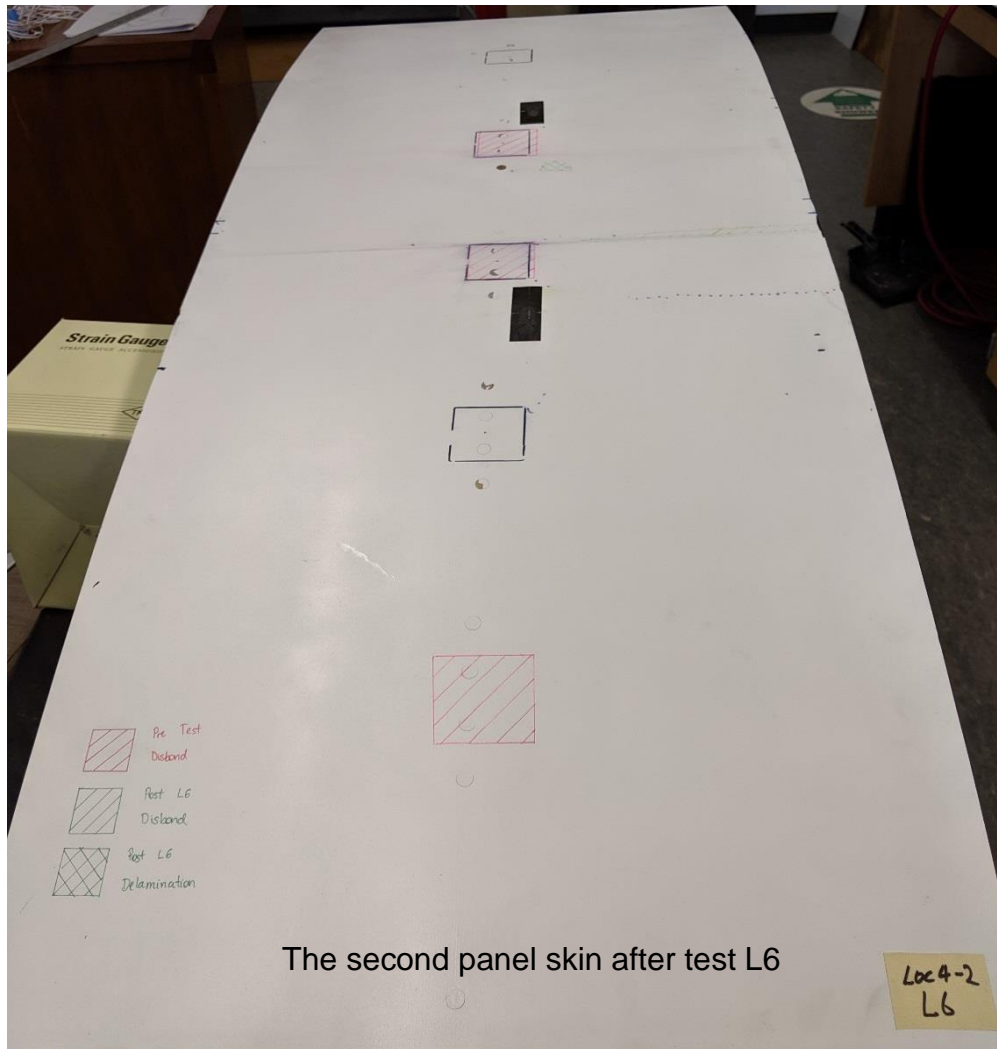
**Figure 3.70: No obvious external damage sign on skin (red hatched areas are pre-existing shim-to-skin disbanding from non-destructive testing).**

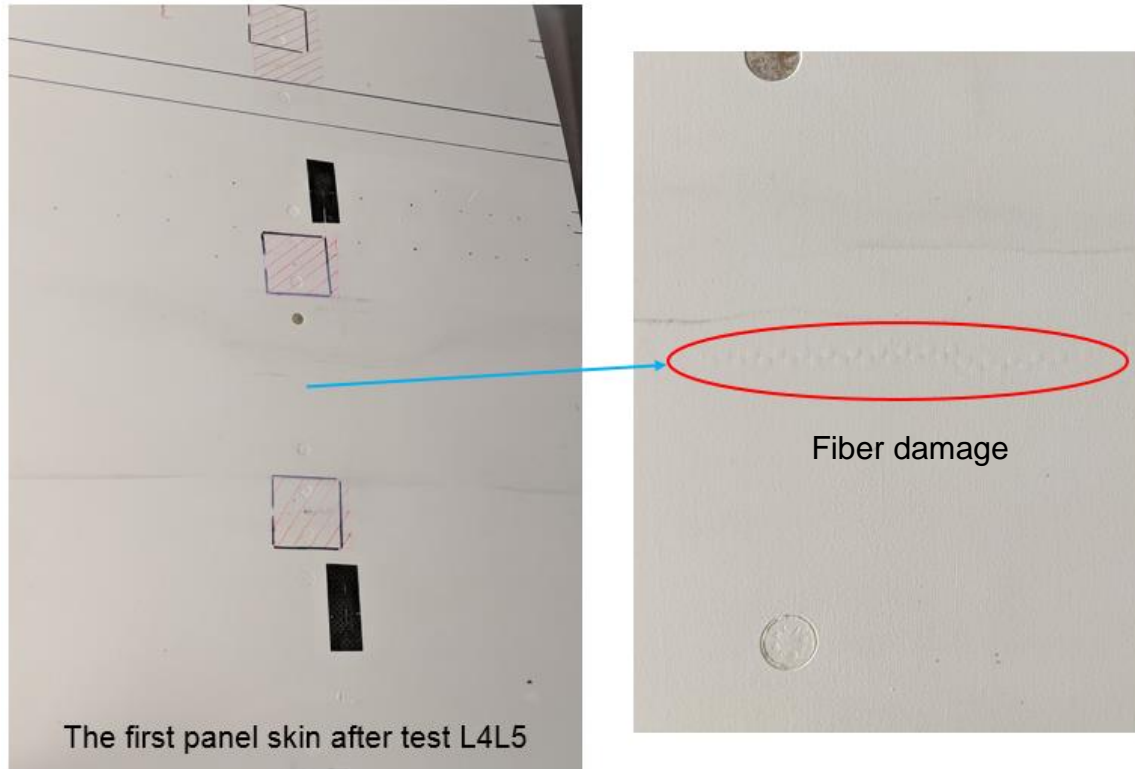
**Figure 3.71: Barely visible skin crack observed at Loc4 in the first panel.**

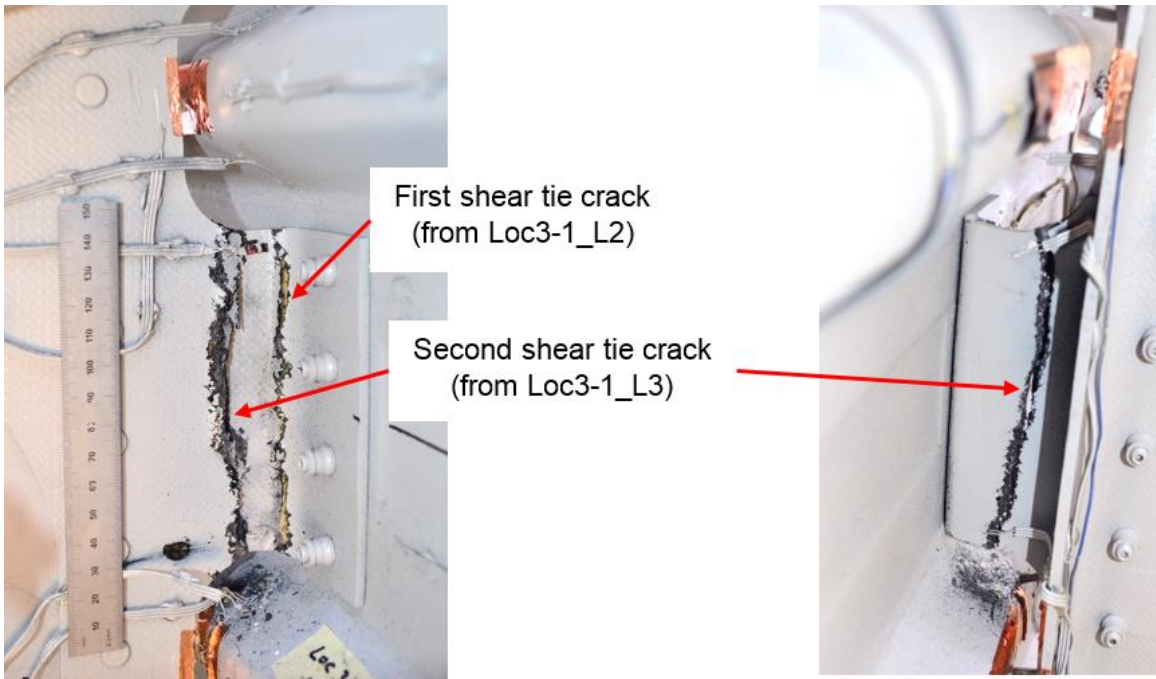
**Figure 3.87: The second crack on shear tie web after Loc3-1\_L3.**

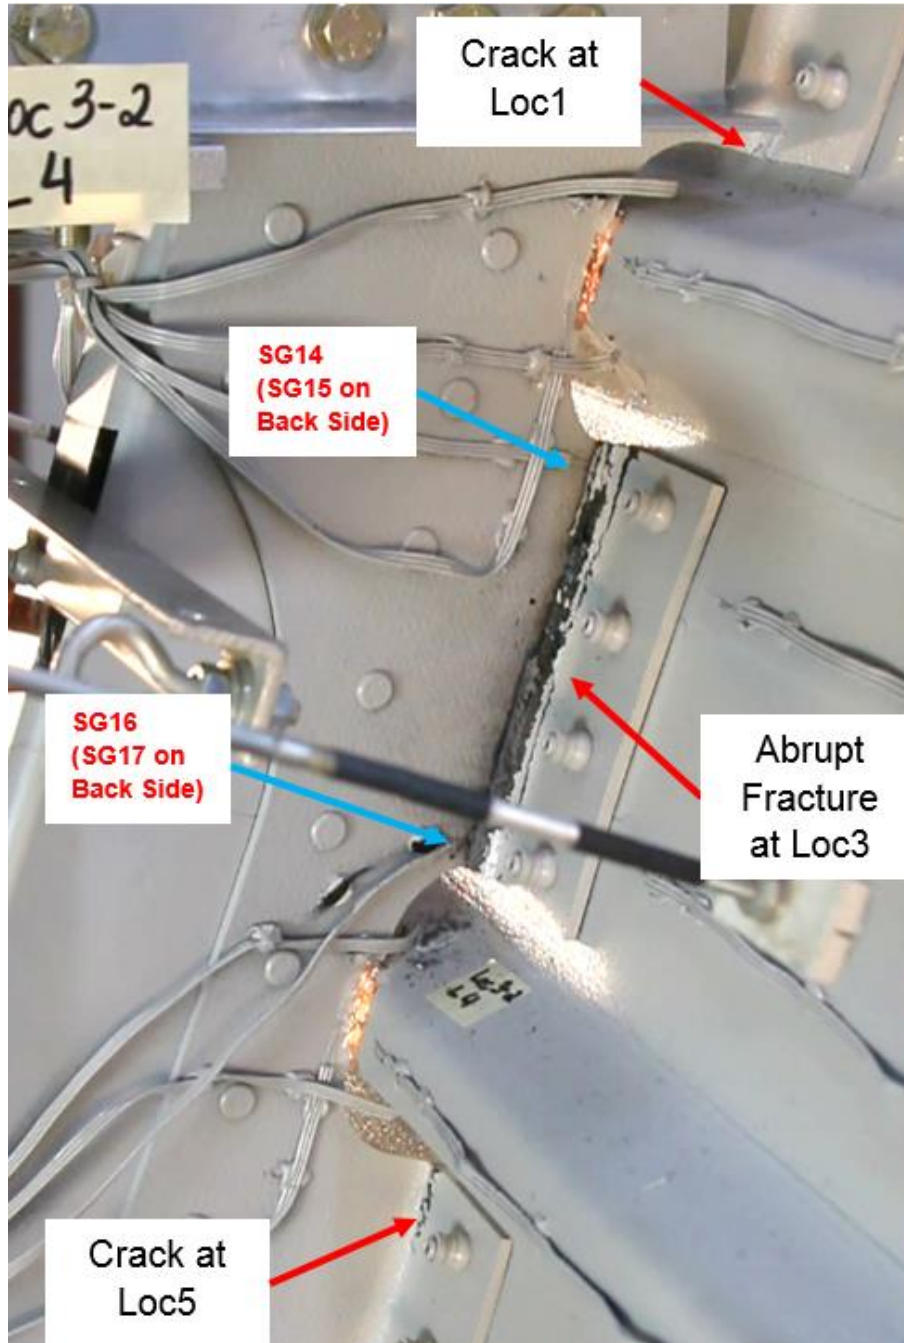
**Figure 3.92: Complete fracture along the shear tie radius during Loc3-2\_L4 test.**

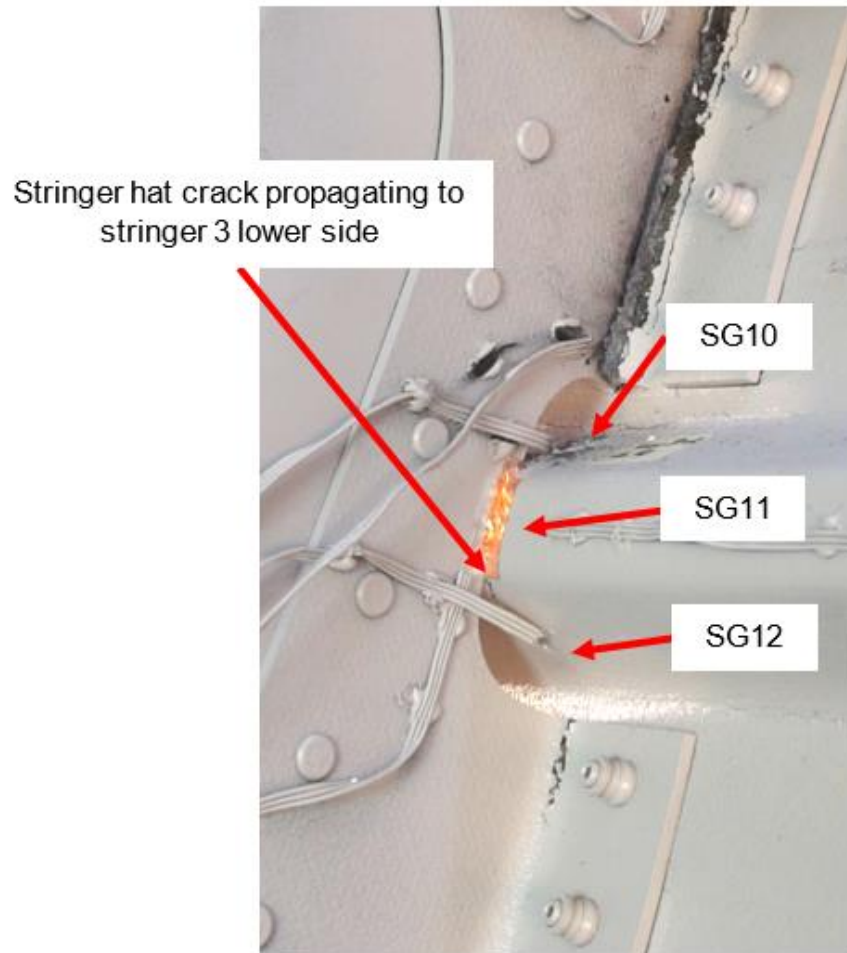
**Figure 3.94: Stringer hat cut at Loc4 by shear tie penetration.**

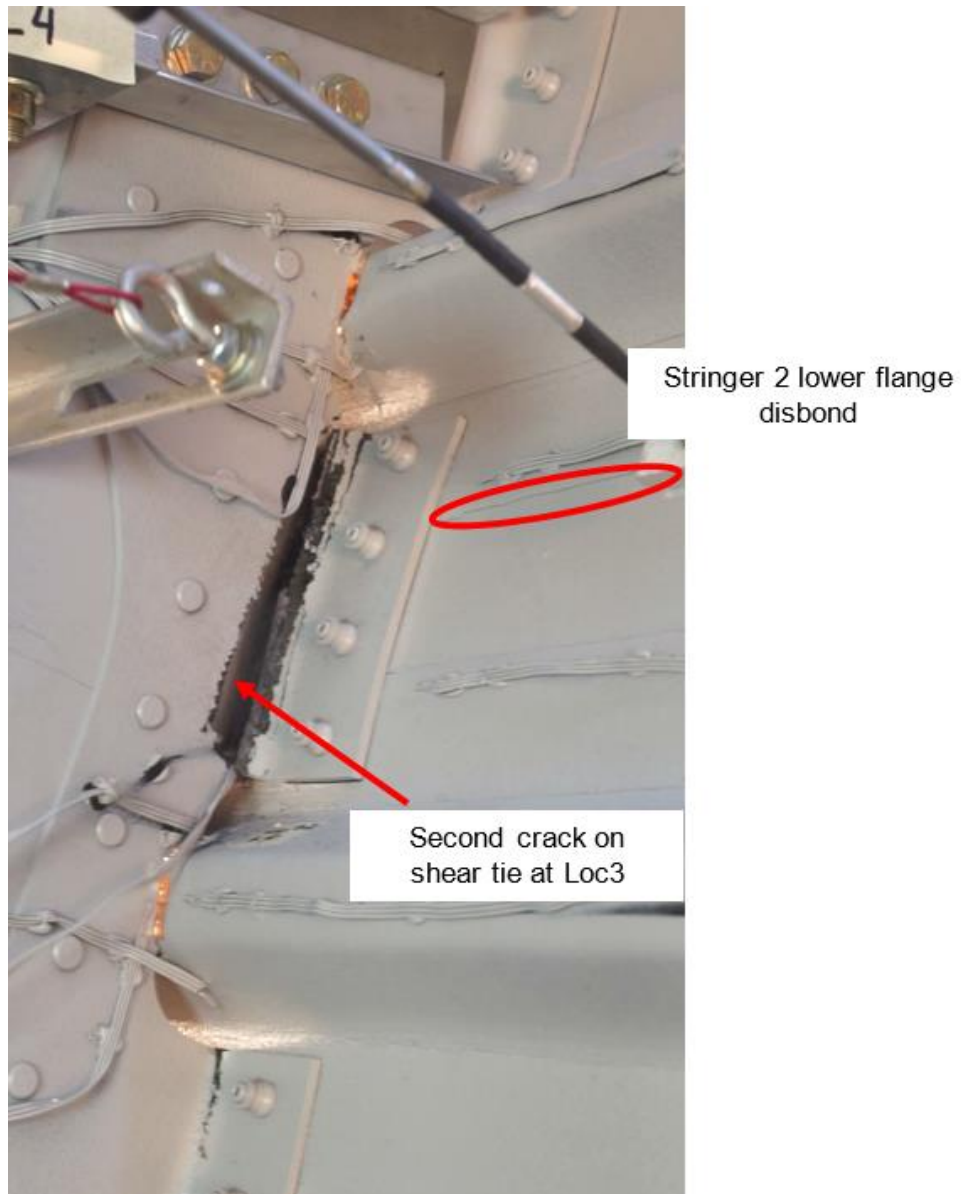
**Figure 3.96: Second fracture on shear tie web due to buckling by eccentric compressive load during Loc3-2\_L4 test.**

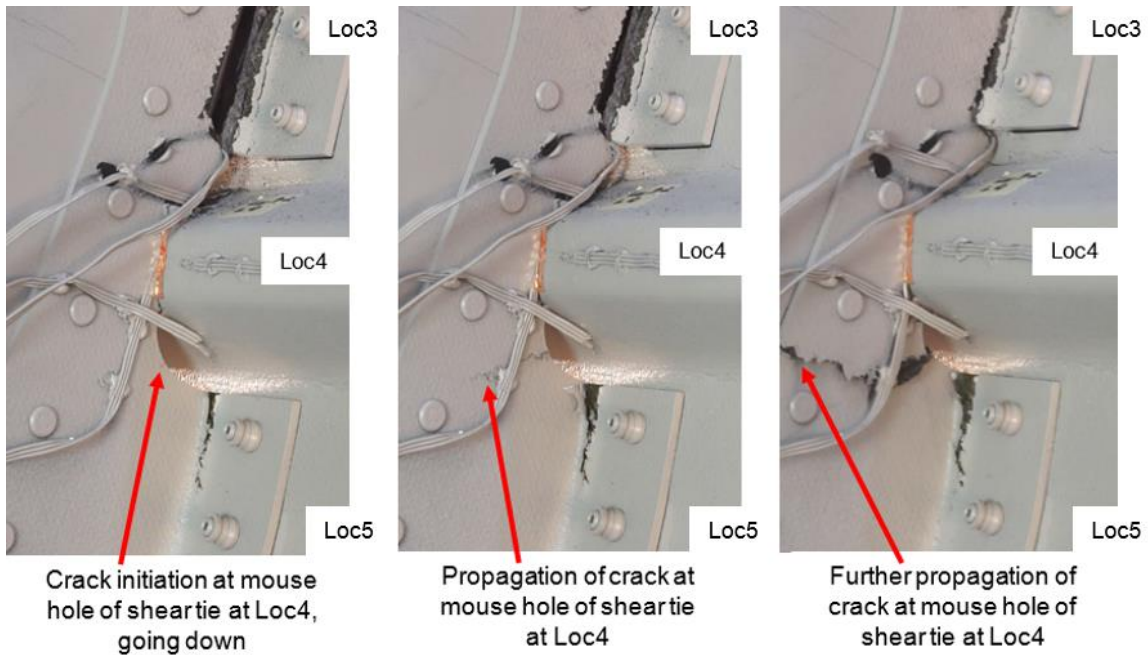
**Figure 3.97: Shear tie crack propagation and stringer cut at Loc4 mouse hole.**

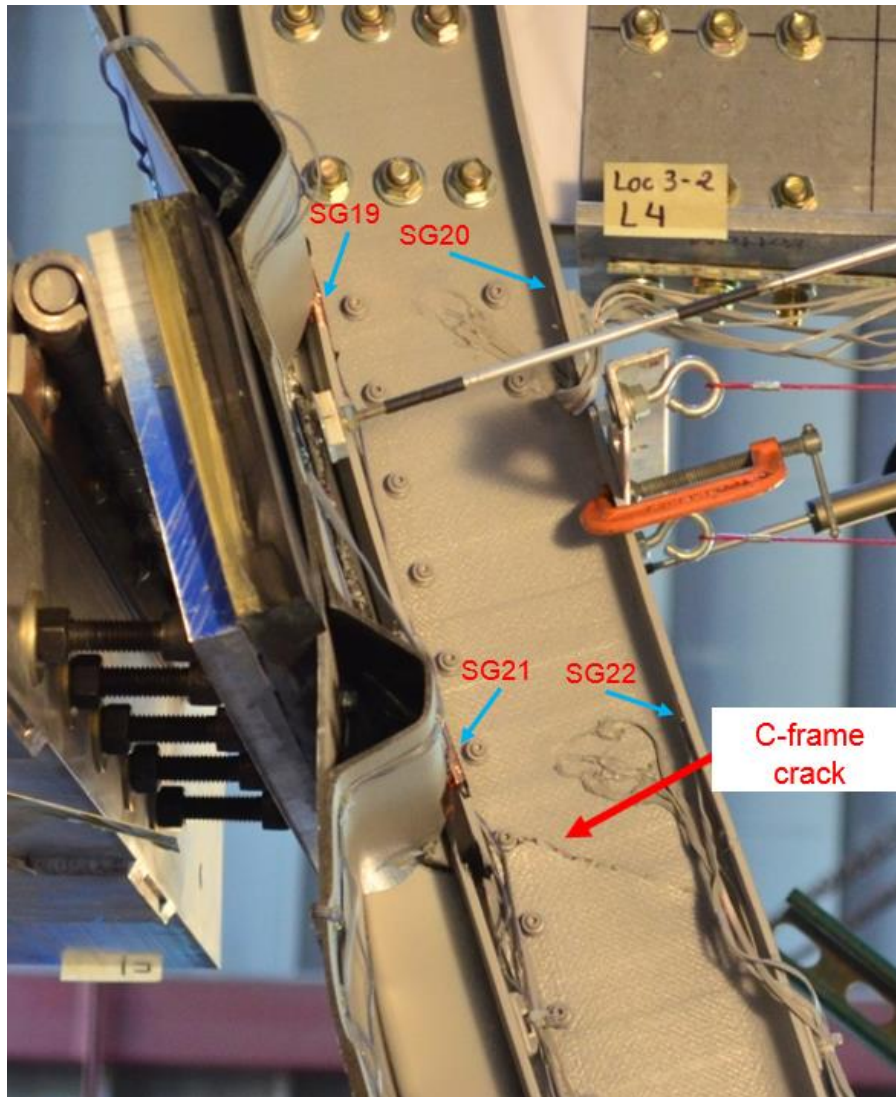
**Figure 3.98: C-frame crack at Loc4 under combined shear and bolt pulling state.**

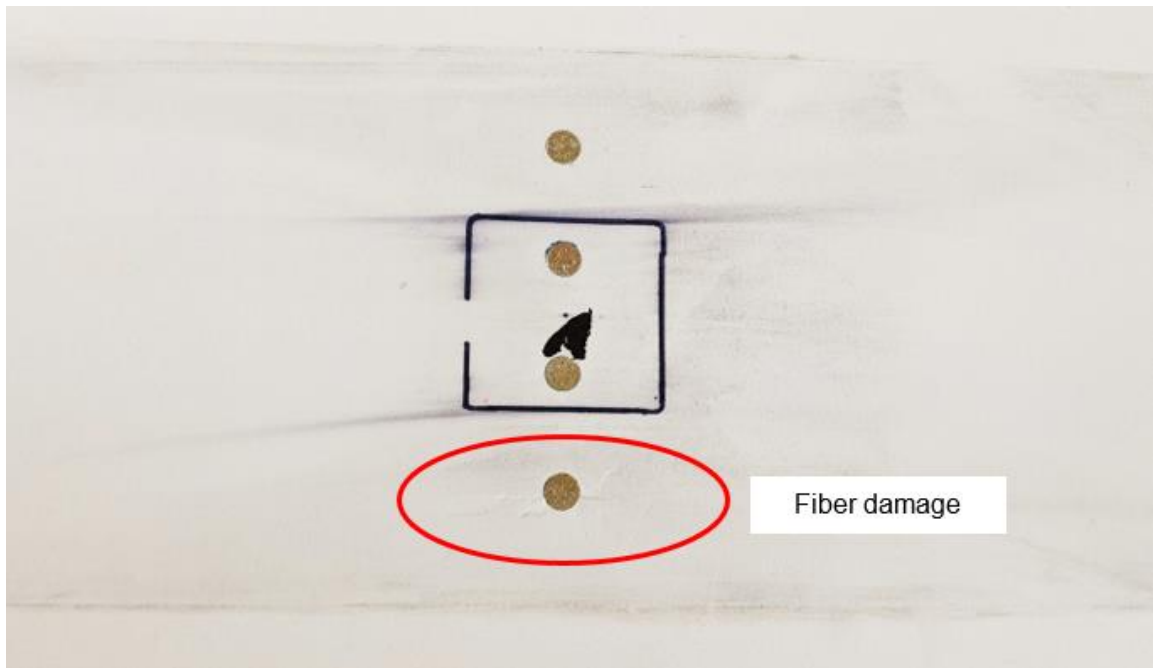
**Figure 3.101: Barely visible skin crack at skin bolt after Loc3-2 test.**

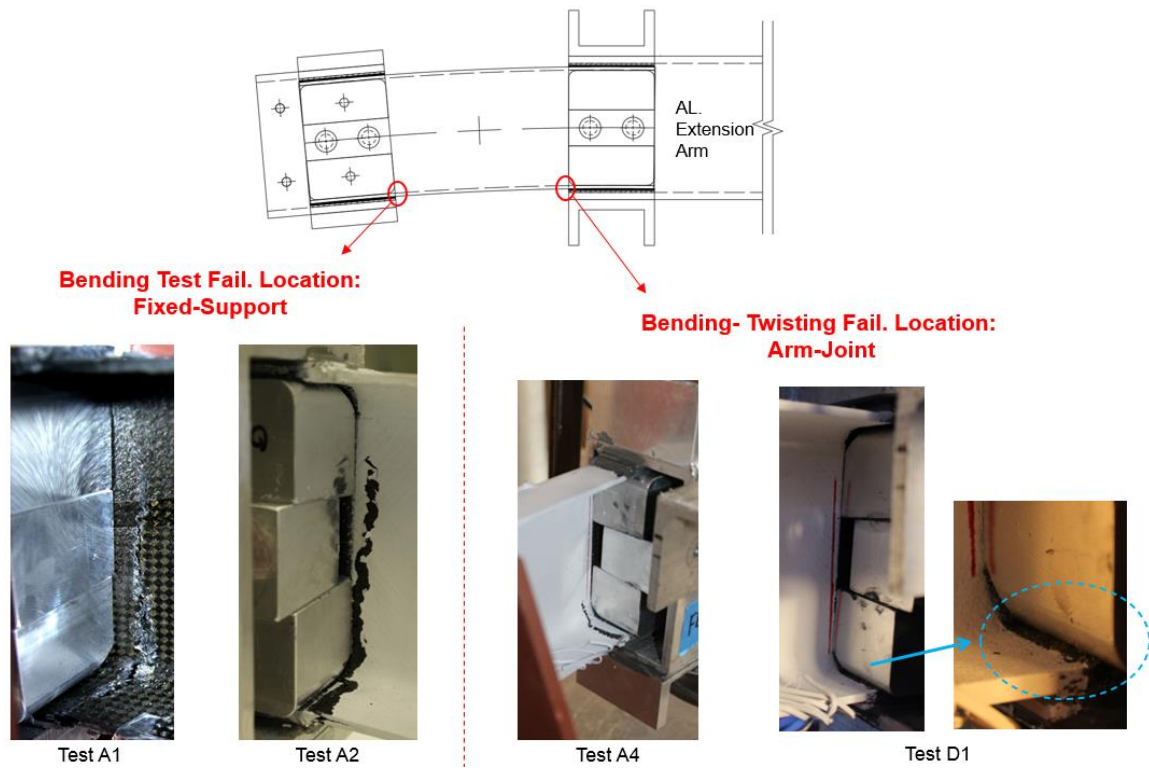
**Figure 4.9: Compression flange fracture with fiber failure.**

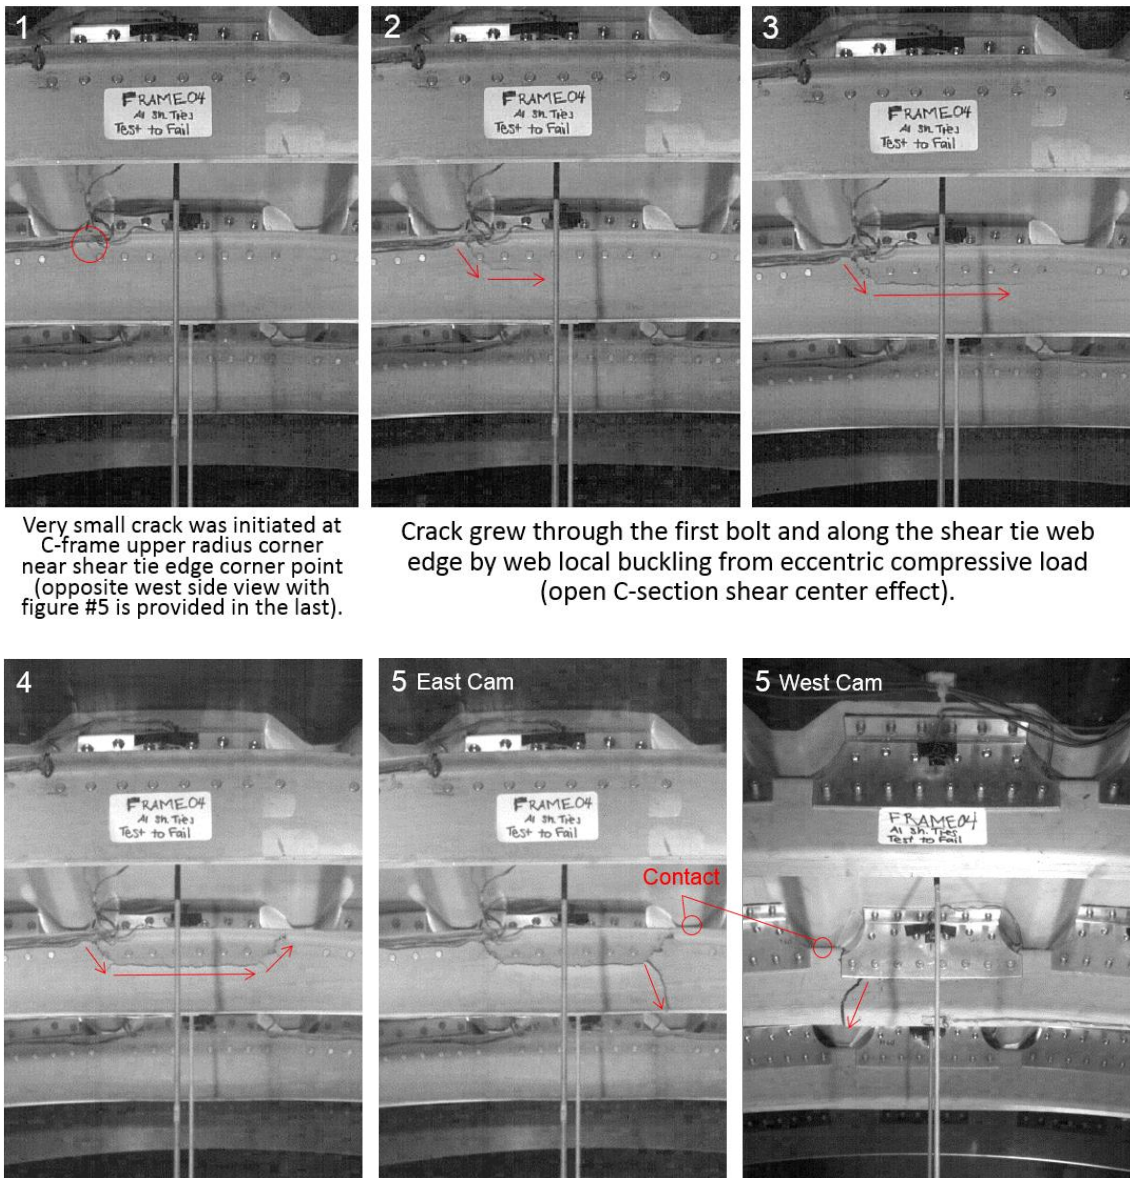
Very small crack was initiated at C-frame upper radius corner near shear tie edge corner point (opposite west side view with figure #5 is provided in the last).
