Towards a Stable Future: A Design Proposal for Cerrito Creek in Blake Garden, Kensington, California

UC Berkeley Dept. Landscape Architecture  
& Environmental Planning

LA 227/Spring 2010

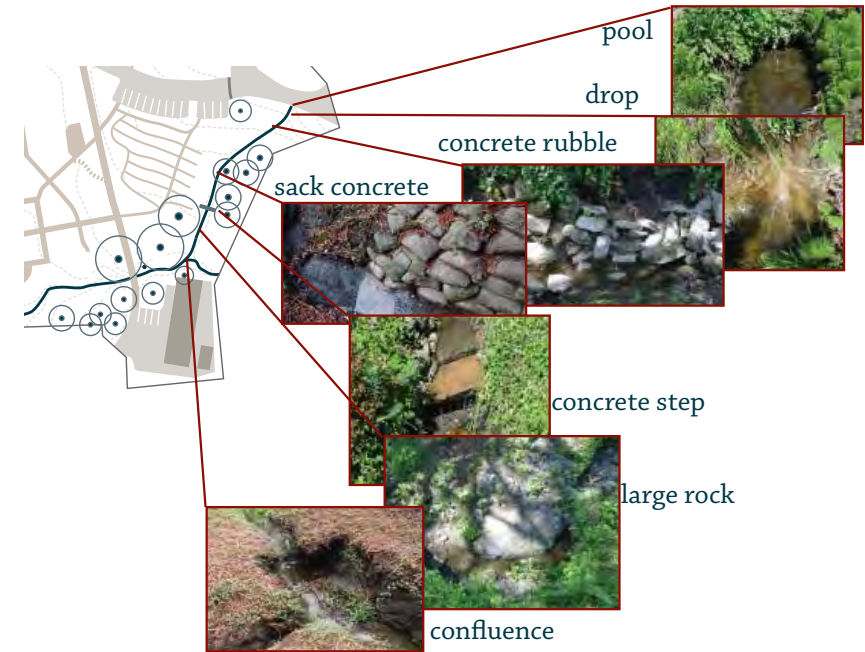
Fig 6: Channel Conditions

As a result, this reach of Cerrito Creek is currently in poor physical shape, and though little information is available about its condition prior to 2007, there is ample evidence that it has been incising for many years: the channel is littered with crumbling sack concrete walls and weirs from previous attempts at stabilization (Fig 6, 8).

In the last year since the stream has been exposed, Podolak and Twitchell agree that the channel has eroded substantially, and several locations noticeably downcut (Fig 8). As manager, Twitchell noted steep banks and bank failure is a growing concern for the safety of visitors to the garden.

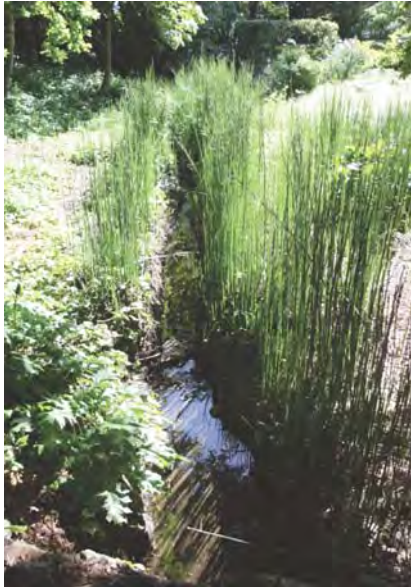
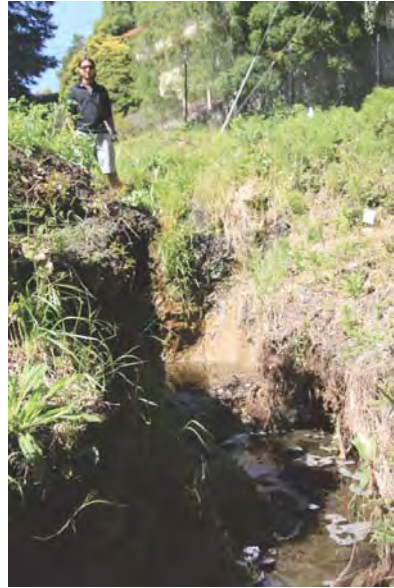
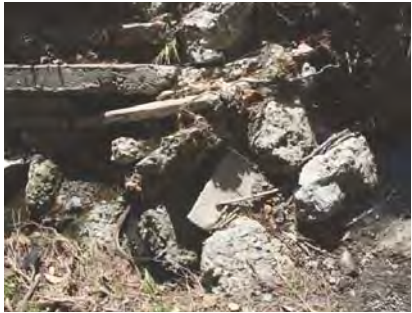
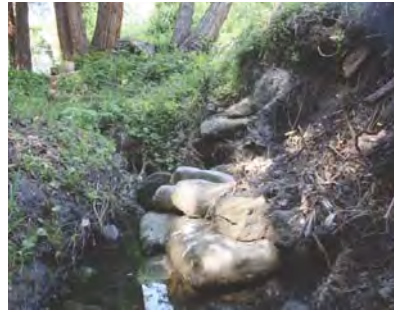
Fig 8: Project Site & Degraded Channel

Field observations of the North Branch indicate long-term and ongoing channel instability. Scouring, headcuts, bank failure, undercutting and incision dominate this reach of the creek. There is a headcut six feet in height just 32 feet downstream from the culverted stormdrain that is the upstream extent of our site. In several locations banks are steep, undercut, and collapsing in on the channel (Fig 16, 18). At one location, unstable banks are causing a Blackwood Acacia to lean across the channel (Fig 7). We measured a 2.5 foot undercut at one location. The channel is intermittently walled with stone and concrete rubble, some of which has already collapsed while the remaining walls are

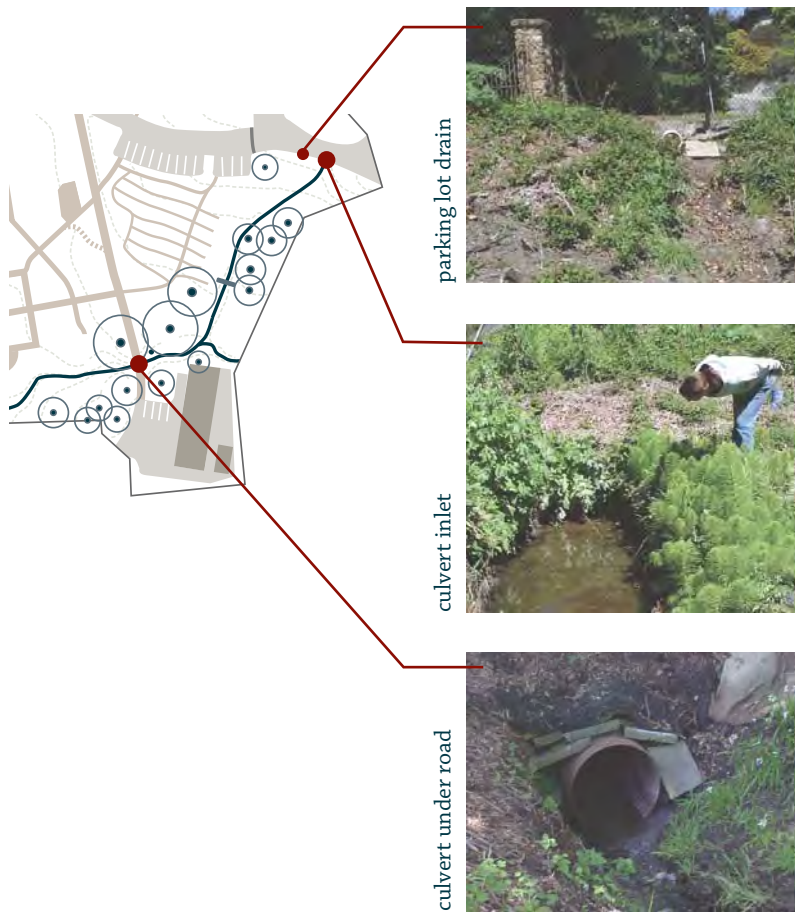
Fig 10: Culverts

When the creek was fully exposed, Twitchell observed that the stormdrain culvert at the upstream extent of the site was clogged with sediment, and water did not flow in a defined direction. She observed that during rain events, water flowed into a depressed wet area adjacent to the Blake property, and expressed concern about water leaving the Blake property. This was mitigated by digging out the deteriorating culvert, excavating a more defined channel, and regrading around the inlet. The excavated sediment was piled along the bank to create a berm, with the goal of preventing water from flowing towards the neighbor's property. These efforts were not sufficient to arrest all flow onto the neighboring property during high water events, though it still forms a berm at the edge of the channel.

There are two culverts on our site (Fig 10). The first conveys stormwater from the residential neighborhoods above the site under the main entry road and into the garden at the upstream extent of our site; this is where the North Branch starts. This culvert is grossly undersized at 16" in diameter, structurally unsound, and visibly rusted through on the bottom six feet of the pipe. Water enters the garden underneath this culvert, indicating that it has holes and is undersized. At the base of this culvert is a large pool, followed by a 6' headcut (described below). The second culvert is 30" in diameter, and conveys the stream underneath a gravel road that connects the greenhouse to the main entry of the garden. This culvert acts as a grade control point, indicated by the stable channel bed extending 50 feet upstream from the culvert with a slope of 2.5% and little evidence of incision. Similarly, for 40 feet downstream from this culvert the bed has a slope of 1.6% and appears stable until it reaches the first in a series of smaller headcuts migrating upstream. While the removal of this downstream culvert would certainly benefit the creek in terms of reestablishing longitudinal connectivity, such an intervention would have to be balanced with the removal of what is now in practical terms a very stable grade control.

*Culverts:* The culvert located upstream, where the North Branch enters the site (Reach 1) is undersized, shows extensive damage, and poses a threat to the road above. We recommended replacement in the near future. As mentioned before, the headcut immediately downstream should be stabilized in the near future, as it threatens to undermine the culvert and road.

The culvert under the bridge, between reaches 4 and 5, was identified in the modeling as acting presently as a dam in large storm events. The pipe is under-dimensioned, and peak flows back up behind the culvert. The culvert serves as a grade control, stabilizing the channel upstream. Therefore, removal of the culvert replacing it with a bridge must be preceded by widening and stabilizing the channel, in reaches 4 and, especially, 5 and 6. Removing the artificial constriction caused by the culvert would drastically increase the in-channel peak flow downstream. Therefore, while replacing the culvert with a bridge is desirable, the reaches below the culvert should be carefully designed to withstand increased peak flows and restored before the culvert's removal.

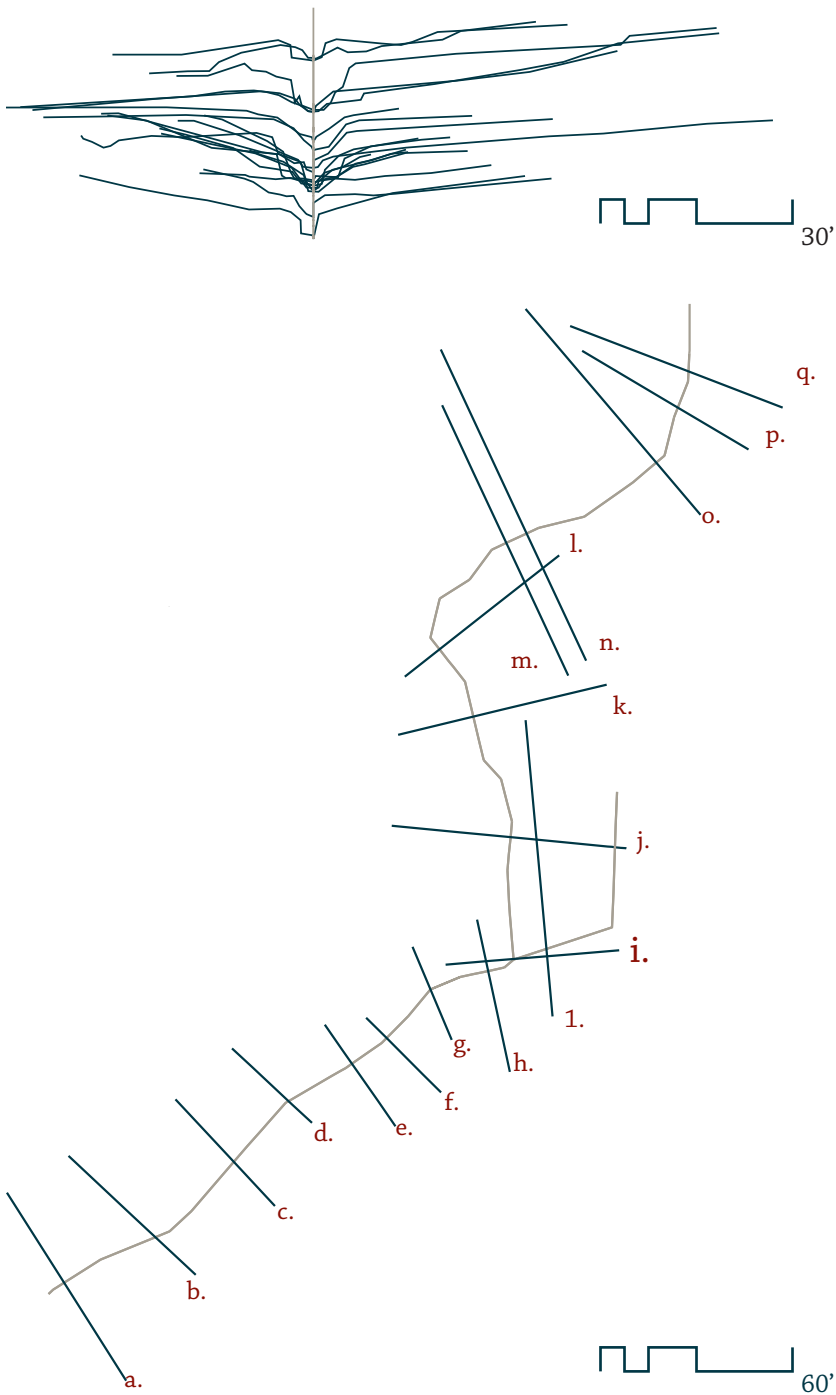
Fig 12: cross sections / april 2010

**Cross Sections:** We surveyed a total of eighteen cross sections illustrating the changing channel morphology (Fig 14). Cross sections N and M depict a stable channel (Fig 17); section N has a channel and small floodplain. Section M is beginning to experience incision and shows a rubble wall on one side constricting the channel (Fig 17). Cross section O demonstrates the most dramatic pool and scouring along the stream banks, below the largest head cut in our survey area (Fig 16). Cross sections J and H demonstrate incision on the North Branch compared to the stable channel on the South Branch (Cross-section 1). The most dramatic undercutting and bank failure occurs at cross section H where both sides of the channel are undercut, one at .75ft and the other at 1.6ft (Fig 18).

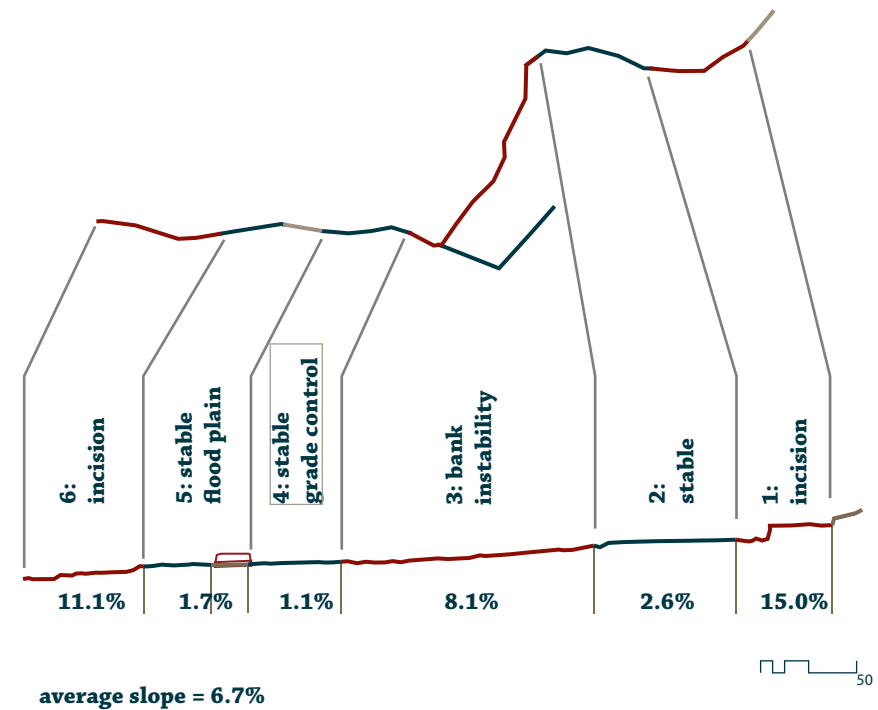
Fig 15: reaches by dominant processes and slope

*Long Profile:* Our survey found that the average slope of the South Branch is 5.7% , and the average slope of the North Branch is 7.1%. The total surveyed reaches have an average slope of 6.7%. (Fig 15)

The channel slope from the upstream culvert where the North Branch enters Blake Garden to the downstream end of our long profile has six different reaches with distinct channel processes and slopes (Fig 15). Reach 1 begins at the culvert

at cross section Q and stretches to cross section O and has an average slope of 20%. Here water enters into a pool from the culvert and then heads down a drop of 8 ft to a second pool (Fig 16). This section is actively incising and threatens to cut back to the culvert outlet just below the road. Reach 2 extends from sections O to M, has a slope of 0.08%, and appears stable (Fig 17). Reach 3, between L to I (confluence) has a slope of 6%. Here the creek is deeply incised from past down-cutting and the banks are much less stable. Further downstream, there is increased undercutting and bank failure. The stream bed appears relatively stable, perhaps because of the more resistant bed material, and side-cutting is the dominant process here (FIGURE 21). We delimit Reach 4 of the long profile from the confluence to the culvert crossing (sections H to E). Here the culvert is acting as a grade control structure, and the average slope is predictably low at 0.08% (image). Reach 5, from the bottom of the culvert to immediately downstream from section C, is stable and still maintains the lateral connectivity to a floodplain, in high flows, with an average slope of 1.6%. Reach 6, from there to the downstream end of our long profile (sections B and A), is much steeper (11.1%). There are active head cuts moving upstream toward the culvert.

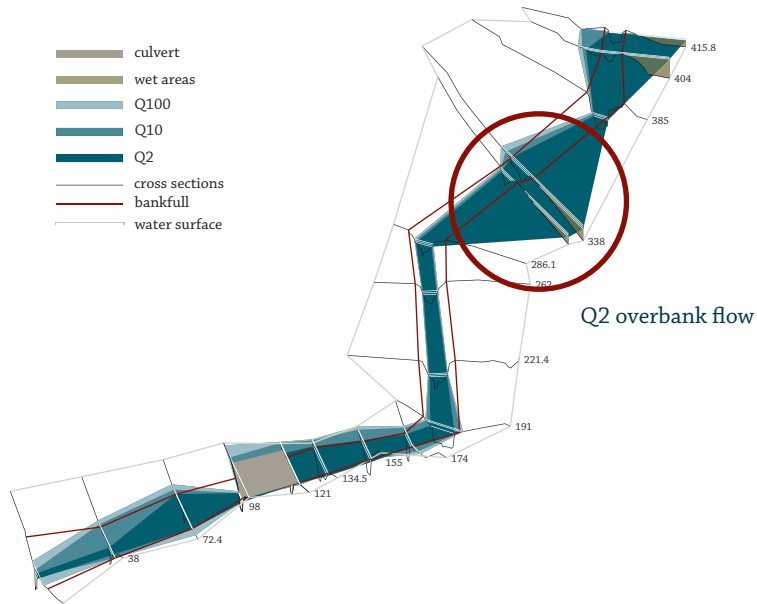
Fig 24: HEC-RAS model of current flow conditions

area from past events, as well as new mounds of soil and sandbags situated to arrest overbank flow. We believe that the overbank flow into the adjacent wet ponding area served a critical role in maintaining the integrity of the channel by detaining water and releasing it slowly back into the system, effectively reducing peak flows following intense rain events (Fig 27). Given the very small lag time for the watershed above the garden, even a few minutes of ponding and spill over would have a very significant effect in reducing peak in-channel flow. The HEC-RAS model backs up our field observations. Based on our hydrologic calculations and field survey, this model indicates that overbank flow occurs in that same reach of the creek during the Q2 storm event, and demonstrates wet areas of low flow adjacent to the channel towards the detention area. That the HEC-RAS model reflects field observations and firsthand accounts is a good indication that our hydrology calculations and field data are somewhat accurate (Fig 24).

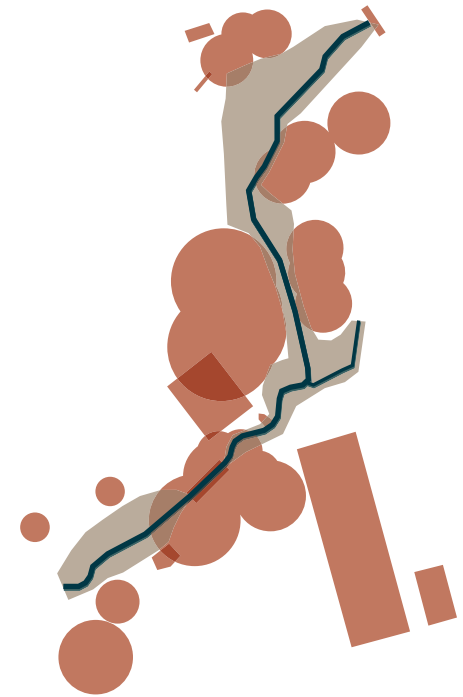
Fig 28: Constraints & Opportunities

Keeping in mind our goal to propose structural and nonstructural interventions, we observed constraints and opportunities. Several areas of the creek were bare on one or both sides, with neither roads, culverts, buildings nor significant plants. These areas present the greatest opportunity for regarding a floodplain. In other areas, trees, roads and structures present constraints (Fig 28).

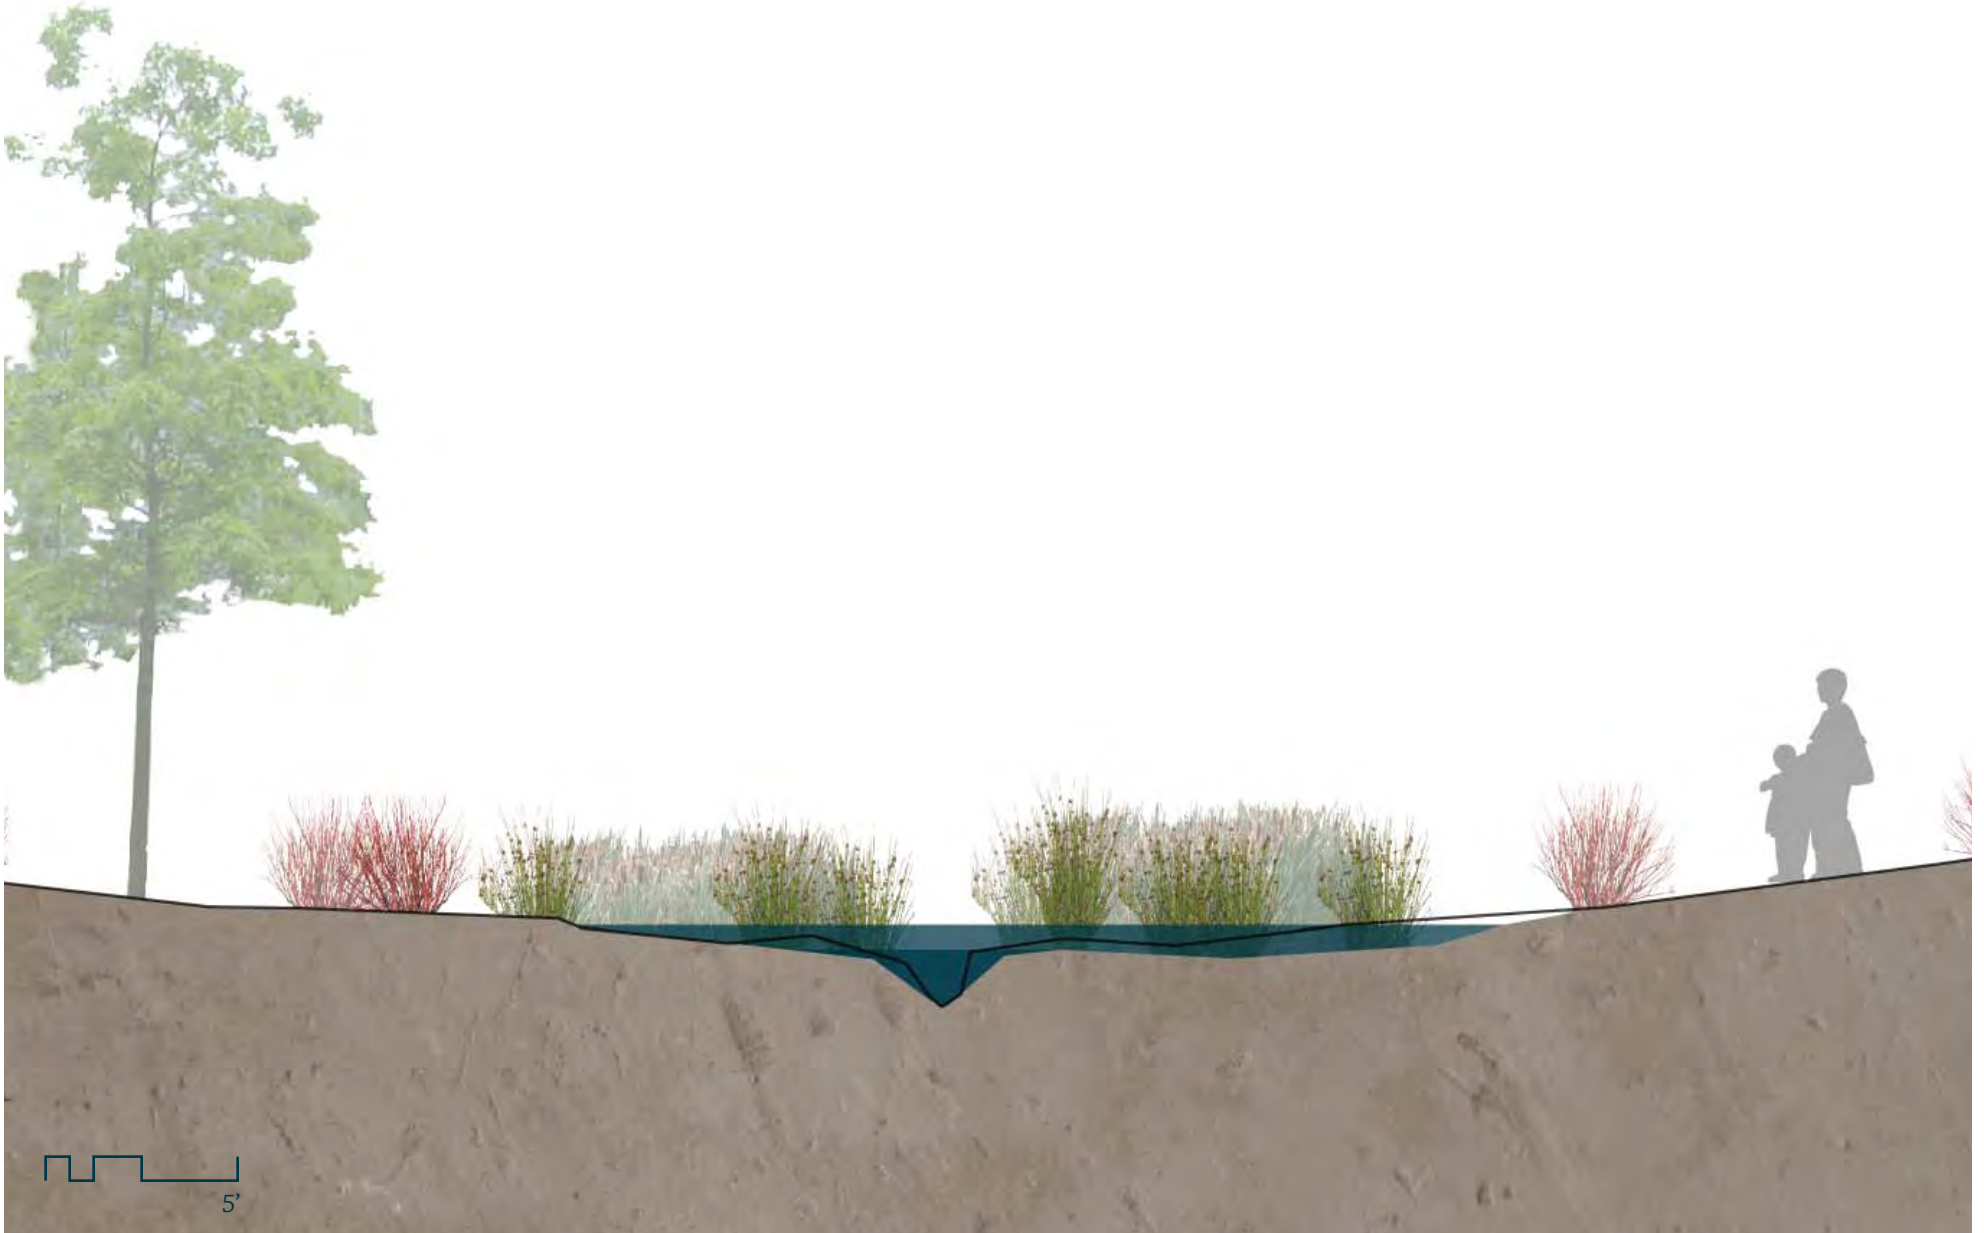
Fig 40: Engage Floodplain  
Section C (Reach 5)

A=19.41 sq ft  
Q=94.26 cfs  
V=4.86 fps

Below the culvert in Reach 5, the in-channel velocity appears slightly above the scouring limit, resulting in some incision and head-cutting. We recommend selecting a few points for one-foot step pools. In this area, there is an existing active floodplain, and we recommend regrading as necessary to maintain lateral connectivity. (Fig 40)
