Physical Damage to Rooftop Mechanical Equipment Considering Variations in Attachment Designs

# 13th National Conference on **EARTHQUAKE ENGINEERING** PORTLAND, OREGON | JULY 13-17, 2026

## **Physical Damage to Rooftop Mechanical Equipment Considering Variations in Attachment Designs**

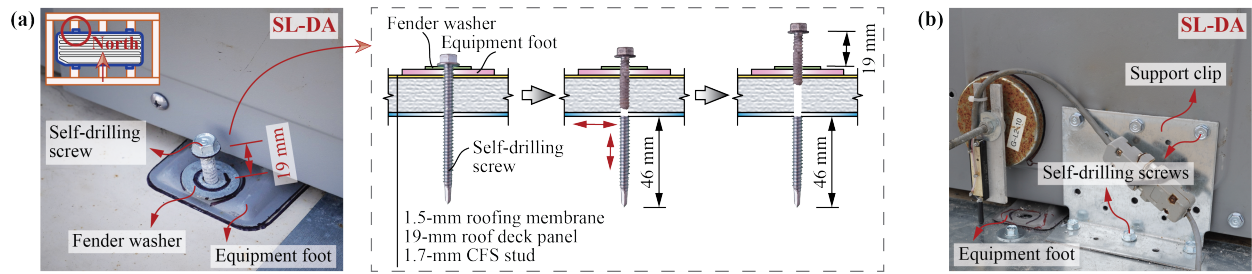
As a benchmark attachment design, a slender unit was directly secured at its four manufacturer-provided feet to the CFS studs of the roof curb using self-drilling screws, each with a thread length of 76.2 mm and a nominal shank major diameter of 6.2 mm. A fender washer measuring 6.4 mm in inner diameter, 25.4 mm in outer diameter, and 1.6 mm in thickness was placed between the screw head and the equipment feet to ensure proper tightening [8]. As shown in Fig. 2(a), attachment failure occurred during the first MCE<sub>R</sub> test, leaving a 19 mm protrusion of the screw at the northwest attachment point. The screw ruptured near the intersection with the CFS stud, leaving approximately two-thirds of its threaded length embedded in the stud. The three remaining attachment points maintained their integrity. Before the second MCE<sub>R</sub> test, to retrofit the damaged anchorage, a CFS support clip was installed near the original equipment foot and secured with six self-drilling screws, three on each leg (Fig. 2(b)). As shown in Fig. 3(a), a maximum uplift of 21.8 mm was recorded by a linear potentiometer installed 101.6 mm from the attachment failure point, occurring 8.3 sec after the initiation of ground motion from the shake table. This maximum uplift lagged by approximately 2 sec behind the peak acceleration response of the equipment (Fig. 3(b)).

As a conservative estimate, screw tensile demands were obtained using the measured peak component accelerations (PCAs) of 2.0 g (x-direction) and 3.4 g (y-direction) to calculate the maximum horizontal seismic force, taken as PCA multiplied by the equipment mass, 146.25 kg. The maximum resultant shear demand, corresponding to 3.9 g, was determined as the square root of sum of the squares of the x- and y-direction PCAs. Fig. 3(c) compares the calculated fastener demands with allowable strengths defined using a safety factor of 3.0. The code-based demand-to-capacity ratio was derived using ASCE/SEI 7-22 [9] Eq. (13.3-1), which defines the horizontal seismic force. Based on measured PCAs, the utilization of allowable strength was 32.9% in shear and 44.4% in tension. When considering the combined effects of shear and tension in screws using AISI S100-16 [10] Eq. (J4.5.3-1a), the summation of demand-to-capacity ratios for shear and tension is 0.77, which exceeds the limit of  $1.3/\Omega \approx 0.43$ . This indicates that screw thread rupture was likely caused by the combined action of shear and tension. However, material uncertainties may also have contributed to the attachment failure, since the above calculations were based on acceleration measured at the top of the equipment, which are expected to be higher than PCAs associated with the center of mass.

Figure 2. Physical damage to the SL-DA anchorage connection: (a) combined shear and tension failure (MID 17) and (b) anchorage retrofit (before MID 18). MID = Motion identification number.

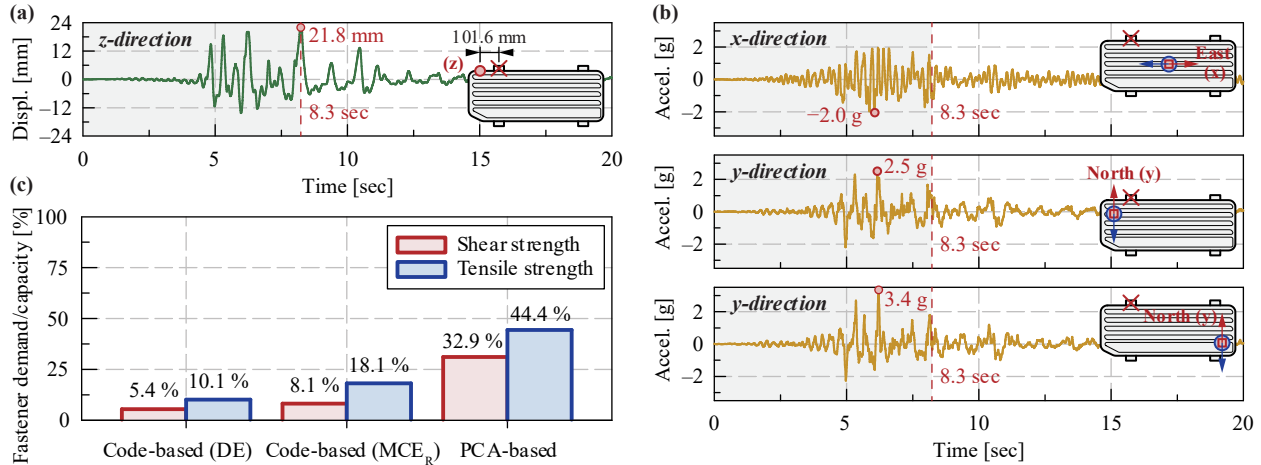
Figure 3. Inference of anchorage failure from measured response of the SL-DA: (a) vertical displacement time history measured near the failure location, (b) translational acceleration time history, and (c) fastener demand-to-capacity ratio.

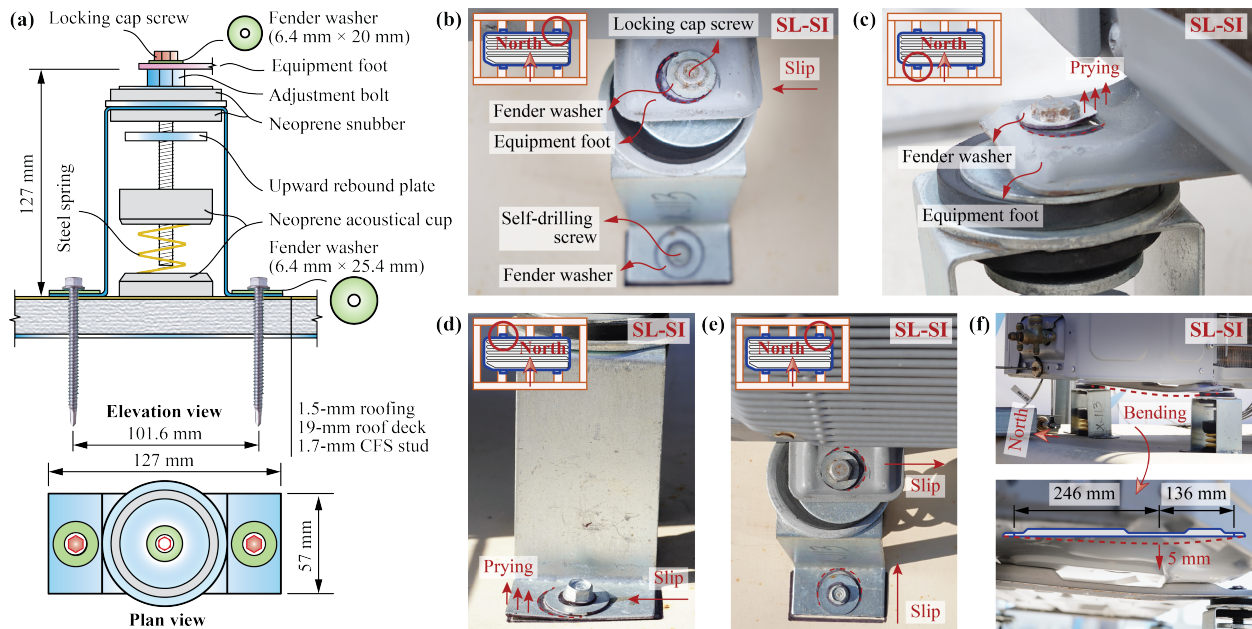
To modify base boundary condition of SL-DA, each equipment foot was supported by a spring isolator (Fig. 4(a)). The localized deformation of the SL-SI attachment observed after the first and the second MCE<sub>R</sub> tests is summarized in Fig. 4(b–f). Fig. 5(a) shows the acceleration response of the SL-SI under the first MCE<sub>R</sub> test. The PCAs were 3.5 g (x-direction) and 2.0 g (y-direction). The occurrence frequency of component acceleration responses was relatively evenly distributed across all directions, mostly within the range of 6% to 10%.

Figure 4. Physical damage to the SL-SI anchorage connection: (a) SL-SI anchorage design, (b) anchorage slip (MID 17), (c) washer prying (MID 17), (d) combined anchorage slip and washer prying (MID 18), (e) anchorage slip (MID 18), and (f) supporting rack bending (MID 18).

However, the plots of displacement response (Fig. 5(b)) indicate that the unit vibrated predominantly along the north–northeast (NNE) and south–southwest (SSW) directions. This behavior is attributed to the unit’s high slenderness ratio of 3.7 in the north–south direction (y-direction), which corresponds to its weak axis and makes it more prone to rocking. In addition, the mass of the slender unit was offset toward the west side opposite the fan, resulting in an uneven distribution of seismic weight. Consequently, the anchorages at the northeast and southwest points, as shown in Figs. 4(b–c), experienced sustained and repeated displacement demands. As shown in Fig. 5(c), a PCA of 4.2 g in the x-direction was recorded for the SL-SI during the second MCE<sub>R</sub> test, representing the highest PCA for this unit across all earthquake tests. Localized deformation was observed in the lower portion of the anchorage, including prying (Fig. 4(d)) and slip of the metal housing (Fig. 4(e)). As shown in Fig. 4(f), a supporting rack beneath the location of the compressor, which carries much of the equipment’s weight, exhibited residual downward bending of approximately 5 mm. This damage is attributed to the uneven cross-section of the manufacturer-supplied rack where the weakened section became the most vulnerable zone and experienced the largest deformation.

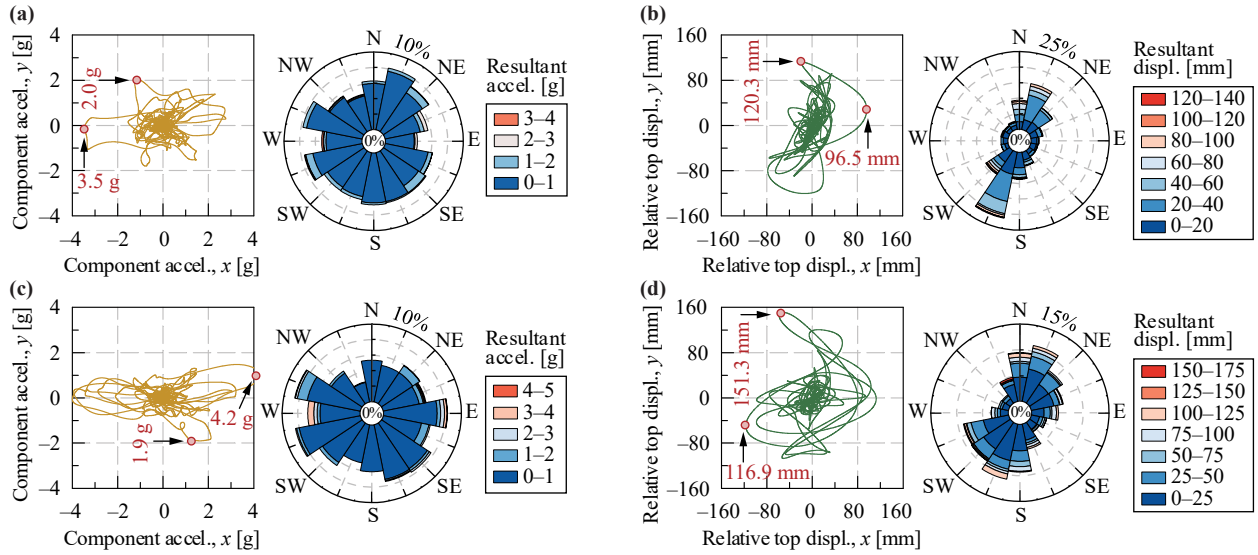
Figure 5. Measured response of the SL-SI: (a) acceleration and (b) displacement under MID17, and (c) acceleration and (d) displacement under MID18. Note that the y-direction acceleration was taken as the average of the measurements from the two top corners of the unit.
