Tassajara Creek, Twenty Years Later: Long-term riparian vegetation restoration monitoring using field surveys and remote sensing

Skyler Lewis
LA254 Rivers & Cities
Spring 2021

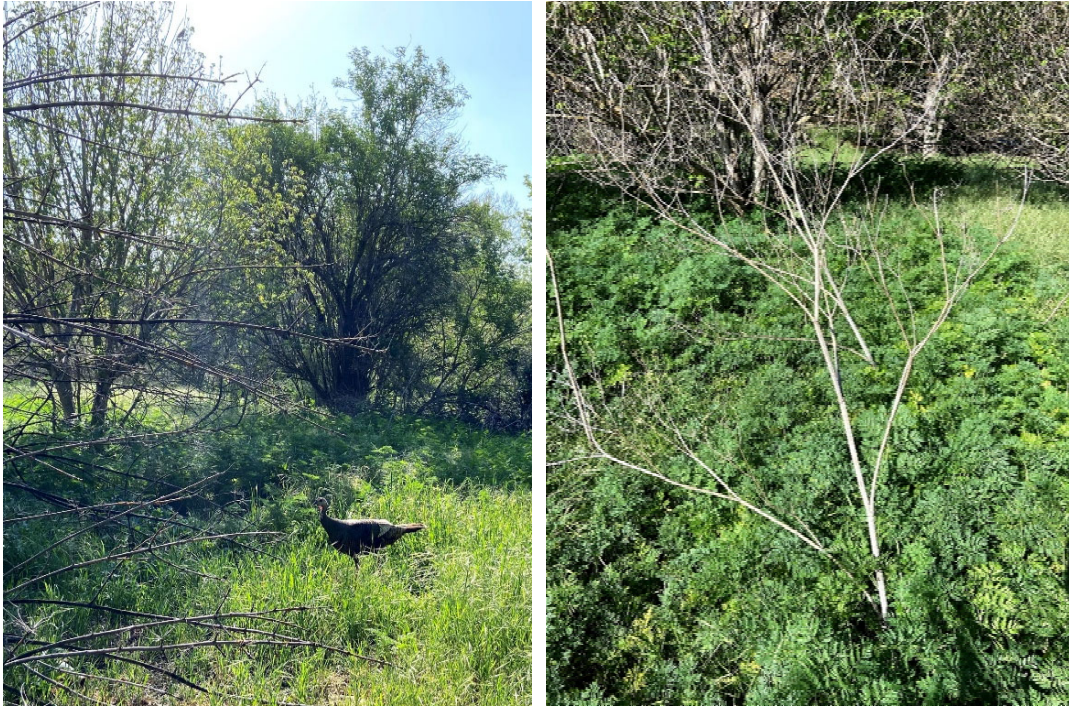
Poison hemlock patch near Transect 1 looking east, with wild turkey (left) and dead shrub (right)

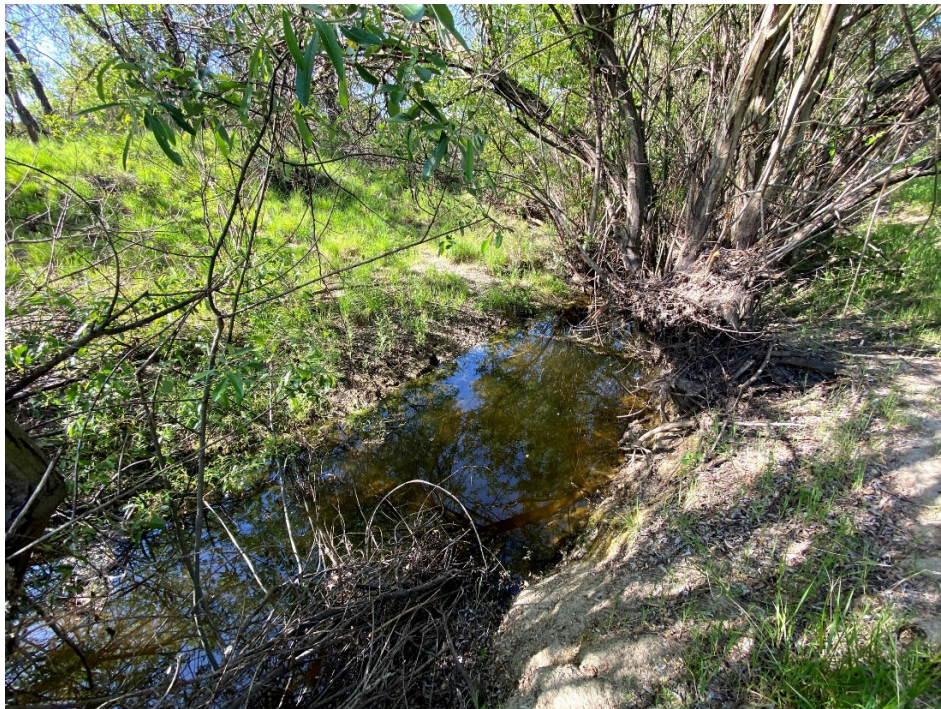
The reach to the north of Gleason Ave (Exhibit 12), is the least modified section of the project and does not follow the same 15-year terrace design as areas farther south. Hydrologically, this reach has the steepest gradient, with the highest energy and most erosive flows. The first 35 feet of the Transect 1 survey, starting at the upper path level, passed through a patch of dense hemlock (*Conium maculatum*). Some unidentified dead shrubs were visible throughout. Descending to the creek channel, willows along the channel edge showed extensive root exposure and instability.

Exposed willow roots and undercutting, end of Transect 1, looking downstream.

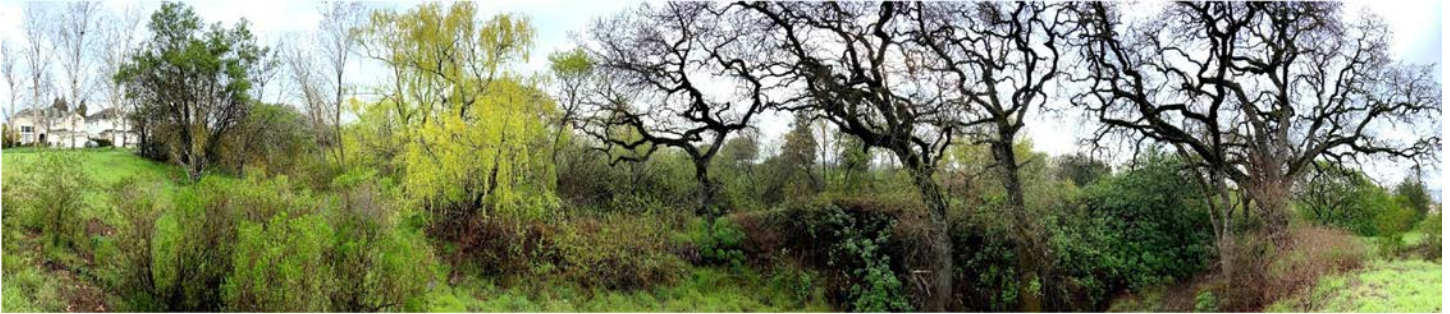
Characteristic panorama looking upstream from near the channel, vegetation and topographic diversity

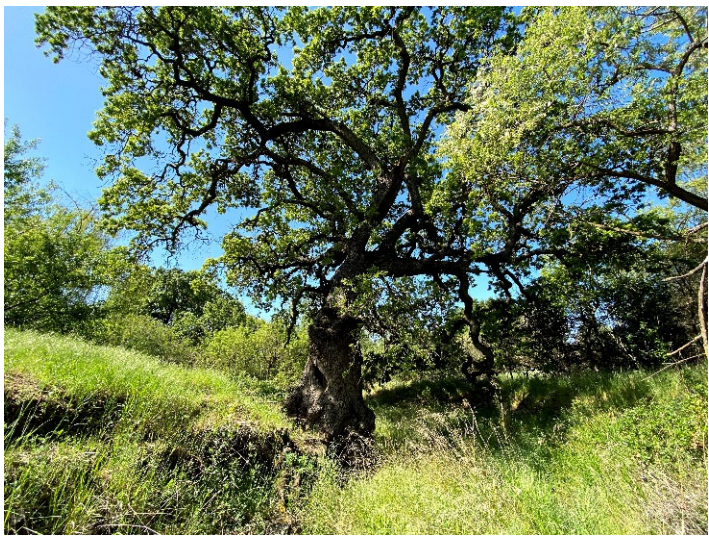
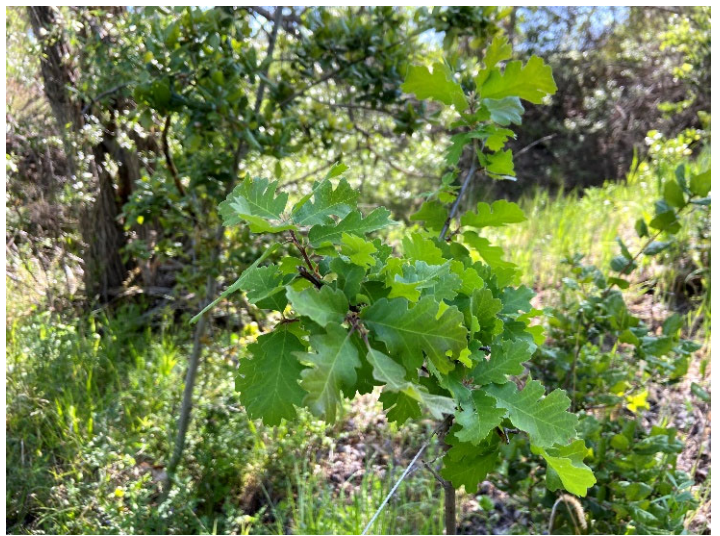
Extant old-growth valley oak (left, looking downstream) and valley oak seedling (right) along Transect 3b

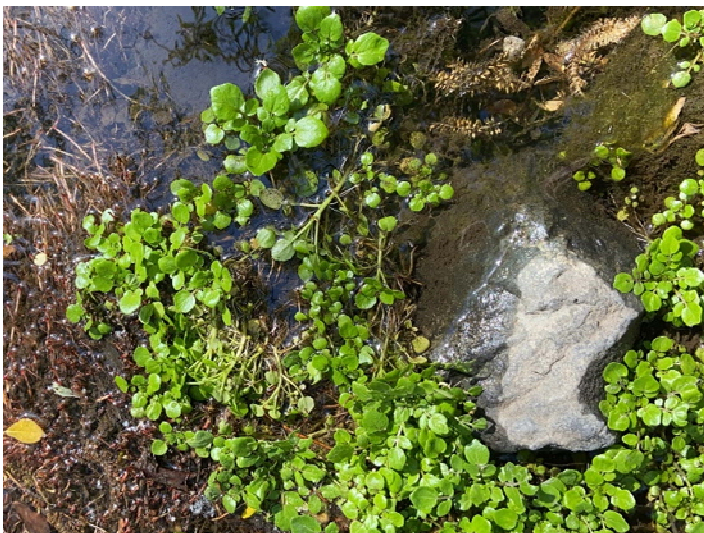
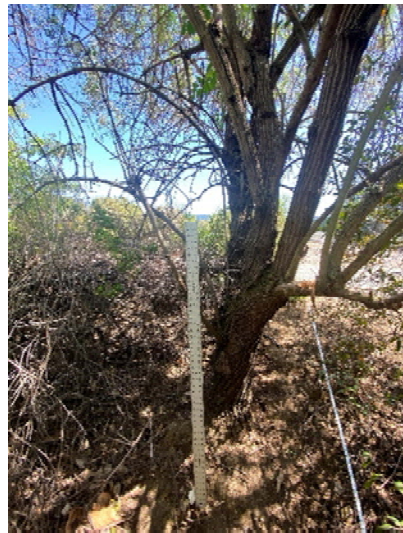
(left) Watercress growing in the main channel, end of Transect 3b

(right) Mature blue elder tree along Transect 4, looking east, with 4-foot straightedge for scale

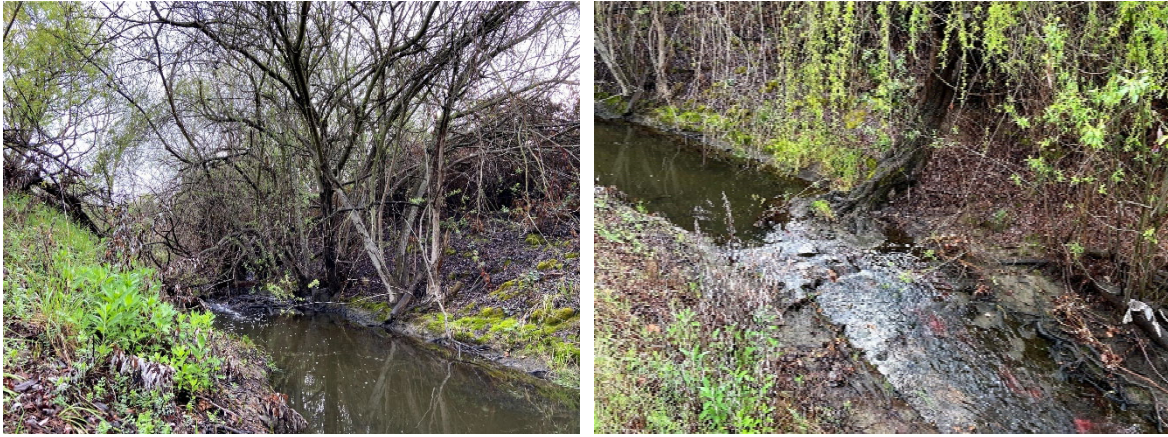
Pools and riffles on the main channel, north of the trail crossing looking upstream.

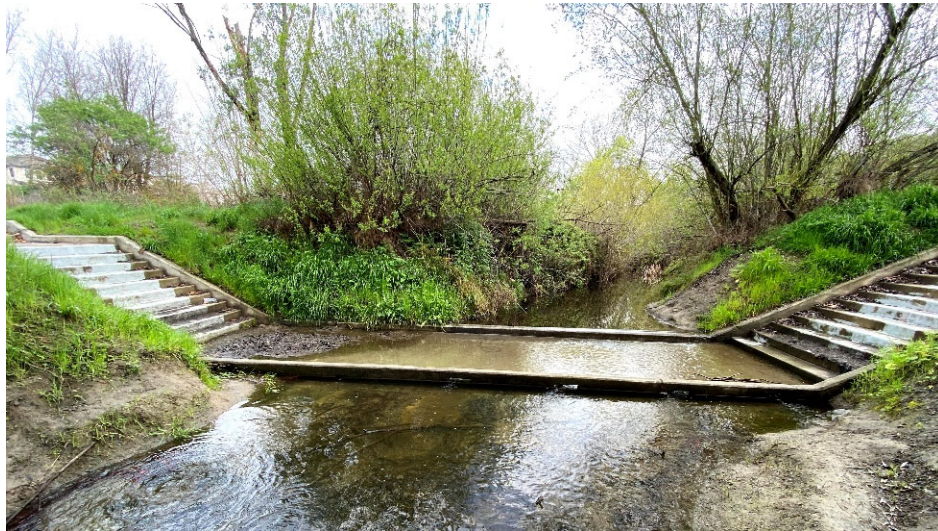
Trail crossing, looking upstream, closed to flooding October through March

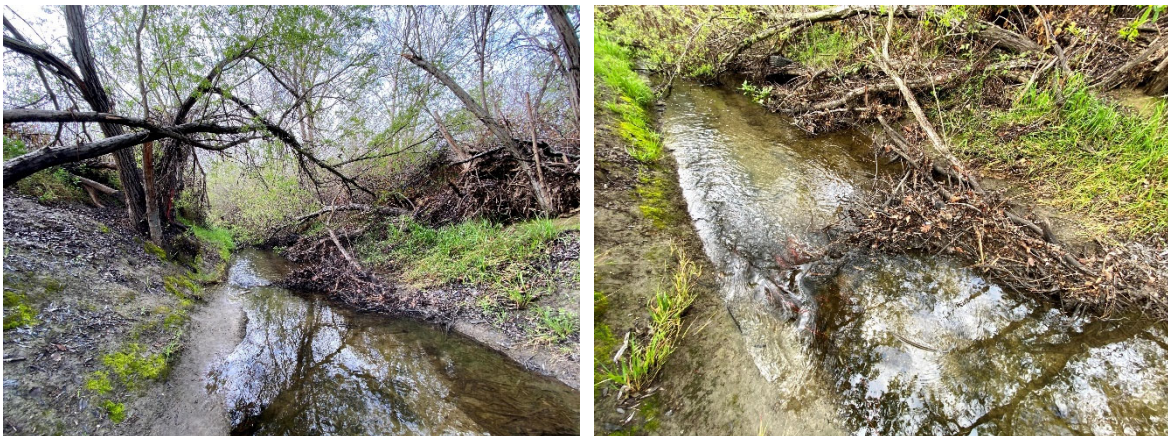
Leaf litter collected in the low-flow channel, south of the trail crossing looking downstream.

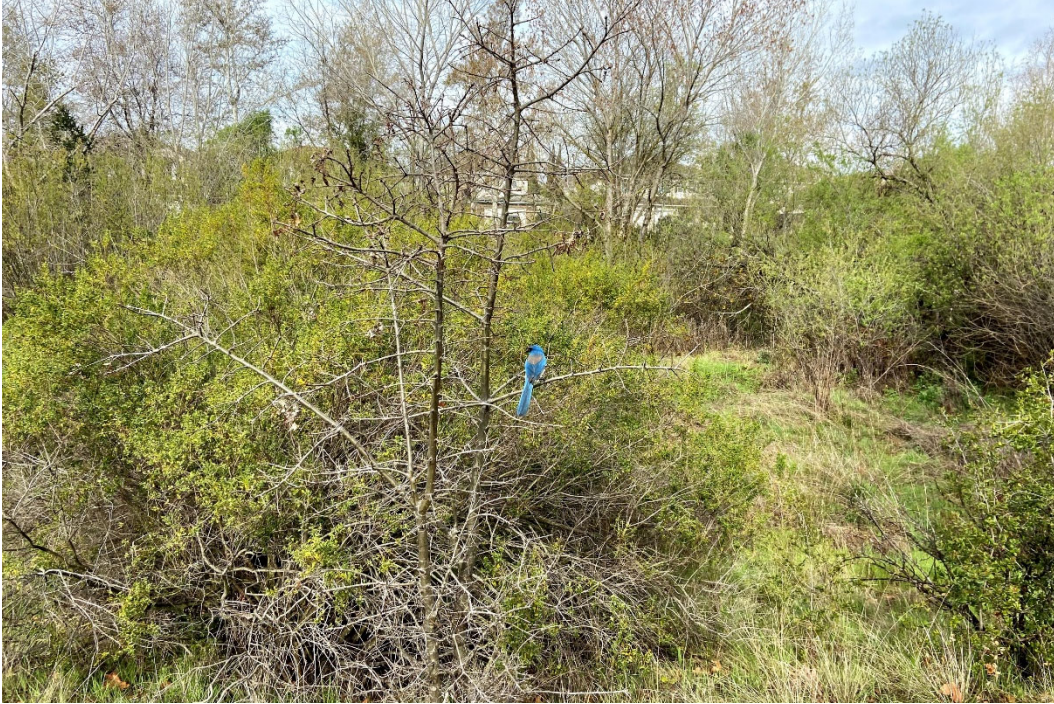
Exhibit 14. Photo observations, south of trail crossing to Central Pkwy
Dense terrace vegetation (e.g. *Baccharis*) looking west

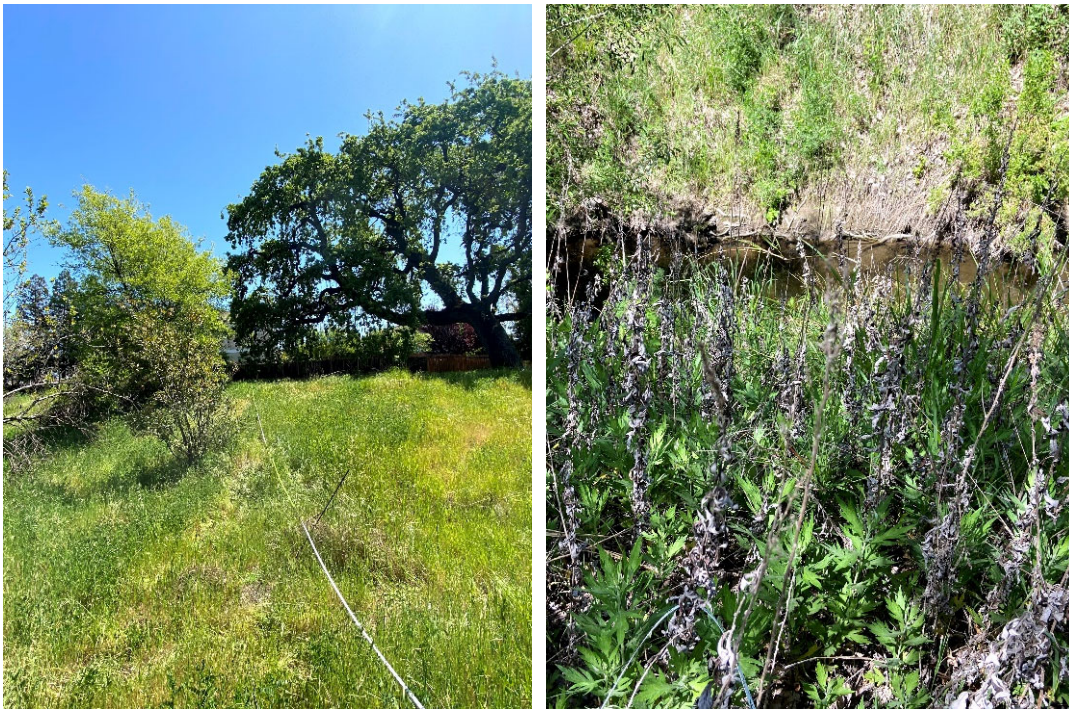
Transect 6: open grassland near start (left) and dense mugwort at low flow channel edge (right)

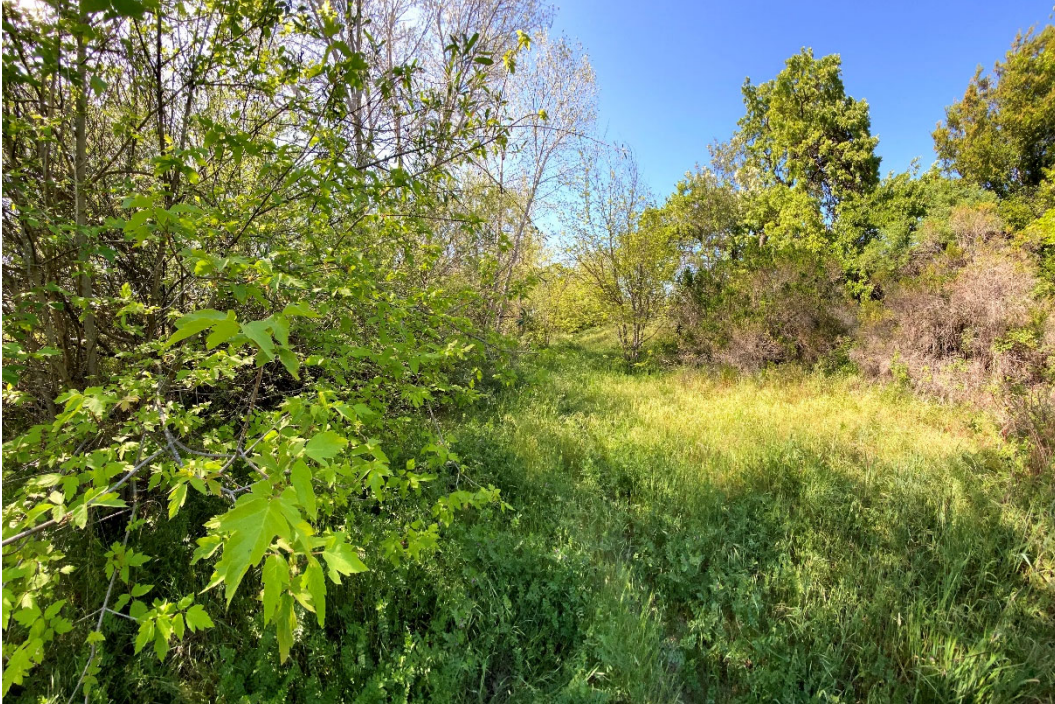
Exhibit 15. Photo observations, Central Pkwy to Dublin Blvd
Vegetated terrace with boxelder maple and vetch, looking upstream.

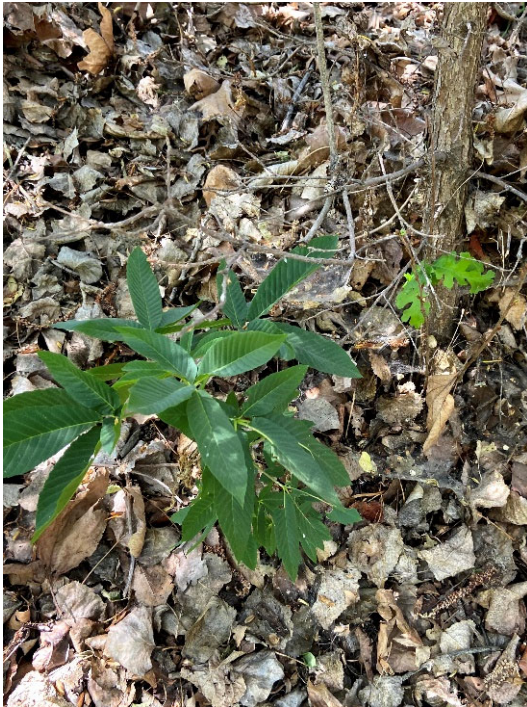
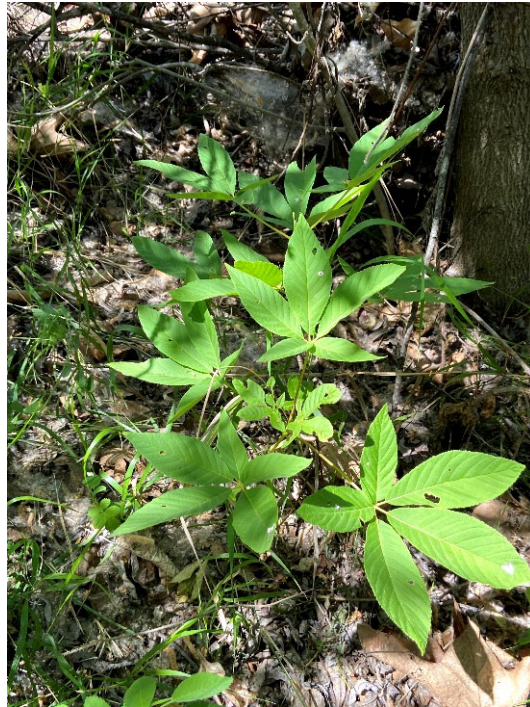
Young buckeye seedlings

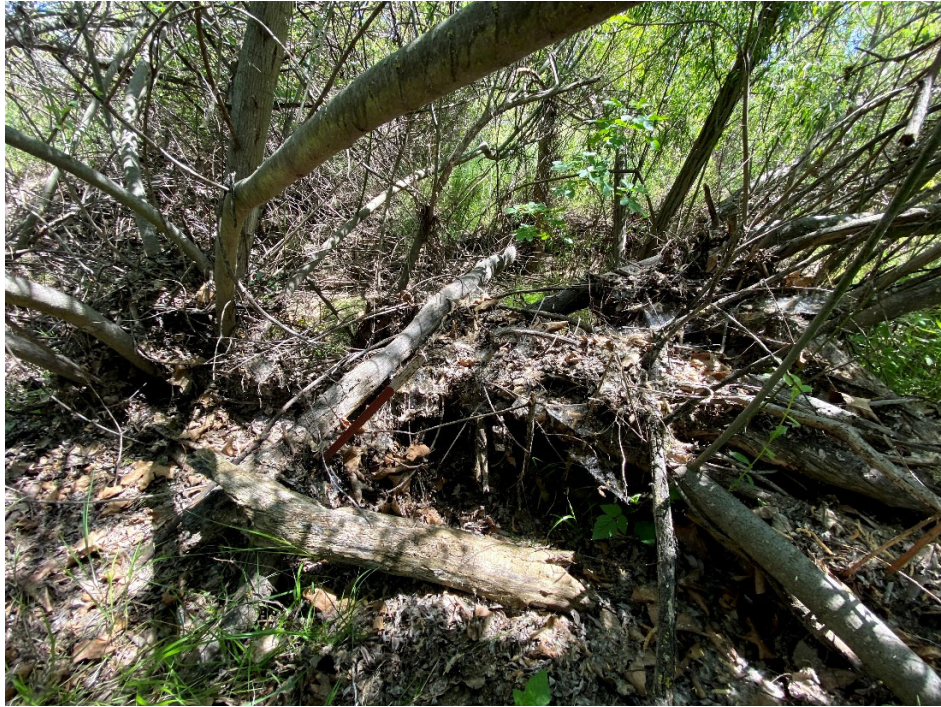
Western slopes farther south (Transects 8 and 9; Exhibit 15) had dense willow growth approaching channel banks. These were also the only transects with extant T-posts marking official transect alignment. At the end of Transect 8, there was evidence of high flows having deposited leaf litter, branches and other debris high in the willow thicket, while also partially knocking over the T-post.

Dense willow thicket at end of Transect 8, with trash lines, buckeye saplings, and T-post.

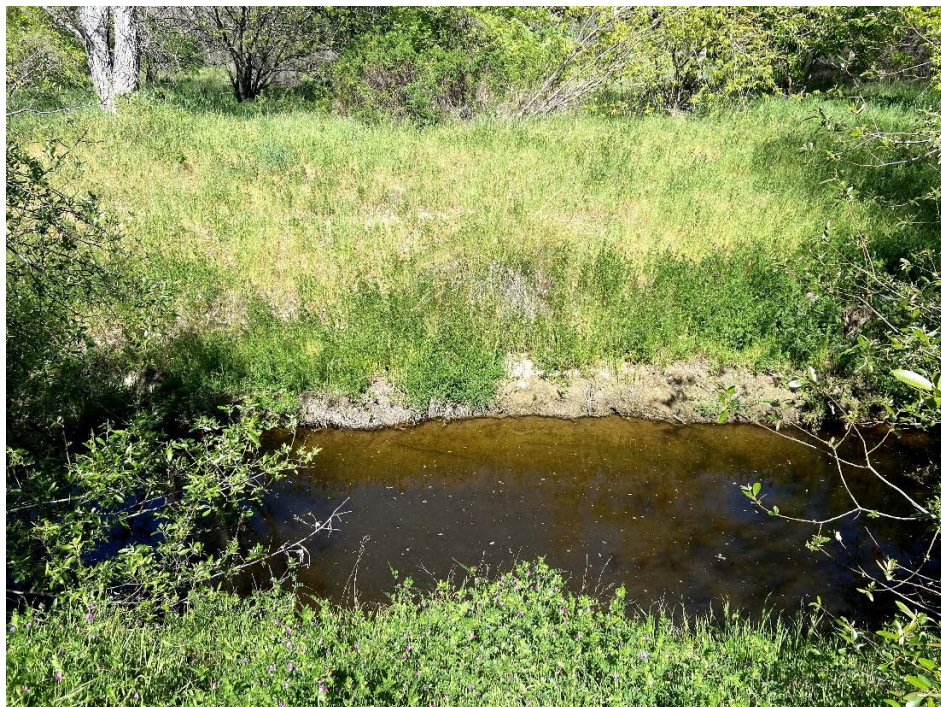
Channel edge at Transect 9, looking east with end of Transect 10 across the channel.
