BEVATRON OPERATION AND DEVELOPMENT. 55. JULY -SEPTEMBER 1967.

BEVATRON OPERATION AND DEVELOPMENT. 55

July through September 1967

Kenneth C. Crebbin and Robert Frias

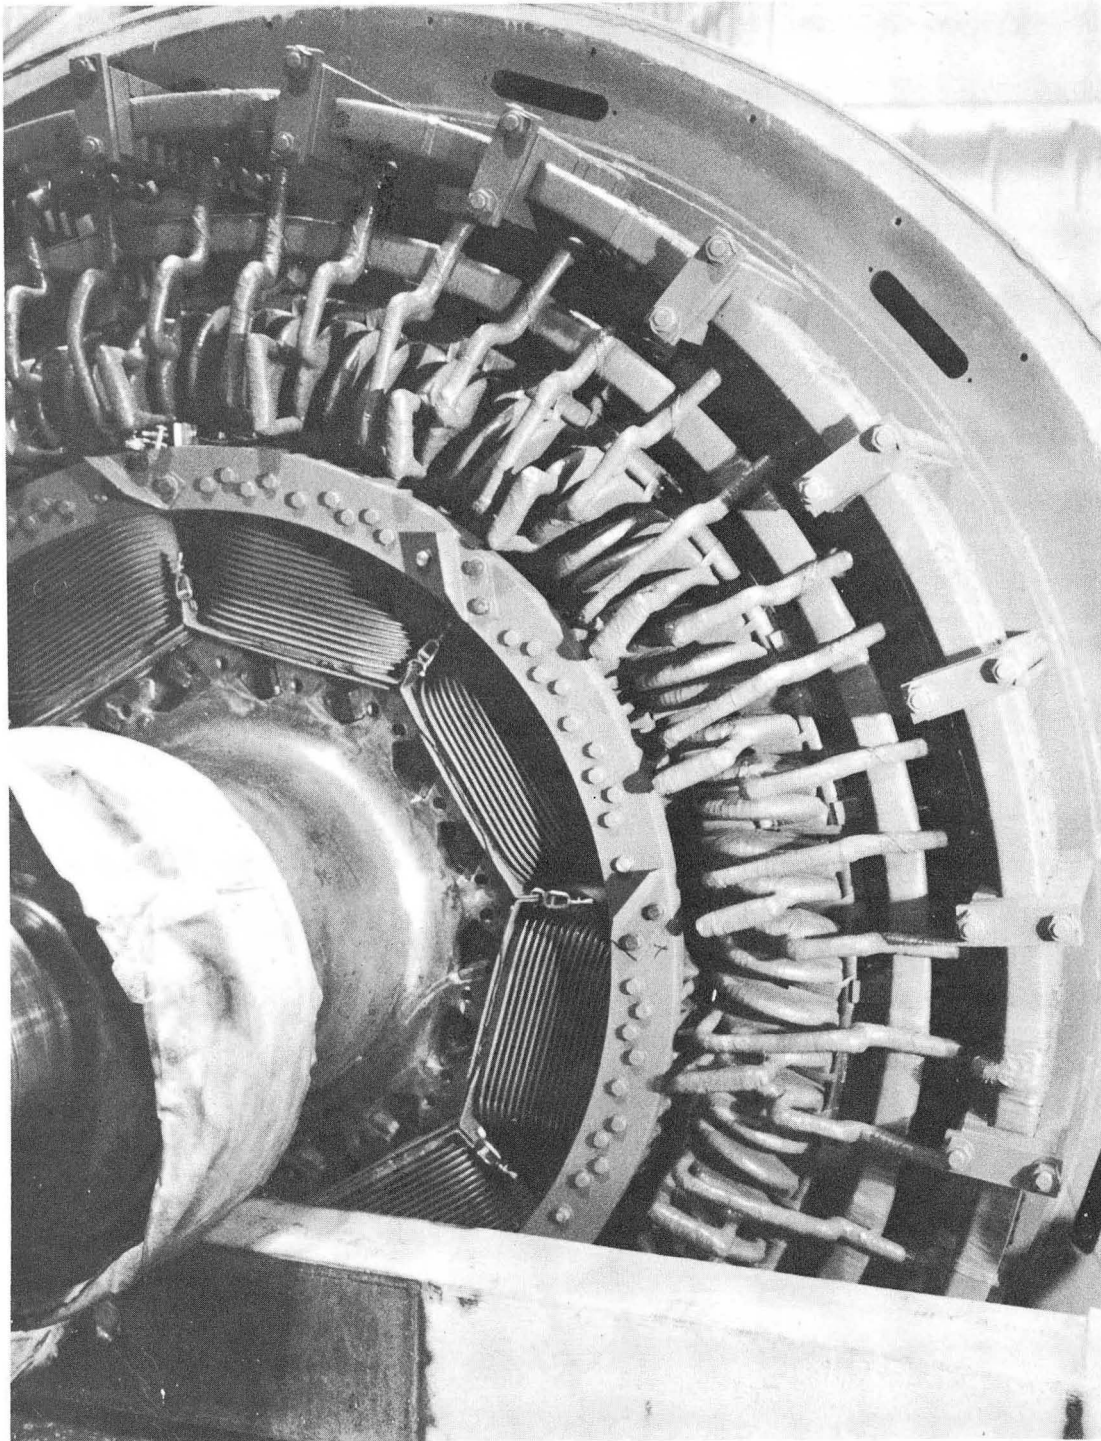
XBB 683-1006

At 0120, 24 September 1967, the field of the east generator was relayed off the line, with an indication of a ground on the field excitation power supply. In attempting to locate the problem, we found by visual inspection that the electrical connection between poles No. 3 and No. 4 had parted and that there was a splattering of copper over the adjacent area. An insulation test of the field to ground was taken; it read 500 000 ohms. A megger test was made on the field on the west machines, and showed 80 megohms. Figures 5 and 6 show the broken brazed connections and their location on the generator rotor.

The field electrical connections on both machines were cleaned, visually inspected, and "Zyglo" checked. The results of these inspections showed, in addition to the original trouble, cracks in the welds between poles 5 and 6 and between 7 and 8, on the east machine. Cracks were detected on the west machine between poles 3 and 4, 5 and 6, and 7 and 8.

x Rays were taken of numerous connections, and showed a high porosity in most of the brazed joints. The electrical connections (all) were cut open on both machines; this revealed that the brazed connections were poorly bonded. The electrical connections were then cleaned and fitted in preparation for rebrazing. The burned and smoked areas were cleaned and the damaged areas eventually attained an insulation level of more than 200 megohms.

Fig. 5. The location of the brazed coil connection on the 46-MVA generator. The connectors are pointed out by the battery clips.

On October 7, after careful consideration of the accumulated data, it was decided to proceed with a technique of brazing on the generators using "Easy Flo" alloy. The connections were made on the west machine and considered to be satisfactory. All brazing was completed by the evening of October 9. The machines were then started and the magnet was pulsed until 0800, 16 October, when they were shut down for normal scheduled maintenance. At this time, all field electrical connections were "Zyglo" inspected and no

faults were found. Voltage drop tests of all connections were made, and considered essentially the same as those made before running. These tests will be continued on a weekly basis until it is assured that the problem has been completely solved.

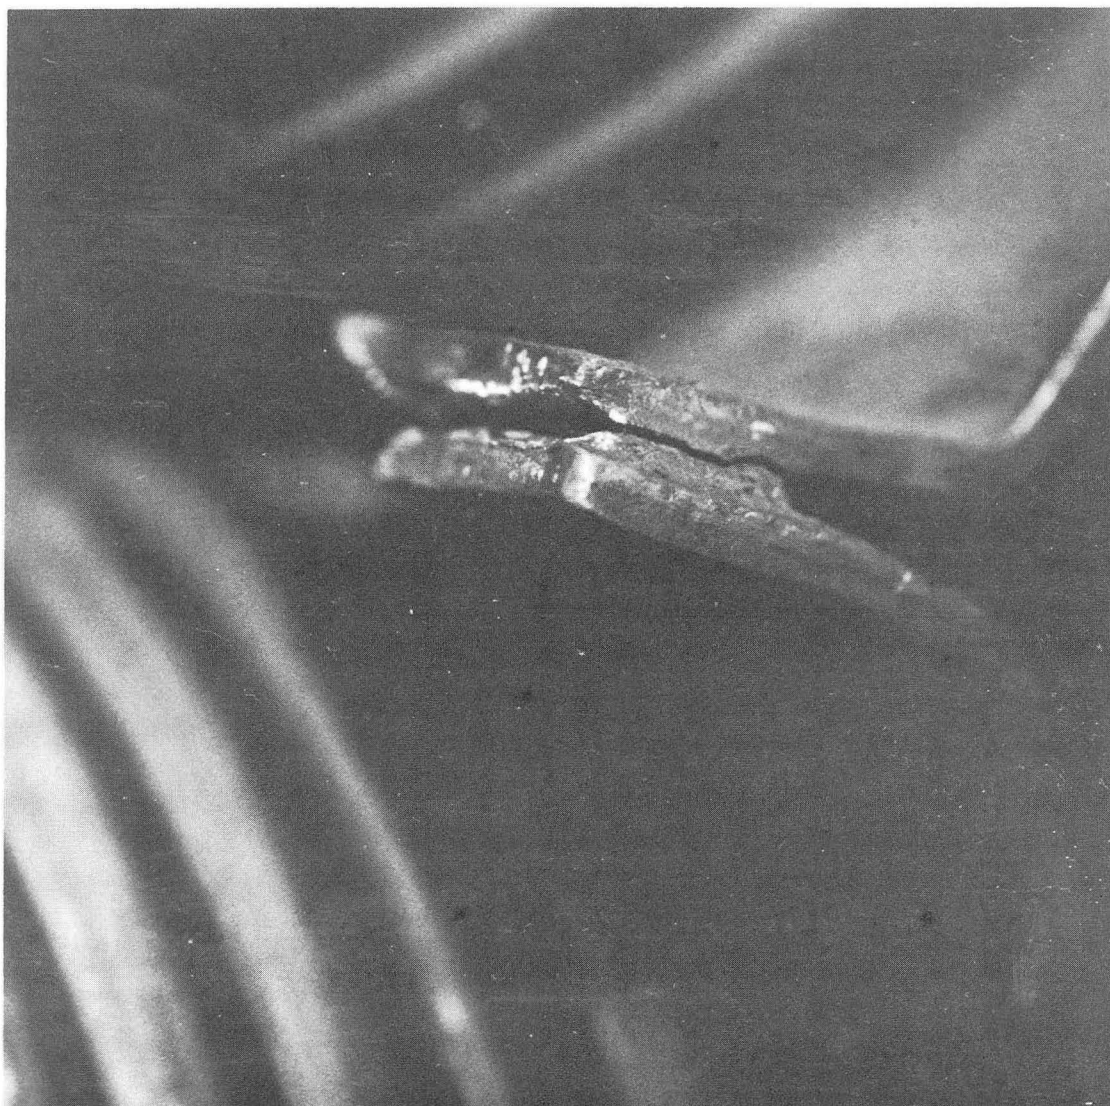
XBB 683-1005

Fig. 6. The break in the pole connection.
