Post project evaluation of Miller Creek (Marin, CA) restoration : vegetation survival

Post Project Evaluation of Miller Creek (Marin, CA) Restoration: Vegetation Survival

LA222 Hydrology for Planners
Spring 2004
Prof. Matt Kondolf

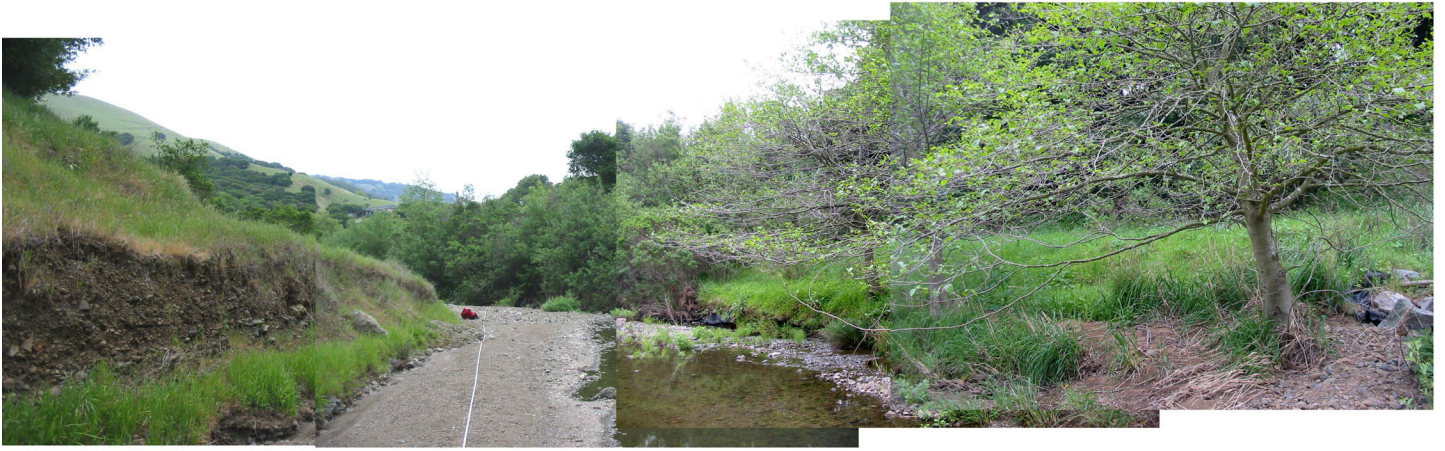
Figure 3. Plot 1 looking downstream

Plot 1 is our most upstream plot. It corresponds to station 46 in the original restoration project plans and in Pope-Daum and Yin's report. As shown in Figure 3, the left bank has fewer trees and shrubs than the right. Figures 6 and 7 show the original planting plan and our vegetation survey for this plot. In general, more of the trees and shrubs planted on the right bank have survived (Figure 12). The creek channel is relatively free of vegetation, except for a small gravel bar that has formed in the middle of the channel and is slowly being covered with young willows and horsetails. Deer grazing has stunted the growth of many of the trees and shrubs in this plot.

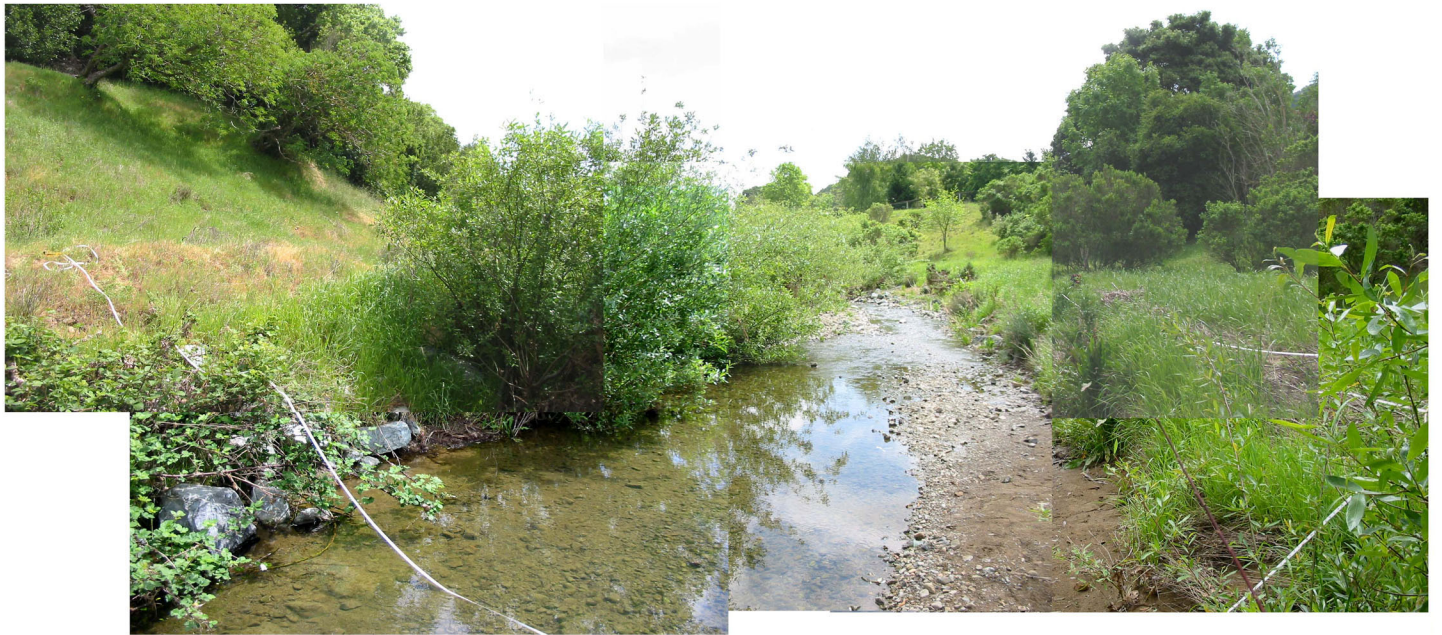
Figure 4. Plot 2 looking downstream

Plot 2 is our middle plot. It corresponds to station 38 in the original restoration project plans and in Pope-Daum and Yin’s report. Figures 8 and 9 show the original planting plan and vegetation survey for this plot. As in the first plot, the left bank is more open and grassy, with occasional shrubs, while the right bank has more trees and shrubs (Figure 4). Deer have grazed on the plants in this section, especially on the oaks. Heavy sand deposits cover the grasses and forbs on both banks.

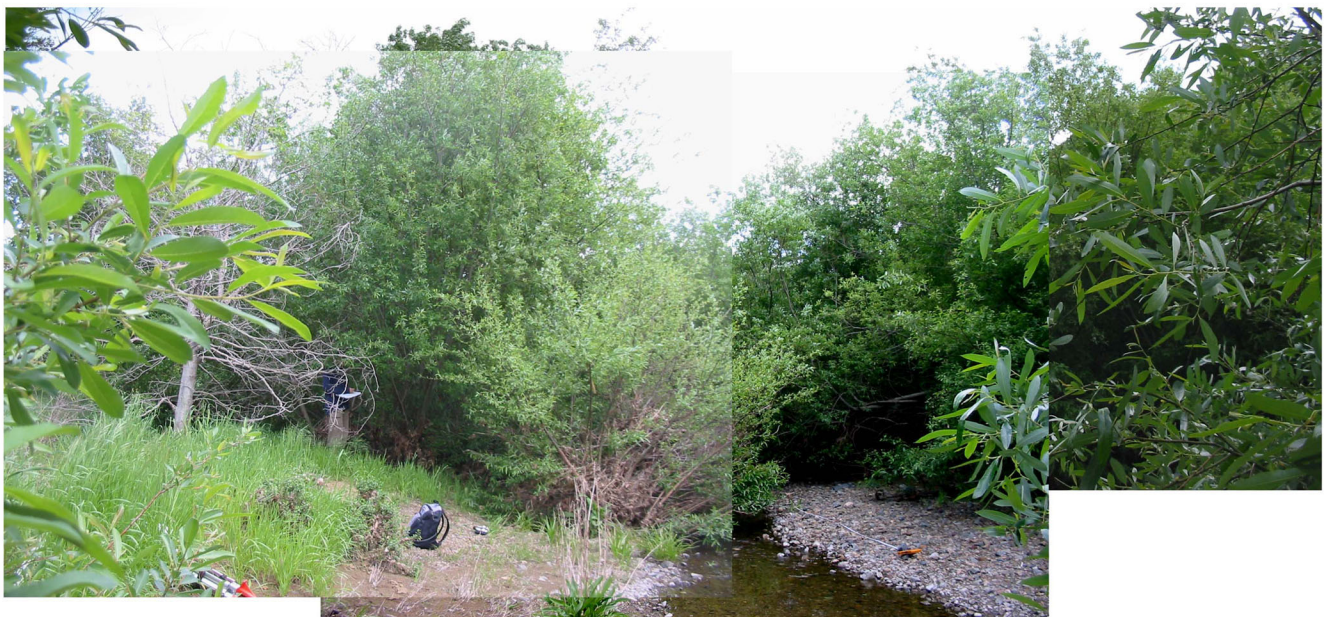
Figure 5. Plot 3 looking downstream

Plot 3 is our downstream plot. It corresponds to station 18 in the original restoration project plans. Figures 10 and 11 show the original planting plan and vegetation survey for this plot. Compared to the other two plots and the designers' anticipated success rates, the restoration planting in this plot was effective (Figure 5). Unfortunately, the planting plans only show the left bank (Figure 10). On the plan, the right bank was planned to be ripped and seeded with grasses. Currently, the right bank supports a fair number of seedlings and young trees, including live oak, valley oak, buckeye, and ash. Newer wire cages suggest that the valley oak (all 18 in tall) were recently planted. The creek bed is lined on both sides by large, dense willows. In contrast to the two upstream sites, the creek is narrower and more shaded in this reach. The planned check dam (riprap) is visible at the bend in the creek created by the gravel bar and willows. Our analysis only considers the left bank, as the right bank was not designed or planted until recently.

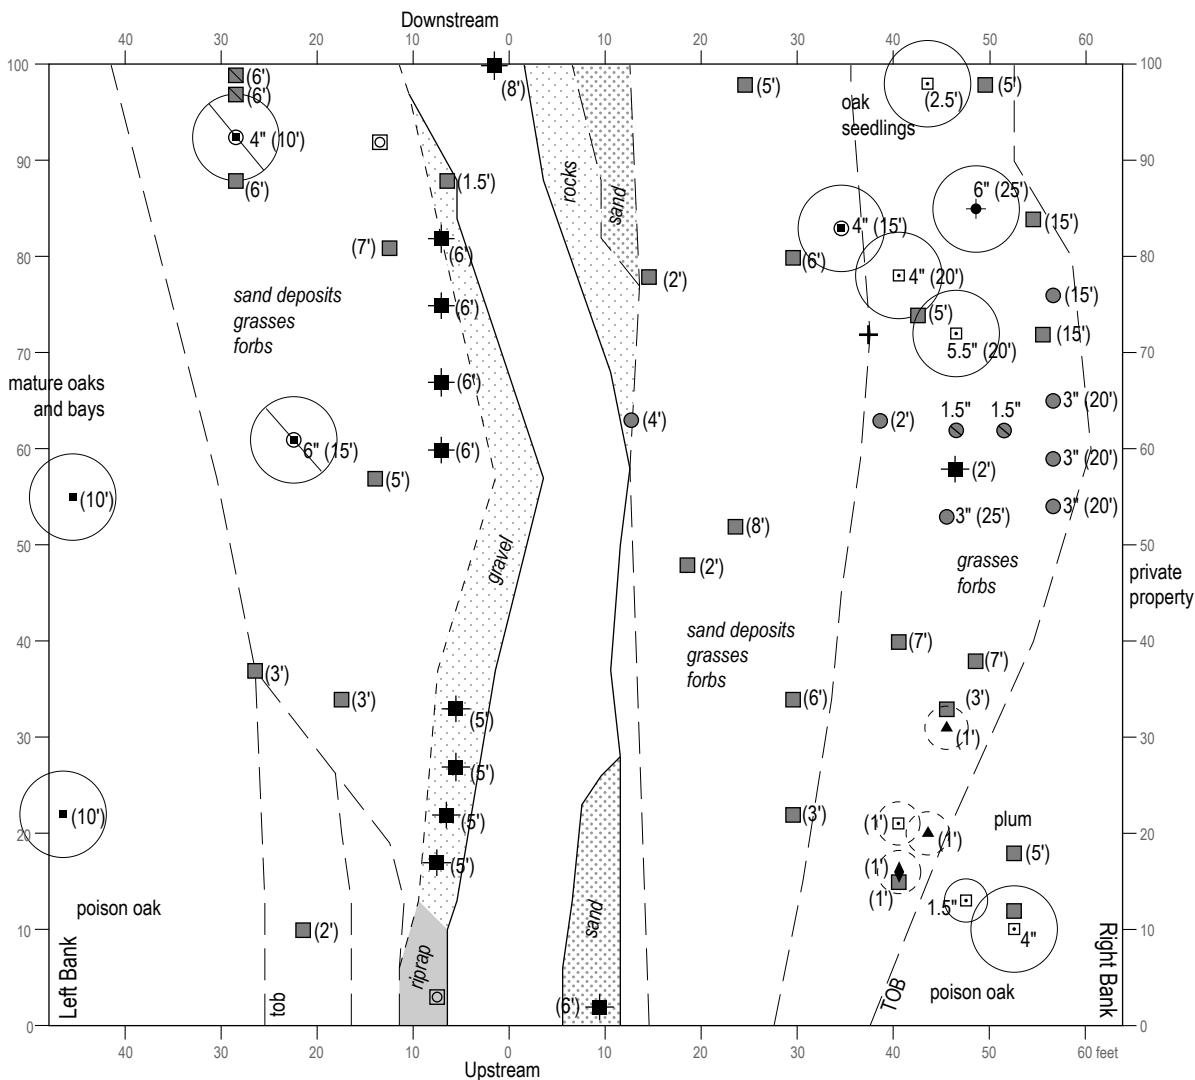
Figure 9. Existing Vegetation Plot 2

Left Bank – On the left bank, two stands of willows of approximately the same age (both are 5 to 6 ft tall) frame the creek bed. These were probably planted, but they are not shown in this particular site on the planting plan. However, a similar clumped pattern was planned (and planted) upstream from this site. Behind the willows, the floodplain is covered with annual grasses and forbs, and dotted with coyote bush of different ages. Two clumps of Himalayan blackberry have established themselves, but none of the California blackberry planted have survived. All of the alders and ash planted in this section have died (Figure 15). The ash have washed away, but the two alders (10 and 15 ft tall) appear to have survived until recently. Two alders further upstream from the plot have also

fared poorly. Further up on the bank, outside of the floodplain, two buckeyes have survived and are healthy (both 10 ft tall).

Right Bank – Vegetation on the right bank varies greatly with elevation. Within the floodplain, native annual grasses and forbs dominate, with occasional coyote brush and elderberry. Outside of the floodplain, we observed a mixture of trees and larger shrubs. In the downstream portion, planted live oaks, alder, and ash thrive. These trees are interspersed with volunteer coyote brush and elderberry (Figure 16). We also found an empty wire cage right at the edge of the floodplain, but could not determine from the planting plan what might have been planted. In the middle portion, elderberry planted higher up on the bank (likely substituted for the coffeeberry on the plan) have thrived, while two lower on the bank have died. Smaller, shrubby oaks and coyote brush that have been grazed on by deer dominate the upstream portion. Of these, only the valley oak is on the plan; the rest are likely seedlings that have been sheltered by the coyote brush (most are under a foot tall).

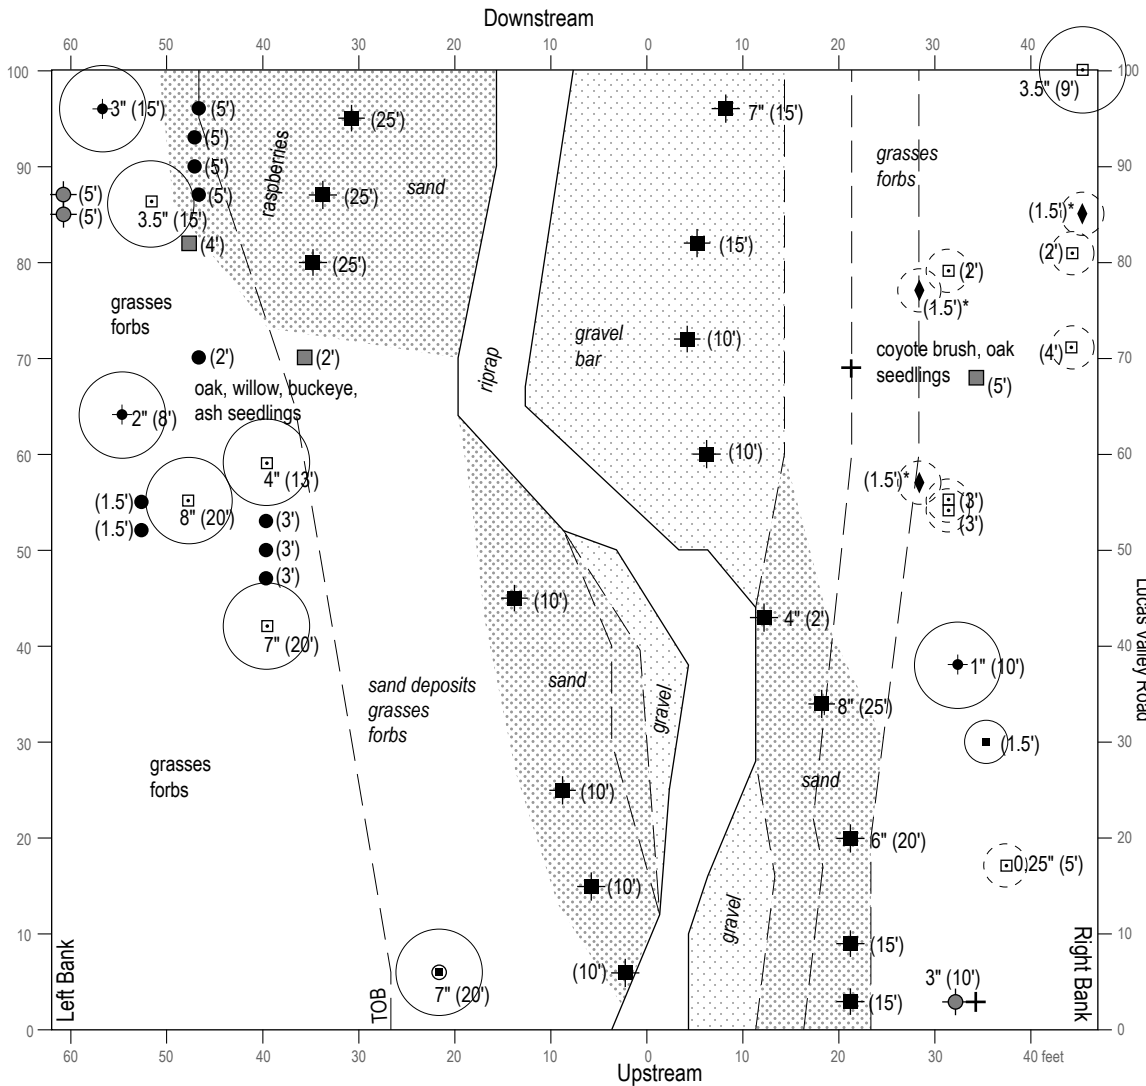
Figure 11. Existing Vegetation Plot 3

Left Bank – On the left bank, all of the trees (except one ash) and most of the shrubs have survived (Figure 11). However, like the alder on the left banks of plots 1 and 2, the alder in this plot has few leaves and dry branches (Figure 17). Willows dominate the creekside, while grasses and forbs cover the rest of the floodplain and higher banks. The downstream portion of the higher bank is characterized by an oak and ash canopy, and a coffeeberry,

toyon, coyote brush (volunteer), and raspberry (volunteer) understory. The shrubs provide cover for the oak, willow, buckeye, and ash seedlings.

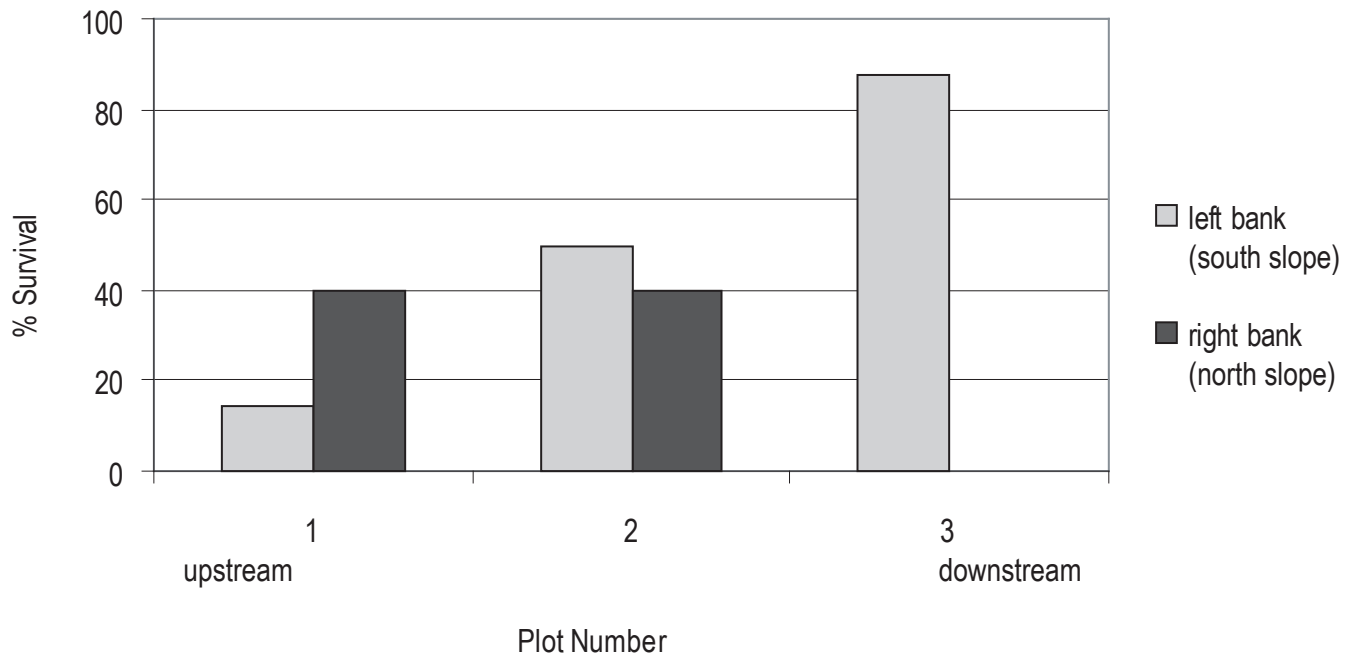
Figure 12. Survival rate by bank and position along stream

Figure 12 compares overall survival rates of the three plots, by bank side. Note that the right bank of plot 3 was not shown in the planting plans, and was not included in the analysis. We noticed two trends. First, survival rate is correlated with plot. The downstream plot has the highest overall survival rate, the middle plot has a medium survival rate, and the upstream plot has the lowest survival rate. It is important to note that Pope-Daum and Yin observed perennial stream flow downstream of the study area and intermittent flow upstream in the dry fall season (2003). Second, more trees on the right bank survived in the upstream plot, while survival rates were about even in the middle plot. Of course, the analysis in this report is qualitative; the small number of individual trees in our survey means that any conclusions that we draw are statistically insignificant.

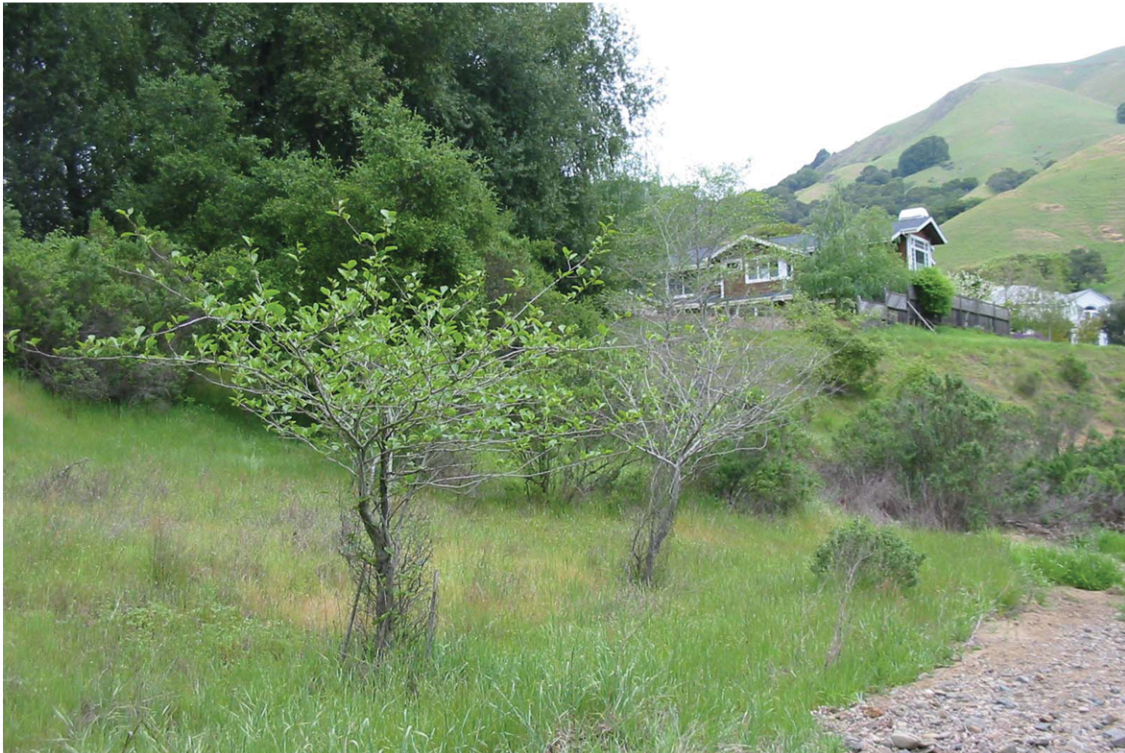
and lower on the bank, two alders have survived but appear unhealthy, tangled in their wire cages with their main stems truncated (Figure 13).

Figure 13. Two alders on the left bank downstream of plot 1, with mature bays in the background.
Source: Photo by authors, April 4, 2004.

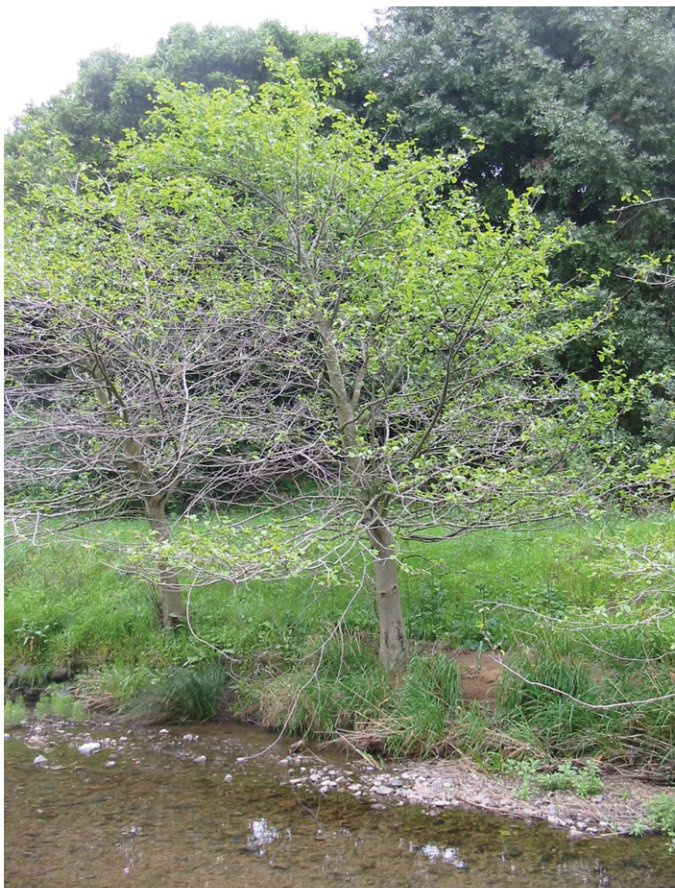
Figure 14. Two alders on the right bank of plot 1.
Source: Photo by authors, April 4, 2004.

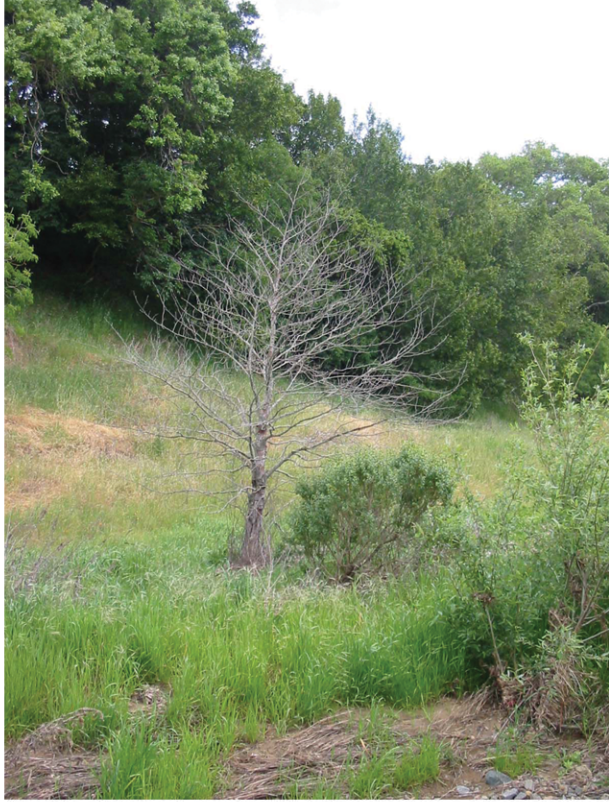
Figure 15. Dead alder on the left bank of plot 2

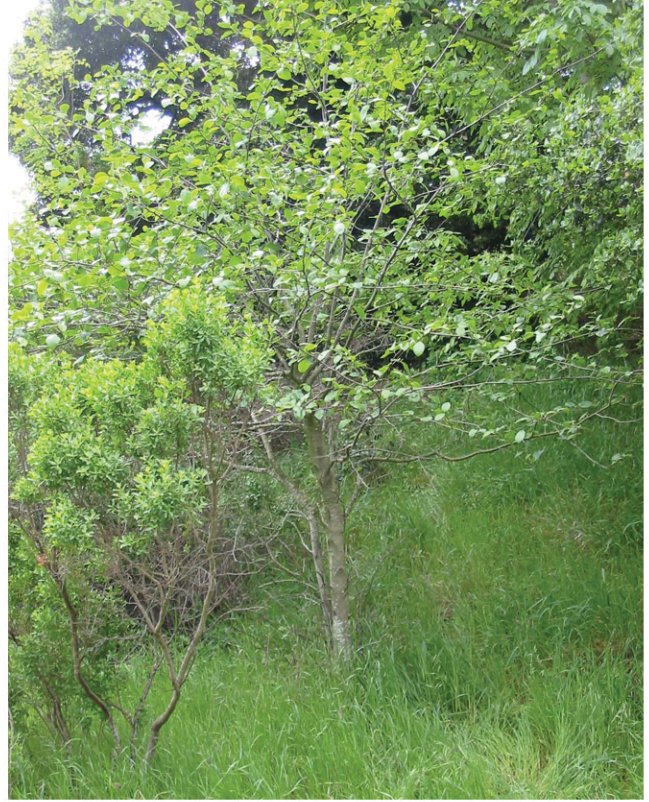
Figure 16. Alder on the right bank of plot 2 with coyote brush in foreground

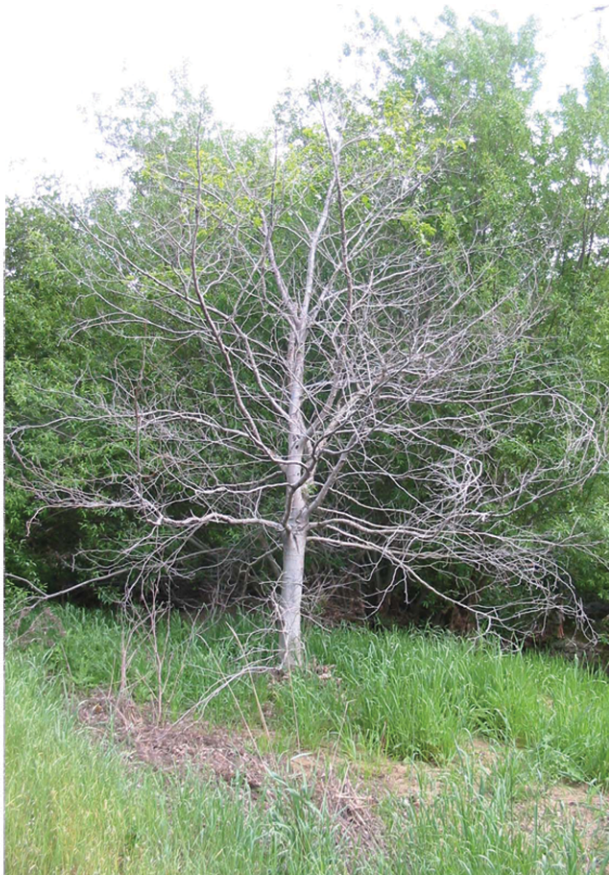
Figure 17. Alder on the left bank of plot 3 with willow in the background

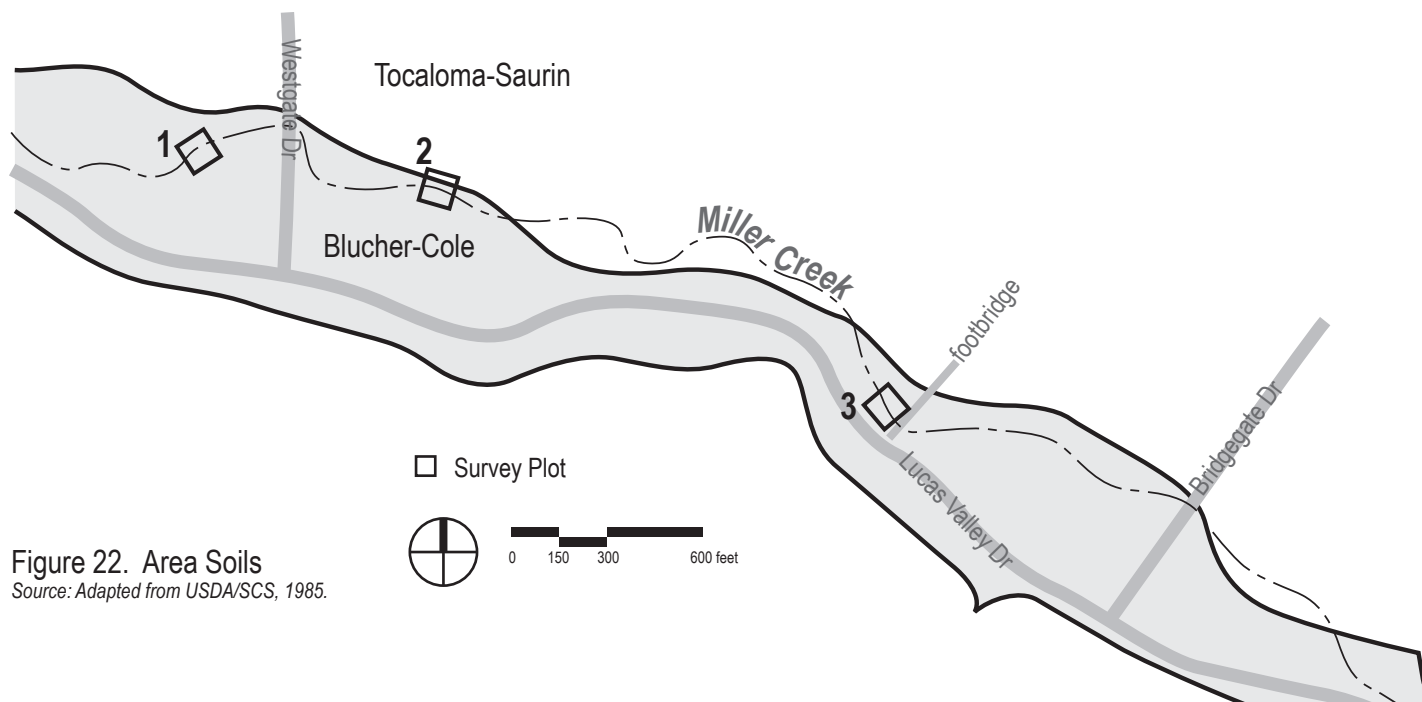
Figure 22. Area Soils

A USDA/SCS soils map of the area shows that the soil in plots 1 and 3 are characterized by the Blucher-Cole complex (Figure 22, Kashiwagi 1985). Plot 2 lies just on the border between soils of the Tocaloma-Saurin association (to the north) and soils of the Blucher-Cole complex (to the south). Within the Blucher-Cole complex, Blucher silt loam dominates the drainageways while Cole clay loam is found on basin rims and in depressional areas. Plots 1 and 3 likely consist mostly of Blucher soils, which are “deep and somewhat poorly drained” (Kashiwagi 1985). Plot 2 likely consists of a combination of Blucher and Tocaloma soils, which are found in the drainageways within the Tocaloma-Saurin association. In contrast to the Blucher soil, the Tocaloma soil is well drained. Table 6 shows the different characteristics of Blucher and Tocaloma soils. Because the Tocaloma soils drain faster and have a lower water-holding capacity, there is a possibility that the areas with lower survival rates of

riparian species are underlain by the Tocaloma soils. While the coarse scale of the published soils map (1:24,000) warrants caution against making any definitive conclusions, we conducted a preliminary assessment assuming that the left bank of plot 2 consists of Tocaloma soils and the other areas consist of Blucher soils. We did not notice any differences in soil types while in the field, but we also did not specifically look at soils.

A preliminary assessment using these assumptions showed that the buckeyes and alders that died may have been planted in the wrong soil types (Table 7). None of the buckeyes planted in the Blucher soils survived, while 2 of the 3 planted in the Tocaloma soils did. This makes sense, since buckeyes are generally intolerant of summer water, and grow on drier slopes (Howard 1992a). The alders had the opposite response: all of those planted in the Blucher soils survived, while none in the Tocaloma did. This also makes sense, as alders generally grow in poorly drained sands and clays, and are restricted to the flooding zone (Uchytel 1989). For all other tree species, however, we could not draw any general conclusions because too few were planted in the Tocaloma soil. Only one ash was planted in the Tocaloma soil, and it died. Seven were planted in Blucher soils, and less than half survived. Finally, no oaks or bays were planted in the Tocaloma soil.
