The 2022 Chihshang, Taiwan, Earthquake: Initial GEER Team Observations

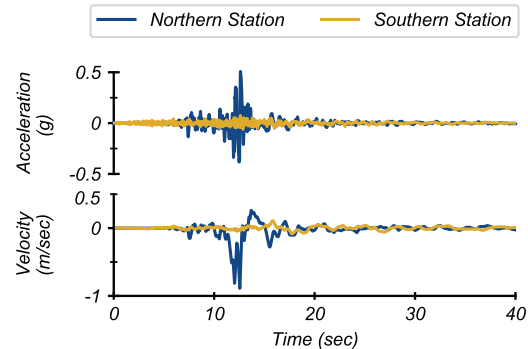
We recently returned from a post-earthquake reconnaissance trip to Taiwan sponsored by the National Science Foundation–funded Geoenvironmental Extreme Events Reconnaissance (GEER) Association. We studied the effects of the September 18, 2022 M_w 6.9 Chihshang, Taiwan earthquake. The earthquake occurred on the Central Range strike-slip fault, with the rupture direction extending north from the epicenter. Nearfield seismic stations measured peak ground accelerations (PGAs) exceeding 0.5 g along the fault. Peak ground velocities (PGVs) increased in the direction of the rupture with average intensities of 8 cm/s near the epicenter, increasing along the fault to 89 cm/s at the northern terminus. The ground motion recordings of the east (approximately fault parallel) component indicated strong velocity pulses in the direction of the rupture (Fig. 1).

Fig. 1. (Color) Acceleration and velocity-time series located at northern (Station EYUL) and southern (Station TTN045) ends of the Central Range fault.
