Hail Ice Damage of Stringer-Stiffened Curved Composite Panels

A Thesis submitted in partial satisfaction of the requirements

Structural Engineering

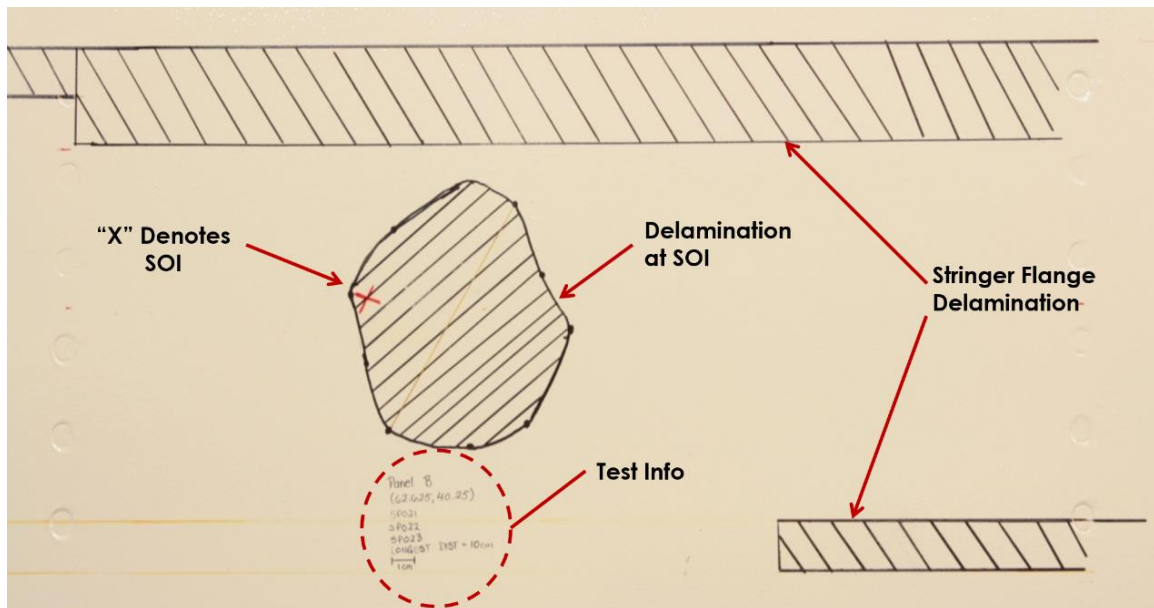
Middle of the bay (mid-bay) impacts caused the skin within the bay to deflect out-of-plane, thus causing delamination at the SOI (in the skin) and/or delamination between the stringer flange and the skin. Delamination was measured in three manners: (1) delamination area at the SOI (in skin), (2) stringer flange delamination from the skin, and (3) total delamination area (see Figure 16). The delaminated area of each of these have been summarize in Table 4 (ordered by increasing energy).

Figure 16. Areas of Delamination Due to Type I Mid-Bay Impacts.

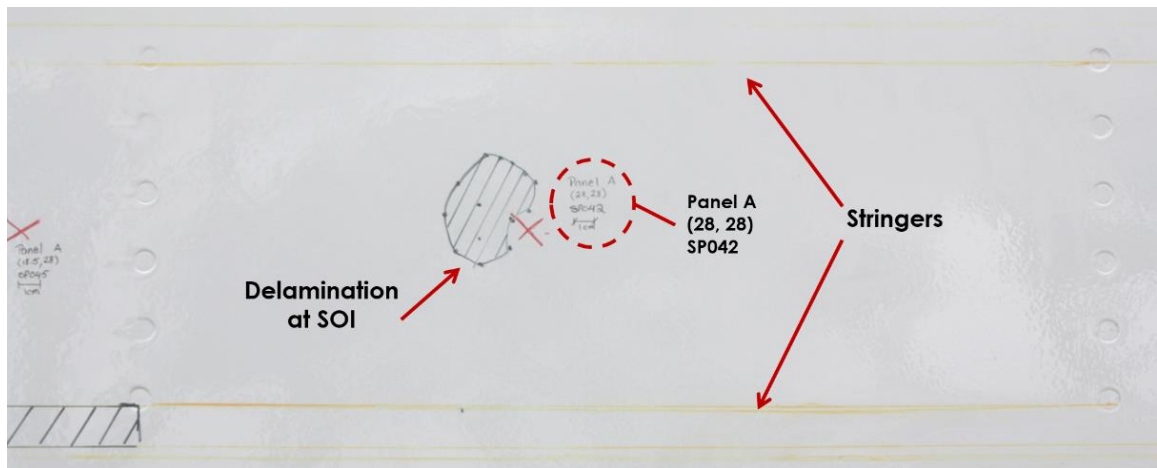
For pristine locations, impact energy close to the FTE range caused small delamination at the SOI (see Figure 18). Impact energies slightly higher resulted in delamination in the nearest stringer flange. As depicted in Figure 19, energy levels much greater than FTE caused delamination in the stringer flange nearest to the SOI, in addition to the delamination described previously.

Figure 18. Type I Pristine Impact – Damage Mode I. Test No. SPO42; Single Hit at 295.4 J.

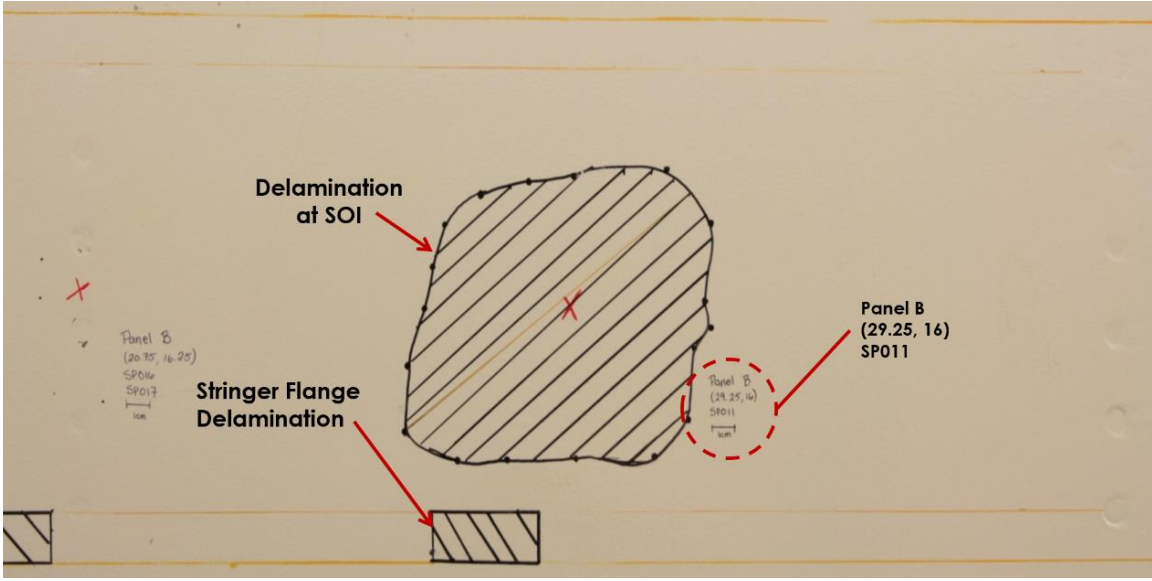
Figure 19. Type I Pristine Impact. Damage Mode III. Test No. SPO11; Single Hit at 745.6 J.

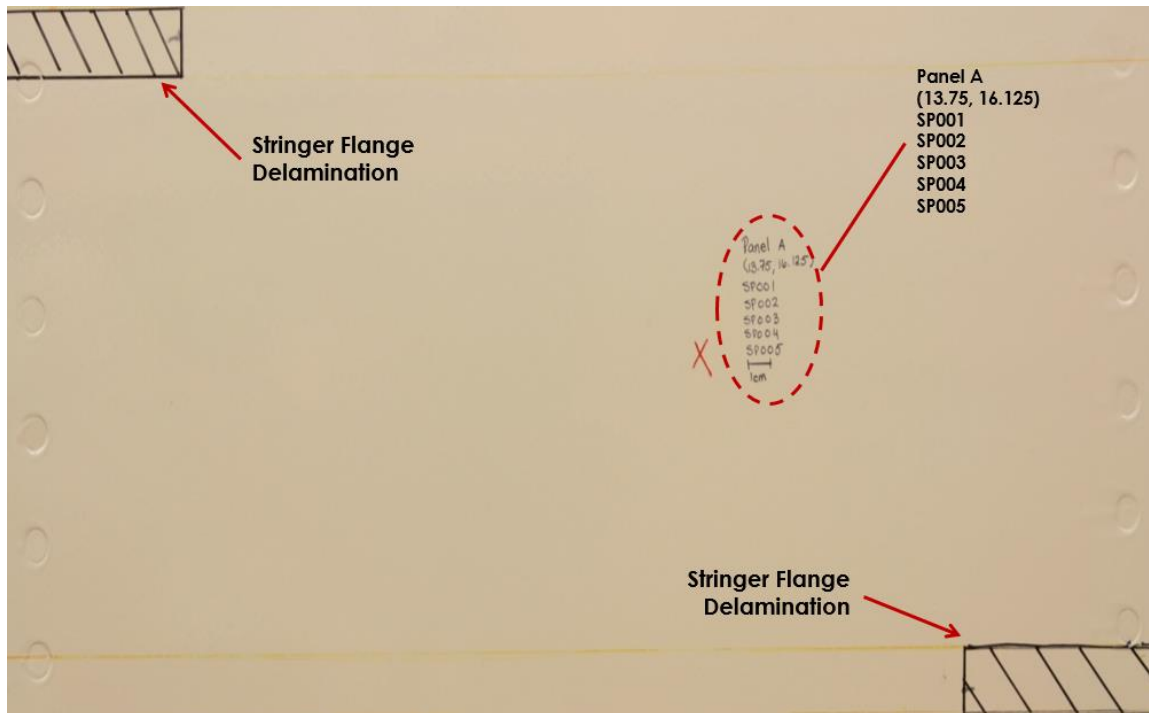
Figure 20 shows the corners of a bay delaminated after being impacted multiple times at increasing energy levels. Another damage mode observed at a site impacted multiple times is delamination at the SOI, in addition to extensive delamination at the corners of the bay (see Figure 21).

Figure 20. Impact at Previously Impacted Location: Damage Mode 1-Delamination in Corners of Each Bay; Multiple Impacts at 104.9 J (76.5 m/s), 107.3 J (89.6 m/s), 109.1 J (91.1 m/s), 108.0 J (100.6 m/s).

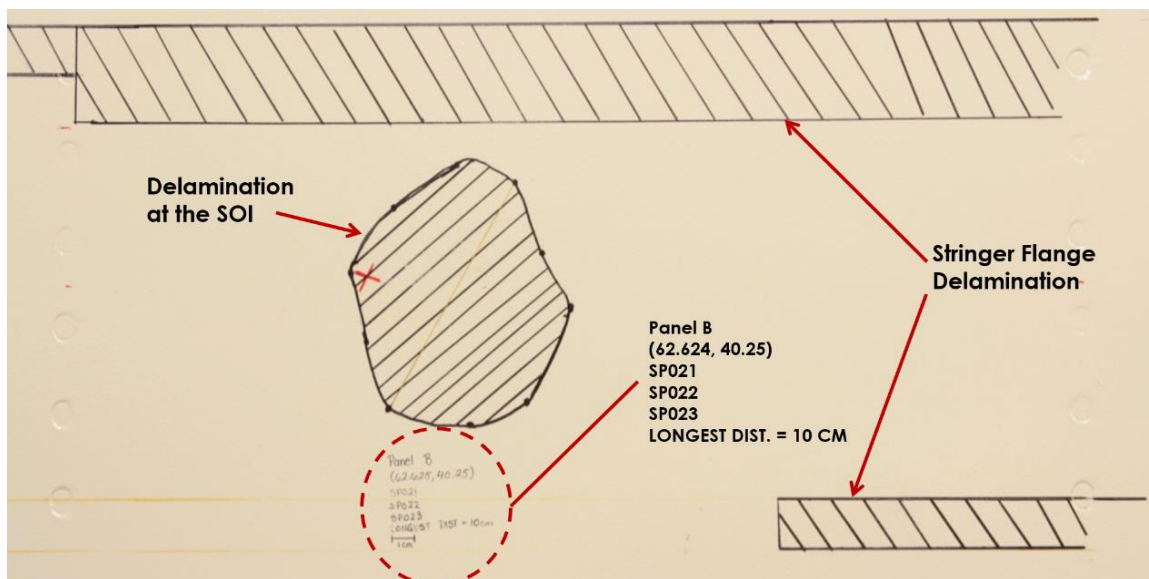
Figure 21. Impact at Previously Impacted Location: Damage Mode 2 - Delamination at SOI and In Peripheral Flanges; Multiple Impacts at 106.7 J (91.3 m/s), 105.8 J (101.0 m/s), 108.1 J (102.0 m/s).

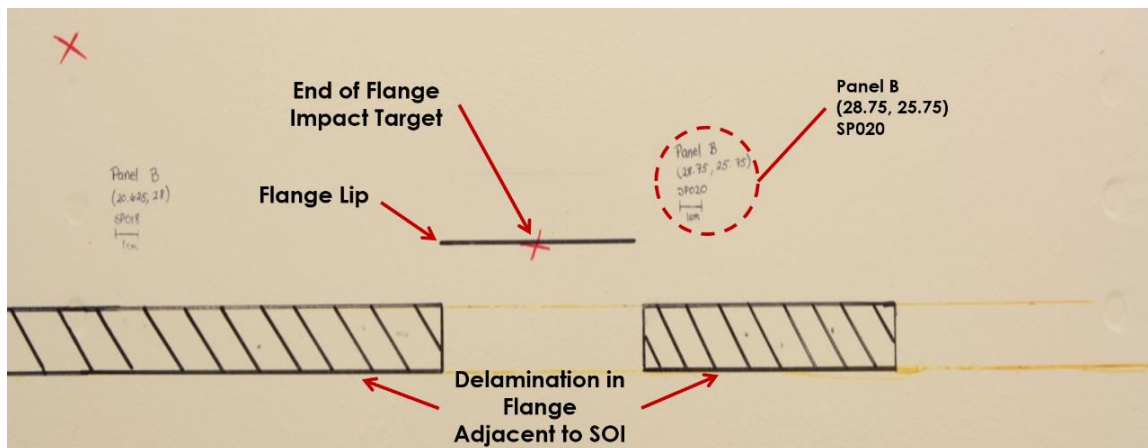
Impacts below the established FTE range for impacts at the end of the flange (Type IIa) were not observed. At 172 J, an impact energy greater than the FTE range, test SP020 caused the flange to create an open lip at the backside that was detectable by touch and delamination in the flange in areas adjacent to the SOI (see Figure 24 and Figure 25). Delamination of the flange at the SOI that was tactile-detectable from the backside, as well as delamination of the flange extending beyond the SOI, were produced by an energy nearly four times the FTE range (see Figure 26). These damage modes which initiated for Type IIa impacts are listed in Table 7.

Figure 24. Delamination Adjacent to the SOI Caused by 172.3 J (56.5 m/s) Impact (Type IIa).

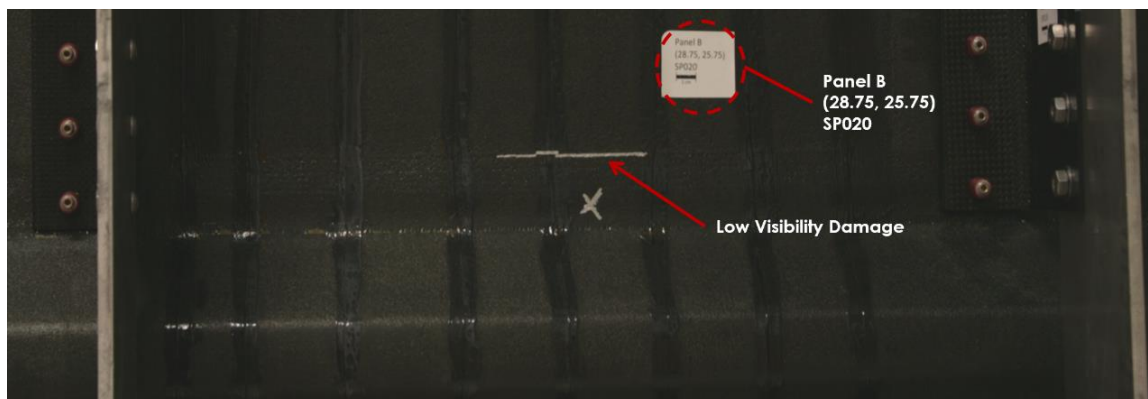
Figure 25. Tactiley Detectable Damage Due to 172.3 J (56.5 m/s) Impact (Type IIa).

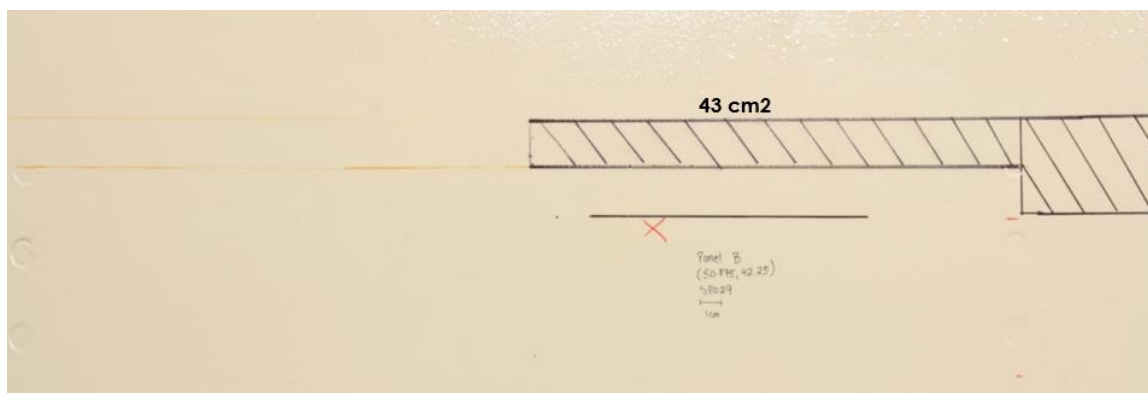
Figure 26. Front Side Damage Caused by 423.3 J (88.9 m/s) Impact at End of Flange - Type IIb.

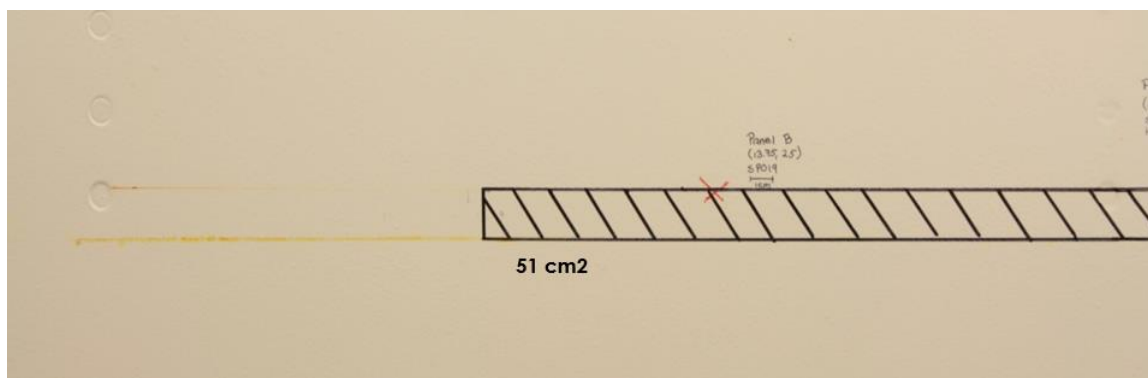
**Figure 27. Front Side of 201.3 J (61.1 m/s) Middle of Flange Impact (Type IIb).**

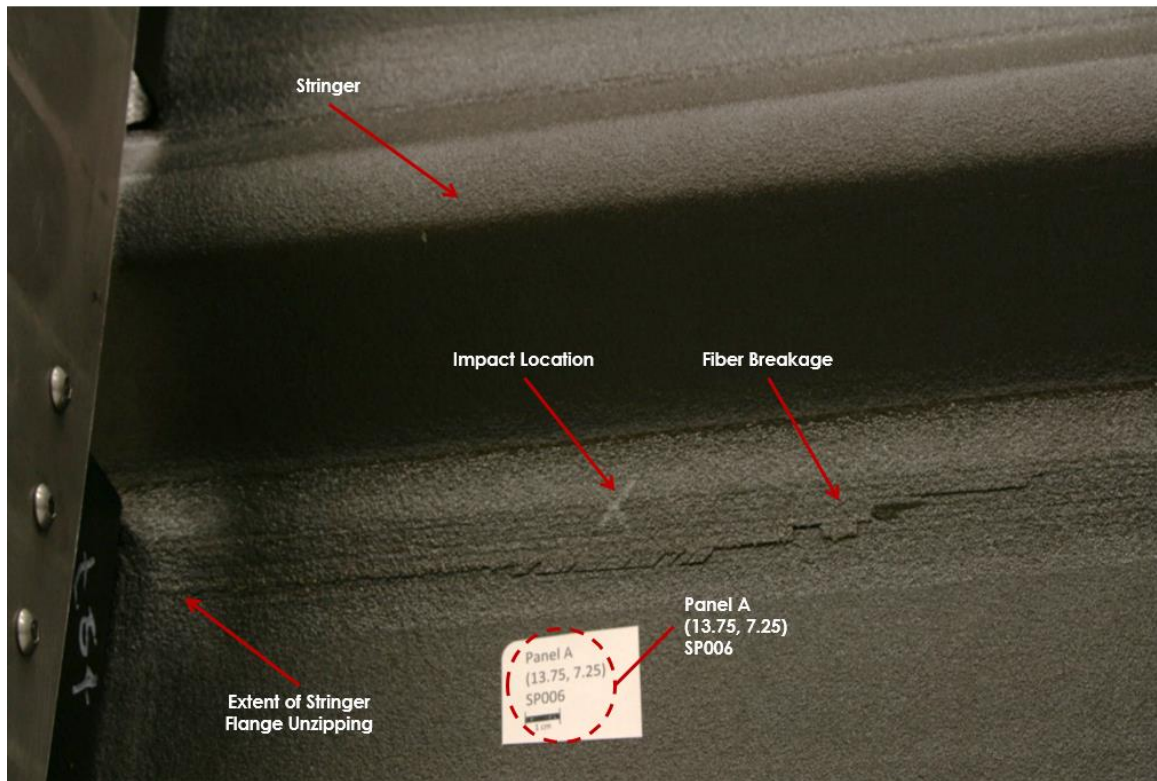
Figure 28. Back Side Damage Caused by 420.7 J (89.6 m/s) Middle of the Flange Impact (Type IIb).

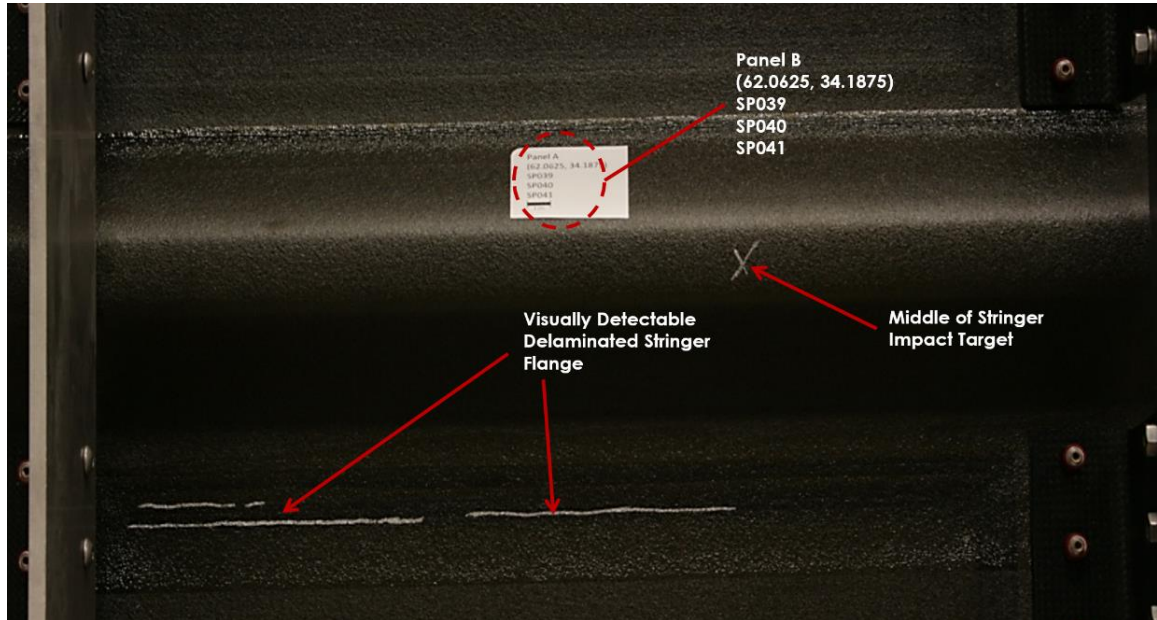
Delamination was not detected for impacts below the 357 J FTE established by the binomial regression analysis. The first damage mode was identified from test SP041 (388.3 J) with delamination in the flanges directly adjacent to the SOI. On the backside, it was visibly detectable that the flanges had delaminated (see Figure 35). Higher impact levels produced delamination at the SOI and in the flange, as well as unzipping of the flange as depicted in Figure 36. These damage modes have been summarized in Table 10.

Figure 35. Visually Detectable Delamination Caused by Type III at an Impact Energy Close to the Established FTE Value.

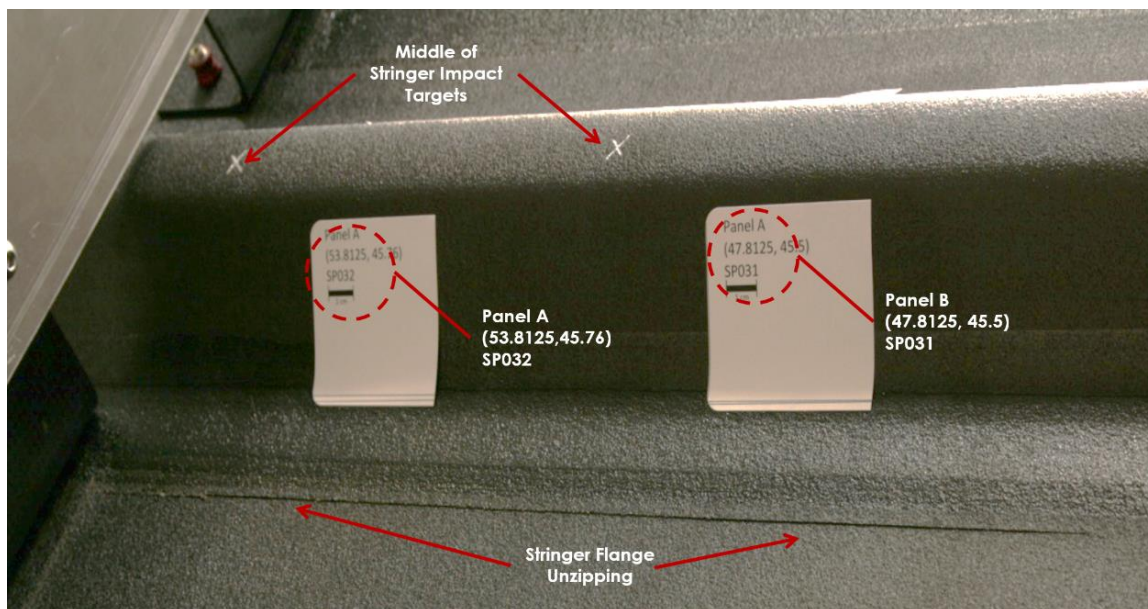
Figure 36. Unzipping of the Flange Due to Impacts Greater than the Established FTE Value (Type III).

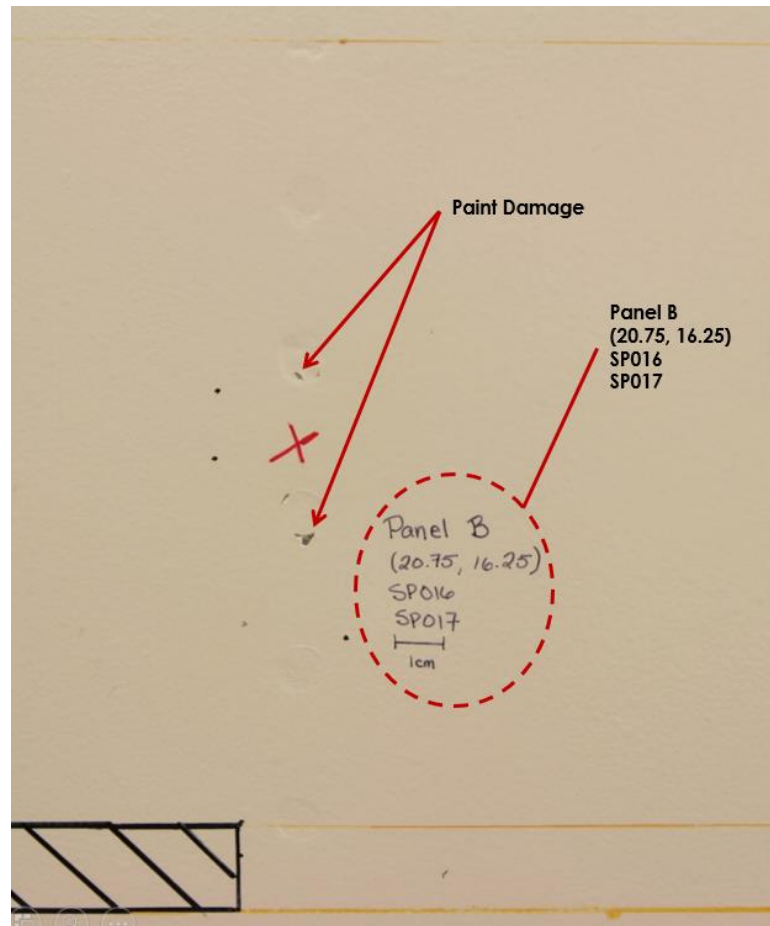
Impacts at energies 476.5 J and less caused the aerospace paint to chip over countersunk rivets, but did not produce any detectable damage (see Figure 39). Figure 40 shows 50 to 60 mm of delamination of the shim and small fiber breakage in the curved section of the shear tie initiated by 669.6 J. As projectile impact energies increased from this value, delamination of the shim and fiber breakage in the curved section of the shear tie extended to the full length of the respective components (see Figure 41 and Figure 42). The damage modes observed are summarized in Table 12.

Figure 39. Visually Detectable Paint Damage Caused by 476.5 J (94.7 m/s) Impact.

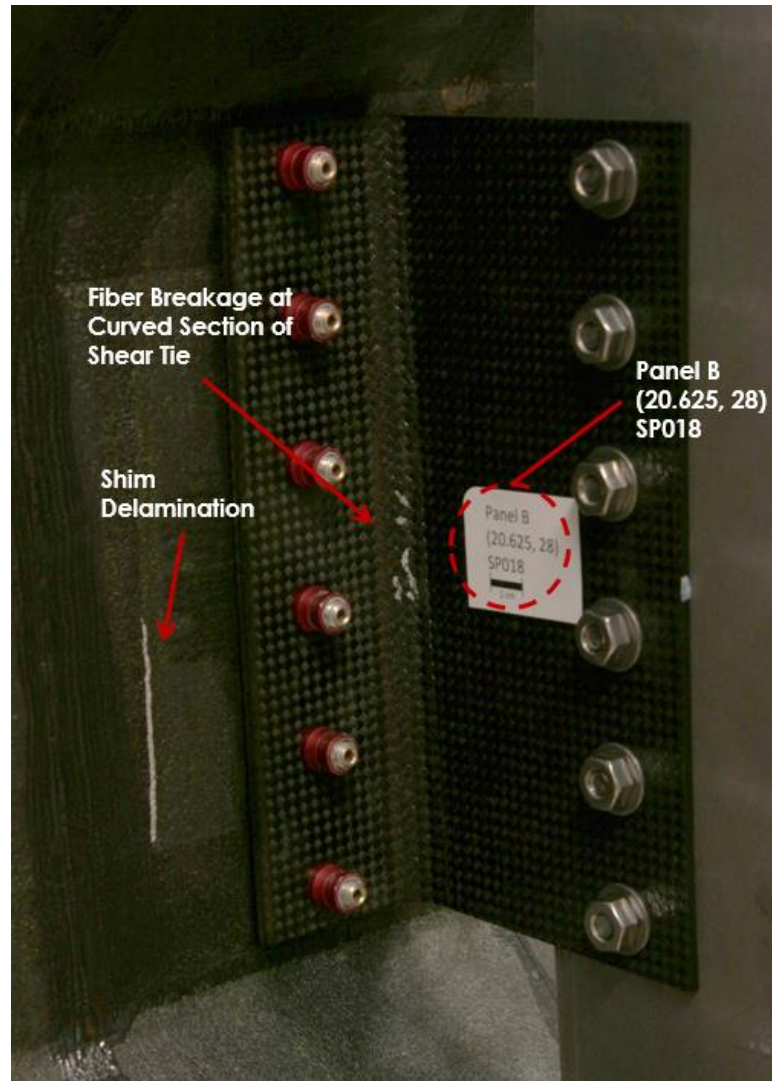
Figure 40. Minimal Backside Damage Due to 669.6 J (111.4 m/s) Impact.

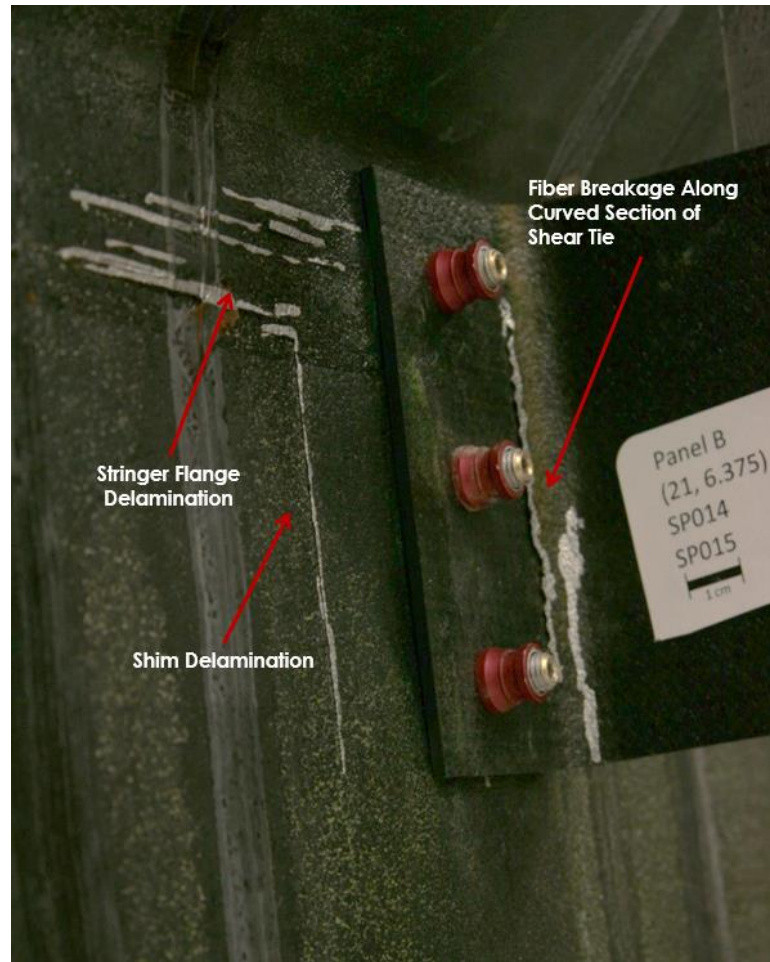
Figure 41. Tests SP014 and SP015 caused fiber breakage along corner of shear tie extending nearly the length of the shear tie as well as delamination of the shim and the stringer flange.

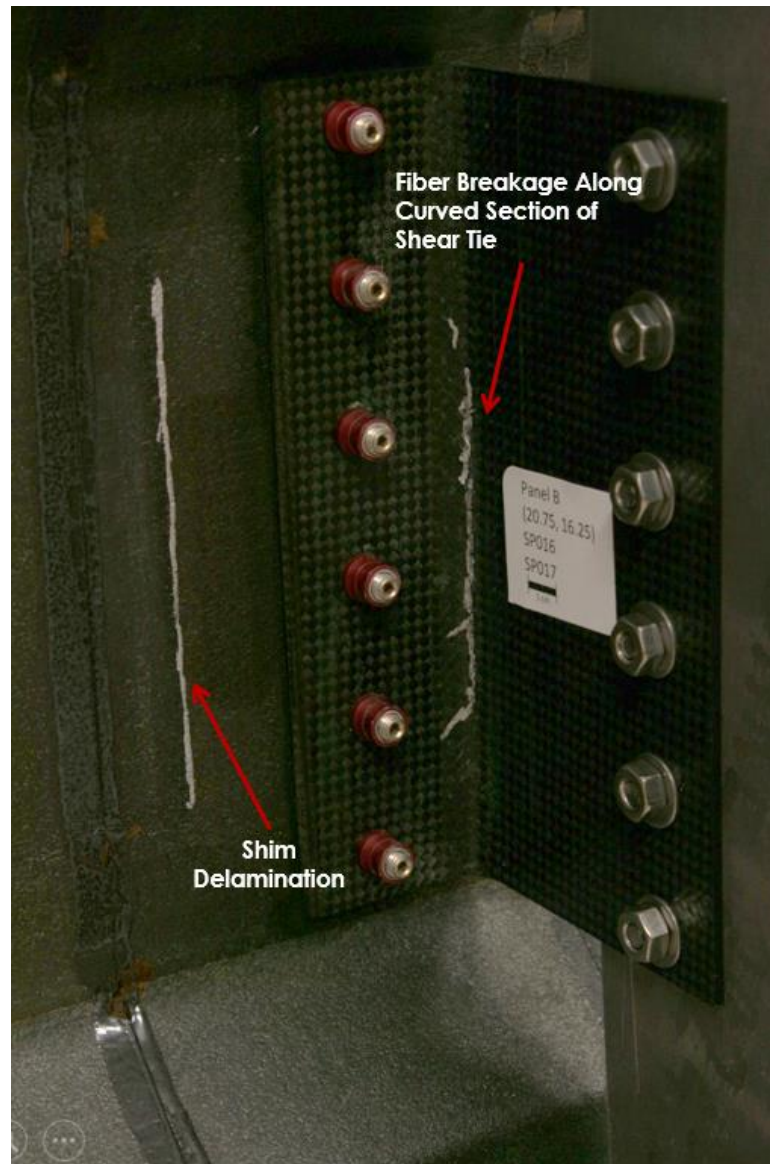
Figure 42. SP017 caused extensive fiber breakage in the corner of the shear tie and delamination of the shim, but did not cause delamination in the stringer flange.

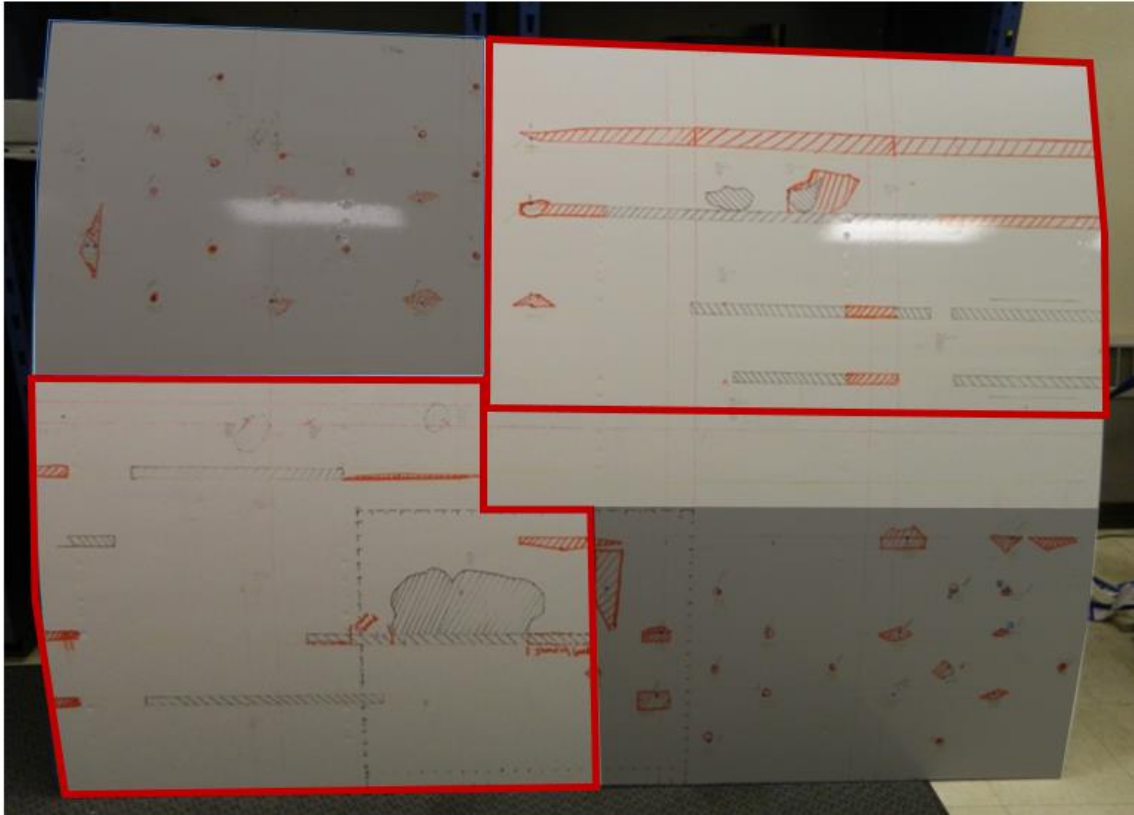
Damaged detected using NDT Automation CBRZ5X2 A-scan was mapped on the panels using black ink. The resulting delaminated areas were presented in the previous sections of Chapter 3. Figure 44 shows additional delamination detected by the MAUS 5 pulse echo unit, marked in orange. The MAUS V pulse echo results found more delamination extending towards the nearest shear tie from test SP032, a middle of the stringer Type III impact. Although these findings would increase the delaminated area calculations presented previously, it would not significantly alter the FTEs identified nor the damage mode progressions identified for each impact type. The damage mode descriptions were inclusive of the additional delamination shown Figure 44.

Figure 44. Damage Mapping of Panel A using A-Scan. Black markings show damage detected using NDT Automation CBRZ5X2 SN:282 by UC San Diego. Additional damage detected using MAUS V pulse echo unit by Sandia National Labs is marked in orange. The red boxes emphasize areas impacted by SHI.

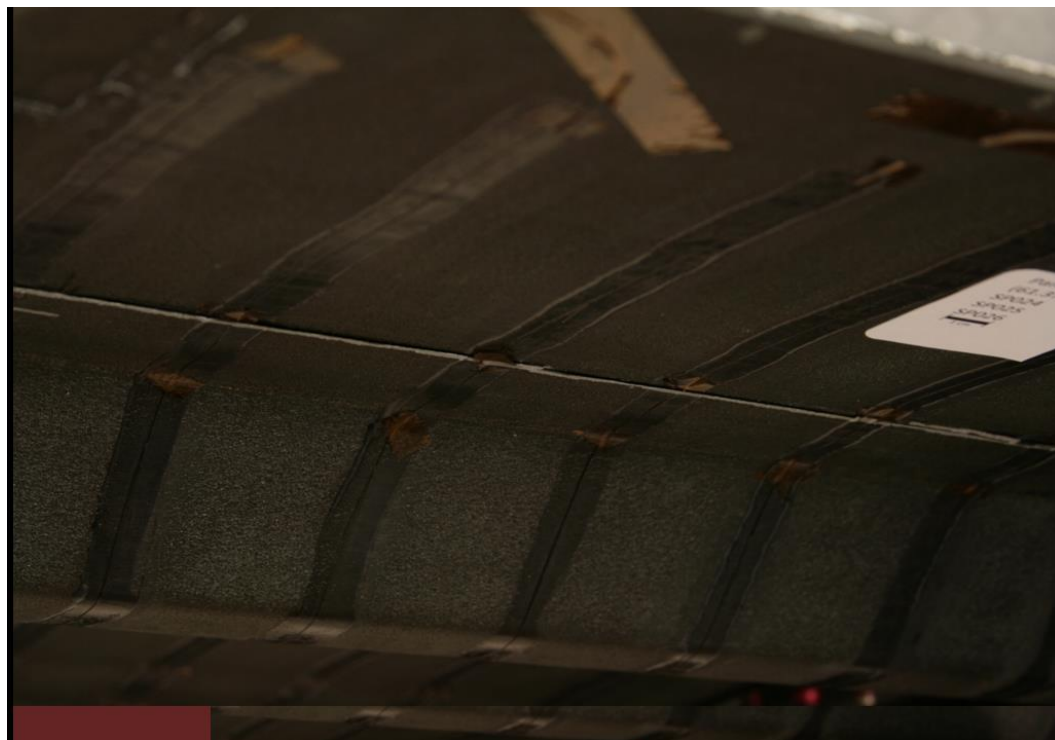
Figure 79. Type I: Unzipping of Flange at Location of Back of SP024 (432.9 J), SP025 (550.2 J), and SP026 (734.8 J).
