The Implementation of the Lower Silver Creek Watershed Project

Christina Keenan and Mariah McPherson

November 12, 2003

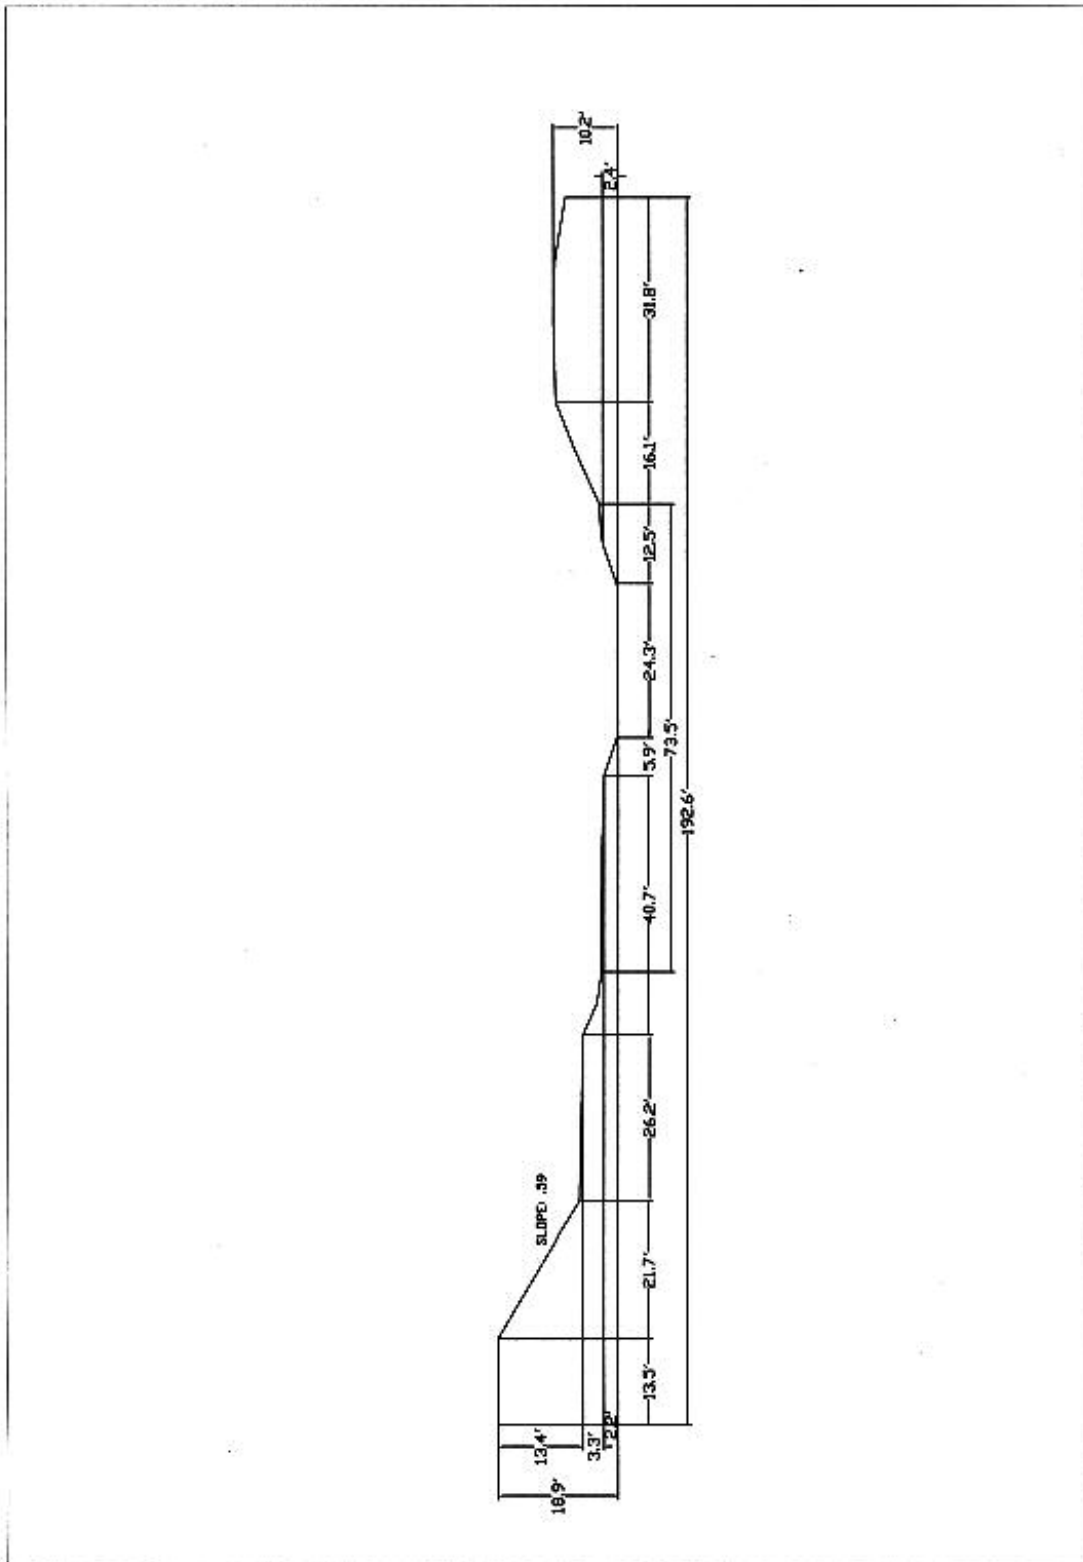
Figure 6: Cross Section One

The depth from the bottom of the channel to the top of the bank was designed to be approximately 18 feet. This dimension was consistent with actual measurements with the exception of the south bank of cross section one, which was only 10.2 feet high. This deviation should not affect the channel's ability to carry flood water due to its proximity to the confluence with Coyote Creek. During a large flood, Coyote Creek will inundate the area near the south bank of cross section one regardless of the height of the bank.

One major discrepancy between the designs and the surveyed cross sections was the width of the low-flow channel. The 1998 plans specified a low-flow channel that was 6 feet in width that would be held in place with willow fascines and a tri-lock block

maintenance road. However, the actual width was approximately 24 feet in cross section one and 19.5 feet in cross section two. Alterations were made to the design drawings in 2001 and the low-flow channel was widened to carry channel-forming flows. The width of this sediment transport channel, unspecified in the 2001 Alteration Plans, is maintained by buried rock walls. A meandering low-flow channel with riffles and pools is expected to form 'freely' after a one- or two-year flood event and establishment of vegetation. The plan anticipates the formation of wetlands in the sediment channel, outside of the low-flow channel. This coupled with the riparian vegetation will decrease the velocity of water (M. Tompkins, University of California, personal communication, 2003).

We recommend that a monitoring plan be continued for reach 1a of Lower Silver Creek. Monitoring could include resurveying cross sections one and two using the established
