REPORT DATE OF PUBLICATION: July 2021
Research Report: UCPRC-RR-2020-01

Concrete Overlay on Asphalt Pilot Project at Woodland SR 113: Construction

Partnered Pavement Research Center (PPRC) Project Number 3.39 (DRISI Task 3201):
Implementation and Field Performance Evaluation of Concrete Overlay on Asphalt

University of California
Pavement Research Center
UC Davis, UC Berkeley

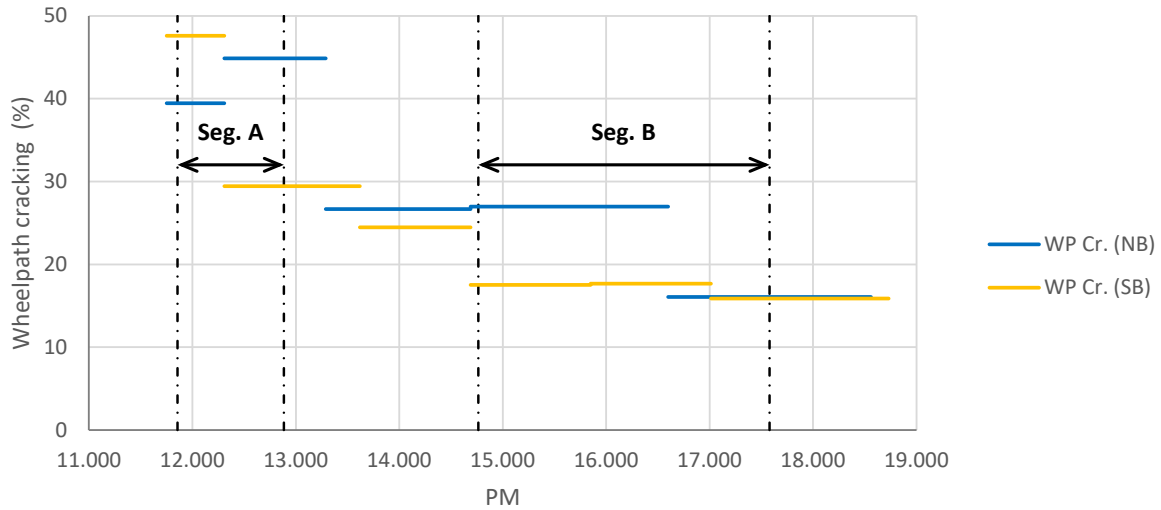
Figure 2.2: Condition of the existing asphalt pavement: cracking.

Before construction, the condition of the existing asphalt pavement at the project site was relatively poor, mainly due to the presence of alligator cracking in the wheelpaths (Figure 2.2). Cracking was more severe in Segment A than in Segment B, probably due to the greater number of trucks and their heavier weights. Rutting was relatively low, varying from 0.1 to 0.2 in. (Figure 2.3). The data used to generate Figure 2.2 and Figure 2.3 come from the Caltrans Automated Pavement Condition Survey. The evaluation of the existing asphalt pavement's condition included coring and falling weight deflectometer (FWD) testing, as explained below.

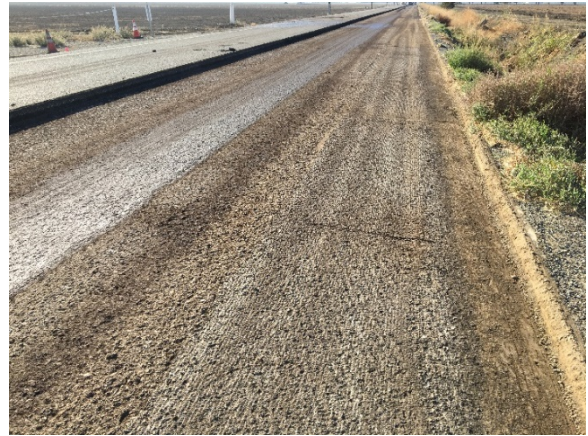
Overall, the milling operation revealed an asphalt base in poor condition. Cracking and areas of delamination were present all over the project (examples in Figure 4.3). Further, in many locations the milling operation either left an insufficient asphalt base or entirely removed the asphalt base at the shoulder edge of the roadway, as shown in the photographs in Figure 4.4. As can be seen in those photographs, the width of the available milled asphalt base was too narrow to provide a continuous support under the COA slabs, which would leave the shoulder edge of the exterior slabs resting on the aggregate subbase instead of the milled asphalt base. This structural condition may eventually cause longitudinal cracking of the concrete overlay. At some locations, the shoulder edge of the milled roadway was paved with asphalt to provide a uniform support for the COA slabs (Figure 4.5).

Segment B: Asphalt cracking and areas with delamination

Figure 4.3: Appearance of the asphalt surface after milling.

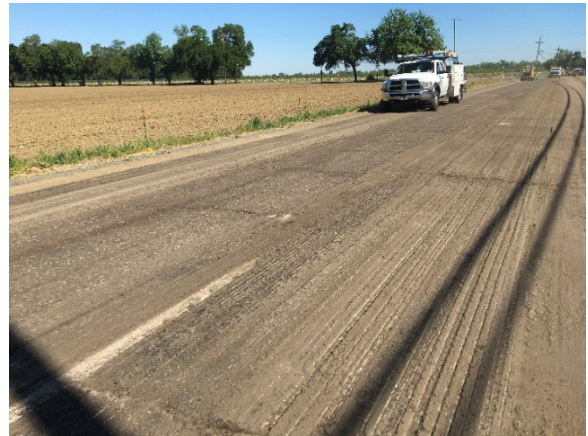
Segment A: Asphalt cracking and areas with delamination

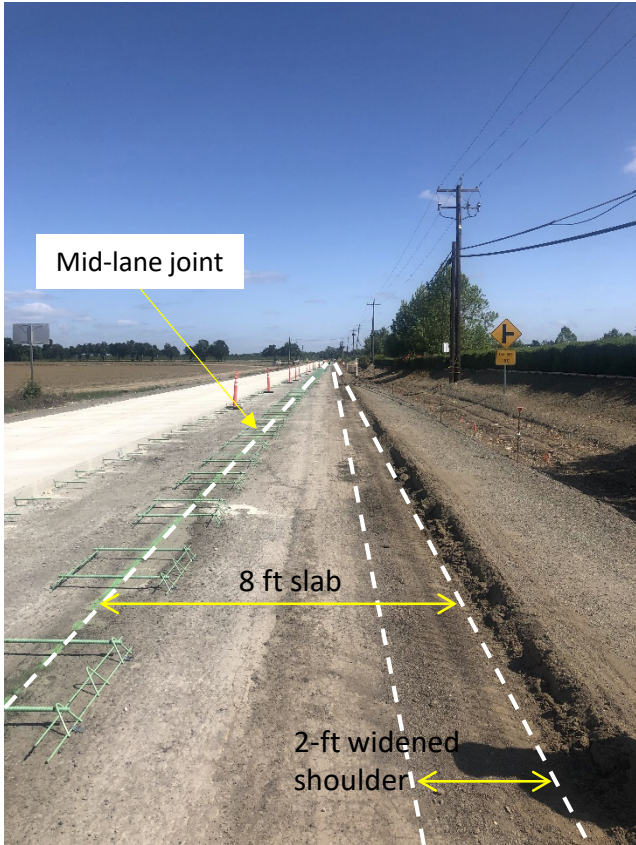
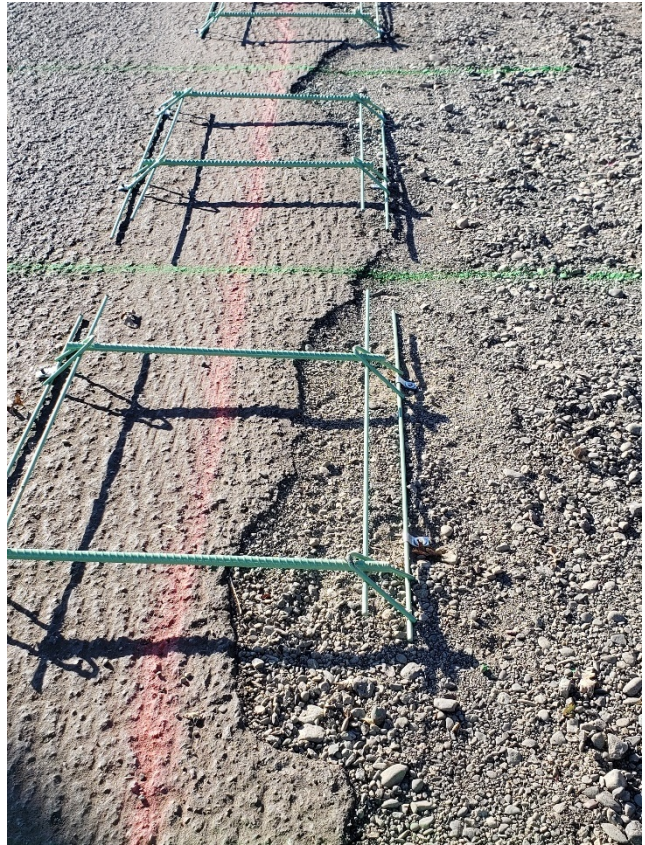
Figure 4.4: Insufficient or and missing asphalt base.

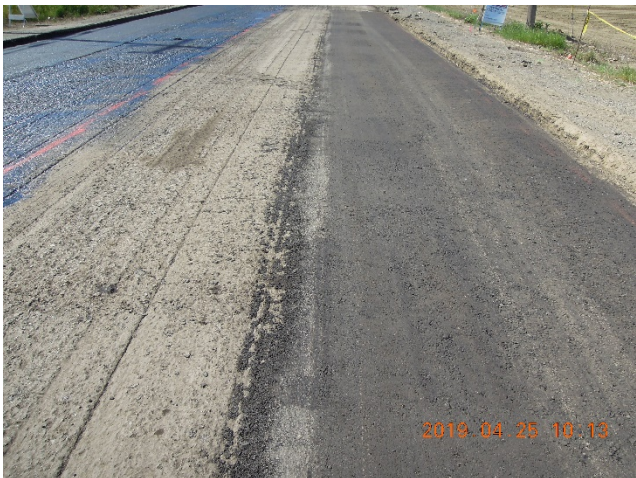
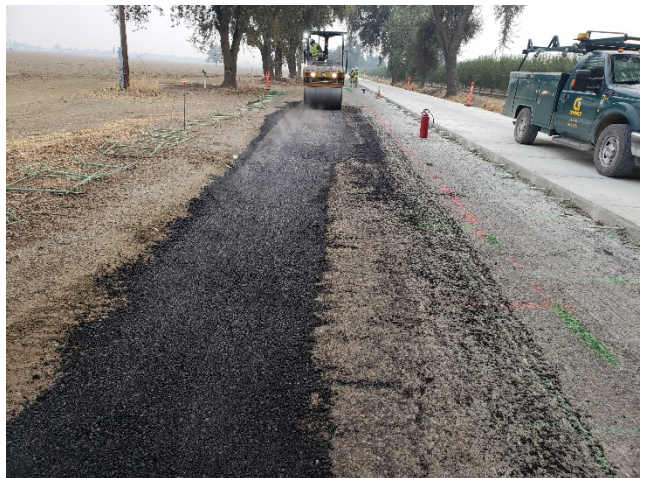
Figure 4.5: Asphalt patching on areas with insufficient or missing asphalt base.

See asphalt patch on the right side of the picture

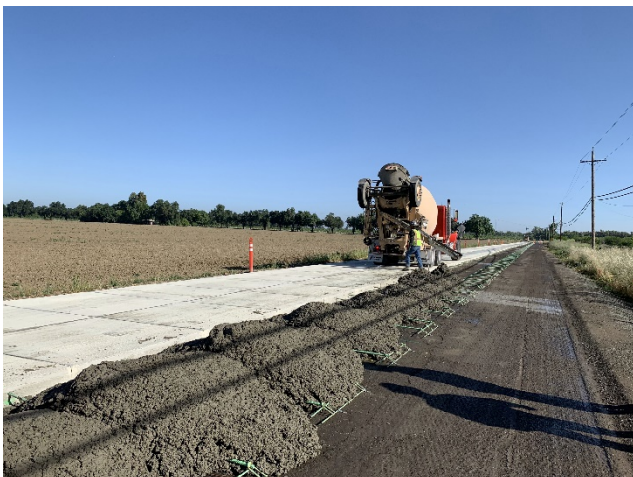
Asphalt surface is adequately wet conditioned: uniformly moist but free of standing or flowing water

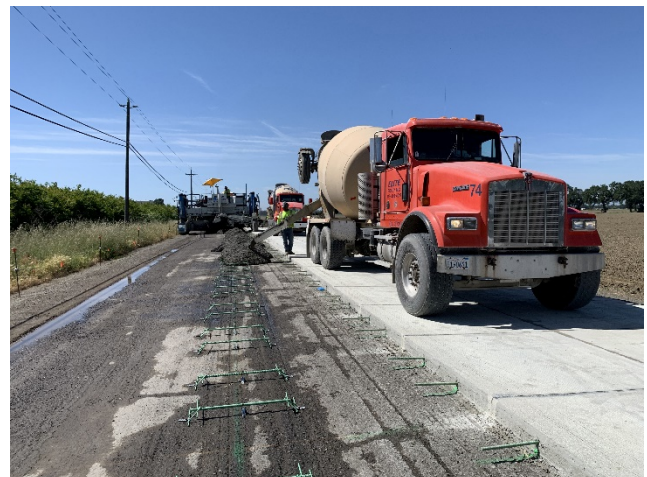
Before placement of the concrete overlay, the asphalt surface was wet conditioned by a truck that sprayed water on it. Overall, the asphalt surface was adequately wet conditioned; it was wet but free of standing water, approximating a saturated surface-dry condition (Figure 4.15, left). At some spots, however, the asphalt surface dried before the concrete was placed (Figure 4.15, right) and it would have been beneficial to have sprayed these spots with water manually. At other locations, the irregularity of the milled asphalt surface caused water ponds to form at the shoulder edge of the roadway (Figure 4.15, right). This standing water may have had a negative effect on the concrete poured at these locations.

Asphalt surface is not adequately wet conditioned: some dry areas; standing water at the shoulder

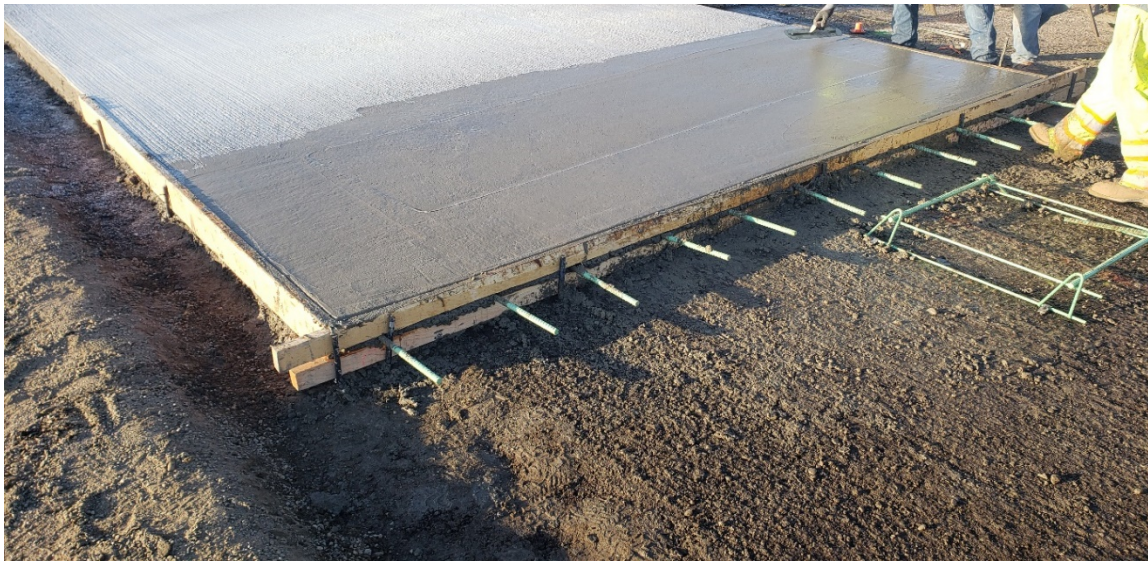
Figure 4.24: Installation of tie bars instead of dowels at a transverse joint (end of paving Shift 1).

Some of the transverse construction joints (beginning/end on paving shifts) were built incorrectly. Specifically, at the first construction joint (Section B, northbound direction, between paving Shifts 1 and 2), tie bars rather than dowels had been installed (Figure 4.24). After learning of the issue, the resident engineer instructed the contractor to use dowels at the transverse construction joints. Even though this was done, in some cases lubricant was applied either poorly or not at all. As a result, some of these joints may have locked.
