Seismic Damage Assessment of a Full-Scale 10-Story Building Using UAV Vision-Based Sensing

This study investigates UAV vision-based sensing for damage assessment of a full-scale 10-story cold-formed steel (CFS) framed building during a series of shake table tests conducted at the 6 degree-of-freedom Large High-Performance Outdoor Shake Table (LHPOST6) at UC San Diego. The schedule and implementation plan for two UAV vision-based inspection approaches during the seismic test program are presented including photogrammetry and image-based inspection. A damage assessment methodology for the image-based inspection is proposed, which integrates high-resolution aerial imagery collected before and after the seismic test and multiple image processing and computer vision algorithms to enable the assessment of structural and nonstructural damage observable at small scales. The location and scale of the damage is extracted by the thresholded absolute difference within the intensity normalized co-registered image pairs with baseline (pre-test) and damage (post-test) images. The proposed methodology is illustrated using a selected damage from the exterior insulation finishing

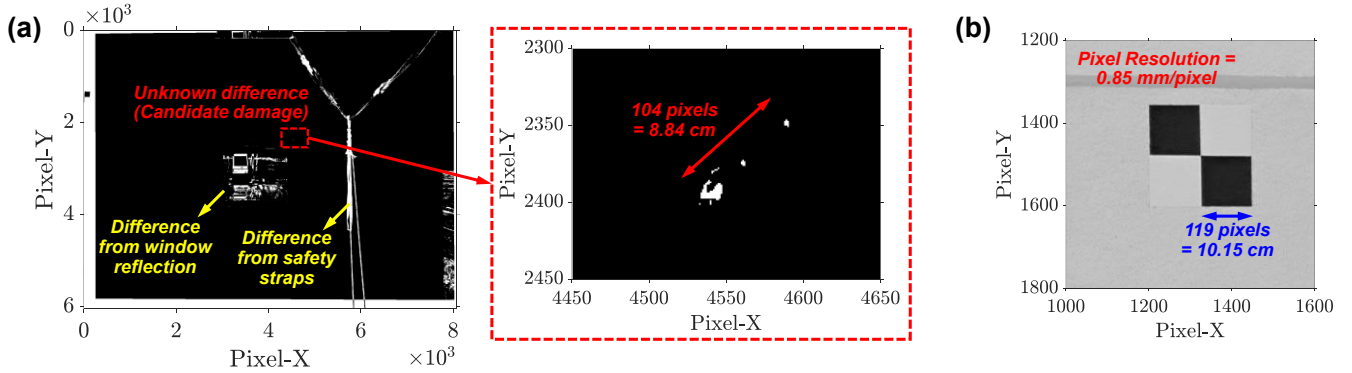
**Fig. 6** (a) Detected difference with zoom-in view for candidate damage, and (b) Pixel resolution calculation using features with known dimensions from the pre-test grayscale image.

It is noted that the binary image result represents all detected differences between the baseline (pre-test) and damage (post-test) image. Therefore, it may include other non-damage differences in the test scene. For the presented example, the non-damage differences include the removal of the safety straps around the building and the difference caused by the various reflection from the window glazing. The final candidate damage could be extracted by excluding the known non-damage differences in the detection result. In addition, the scale of the damage could be estimated from the pixel resolution of the image extracted from features with known dimensions in the image frame. In the presented case, the pixel resolution of the image frame is 0.85 mm/pixel extracted using the black-and-white checkerboard reference target on the building façade as shown in Fig. 6(b). The total scale of the detected damage is extracted as 104 pixels which correspond to 8.84 cm in length.

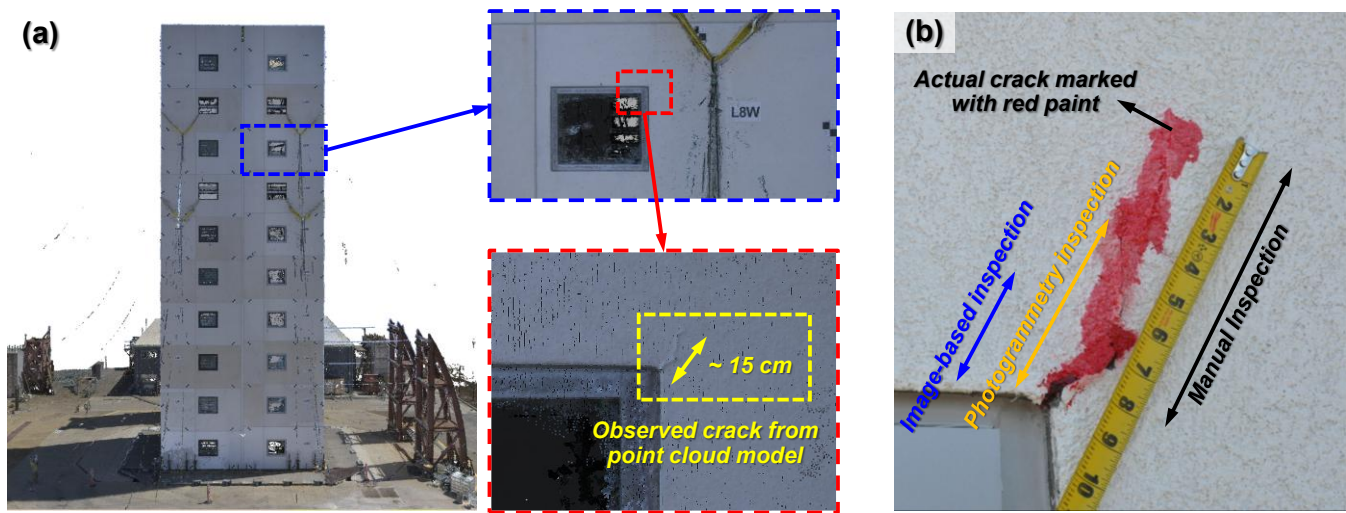
For the selected crack damage located at the upper-right corner of the Level 8 west window from the EIFS on the north façade of the building, the damage is successfully located and extracted with an identified length of 8.84 cm. Fig. 7 presents the same damage observed from a point cloud model based on photogrammetry and a close-up view obtained with manual inspection using a traditional digital single-lens reflex (DSLR) camera. The length of the crack was measured as around 15 cm from the point cloud model and around 8.75 inches (22.23 cm) from the manual inspection. Although it is noted that the scale of the damage extracted from the image-based inspection and photogrammetry inspection are smaller than the actual dimension measured during manual inspection as shown in Fig. 7(b), the proposed damage detection methodology for image-based inspection could provide rapid localization and coarse scale estimation using the UAV-captured images with minimized manual operations.

**Fig. 7** Crack at the upper-right corner of the L8 west window observed from (a) point cloud model based on photogrammetry, and (b) close-view manual inspection.
