Hail Ice Impact of Lightweight Composite Sandwich Panels /

Hail Ice Impact of Lightweight Composite Sandwich Panels

A Thesis submitted in partial satisfaction of the
requirements for the degree of Master of Science

Sean Dustin Luong

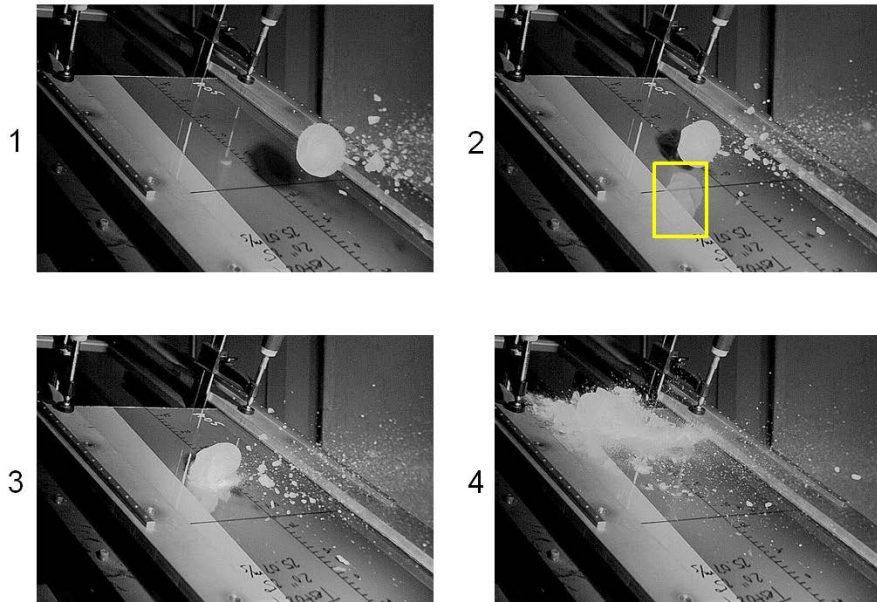
The importance of the SHI integrity cannot be understated; in the second image of Figure 2.1.2, it can be seen in the reflection highlighted by the yellow box that the SHI broke in half prior to impact. This led to a higher than usual level of crushing during impact which dissipated a lot of the energy. Although this test was a high velocity/energy test at 49.38 m/s and 75.24 J, it produced a dent of only 0.02 mm, whereas a test with similar conditions at 48.26 m/s produced a significantly noticeable dent because the SHI did not lose energy from breaking apart.

Figure 2.1.2. SHI cracked prior to impact, resulting in significantly reduced damage.

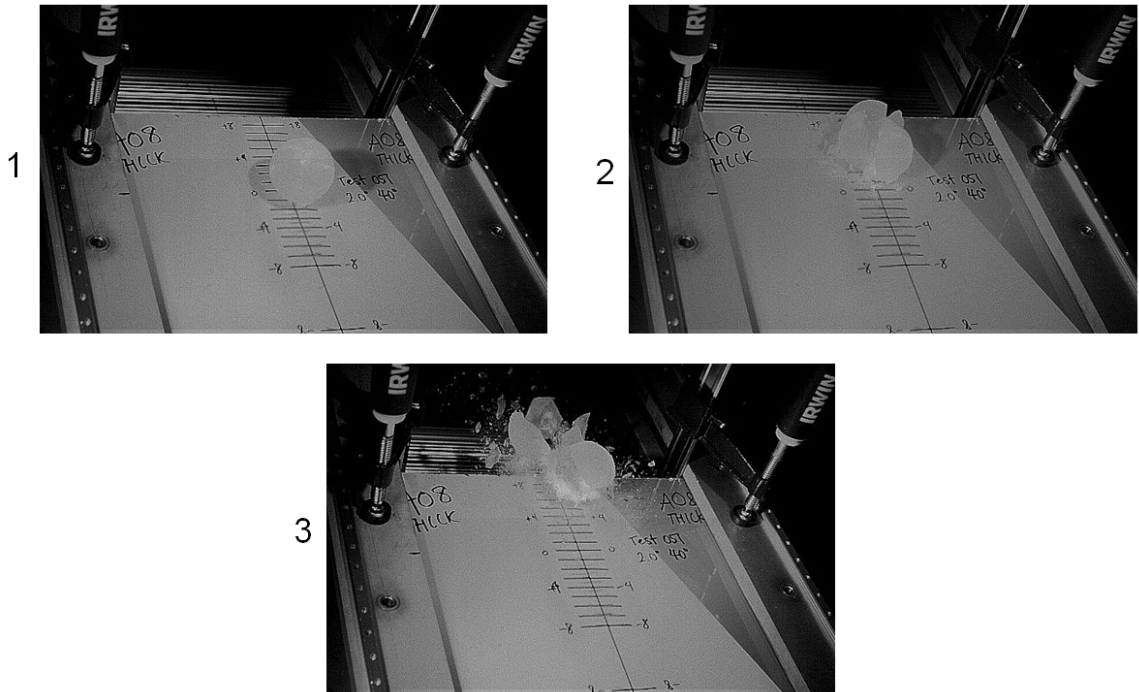
Though the SHI in Figure 2.1.3 broke upon impact, it did not completely crush like the one in Figure 2.1.2, and it resulted in a higher level of internal damage even though the test was a lower velocity/energy test at 25.46 m/s and 20.45 J. However, it should be noted that this specimen was impacted at a steeper angle of 40 degrees.

Figure 2.1.3. SHI intact prior to impact, but broke on impact, resulting in core damage without dent.

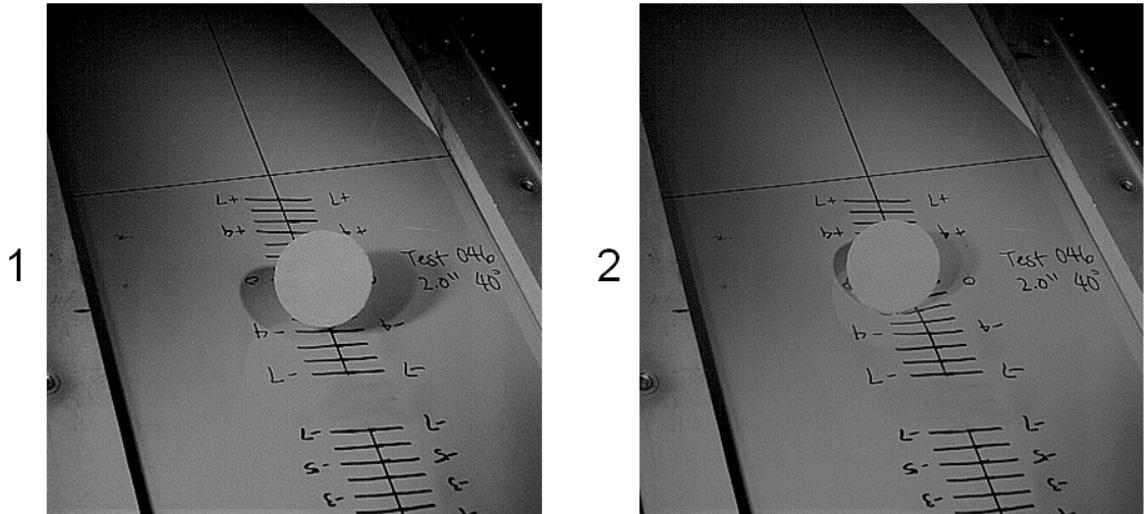
Finally, Figure 2.1.4 shows the case where the projectile stayed intact during the impact. Since the SHI did not break, no energy was lost and more of it was transferred into the target, which resulted in facesheet penetration.

Figure 2.1.4. SHI did not break during impact, resulting in facesheet penetration.

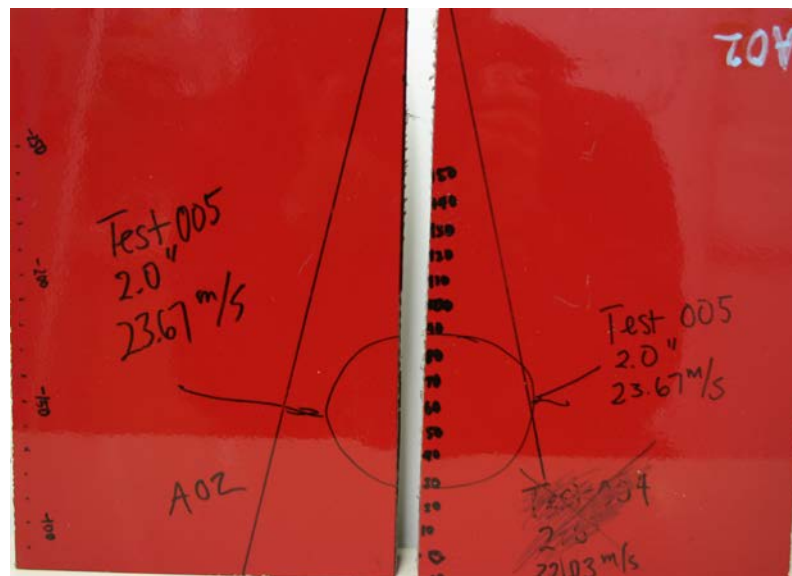
Figure 3.1.1. Bisection through impact zone of Test-005 on Panel A02.

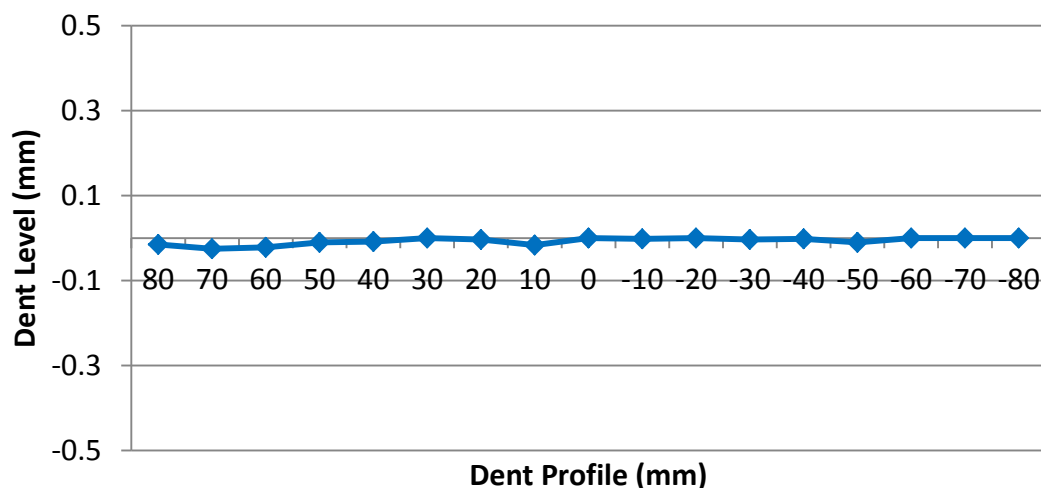
Figure 3.2.1. Dent profile of Test-052 on thick facesheet Panel A08 (23.14 m/s at 40 degrees).

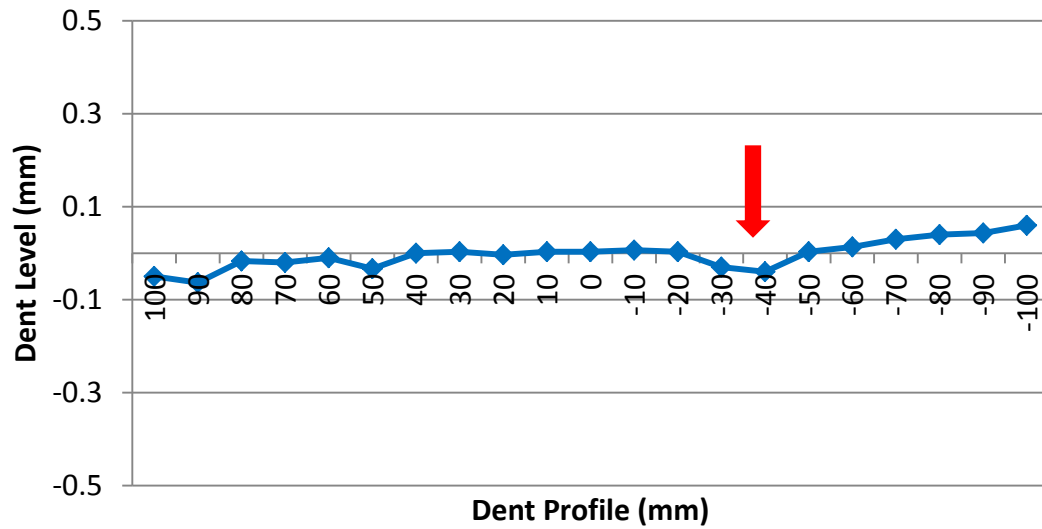
Figure 3.2.2 features Mode B damage where the impact did not leave a readily visible dent, but there was a measurable dent of 0.04 mm at the point of impact around -40 mm.

Figure 3.2.2. Dent profile of Test-008 on thin facesheet Panel A03 (23.90 m/s at 25 degrees).

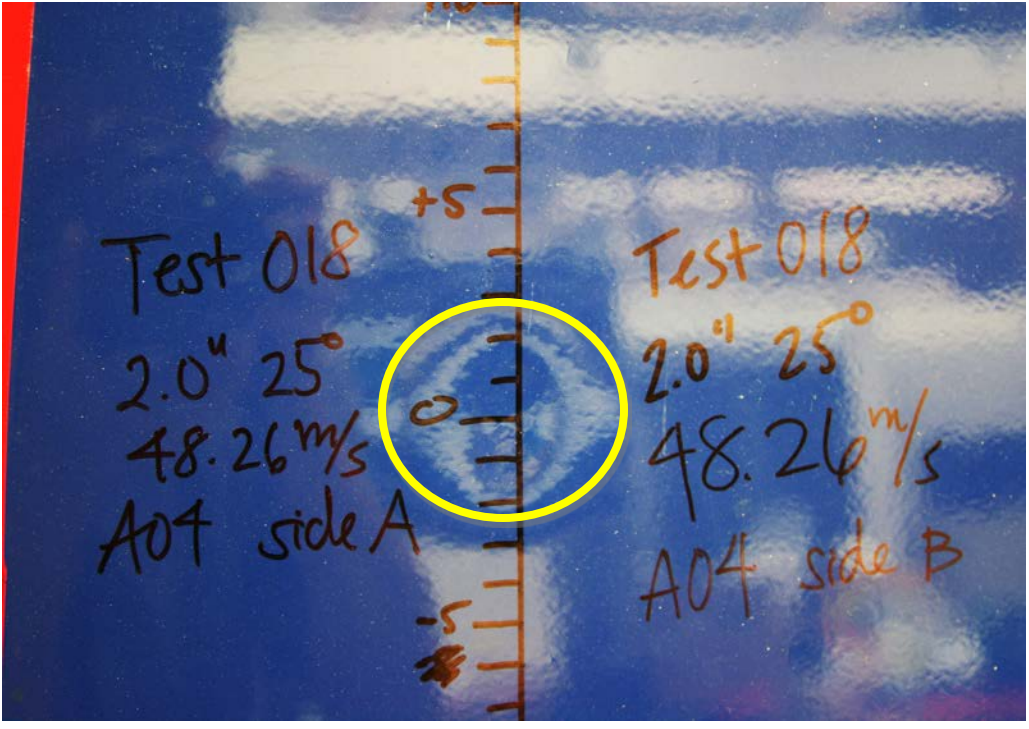
Mode C can be seen in Figure 3.2.3 and Figure 3.2.4 where there is an easily visible dent on the surface highlighted by the yellow circle as well as a clearly defined dent profile.

Figure 3.2.3. Visible dent from Test-018 on thick facesheet Panel 04.

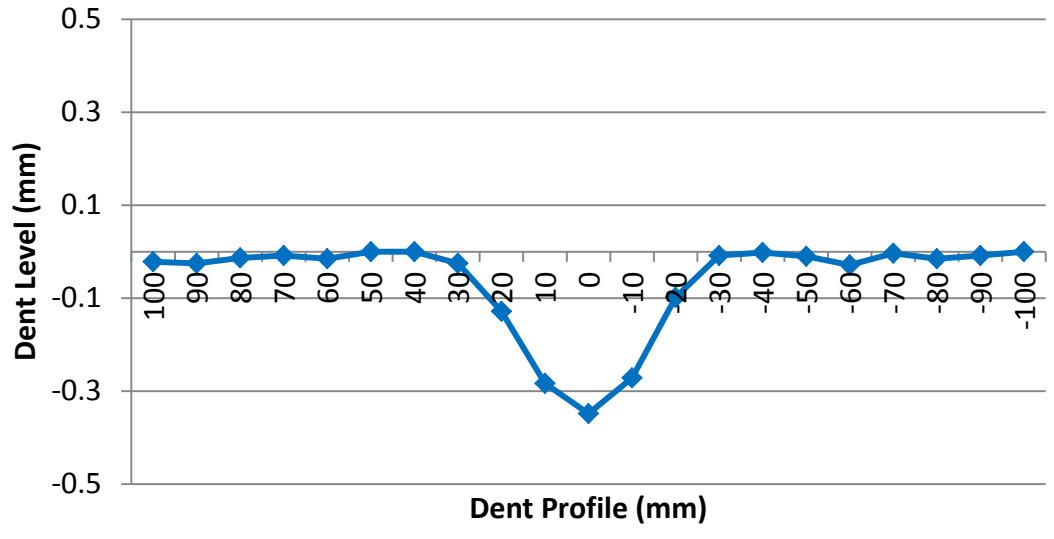
Figure 3.2.4. Dent profile of Test-018 on thick facesheet Panel 04 (48.26 m/s at 25 degrees).

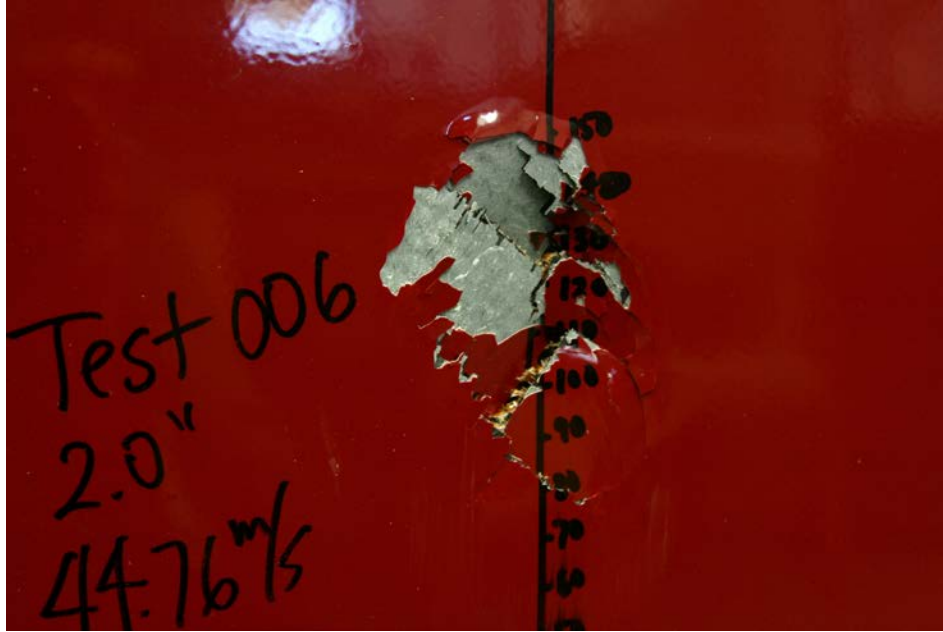
Mode D can be seen in Figure 3.2.5; a dent profile was not created for Test-006 because the facesheet was penetrated.

Figure 3.2.5. Visible skin penetration from Test-006 on thin facesheet Panel A02 (40 degrees).

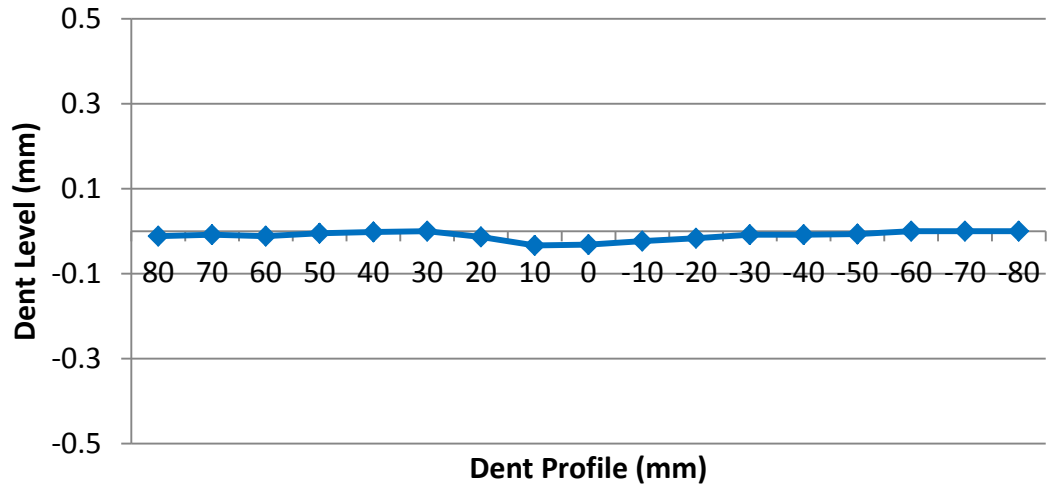
At first glance, Figure 3.2.6 appears to be a Mode A case where there is no visual/measurable damage, perhaps suggesting that there is no internal damage (such as in Figure 3.2.1). However, after destructive sectioning is performed, it is clear that there is significant core damage and the case actually represents Mode E. Therefore, visual inspections and even procedures conducted on the surface are not necessarily reliable metrics to determine the presence of internal damage.

Figure 3.2.6. Dent profile of Test-051 on thick facesheet Panel A08 (25.46 m/s at 40 degrees).

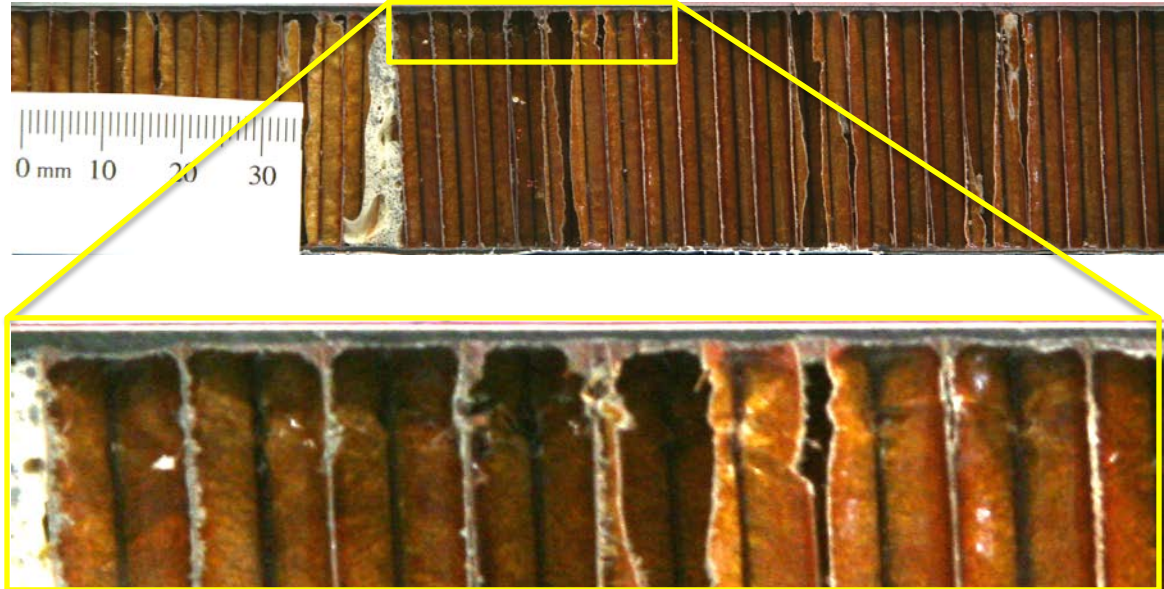
Once a panel had been thoroughly examined and all necessary measurements were taken, it would then be longitudinally sectioned down the mid-line of impact zone. Destructive sectioning of all the thin facesheet specimens revealed that all of them had varying degrees of core damage which can be organized into three modes: I) slight cell wall wrinkling, II) cell wall buckling, III) core fracture. The thin facesheet specimens were impacted at 25 degrees, 40 degrees, and 90 degrees, at both 25 m/s and 50 m/s (nominal speeds), and the 50 m/s impacts consistently produced facesheet penetration at every test angle. Mode I core damage was only present in the 25 degree impact tests at 25 m/s. Figure 3.3.1 shows a thin facesheet specimen that exhibits Mode I core damage.

Figure 3.3.1. Mode I core damage in Test-017 on thin facesheet Panel A04 (28.02 m/s at 25 degrees, 0.07 mm peak dent).

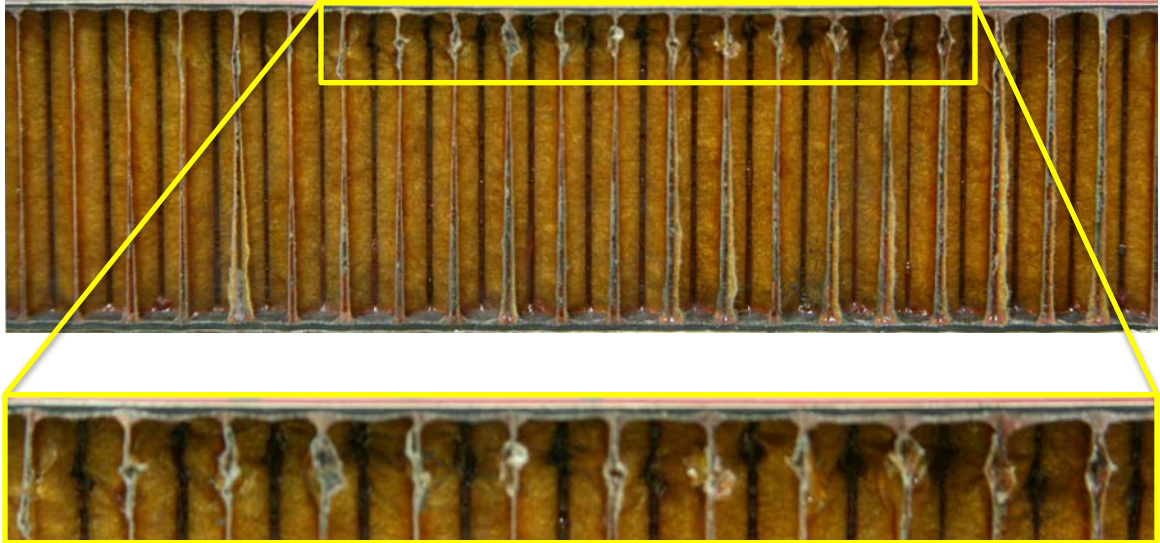
Mode II core damage is distinguished by more pronounced folds in the cell wall structure. The span of core damage is nearly twice as long as usual in Figure 3.3.2 because two impact tests (Test-003 and Test-004) took place in that region. This occurred when the SHI fired slower than predicted due to a significant amount of pressure leaking out of the gas gun prior to firing. The result was that the SHI exited the barrel at a lower speed and struck the panel beneath the target, ending up next to the previous impact zone. For thin facesheets, Mode II core damage only occurred in the 40 degree impact tests at the 25 m/s speed, whereas the 50 m/s test penetrated the outer facesheet.

Figure 3.3.2. Mode II core damage in Test-003 on thin facesheet Panel A02 (24.69 m/s at 40 degrees, 0.64 mm peak dent).

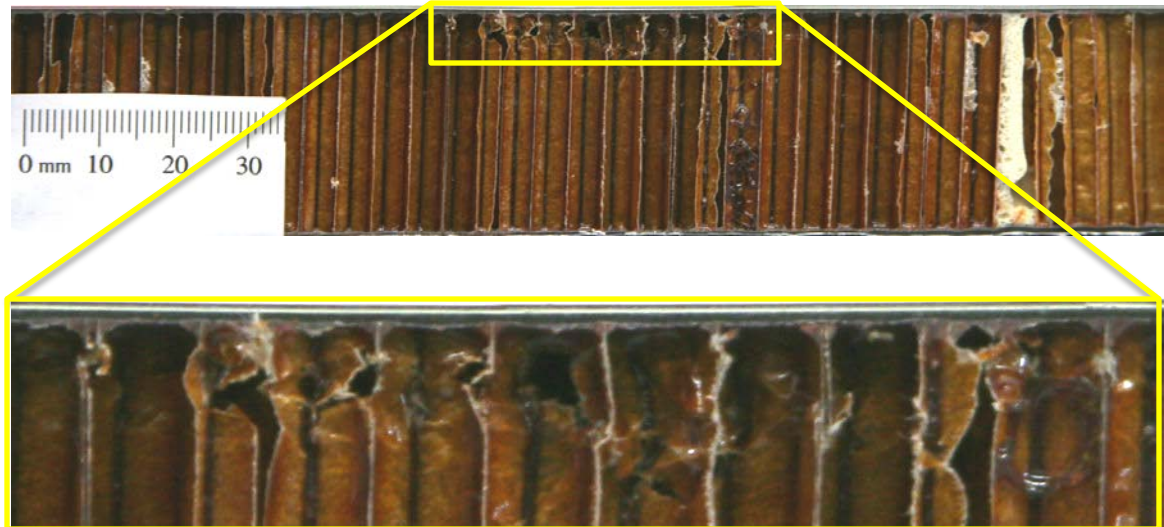
Mode III core damage is different from the previous two damage modes in that the cell walls actually fractured in addition to wrinkling. For the thin facesheet specimens, this damage mode only occurred in one test at 25 degrees and 50 m/s. This scarcity is likely because this damage mode represents a more local event that requires a higher velocity impact without penetrating the facesheet (otherwise the penetration would result in a lot of core buckling, but not fracture). Significant core fracture damage can be seen in Figure 3.3.3.

Figure 3.3.3. Mode III core damage in Test-015 on thin facesheet Panel A03 (43.31 m/s at 25 degrees, 0.44 mm peak dent).

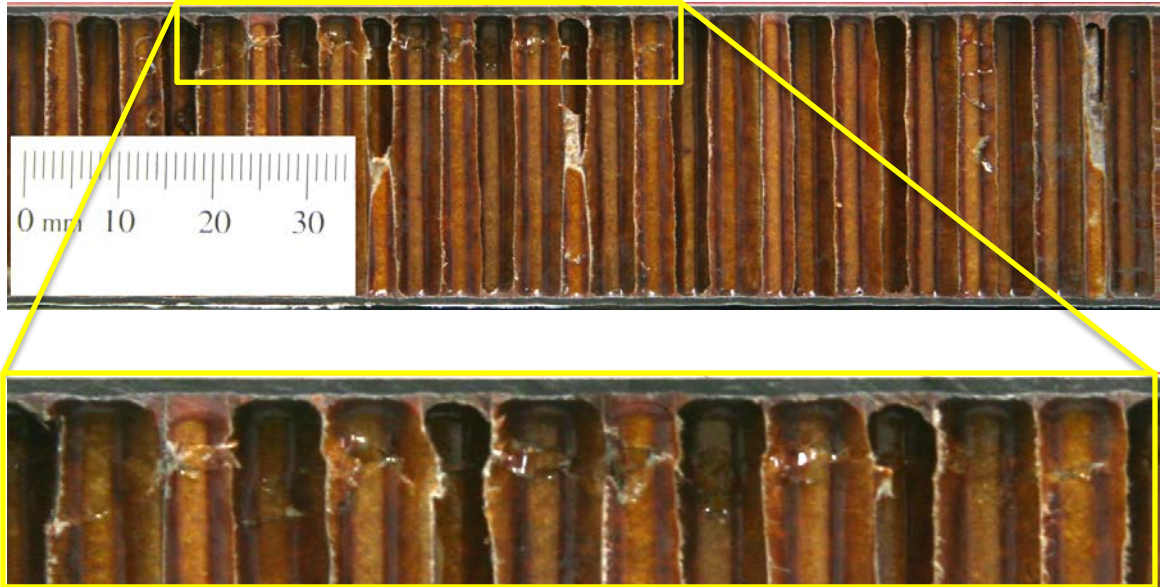
The thick facesheet specimens behaved quite differently from the thin facesheet specimens. These specimens were only impacted at 25 degrees and 40 degrees at 25 and 50 m/s. The results were inconsistent and not quite predictable: out of three 25 degree tests at 50 m/s, two exhibited Mode III damage while one barely showed any sign of Mode I wrinkling. Out of two 40 degree tests at 25 m/s, one exhibited Mode III damage while the other had no evidence of damage. These results show that Mode III damage can occur at varying levels of energy. Figure 3.3.4 shows very pronounced core fracture that was caused by a high 89.56 J energy impact, while Figure 3.3.5 shows that similar damage can be produced by a low 20.45 J energy impact.

Figure 3.3.4. Mode III core damage in Test-036 on thick facesheet Panel A06 (51.81 m/s at 25 degrees, 0.16 mm peak dent).

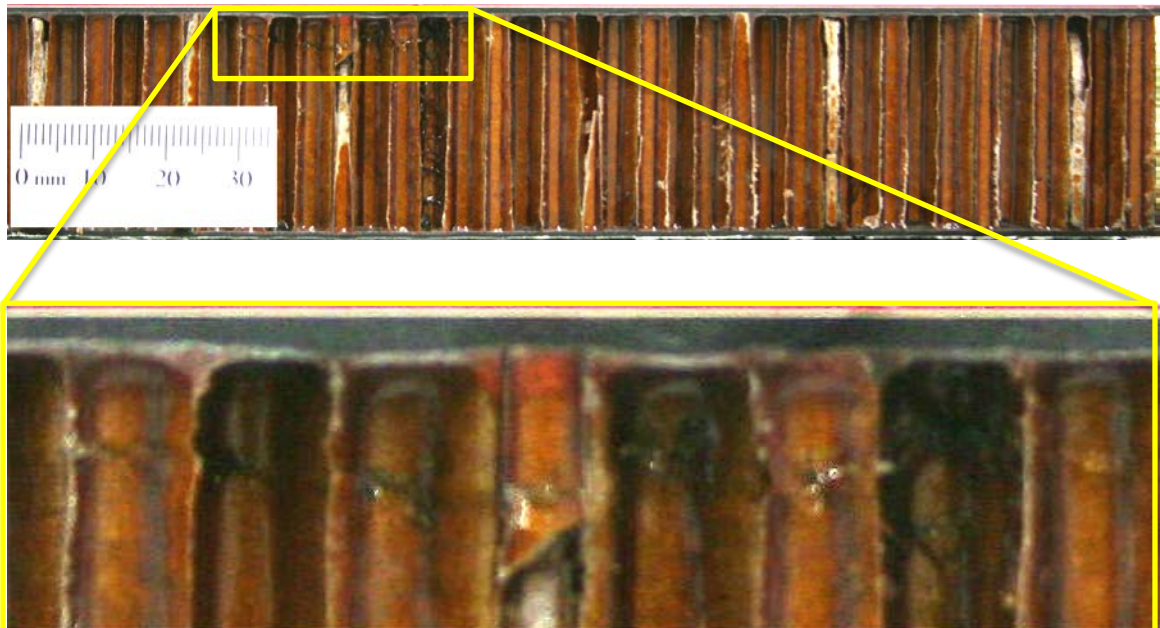
Figure 3.3.5. Mode III core damage in Test-051 on thick facesheet Panel A08 (25.46 m/s at 40 degrees, 0.03 mm peak dent).

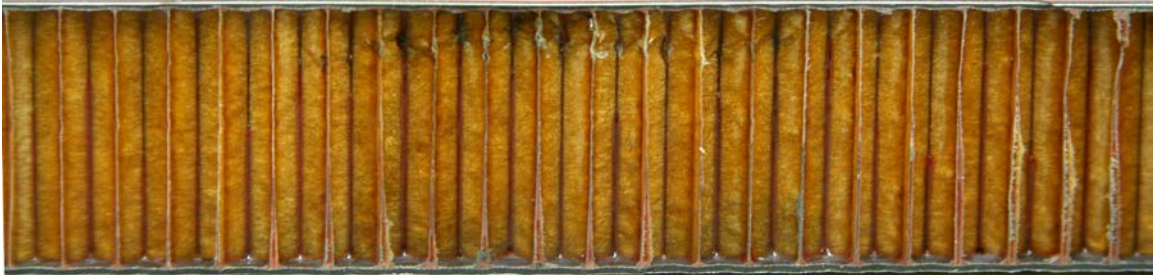
Peak dent 0.53 mm, Test-005 on thin facesheet Panel A05 (23.67 m/s at 40 degrees),
visible dent with Mode II core buckling

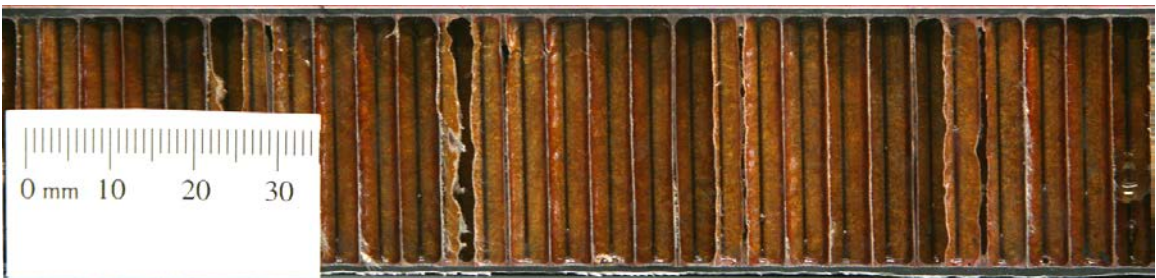
Peak dent 0.04 mm, Test-008 on thin facesheet Panel A03 (23.90 m/s at 25 degrees),
no visible dent with Mode I core wrinkling

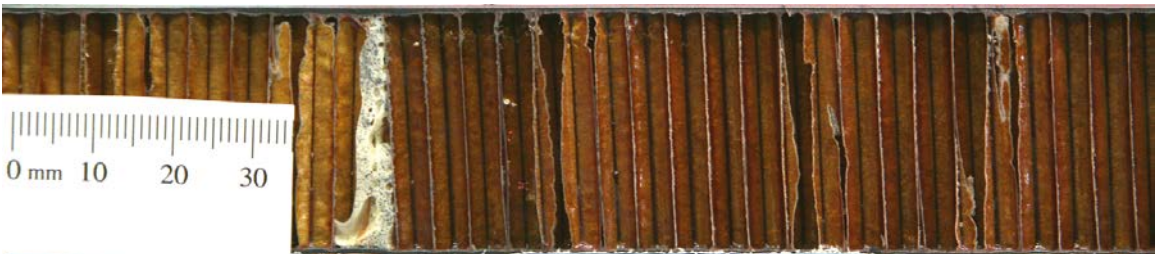
Peak dent 0.07 mm, Test-017 on thin facesheet Panel A04 (28.02 m/s at 25 degrees),
no visible dent with Mode I core wrinkling

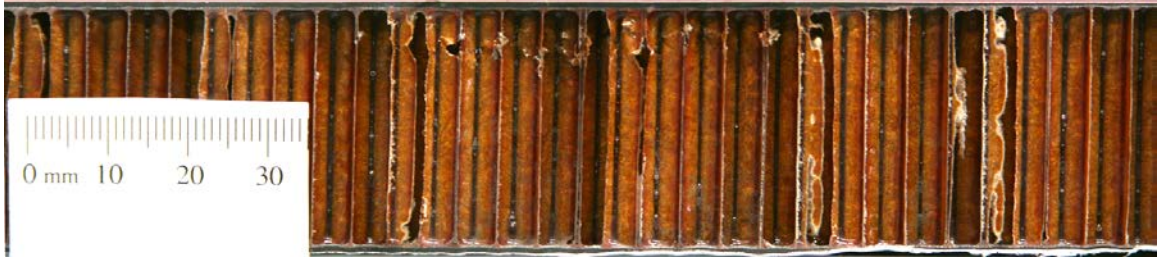
Peak dent 0.35 mm, Test-018 on thick facesheet Panel A04 (48.26 m/s at 25 degrees), ice cracked, slid and then reflected off the panel, visible dent with Mode III core fracture

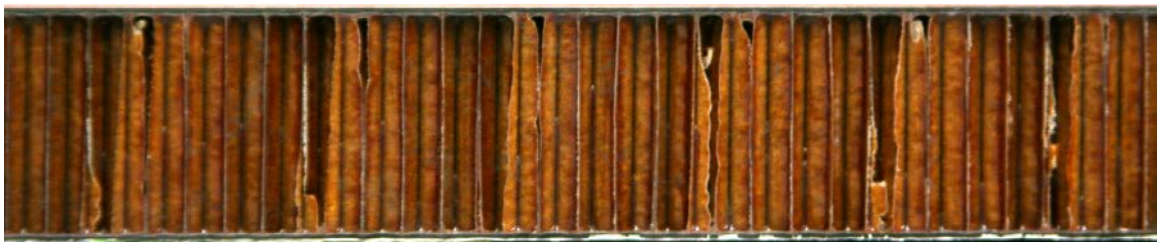
Peak dent 0.01 mm, Test-029 on thick facesheet Panel A05 (25.07 m/s at 25 degrees), status of ice upon impact unknown, no visible dent

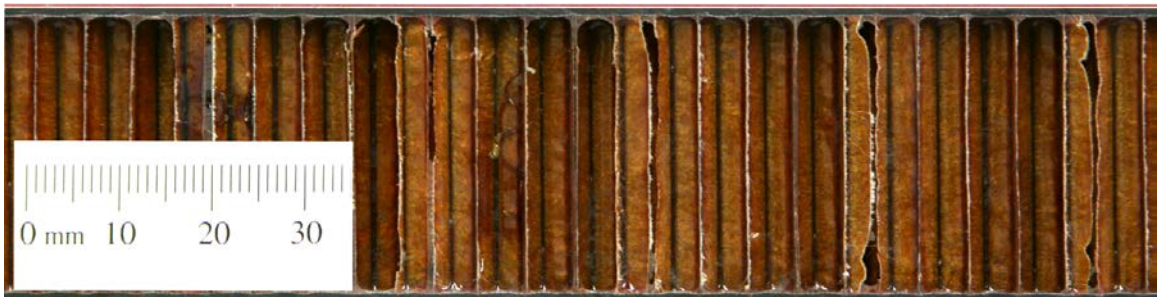
Peak dent 0.02 mm, Test-032 on thick facesheet Panel A05 (49.38 m/s at 25 degrees), ice broke prior to impact, very slightly noticeable dent, minor Mode I core wrinkle

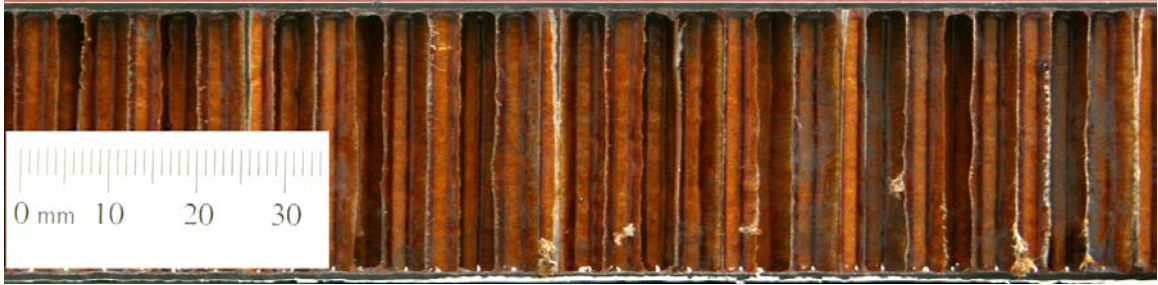
Peak dent 0, Test-045 on thick facesheet Panel A07 (speed unknown at 40 degrees), ice crushed before impact, no visible dent, no core damage

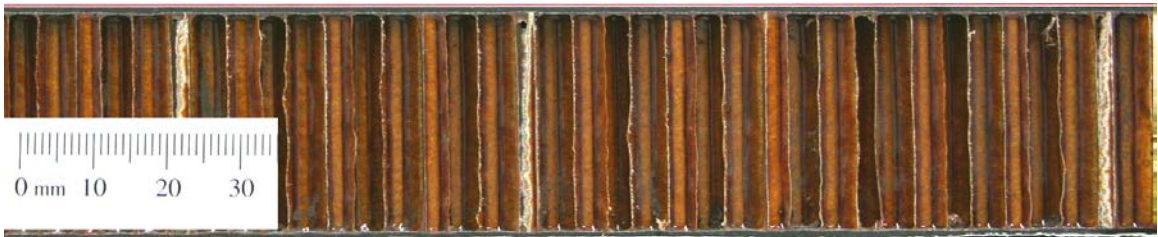
Peak dent 0.02 mm, Test-052 on thick facesheet Panel A08 (23.15 m/s at 40 degrees), ice broke up on impact, no visible dent, no core damage
