**REPORT NO.
UCB/SEMM-97/04**

**CYCLIC TESTING OF
FOUR FULL-SCALE STEEL
BEAM-COLUMN CONNECTIONS
WITH "DOGBONES"**

Report to DASSE Design, Inc.

FEBRUARY 1997

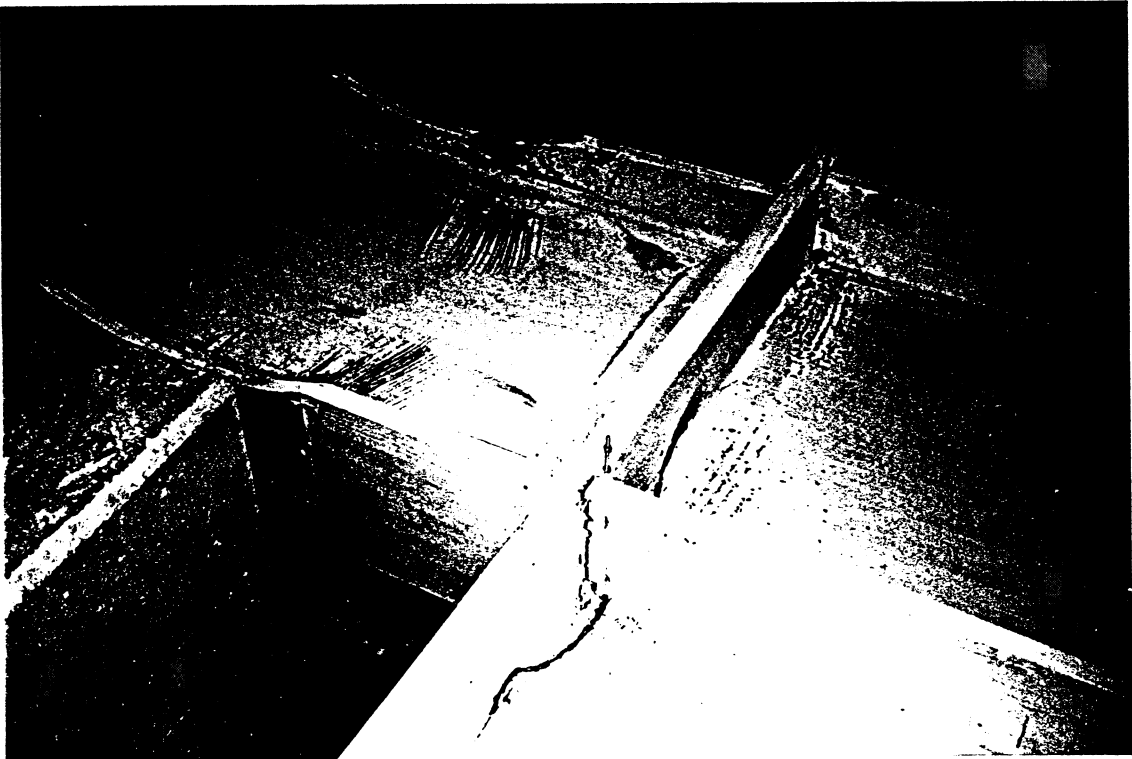
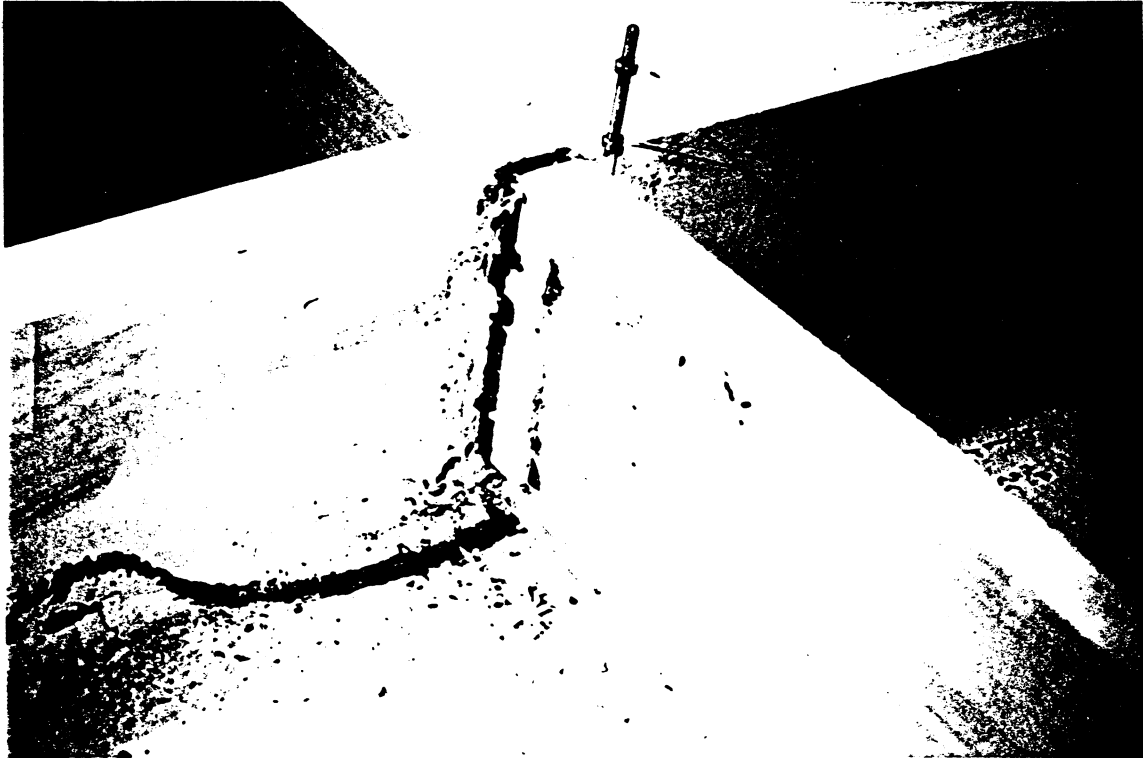
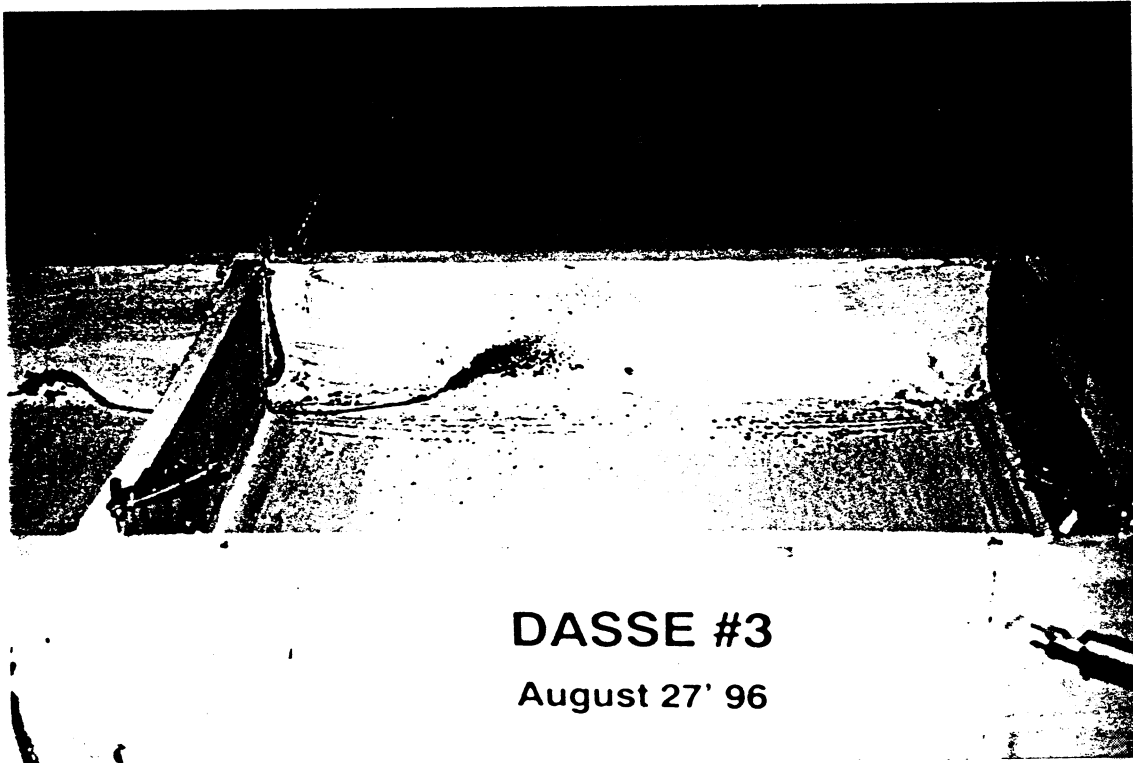
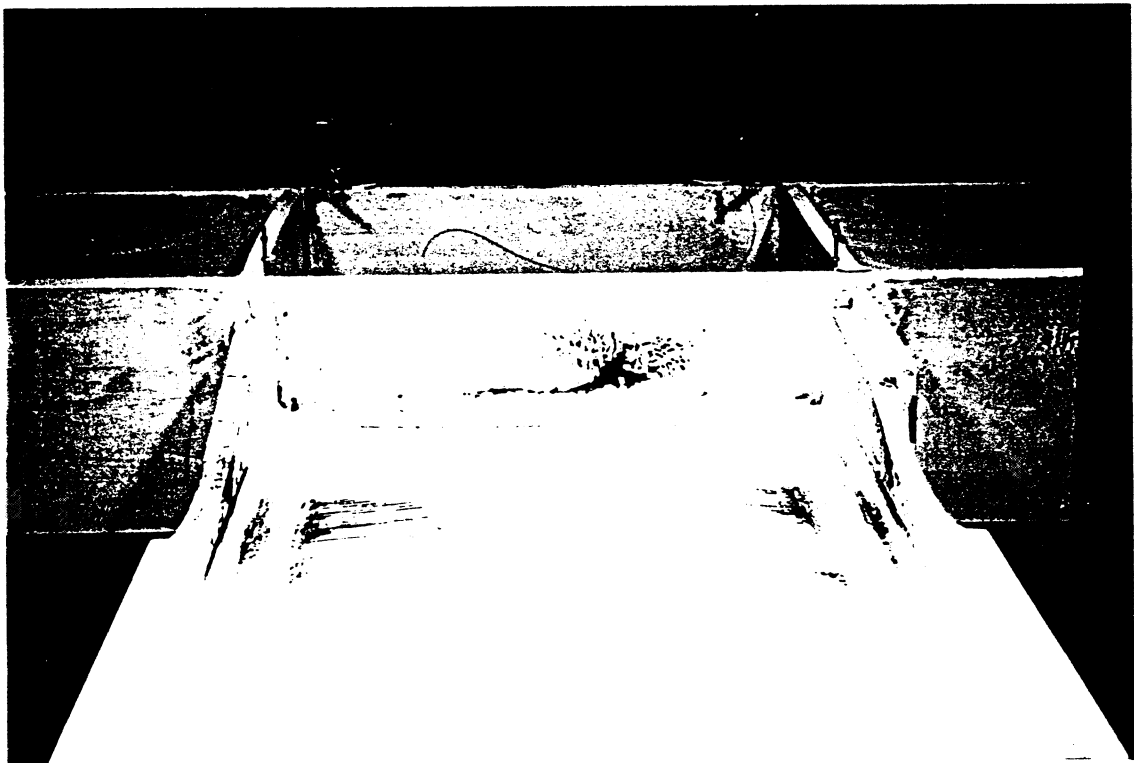
The specimen failed suddenly during the second 3" cycle. Welds between bottom continuity plates and column fractured and the cracks cut the column web at about 9" each way from the continuity plate. It should be noted that only two fractured welds had back-up bars left in place. Six others welds of this type were rejected by UT (as it was reported) and repaired.

Additional metallurgical analysis of the failed weld joint were performed by Schwein/Cristensen Laboratories, Inc. According to their study [5] both welded joints were cracked prior to the test at UC Berkeley. This was because "the preheat temperature was not properly maintained and/or the 150°F minimum code requirement is inadequate for this thickness of material and the highly constrained joint condition."

FIGURE 84: SPECIMEN 3 -- FRACTURE PATTERN

FIGURE 85: SPECIMEN 3 -- FRACTURE

FIGURE 86: SPECIMEN 3 -- FRACTURE

FIGURE 87: SPECIMEN 3 -- UNDERSIDE VIEW OF THE CRACK

FIGURE 88: SPECIMEN 3 -- CRACK TRACE ON THE OUTER COLUMN SURFACE
