Post-Project Performance Assessment of a Multi-Phase Urban Stream Restoration Project on Lower Codornices Creek

LA227 - Restoration of Rivers and Streams

UC Berkeley - Fall 2011

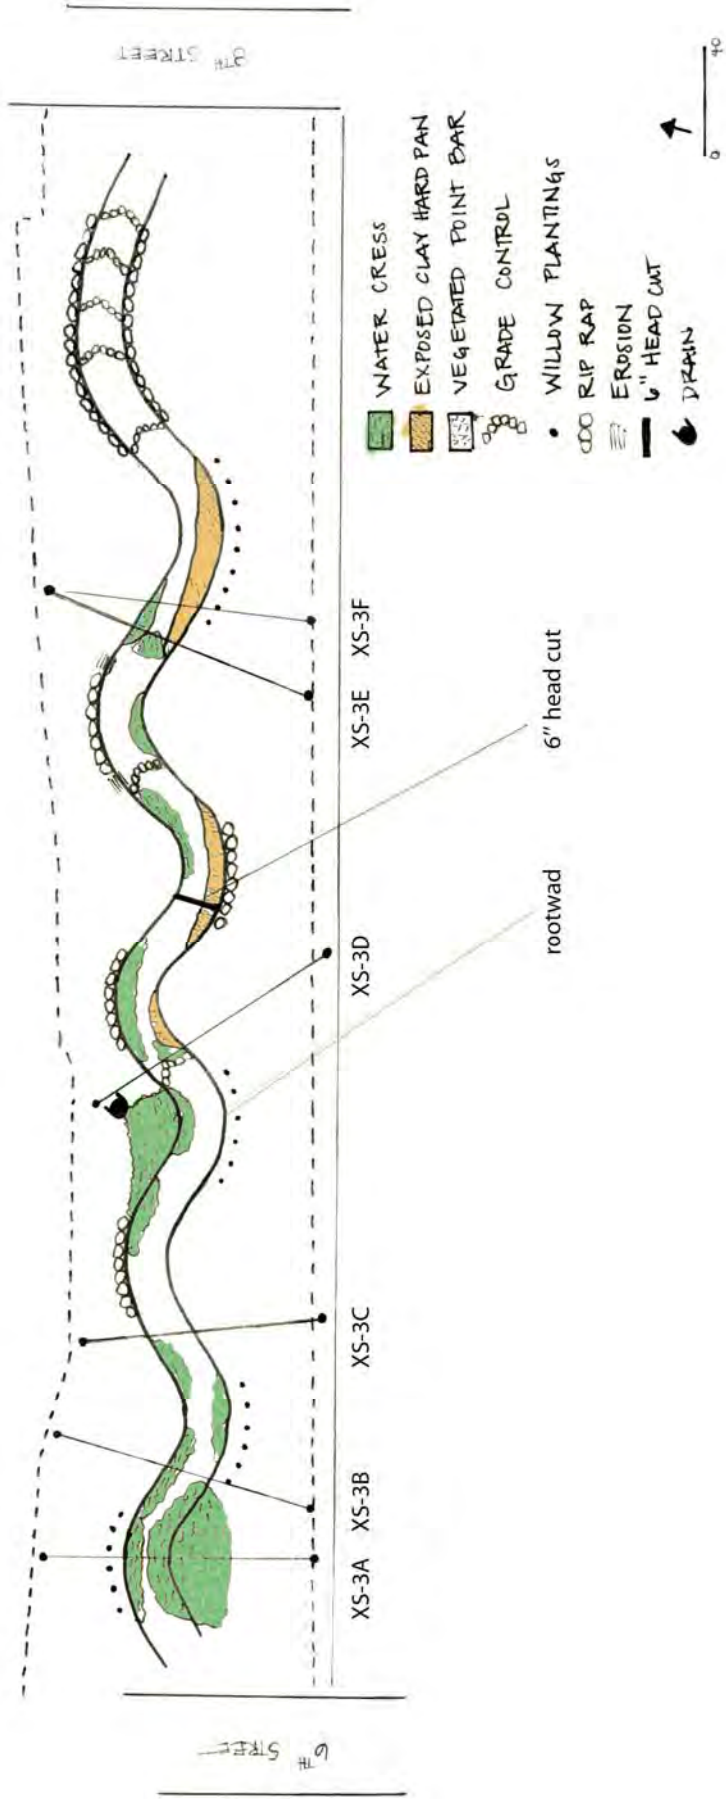
FIGURE 4. HIGHLIGHTED FEATURES OF PHASE 3

A visual assessment of Phase 3 suggests the channel has incised in the upper segment (RS 17+00 to 19+95), as evidenced by the exposed clay hardpan composing the channel bed and lack of mobile bed substrate (Figure 10). These areas are mapped in Figure 4. Other evidence is the exposed undersides of riprap along outer meander bends (Figure 11) and an active headcut at RS 17+25 (Figure 12). Evidence of minor lateral erosion is evident along the outer edges of meander bends, primarily at the upstream and downstream ends of riprap. It is also apparent that a plug of coarse sediment has accumulated at the 6th St culvert at the downstream end of Phase 3 (Figure 13). The non-native invasive emergent vegetation species watercress (*Nusturtium aquaticum*) along with sedge species has established a dense mat over the deposited sediment. The pioneer species watercress is prevalent throughout the reach, forming dense mats over fine sediment deposits and point bars (Figure 4).

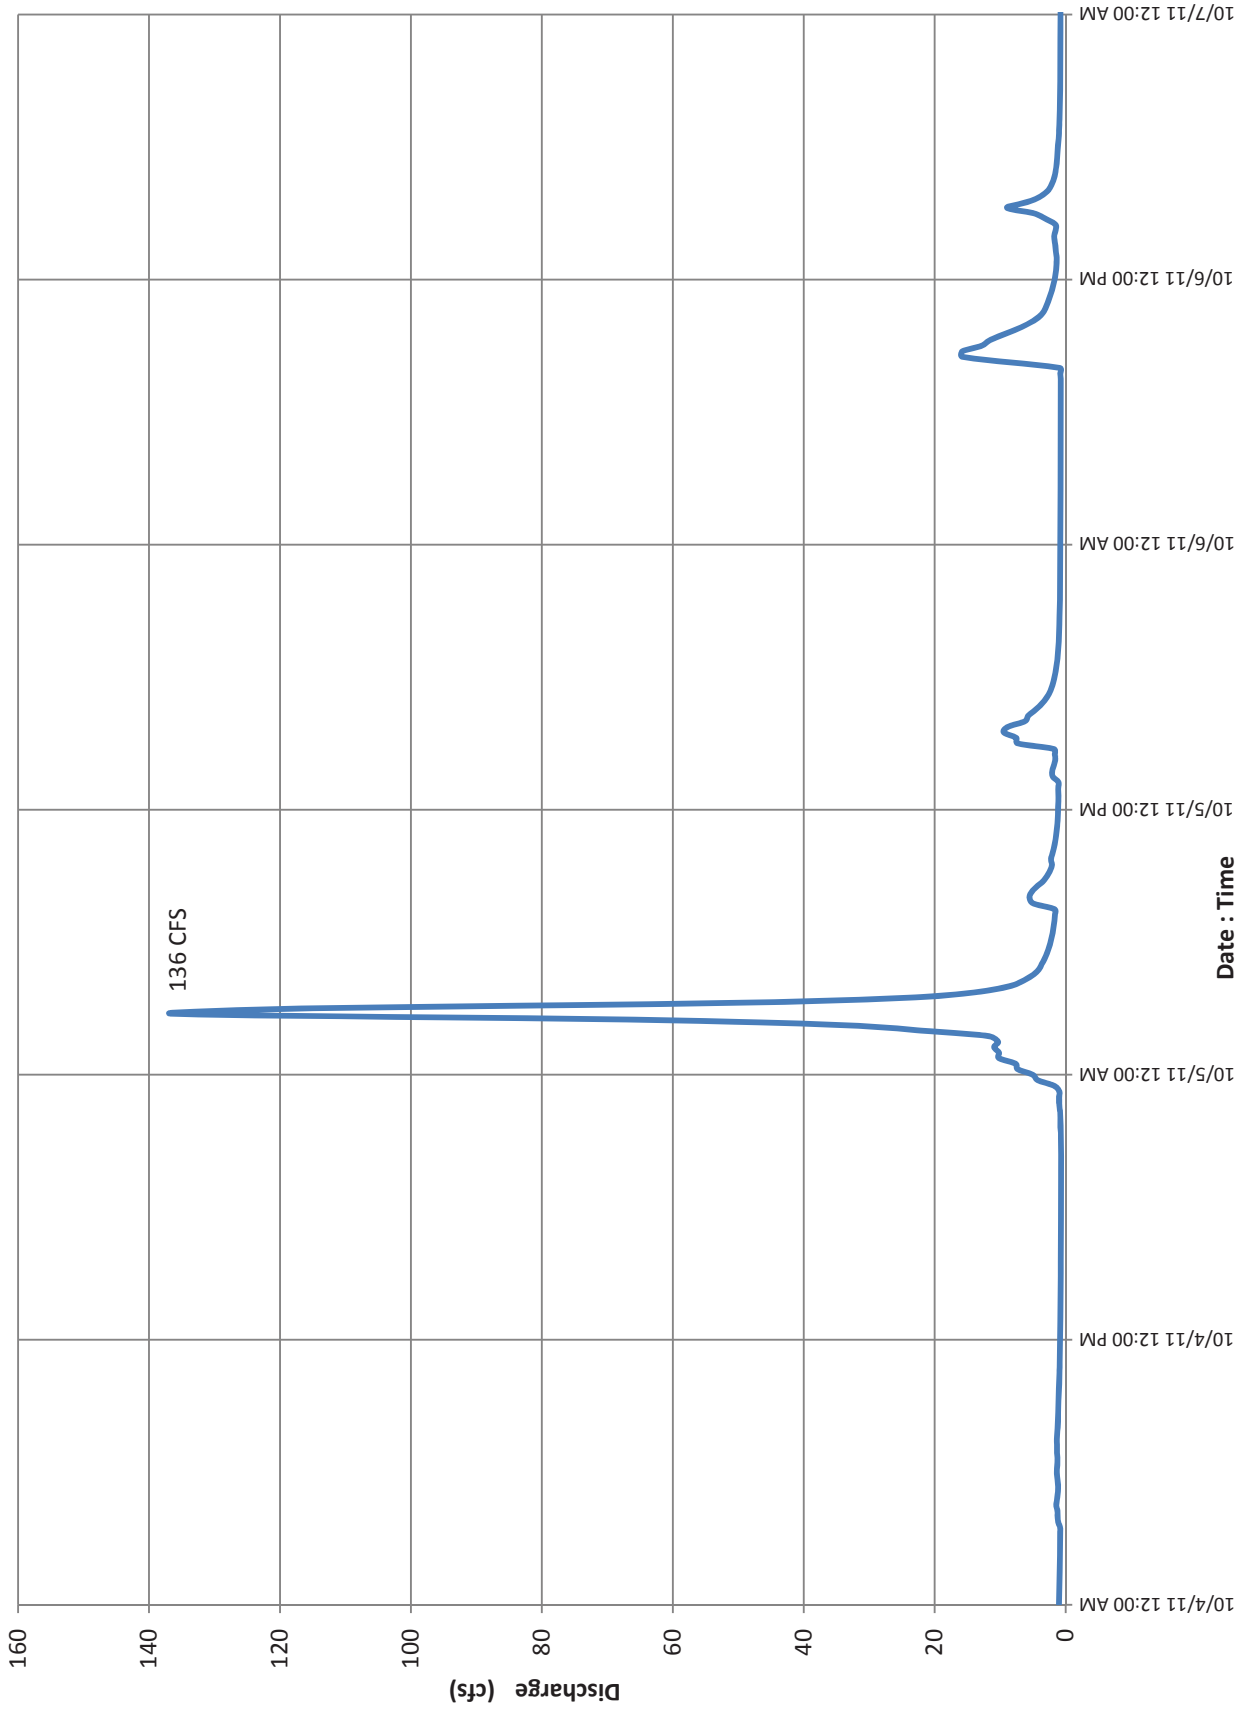
FIGURE 6. HYDROGRAPH OF OCTOBER 5TH FLOW (Balance Hydrologics, 2011)

Gage data show a peak discharge of 136 cfs on October 5, 2011 (Figure 6), in response to a 1.78 inch 24-hour rainfall total. The hydrograph shows a pre-storm baseflow of 0.7 cfs which peaked at 136 cfs then receded to 1.7 cfs, all within 8 hours. The flashiness exhibited here is typical of urbanized watersheds (Seaburn, 1969), and can likely be attributed to the long narrow shape, high gradient (15.8% mean basin slope), and high impervious surface cover (ISC) (28%) of the basin (NLCD 2001). Based on this ISC, the peak discharge is likely elevated

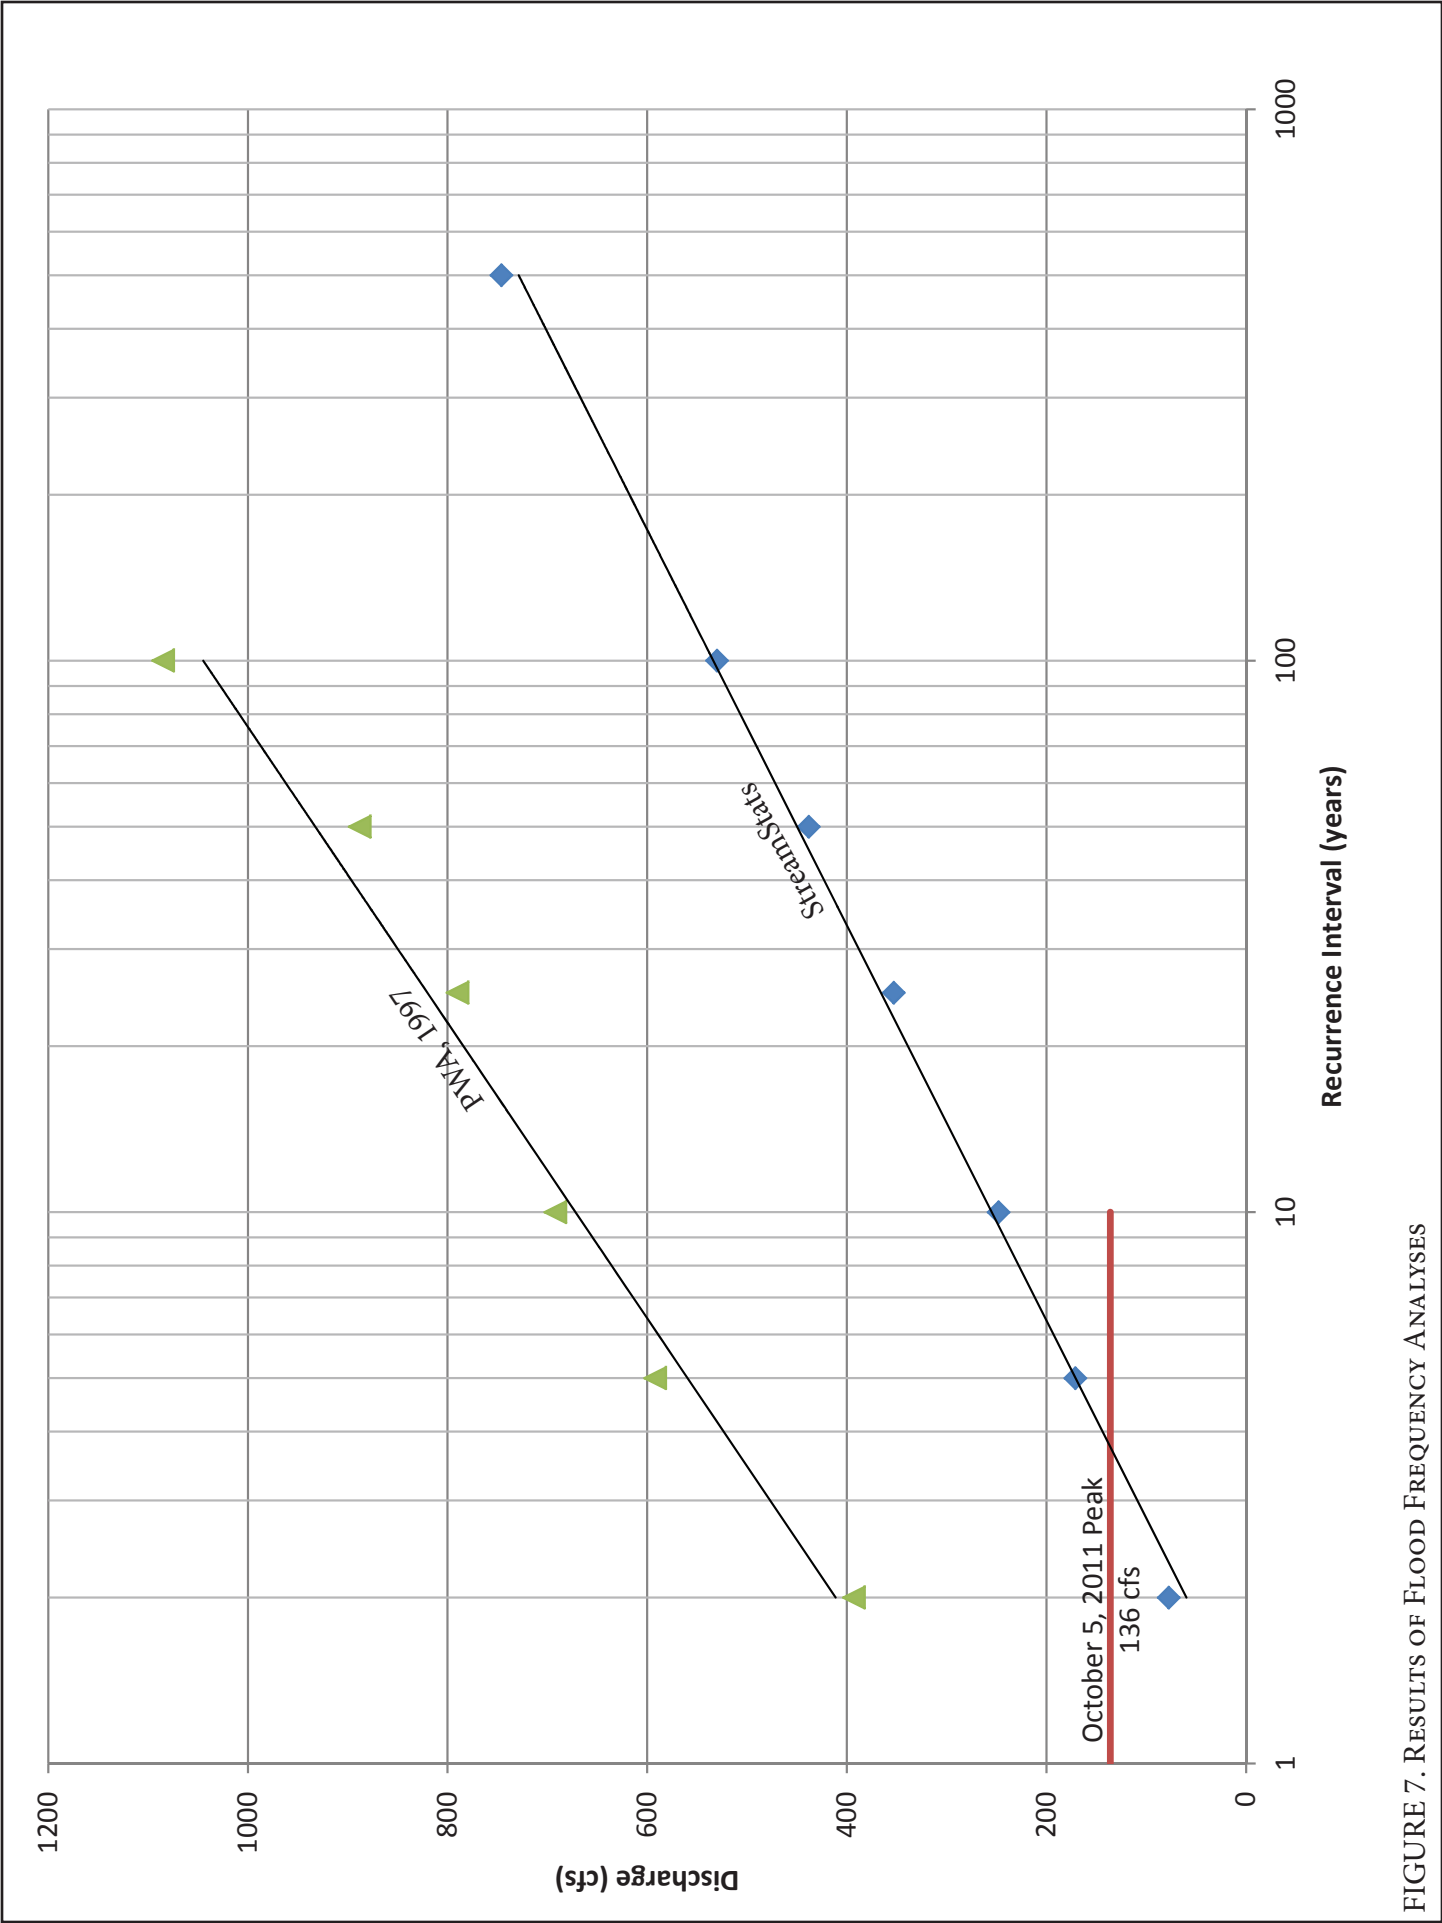
FIGURE 7. RESULTS OF FLOOD FREQUENCY ANALYSES

Results of the 1997 PWA and StreamStats flood frequency analyses are presented in Table 2. The differences are drastic, with the PWA calculations showing a 2-year flow discharge five-fold larger than the StreamStats analysis. When plotted against a regression of these points, the October 5, 2011 peak flow of 136 cfs is less than a 1-year flow according the PWA calculations and approximately a 3-year event according to the StreamStats calculations (Figure 7).

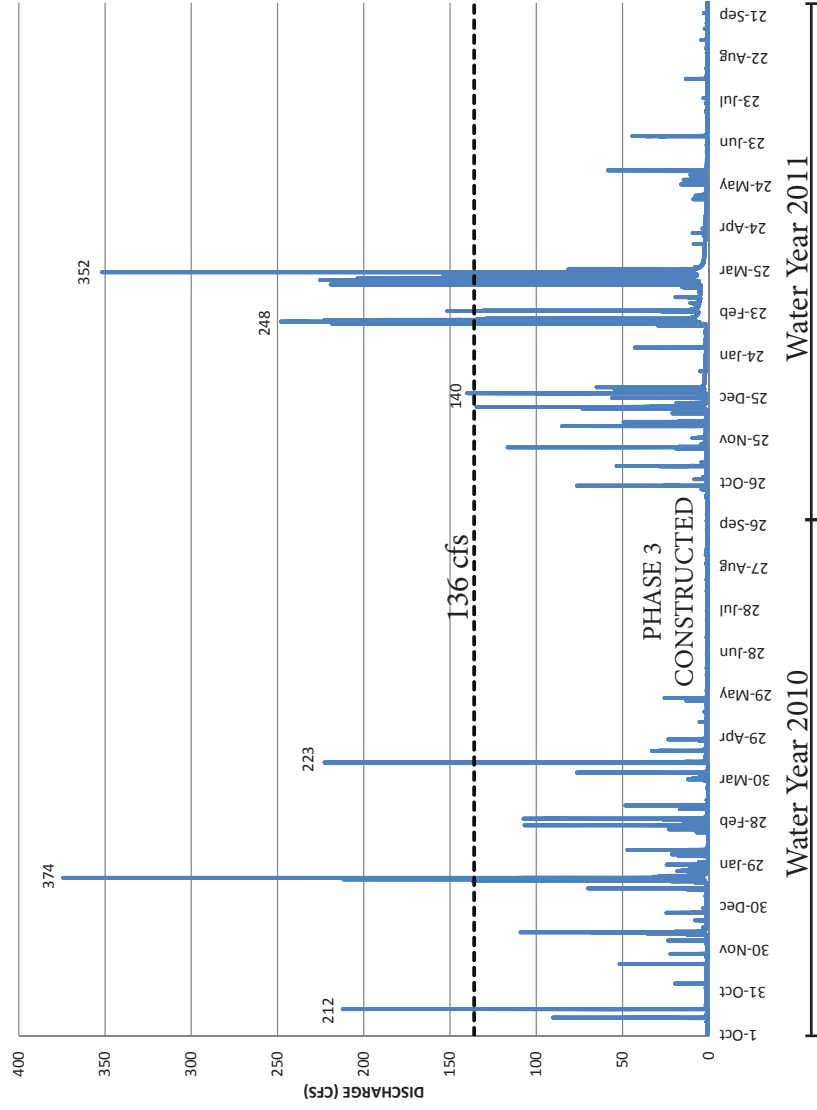
FIGURE 8. 2010-2011 WATER YEAR HYDROGRAPHS (Balance Hydrologics, 2011)

Gage data from the previous two water years (2010, 2011) demonstrate that the 136 cfs flow was exceeded multiple times both years, including at least 6 distinct events since Phase 3 construction was completed in the summer of 2010 (Figure 8). Therefore the StreamStats calculation is likely a significant underestimation of the recurrence intervals of the flows specified. Although difficult to conclude without a longer period of record, the 1997 PWA calculations appear to be a more realistic, if not conservative, estimate of flood frequency in the existing watershed condition. The annual peak flows of the previous two water years were 373 cfs on January 20, 2010, and 352 cfs on March 24, 2011.

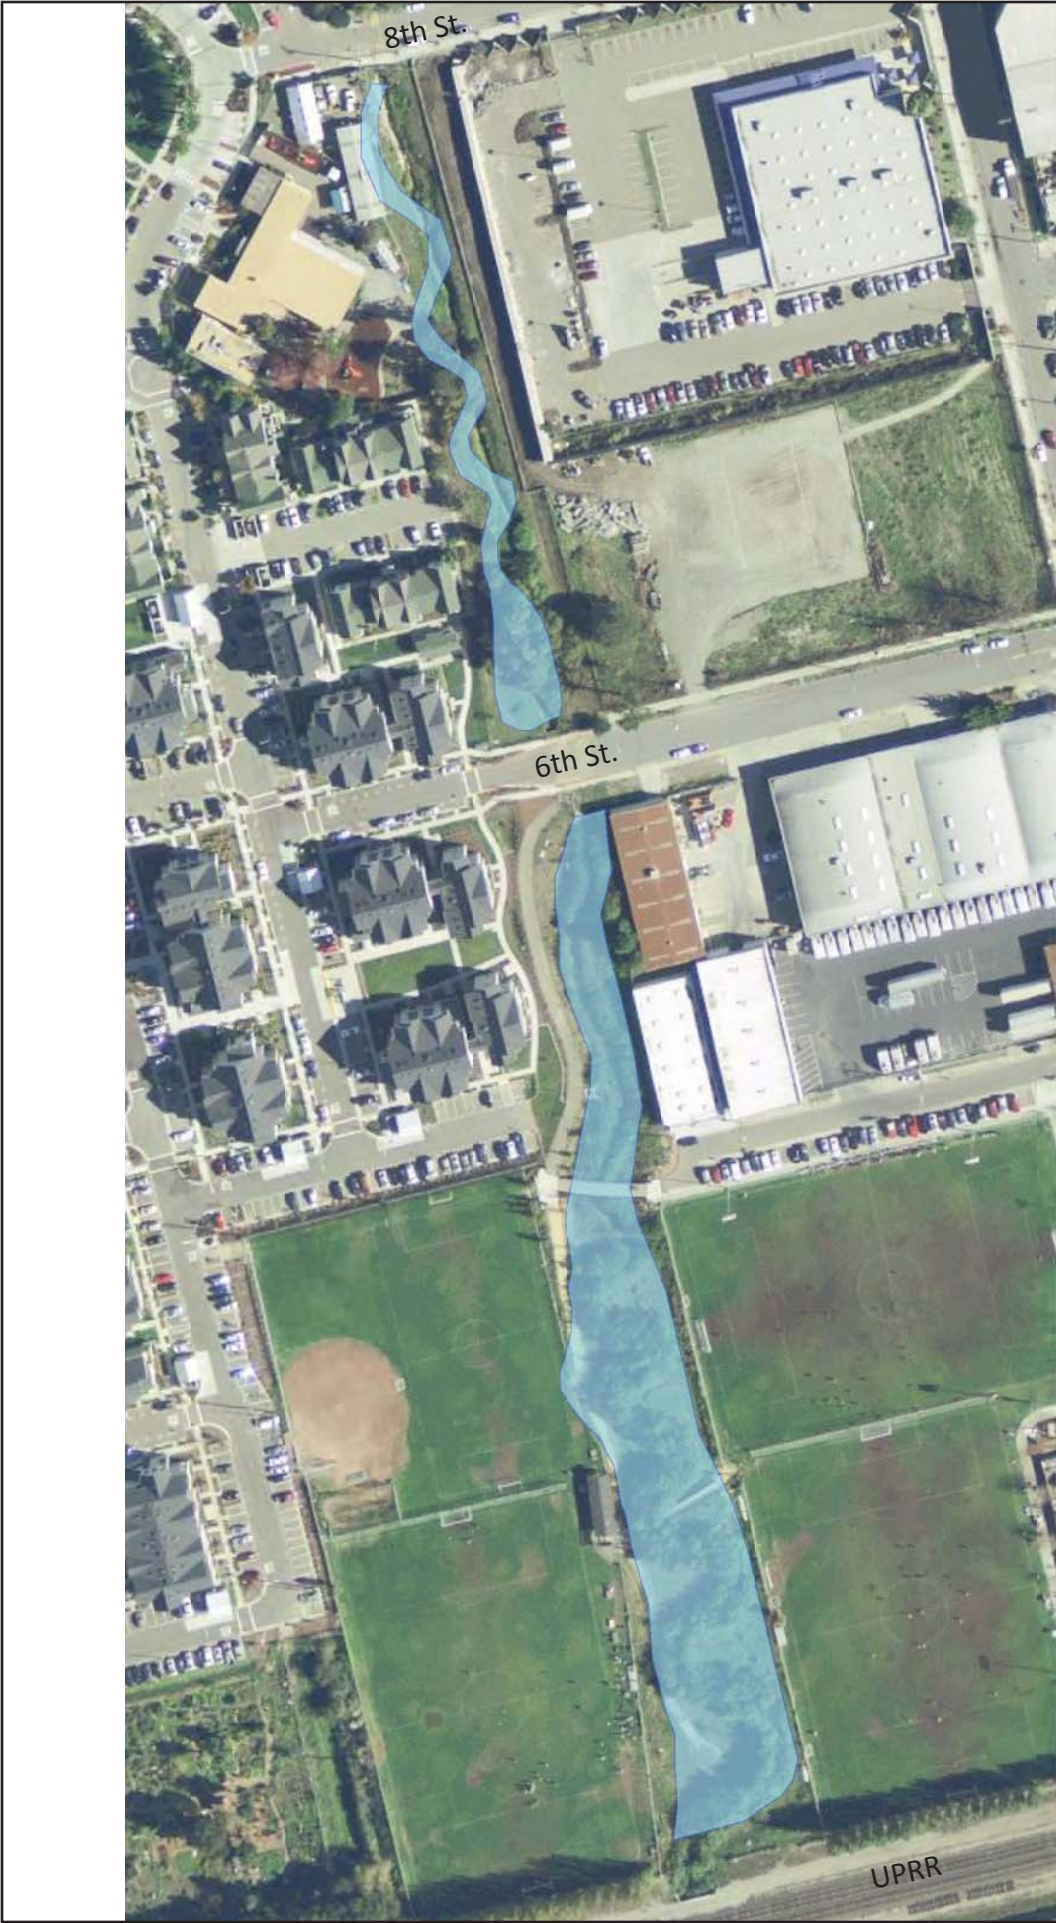
FIGURE 9. APPROXIMATE FLOODING EXTENTS OF OCTOBER 5, 136 CFS FLOW

occur in the downstream portion of the reach, near RS 16+00 and downstream to the 6th St culvert at RS 14+00, where flow high water marks were noted on the floodplain along the toe of the side slope. In Phases 1 and 2, overbank flow was widespread, with evidence of flow inundating the soccer fields to the north near RS 7+00. Figure 9 shows the approximate flooding extents, created using high water mark elevations surface topography.

Comparison of the top of low bank profile surveyed to water surface elevation calculated from our high water marks confirms that the October 5 storm event caused widespread inundation in Phases 1 and 2. In Phase 1, the high water marks extend to the soccer fields to the north of low flow channel. In Phase 2, the high water marks extend to the toe of the adjacent footpath. In contrast, flows did not escape channel banks for the majority of Phase 3, save for in the lower portion of the reach (Figure 9).

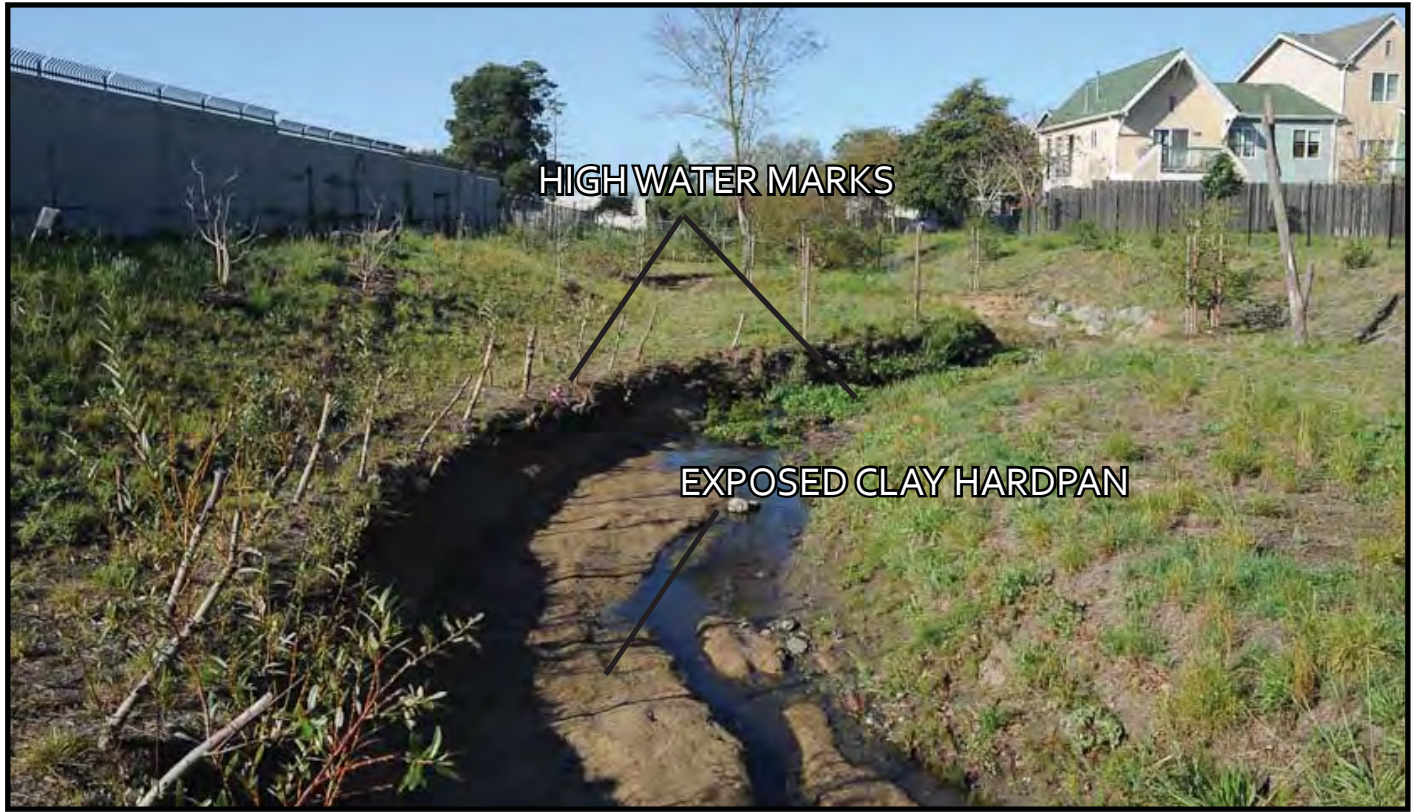
FIGURE 10. PHOTOGRAPH OF PHASE 3 NEAR RS 18+00

shear stress. With the channel unable to expand laterally, it responded in turn by exerting hydraulic forces vertically. Active incision is evident at the 6-inch headcut at RS 17+40. The headcut is likely to migrate upstream to the next grade control structure at RS 18+25. Upstream of the RS 18+25 grade control structure, the gradient has nearly flattened and is unlikely to incise more, unless upstream grade control structures fail.

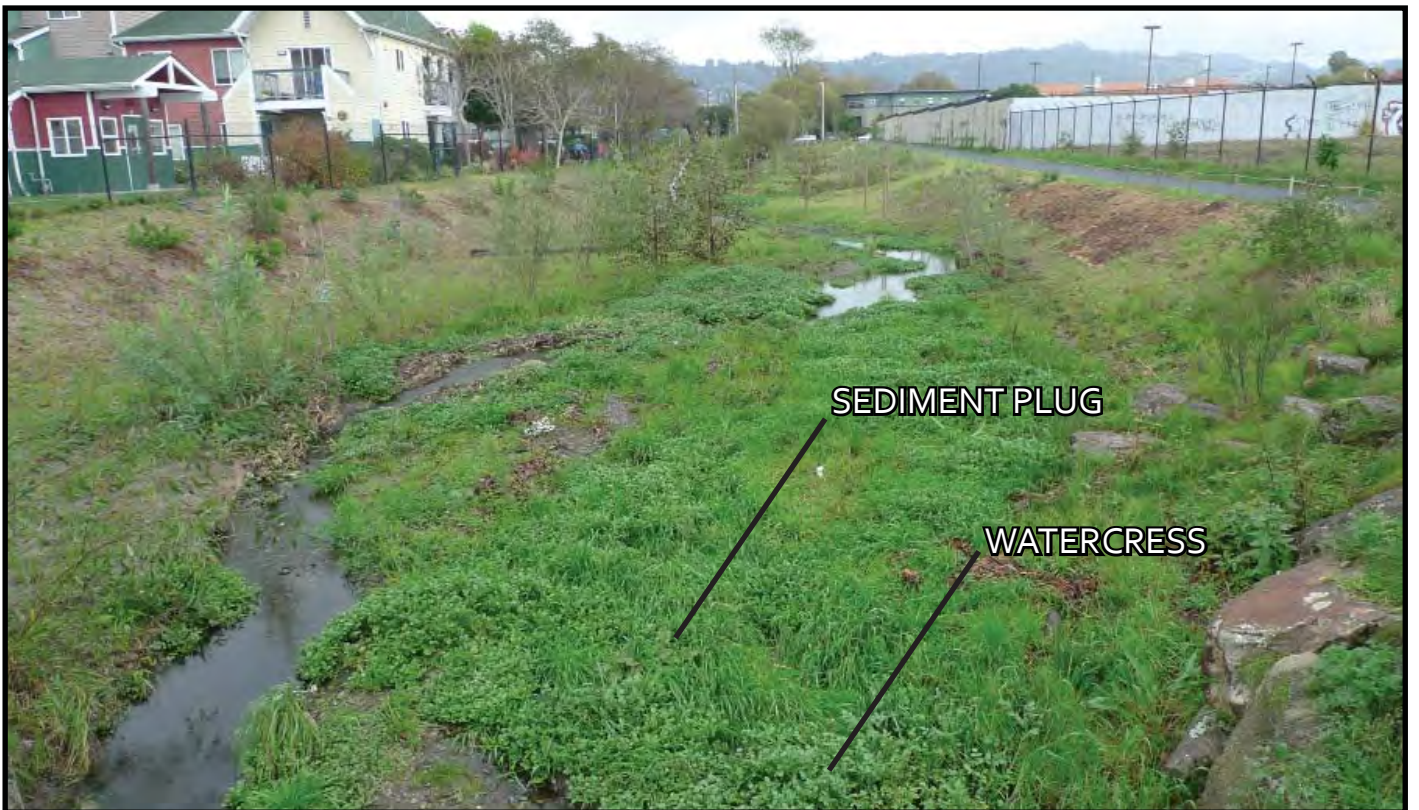
FIGURE 13. PHOTOGRAPH OF PHASE 3 NEAR RS 14+00

Aggradation at the 6th St culvert is likely due to a backwater effect created at high flows by the undersized 6th St culvert. This causes the velocity of turbid water to slow and the suspended and bedload sediment to settle and accumulate. The 6th St culvert was not replaced during the restoration phase due to the complications with addressing downstream constrictions and flood risks (RDG 2011, pers. comm., 14 Nov). It is possible that the sediment deposited here is the same sediment scoured from the upstream segment of Phase 3. Regardless, the sediment scoured from the channel bed in the upper reach has not been replenished by upstream sources.

While the sediment plug at the 6th St. culvert is likely to pass through over time, the aforementioned plug of sediment is being stabilized by the dense mat of grass and watercress. The mats may be problematic as they occupy potential habitat for native species and can decrease baseflow channel capacity which could potentially accelerate incision (Tabacchi et al, 2000). There was no watercress found in Phases 1 and 2, likely due to the lack of available light from dense willow/alder thickets. It is likely the watercress will be shaded-out if a riparian canopy is allowed to develop; however preferences for visual aesthetics and accessibility calls for maintenance of woody riparian vegetation in Phase 3.

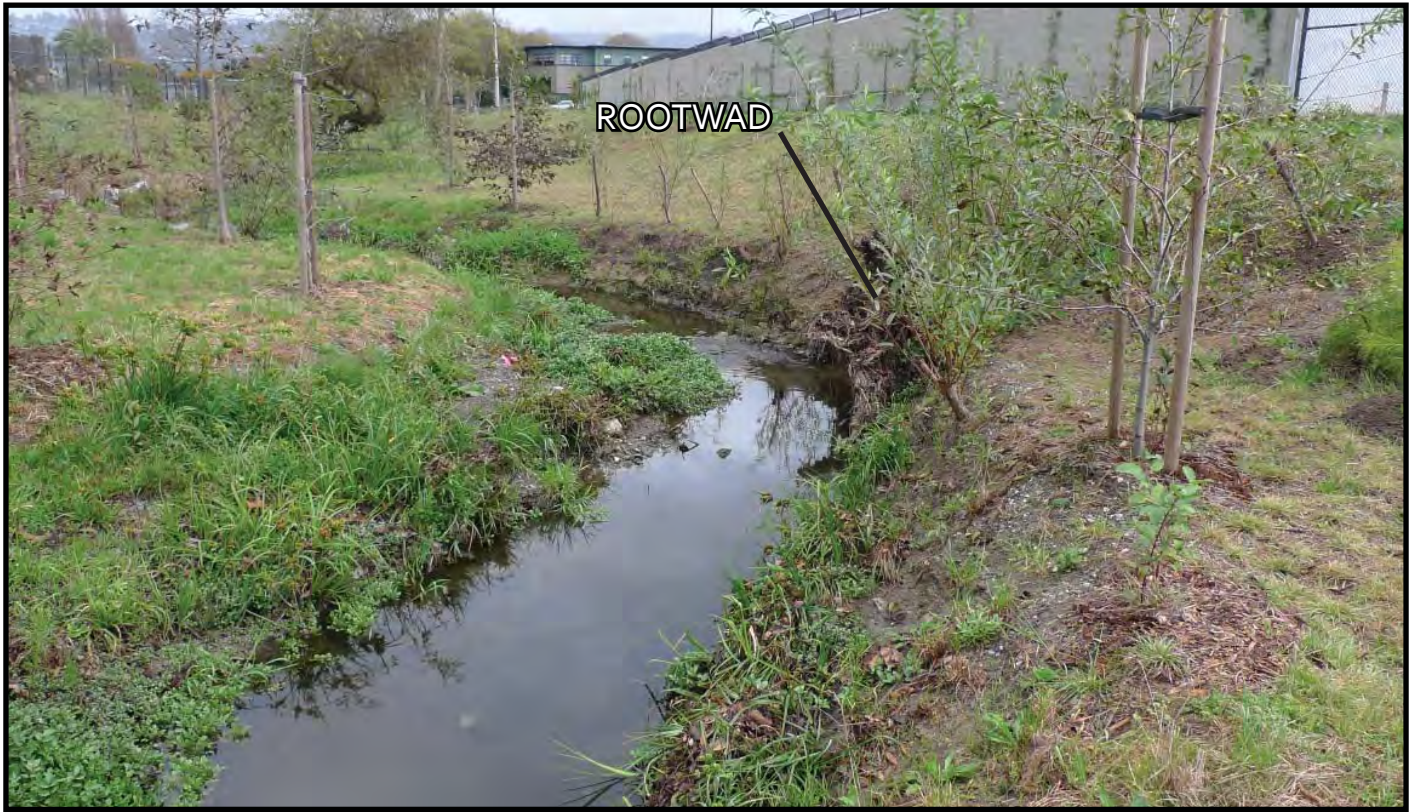
FIGURE 14. PHOTOGRAPH OF PHASE 3 NEAR RS 16+40.

Despite being highly sinuous, the channel lacks in-stream complexity features, such as large woody debris, that are capable of trapping sediment, creating scour pools, and providing habitat (Gurnell et al, 2002). The lone wood structure, a rootwad embedded in the left bank at RS 16+40, has induced a scour pool and provides some habitat (Figure 14). As described above, the majority of the channel is composed of clay-hardpan, which provides little habitat for macroinvertebrates or salmonid spawning.

In some locations of Phase 3, ecologically valuable substrate has been scoured from the channel bed and is not being sufficiently replaced. Little channel complexity or roughness exist to encourage deposition and creation of further channel complexity. Such incision has also resulted in less frequent inundation of the floodplain. Inundation patterns in Phase 3 differ from those in Phases 1 and 2. A moderate discharge that inundated a majority of the floodplain in Phases 1 and 2 only escaped Phase 3 banks in areas where the aforementioned culvert caused backwater build-up in lower reaches. Significant woody debris is unlikely to recruit naturally at the site due to the many road crossings and culverts upstream of the study area. Further monitoring should be completed to determine the potential need to add additional roughness to the channel to increase complexity, aggradation, and potentially more frequent floodplain inundation.

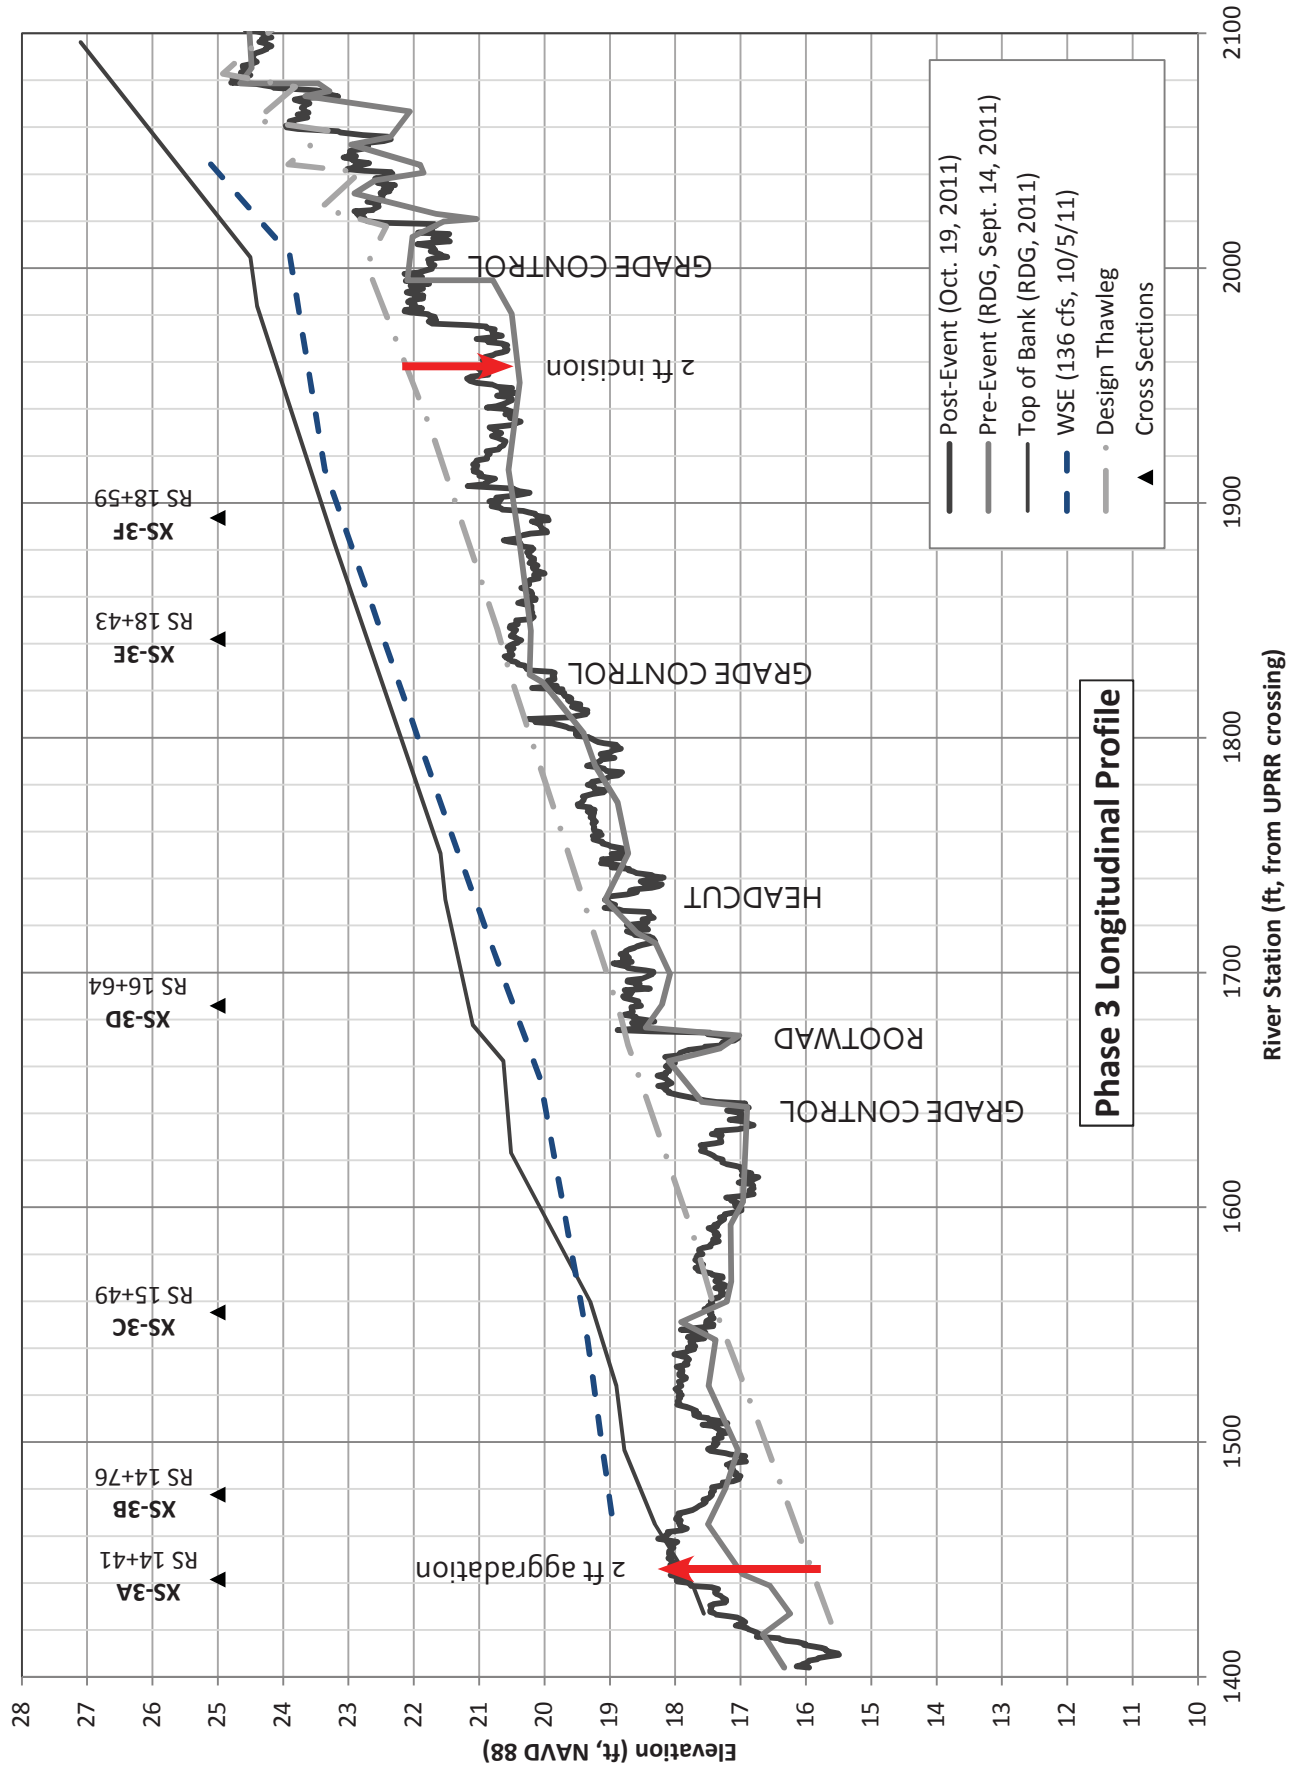
FIGURE 15a. LONGITUDINAL PROFILE COMPARISON AND HIGH WATER SURFACE ELEVATION OF PHASE 3

The Phase 3 longitudinal profile and high water marks surveyed subsequent to the October 5 storm are plotted against the September 2011 RDG longitudinal profile, as-built profile, and RDG top of bank in Figure 15. This comparison shows up to 2 ft of aggradation near the 6th St culvert (RS 14+90) since construction, and up to 1 ft due to the October 5th storm. Upstream of RS 15+90 the thalweg profile shows incision from the design profile, with a maximum amount of 2 ft of incision since construction. The scour pool caused by the rootwad is evident at station 17+09, as well as the headcut at RS 17+40. Incision was most severe from the grade control structure at RS 18+30 to the grade control structure at RS 19+90. Comparison of

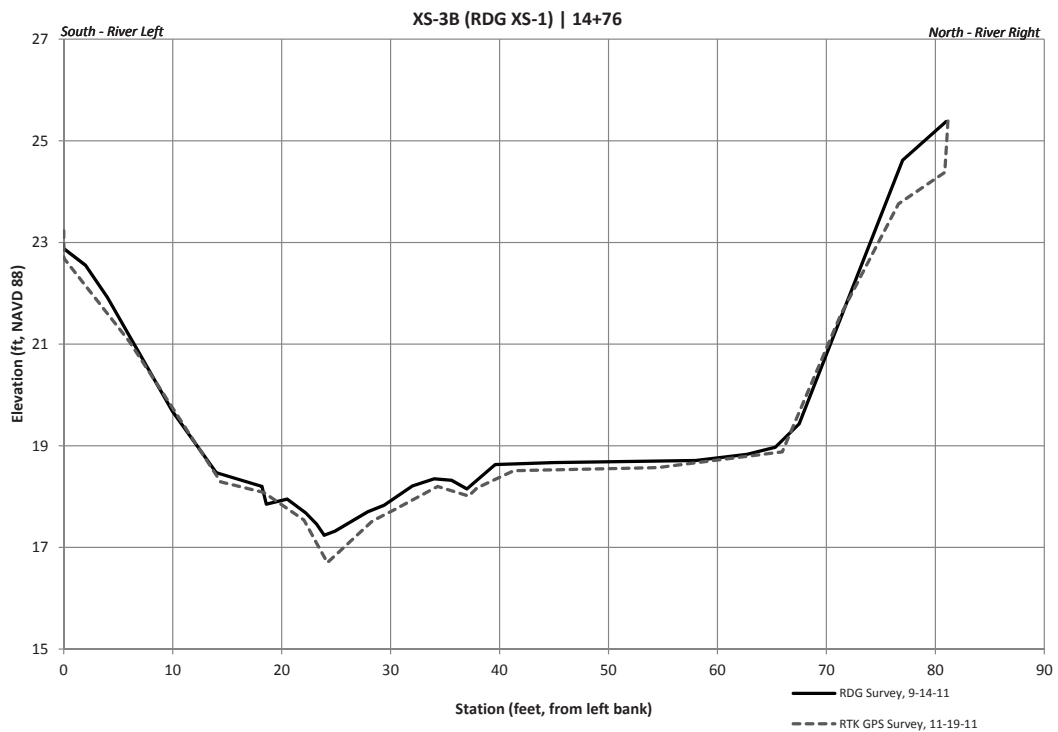
FIGURE 16a. COMPARISON OF XS-3B WITH RDG SEPT. 2011 SURVEY

cross-sections 3B and 3E with the September 14th, 2011 RDG cross-sections shows approximately 6 inches of incision at 3B and minimal change at 3E (Figure 16). There was no evidence of significant lateral change.
