Post-Project Appraisal of Baxter Creek at Booker T. Anderson Park  
Shopping Carts: The New Boulders

December 2005

By:  
Colleen Bronner  
Maggie McKeon  
Janel Weston

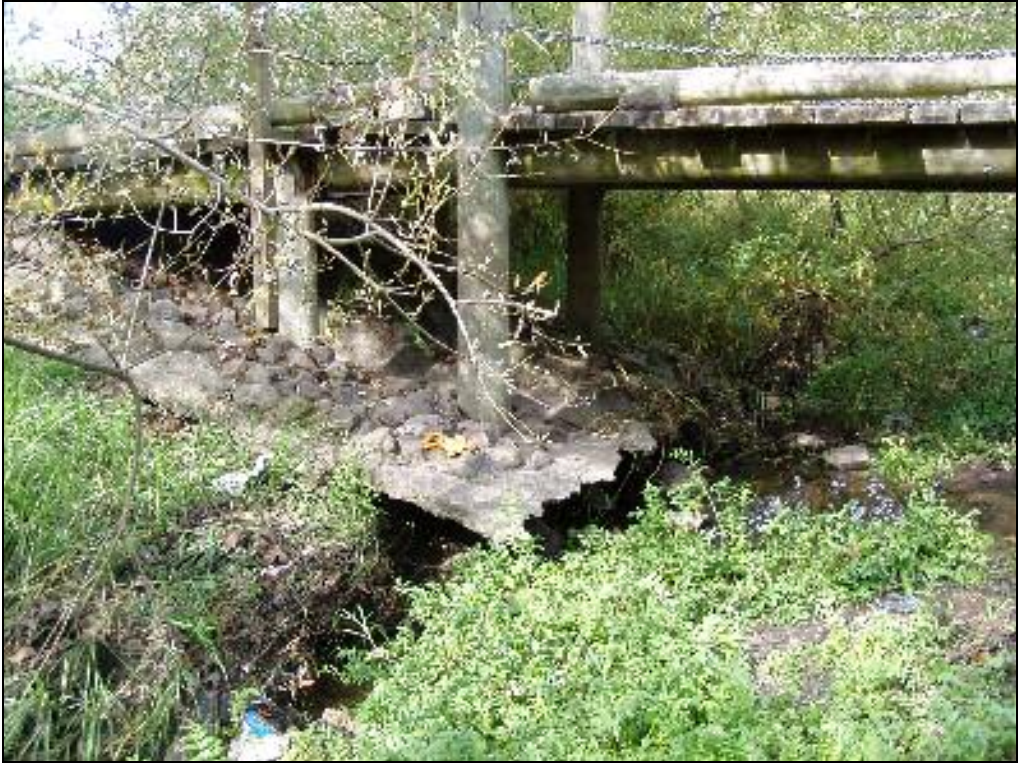
*Figure 3: Site 2*

Site 2 is located approximately 430 feet downstream from the inlet and approximately four feet downstream from a bridge that crosses the creek (Figure 3). We conducted tests at the point immediately downstream of the concrete structure that juts out over the creek. Site 3 is located approximately 205 feet downstream from the inlet and is adjacent to the wooden structure that surrounds the Baxter Creek information sign, next to the playground (Figure 4 and 5). Site 4 is approximately 30 feet downstream from the inlet (Figures 6-8).

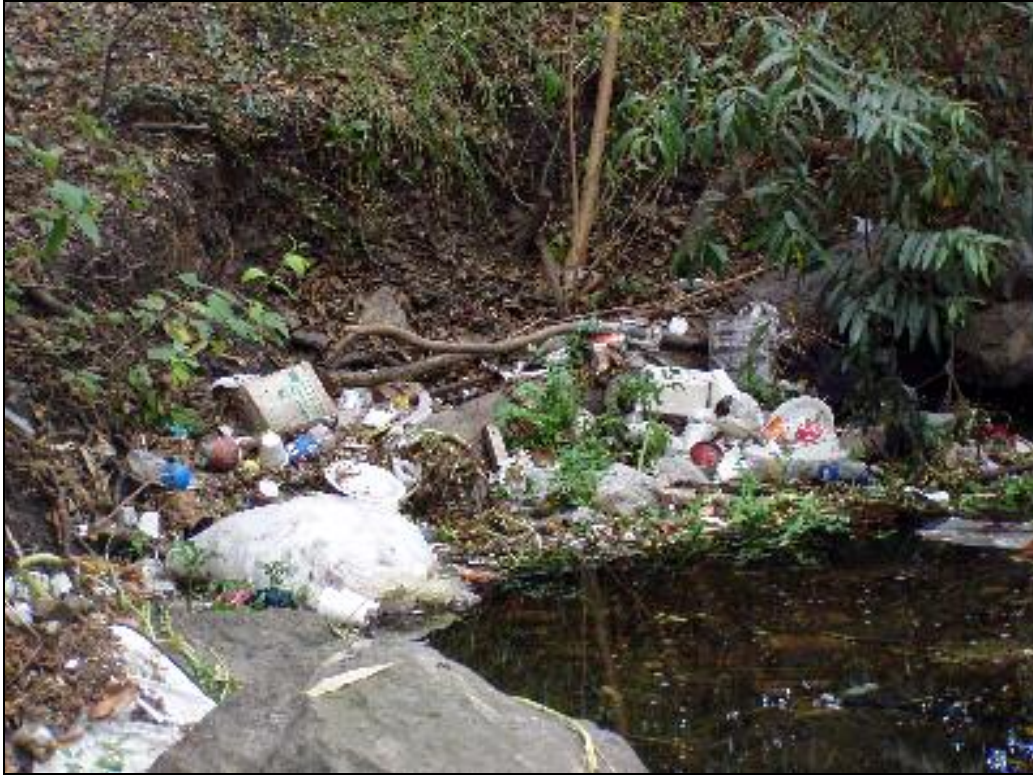
*Figure 8: Site 4 – Trash Bar*

We found the temperature to be similar at each site, only varying 0.5 °C, and the average temperature being 15.8 °C. We observed flow at Site 2 and Site 3 to be fairly similar, with the average flow being 0.31 ft<sup>3</sup>/sec. We were unable to test the discharge at Site 4 due to the large amount of trash.

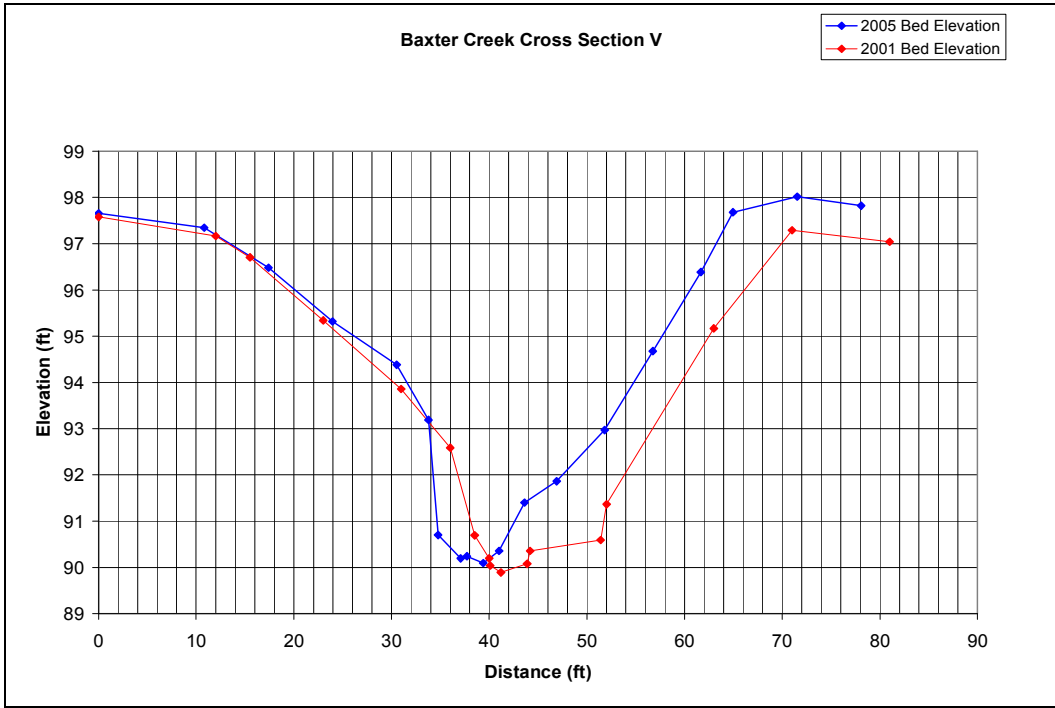
Figure 10: Cross Section V

Due to the uncertainty in our cross section locations, the longitudinal profile is a better indication of changes since 2000. The profile shows that the slope in the upper reach has not appreciably changed. A visual comparison suggests that there has been some channel incision, but the difference in average thalweg elevation is only 0.6 ft, indicating that the channel as designed has been relatively stable since its implementation in 2000. Although there is more uncertainty associated with a comparison of the cross sections V and VI (Figure 10 and 11), they also roughly indicate channel stability—certainly no drastic changes have taken place.

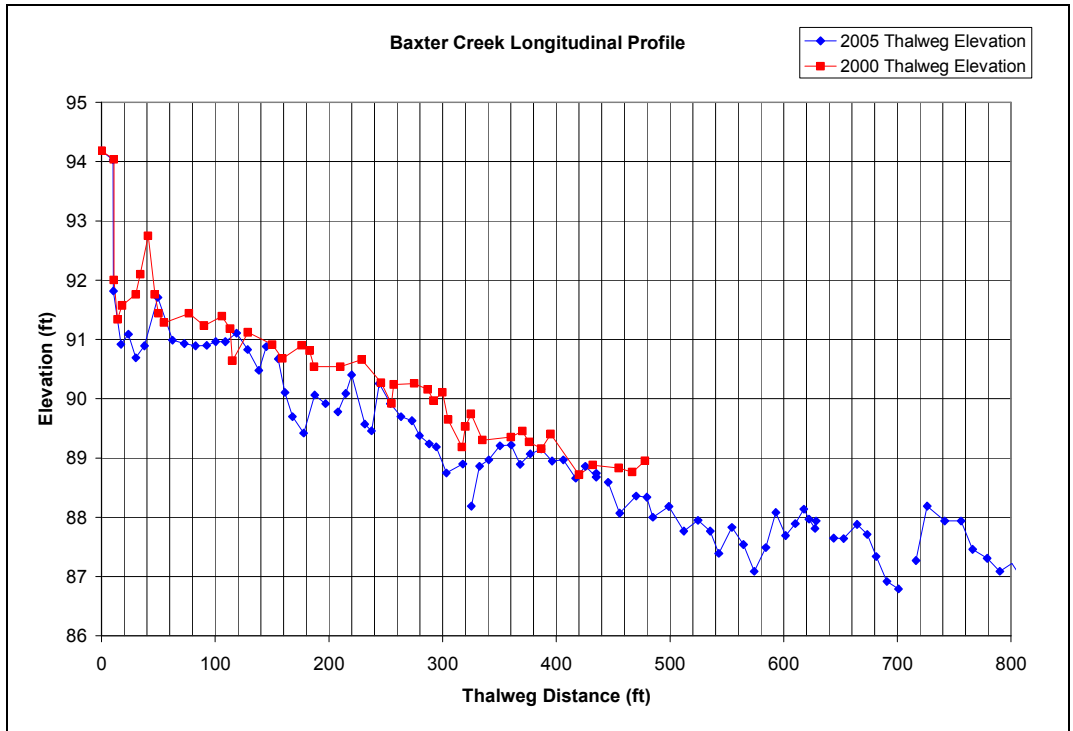
Figure 13: Longitudinal Profile

Results of the cross section profiles V, VI and VII are shown in Figures 10, 11 and 12, respectively. Figure 13 shows the longitudinal profile. The 2000 longitudinal profile indicates a slope of  $0.80 \pm 0.05$  %. We used a regression analysis of the thalweg elevation to calculate the slopes; our 2005 survey shows a slope of  $0.78 \pm 0.06$  % in the reach surveyed in 2000 and an overall slope of  $0.56 \pm 0.03$  %.

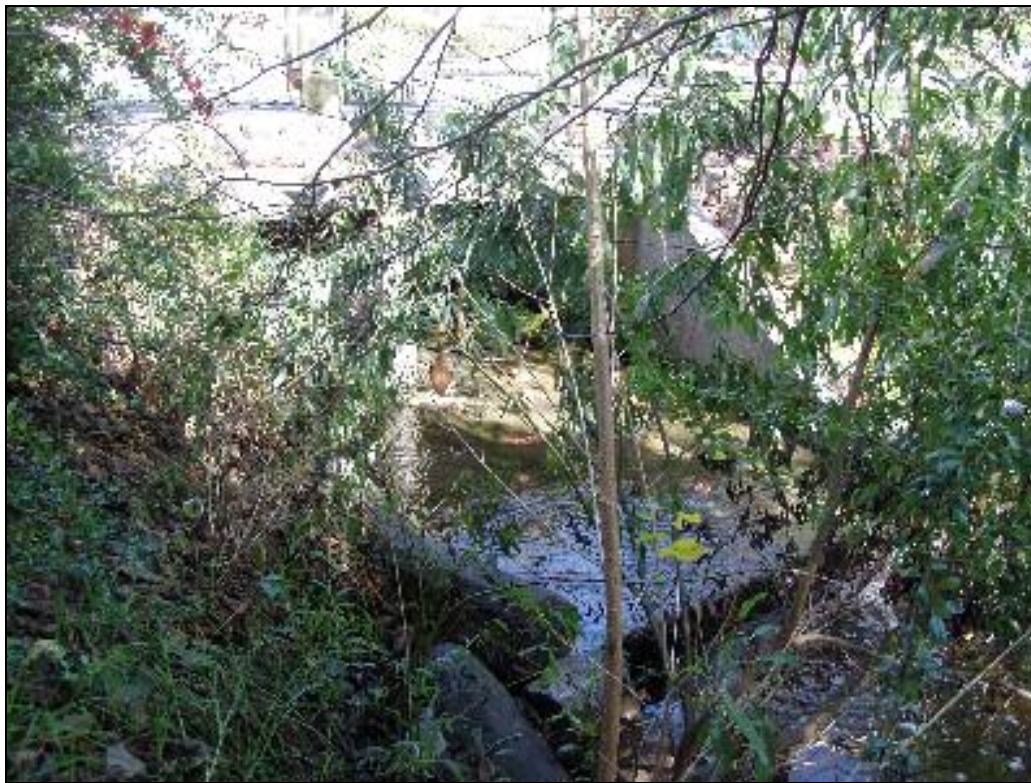
*Figure 14: Beginning of project reach*

The complete site map is located in Appendix A. We noted important features throughout the site mapping process including: steep banks in the upstream half of the reach, significant amounts of trash collected on bars or floating in pools, grassy vegetation/weeds dominating bars and growing in the creek. Although we did not complete any pebble counts, we estimated the bars to be dominantly silt/sand as noted on the site map. Riffles and pools were observed throughout the reach. Figures 14 – 20 show significant sites of the site mapping.
