CONDITION OF COMMERCIAL HIGH-EFFICIENCY FILTERS UPON RECEIPT OR INSTALLATION

UCRL-8862

**Myron D. Thaxter**

**July 1959**

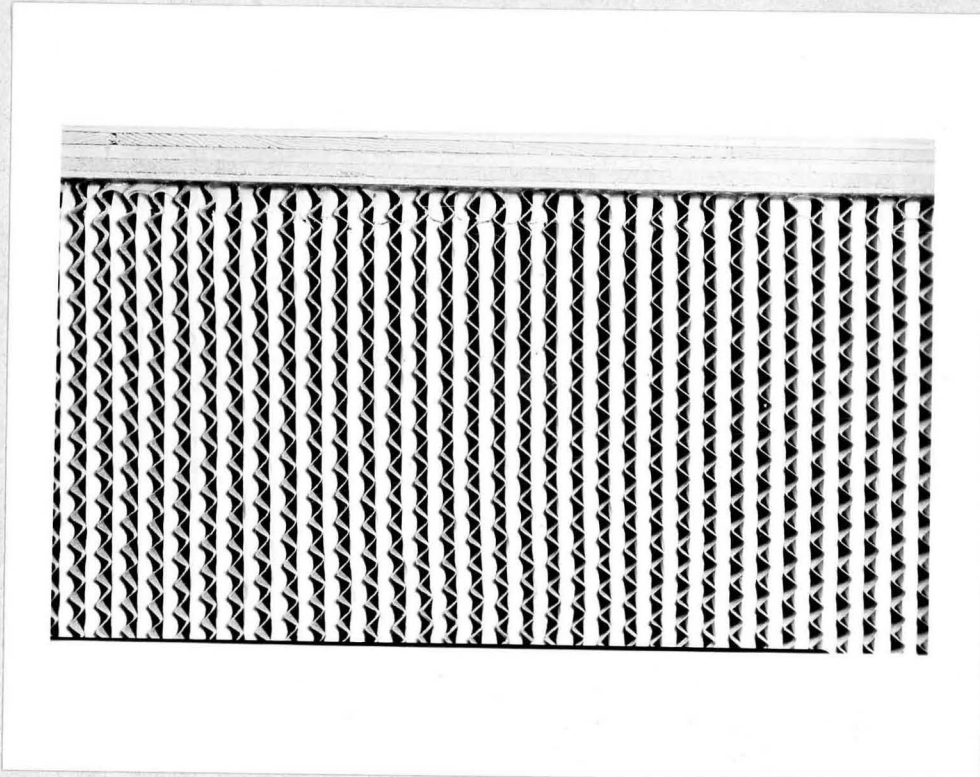
Fig. -1

- Fig. 1. Commercial high-efficiency filter with glass media and kraft separators, showing transverse media break.
- Fig. 2. Commercial high-efficiency filter with glass media and aluminum separators, showing pleat-edge media break.
- Fig. 3. Commercial high-efficiency filter with glass paper media and asbestos separators, showing transverse media breaks.
- Fig. 4. Commercial high-efficiency filter with glass paper media and kraft separators, showing damage on receipt (external shipping carton undamaged).
