Evolution of a Compound Channel: Tassajara Creek, Dublin, California

Term Project  
LAEP 227: Restoration of Rivers and Streams

Final Draft  
December 17, 2007

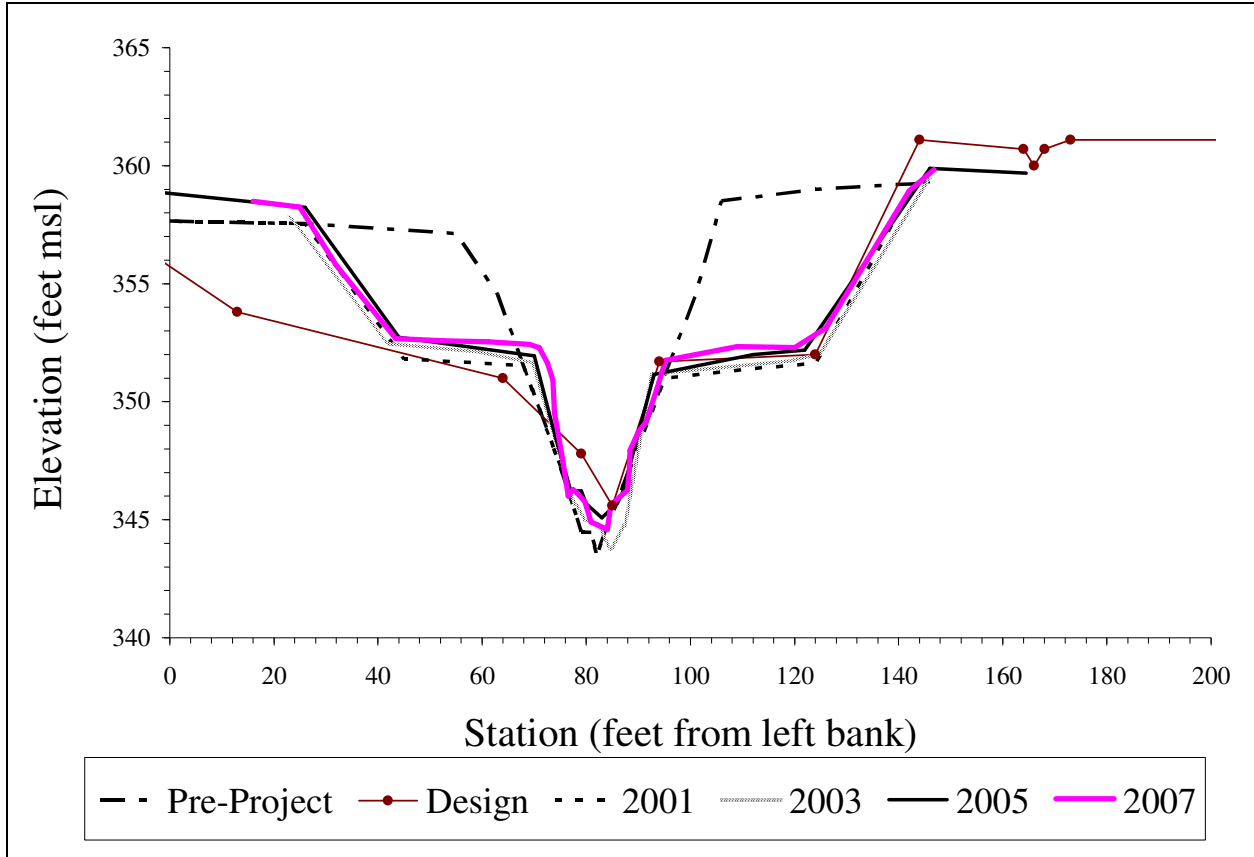
**Figure 7: Cross Section E-E' Downstream of the Central Pkwy. Bridge**

When we plot cross-section E-E' data with previous survey data (Figure 7), we see that the left bank has been eroded and the channel is meandering towards the left. Based on our data the thalweg incised as it moved towards the left bank, but the degree of incision between subsequent appraisals is uncertain due to previously mentioned survey inaccuracies. Cross section F-F' is plotted in Figure 9. The left bank had dense bulrushes growing (Figure 10.1) whose roots appeared to be stabilizing the upper bank and perhaps facilitating the aggradation measured in our data. Although it was not captured by the survey, the lower bank was beginning to undercut below the bulrush. The channel bottom was composed of extremely fine, soft sediments, a finding that supports the aggradation seen in our data. Section G-G' is plotted and compared to previous data in Figure 11. The channel was heavily vegetated at the cross-section (Figure 12.1 and 12.2) and we believe the vegetation stabilized the channel bottom and reduced flow velocities, increasing aggradation. We observed during our survey that the channel was braided upstream and downstream of this cross-section with two of the braids actively conveying water. We noticed a third braid which would fill during higher flows, but was not conveying water during our surveying. Previous reports and data do not mention any braiding, so we conclude

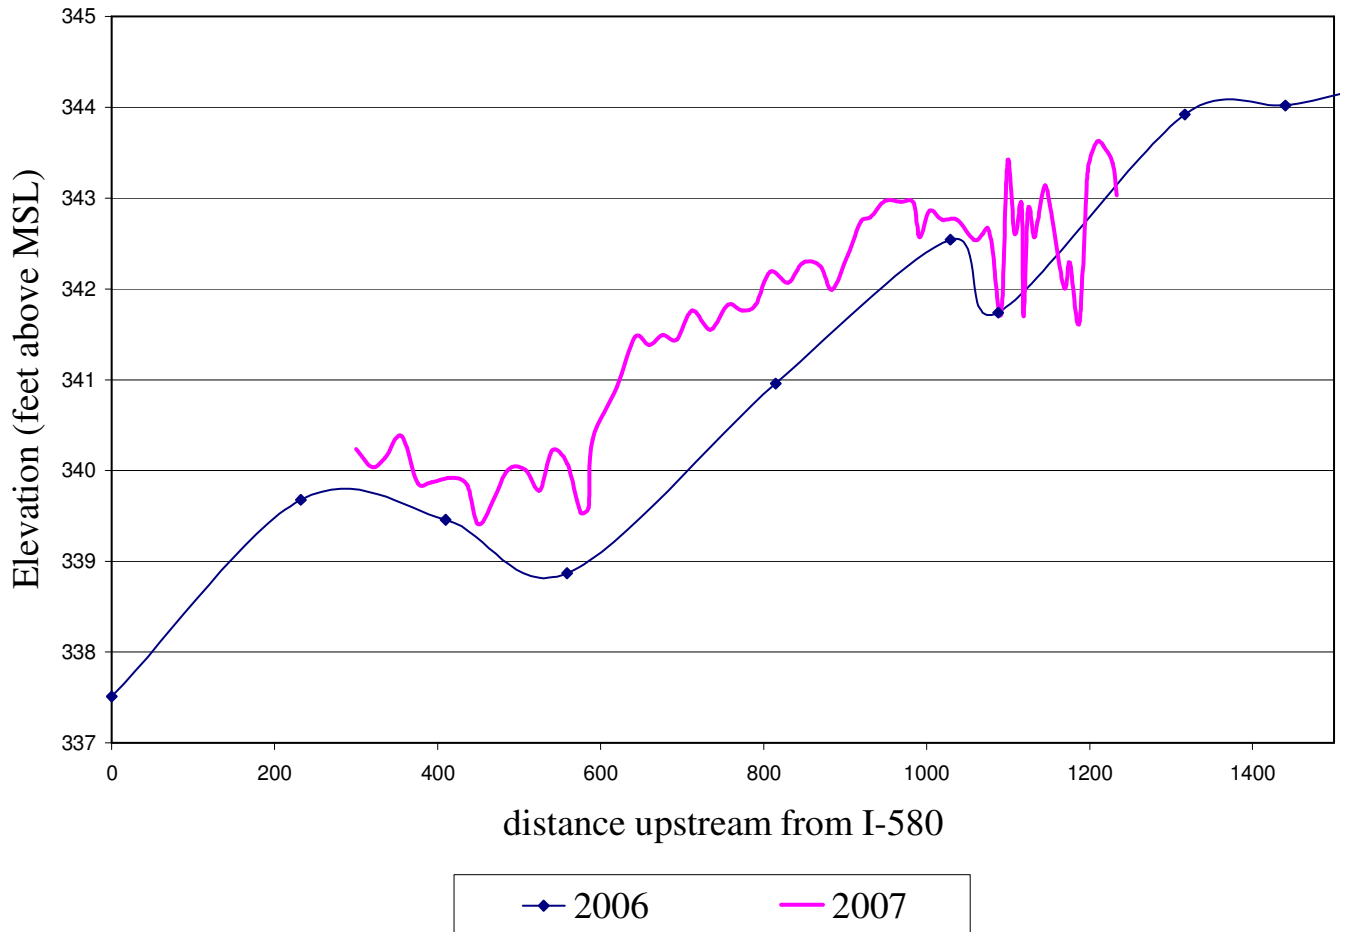
**Figure 13: Long Profile Plot from Dublin Blvd. Bridge toward I-580**

According to our long profile survey data, Tassajara Creek has generally aggraded downstream of the Dublin Blvd. Bridge, but still is local incising at some points (Figure 13). It is difficult for us to draw specific conclusions about the evolution of Tassajara Creek from comparisons of our long profile data with previous years. We only have data from a 2006 long profile to compare our data with and the previous data had a much larger increment between measurements. Many features we captured in our survey data would not appear in the previous year's data since the increments were so much larger. We can make several general conclusions though. We believe the aggradation seen in our data between 600 ft. and 1000 ft. upstream of I-580 is a real change from the previous year and not an artifact of our increased resolution. We observed significant cattail and bulrush growth in the channel throughout this reach which we think promoted aggradation of the channel bottom. Our data also indicates that there is a step-pool formation occurring between 700 ft. and 900 ft. upstream of I-580. We interpret the local incision shown in our data around 1200 ft. though as possibly an artifact of our smaller increment between measurements than previous years. Further monitoring at high resolutions would be necessary to determine if the incision is real.

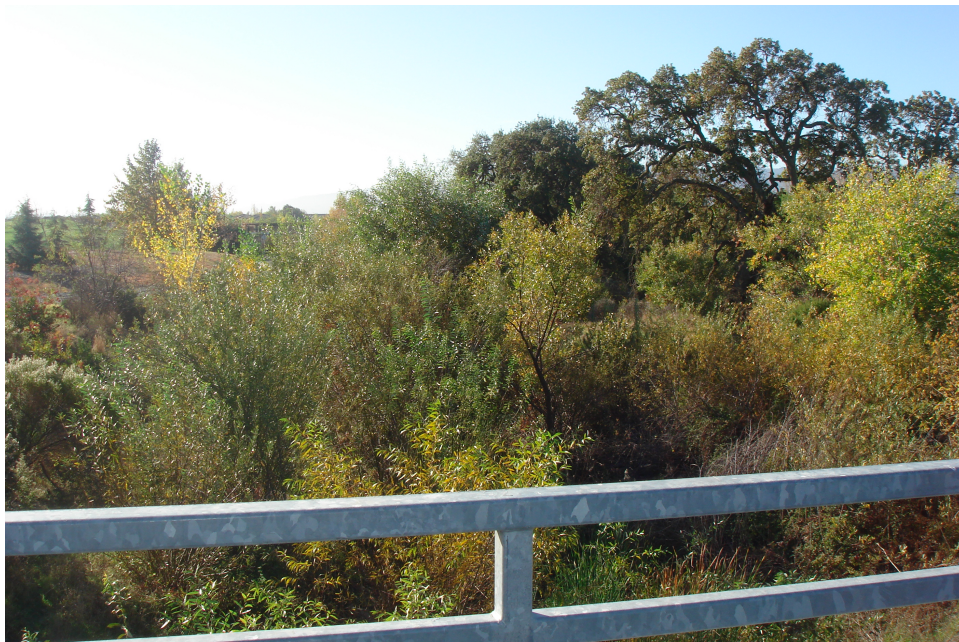
**Figure 14.4: 2007 - standing on Gleason Ave Bridge looking downstream – mid bridge 3<sup>rd</sup> vertical railing shown; oak tree seen in all previous photos seen in upper right corner**
