Post-restoration changes in bed material and channel features, Redwood Creek, Marin County

Post-restoration Changes in Bed Material and Channel Features, Redwood Creek, Marin County

Mike Matz and Alison Purcell

May 11, 2004

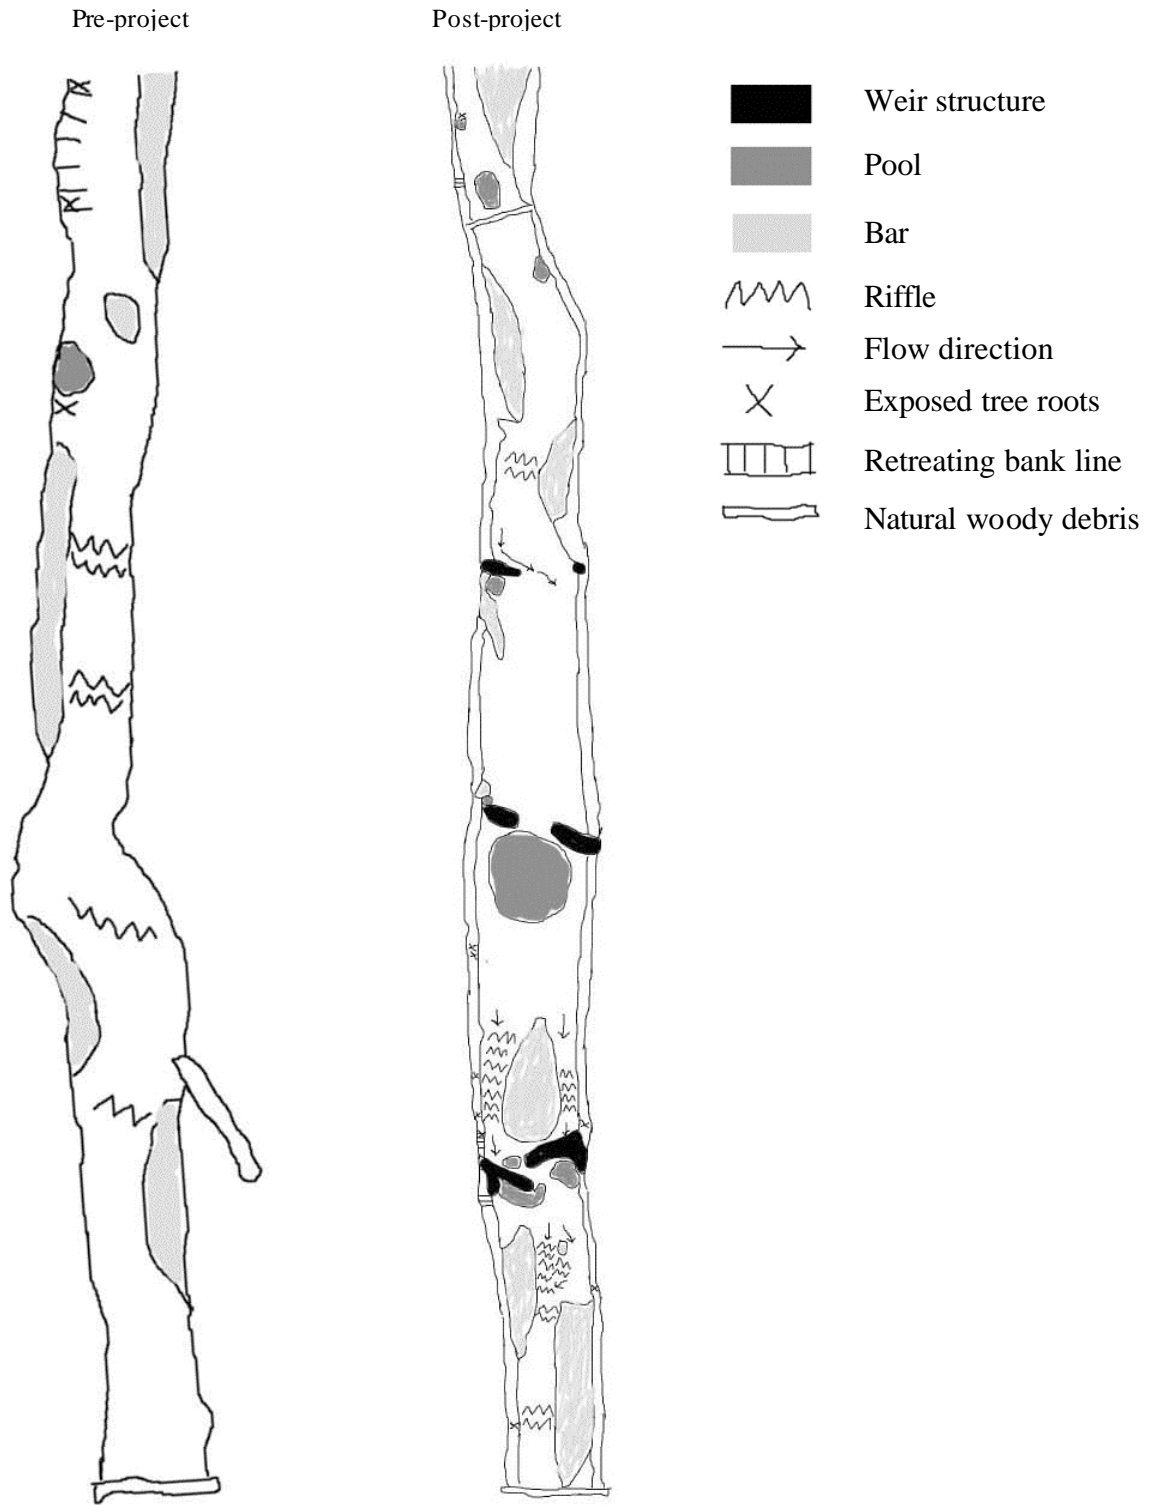
Figure 5. Pre-project and Post-project Geomorphic Survey Maps side-by-side for comparison at same scale

1. Pools. While the pre-project GSM showed one small pool in our 432-foot reach, our post-project GSM indicated nine pools. New pools formed downstream of all three installed weir structures. In particular, an approximately 600-square-foot pool was located downstream of weir structure 5 (Appendix A, Photo 9).

2. Bars. The pre-project GSM contained five bars, while the post-project GSM indicated nine bars. New bars formed upstream of all three weir structures. An especially striking example was the nearly 500-square-foot bar in the center of the channel immediately upstream of weir structure 6-7-8 (Appendix A, Photo 10). The locations of the bars are dramatically different in the pre- and post-project GSMs.

3. Riffles. The pre-project GSM had four riffles while the post-project GSM contained five riffles, all of which were in new locations. New riffles formed immediately upstream of weir structure 4 (Appendix A, Photo 11), and upstream (Appendix A, Photo 12) and downstream of weir structure 6-7-8 (Appendix A, Photo 13). We did not compare sizes of pre- and post-project riffles because it was difficult to gauge the size of the riffles on the pre-project GSM.

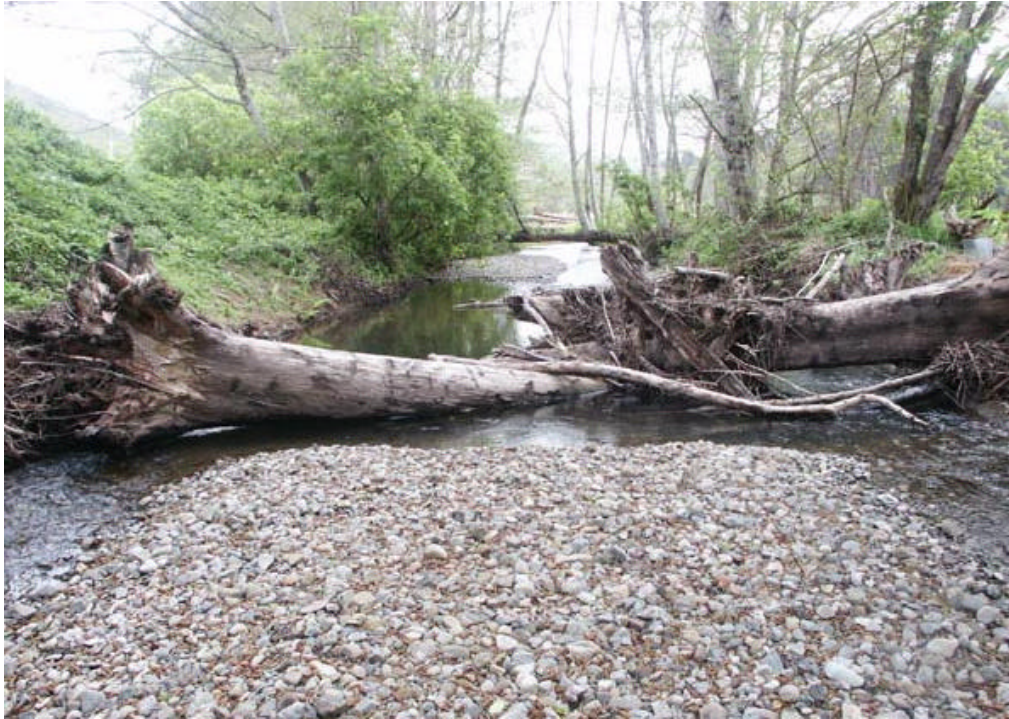
Photo 3. Looking downstream at weir structures 6, 7, and 8. A cobble/gravel bar has formed directly upstream of the structure.

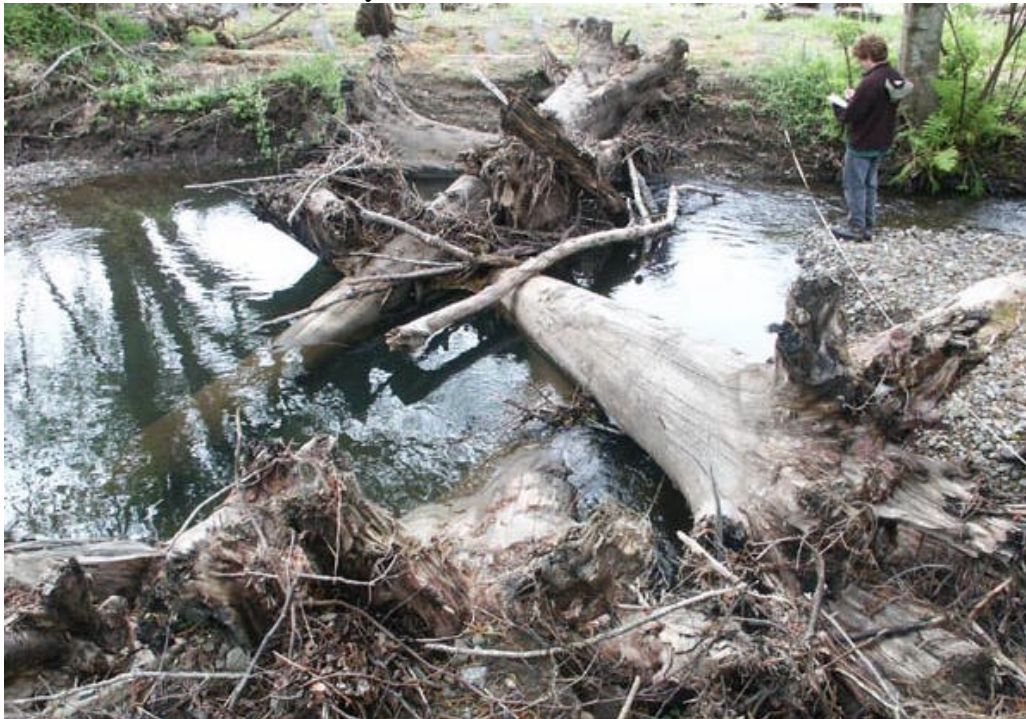
Photo 4. Looking towards the right back at weir structures 6, 7, and 8. A pool has scoured directly downstream of the structure.

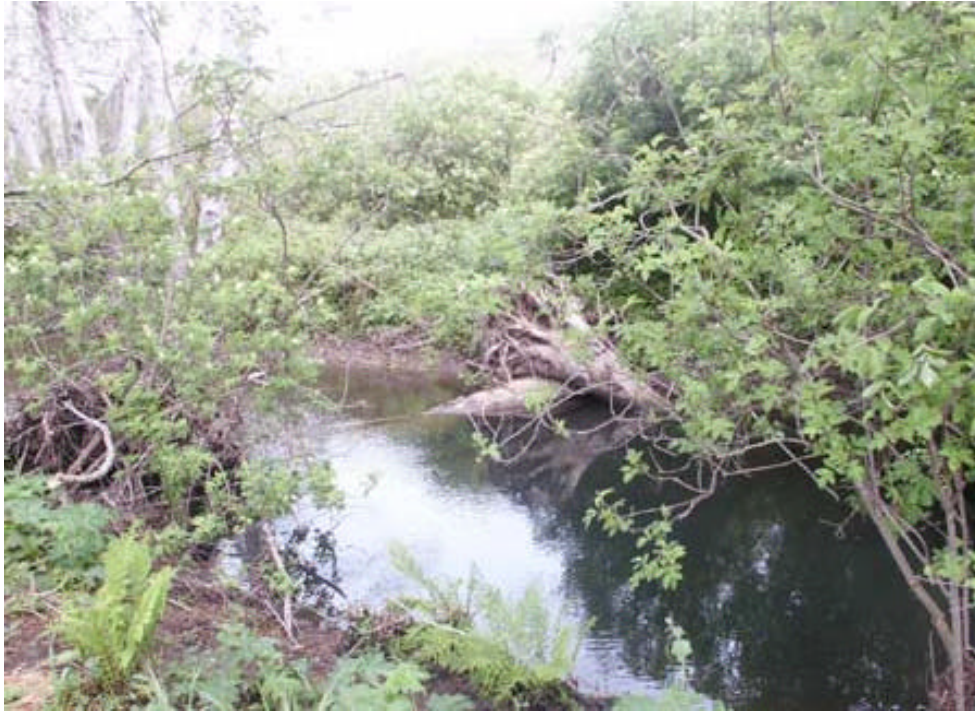
Photo 9. Pool immediately downstream of weir structure 5 (view from right bank).

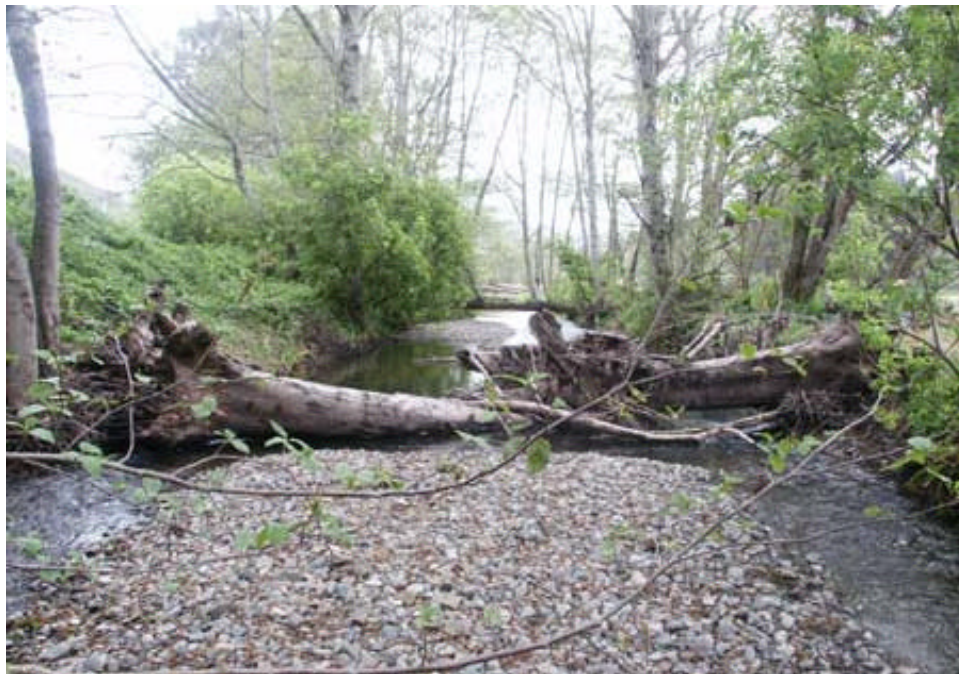
5. Split channel. The entire pre-project reach was a single channel. In the post-project GSM, bars upstream and downstream of weir structure 6-7-8 split the channel into two (Appendix A, Photo 10). Elsewhere, the post-project reach was a single channel.

Photo 10. Looking downstream at bar 6, riffles 2 and 3, split channel, and weir structure 6-7-8.

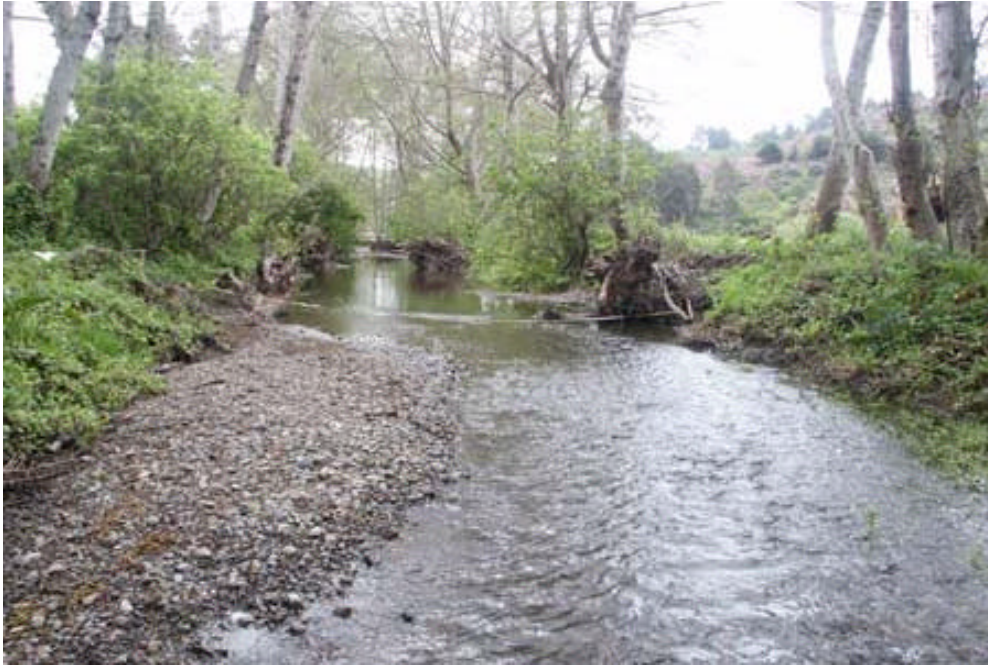
Photo 11. Looking downstream at riffle 1, bar 3, and weir structure 4.

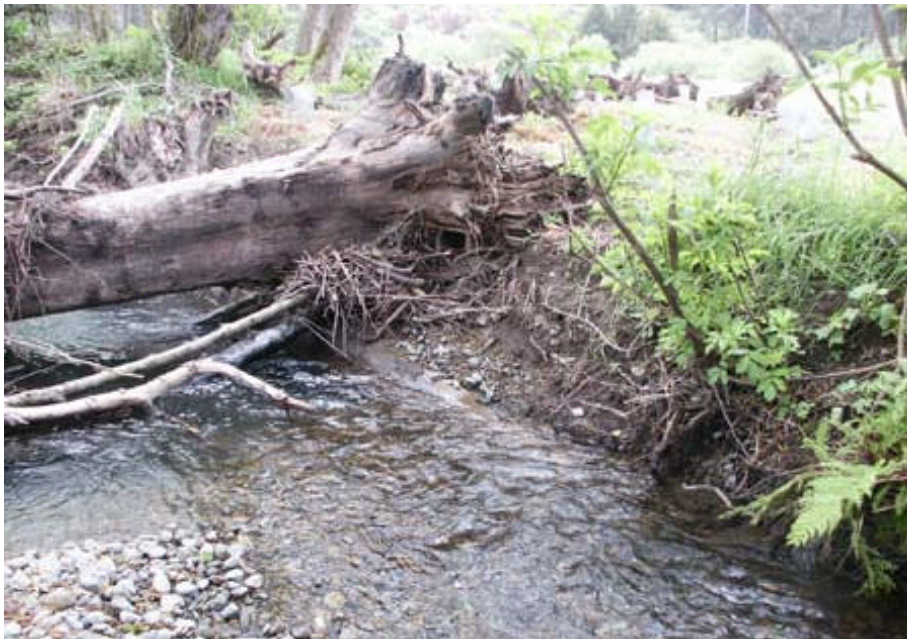
retreating bank line areas in new locations, including one just downstream and one upstream (Appendix A, Photo 12) of weir structure 6-7-8.

Photo 12. Exposed tree roots and eroding bank area on right bank upstream of weir structure 6-7-8.

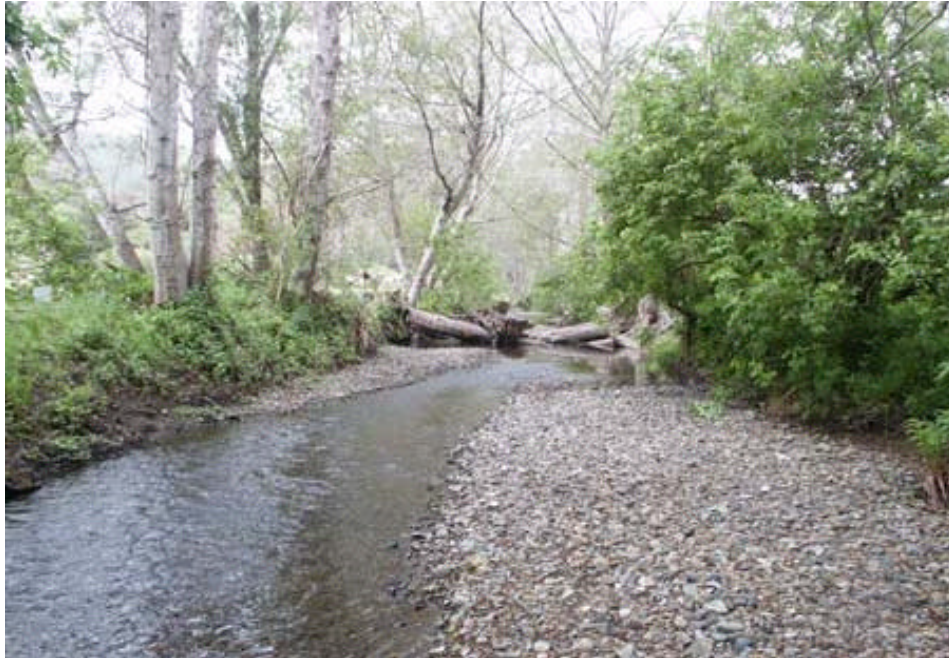
Photo 13. Looking upstream at riffles 5 (foreground) and 4, bars 9 (foreground) and 8, and structure 6-7-8. (View from log at endpoint of study reach)

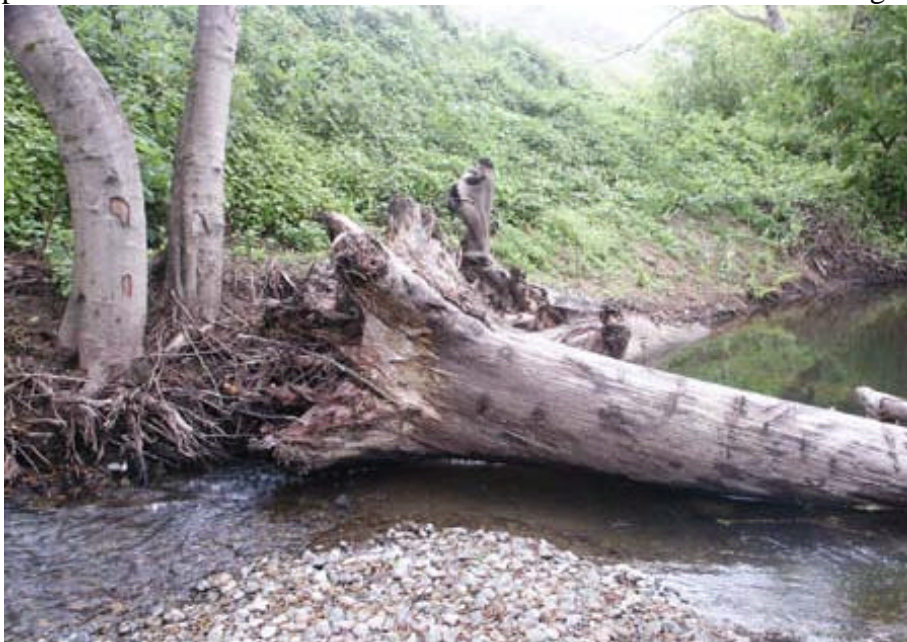
4. Exposed roots. There were three exposed root areas in the pre-project GSM and seven exposed root areas in the post-project GSM. The most dramatic change was the four new exposed root areas upstream of weir structure 6-7-8. (Appendix A, Photo 14 shows one of these areas.)

Photo 14. Exposed tree roots on left bank near weir structure 6-7-8. Bar 6 in foreground.

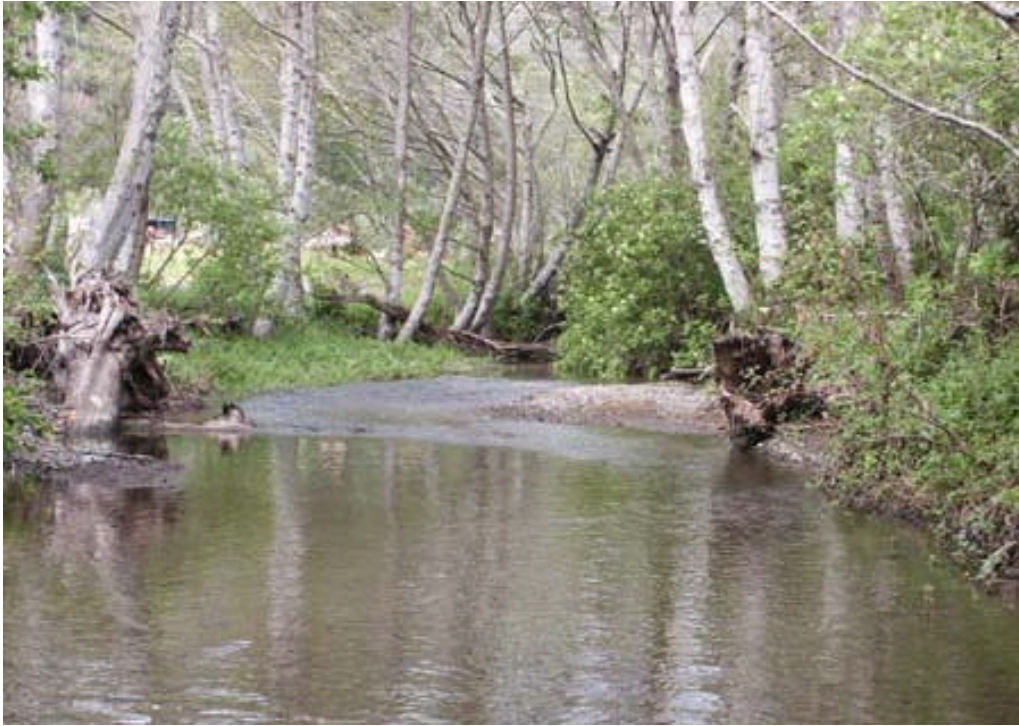
7. Flow direction: The pre-project GSM did not indicate any unique flow direction features. On the post-project GSM, weir structures 4 and 6-7-8 re-directed the flow (see Appendix A, Photo 15; Appendix B, longitudinal range 320-344 feet).

Photo 15. Looking upstream at flow direction change along weir structure 4.

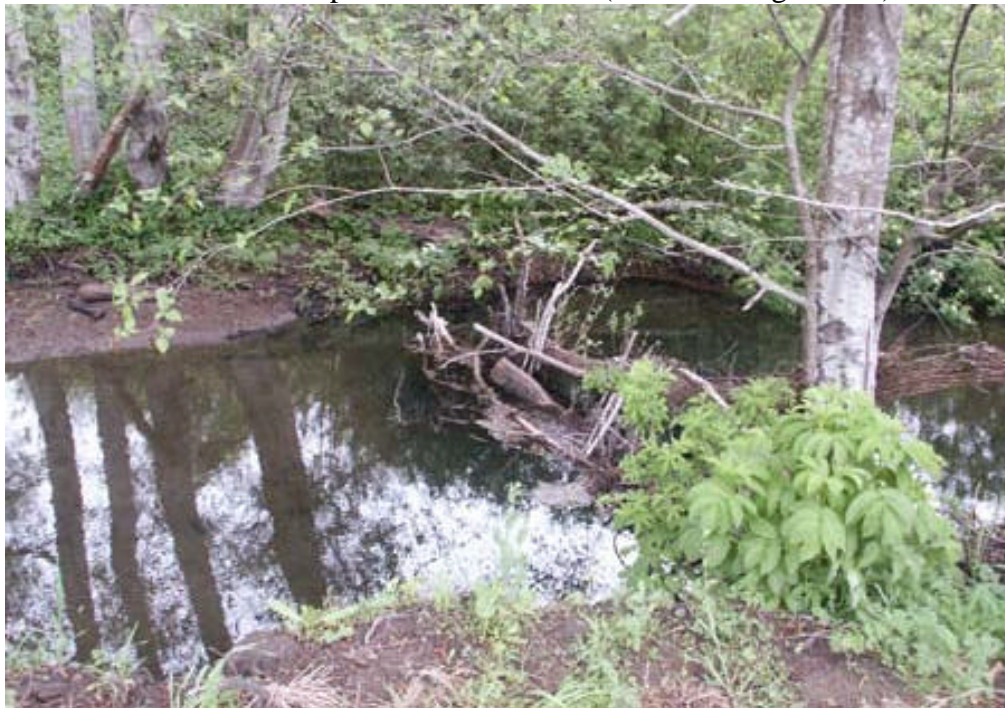
Photo 16. Silt deposition on left bank (view from right bank).

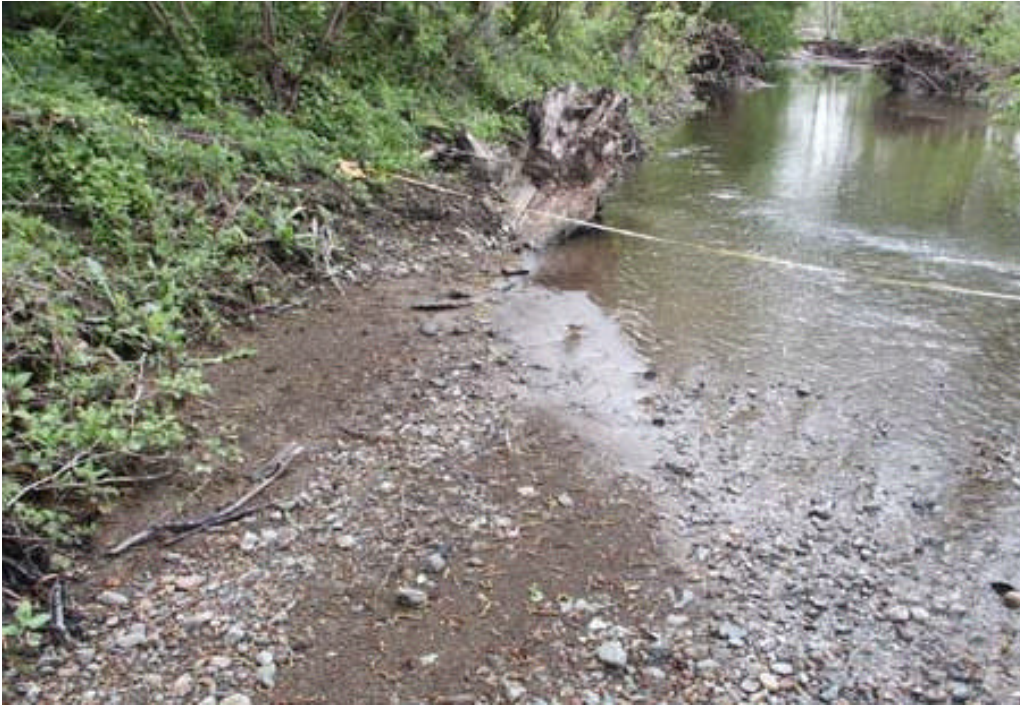
Photo 17. Looking downstream at silt deposition adjacent to weir structure 4 (left bank).

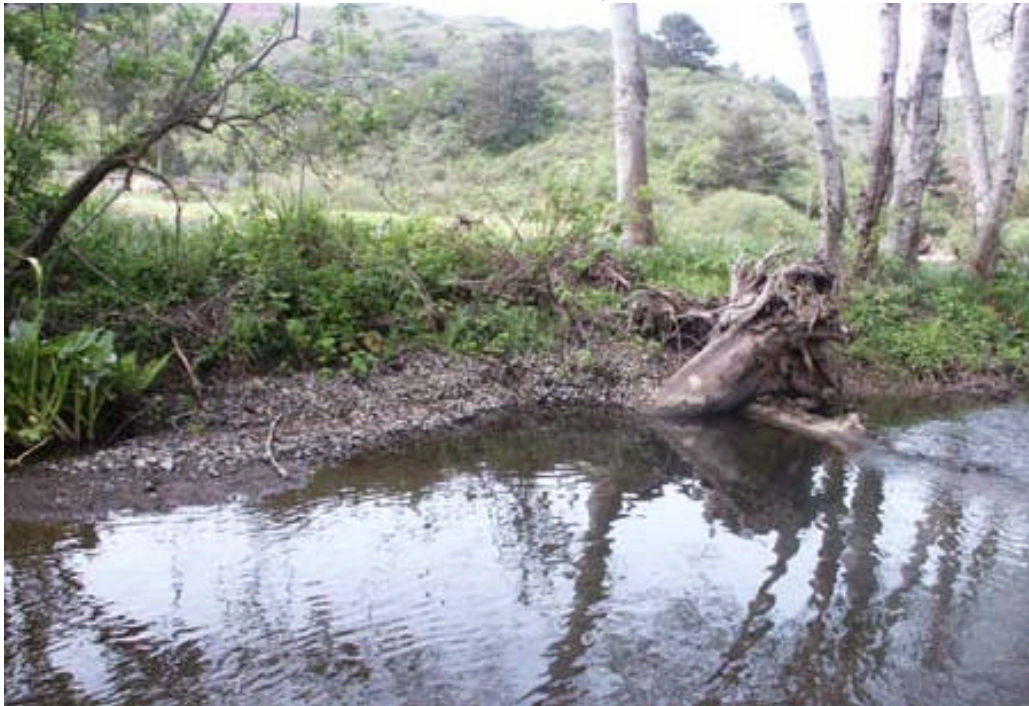
Photo 19. Pool and bar 4 along right bank, immediately downstream of weir structure 4.(view from left bank).

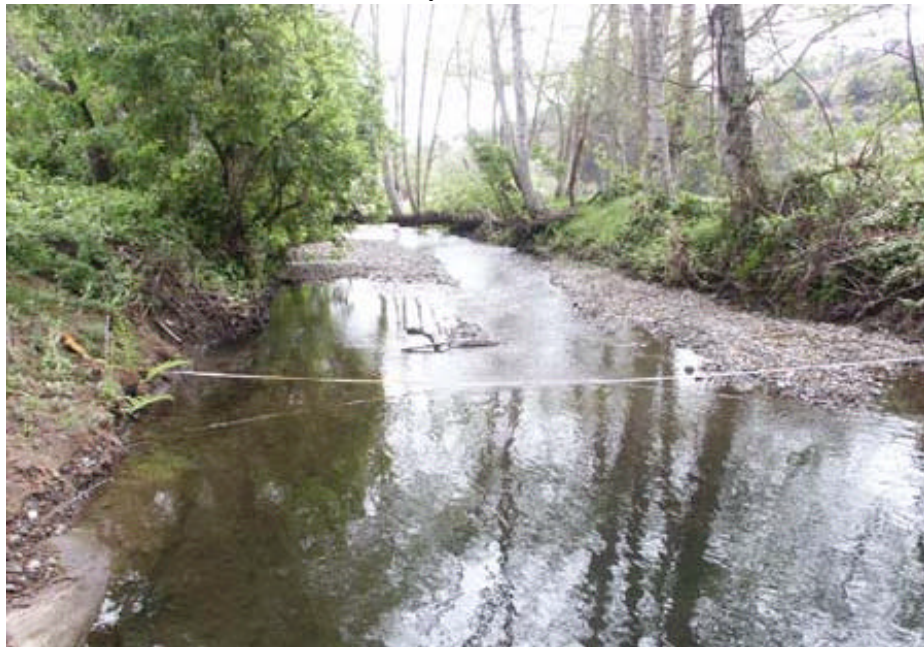
Photo 20. Pool immediately downstream of structure 6-7-8.
