# UC San Diego

## UC San Diego Electronic Theses and Dissertations

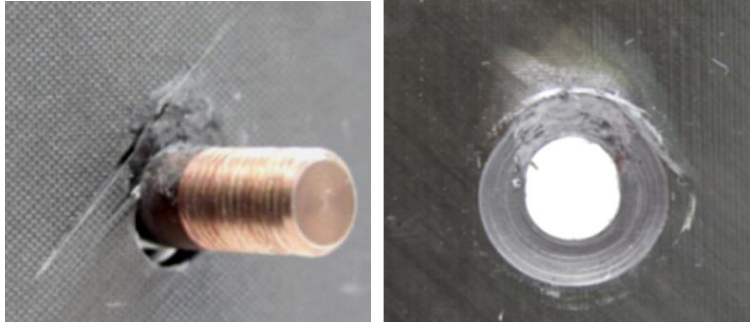
**Figure 1.1: Bearing failure due to cyclic loading of a countersunk bolted joint.**

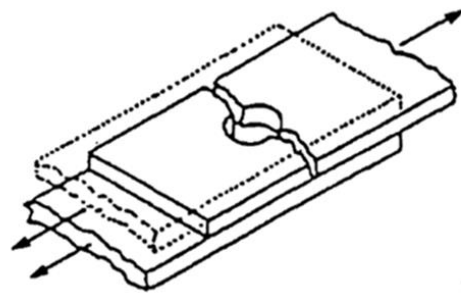
(A) Net-section Failure

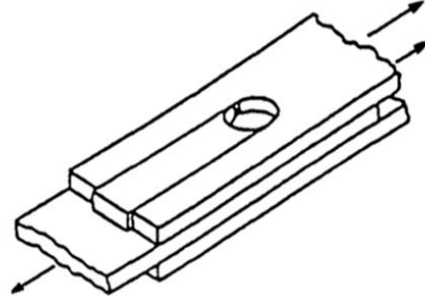
(B) Shear-out Failure

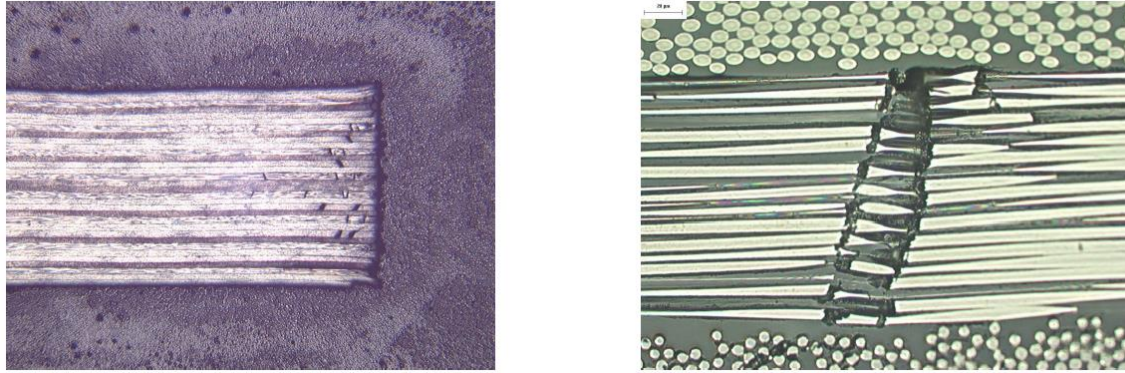
**Figure 2.2: Bearing failure of joint loaded to 23 kN (left) and formation of kink bands in bearing plane (right) [4].**

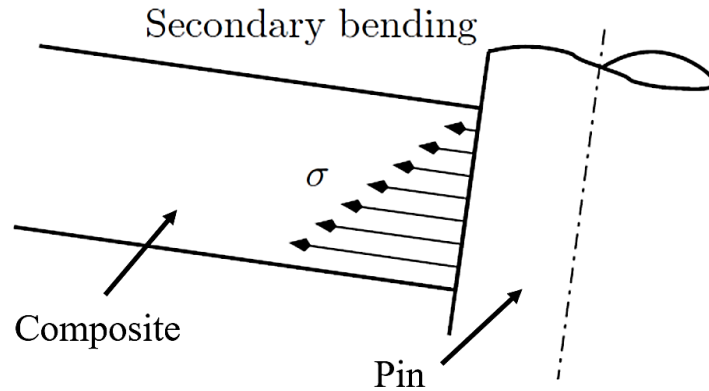
**Figure 2.5: Contact stress due to secondary bendingpin [4].**

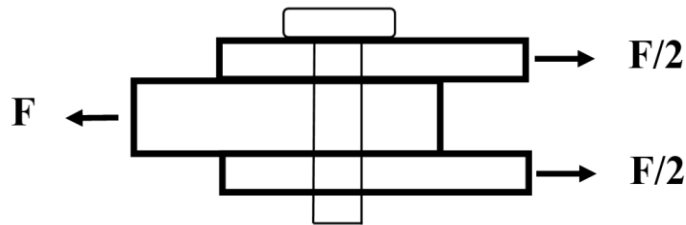
**Figure 2.7: Double lap shear joint configuration cross-sectional view.**

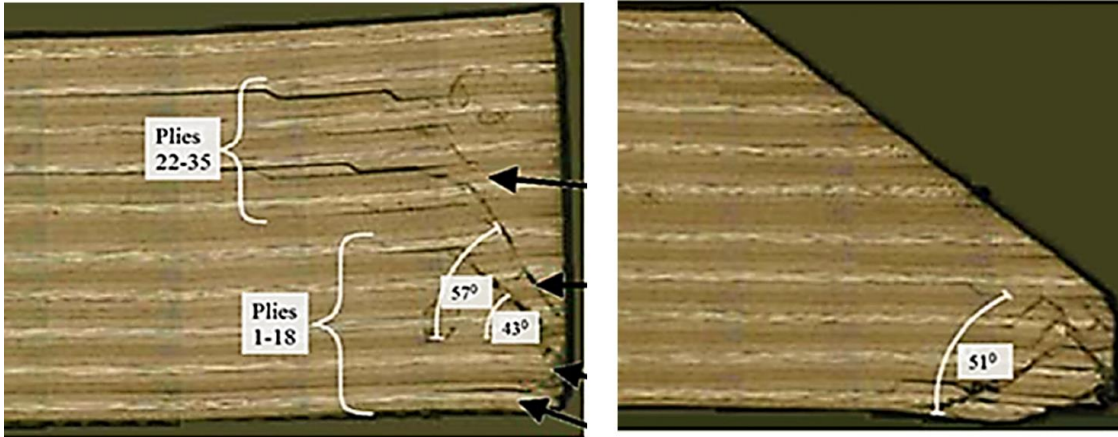
Figure 2.8: Microscopy of composite material experiencing bearing load with a protruding head (left) and countersunk (right) fastener [6].

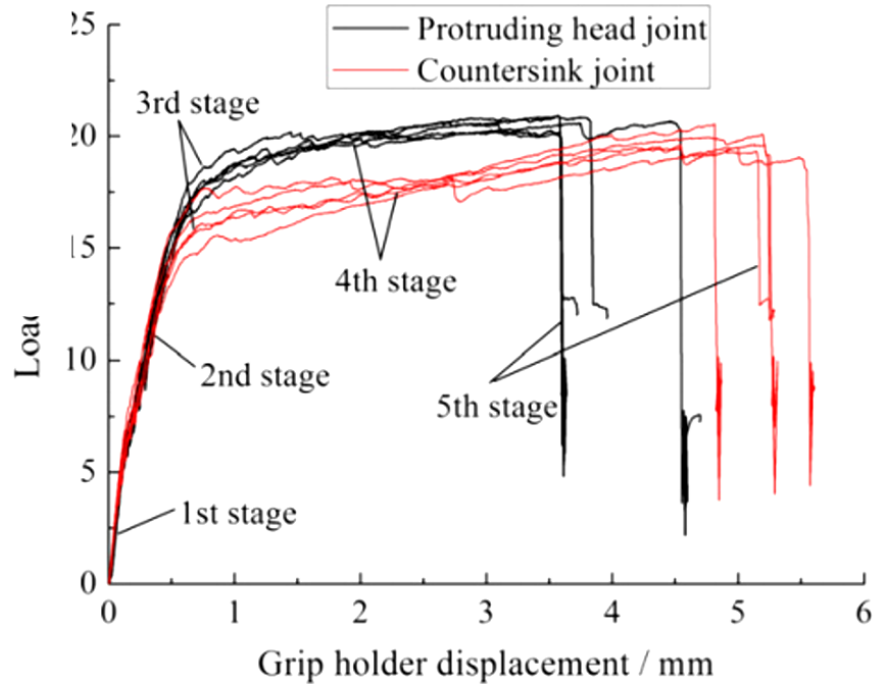
**Figure 2.10: Bearing static test results for protruding head joint versus countersunk joint [7].**

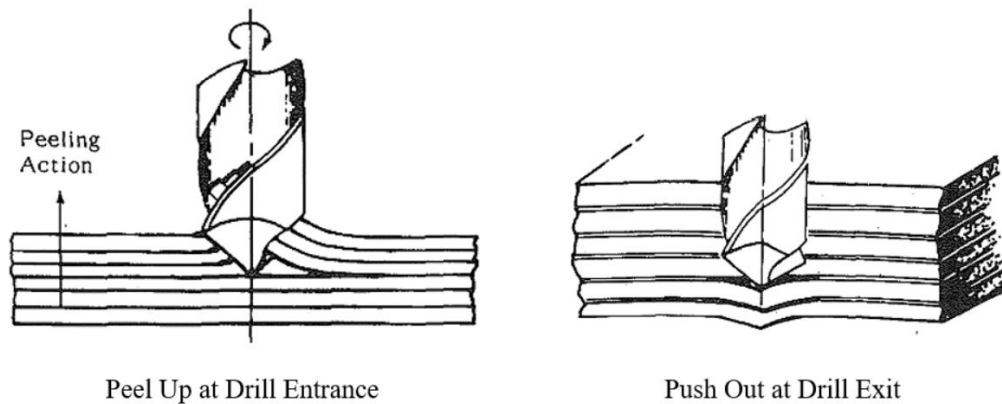
**Figure 2.11: Peel up delamination when drill enters (left) and push out delamination when drill exits (right) [12].**

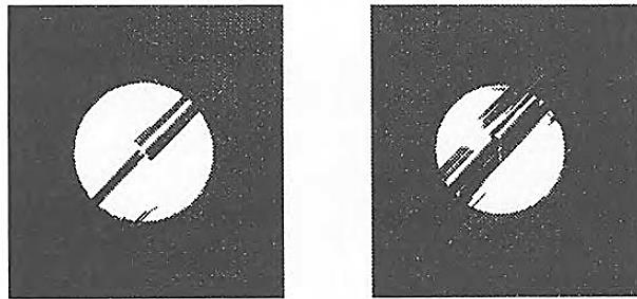
**Figure 2.12: Uncut fibers at the exit side caused by a sharp drill (left) and blunt drill (right) [9].**

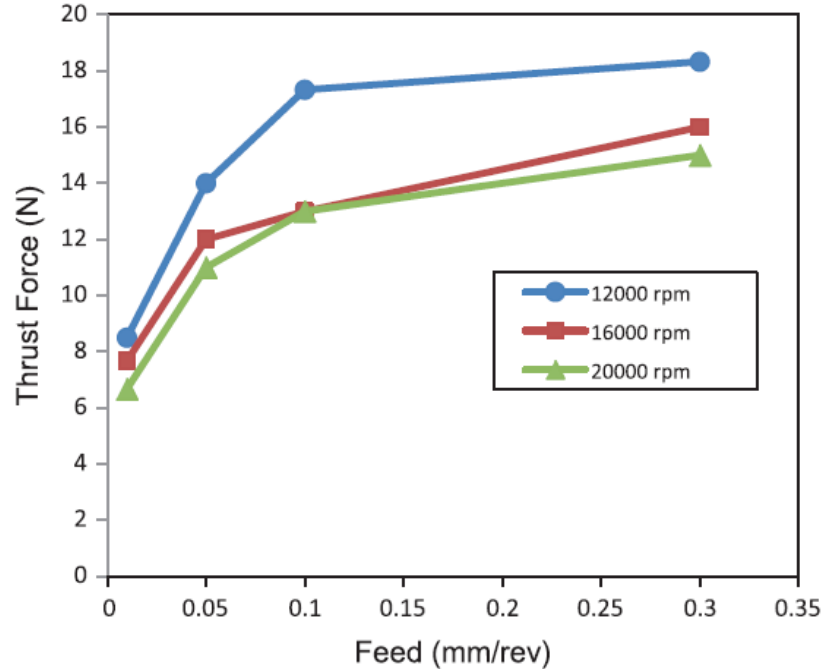
Figure 2.13: Effect of speed and feed rate on thrust force [14].

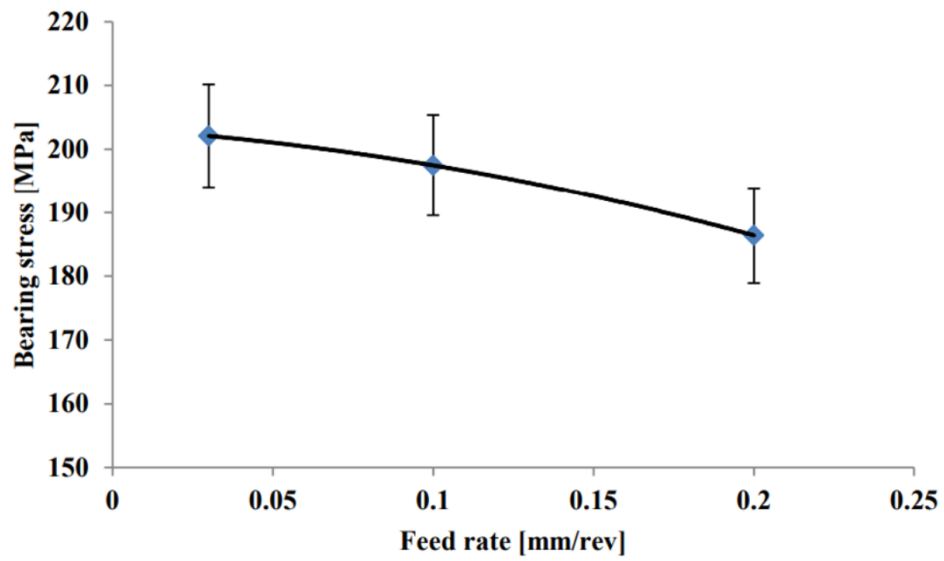
Figure 2.15: Bearing stress due to various drilling feed rates [15].

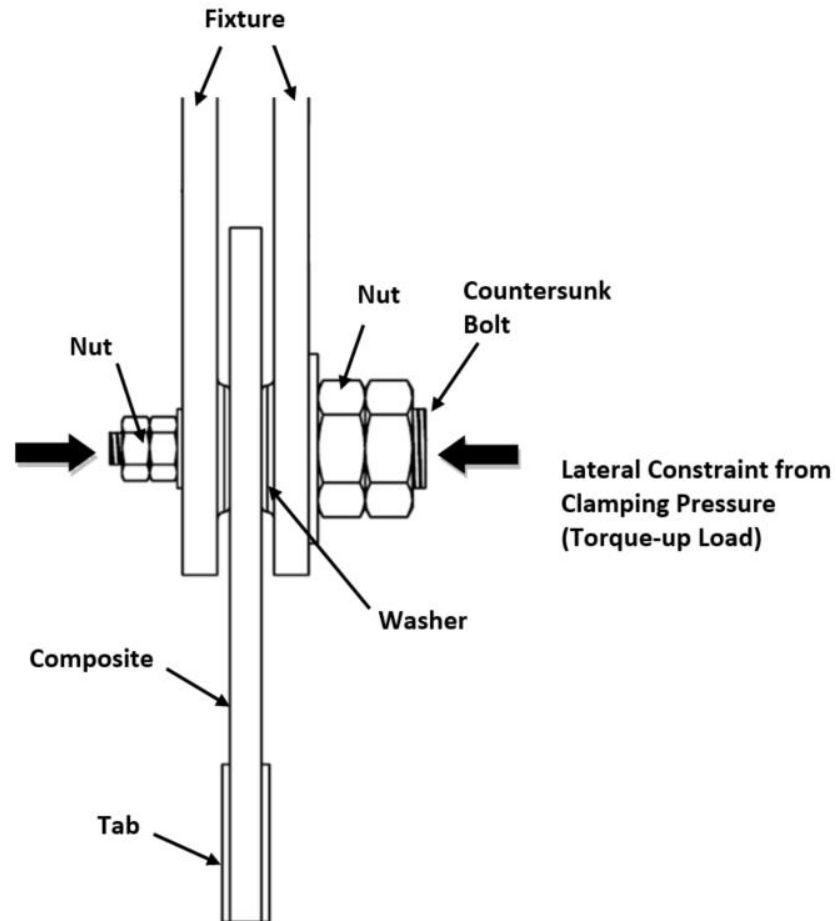
**Figure 2.16: Double lap joint fixture and specimen assembly. The applied torque-up load on the nut and transferred to the washers to provide lateral constraint (out-of-plane deformation).**

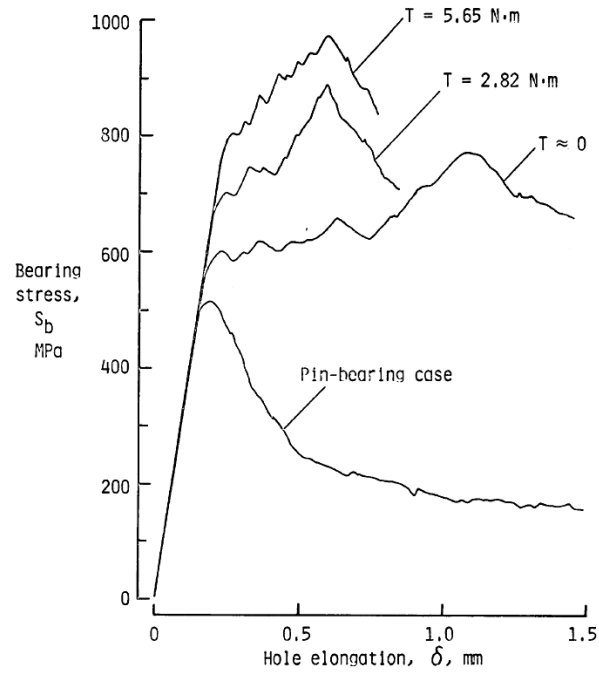
Figure 2.17: Effect of clamping pressure on bearing strength and hole elongation [16].

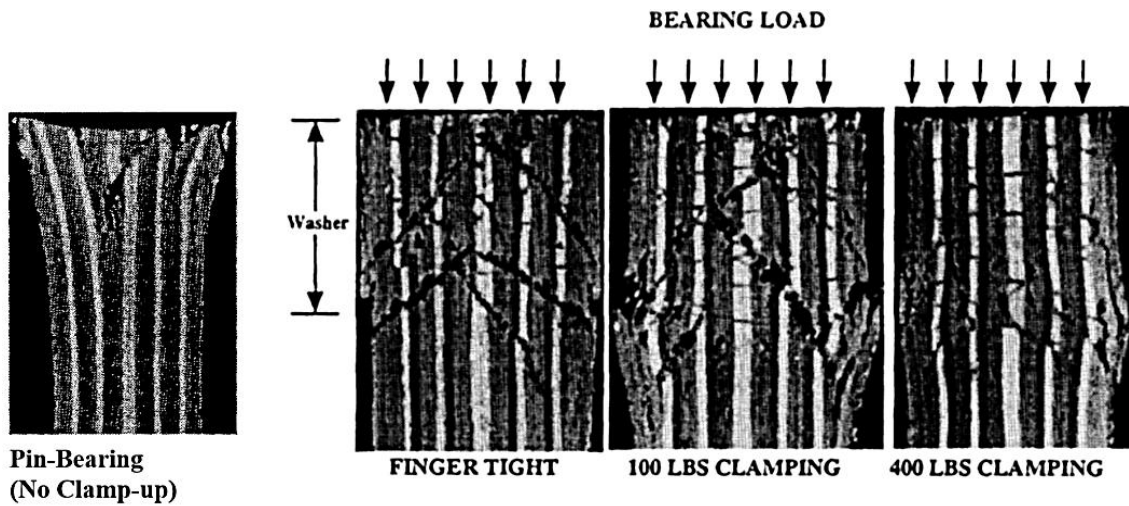
Figure 2.18: Optical microscopies of bearing damage in bolted joints with various clamping pressure [16].

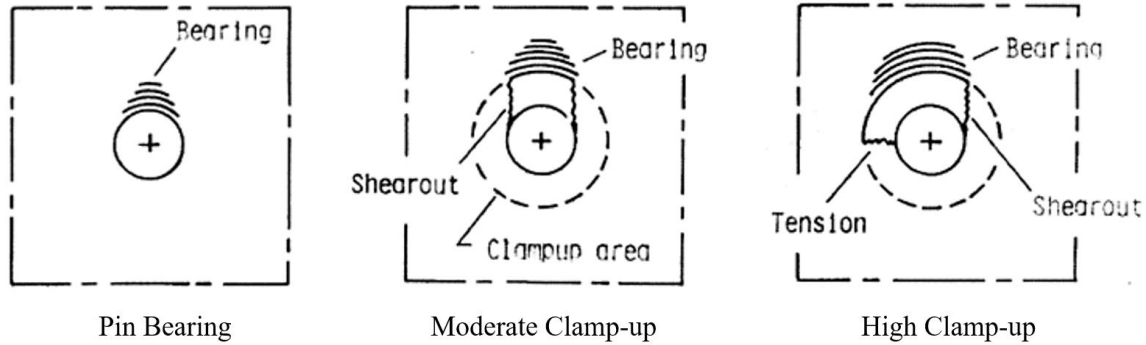
**Figure 2.19: Bearing failure modes due to clamping pressure [16].**

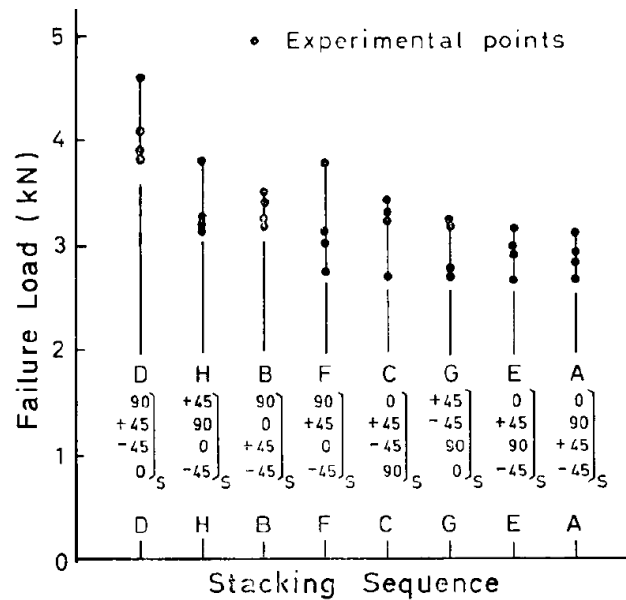
Figure 2.20: Effect of stacking sequence on bearing failure load [22].

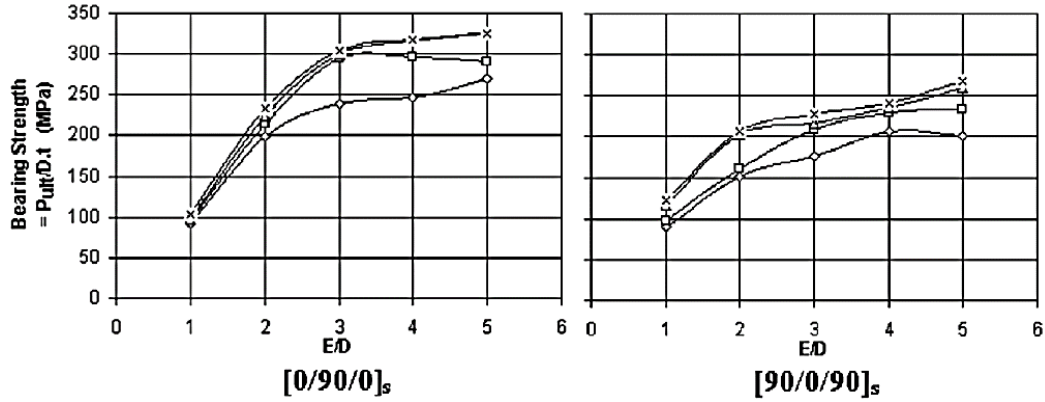
Figure 2.21: Effect of 0° plies versus 90° plies on bearing strength [25].

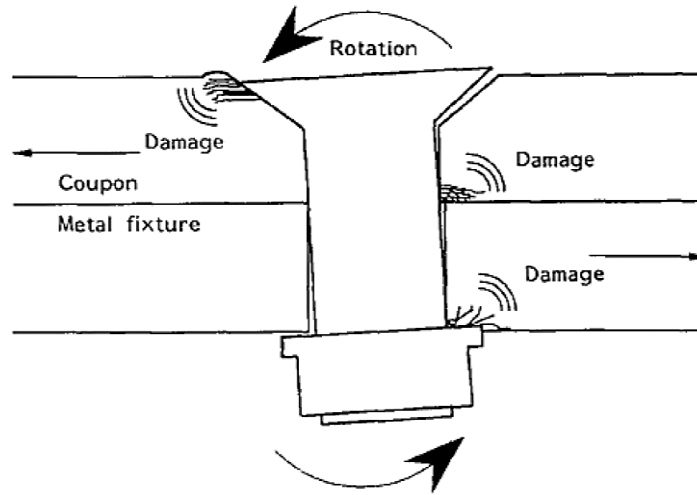
Figure 2.22: Movement of bolt during fatigue loading [26].

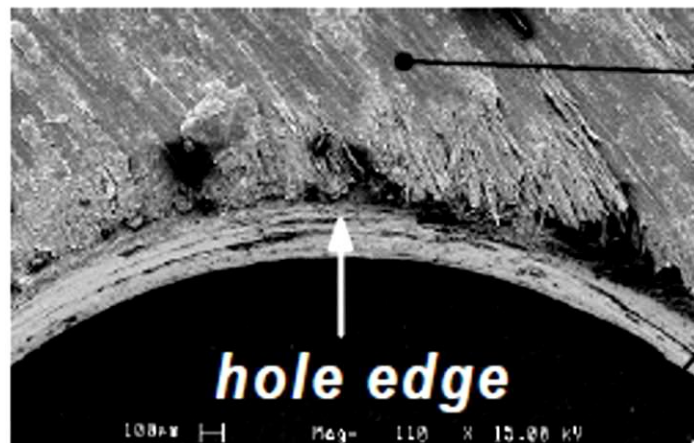
Figure 2.23: Hole wear caused by fatigue loading in composite bolted joint [27].

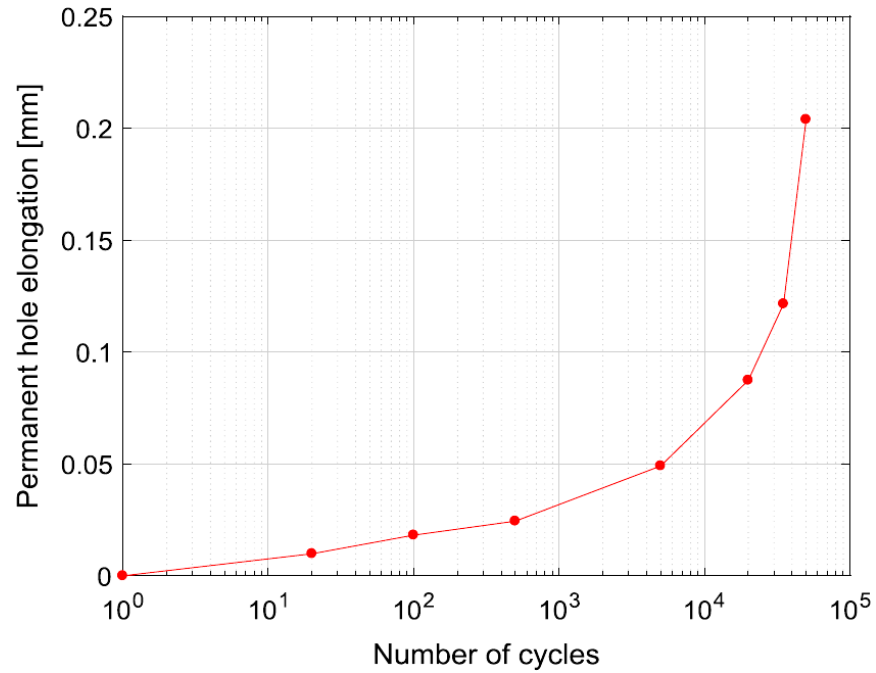
**Figure 2.24: Hole elongation during pin-bearing fatigue test [28].**

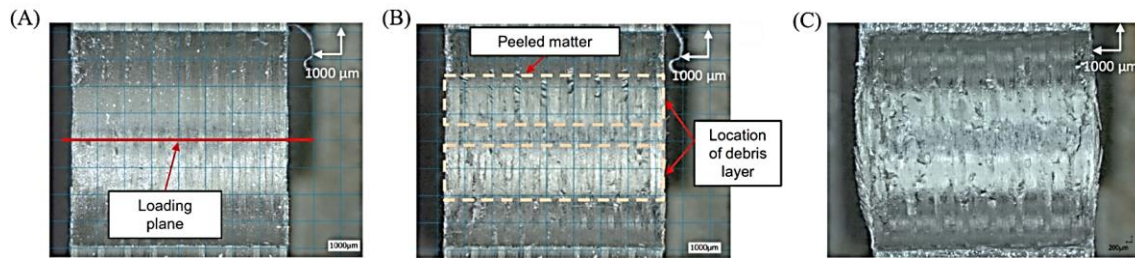
**Figure 2.25: Fatigue test of pin-bearing failure sequence [28].**

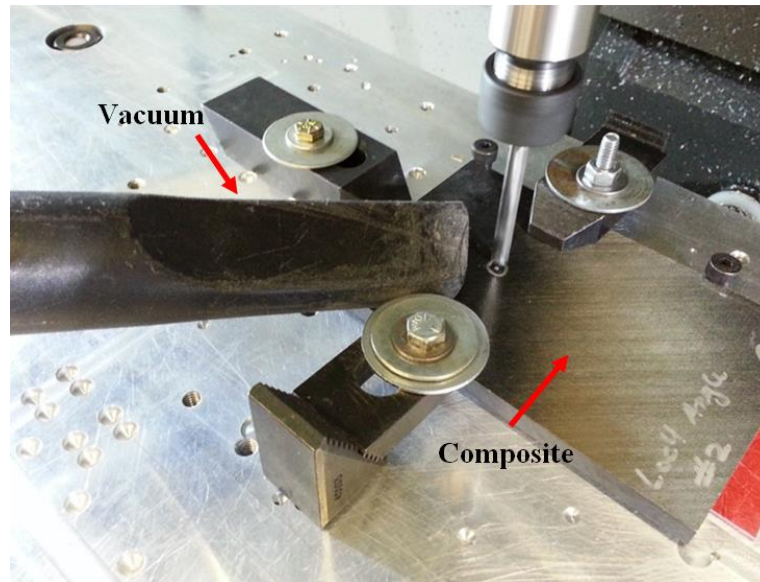
**Figure 3.3: Composite hole drilling setup on the CNC milling machine.**

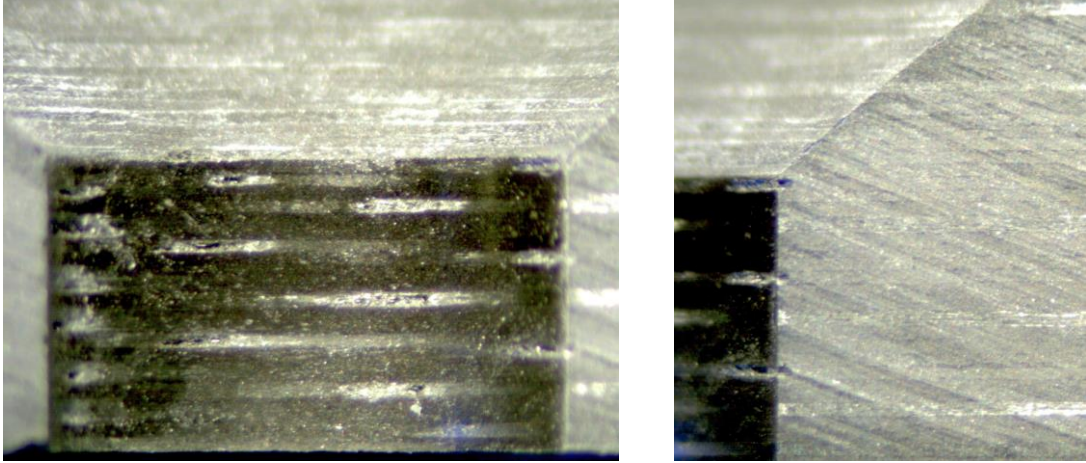
**Figure 3.5: Optical microscopy of countersunk hole with slow feed rate. The tool overheats due to friction causing gouches from matrix burn-out.**

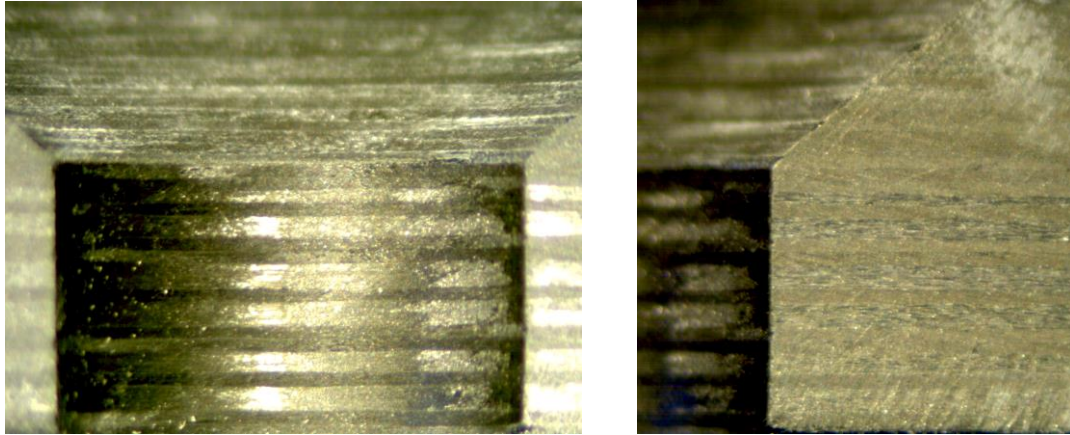
**Figure 3.6: Optical microscopy of countersunk hole showing no flaws (i.e., delamination and gouges from matrix burnt-out). Drill parameters used to create this hole was used to fabricate all 9.53 mm countersunk hole for tested specimens.**

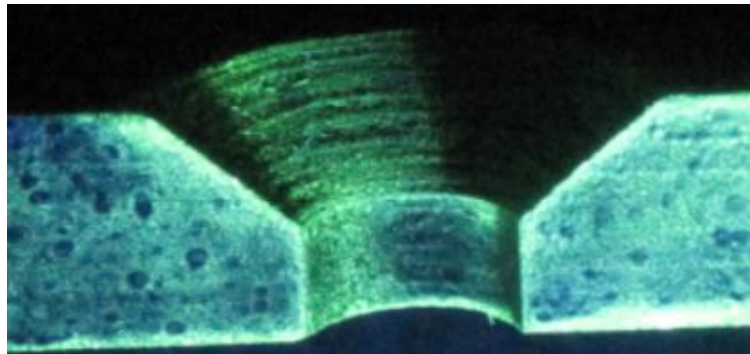
**Figure 3.7: Fluorescent dye penetrant test performed on the specimen that was fabricated with the optimal drill, ream and countersunk parameters. No matrix burnt-out or delamination on hole surface. Gouges on the side of specimen was due to sectioning the specimen with a wet tile-saw.**

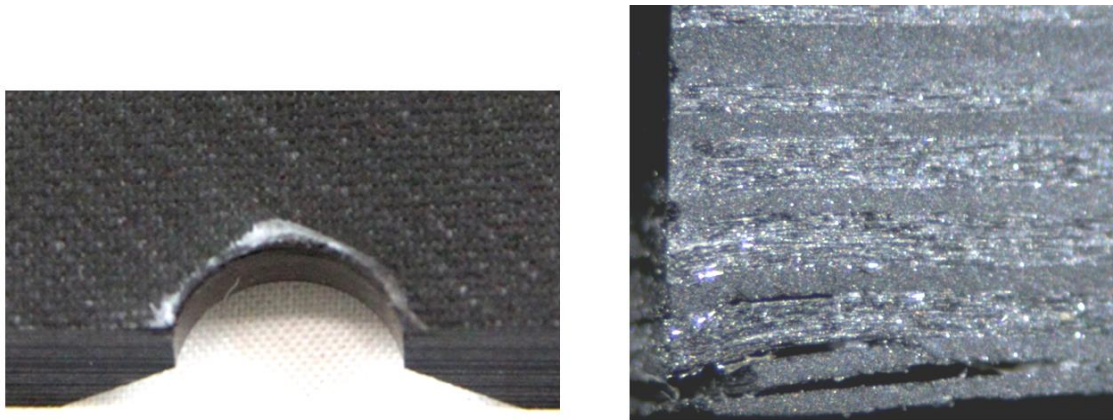
**Figure 3.8: Delamination induced due to high drill feed rate and no stiff support where the tool exits.**

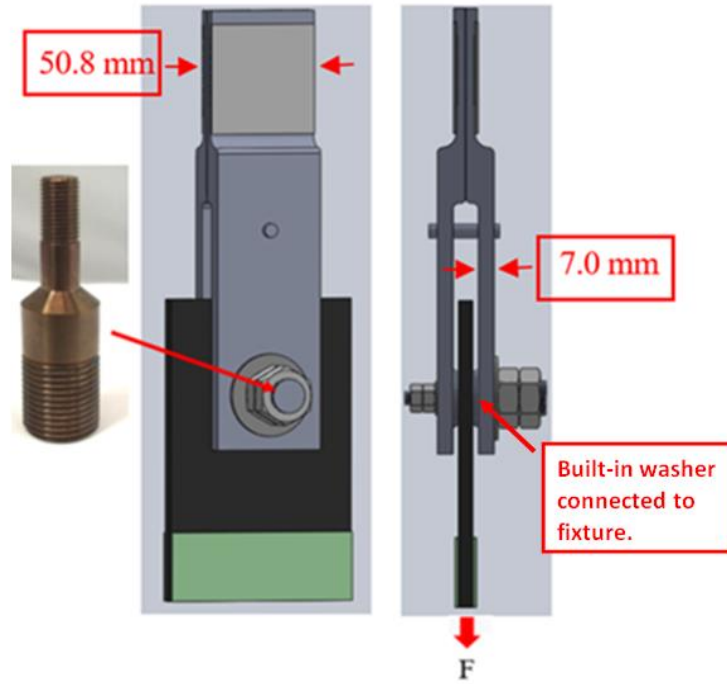
Figure 3.9: Double lap shear test configuration using a custom designed countersunk bolt. A torque load of 0.50 N-m (finger-tight) was used in this setup.

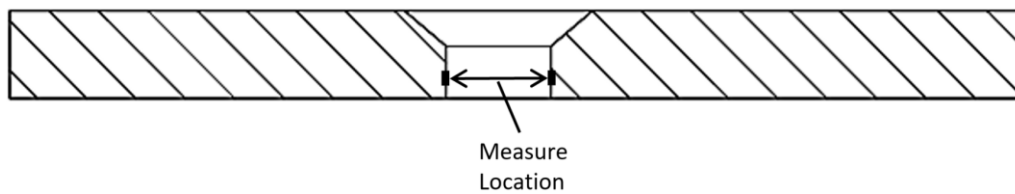
**Figure 3.11: Location of where the hole elongation is measured using a hole gauge and micrometer. Measurements were taken three times and the averaged.**

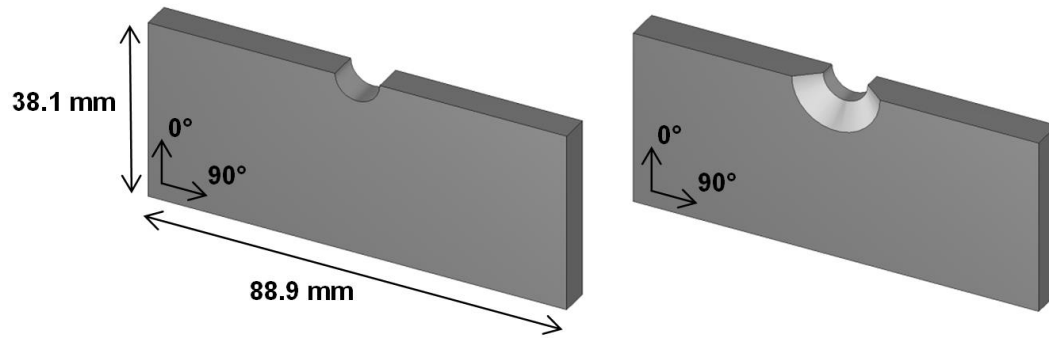
Figure 3.12: SCN through-hole and countersunk specimen geometry.

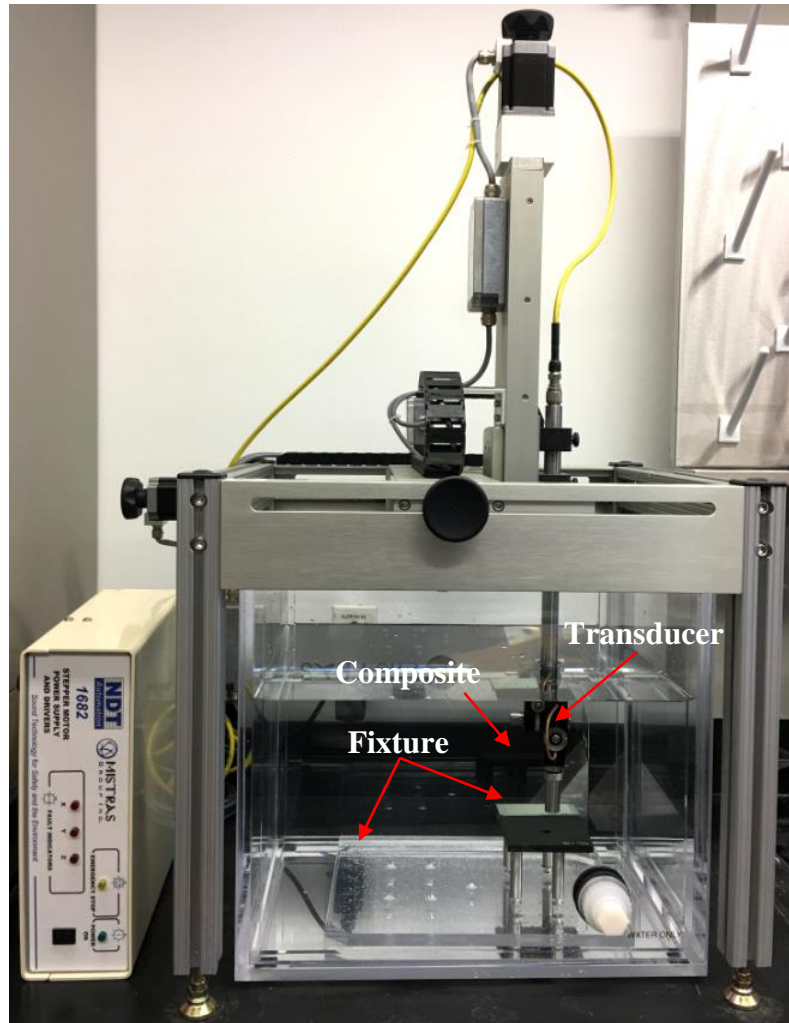
**Figure 3.15: Ultrasonic C-scan system.**

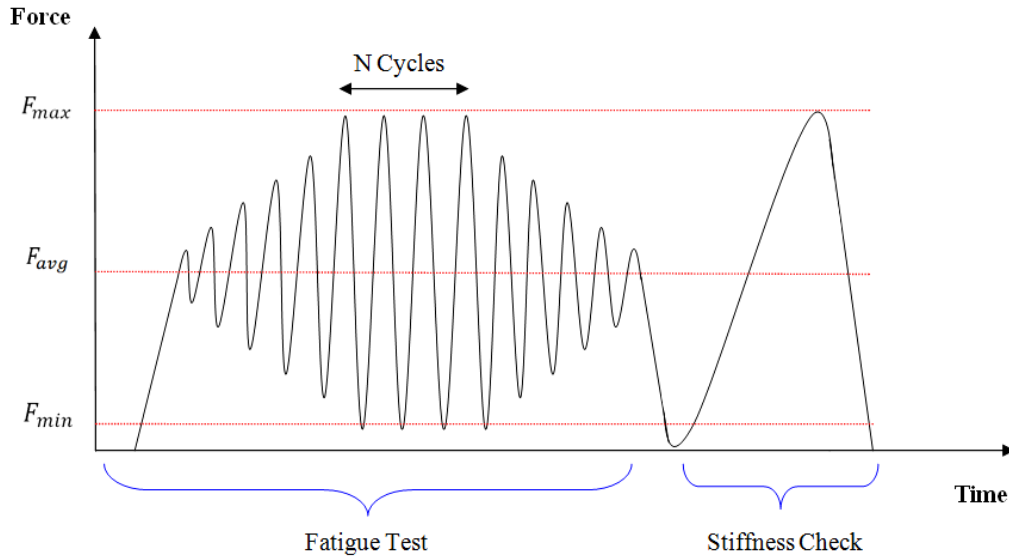
**Figure 3.18: Illustration of cyclic loading procedure.**

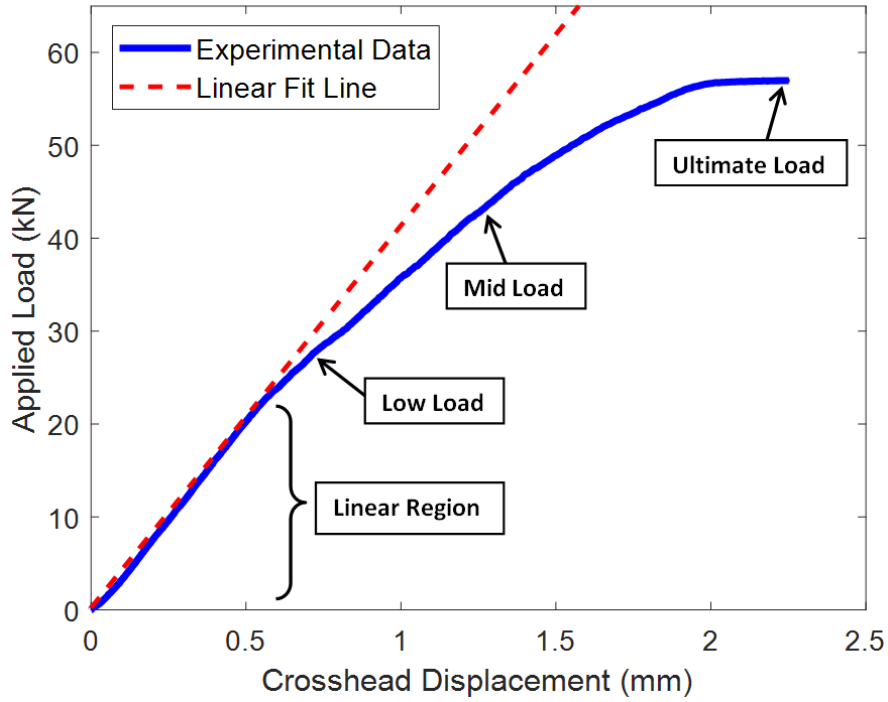
**Figure 4.1: Typical bearing load vs. displacement plot from a static test. Load level definitions used to study progressive damage of composite specimens are indicated.**

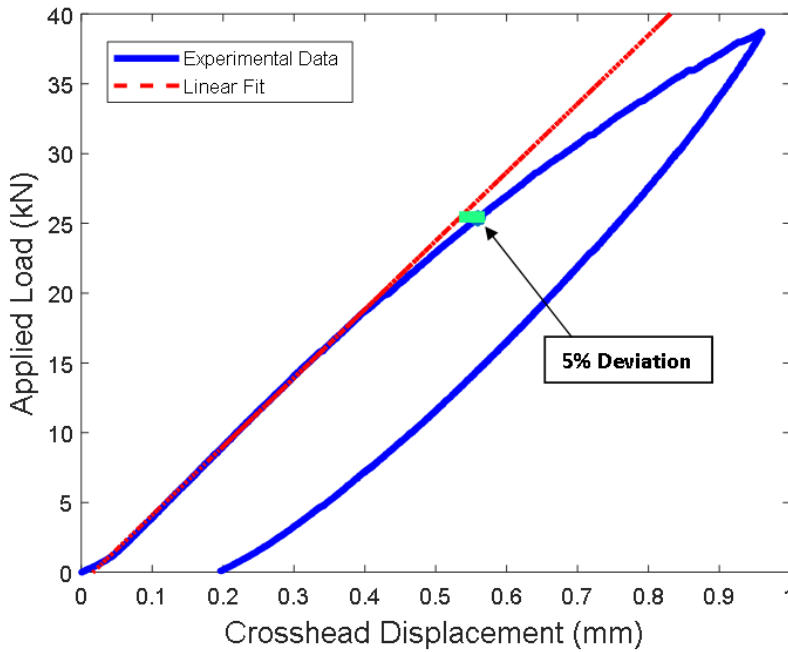
**Figure 4.2: Onset of bearing damage defined by 5% deviation from the experimental results.**

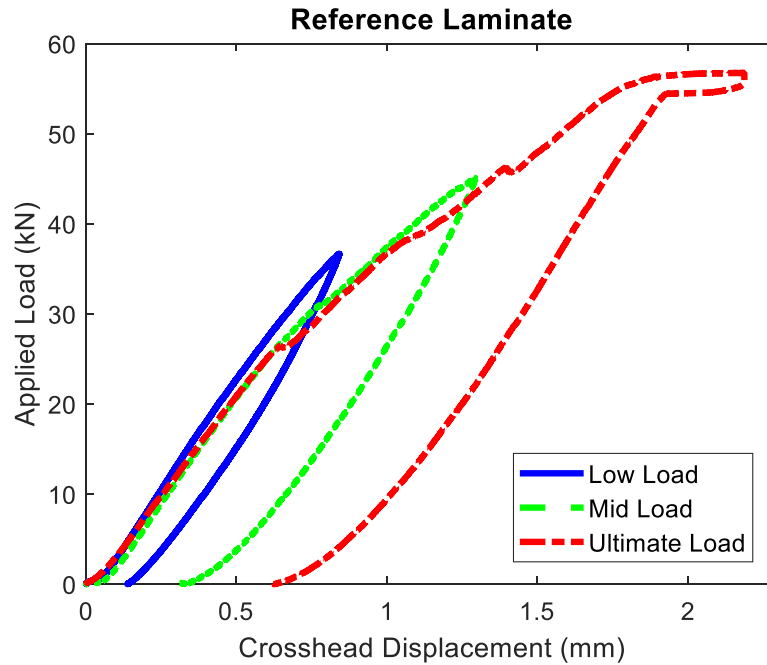
Figure 4.3: DLS static test of three Reference laminate tested at low, medium and ultimate loads.

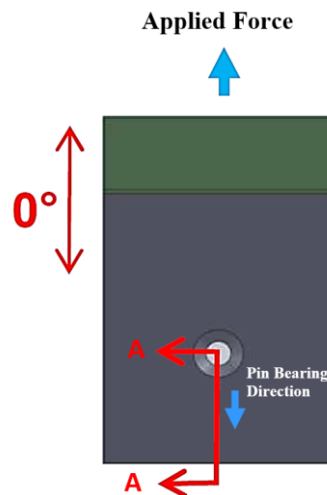
**Figure 4.6: Schematic view of microscopy sectioning.**

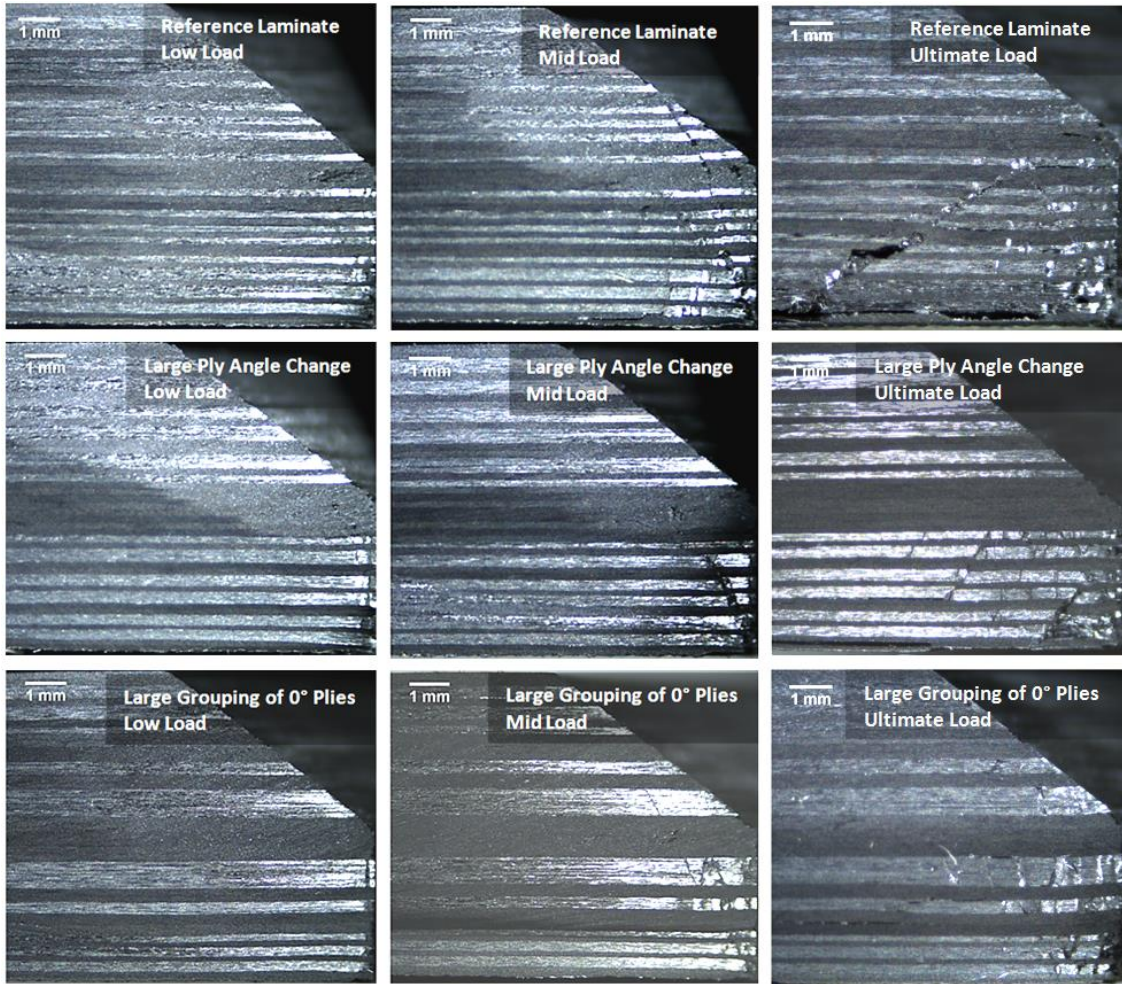
**Figure 4.7: Optical microscopies of DLS static specimens tested at low, mid and ultimate failure loads.**

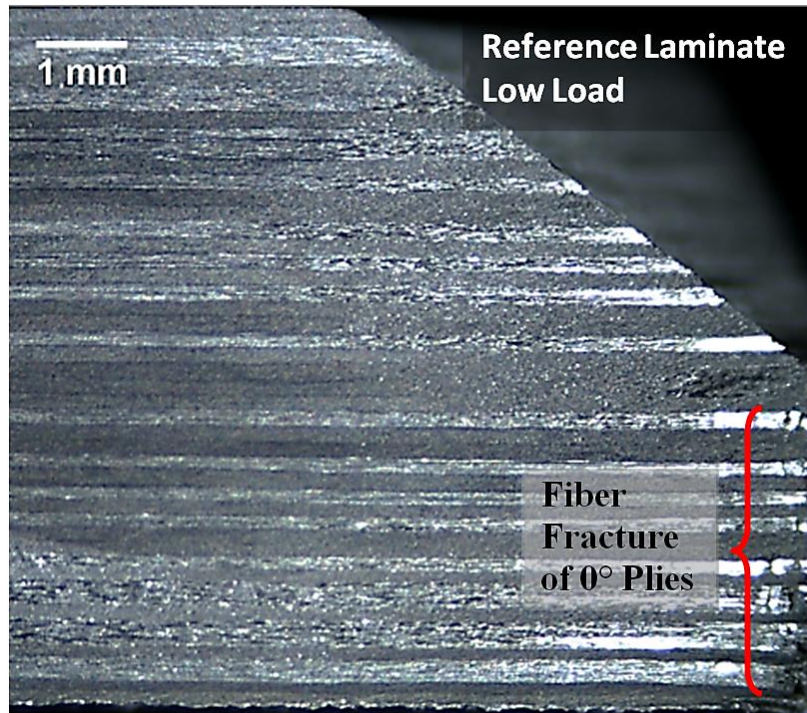
Figure 4.8: Microscopy of the DLS specimen from the reference laminate after loaded to low load (28.6 kN).

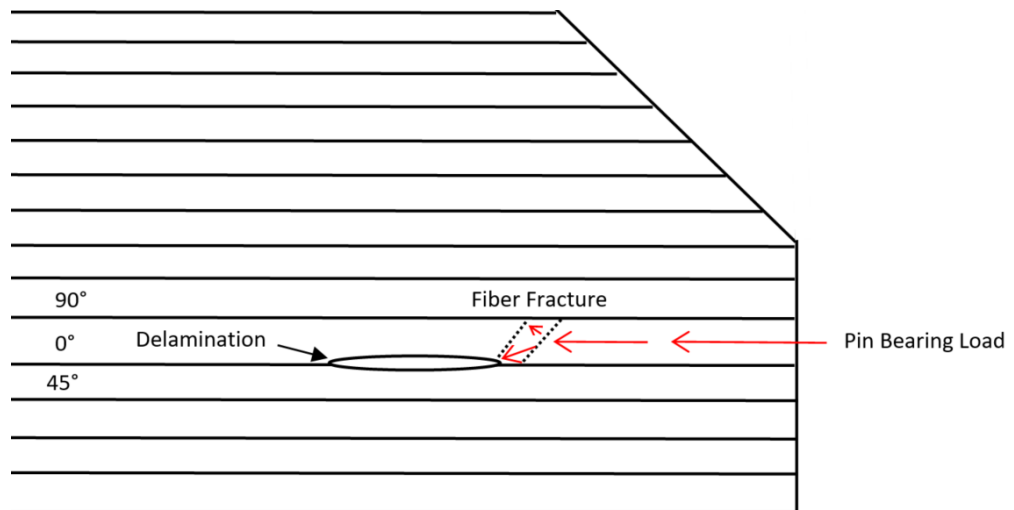
**Figure 4.17: Demonstration of delamination initiation after fiber fracture.**

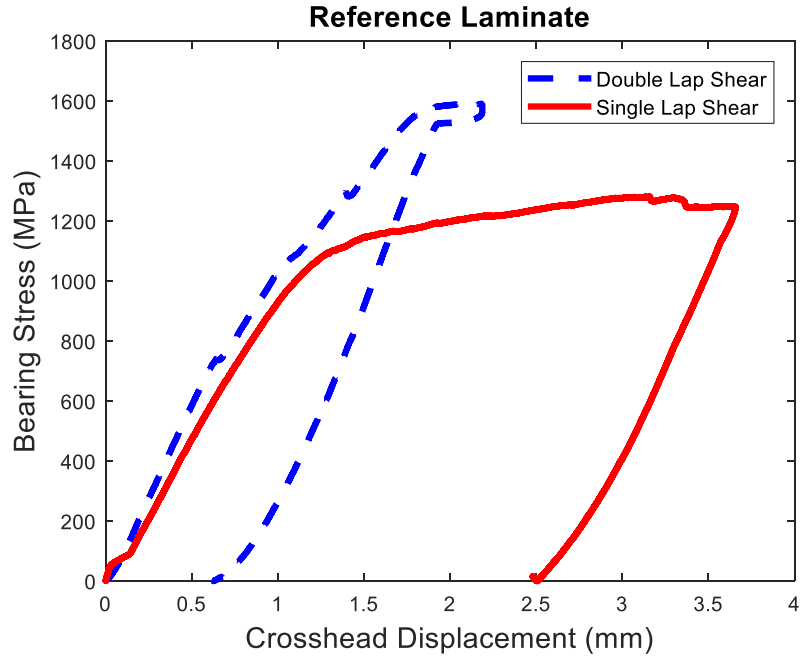
Figure 4.18 DLS versus SLS static test results for the reference type specimen.

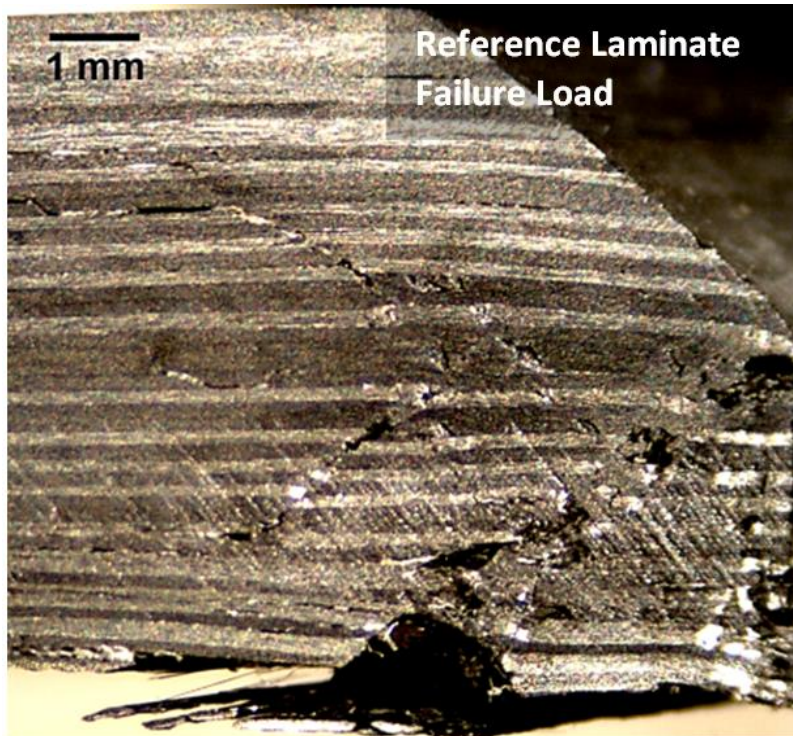
**Figure 4.21: Microscopy of the SLS reference laminate that experienced 45.9 kN.**

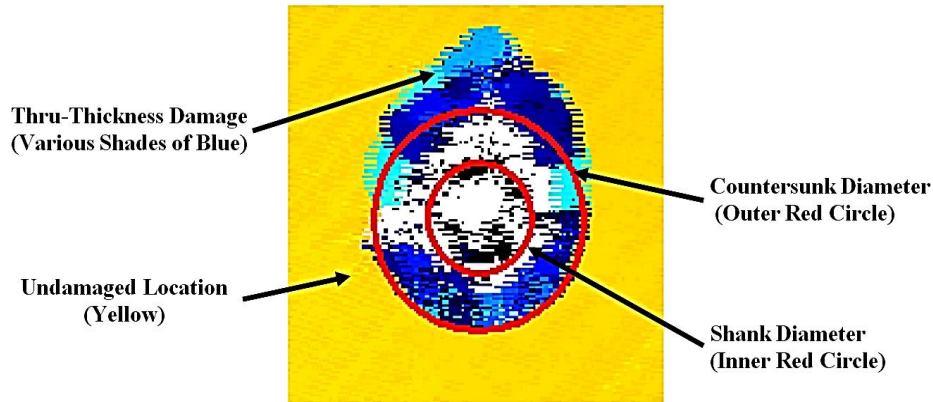
**Figure 4.24:** Example of a countersunk specimen C-scan image.

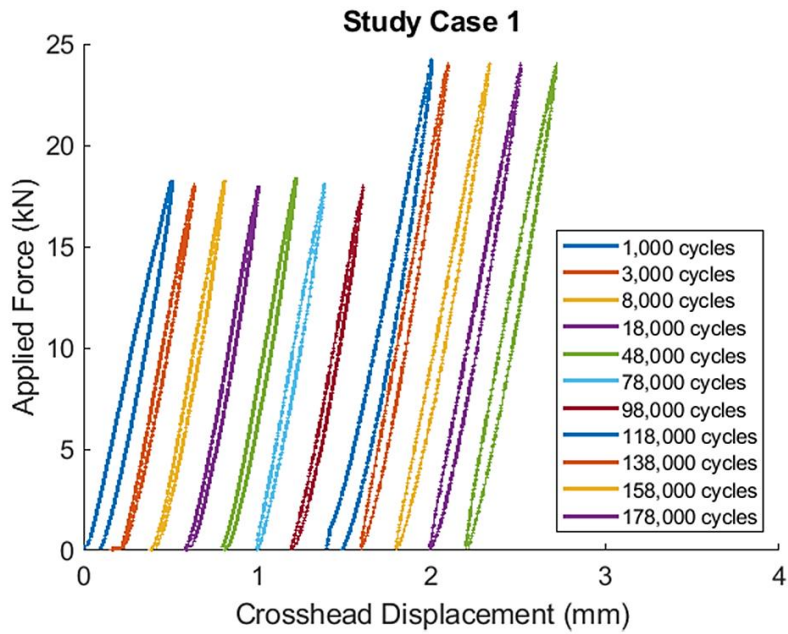
Figure 4.25: Static test plots performed after completing a set number of cyclic loading for a single specimen.

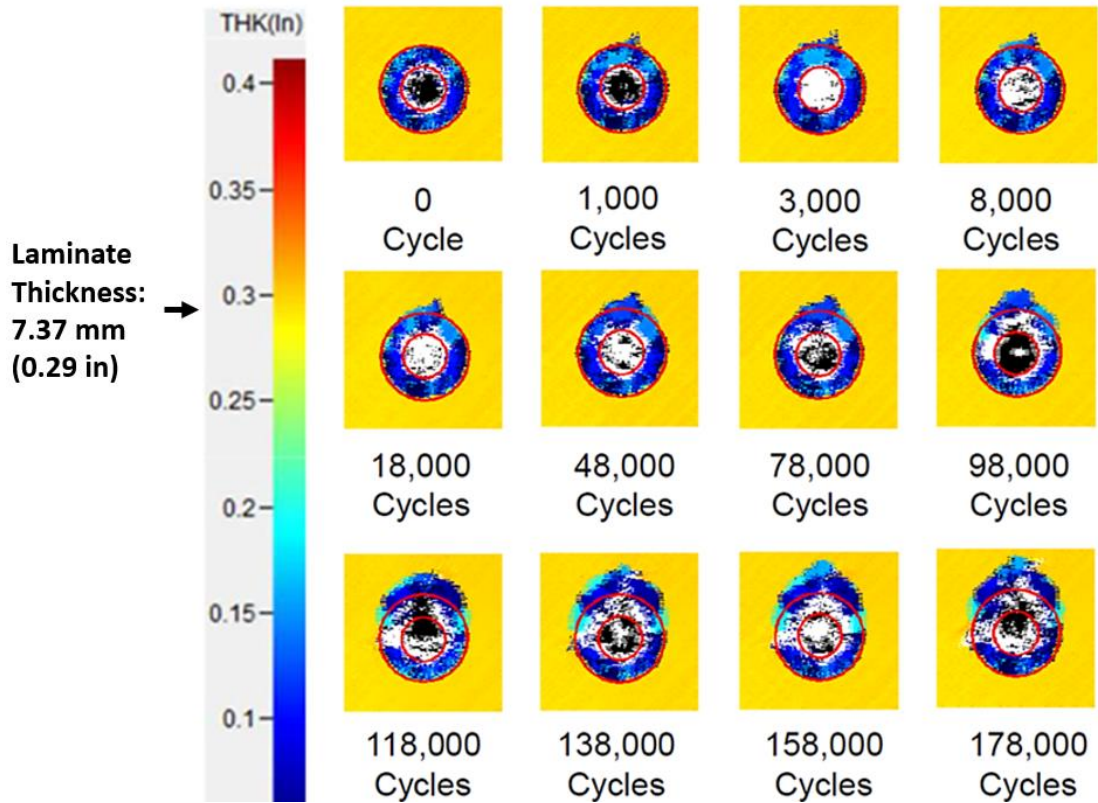
**Figure 4.27: Ultrasonic C-scan images for a single DLS fatigue specimen used to monitor delamination propagation. There are no significant delamination growth until increasing load, which can be observed at 78,000 cycles and 98,000 cycles.**

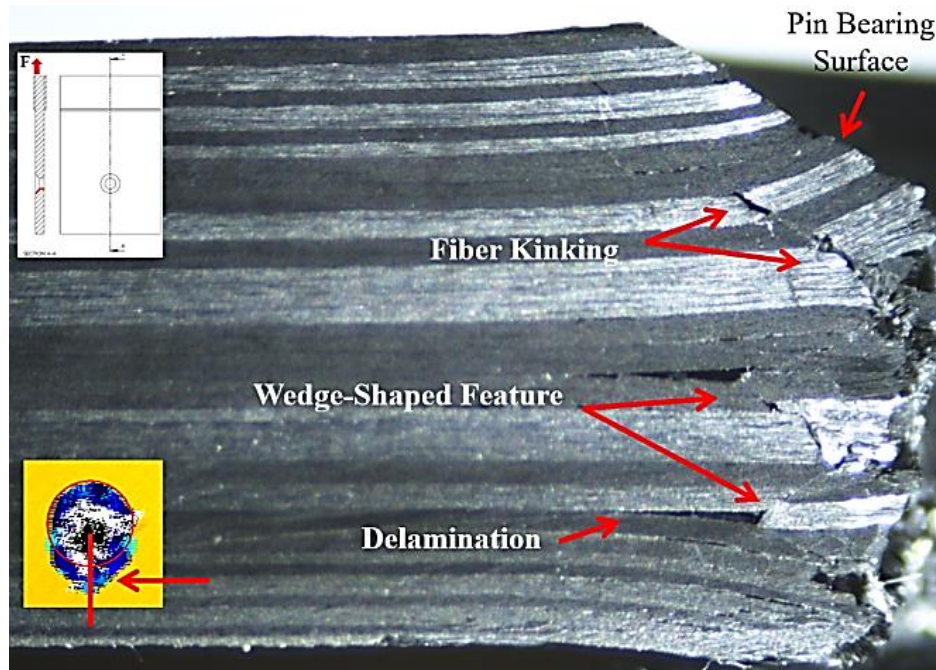
**Figure 4.28: Optical microscopy of a DLS specimen after performing 178,000 cycles. Significant damage occurred in the straight shank region of the bolted hole.**

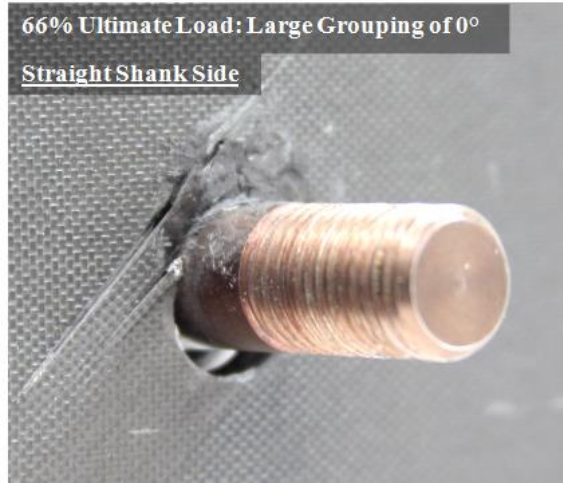
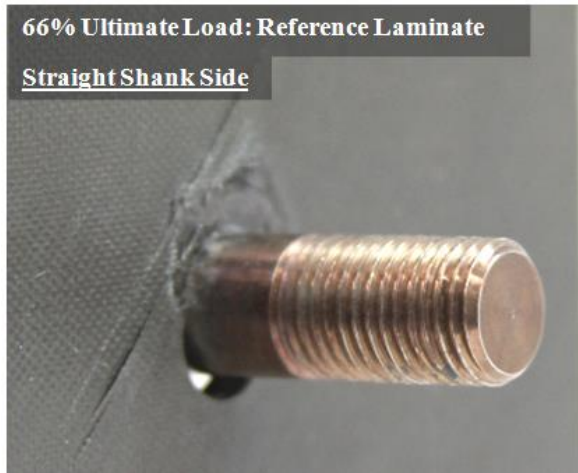
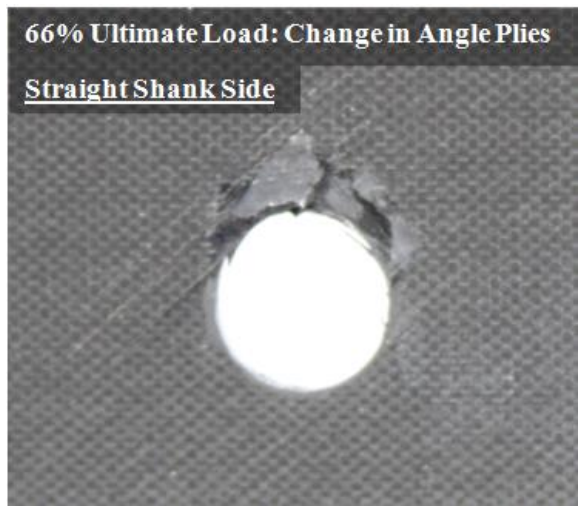
Figure 4.29: Bolted joint after 4,000 loading cycles at 66% of the ultimate bearing load.
