# UC San Diego

## UC San Diego Electronic Theses and Dissertations

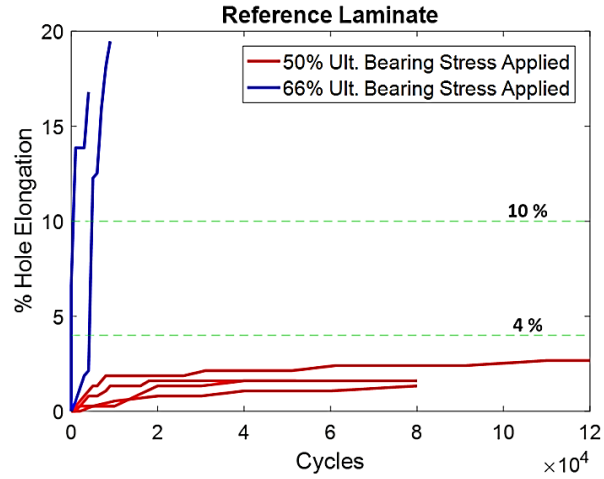
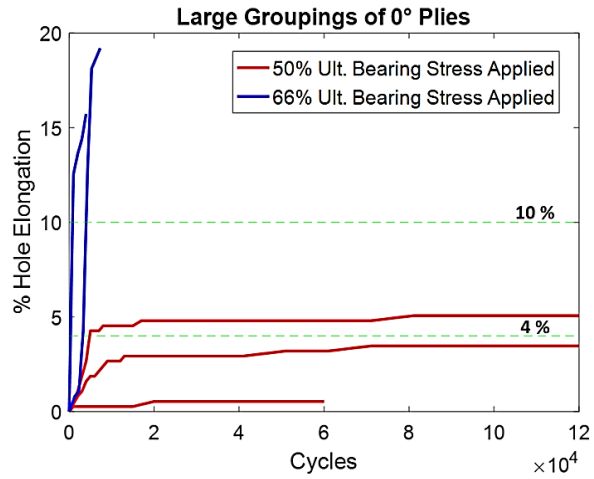
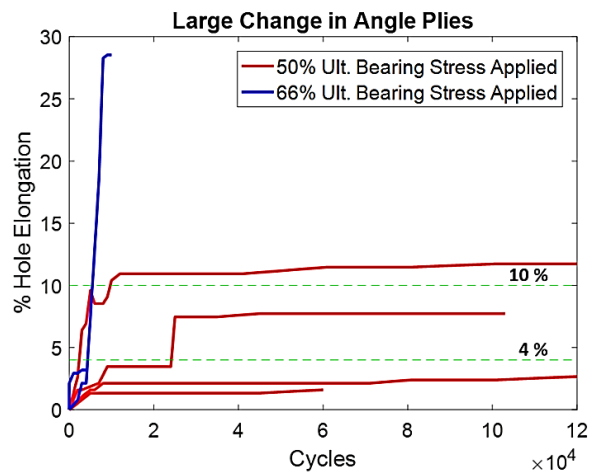
**Figure 4.30: DLS fatigue test results for each laminate type comparing specimens loaded at 66% versus 50% ultimate bearing stress.**

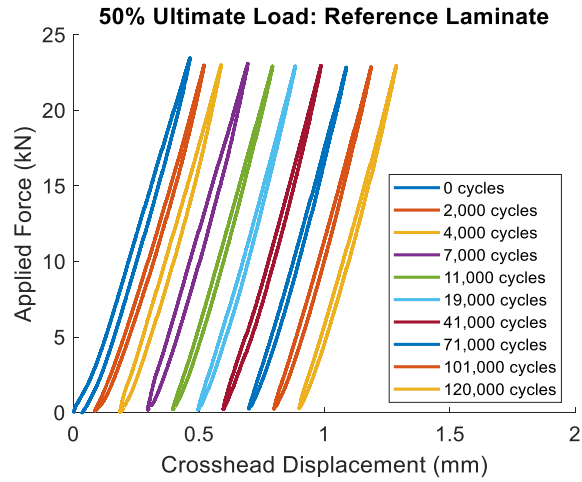
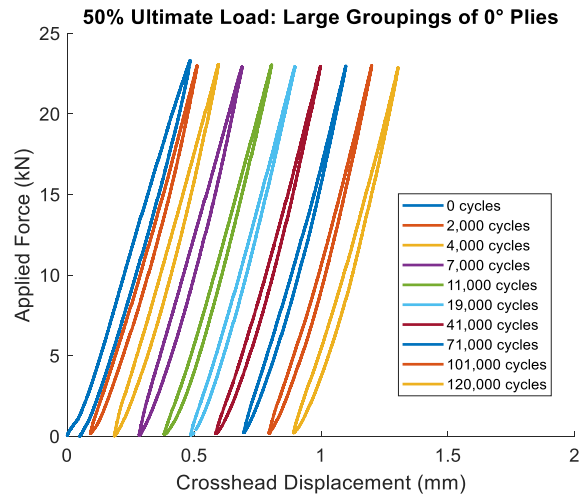
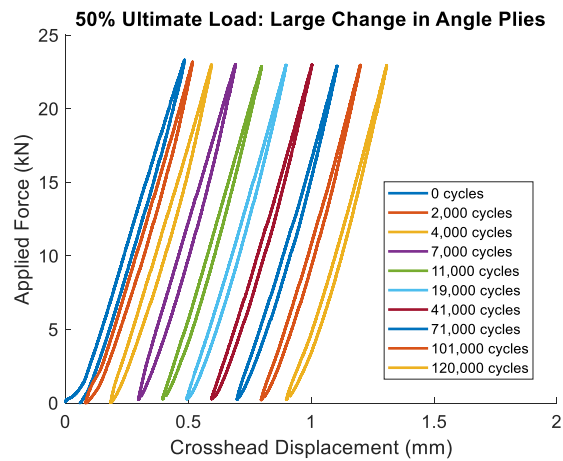
**Figure 4.32: Static tests performed after completing a set of cyclic loading to monitor bolted joint stiffness for all laminate types.**

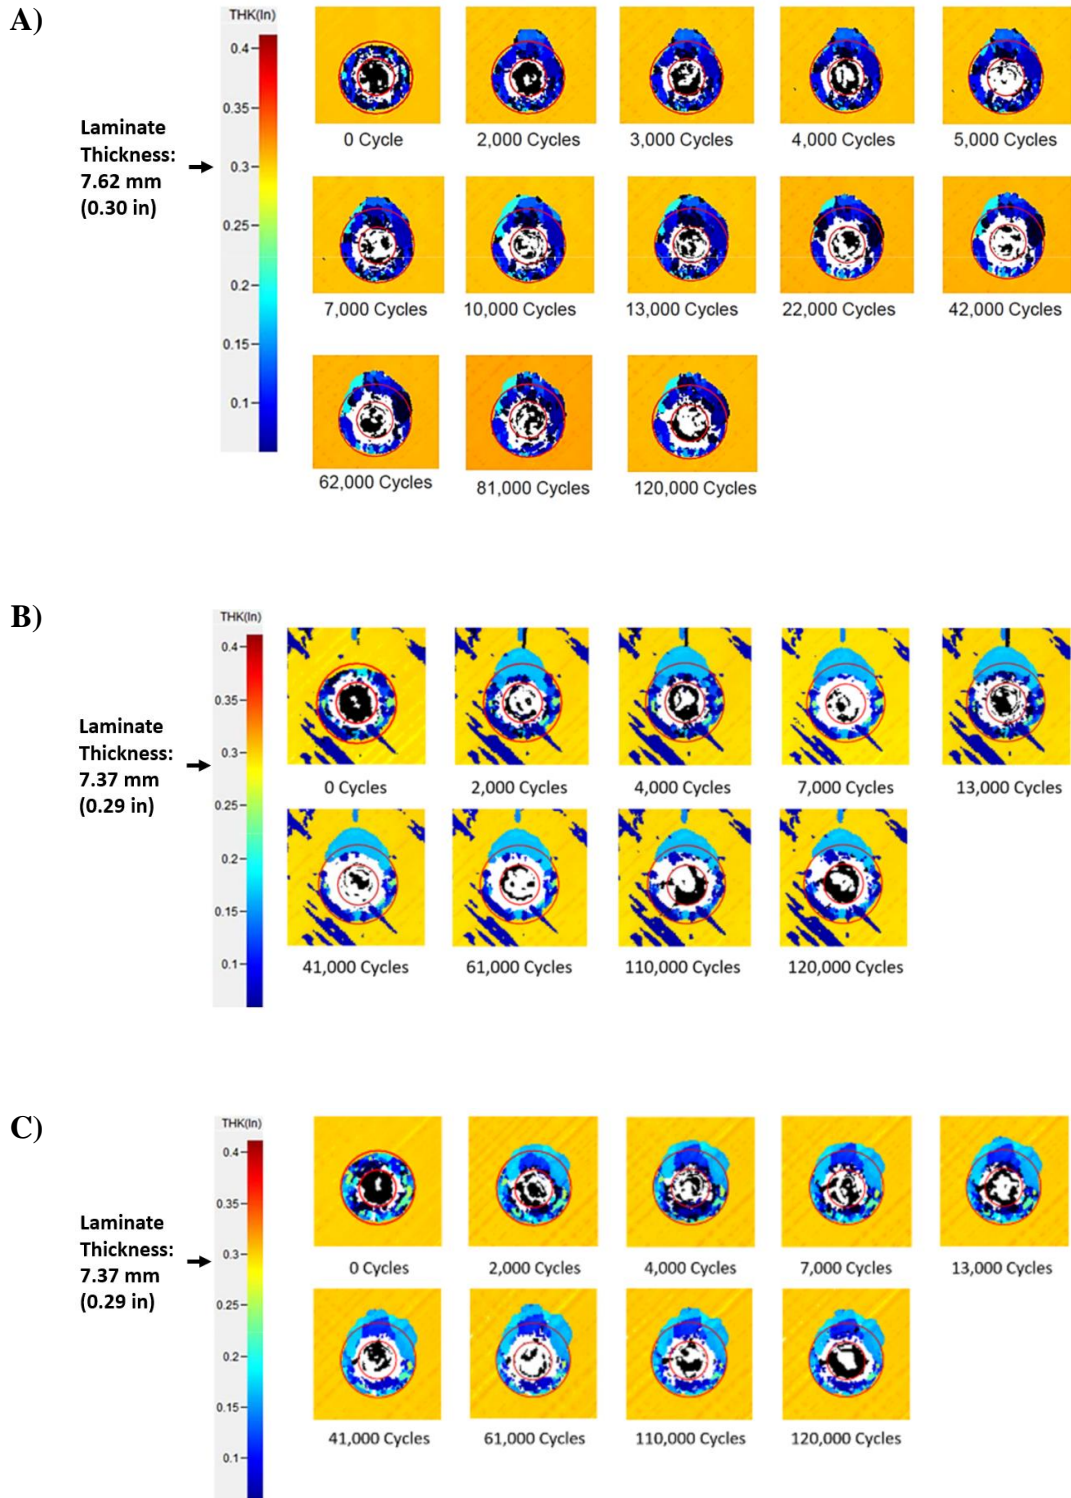
Figure 4.36: C-scan images used to monitor delamination growth in fatigue test for A) large groupings of  $0^\circ$  plies, B) reference lamiate and C) large change in angle plies.

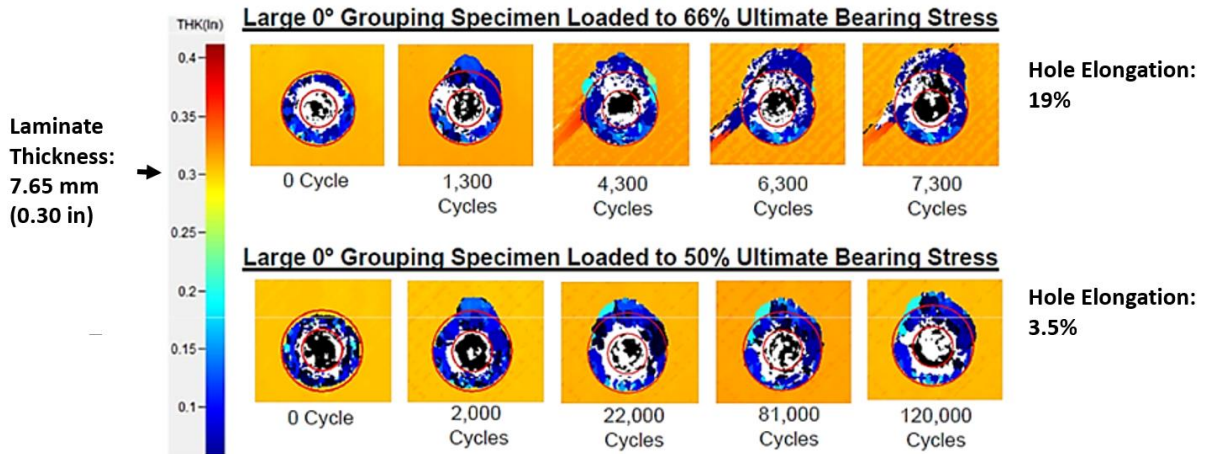
**Figure 4.37: Ultrasonic C-scans of specimen cycled at 66% ultimate bearing stress (top) versus 50% ultimate bearing stress (bottom).**

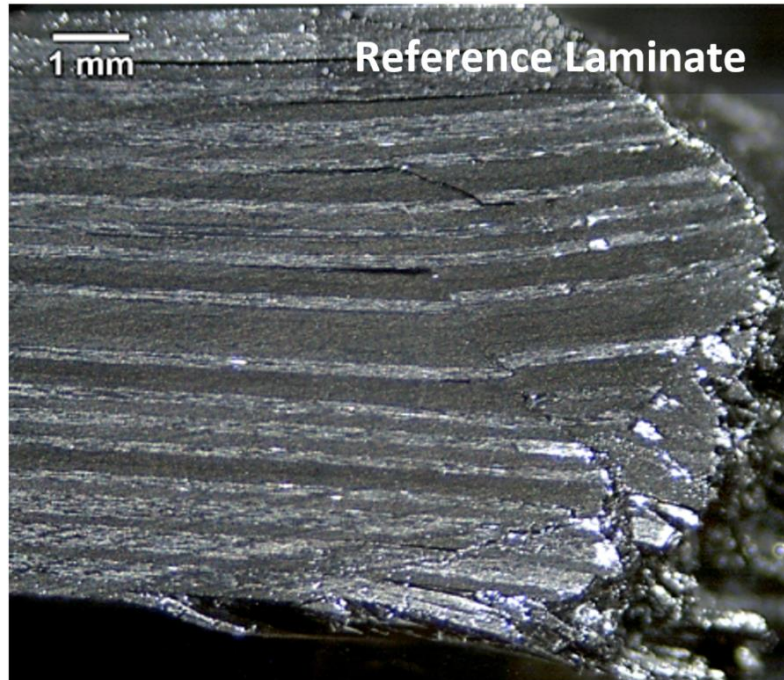
**Figure 4.38: Microscopy of the reference laminate after cyclic loading it to 66% ultimate bearing stress.**

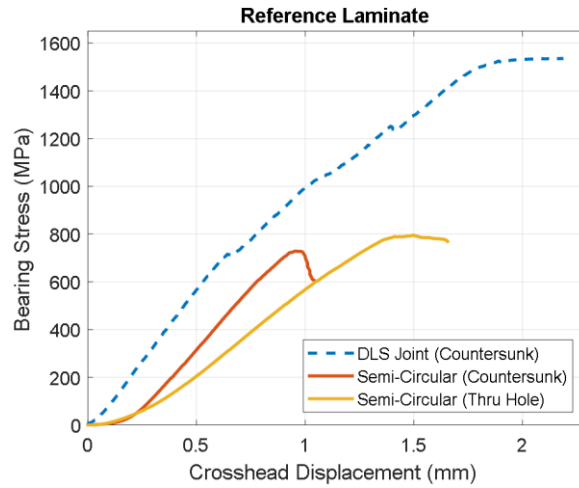
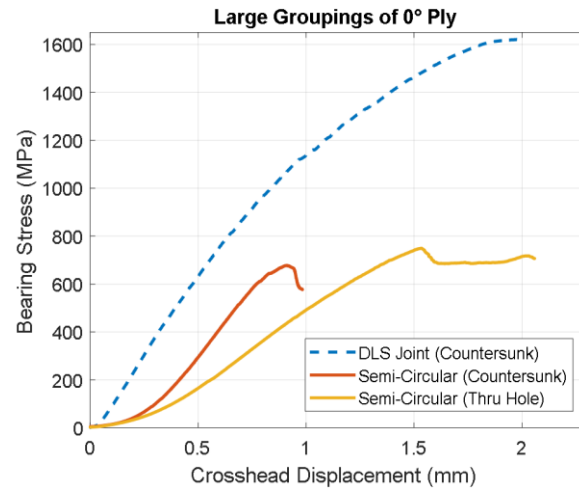
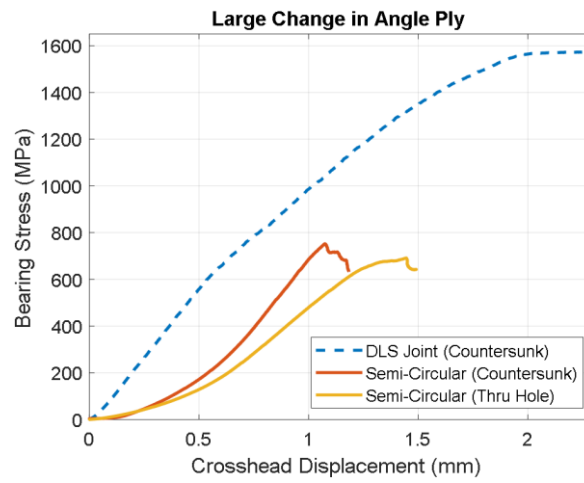
**Figure 4.44: DLS and SCN static test results for three laminate types**

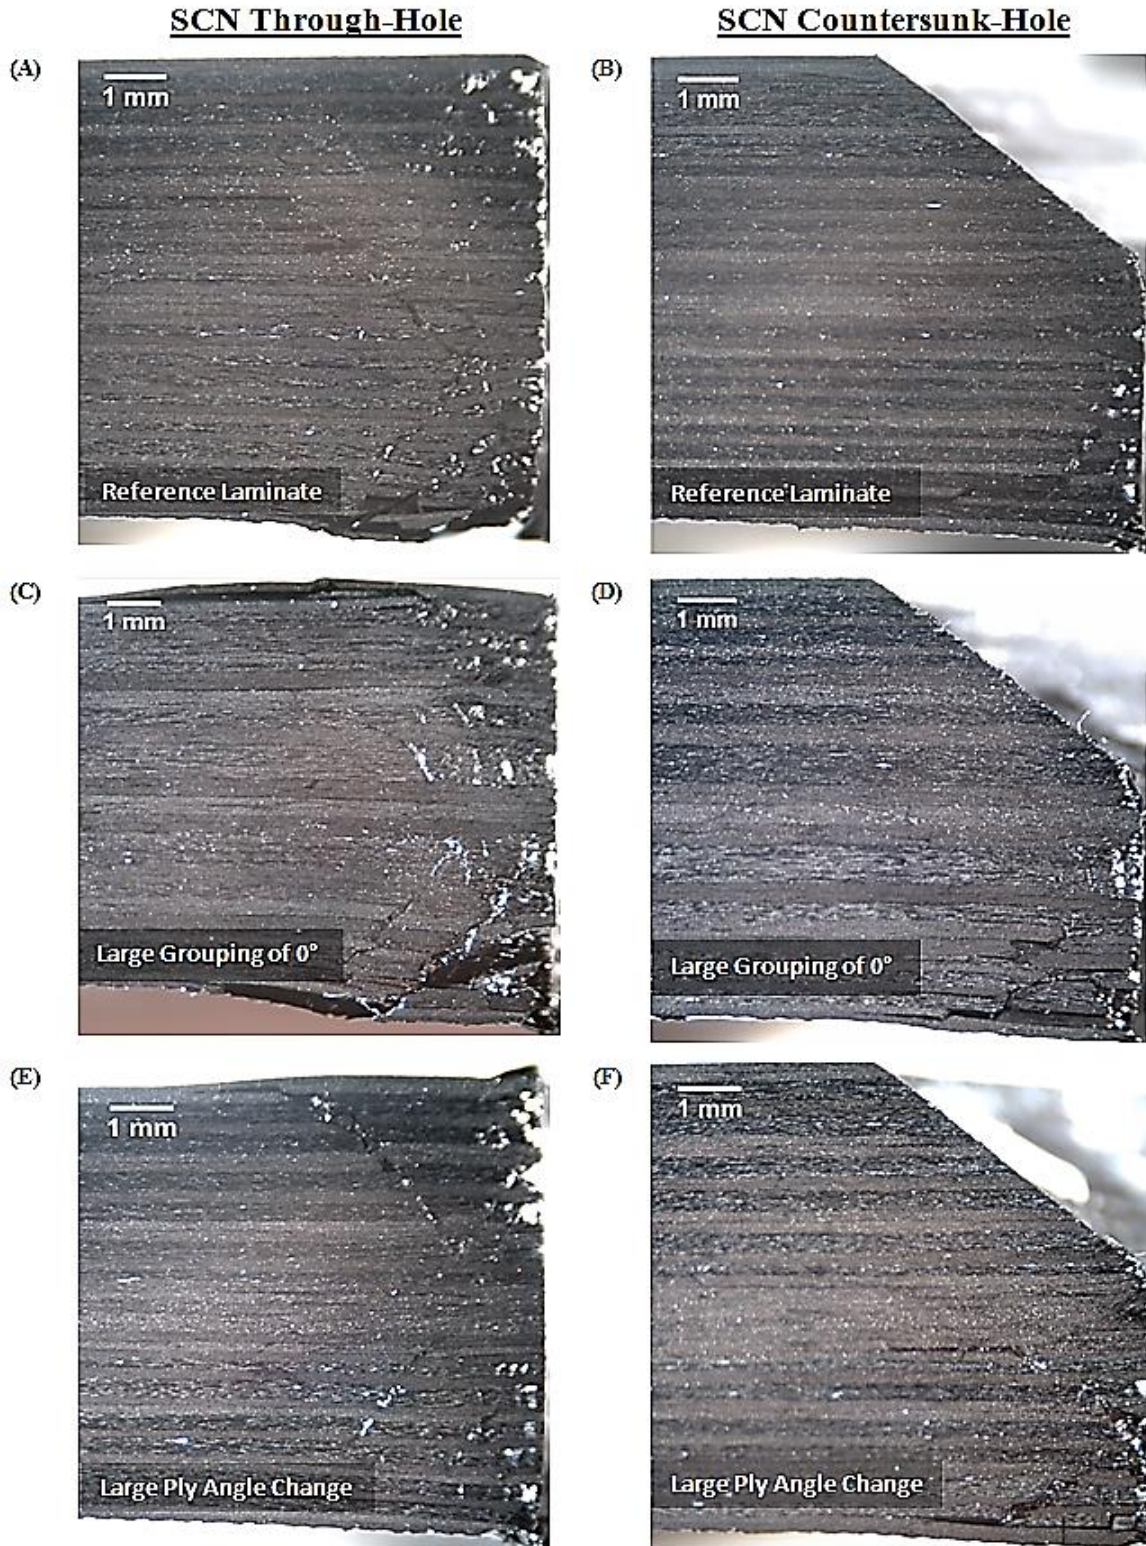
Figure 4.45: Microscopies of SCN through-hole (left) and countersunk (right) specimens after bearing static test.

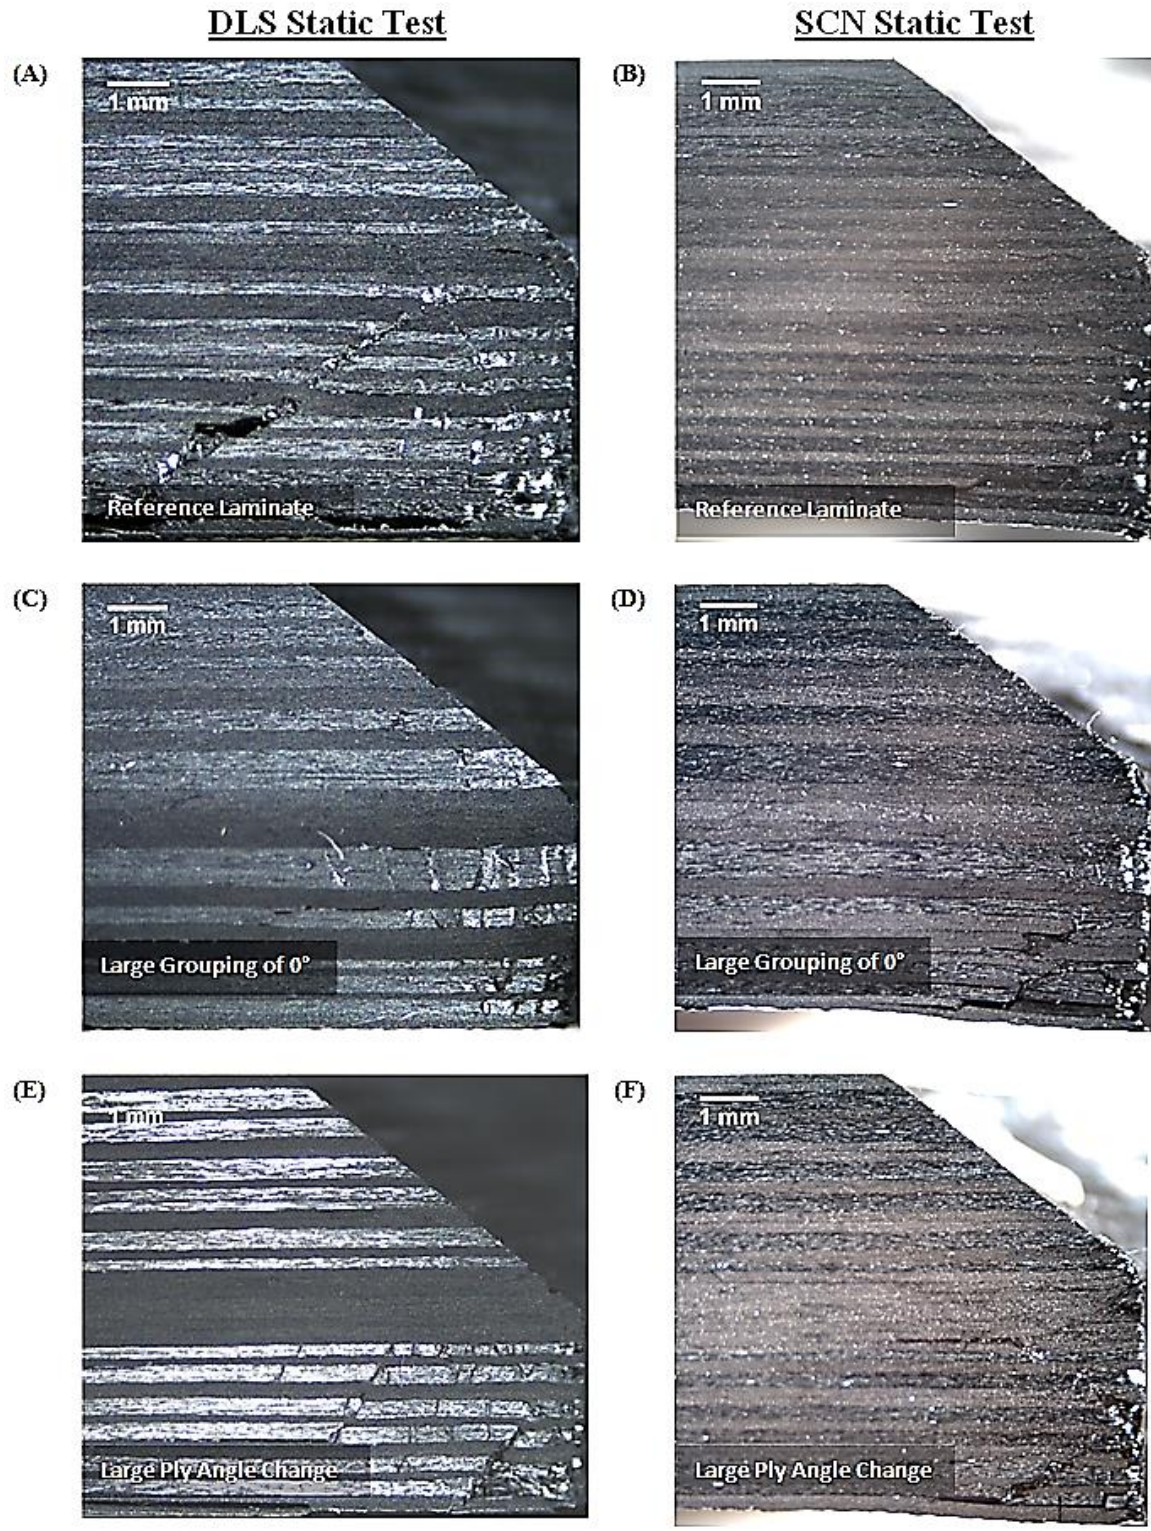
**Figure 4.47: Microscopies of DLS versus SCN countersunk specimens after performing static test.**

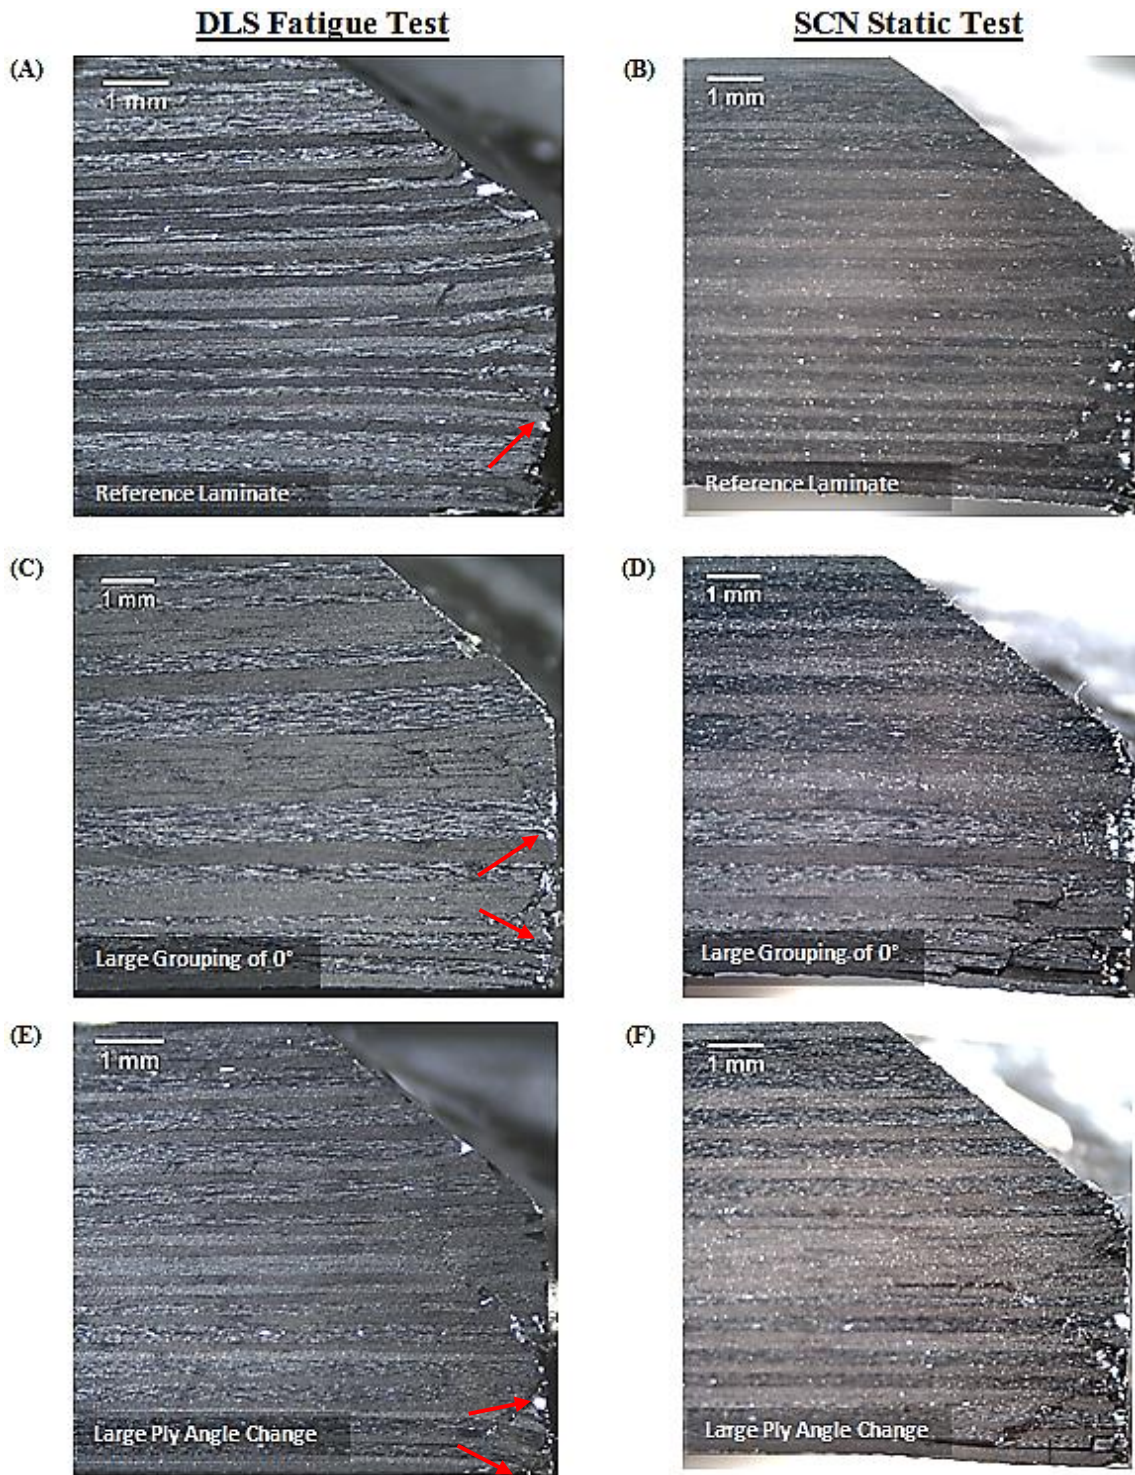
Figure 4.48: Optical microscopies of DLS fatigue versus SCN countersunk static tested specimen for all laminate types.

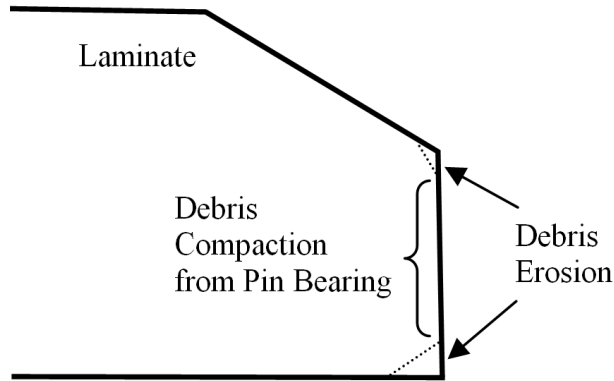
**Figure 4.49: Pin bending effect on material erosion during fatigue test**

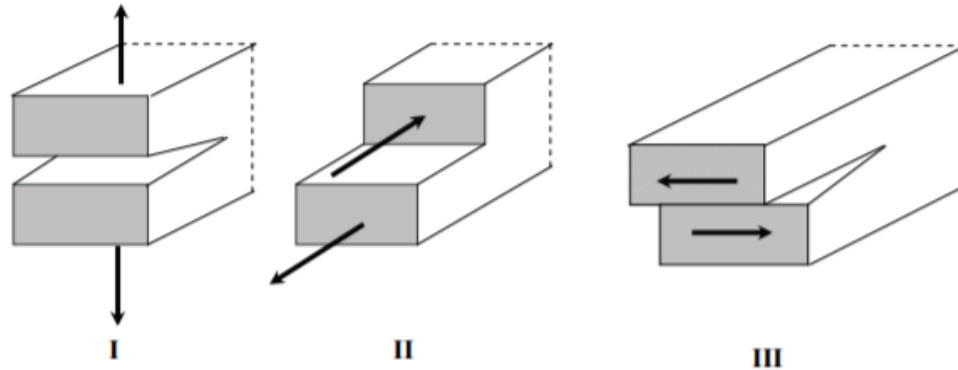
**Figure 5.1: Three fracture modes including Mode I (opening mode), Mode II (sliding mode), Mode III (tearing mode) [30].**

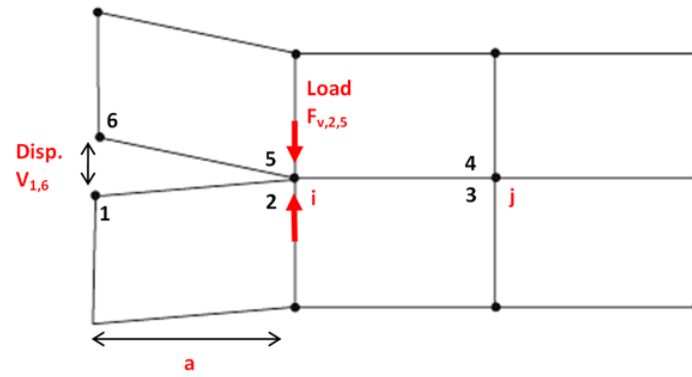
$v_{1,6}$  is the vertical displacement between nodes 1 and 6

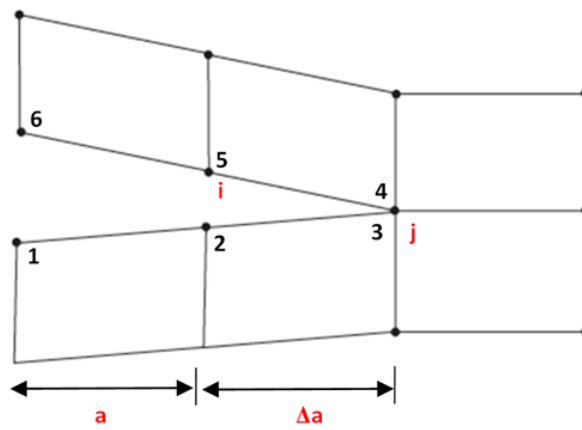
(B) Nodes 2 and 5 released to open crack

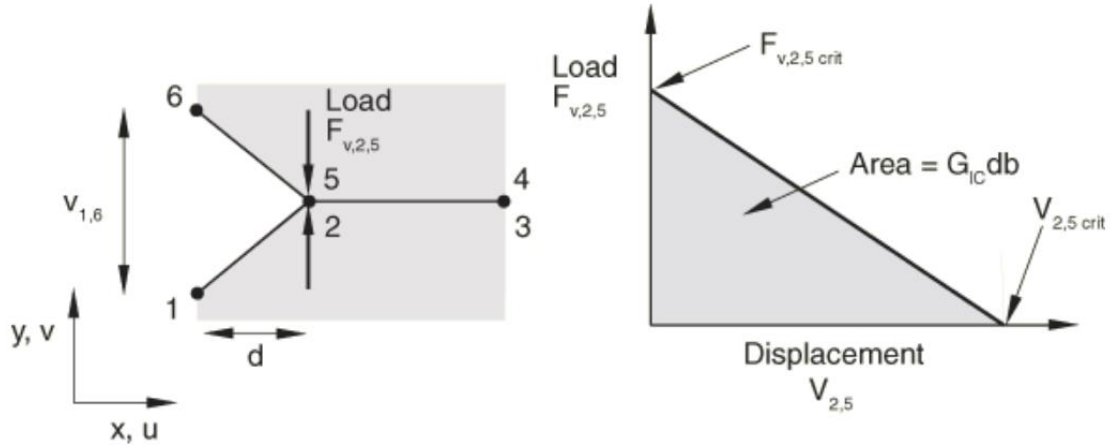
Figure 5.3: Area under the force versus displacement plot from nodes 2 and 5 is used to calculate strain energy release rates [34].

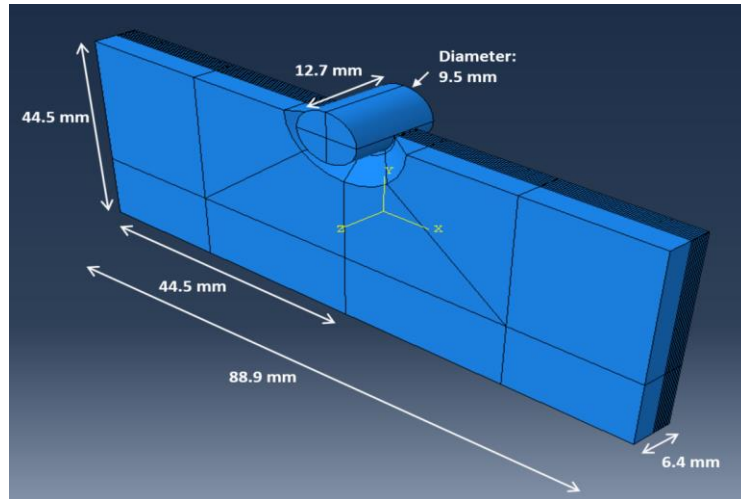
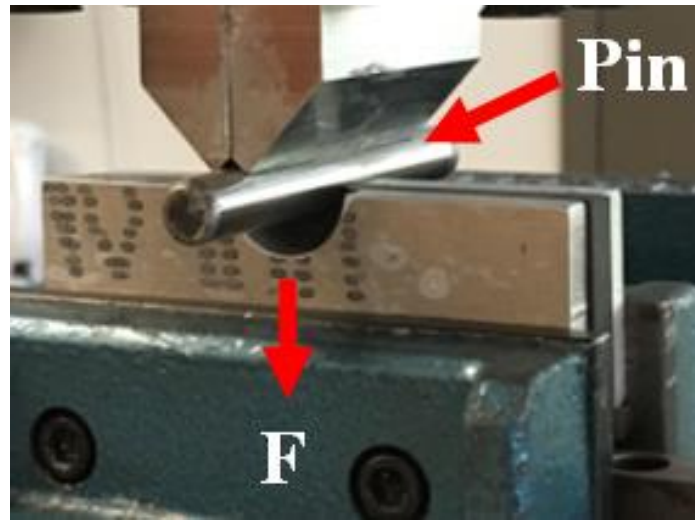
Figure 5.4: FE model of SCN specimen with steel pin assembly (top) representing the setup for SCN test configuration without the aluminum plates on both sides (bottom).

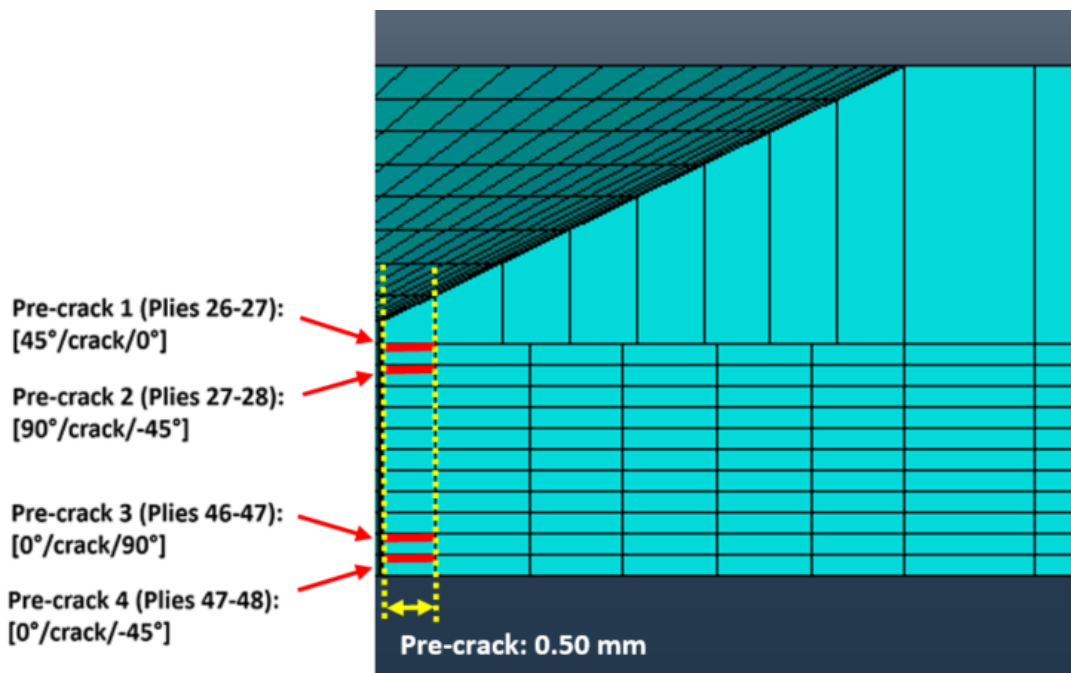
Figure 5.6: FE model of SCN specimen illustrating pre-crack locations for using VCCT in Abaqus.

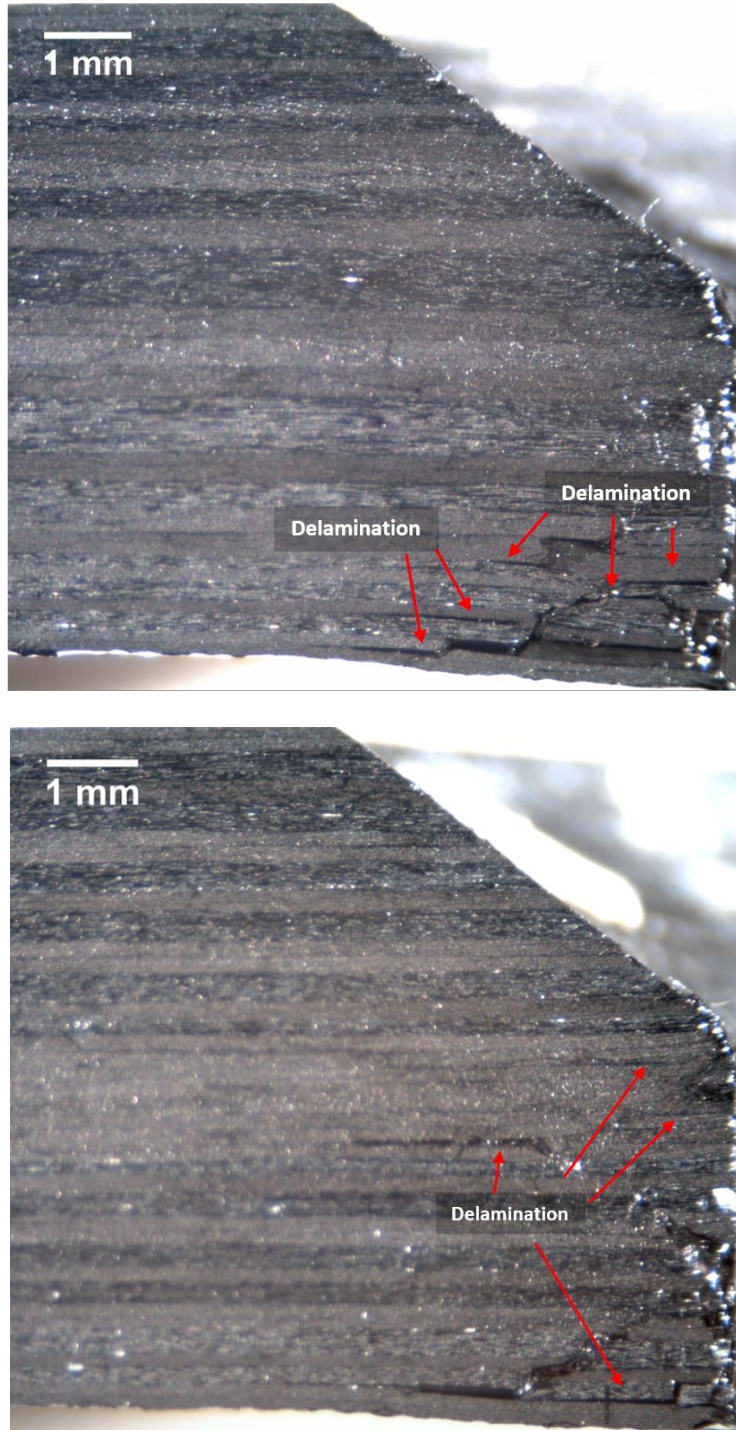
**Figure 5.7: Optical microscopy from SCN specimens showing delamination locations, which was used to determine the placements of pre-cracks in the FE model.**

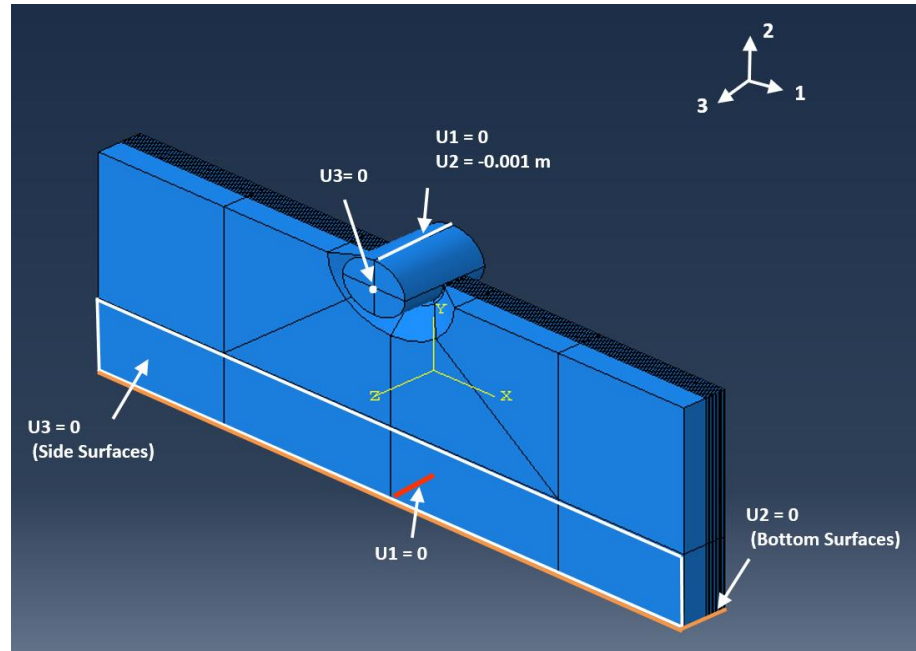
**Figure 5.8: Boundary conditions and displacement applied to the SCN FE model in Abaqus.**

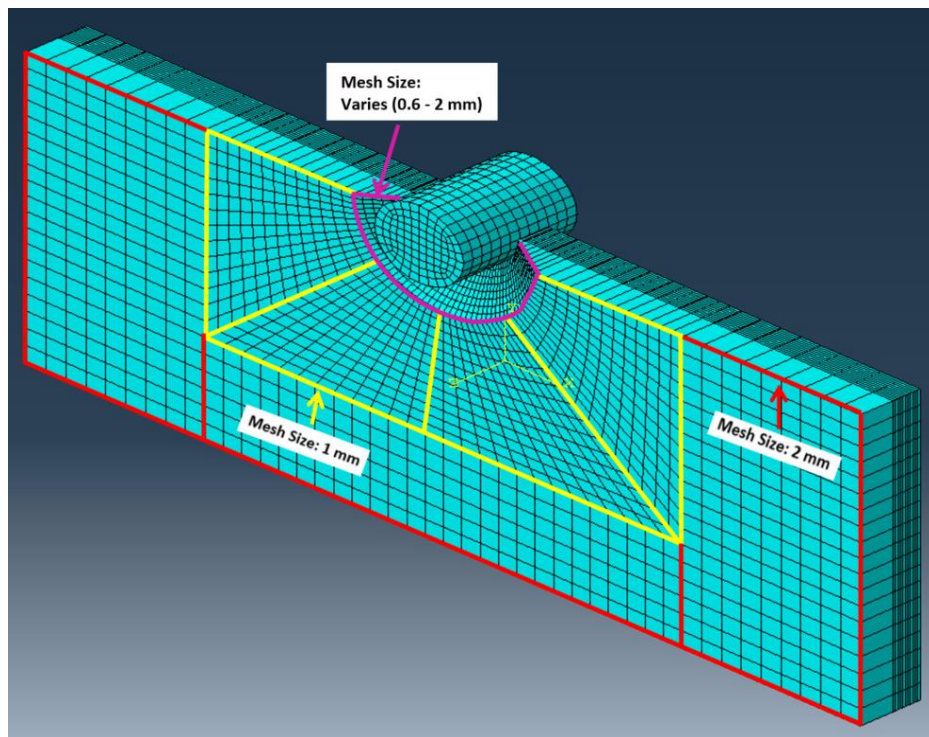
**Figure 5.9: Element size for mesh sensitivity study. The mesh size was changed in the radius geometry near the crack tip.**

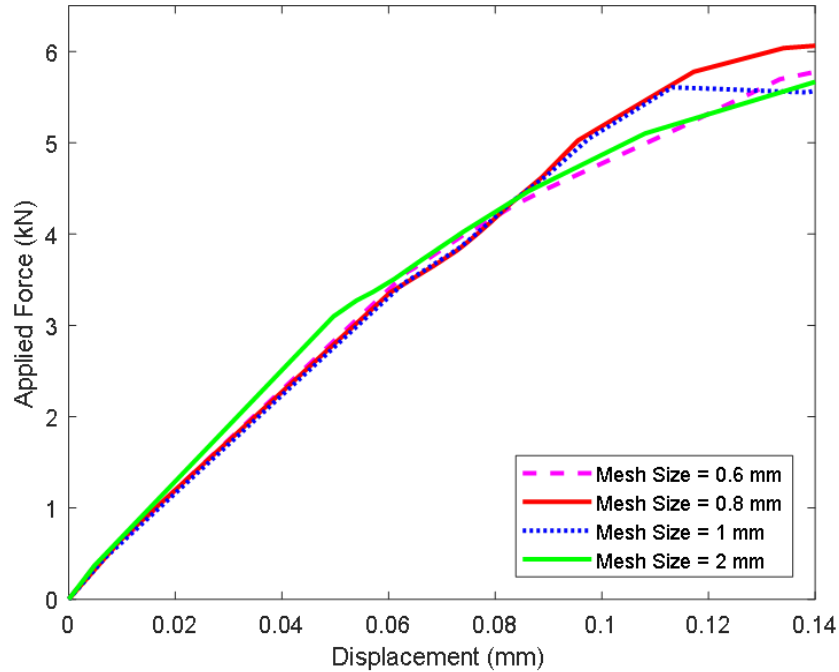
**Figure 5.10: Mesh sensitivity study for SCN FE model with VCCT and Hashin damage included. Mesh size 0.8 mm and 1 mm show closer convergence behavior.**

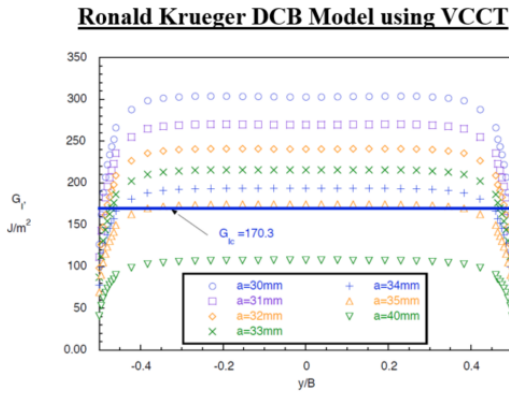
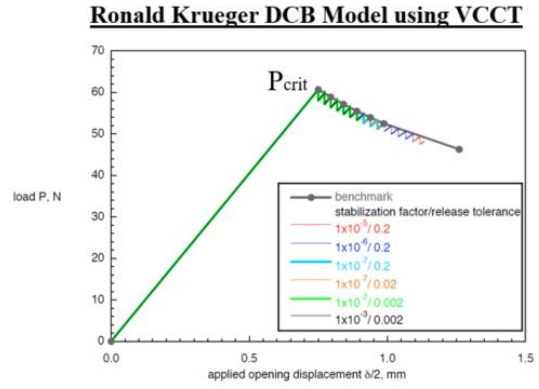
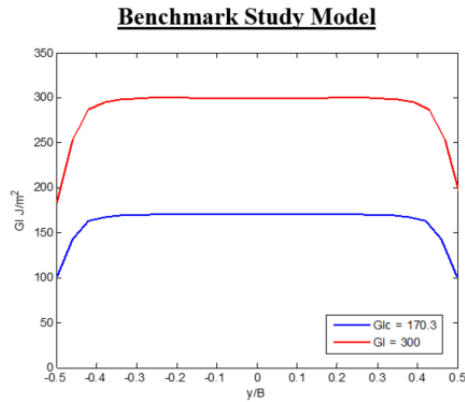
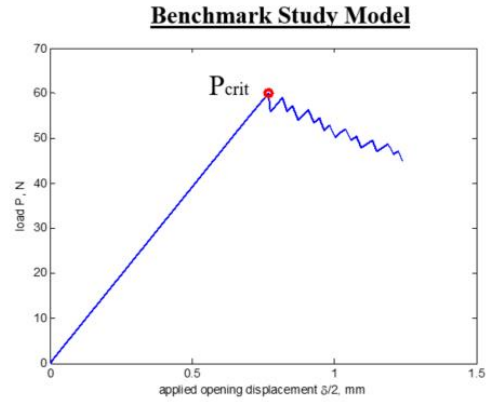
**Figure 5.11: Benchmark study case performed on DCB model to verify VCCT process in Abaqus is correct. Strain energy release rate (left) and critical load at crack initiation (right) was matched with Ronald Krueger's DCB model.**

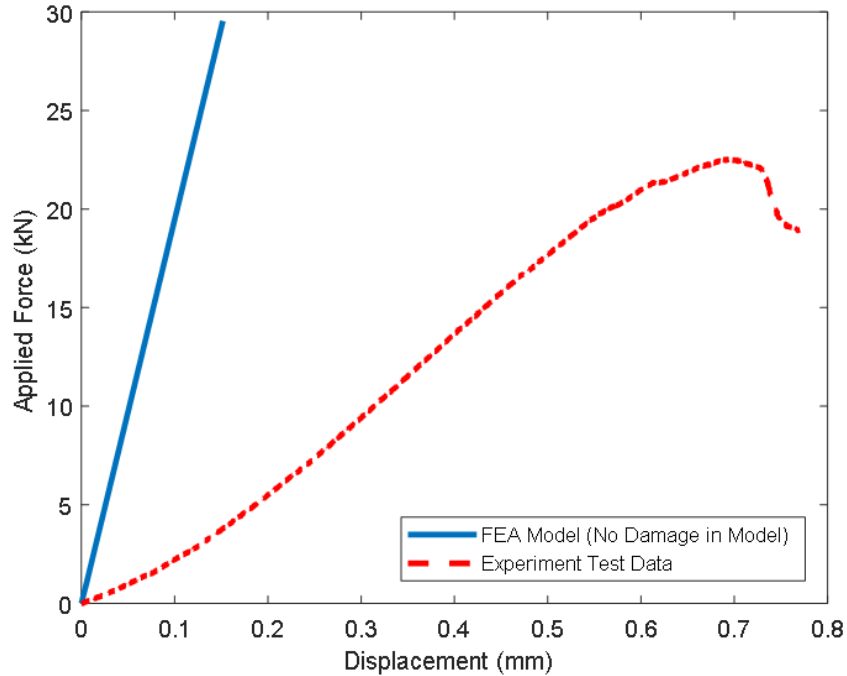
**Figure 5.12: FE model of SCN specimen with and without damage compared to experimental test data for model verification.**

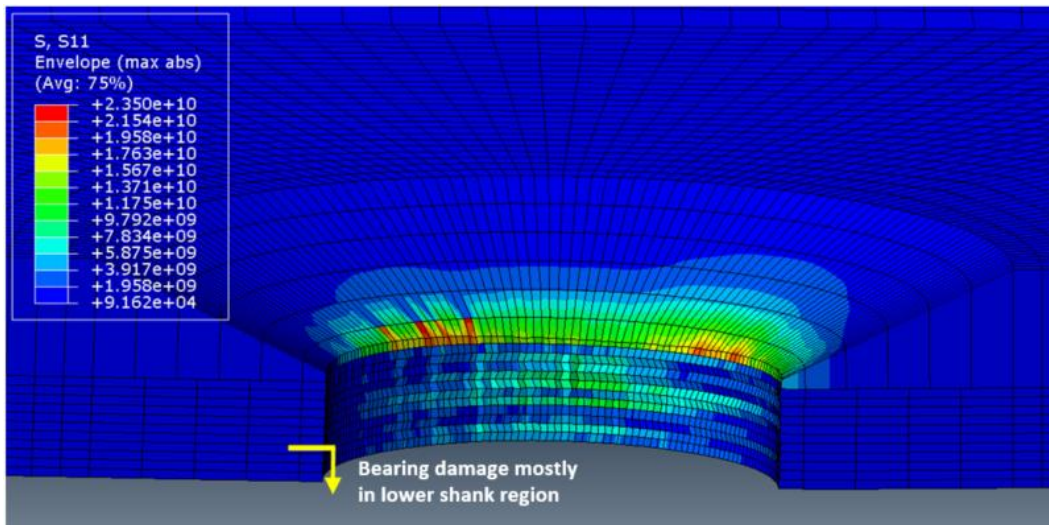
**Figure 5.13: Contour plot of the bearing stress distribution on the loading direction. Units for stress displayed is Pa.**

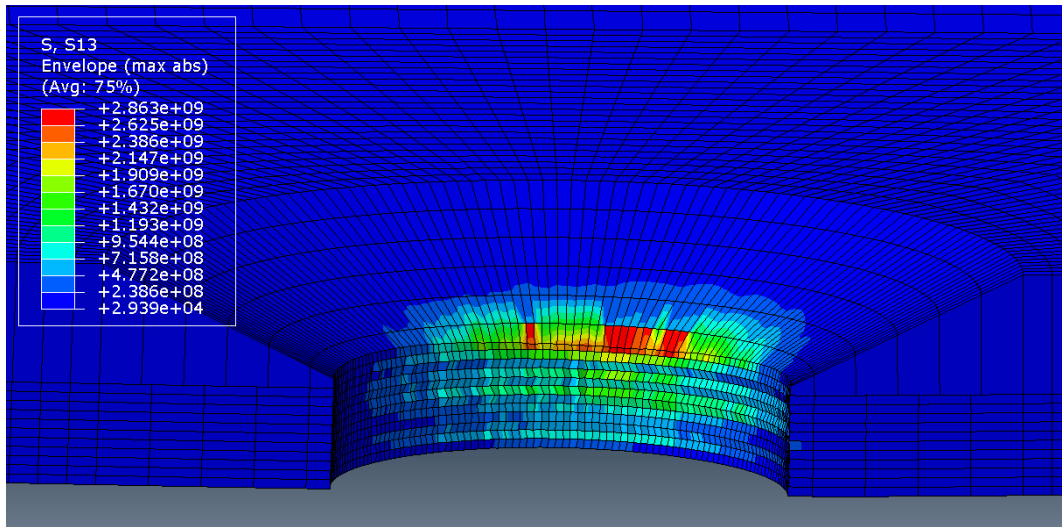
**Figure 5.14: Transverse shear stress of SCN FE model show greatest shear stress at the center of the pin-bearing surface on the conical region. Units are in Pa.**

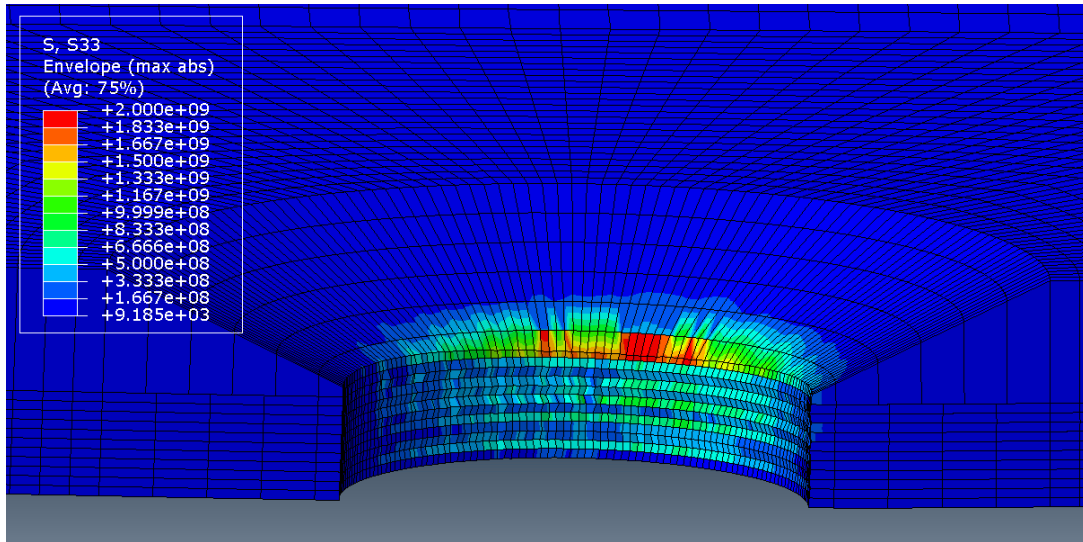
**Figure 5.15: Transverse normal stress on the pin-bearing surface of the SCN laminate. Stress units displayed is Pa.**

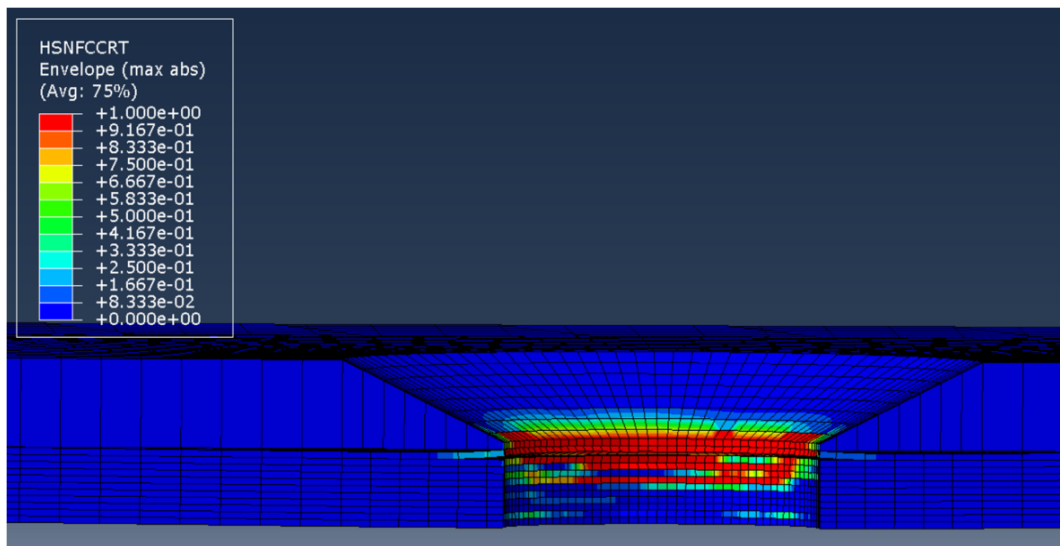
**Figure 5.16: Hashin fiber compression failure, which show locations where pin loading has the most affect on the bolt-bearing surface. Red color (value of 1) indicates damage has occurred, whereas blue color (value of 0) means there is no damage.**

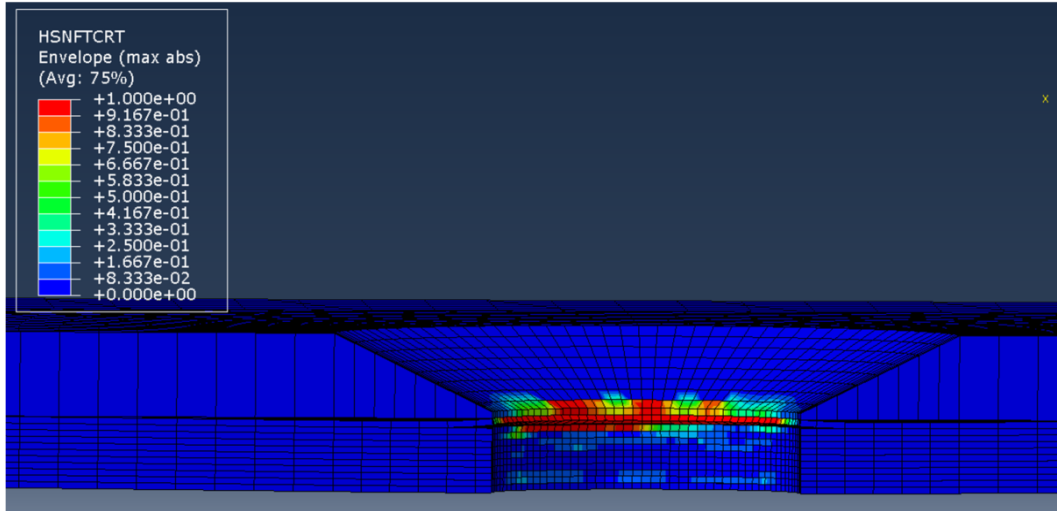
**Figure 5.17: Hashin fiber tension failure image illustrating locations where fibers have high tensile stress. Red color (value of 1) indicates damage has occurred, whereas blue color (value of 0) means there is no damage.**

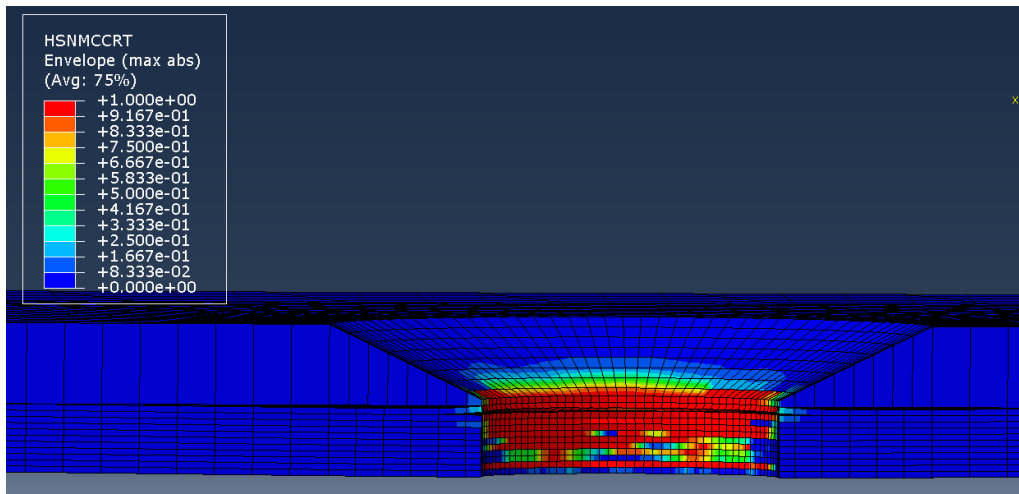
**Figure 5.18: Hashin matrix compression failure with four pre-cracks, which occurs first before other failure modes occur (i.e. fiber tension and compression). Red color (value of 1) indicates damage has occurred, whereas blue color (value of 0) means there is no damage.**

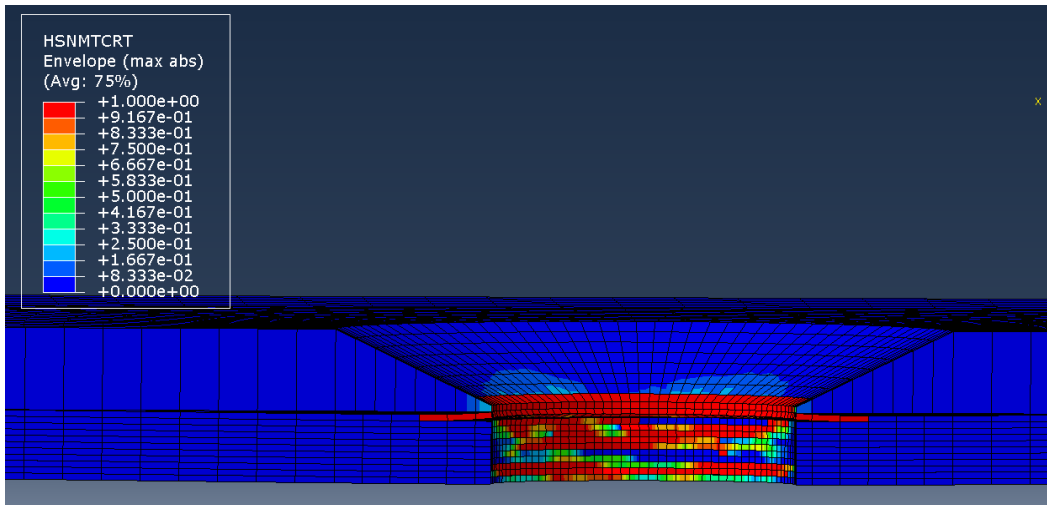
**Figure 5.19: Hashin matrix tension failure in indicating tensile stress in matrix is greatest where delamination occurs. Red color (value of 1) indicates damage has occurred, whereas blue color (value of 0) means there is no damage.**
