# UC San Diego

## UC San Diego Electronic Theses and Dissertations

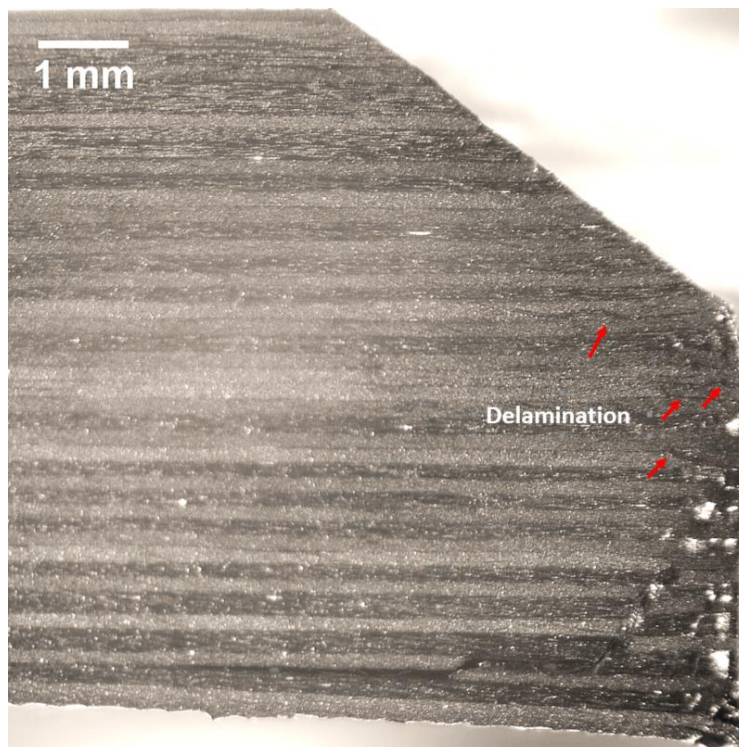
**Figure 5.20: Microscopy of the reference layup type specimen showing location of delamination. This supports the damage observed in the FE model.**

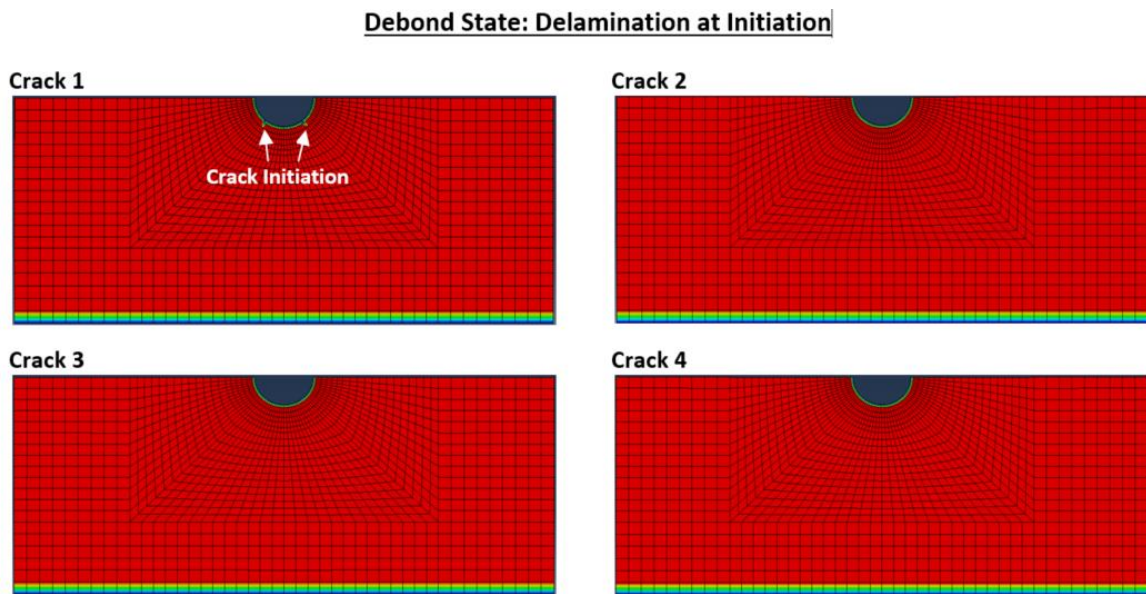
**Figure 5.21: Bond state mapping of each crack. Red color indicate the plies between the cracks are still bonded and blue represents disbond. Crack 1 shows delamination initiation first.**

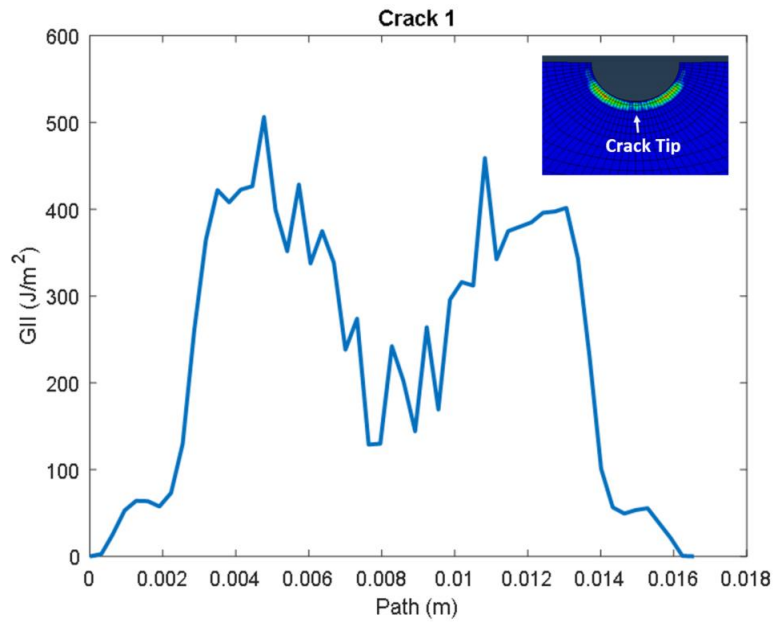
**Figure 5.22: Strain energy release rate from Mode II of crack 1 prior to delamination initiation. Mode II is the dominating failure mode for delamination in this joint configuration. The material fracture toughness input was 554 J/m<sup>2</sup>.**

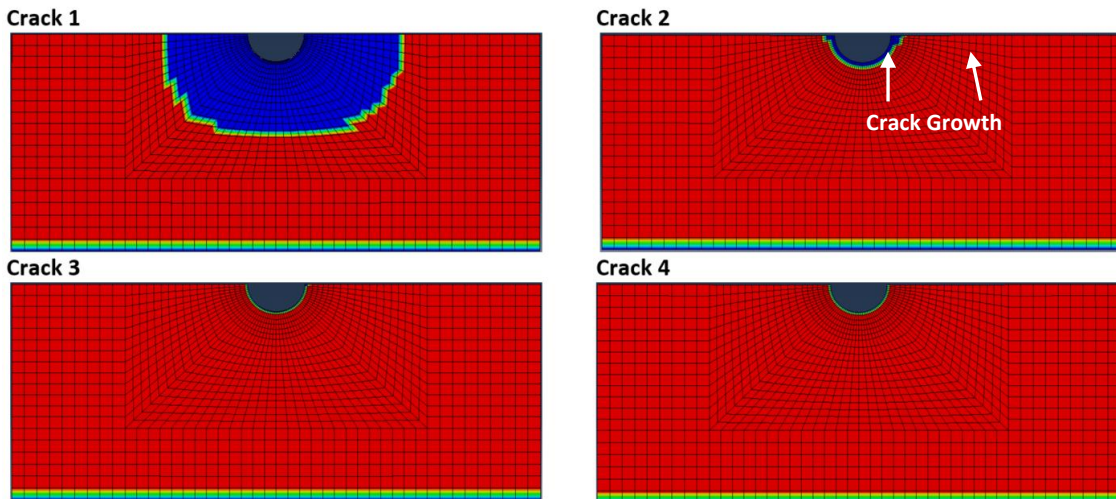
**Figure 5.23: Final bond state status before analysis was terminated. Delamination propagated in Crack 1 and nodes began to release in crack 2.**

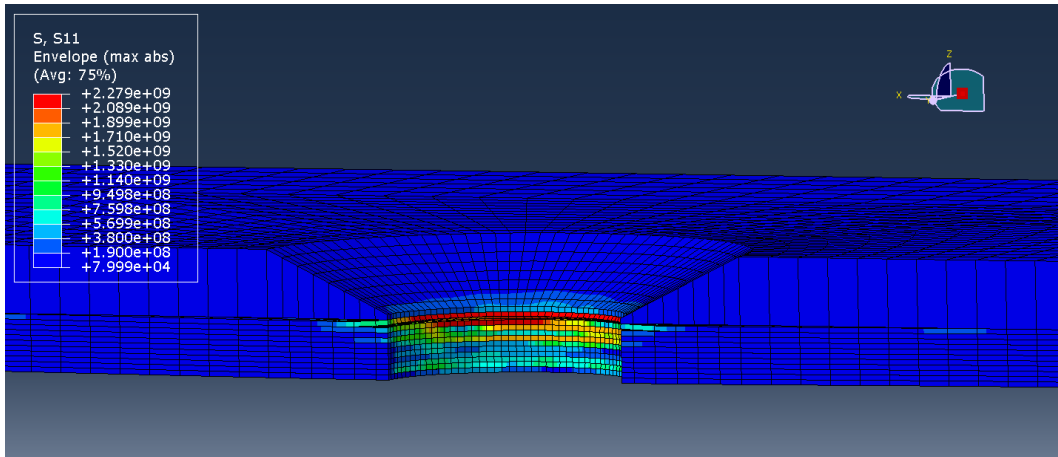
**Figure 5.24: Bearing stress on the bolt-hole surface showing stress concentration between the conical and shank interface.**

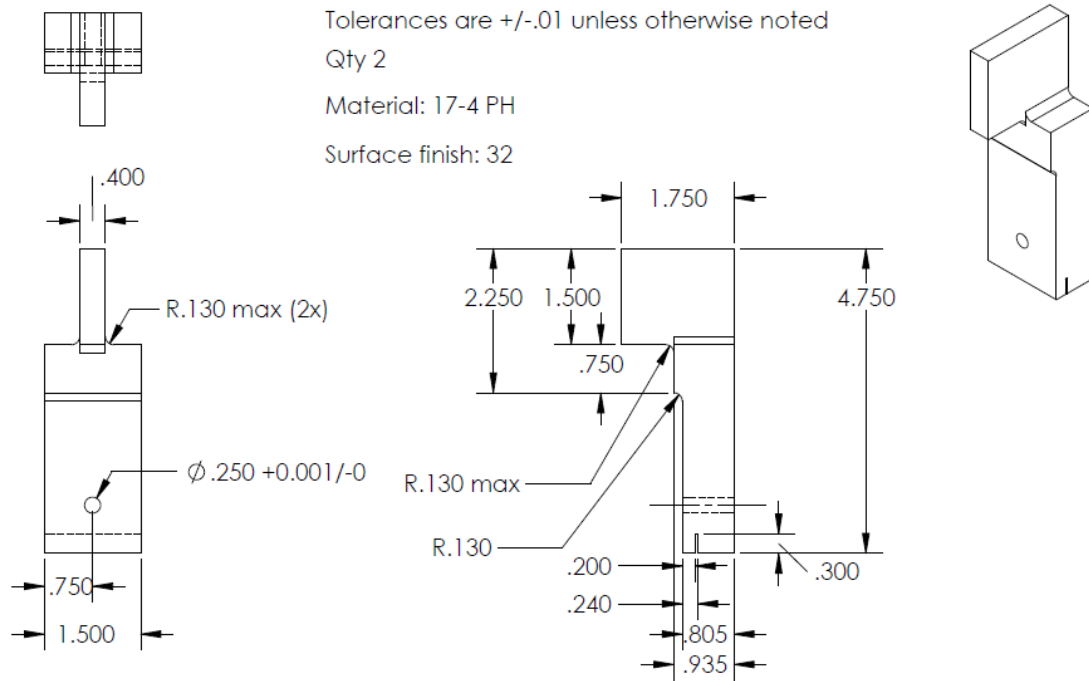
**Figure 6.1: Single lap shear test fixture with dimensions in inches.**
