Tassajara Creek, Twenty Years Later: Long-term riparian vegetation restoration monitoring using field surveys and remote sensing

Skyler Lewis
LA254 Rivers & Cities
Spring 2021

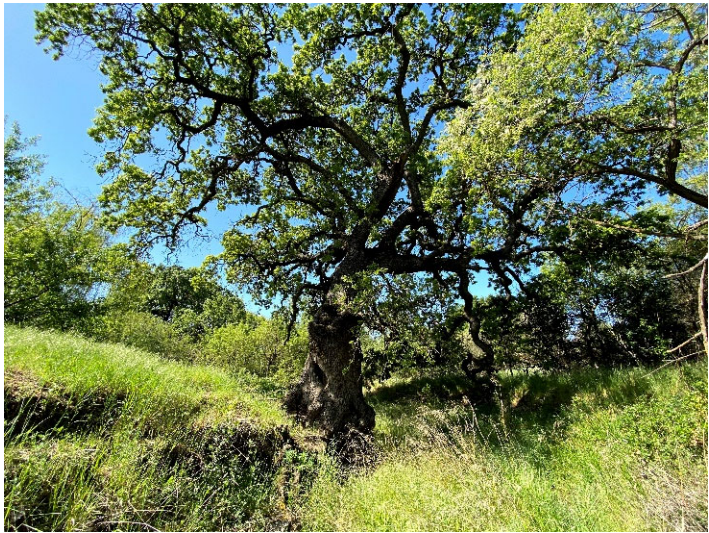
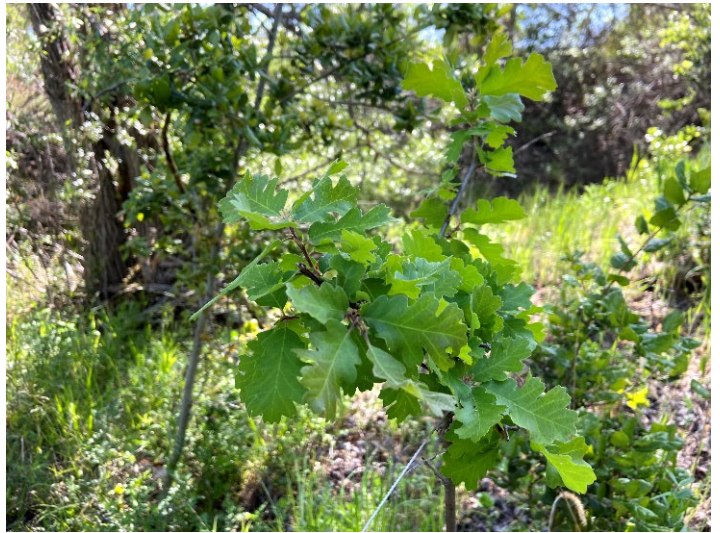
Extant old-growth valley oak (left, looking downstream) and valley oak seedling (right) along Transect 3b
