Restoration With Reference: Rediscovering Cerrito Creek in Blake Garden

FINAL DRAFT Final Project
LA 227 – Restoration of River and Streams
University of California, Berkeley

Jessica Ludy & Kristen Podolak

December 17, 2007

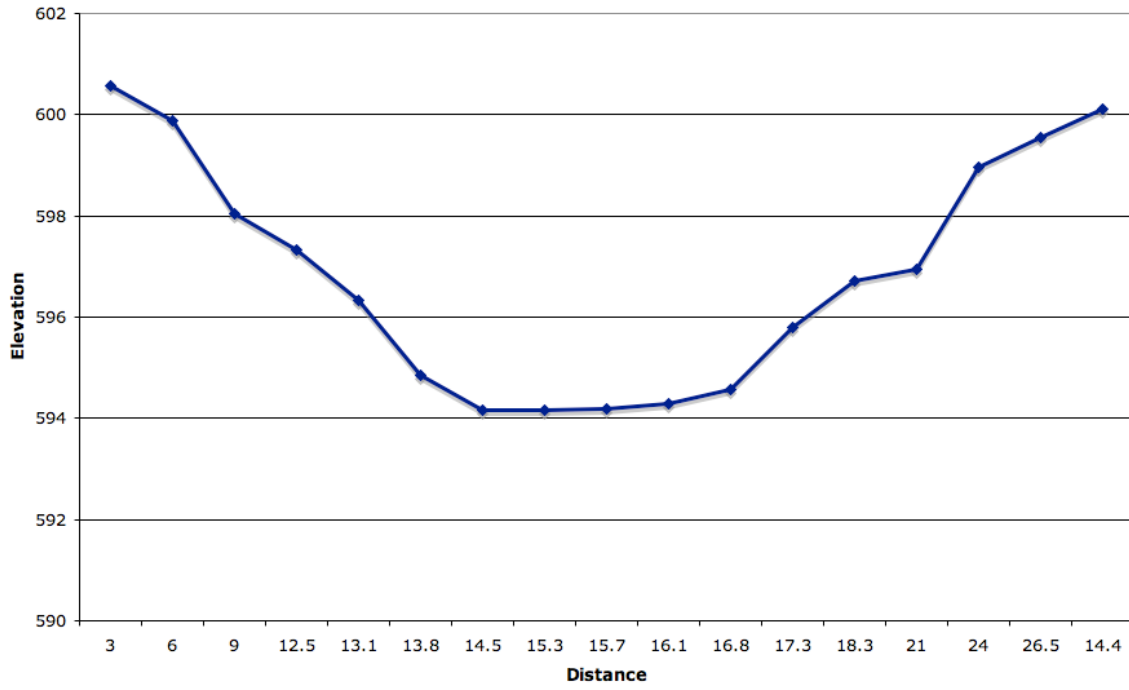
Figure 7:

Cross-Section 4: Upstream Culvert

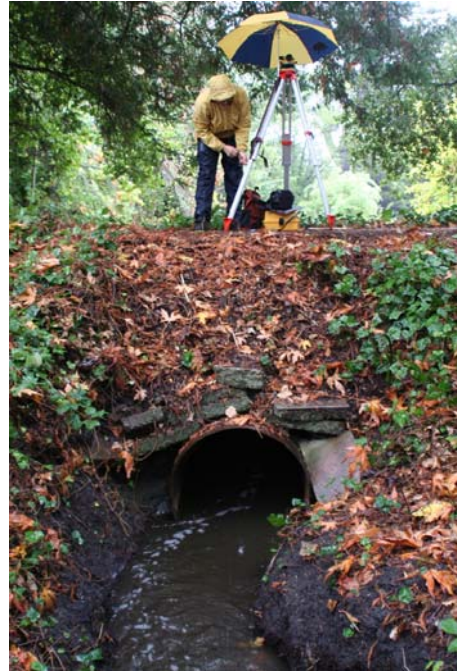
Figure 14: Lauri Twitchell looks at debris on the stormdrain upstream of the garden where runoff flows into Cerrito Creek

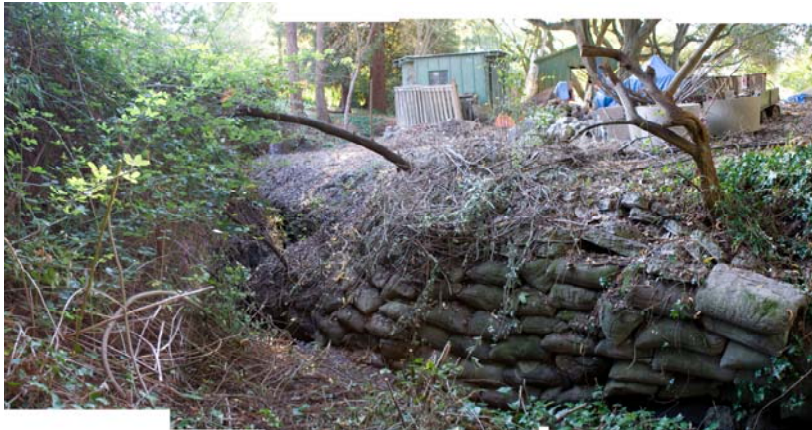
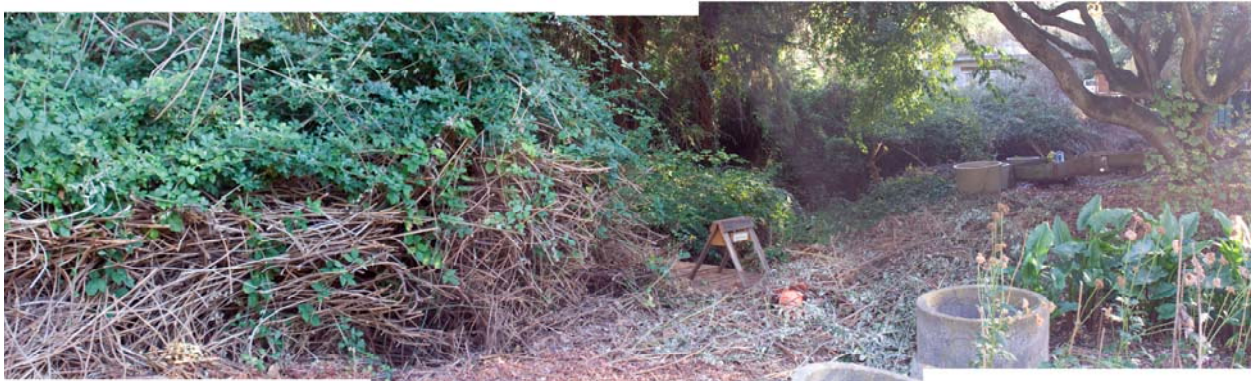
Figures 18-19: Check dams downstream of surveyed reach

Long-term: To address the potential erosion from recently cleared streambanks, we recommend geotextile reinforcement on barren and steep sections of the reach. The garden layout and our observation of visitor circulation suggest the river right bank below the road is the best access point to the creek, but it is incised and steep, and should be regraded to improve access and safety. Considering longitudinal connectivity and habitat, we suggest removing the two concrete check dams downstream of the study reach and replacing them with alternative stabilization measures.

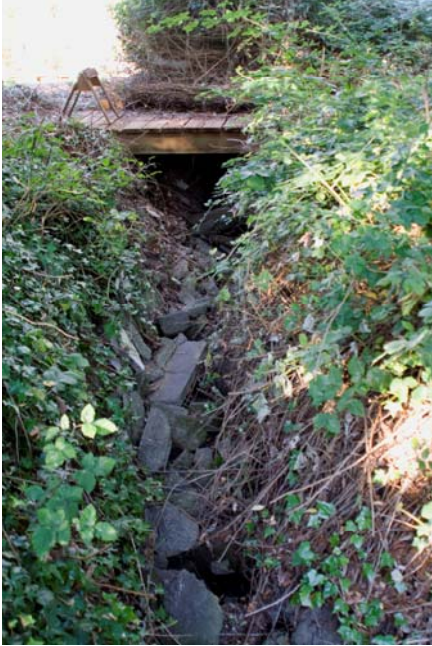
Figures 20-21: View of blackberry clearing above tool shed and armored right bank
