Images in Emergency Medicine: Pacemaker Extrusion Causing Chest Pain

Sanjay Arora, MD

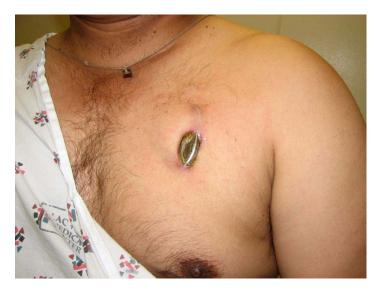
Figure.

A 55-year-old Hispanic male had a pacemaker placed in Mexico approximately one year prior to presenting to the Emergency Department. He noticed minor discomfort in his left chest one month earlier but did not see a physician. The discomfort steadily increased and he saw a small piece of metal poking through the skin. He assumed it was a staple or something minor related to the surgery; however, it gradually increased in size over the next few weeks until he realized it was the pacemaker itself eroding though his chest wall. A cardiology consultation was called, and an EKG showed

that the pacemaker was still functioning normally. He was admitted with a plan for operative repair.

Pacemaker erosion or extrusion has been reported in 0.9% of patients receiving the device. The two main causes are infection and pressure necrosis. Infection has been shown to be reduced by antibiotic treatment during the peri-placement period, and pressure necrosis appears to be influenced largely by the size of the device, complexity of the connections and technical skill with which the pocket is created. After extrusion, the pacemaker should be considered contaminated and removed.
