Restoration of Rivers and Streams (LA 227)

Post project appraisal of Green Valley Creek, Solano County, California : design and management review

Post Project Appraisal of Green Valley Creek, Solano County, California:
Design and Management Review

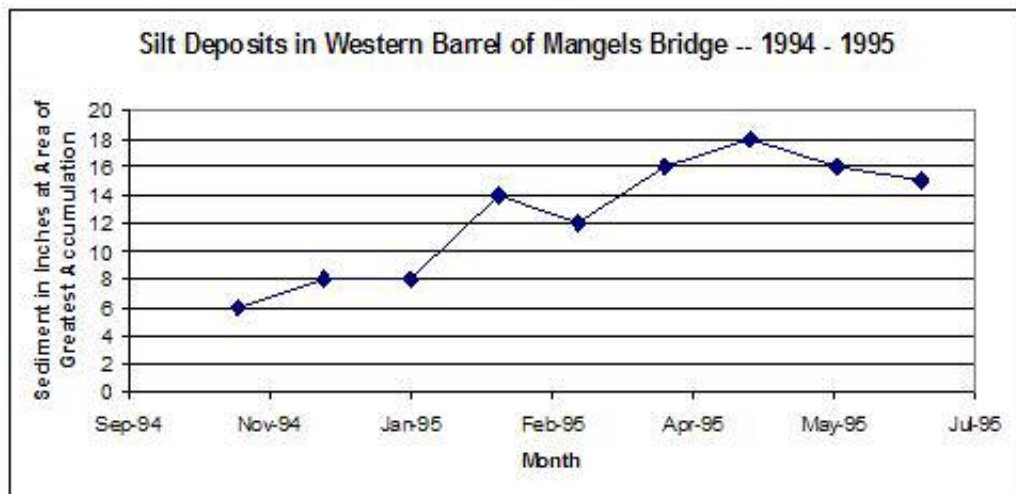
The City discovered problems with the silt flows in Hennessey Creek beginning on January 3, 1995. During this particular rainfall event, total suspended solids (TSS) at Green Valley Creek and Reservoir Lane (north of confluence with Hennessey Creek) was documented to be 9mg/L. At Hennessey Creek TSS concentration was 366 mg/L, and at the south end of the project was 109 mg/L (Beck, 1996). The difference between inflow and outflow TSS concentrations within the project reach shows sediment was transported from Hennessey Creek to Green Valley Creek and deposited along the project reach. These results indicate that the two-terrace design was appropriate and successful because most of the sediment was deposited in the upper terrace. Results of silt accumulation in Mangels Bridge baffles were recorded by Zentner & Zentner and are provided in Figure 4. Sediment accumulation in the baffles reached between 6 and 19 inches. Despite the success of the channel design, large amounts of sediment from Hennessey Creek were transported downstream to Suisun Marsh.

Figure 4. Recreation of Sediment Deposits on Baffles of Mangels Bridge after storms in 1995

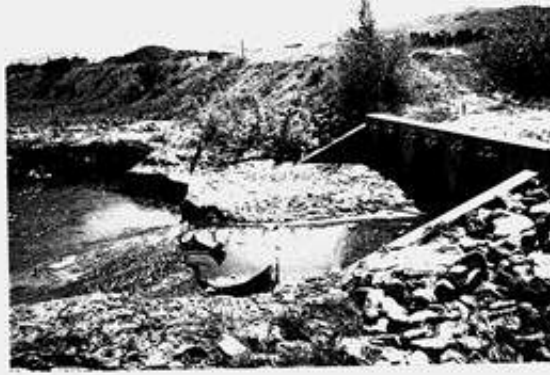
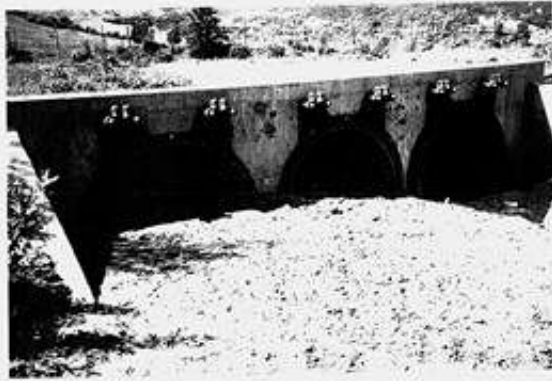
3/29/96 Silt deposits at pipe outfall at Green Valley Creek

Figure 5. Photographs of storm drains at confluence of Hennessey and Green Valley Creek after storms in the winter of 1995-1996

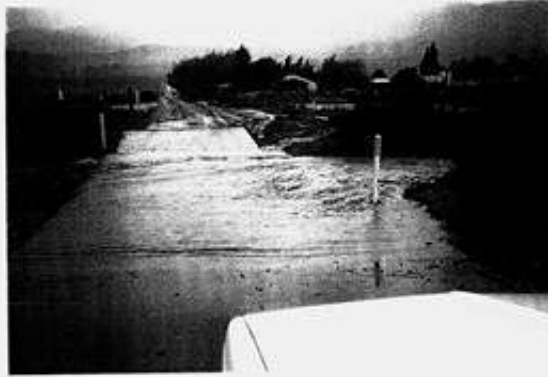
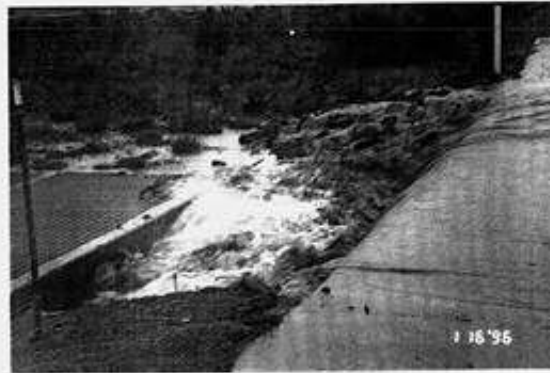
Following the significant floods of 1995 (estimated at near 100-year storm levels by Zentner & Zentner), significant erosion occurred on the most downstream curve of the low-flow channel, at two locations where the low-flow channel entered the overflow terrace (due to silt fencing confining the flows) and at the upstream reach where Hennessey Creek enters the overflow terrace. A significant amount of sediment traveled down Hennessey Creek from upstream sources and plugged the three 72 inch storm drains (Figure 5). This drain clogging in turn caused Hennessey Creek waters to flow into the overflow terrace (Figure 6), cutting a channel around the pipe's head wall into Green Valley Creek (Zentner & Zentner, 1995).

1-16-93 Hennessey Creek storm water flowing south over Reservoir Lane

Storm water flowing into inlet structure

Figure 6. Photographs of Hennessey Creek flooding around storm drains, over Reservoir Rd., through the overflow terrace into Green Valley Creek during storm in winter of 1995-1996

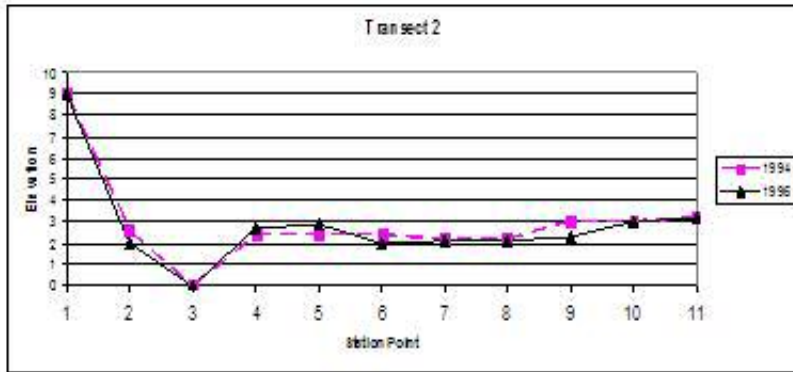
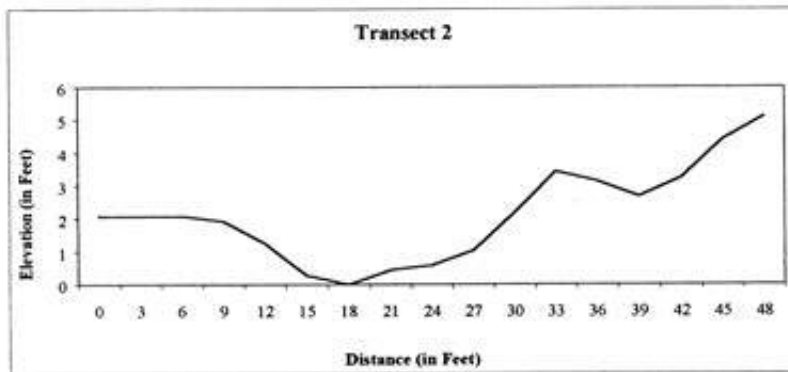
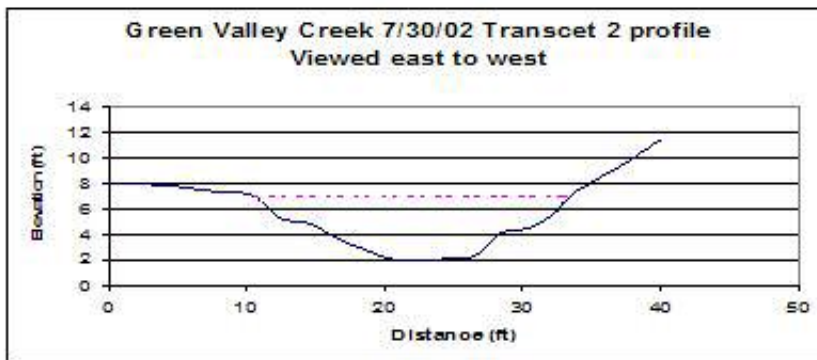
Transect data collected by Zentner and Zentner in 1994 and 1996 used the same distance scale (stations) but in 1998 a different frame of reference was used (feet) (Figure 7). Not only can Zentner and Zentner data not be recreated (because there are no survey tabulations) to compare directly to ECORP's data, but also cannot be compared between 1998 and previous Zentner and Zentner surveys due to the change in transect format. Zentner and Zentner's survey graphs do not indicate water level any year, further arresting the comparison of low flow channel location and condition from year to year (Figure 8-12).

Figure 7. Example of different datum used for same transect making direct comparison of surveys impossible

There is little valuable evidence documenting channel evolution during the first six years of monitoring. During the first six years major storms and sedimentation occurred yet there is no way to quantify how the channel changed in response to those conditions. The first recommendation would be to establish consistent monumented transects. Once monumented transects have been established, it would also be beneficial to geo-reference the monuments so they could be easily re-established in the event of flood or vandalism.

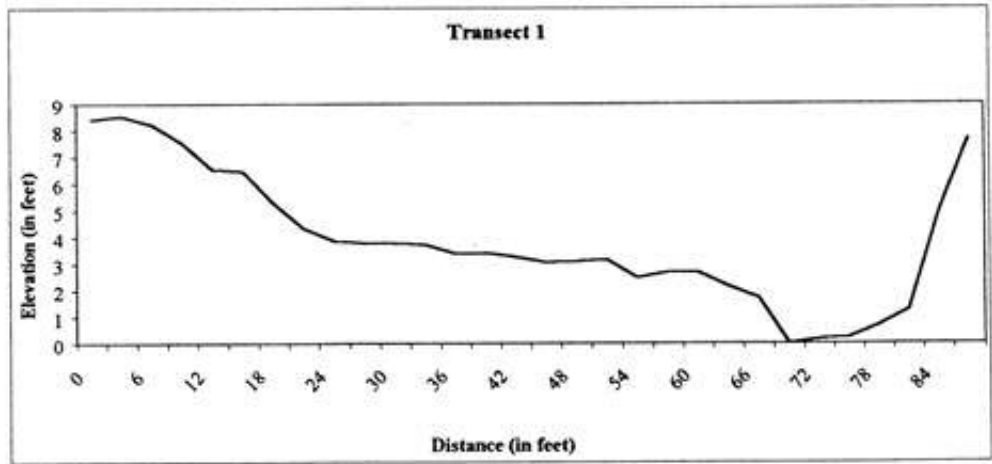
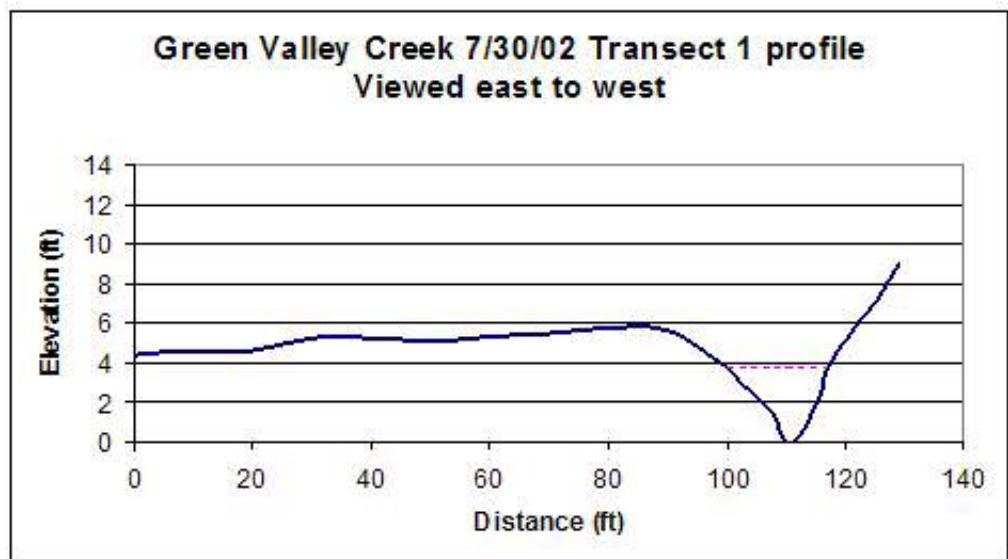
Ignoring the difference between datum and water surface profiles we have made some basic inferences as to how the channel has changed over time. Along transect 1 there has been slight aggradation along the east overflow terrace. The banks of the low flow channel have steepened. The channel may have migrated west since 1998 (Figure 8). Along transect 2 there might have been as much as 6ft of sedimentation along the east overflow terrace. Despite the apparent overall increase in elevation of the banks, the two terrace form is still present (Figure 9). Along transect 3 approximately 2ft of sediment has accumulated in the middle of the low flow channel, creating a small island during low flow periods. The west bank of transect 3 has eroded and the eastern bank has aggraded (Figure 10). Along transect 4 banks have steepened and the channel appears much narrower than it did in 1998. The low flow channel along this transect has migrated to the east (Figure 11). Along transect 5 both the eastern and western overflow terrace slopes have lessened due to sedimentation (Figure 12). Transect 6 was provided but runs through a wetland and not the low flow channel and is not included in this review.

Figure 8. Comparison of Zentner and Zentner's 1998 survey to ECORP's 2002 survey of transect 1

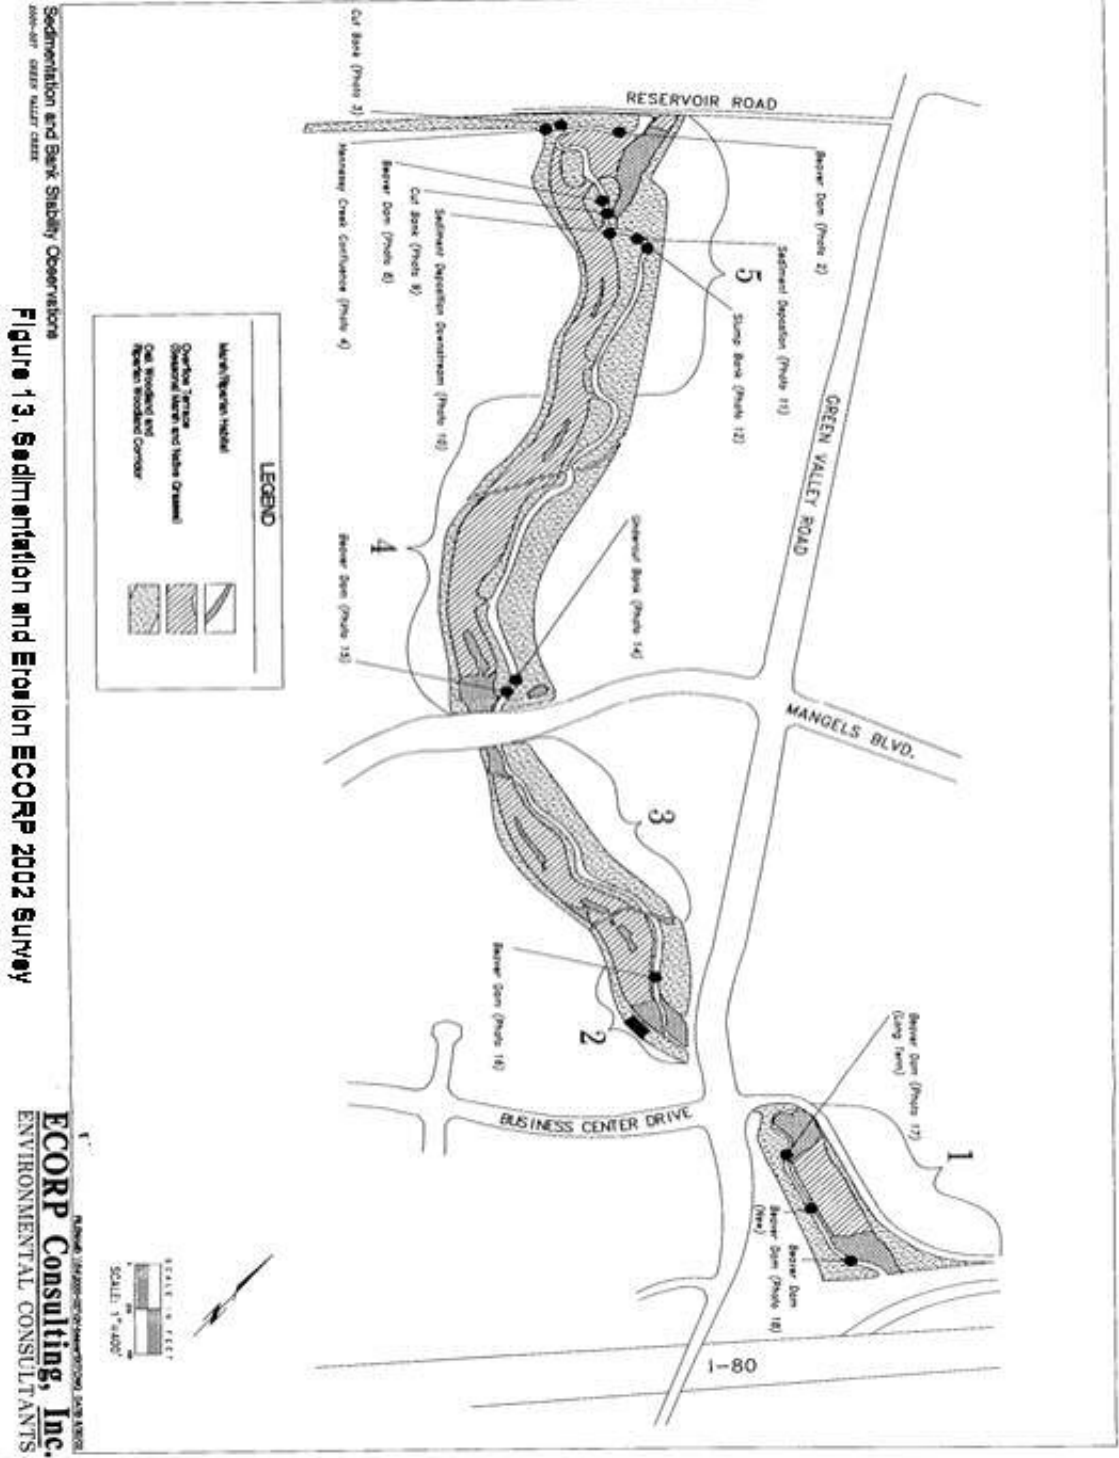
Figure 13. Sedimentation and Erosion ECORP 2002 Survey

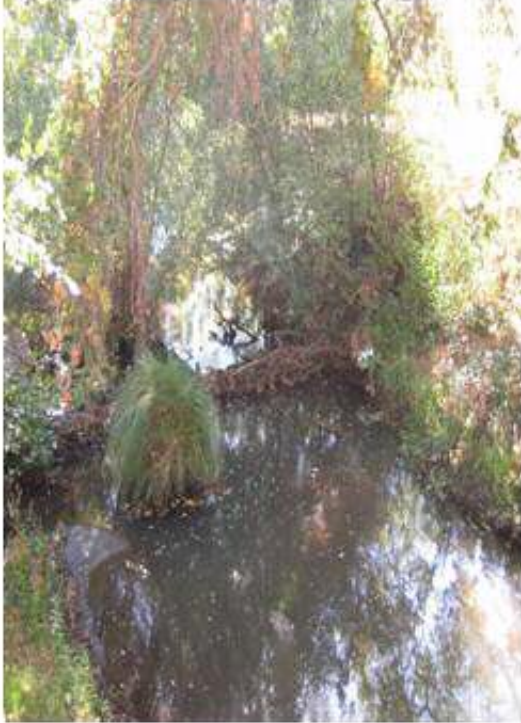
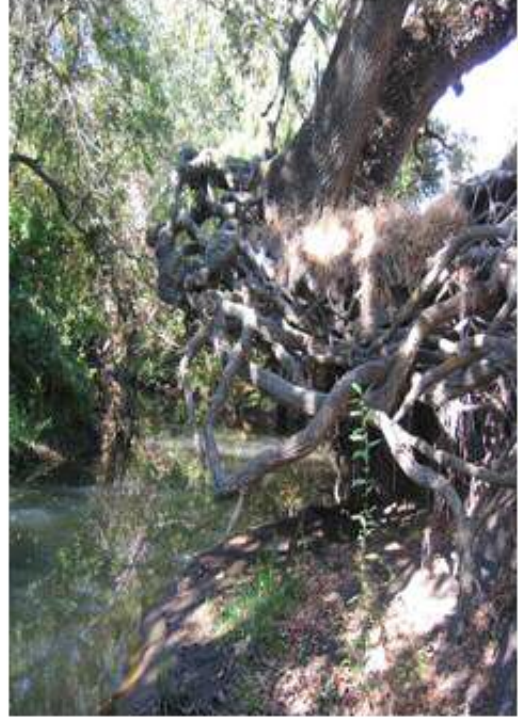
Beaver dams have been constructed in lower and upper most sections of the project since 1998. In 2002, ECORP recorded 1.5 -2 feet of fine sediment accumulated in one pool in reach 5. During our visit, we observed this beaver dam but did not measure sediment. In reach 4, the eastern banks of the river have been significantly undercut, potentially caused by a beaver dam built directly downstream (Figure 14). The dams are located in section 1 (three dams), section 2 (one dam), and section 5 (two dams) (Figure 13). ECORP recorded the largest dam in section 1, located just downstream of Business Center Drive at the staff gage. ECORP observed the cascade and plunge pool to see if salmon could advance past the dam. One fish attempted to swim up the cascade but was unsuccessful (ECORP, 2002).

Figure 14. Beaver dam in reach 5 and undercut eroding bank directly upstream from dam

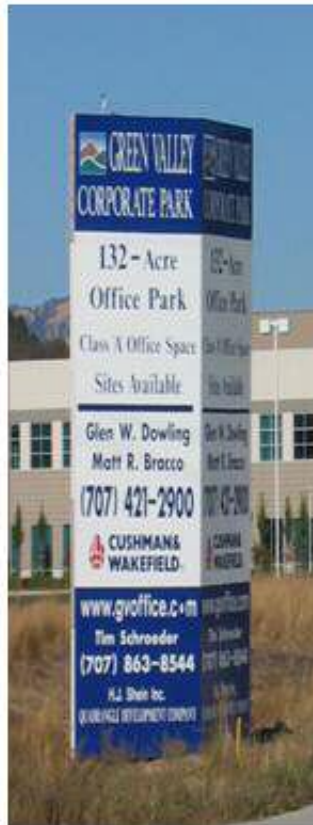
Two sites within the river corridor are graded for commercial development north of Business Center Drive (Figure 15). These sites were observed by ECORP during a storm November 30 and December 1, 2001. ECORP found no indications of sediment transport from the graded sites to the restoration site. Both construction sites are bordered with waddles and silt fencing to protect the project site from soil erosion, deposition or construction waste. During those storms construction crews were maintaining the sediment structures during the peak of the storm on December 1, 2001. Since ECORP does not provide measurements of TSS before and after these sites during the storm, it is difficult to quantitatively determine the effect these sites actually have on sediment transport.

Figure 15. Land graded by Redevelopment Agency of Fairfield for commercial development to the north of Business Center Drive.
