The Urban Gauntlet for Steelhead Trout: A Reconnaissance Study of Habitat in UpperBollinger and Little Pine Creeks, Contra Costa County

Ali Parmer, Derek Morimoto, Rebecca Kaliff

December 15, 2020

UC Berkeley, Landscape Architecture 227: River Restoration

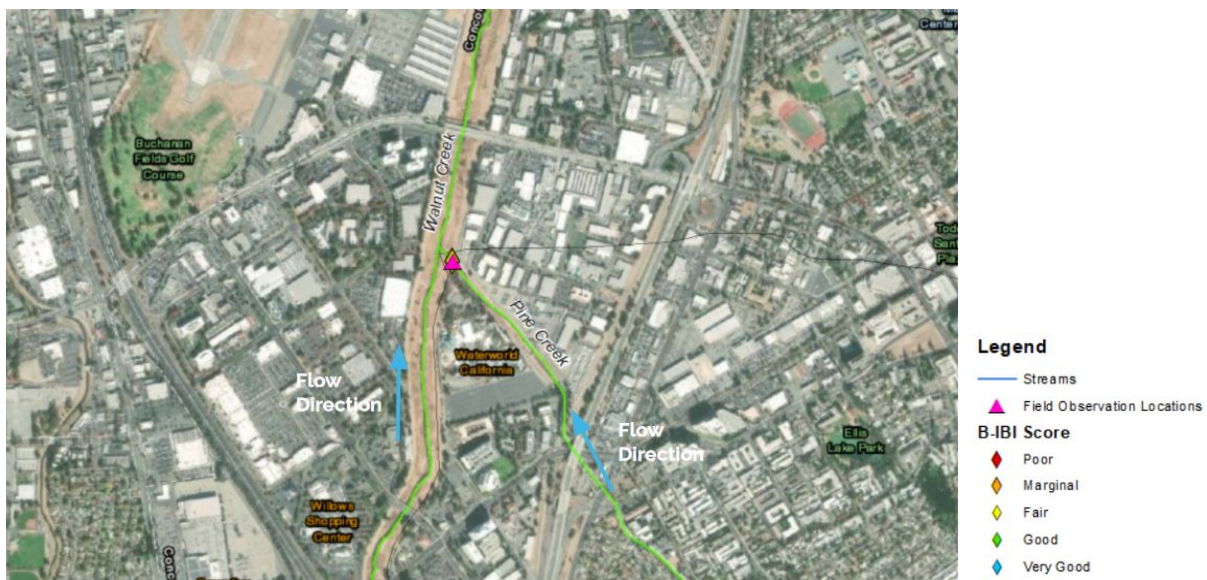
**Figure 8:** The confluence of Pine Creek with Walnut Creek.

Pine Creek, part of the Urban Gauntlet, had an engineered channel. Aerial observations and the 2020 Walnut Creek Watershed Opportunity Atlas' impervious cover data (Appendix C,

Map W-4. Current Watershed Conditions) indicated that this site is in a highly impervious drainage area with over 60% of surfaces being impervious. The Atlas' associated this level of impervious cover with urban drainage and poor water quality, consistent with the fair B-IBI score (Appendix D), shown in Figure 8 above.

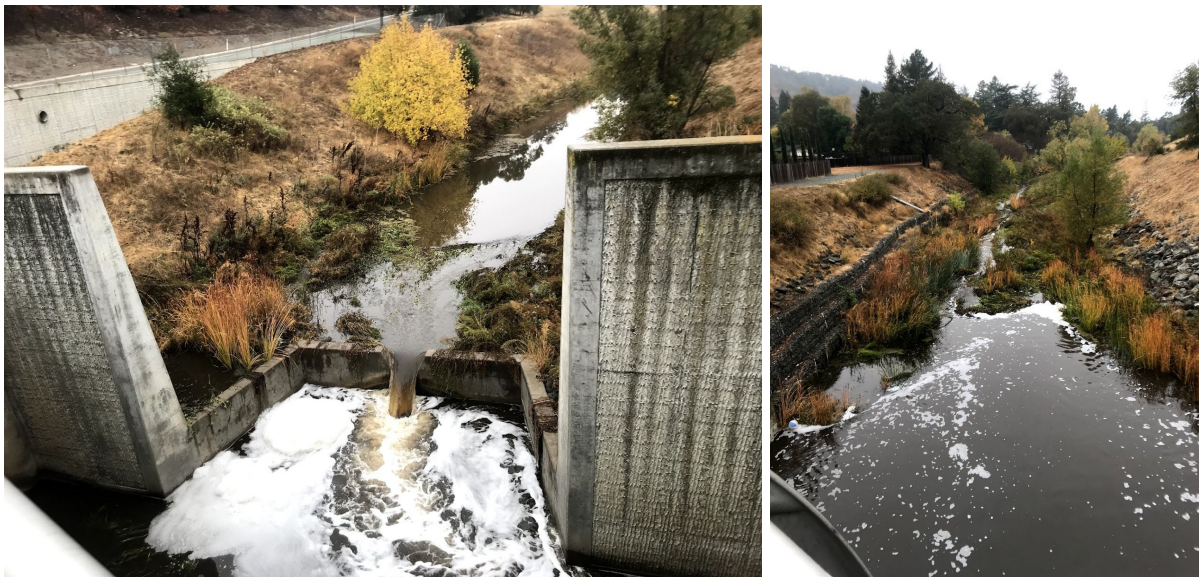
### Observation Point 1 of 1 - Livorna Road (37.86709, -122.04014)

San Ramon Creek was our second Urban Gauntlet observation site with “fair” B-IBI and “very likely altered” CSCI scores. Most notable was a drop structure and brown foamy water with moderate flow (Figure 9a). The engineered channel was earthen and trapezoidal in shape. Gabion structures and boulders lined the bank (Figure 9b). There was minimal canopy cover and channel access was blocked to further observe.

**Figure 9:** San Ramon Creek at Livorna Rd.  
(a) Left: Concrete drop structure. (b) Right: Downstream view.

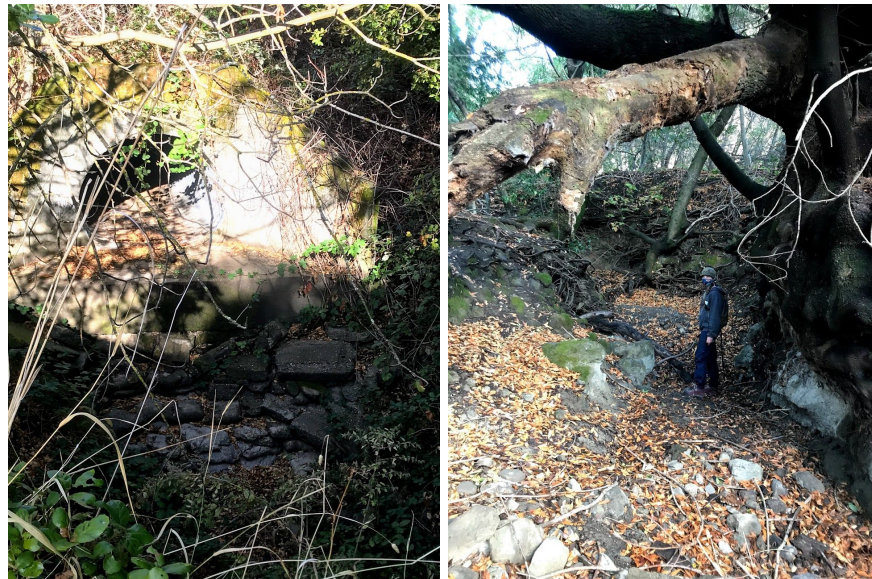
### Observation Location 1 of 3 - Most Upstream Location (37.816545, -122.049726)

A large culvert, 60-72-inch corrugated metal pipe, flowed underneath the parking lot entrance to the observation site (Figure 11a: outfall to channel bottom, approximately 10 feet (ft)). As seen in Figure 11b, downstream of the culvert, the channel was an earthen trapezoidal channel with a bottom width of approximately 8 ft, depth of approximately 13 ft, and steep

side-slopes. The channel appeared incised for approximately 100 ft, but downstream it became wider with overhanging banks for cover and space for step pools as the creek meandered around mature trees. Grain size decreased moving downstream of the culvert and spawning gravels were observed. Canopy cover remained at 90% along the channel.

**Figure 11:** (a) Left: Facing upstream, corrugated metal pipe culvert pictured. (b) Right: Facing upstream.

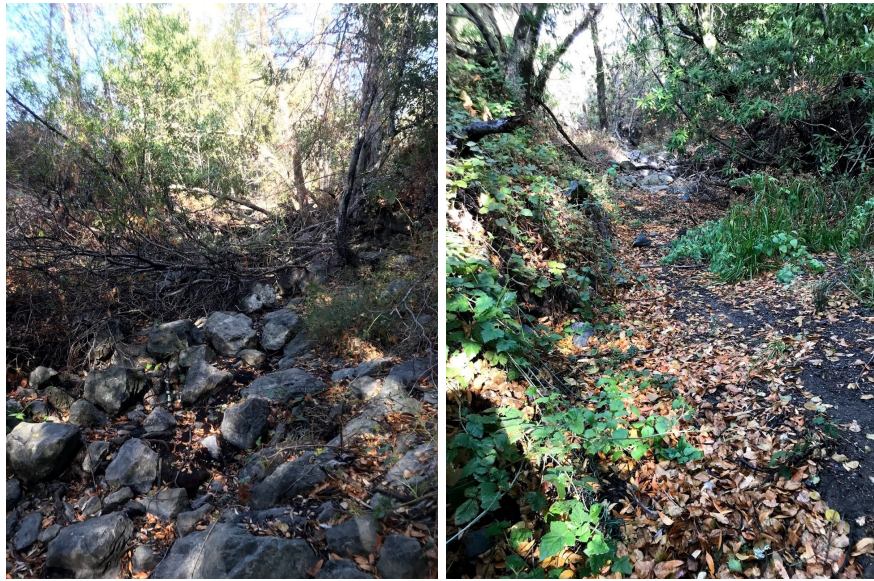
#### **Observation Location 2 of 3 - Mid-Reach (37.811365, -122.043544)**

The second Bollinger Creek observation was approximately 0.8 miles upstream of a B-IBI and a CSCI sampling location, scored at “very good” and “likely intact,” respectively. Clustered boulders formed space for step pools, large woody material added habitat cover, and spawning gravels were present (Figure 12). Canopy cover was approximately 80%. The bottom width of the trapezoidal earthen channel was 30 ft at its widest. Moving downstream, the channel started to narrow and bend.

**Figure 12:** (a) Left: Facing upstream with step pools. (b) Right: Facing downstream.

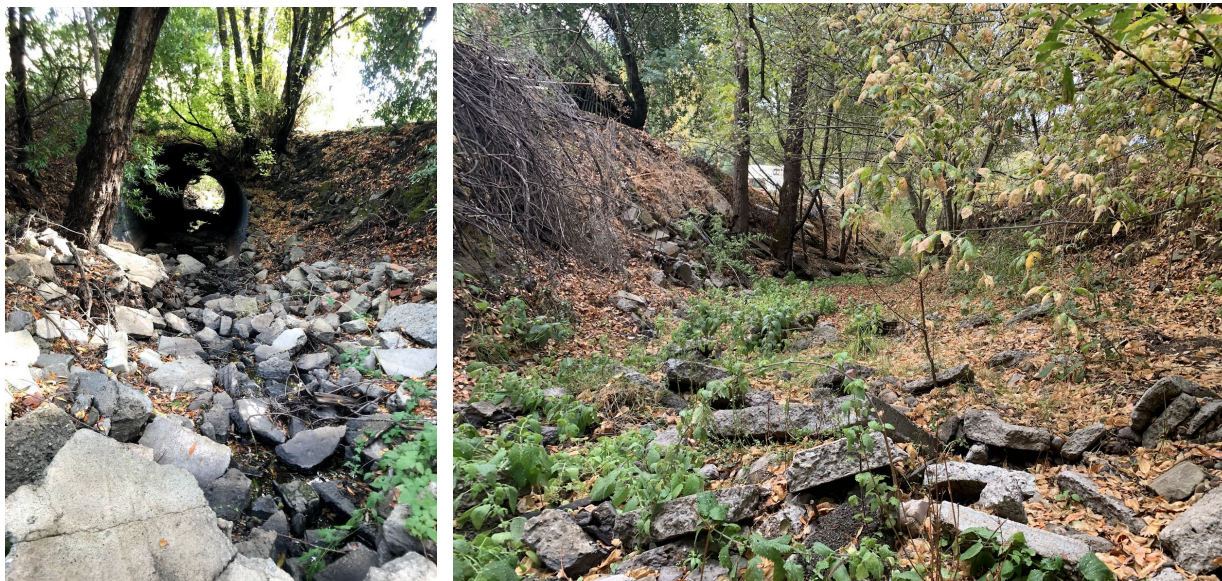
#### **Observation Location 3 of 3 - Most Downstream (37.78972, -122.01037)**

The furthest downstream location observed along Bollinger Creek cut between two private properties. This site had a “good” B-IBI score. The channel passed under Bollinger Canyon Road via a large, corrugated metal pipe approximately 120 inches in diameter (Figure 13a). The earthen trapezoidal channel had one bank significantly steeper and taller (10 ft) than the other. Channel bottom width was 15 ft and canopy cover was 60%. Habitat cover was high with ample large woody debris. Substrates consisted primarily of boulders and gravel suitable for spawning with some cobble, as seen in Figure 13. However, approximately 20% of the boulder sized rocks were riprap (Figure 13b).

**Figure 13:** (a) Facing downstream, corrugated metal pipe culvert. (b) Facing upstream with riprap.

although this part of the creek had high canopy cover, large riprap is not an ideal bed material as it can alter flow velocity. Downstream of the Bollinger Canyon Creek confluence with San Ramon Creek, the habitat quality degraded further. At Livorna Road, a drop structure was flagged as a potential migration barrier. Furthermore, brown foamy water suggested poor water quality, which was consistent with a CSCI score of “very likely altered” and a B-IBI of 24 or “fair.” Therefore, although there may be potential spawning habitat for steelhead trout in the uppermost reaches of Bollinger Canyon Creek, the drop structures and degraded water quality in San Ramon Creek, an Urban Gauntlet reach, may prohibit them from arriving at those sites.

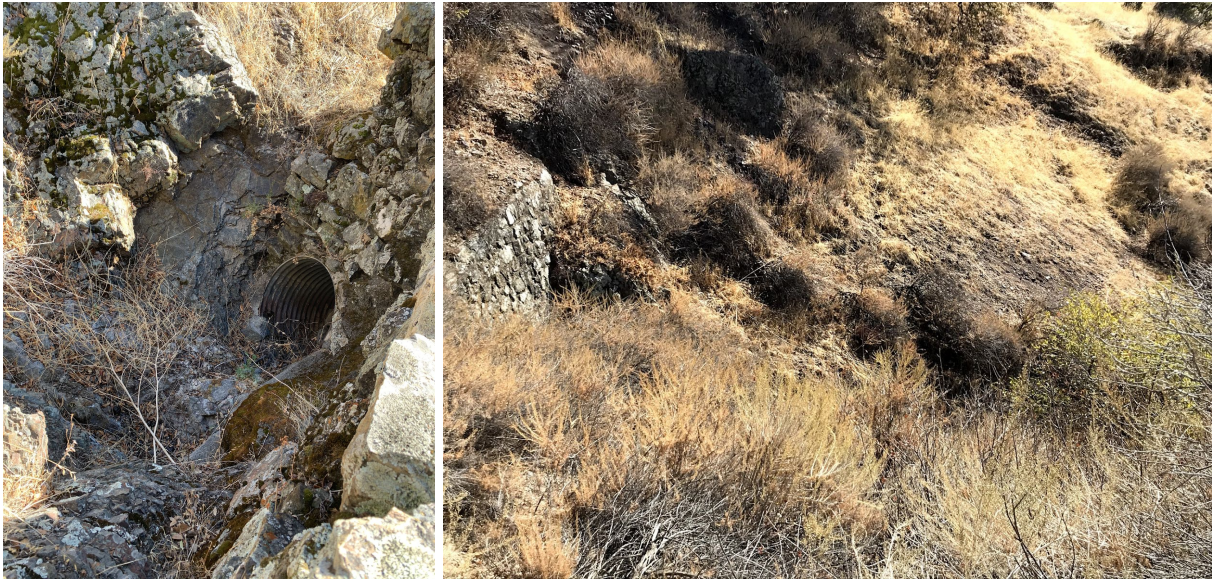
### Observation Location 1 of 3 - Most Upstream (37.8792, -121.9635)

The creek was a v-shaped channel with steep side-slopes primarily composed of bedrock. A reinforced concrete pipe culvert crossed under the road before traveling down a steep hillside (Figures 15a, 15b). The bottom width and top width measured 3 ft and 30 ft respectively and the steep side-slopes carried the channel depth to approximately 30 ft. There was little observed habitat cover, no spawning gravels, and minimal canopy cover of about 10%.

**Figure 15:** (a) Left: Upstream culvert with pipe (b) Right: Downstream of North Gate Road culvert.

Little Pine Creek had different habitat characteristics than Bollinger Canyon Creek. At the most upstream observed reach, the bedrock v-shaped channel had no gravel and minimal canopy cover, suggesting inadequate spawning habitat conditions. Conversely, the second observation location downstream had 70% canopy cover and had a gravel-dominated bed. These improved habitat conditions were consistent with the “very good” B-IBI score. Although these conditions aligned with steelhead trout habitat preferences, there were two small drop structures observed, which could hinder them from reaching further upstream. The third reach along Little Pine Creek reverted to similar conditions as the uppermost reach, which 10% canopy cover but had primarily fine-grained bed material. Thus, this location was not an optimal spawning habitat, but could serve as a passageway to swim to the better habitat upstream. Lower in the Pine Creek subwatershed, satellite images revealed Pine Creek as a rectangular concrete channel, in addition to the myriad of drop structures, thus would not be an optimal spawning habitat for steelhead trout. Therefore, efforts would need to be made to allow steelhead trout to reach the second observation location along Little Pine Creek.

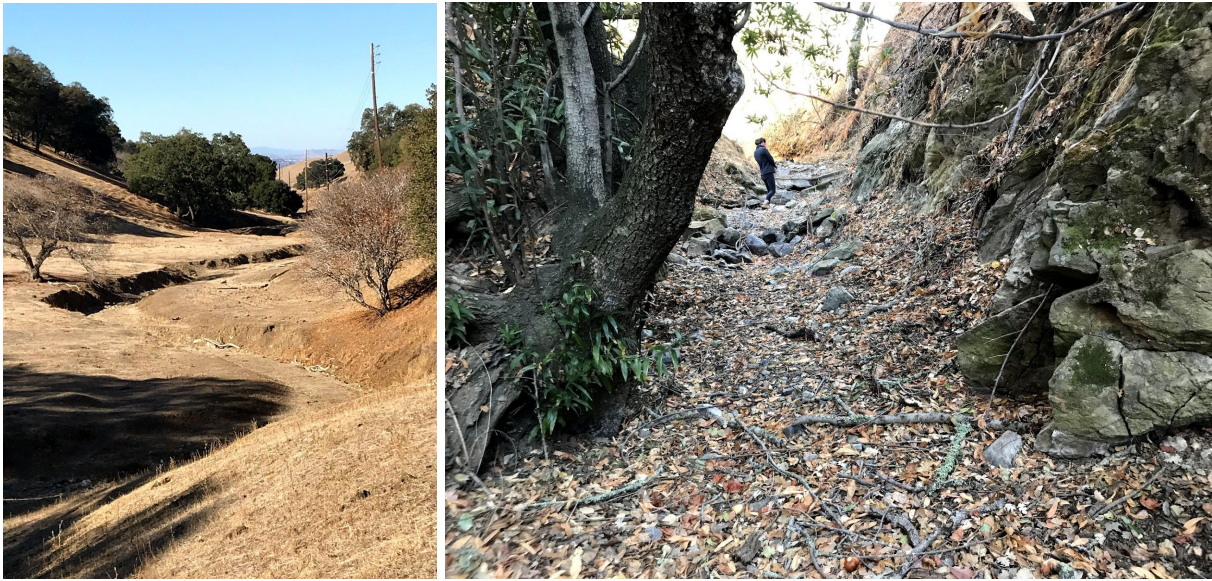
**Observation Location 2 of 3 - Mid-Reach (37.88403, -121.97694)**

This segment started as a narrow, grassy, earthen channel. In contrast, just around a bend the earthen trapezoidal channel transitioned for approximately 400 ft to conditions containing spawning gravels, 70% canopy cover and habitat cover. Substrates were estimated at 20% Boulders, 30% Cobbles, 40% Gravels, and 10% Fines. However, two small drop structures (3ft high) were in this section, shown in Figure 16b. Downstream, the channel returned to a narrow grassy channel and was intersected by a cattle grazing fence (Figure 16a). The B-IBI score at this site was “very good.”

**Figure 16:** (a) Left: Downstream segment with sparse vegetation  
(b) Right: Drop structures

3. Invite fish passage experts in the field to assess whether steelhead trout can safely migrate up tributaries across drop structures on Little Pine and through observed culverts and long stretches without canopy cover. If not, ask the experts for recommendations on how to modify structures to permit fish passage.

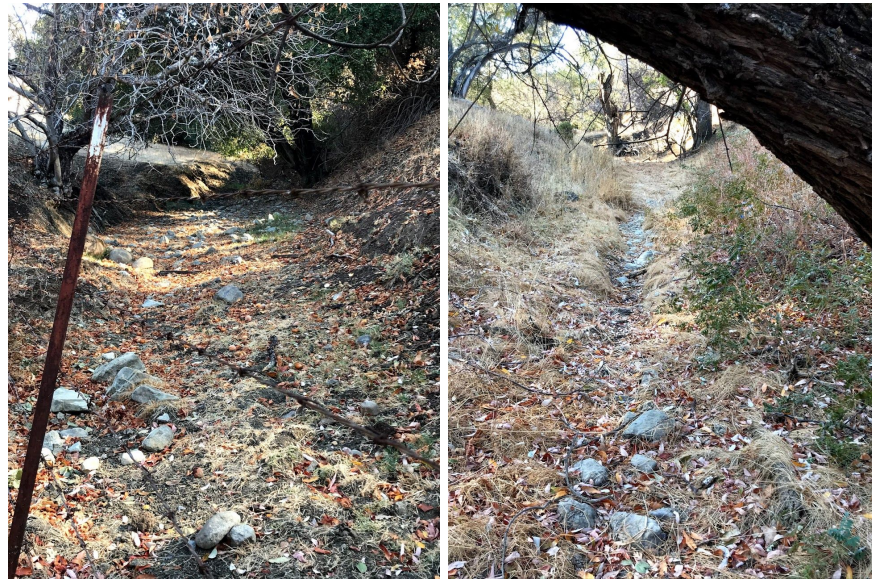
**Observation Location 3 of 3 - Most Downstream (37.8906789, -121.9844849)**

This segment was a trapezoidal earthen channel noticeably shallower than previous Little Pine segments (Figure 17b). There was little habitat cover observed. Canopy cover was approximately 10% and ground cover was high consisting primarily of wild licorice. There was minimal substrate variety; scattered boulders and cobbles, but clay and fines dominated the channel. Notably, the area neighboring the site smelled of manure and a barbed wire fence ran adjacent and across the channel to contain grazing cattle (Figure 17a).

**Figure 17:** (a) Left: Facing upstream. Earthen trapezoidal shape. Bound by fence.  
 (b) Right: Facing downstream. Channel becomes narrow and shallow.

reduce costs. In discussing our observations with Jen Natali, Natali pointed out that the cattle grazing in the Little Pine Creek drainage area could contribute to sedimentation in the creek. Additionally, cattle grazing has the potential to reduce ground cover and soil roots, consequently altering flows. Therefore, research and preservation efforts may be more feasible for Little Pine Creek compared to Bollinger Canyon Creek, but the extent of cattle grazing should be further assessed.

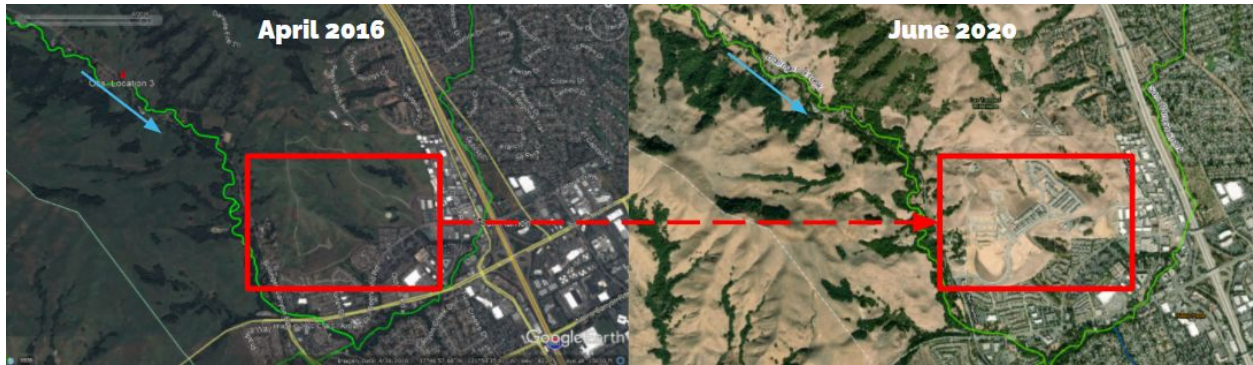
D. The bottom of Bollinger canyon hosts a new housing development adjacent to the creek.

**Figure 18:** April 2016 near Bollinger Canyon Creek observation location 3, pre-development left, post development right. Approximately 135 acres.

The 2020 Walnut Creek Watershed Opportunities report estimated that up to 70% of Walnut Creek's watershed remains unprotected from development. Relevant to our study, land use change near Bollinger Canyon Creek could be of concern, as seen by the new housing development at the bottom of the canyon adjacent to the creek and two newly constructed parking lots located at the top Bollinger Canyon Road. Such land use, development, and hydromodification contributes to erosion and sedimentation on spawning gravels, especially in sections of the creek lacking flow velocity high enough to remove excess sediment.

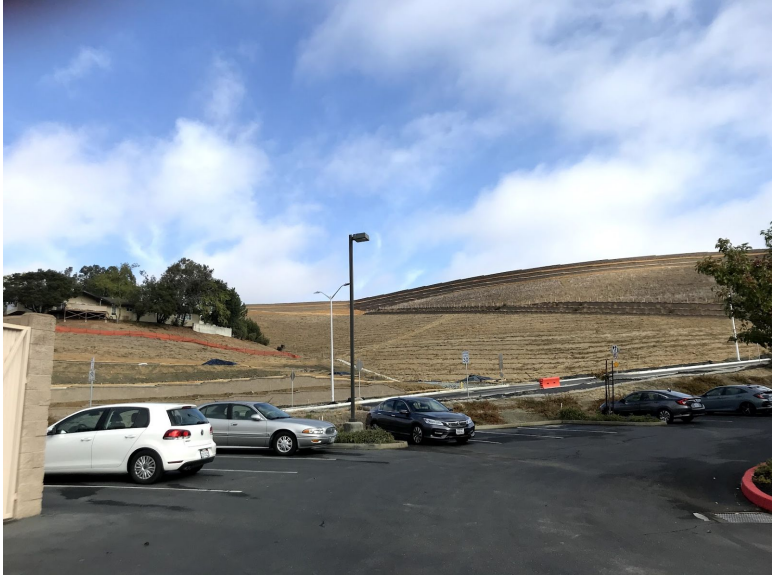
| Photo | Description |
|---|---|
| | <p>Land prepped for new housing development at the bottom of Bollinger Canyon Creek.</p> |

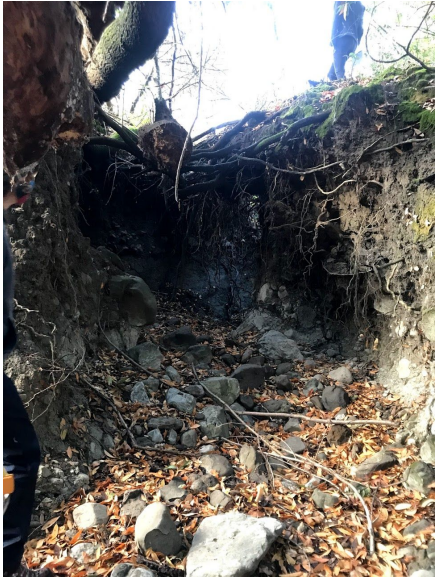
- A. Bollinger Canyon Creek, field site one, had bank erosion adjacent to the parking lot.
- B. The field team observed an accumulation of trash (plastic wrappers and broken bottles) in the channel at the second Bollinger Canyon Creek site and bank erosion from the adjacent parking lot.
- C. Near private property along Bollinger Canyon Creek, site three, there was tilled land to the edge of the creek bank that created several inches of loose soil, and a large pile of disposed leaves in the channel.

| Photo | Description |
|---|---|
| | <p>Bank erosion from parking lot runoff at Bollinger Canyon Creek, stop 1.</p> |

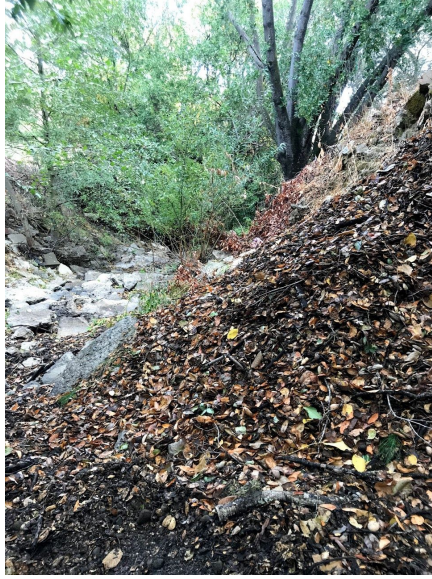
The observed trash, loose soil, and leaf litter deposited by residents along the creek could also degrade spawning habitat by introducing chemical pollutants, smothering eggs, and decreasing dissolved oxygen (United States Environmental Protection Agency 2020; Reiser and White 2011; Duan et al. 2014). It is worth monitoring these impacts to ensure Bollinger Canyon creek remains a potential steelhead trout spawning tributary.

Leaf pile from adjacent property in Bollinger Canyon Creek, stop 2.

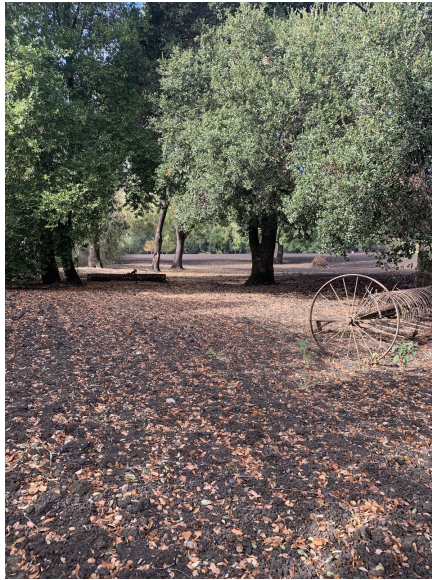
Tilled land created loose dirt right up to creek bank edge, Bollinger Canyon Creek, stop 3.
