Engineering Reconnaissance following the 2016 M6.0 Central Italy Earthquake: Ver 1

Report No. GEER-050A

15 September 2016

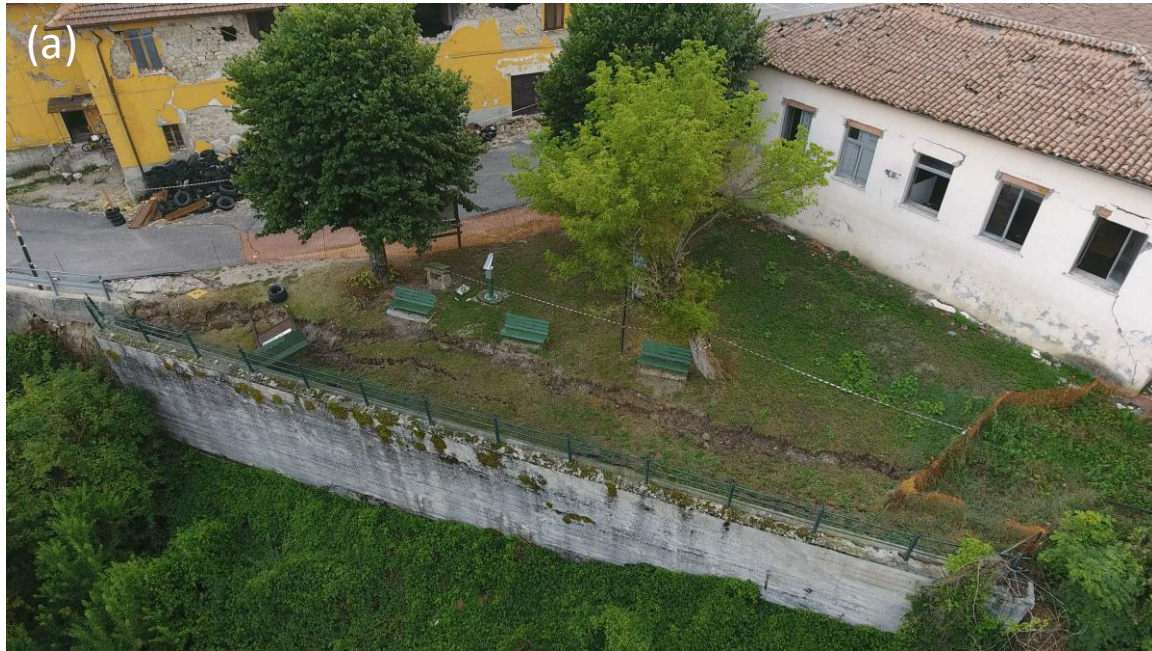
Using a DJI™ Phantom 4 drone, a customized Align™ T-Rex 800 drone, and an Ebee Sense Fly drone, we imaged the four locations shown in Figure 1. These data will be used also for for high resolution digital map creation (orthophoto) Digital Surface Model (DSM) and 3D models of the acquired areas. Information on where to find down-sampled video for two of these locations (Accumoli and Pescara del Tronto) are provided on the Central Italy Earthquake event page within the GEER Association website (www.geerassociation.org). Figure 6 shows aerial photos taken by drones at Accumoli (Figure 6a) and Pescara del Tronto (Figure 6b).

Figure 6. Aerial photos taken by drones at: (a) Accumoli (N42.69425, E13.24993, 9 September 2016); and (b) Pescara del Tronto (N42.750401, E13.272109, 9 September 2016).

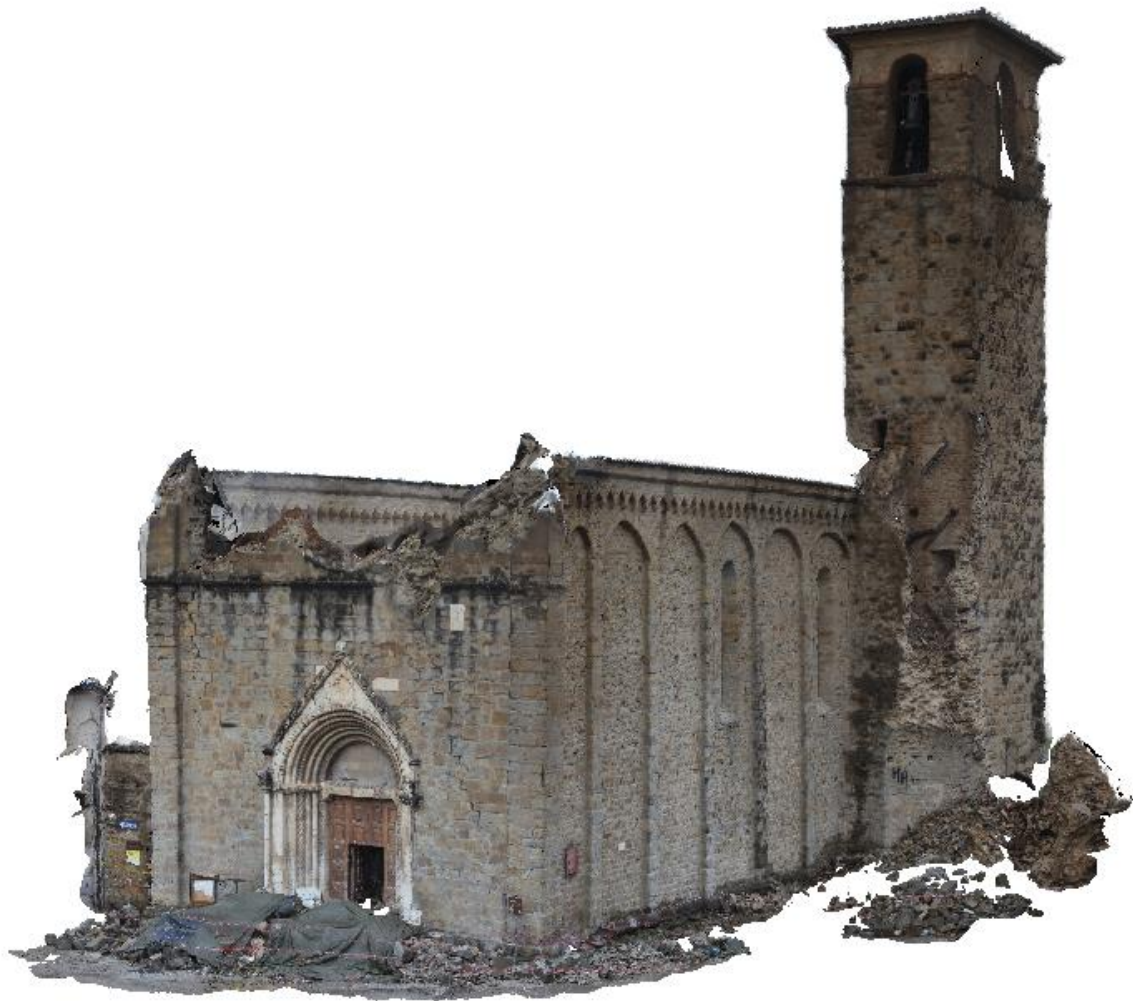
We also performed detailed aerial imaging of the Pescara del Tronto village, which will support the development of a 3D model for subsequent damage studies. Aerial flights were not authorized over the structures in the village of Accumoli during our reconnaissance. Close range photogrammetric survey for Digital Surface Model generation was also completed for the Sant'Agostino church and its bell tower in Amatrice (Figure 9), which can be used to generate 2D or 3D models of the structure.

Figure 9. 3D textured model of the Sant'Agostino church and its bell tower in Amatrice. (N42.628, E13.2914, September 7 2016, Figure prepared by: F Chiabrando, V Di Pietra, and N Grasso).
