Engineering Reconnaissance following the October 2016 Central Italy Earthquakes

Geotechnical Extreme Events Reconnaissance Association

Report No. GEER-050C

9 January 2017

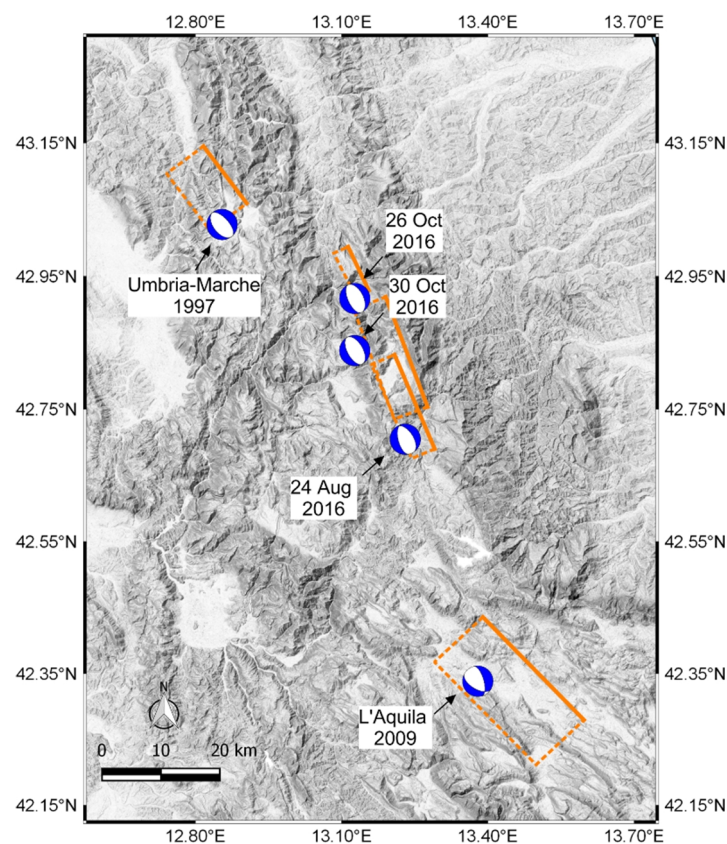
Figure 1. Map of central Italy showing moment tensors of major earthquakes since 1997 and the intermediate gap areas. Finite fault models from Chiaraluca et al. (2004; 1997 Umbria-Marche event), Piatanesi and Cirella (2009; 2009 L'Aquila event), Tinti et al. (2016, 24 August event), and GdL INGV sul terremoto in centro Italia, 2016, 26 and 30 October events). Moment tensors for 26 and 30 October 2016 earthquakes are also shown.

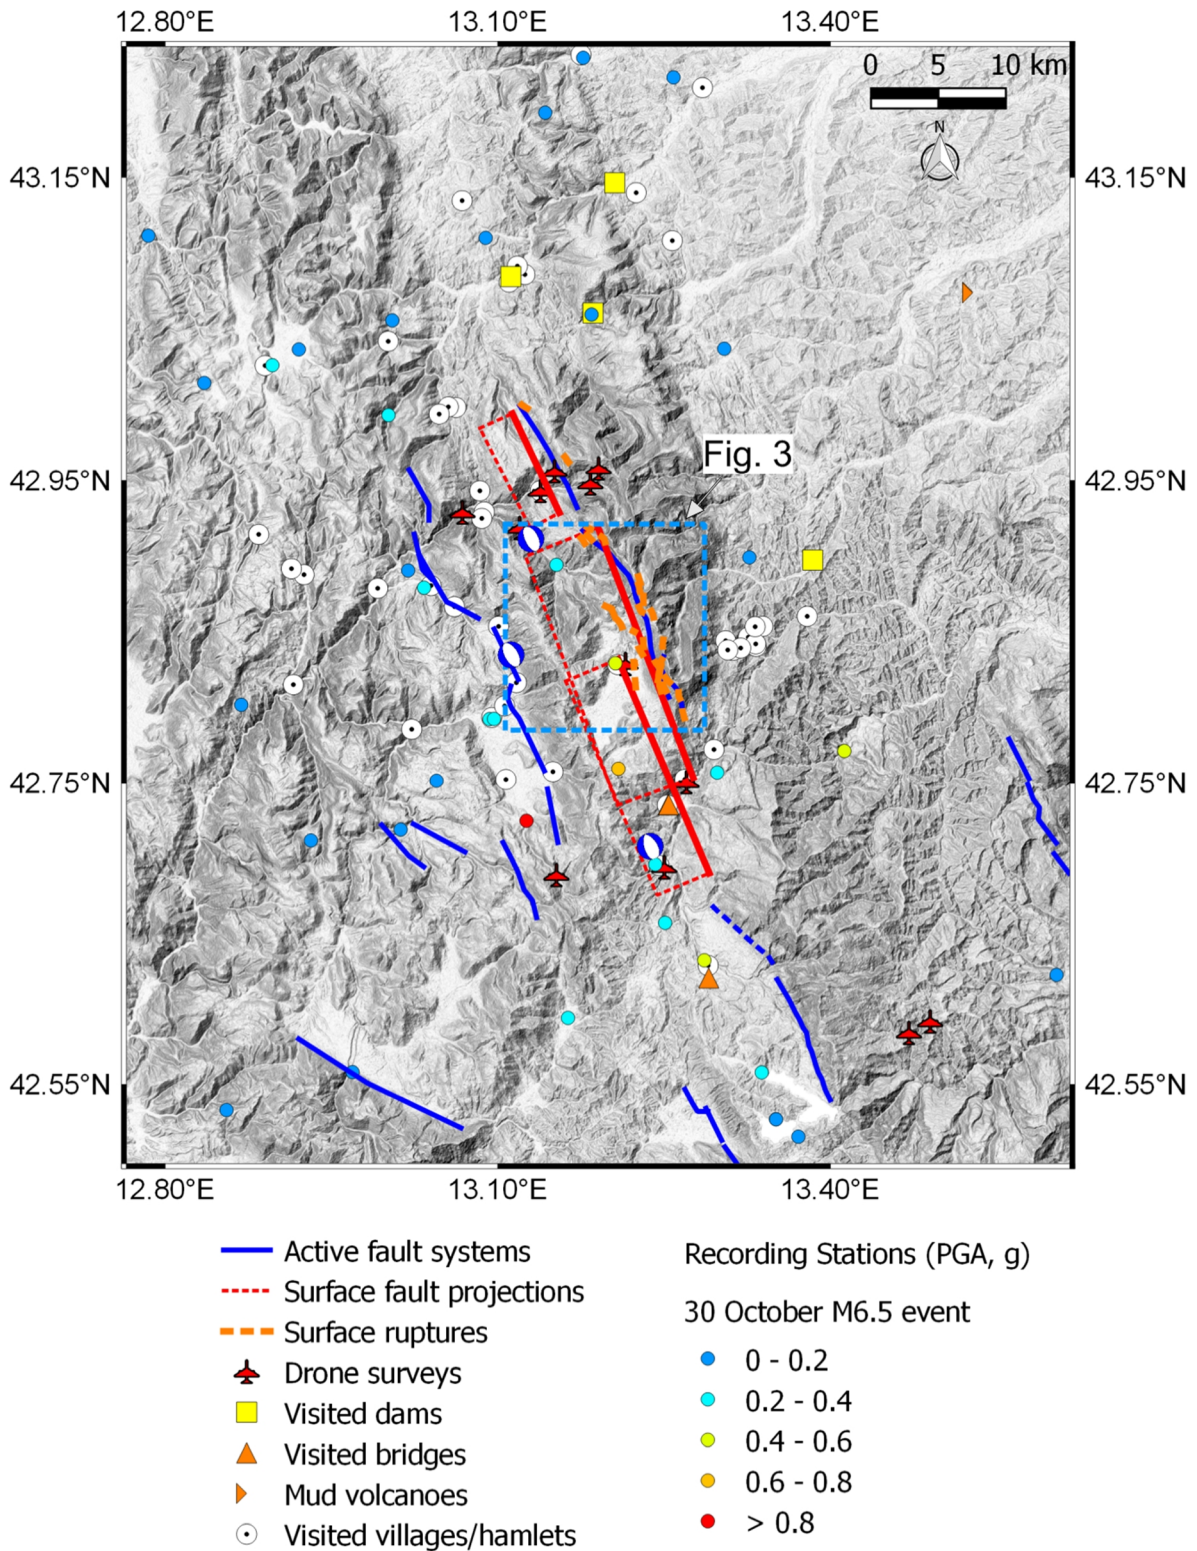
Figure 2. Regional map showing the active fault systems, finite fault models and epicenters of the 24 August, 26 and 30 October events, ground motion station locations and recorded peak ground accelerations (PGA) for the 30 October events, and locations of various earthquake effects discussed in this report.

Similar to reconnaissance activities following the 24 August 2016 event, the GEER team investigated earthquake effects on slopes, villages, and major infrastructure. Figure 2 shows the most strongly affected region and locations described subsequently pertaining to:

Two networks operate broadly distributed permanent ground motion installations in Italy: INGV and Dipartimento della Protezione Civile (DPC). Data from these networks are disseminated at <http://esm.mi.ingv.it>. We have not downloaded and processed ground motion data at this time, although we have noted the locations of stations that appear to have produced usable recordings. The locations of such instruments in the near-fault region are shown in Figure 2.

Figure 2 also shows the locations of temporary instruments deployed after the 24 August event, which we expect to have been operational for the 26 and 30 October events. Data from these temporary arrays have not been released as of this writing. Further information on temporary arrays is available in Table 3.1 of GEER (2016).

As shown in Figure 2 and Table 1, aerial imaging was performed of eight landslide features. This imaging was performed using one or more of the following apparatus: a DJI™ Phantom 4 drone, a customized Align™ T-Rex 800 drone, or an Ebee Sense Fly drone. These data are being used to develop digital maps (orthophotos), Digital Surface Models (DSM), and 3D models of the surface morphology. Table 1 also shows locations of landslides mapped as part of the GEER activities that do not have sufficient aerial imagery to develop 3D models.

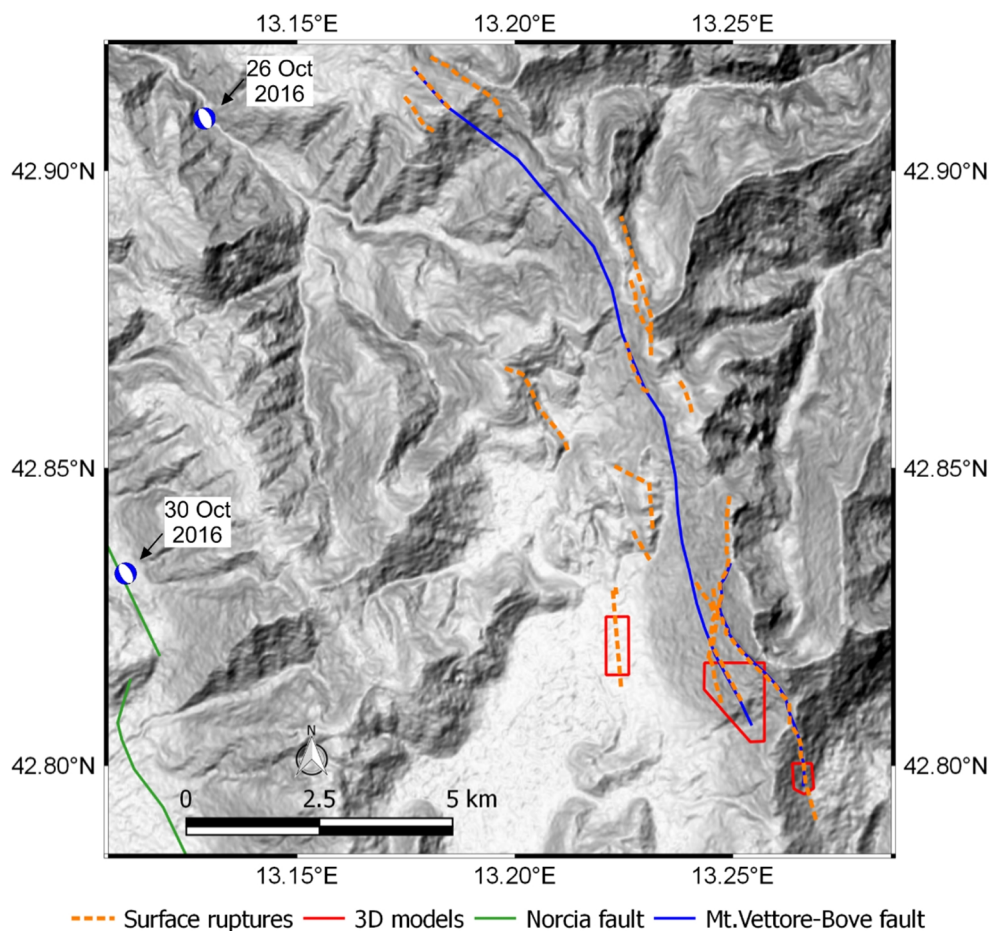
Figure 3. Detailed map of surface fault rupture, pre-event mapping of Mt. Vettore-Mt. Bove (blue) and Norcia (green) fault systems, and locations of 3D models.

We performed detailed measurements and imaging of fault rupture in three areas shown in Figure 3. Whereas the 24 August event produced displacements on the main fault trace ranging from null to 35 cm (mostly 10-25 cm), we found in some of these same areas displacements of up to ~ 1.6 m on the main fault trace. We also found displacements of up to several tens of cm on two secondary faults (Figure 3), which had not displaced on the 24 August event. Figure 4 shows an example of large fault displacement at the location shown in Figure 3.

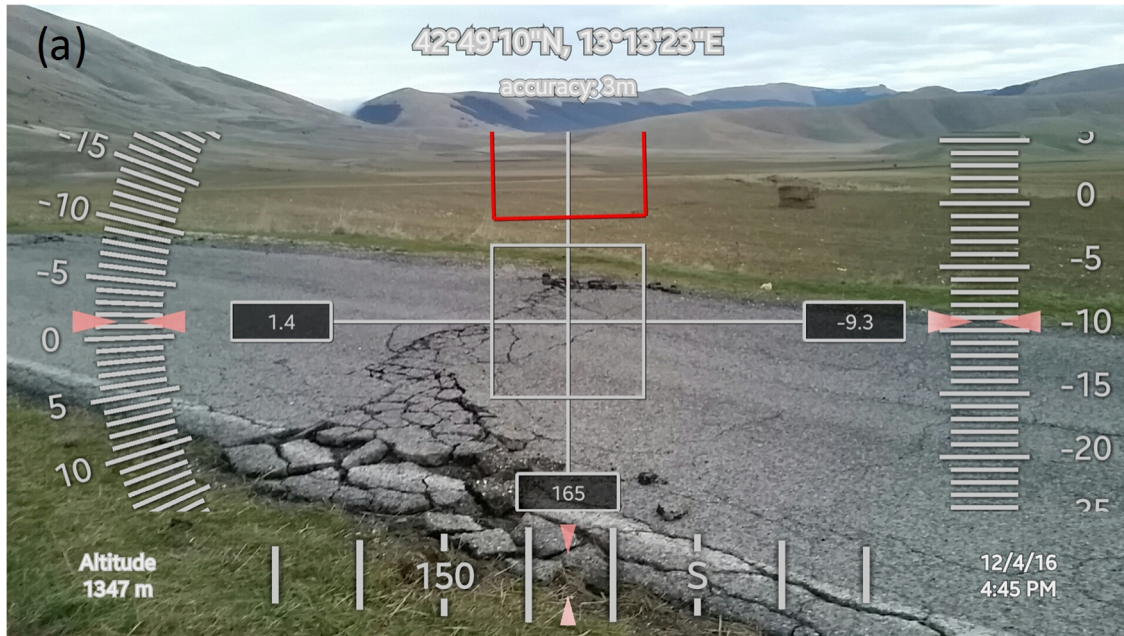
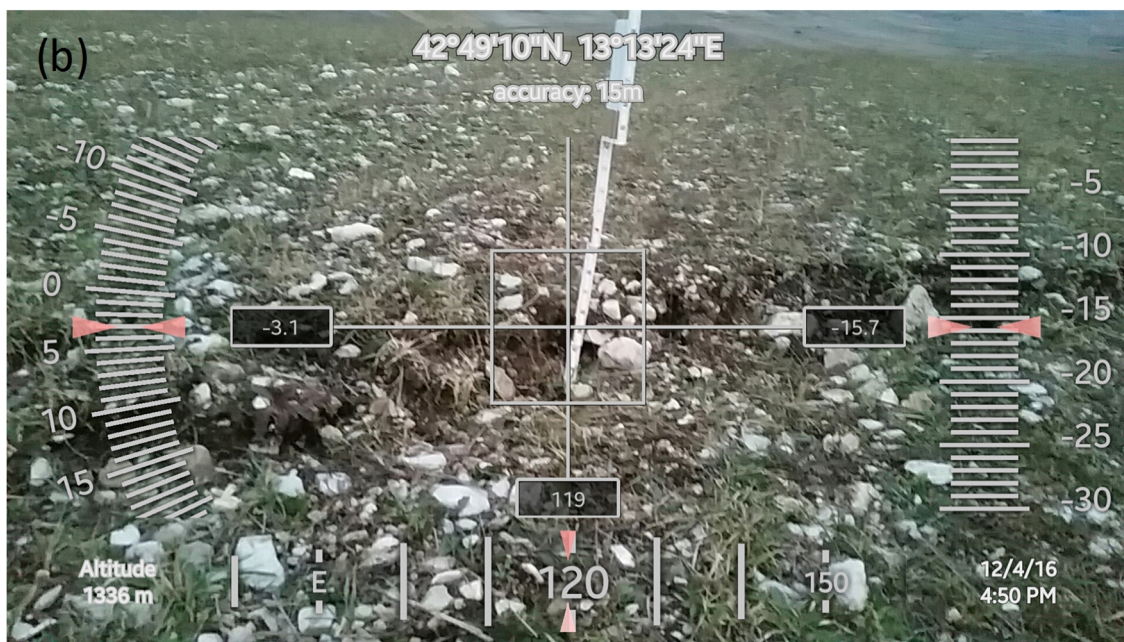
Figure 4. Pictures of the Piano Grande fault offset location; (a) surface rupture manifestation on the road, and (b) rupture manifestation with vertical offset equal to 15 cm.

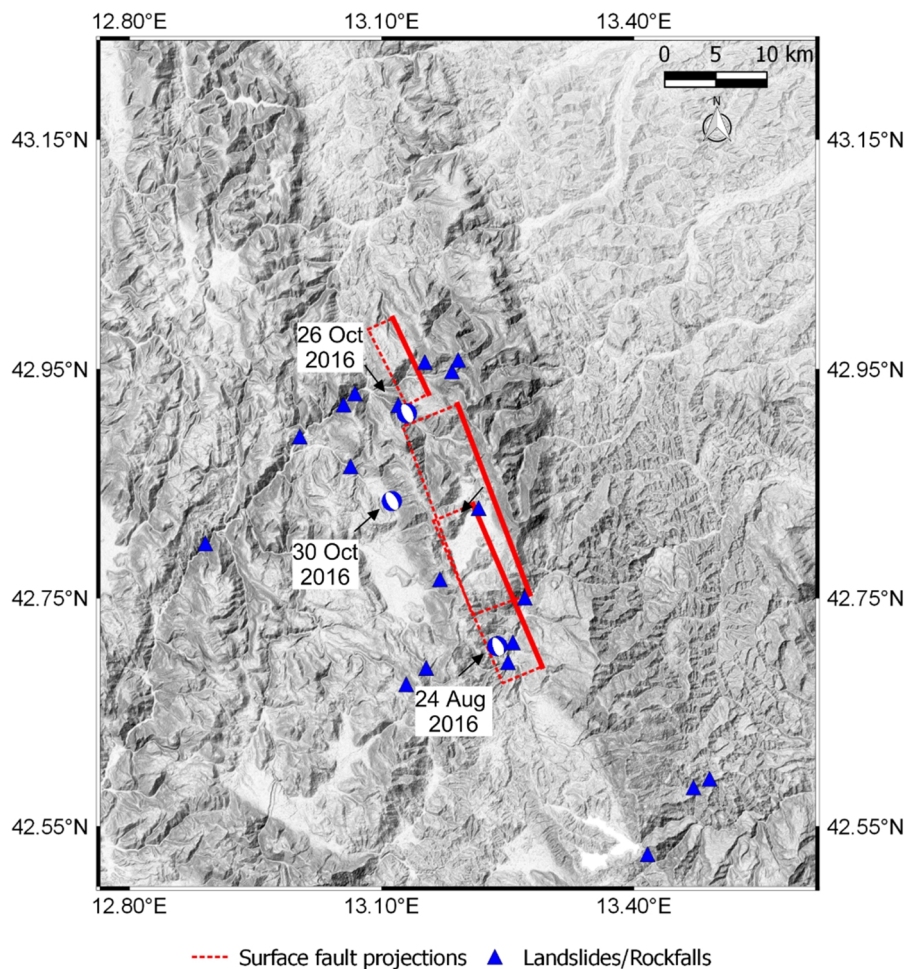
Figure 5. Mapped rockfalls and landslides relative to finite faults of earthquake sequence.

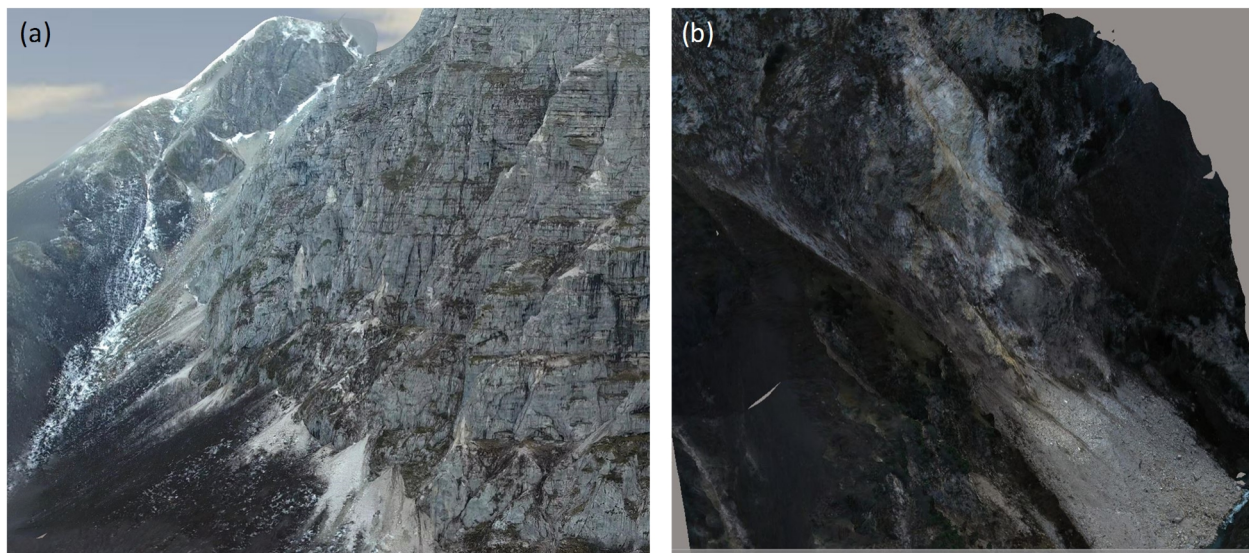
Two particularly massive landslides were the Mt. Bove landslide and the Nera river landslide. Aerial images of each are shown in Figure 6. The Mt. Bove landslide source area is near the summit and involved a large volume of slide debris. We have aerial imagery of this feature, which has been used to produce a 3D model. This landslide was detected by the damage proxy map by JPL-Caltech¹ using satellite images collected after the 26 October event; hence, the landslide is attributed to that earthquake. This information has been confirmed by a local engineer who observed the feature following the October 26 event but prior to 30 October. The Nera river landslide, is a 300 meter-high wedge-type translational slide that became a large rockfall that dammed the river below and closed the highway. We performed extensive imaging of this feature, which has been interpreted to form a 3D model. From the similar markings and discolorations on the mountainside, it appears that similar events may have occurred previously.

Figure 6. (a) Screenshot of the Mt. Bove landslide 3D model, and (b) screenshot of the Nera river landslide 3D model.

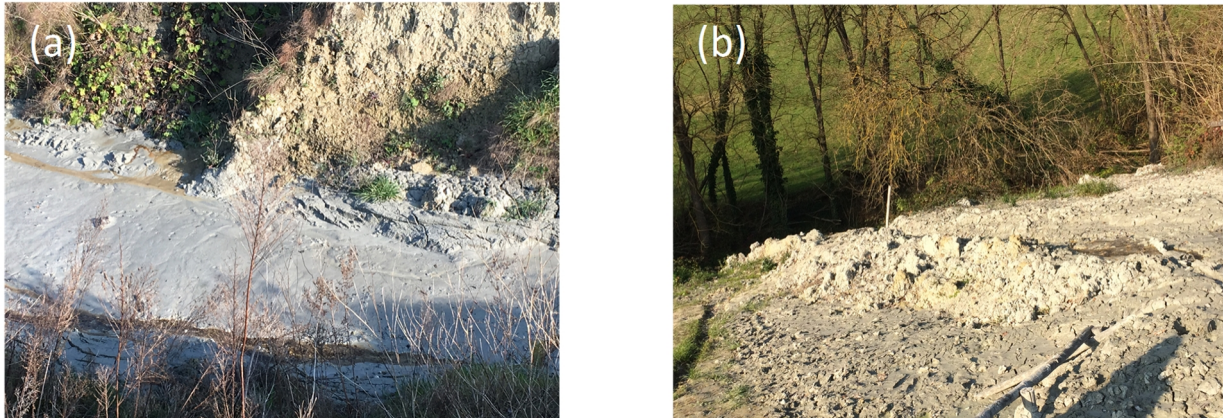
In an area near the village of Monteleone di Fermo, mud volcanoes are a regularly occurring phenomenon, in fact comprising a tourist attraction. Following the 30 October seismic sequence, observers from INGV (INGV Terremoti blog, available at: <https://ingvterremoti.wordpress.com/2016/11/11/sequenza-sismica-in-italia-centrale-i-vulcanelli-di-fango-in-provincia-di-fermo/>, last accessed 8 January 2017) found an accelerated rate of water extrusion that continued for several days from four pre-existing mud volcanoes.

The materials extruded appeared to be fine-grained (even clayey) in composition. At a nearby location (Santa Vittoria in Matenano), two new mud volcanoes formed after the 30 October event. These too continued to flow for several days following the event. Figure 8 shows photographs of mud volcanoes from pre-existing features in Monteleone di Fermo.

Figure 8. mud volcanoes in Monteleone di Fermo: (a) along the Ete river (Porto San Giorgio), and (b) in the area of Valle Corvone.

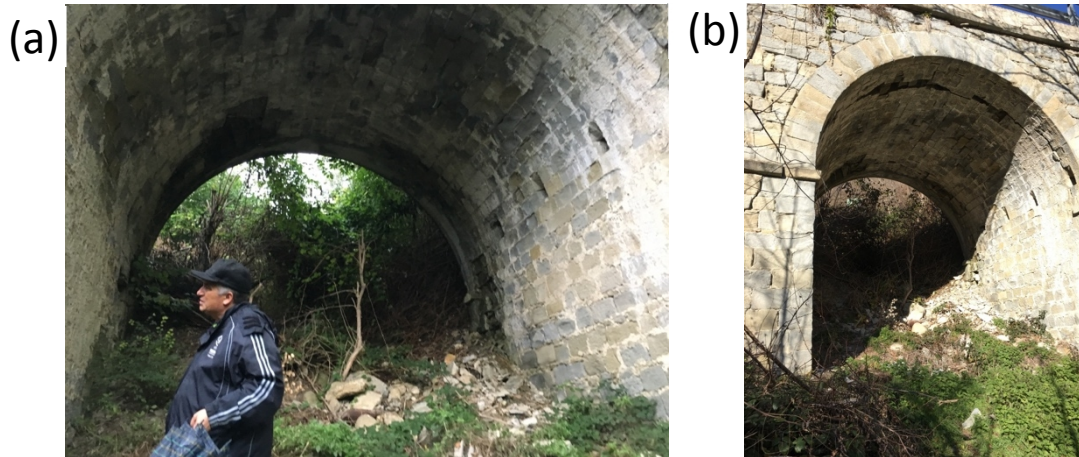
Figure 9 shows two comparative pictures (taken after the 24 August and the October events) of the 1-span masonry bridge along the Trisungo route (along the SP129). The bridge now presents additional cracks in the internal part of the arch (Figure 9b), but there was no additional spalling of masonry elements, as had occurred in the 24 August event. Figure 10 shows the response of the second arch along the Trisungo route (3 spans bridge) after the different events (24 August and October 2016). In this case the cumulative damage was significant: part of central arch, already damaged after the first event, collapsed after the October earthquakes (Figure 10b and 10d). The Ponte a Tre Occhi (Three eyes) near Amatrice (Figure 11) also experienced additional damage, consisting mainly of spalling of outer-layer masonry elements located along abutment areas (not involving the three arches) (Figure 11b).

Figure 9. Roman-era bridge along the Trisungo route (1 span bridge - Tufo area – Arquata del Tronto): (a) after the 24 August event (photo on September 7 2016) and (b) after the October events (photo on December 13 2016) (N42.735981, E13.254862).

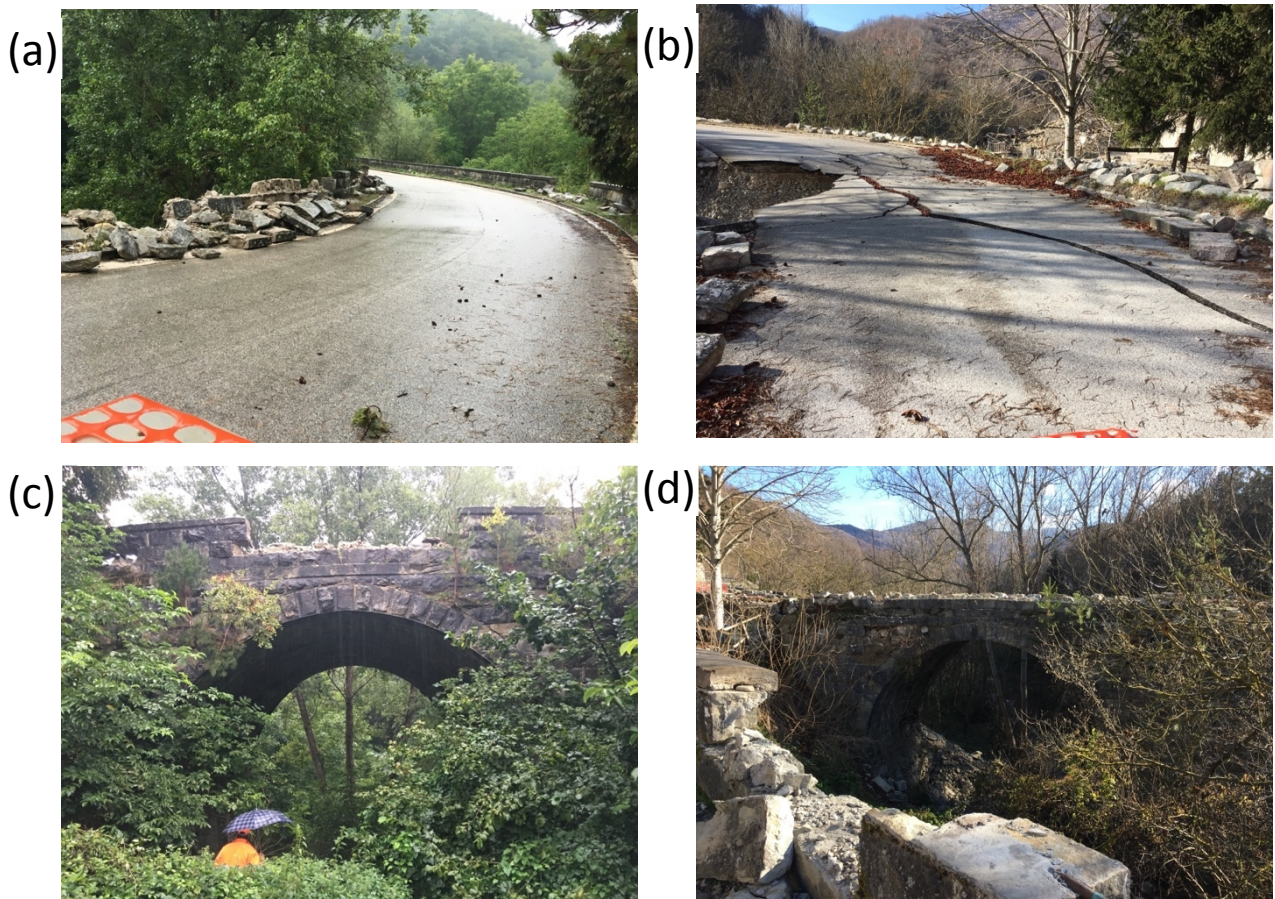
Figure 10. Roman-era bridge along the Trisungo route (3 spans bridge - Tufo area – Arquata del Tronto): (a, c) after the 24 August event (photo on September 7 2016) and (b, d) after the October events (photo on December 13 2016) (N42.73538, E13.253655).

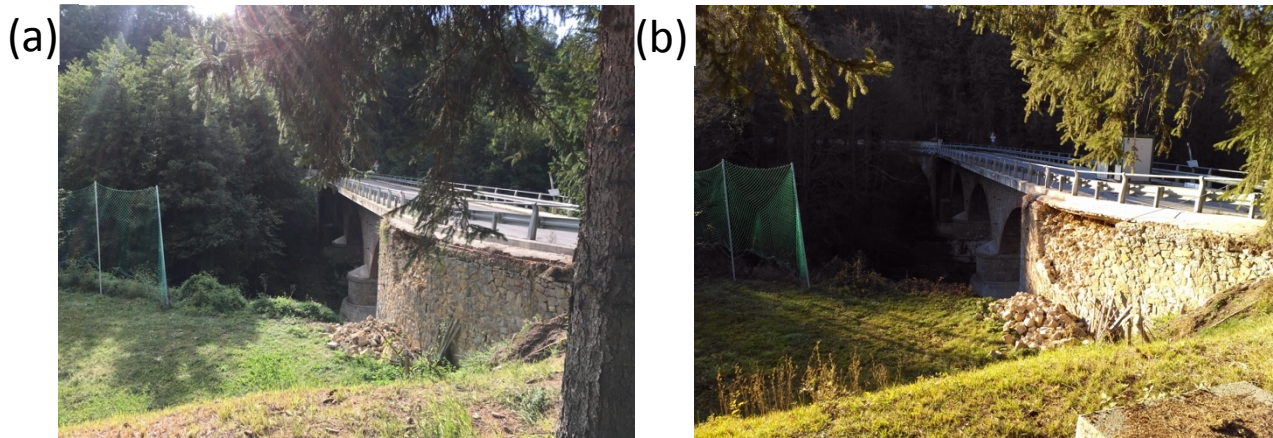
Figure 11. Ponte a Tre Occhi – Amatrice: (a) after the 24 August event (photo on September 7 2016) and (b) after the October events (photo on December 13 2016) (N42.620668, E13.290176).

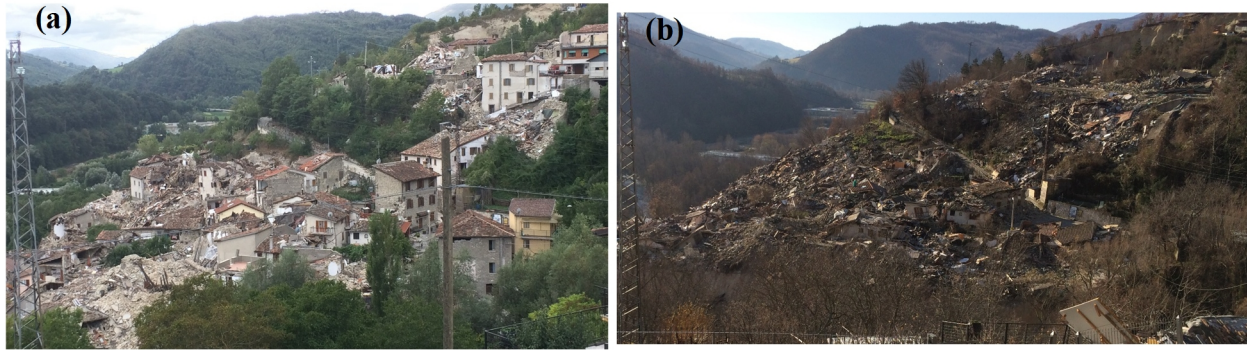
As shown in Table 3, most villages experienced increase damage, in many cases dramatically so such that the average damage level became D5. Particularly dramatic is the situation in Pescara del Tronto, Arquata del Tronto, Accumoli, Amatrice, and Tufo. Figures 12, 13, and 14 show pictures taken from a common perspective following the 24 August and October events of Pescara del Tronto, Tufo, and Accumoli, respectively. The incremental damage is substantial.

Figure 12. Incremental damage in Pescara del Tronto after the October earthquake events. (a) Overview of Pescara del Tronto on 9 September 2016, (b) Overview of Pescara del Tronto on 12 December 2016.

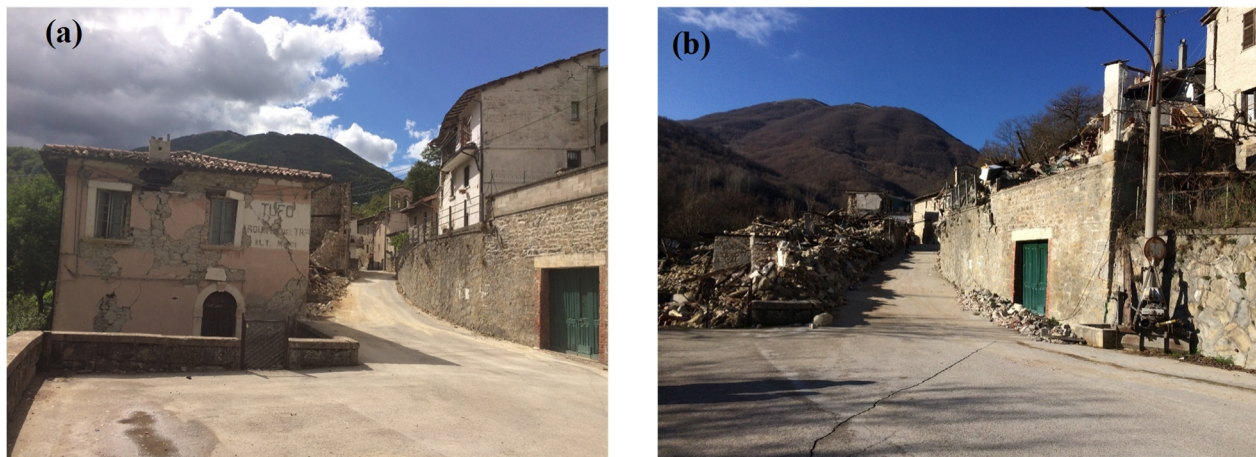
Figure 13. Incremental damage in Tufo after the October earthquake events. (a) Overview of Tufo on 9 September 2016, (b) Overview of Tufo on 12 December 2016.

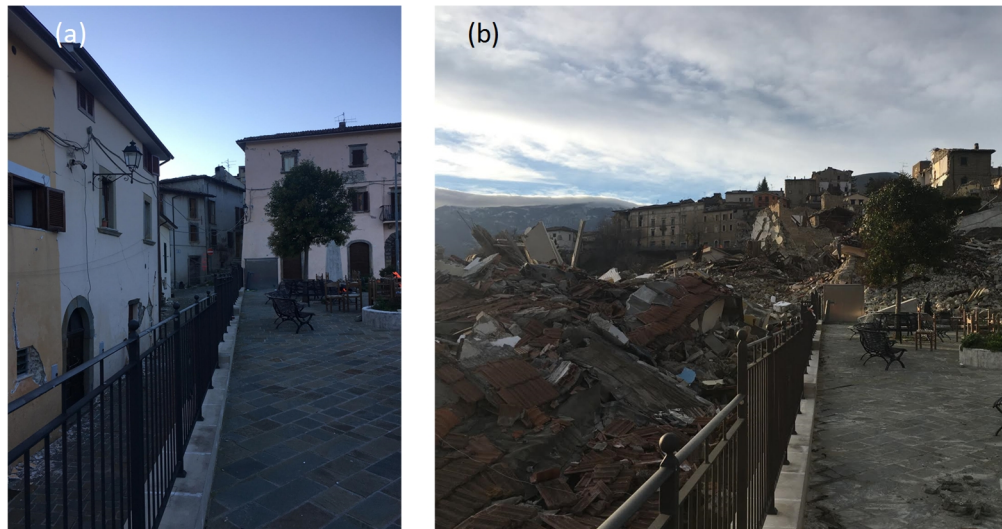
Figure 14. Incremental damage in Accumoli after the October earthquake events. (a) Overview of Accumoli, September 2016, (b) Overview of Accumoli December 2016.

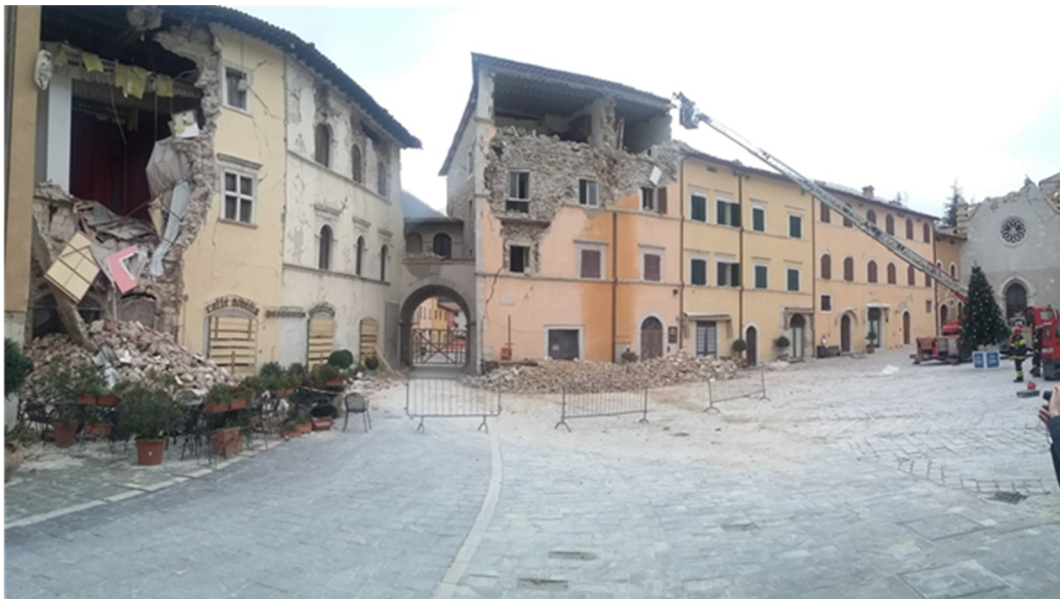
Visso and Ussita are the most proximate villages to epicenter of the 26 October event. In both villages, the majority of the structures are 2-3 story masonry buildings. The average damage level observed in both villages is D4-D5. Figure 15 shows damages in Piazza Martiri Vissani, located in the centre of Visso. Figure 16 shows the damage pattern and a damage zonation for Ussita. In both villages, historical buildings and monuments suffered heavy damage. Particularly in Ussita there are variations of structure ages and types; findings regarding relative performance by building type have not yet been developed.

Figure 15. Damages observed in Piazza Martiri Vissani (Visso).

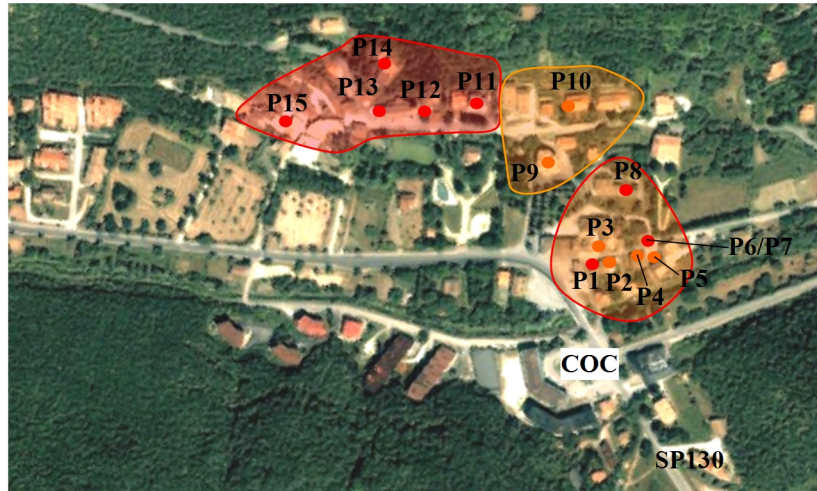
D3/4: Heterogeneous area, which seems to be always characterized by high damages to non structural elements, often by damages to load bearing elements and in some cases, by local collapse.
	D3: Overall, major damage to non structural elements and limited to significant damage to load bearing elements can be identified.
	D4: Strip characterized by structures interested by huge damage to load bearing elements and local collapse.

Figure 16. Locations of representative structures inspected in Ussita, and damage zonation within the village.
