# Reflective Cracking Study: First-Level Report on HVS Testing on Section 590RF — 90 mm MB4-G Overlay

**Authors:**  
D. Jones, B Tsai and J. Harvey

Partnered Pavement Research Program (PPRC) Contract Strategic Plan Element 4.10:  
Development of Improved Rehabilitation Designs for Reflective Cracking

University of California  
Pavement Research Center  
UC Davis, UC Berkeley

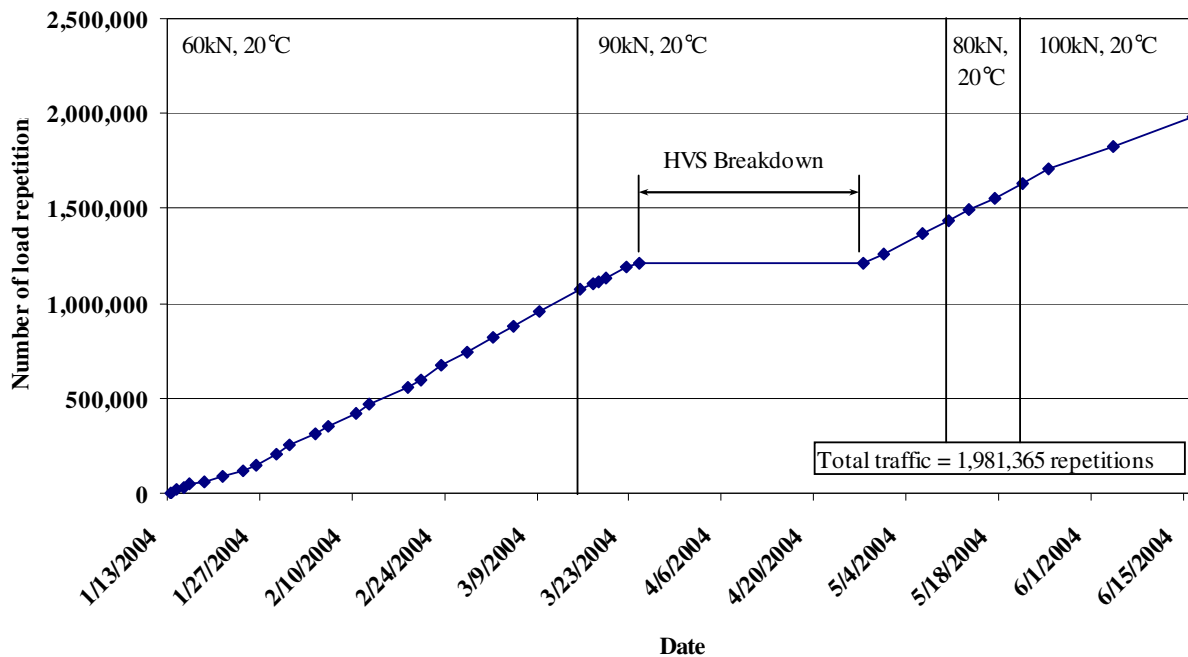
**Figure 2.6: Cumulative traffic applications and loading history.**

- 1,071,004 repetitions of a 60 kN (13,500 lb) load,
- 368,894 repetitions of a 90 kN (20,250 lb) load,
- 189,160 repetitions of an 80 kN (18,000 lb) load, and
- 352,307 repetitions of a 100 kN (22,500 lb) load.

This loading equates to approximately 37 million equivalent standard axles (ESALs), using the Caltrans conversion of  $(\text{axle load}/18000)^{4.2}$ , which in turn equates to a Traffic Index of 14.

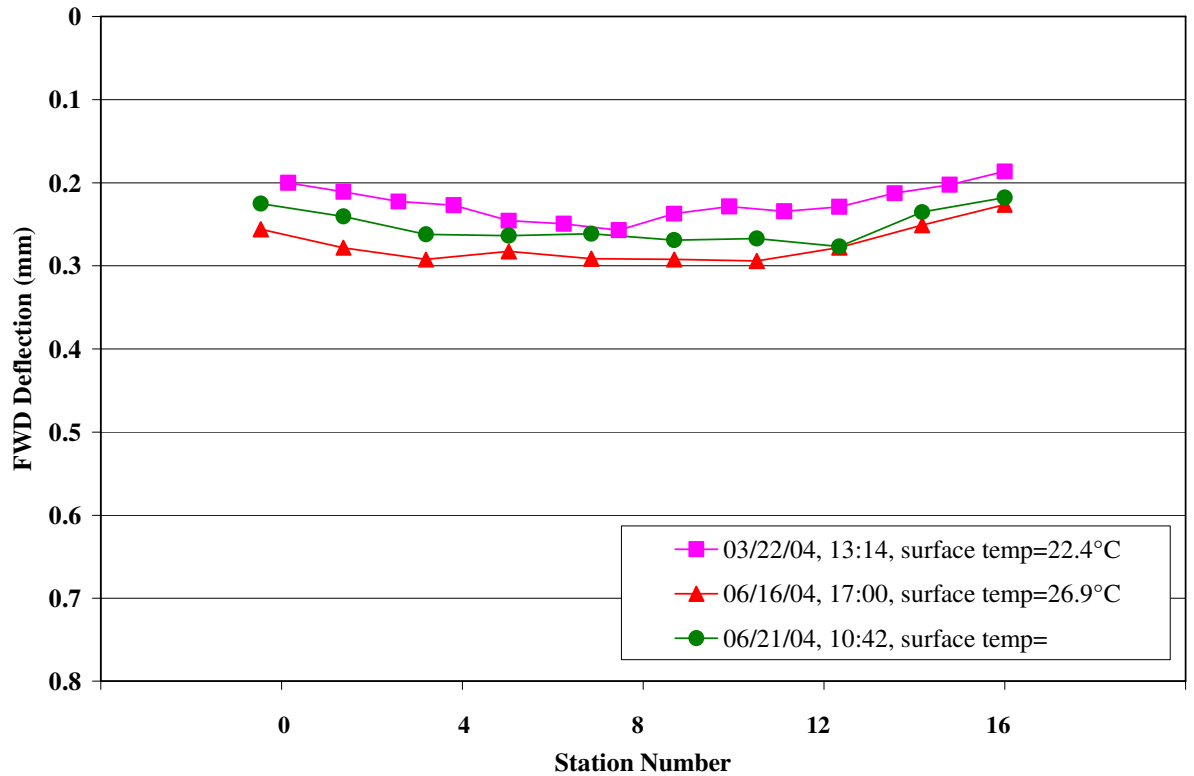
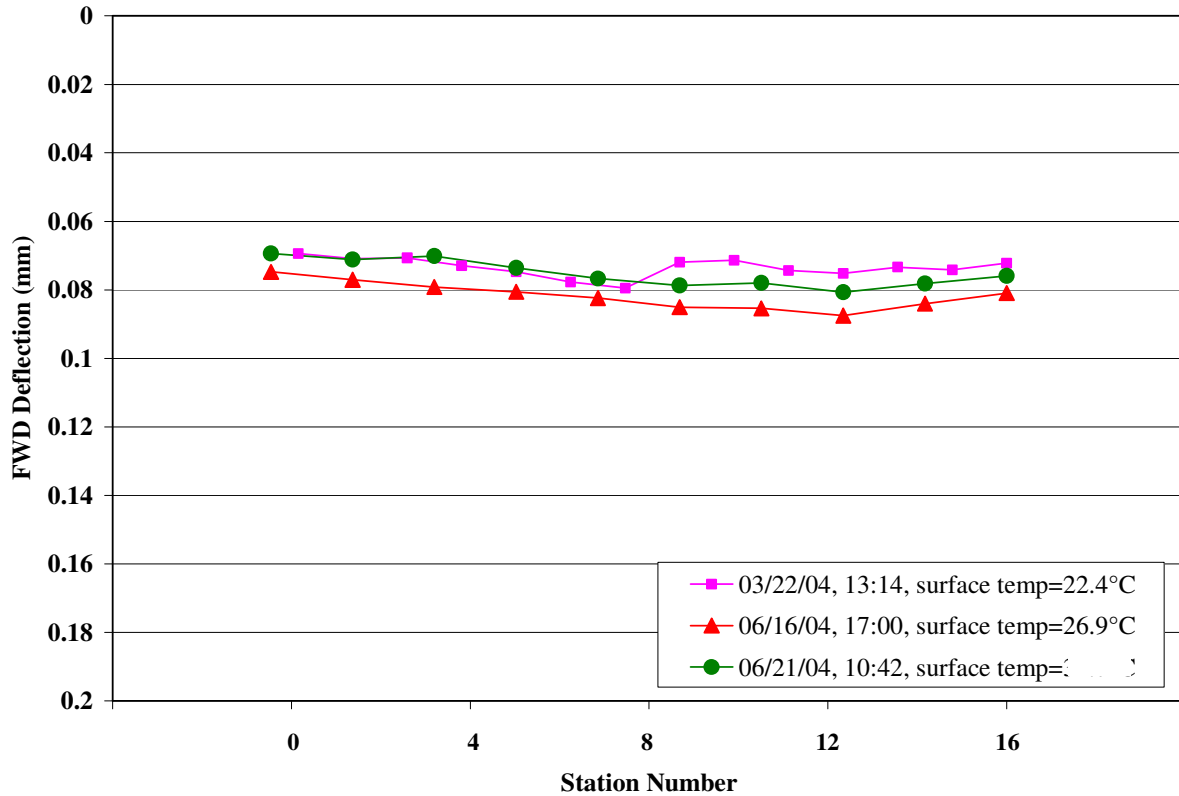
**Figure 3.15: Composite pavement stiffness (FWD Sensor 1) outside trafficked area.**

Figure 3.16: Subgrade pavement stiffness (FWD Sensor 6) outside trafficked area.

Figures 3.15 and 3.16 show FWD deflections taken along the side of the HVS test section but outside the trafficked area (i.e., the area tested did not have traffic damage). The figures can be used to understand the influence of environmental conditions on the performance of the section. The figures show very little change over the course of the experiment, but do show some influence of temperature. No temperature measurement was recorded on June 21, 2004, but time of measurement indicates that the temperature would have been lower than that recorded on June 16, 2004.

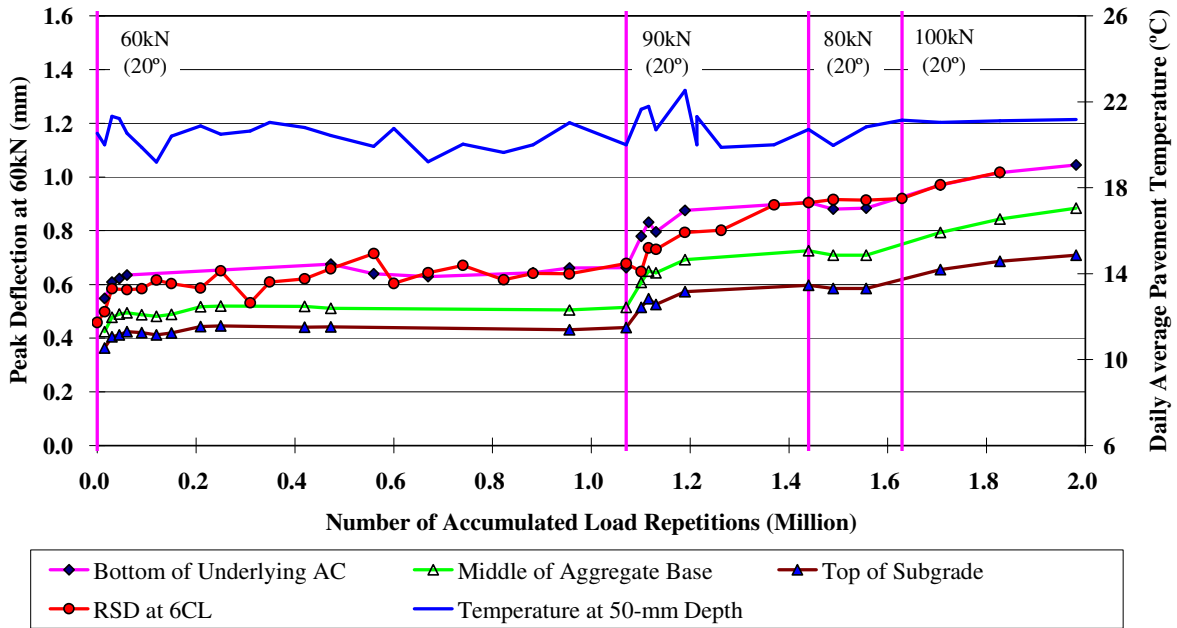
**Figure 3.17: Elastic deflections at MDD6 with 60 kN test load.**

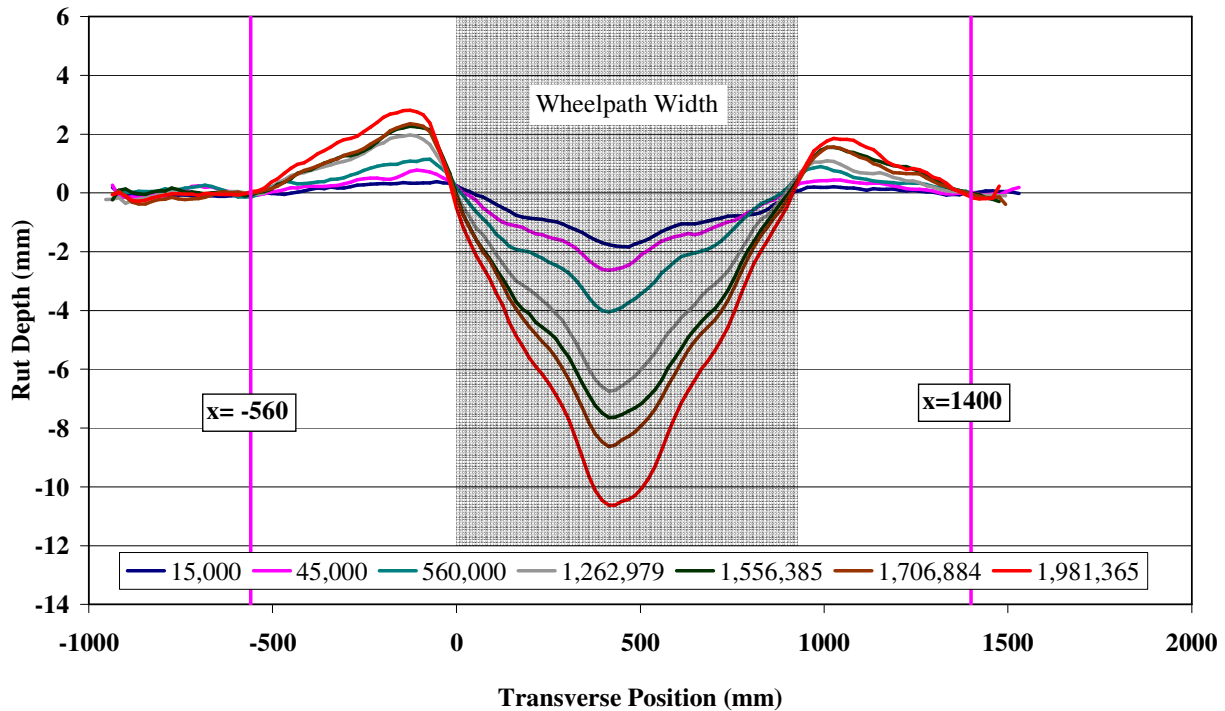
**Figure 3.20: Laser Profilometer cross section at various stages of trafficking.**

Figure 3.20 shows the average transverse cross section measured with the Profilometer at various stages of the test. This plot clearly shows the increase in rutting and deformation over the duration of the test.

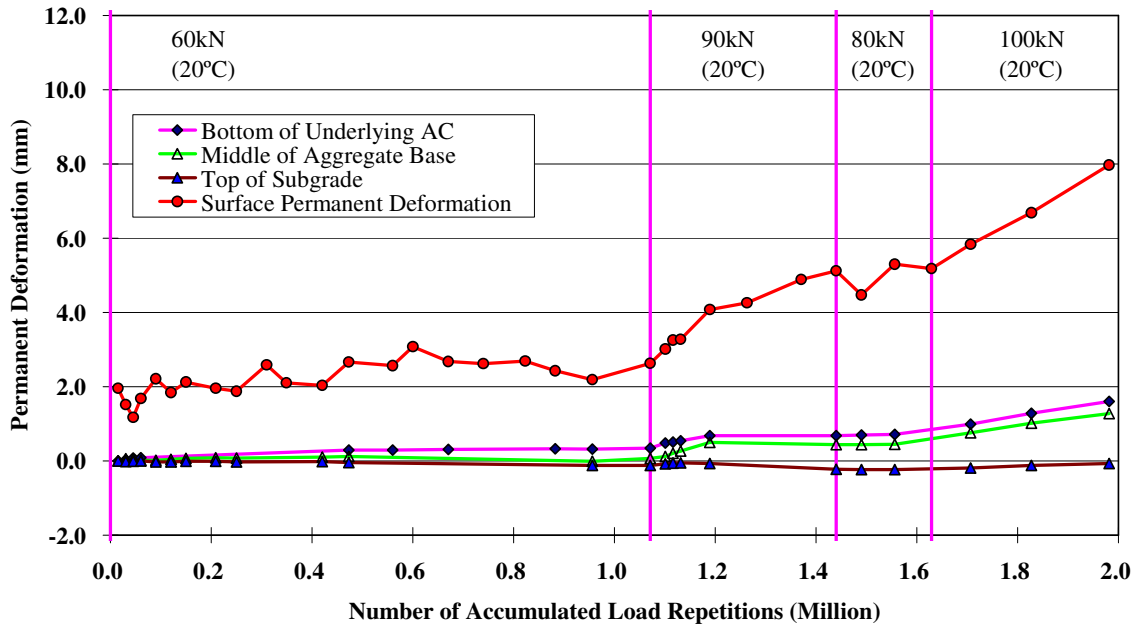
Figure 3.30: In-depth permanent deformation at MDD6.

**Figure 3.32: In-depth permanent deformation at MDD10.**

Permanent deformation at the upper MDD module (158 mm) accumulated at similar rates for both MDDs up until the 90 kN load change. At this change, permanent deformation at this module in MDD10 was approximately 1.1 mm higher than that recorded at MDD6. The rate of increase continued through the 90 kN loading phase. The permanent deformation in the upper portion of the pavement at MDD10 on completion of testing was about 1.5 mm higher than that at MDD6. This was attributed to the cracked DGAC layer. The permanent deformation recorded at the 363 mm and 588 mm modules for both MDDs are very similar. At the 363 mm modules, permanent deformation did not increase significantly during the 60 kN loading phase, but increased sharply at the 90 kN load change. Thereafter a gradual increase was recorded through the remainder of the 90 kN and through the 80 kN phases. The rate of permanent deformation increased again through the 100 kN loading phase. Very little permanent deformation was recorded at the 588 mm modules.

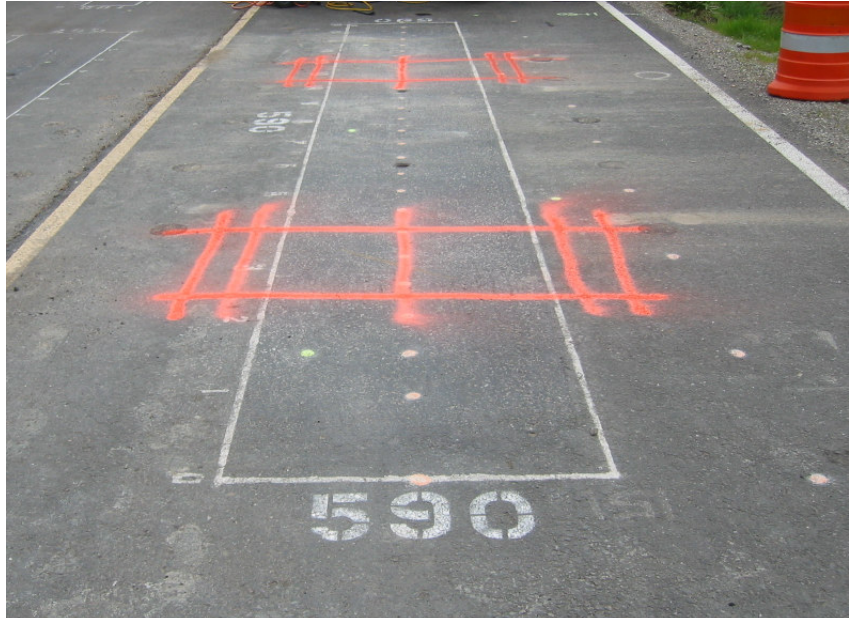
**Figure 3.34: Section surface after completion of trafficking.**
